PSC CASE NUMBER: PU-06-421

DAILY REPORT

Job Site: North Spread

Date: 8-27-09

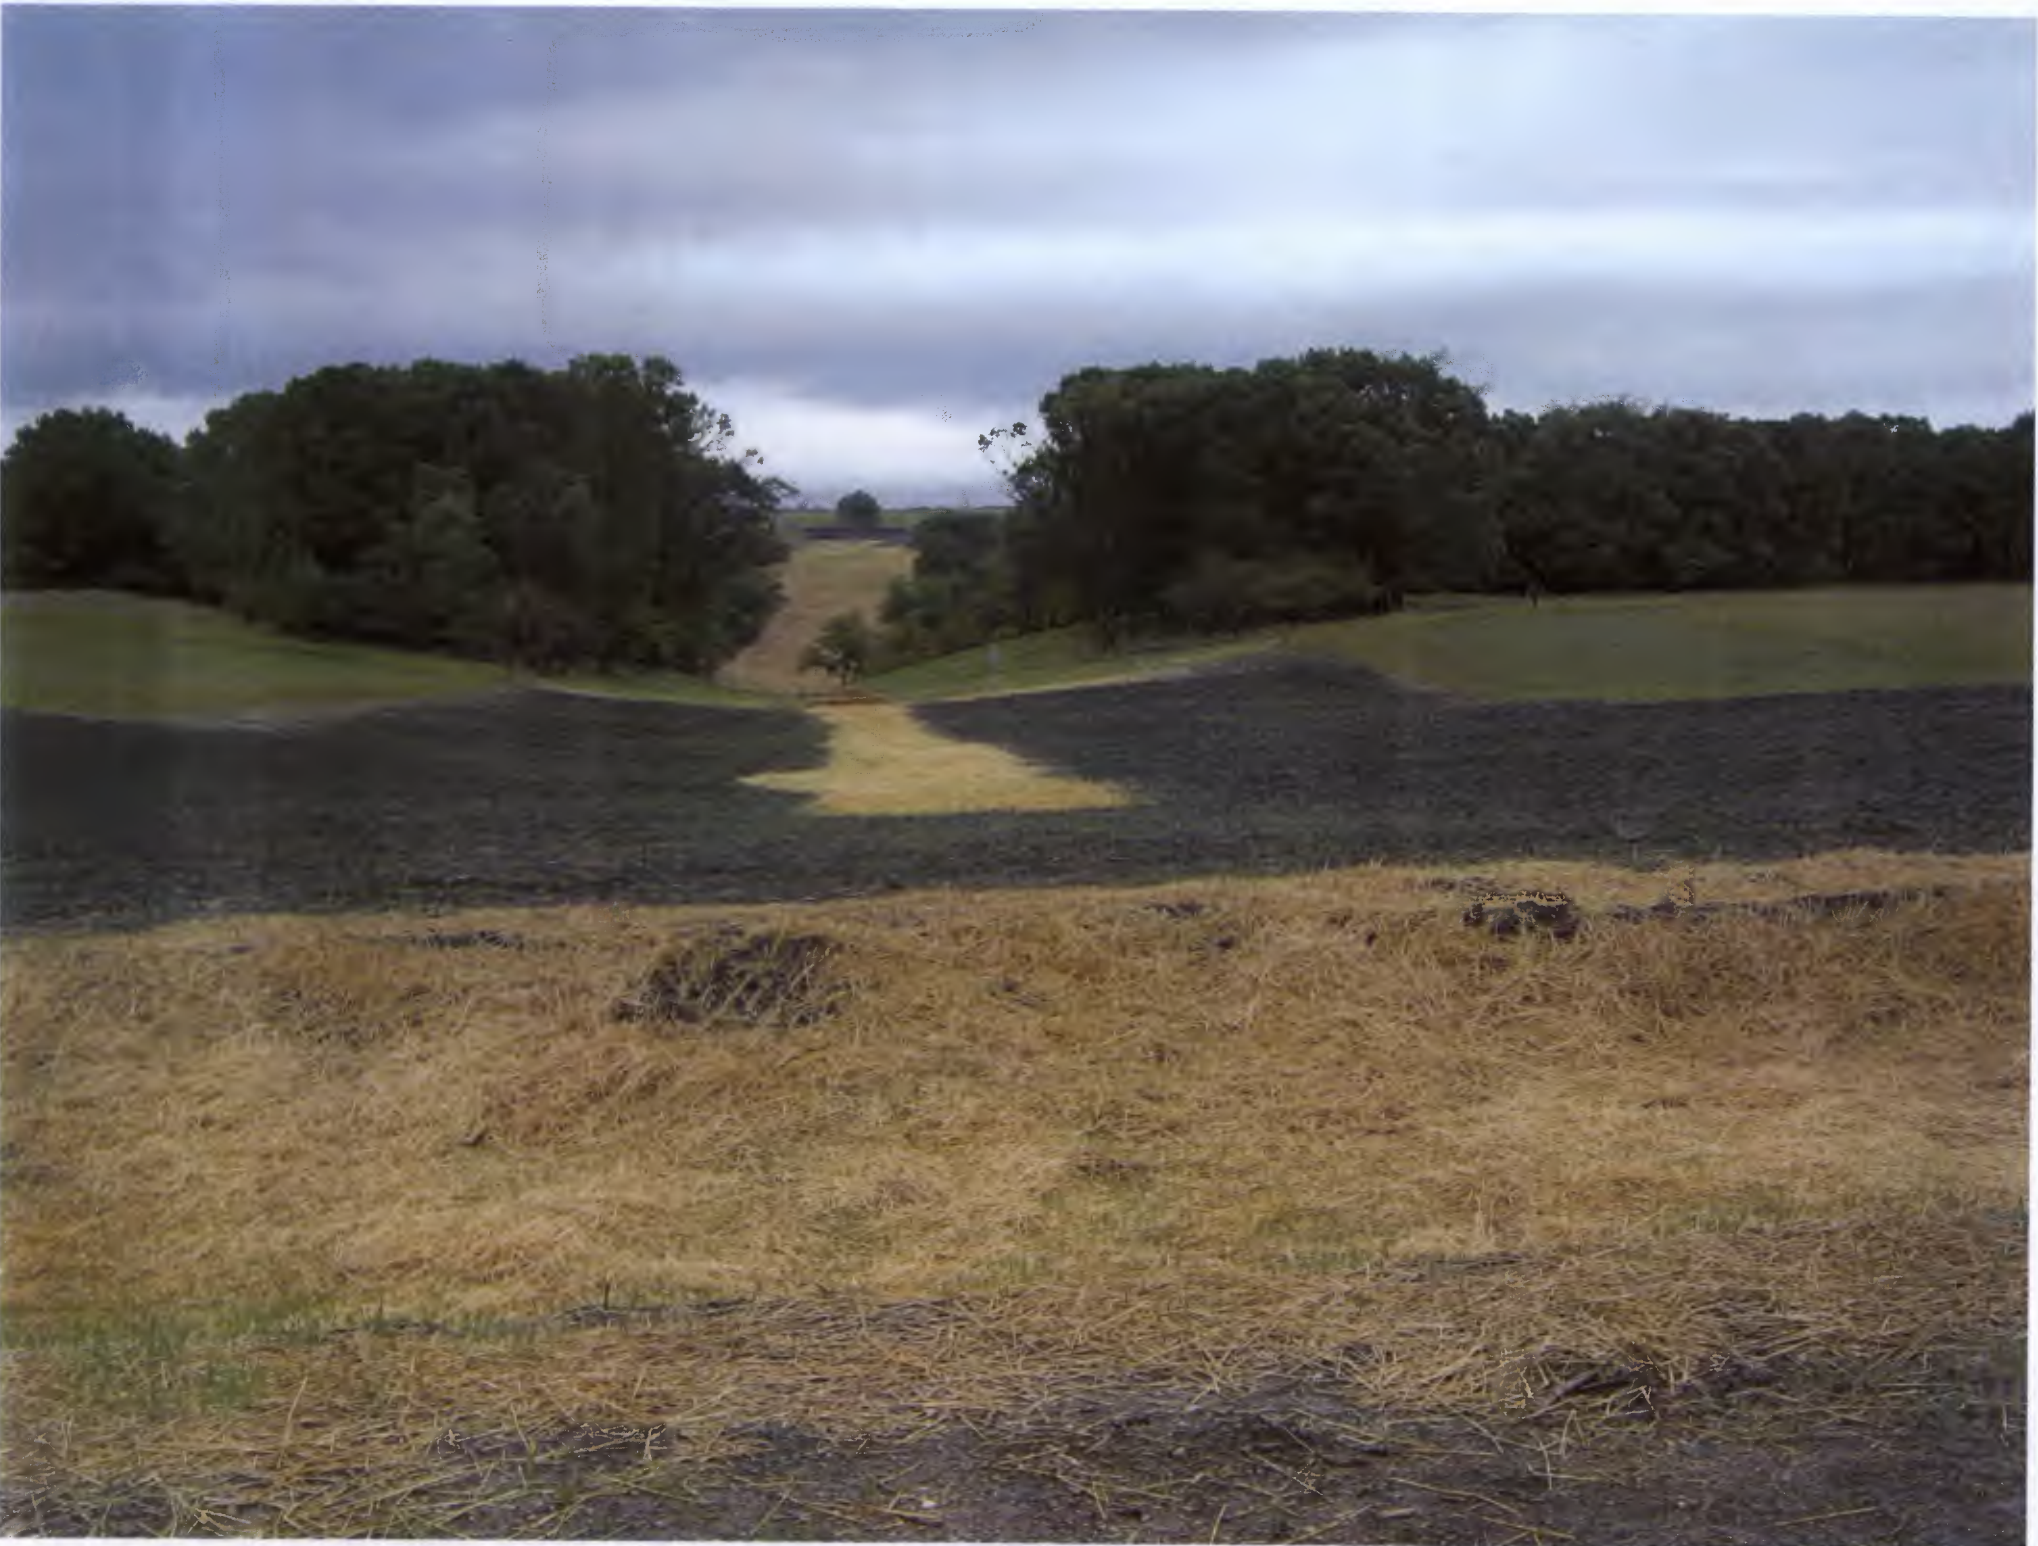
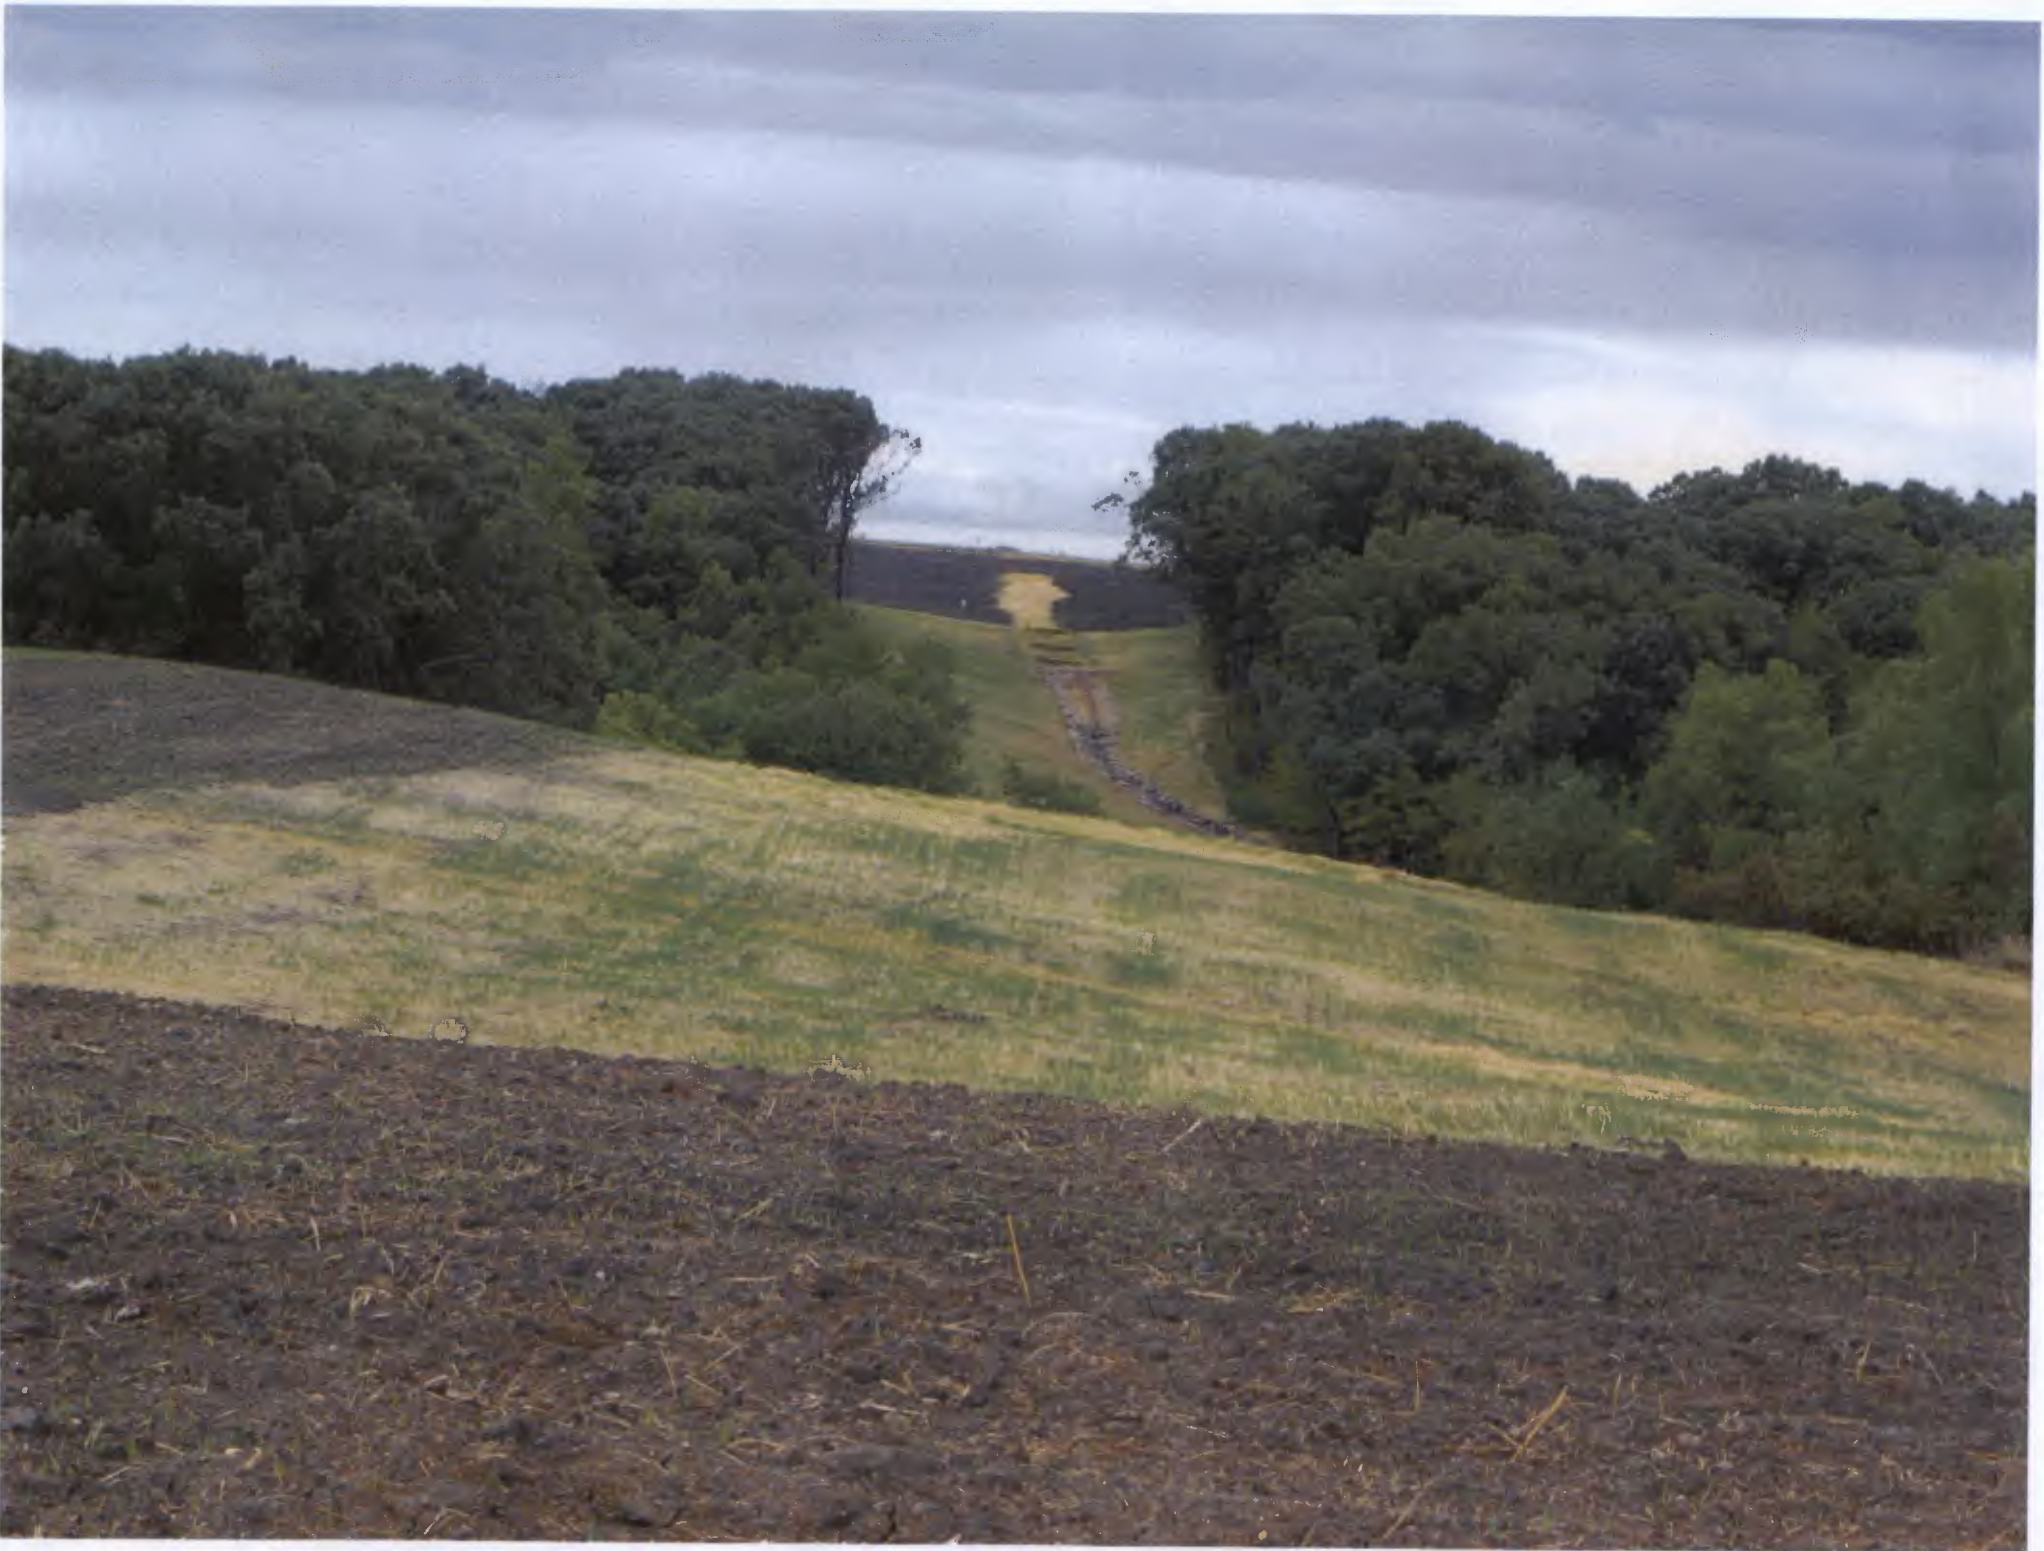
Mi. 54-55 - No activity Reclamation through the Forest
River valley, just East of Matecjek Dam looked very good.

Straw matting & rock was used on south bank to control

soil erosion from field run-off. Grass cover that had been seeded earlier this month was beginning to emerge.
(See pictures 2009 & 2011)
