*Keystone*

**Final Inspection**

*1-5-2011*

PROJECT Keystone Pipeline - North Spread

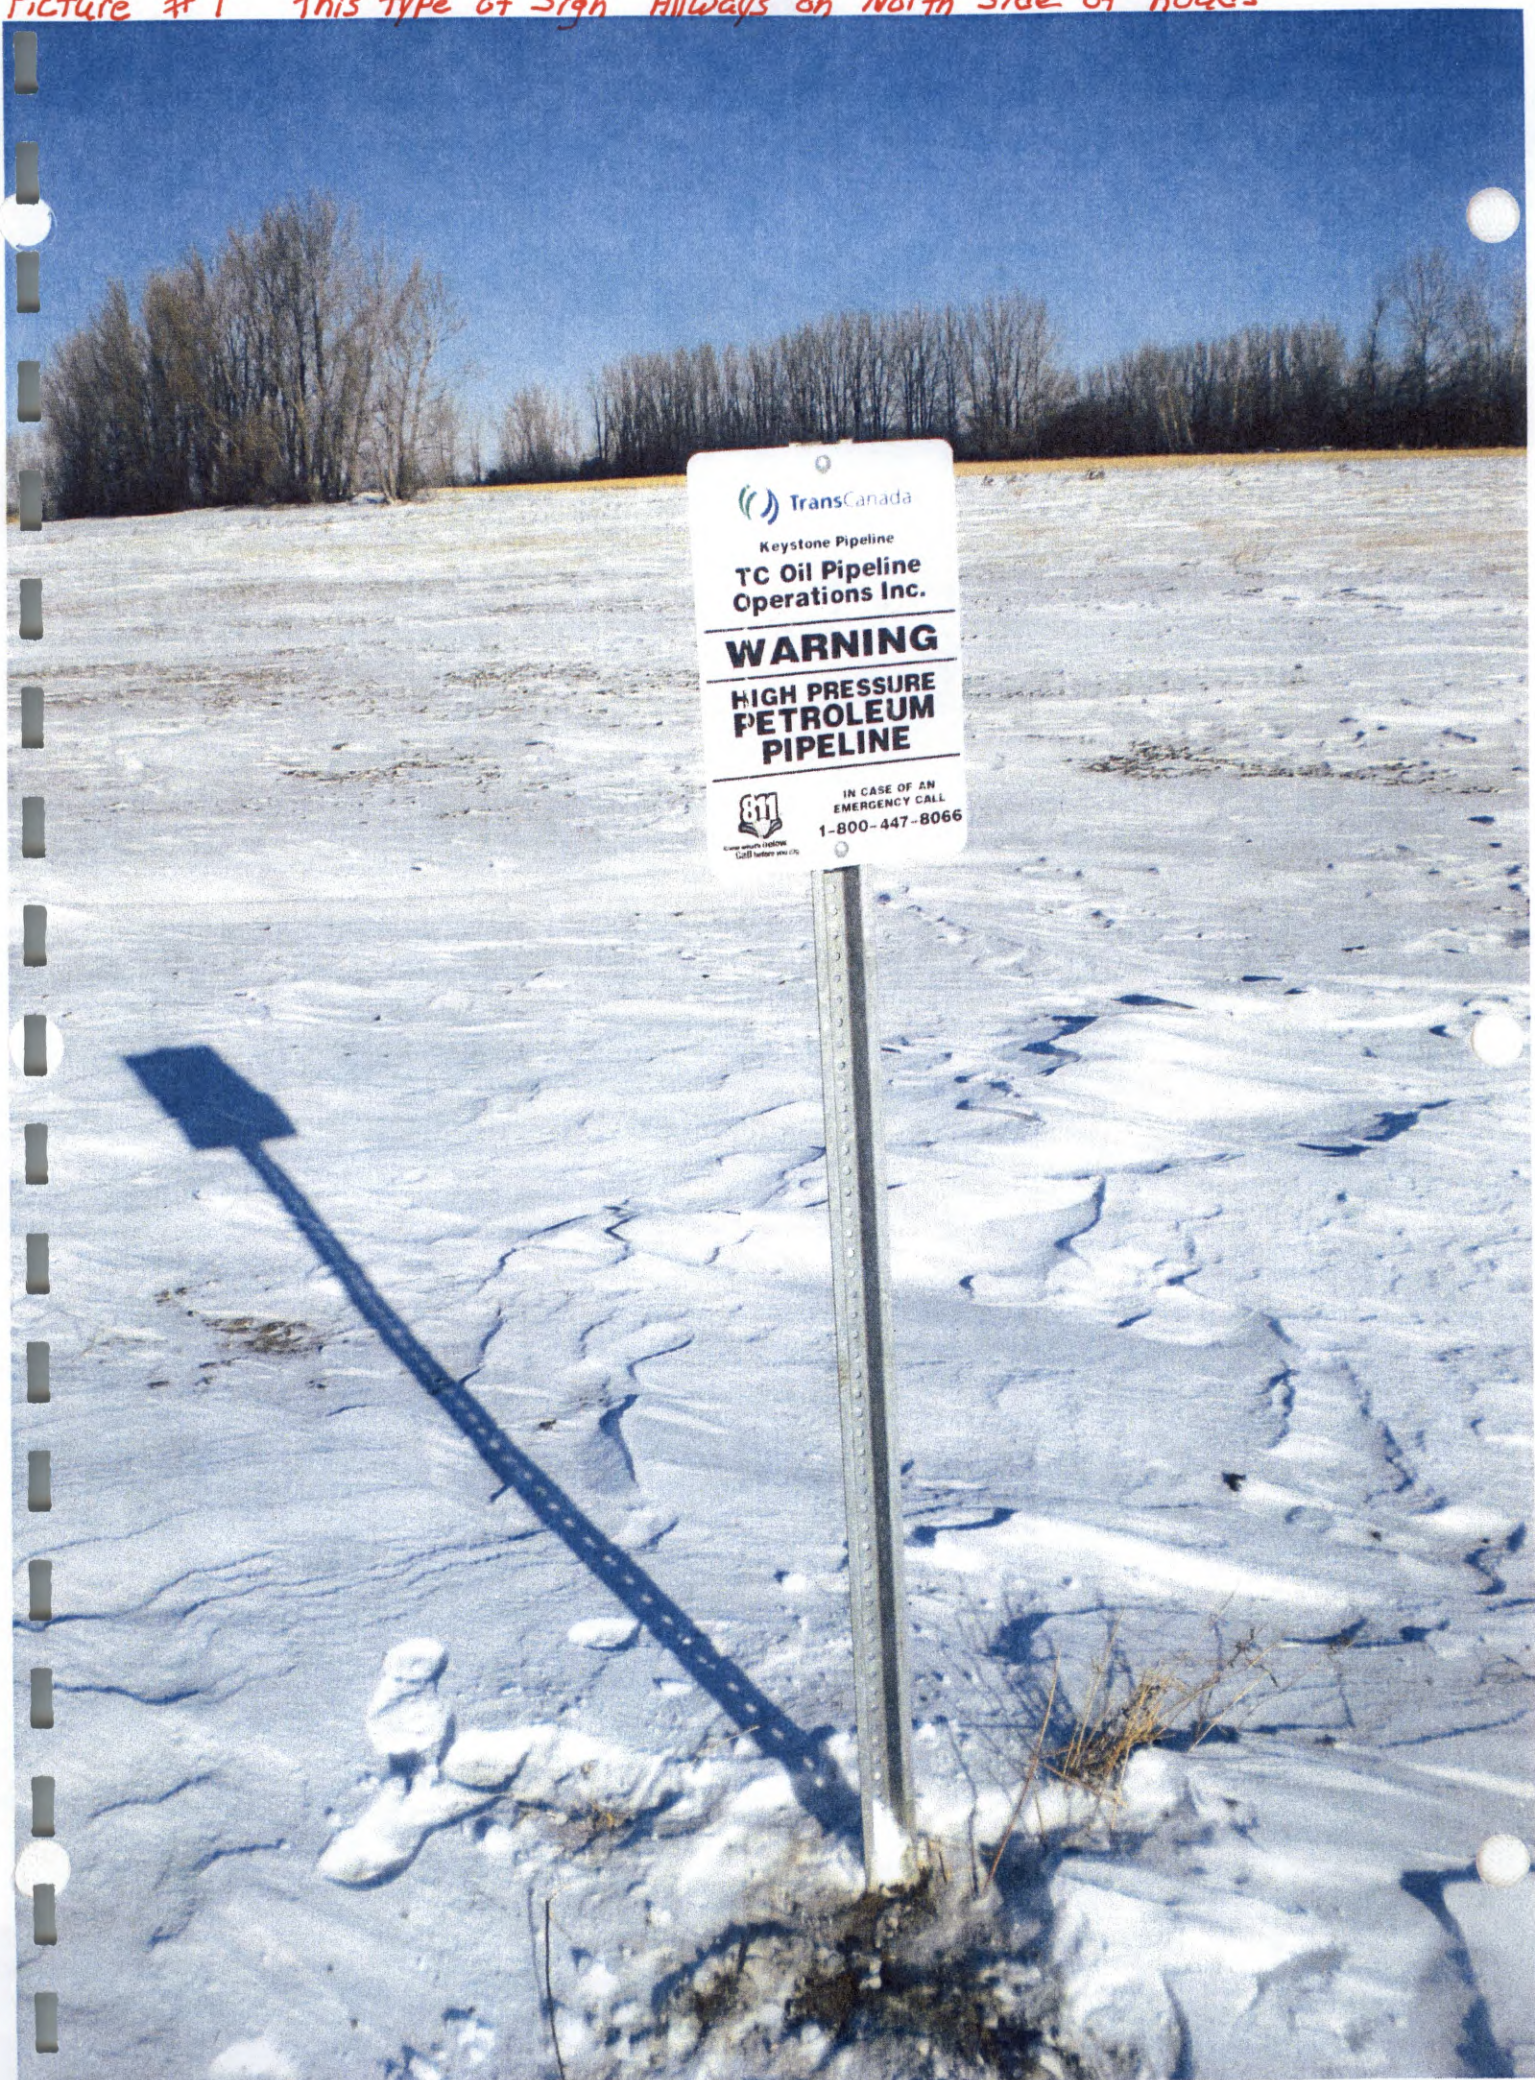
Picture #1 This type of sign Allways on North side of Roads

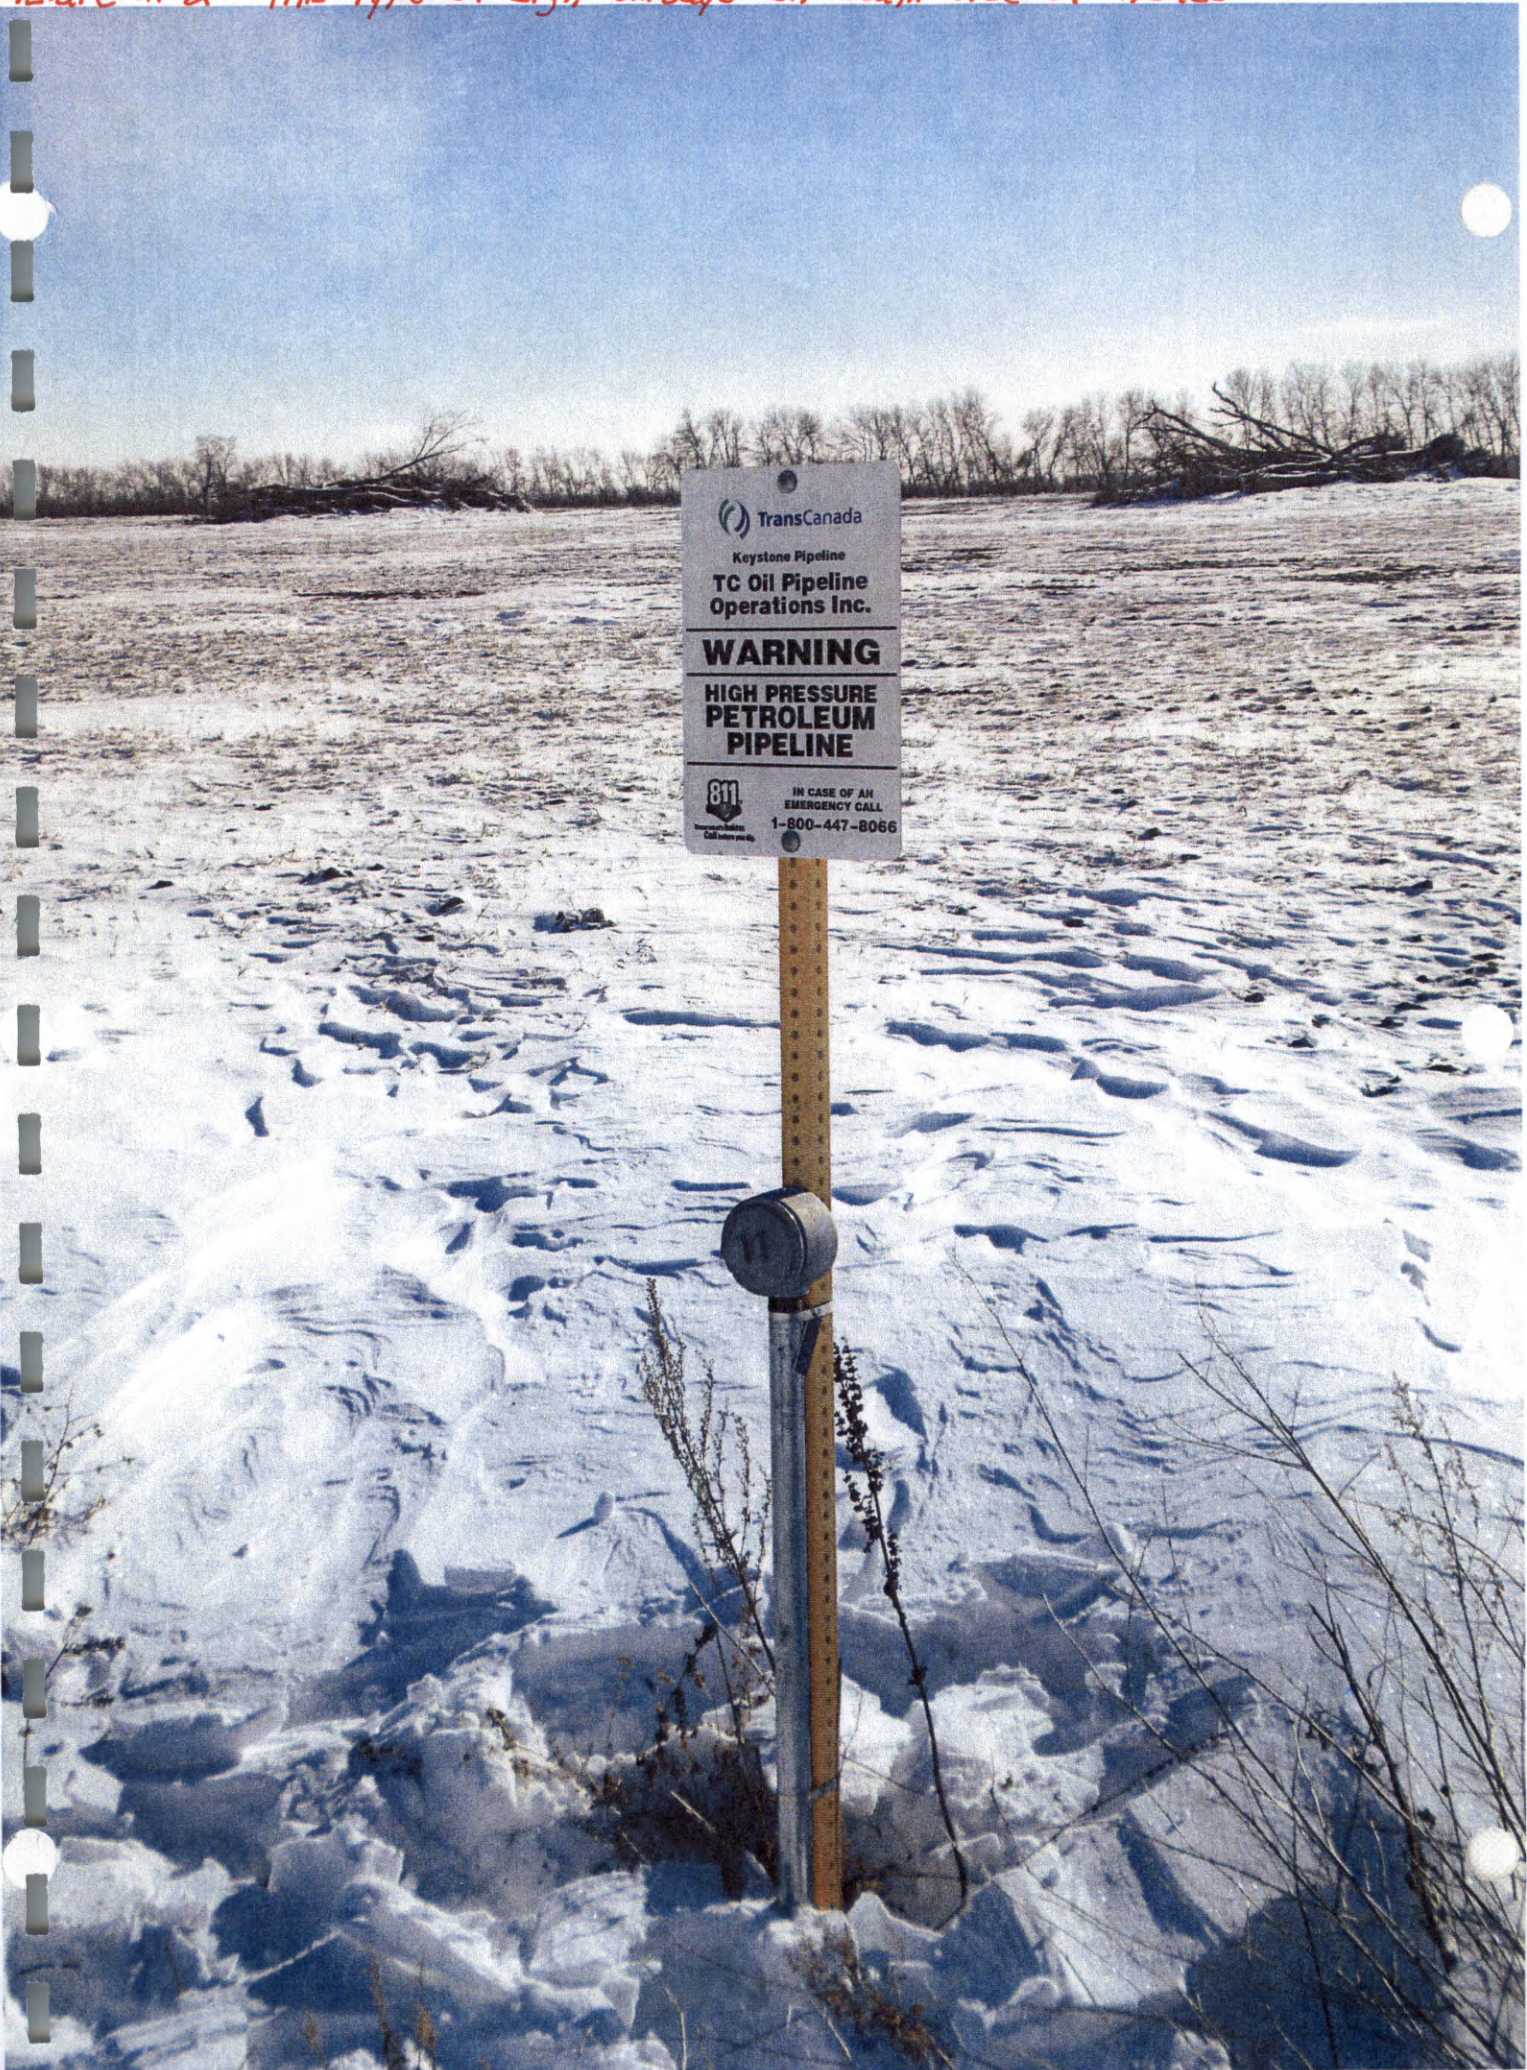
Picture # 1 This type of sign always on South Side of Roads

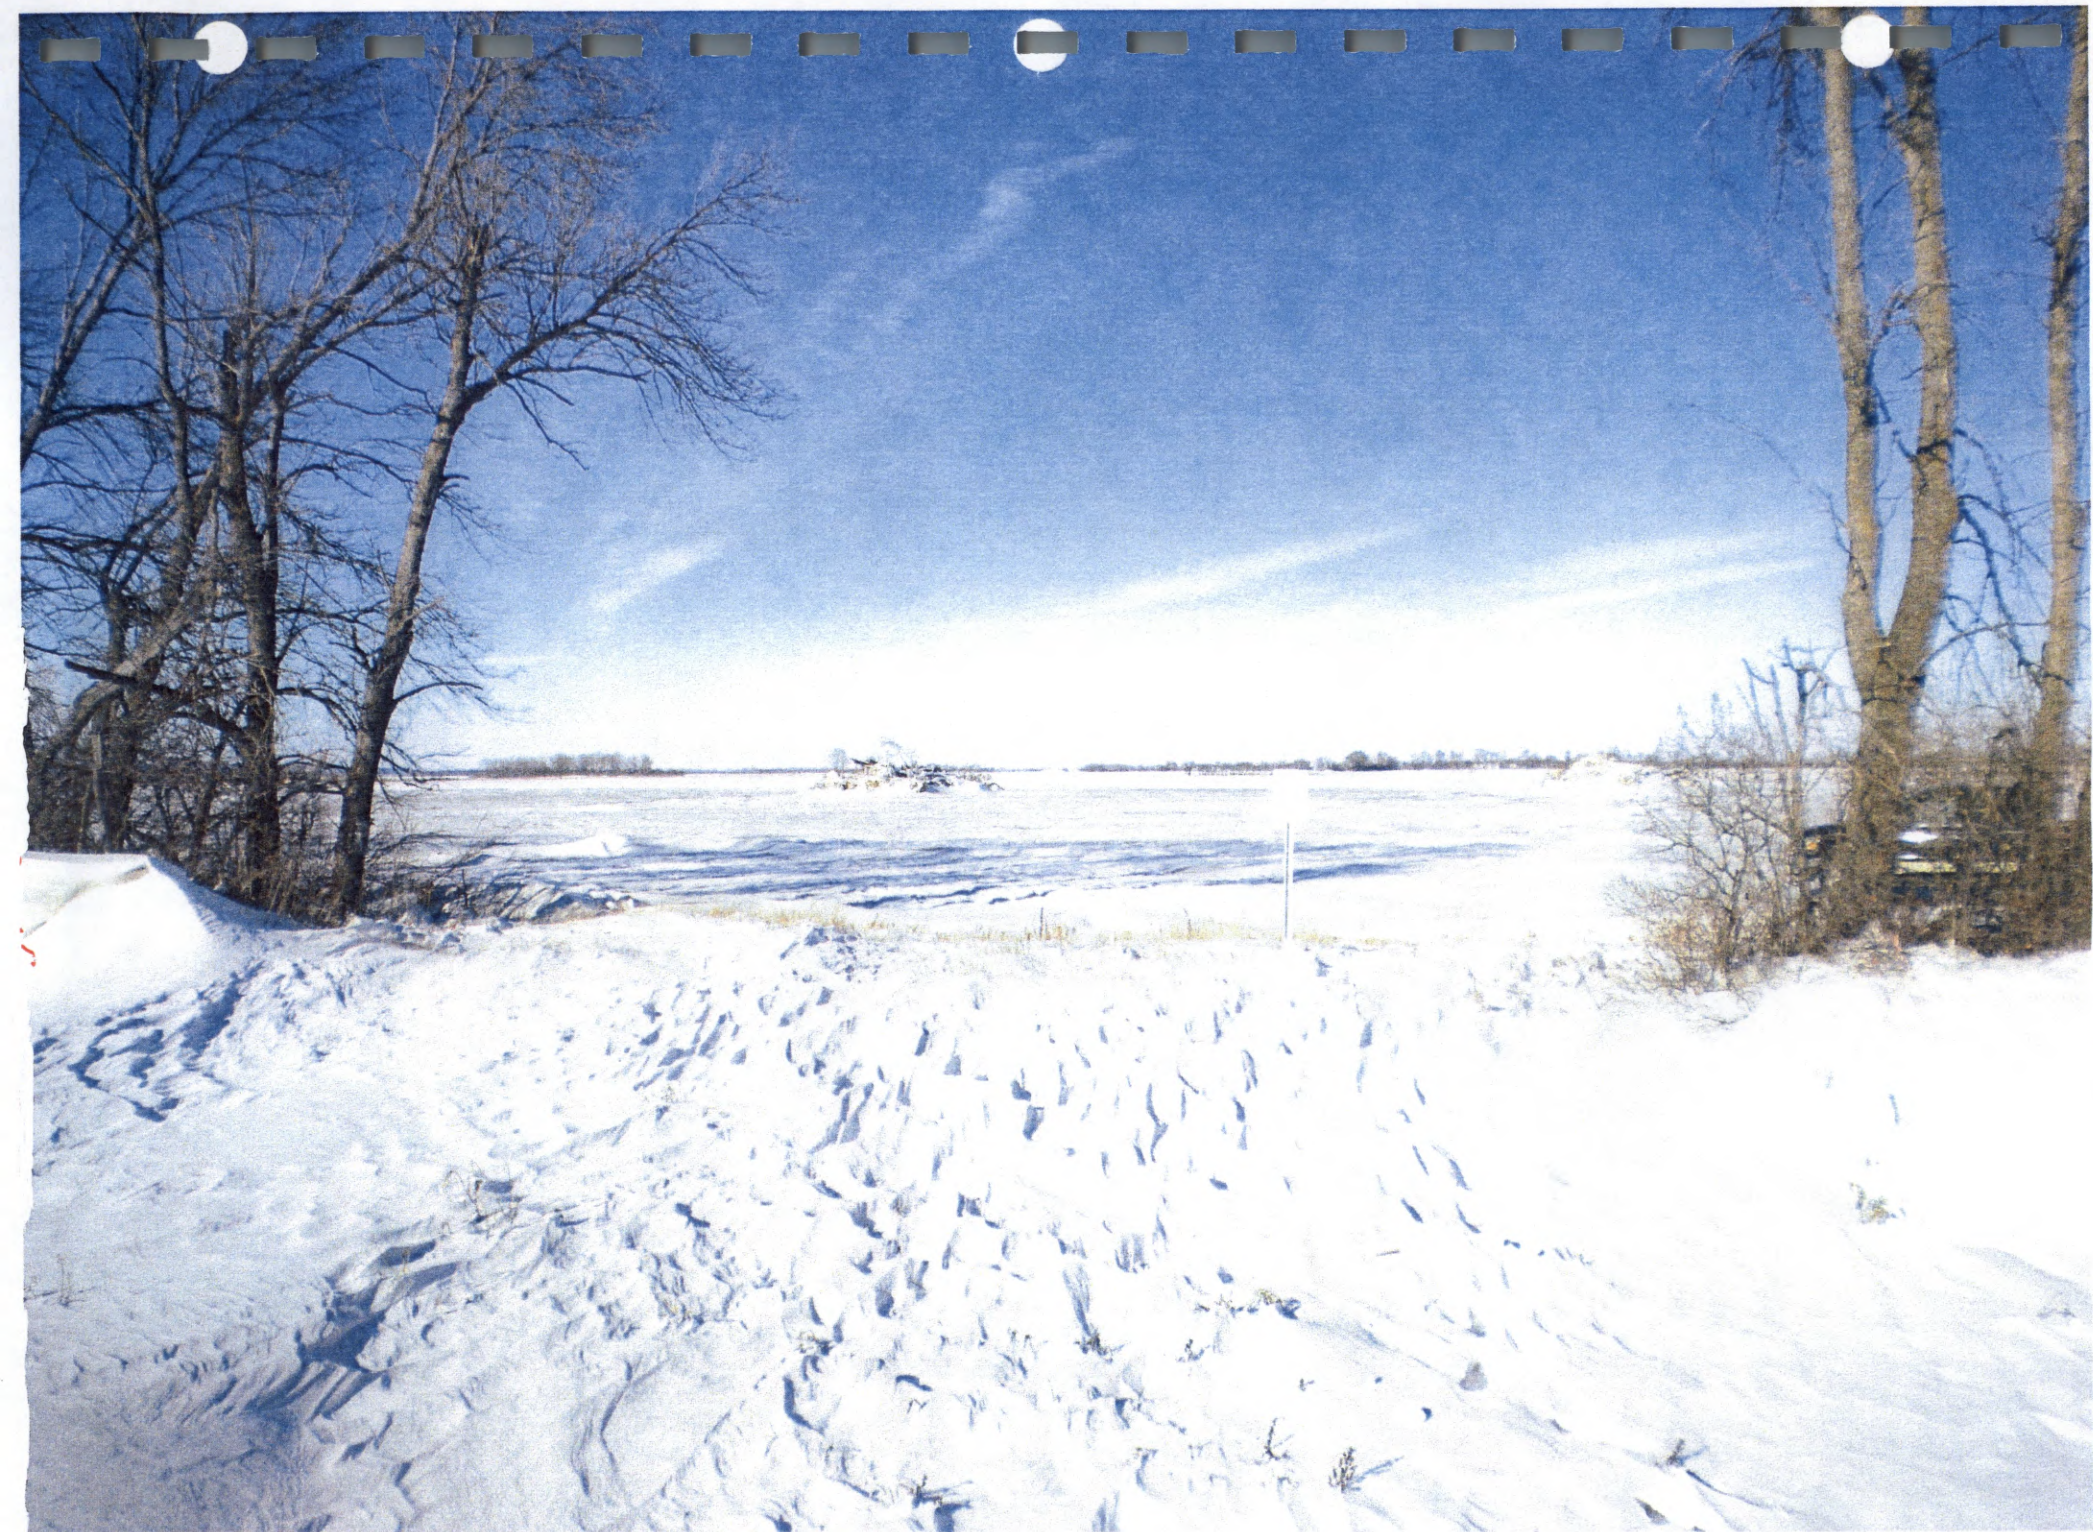
width of clear cut through shelterbelt is 50' with sign showing  $\pm$  of Pipe

Picture #3 clear cut through shelterbelt 50'

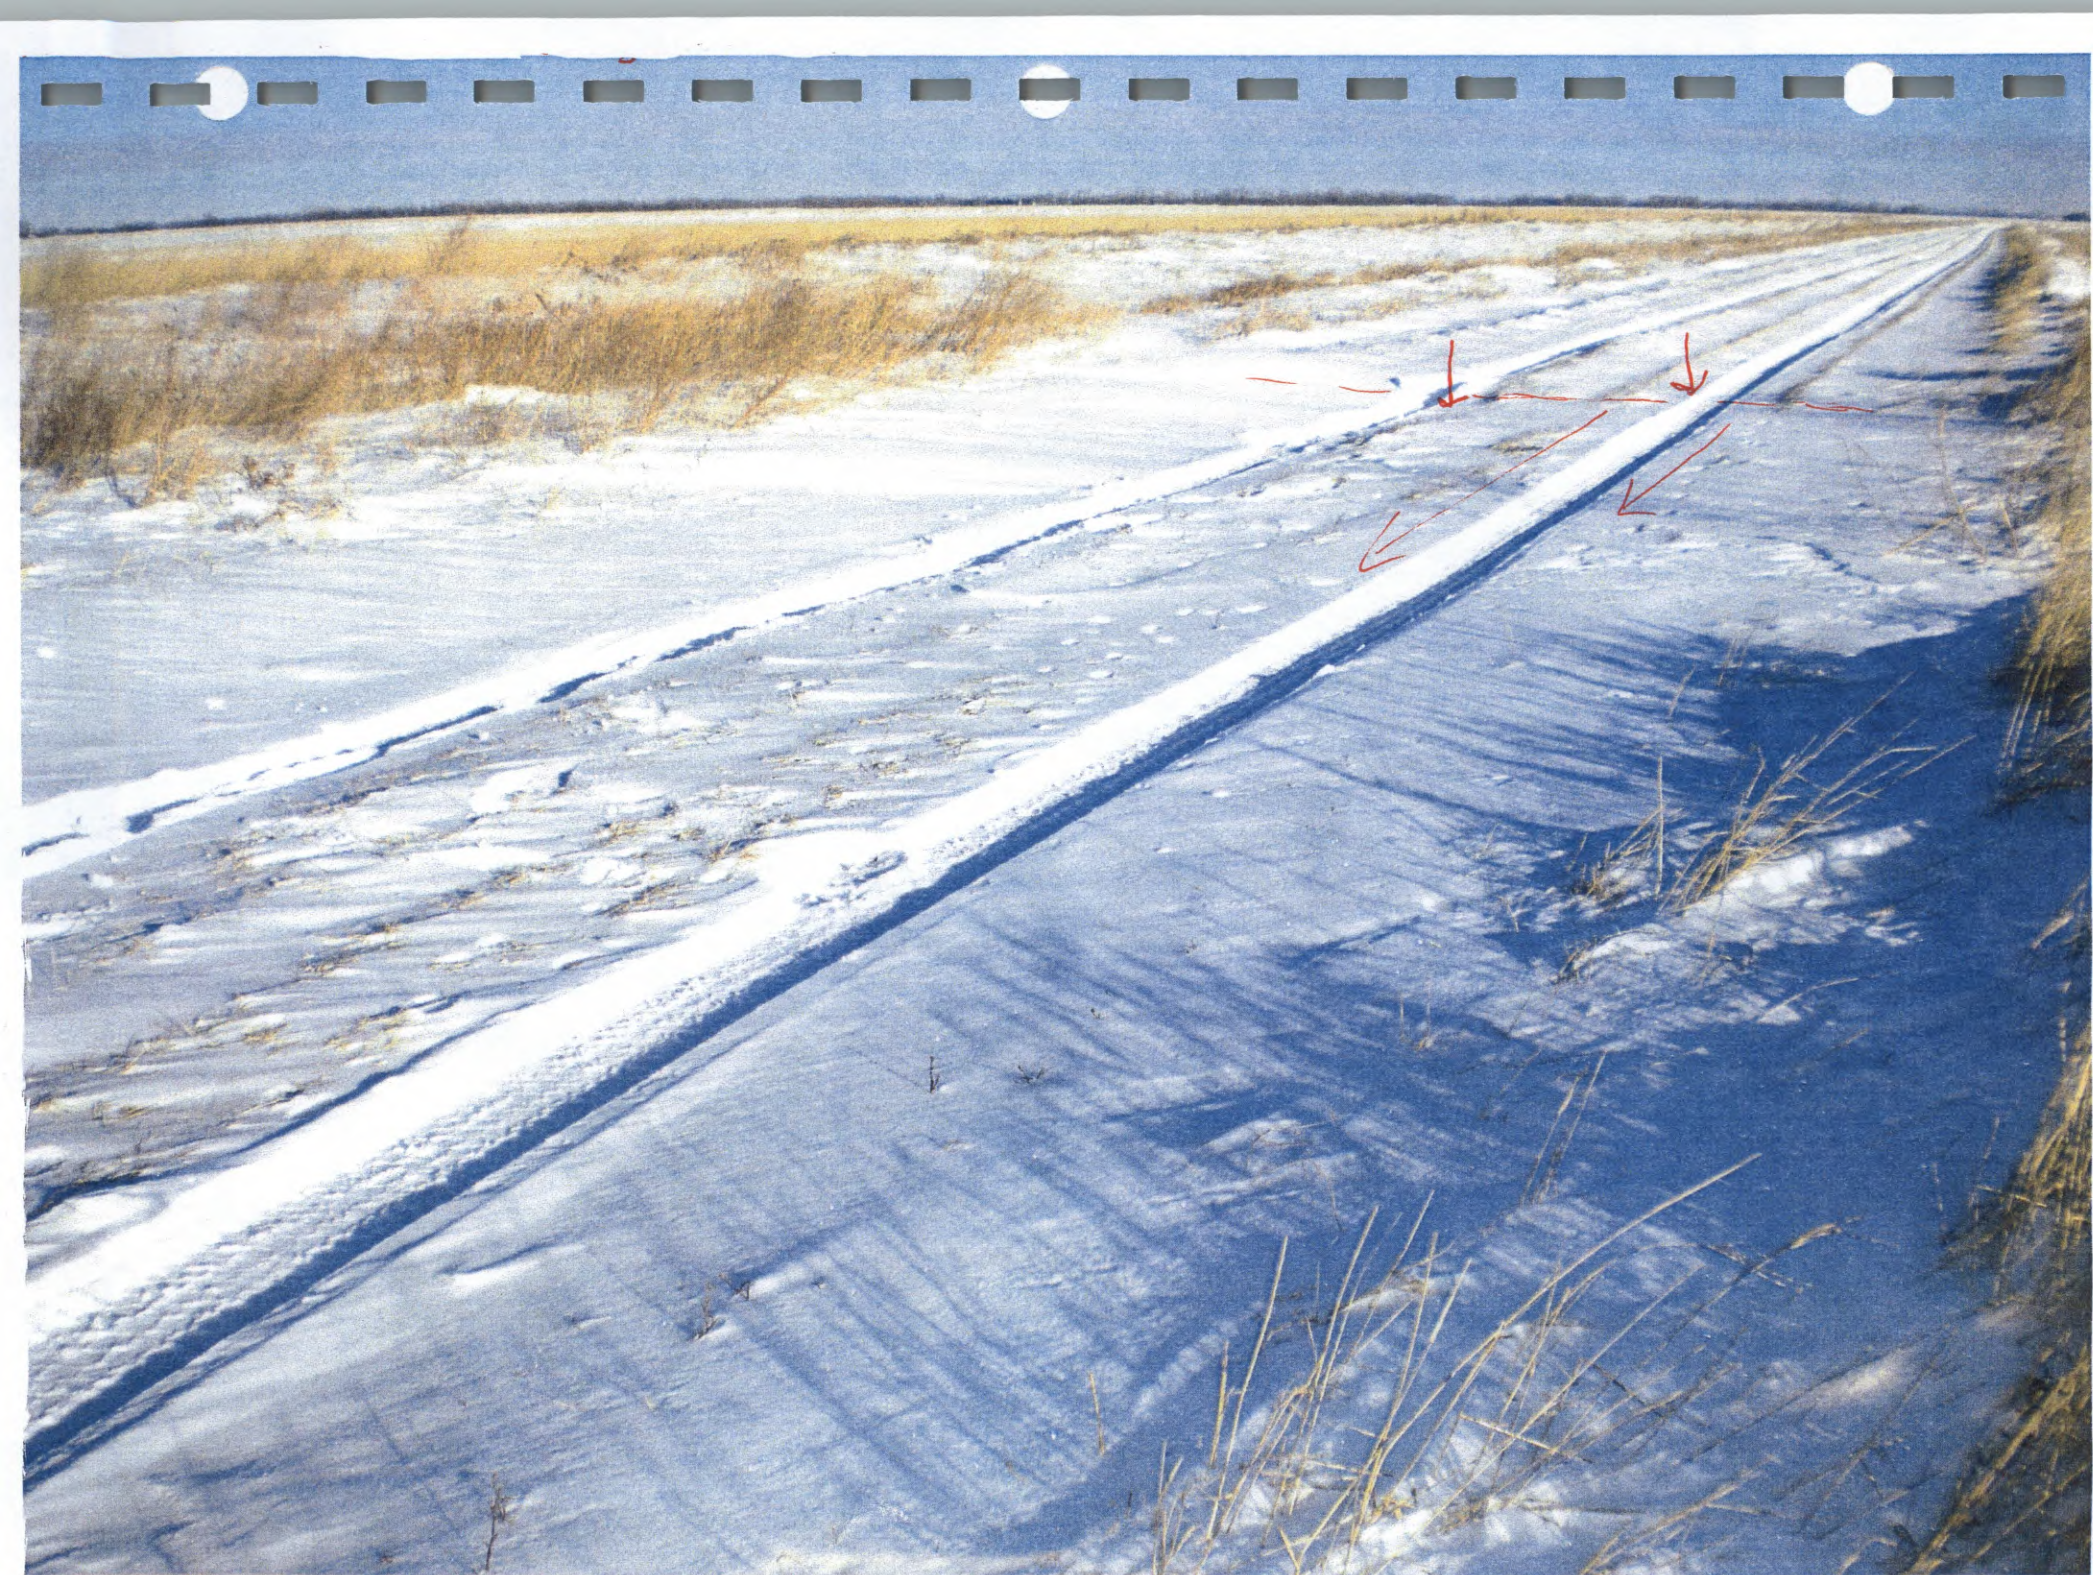
Picture #5 Signs in place on both sides of 107st NE ☐ of pipe  
→ Seems to be slight settlement of Roadway between signs compared to rest of Road  
no subsidence noticed in fields

Picture #5 Seems to be slight Settlement

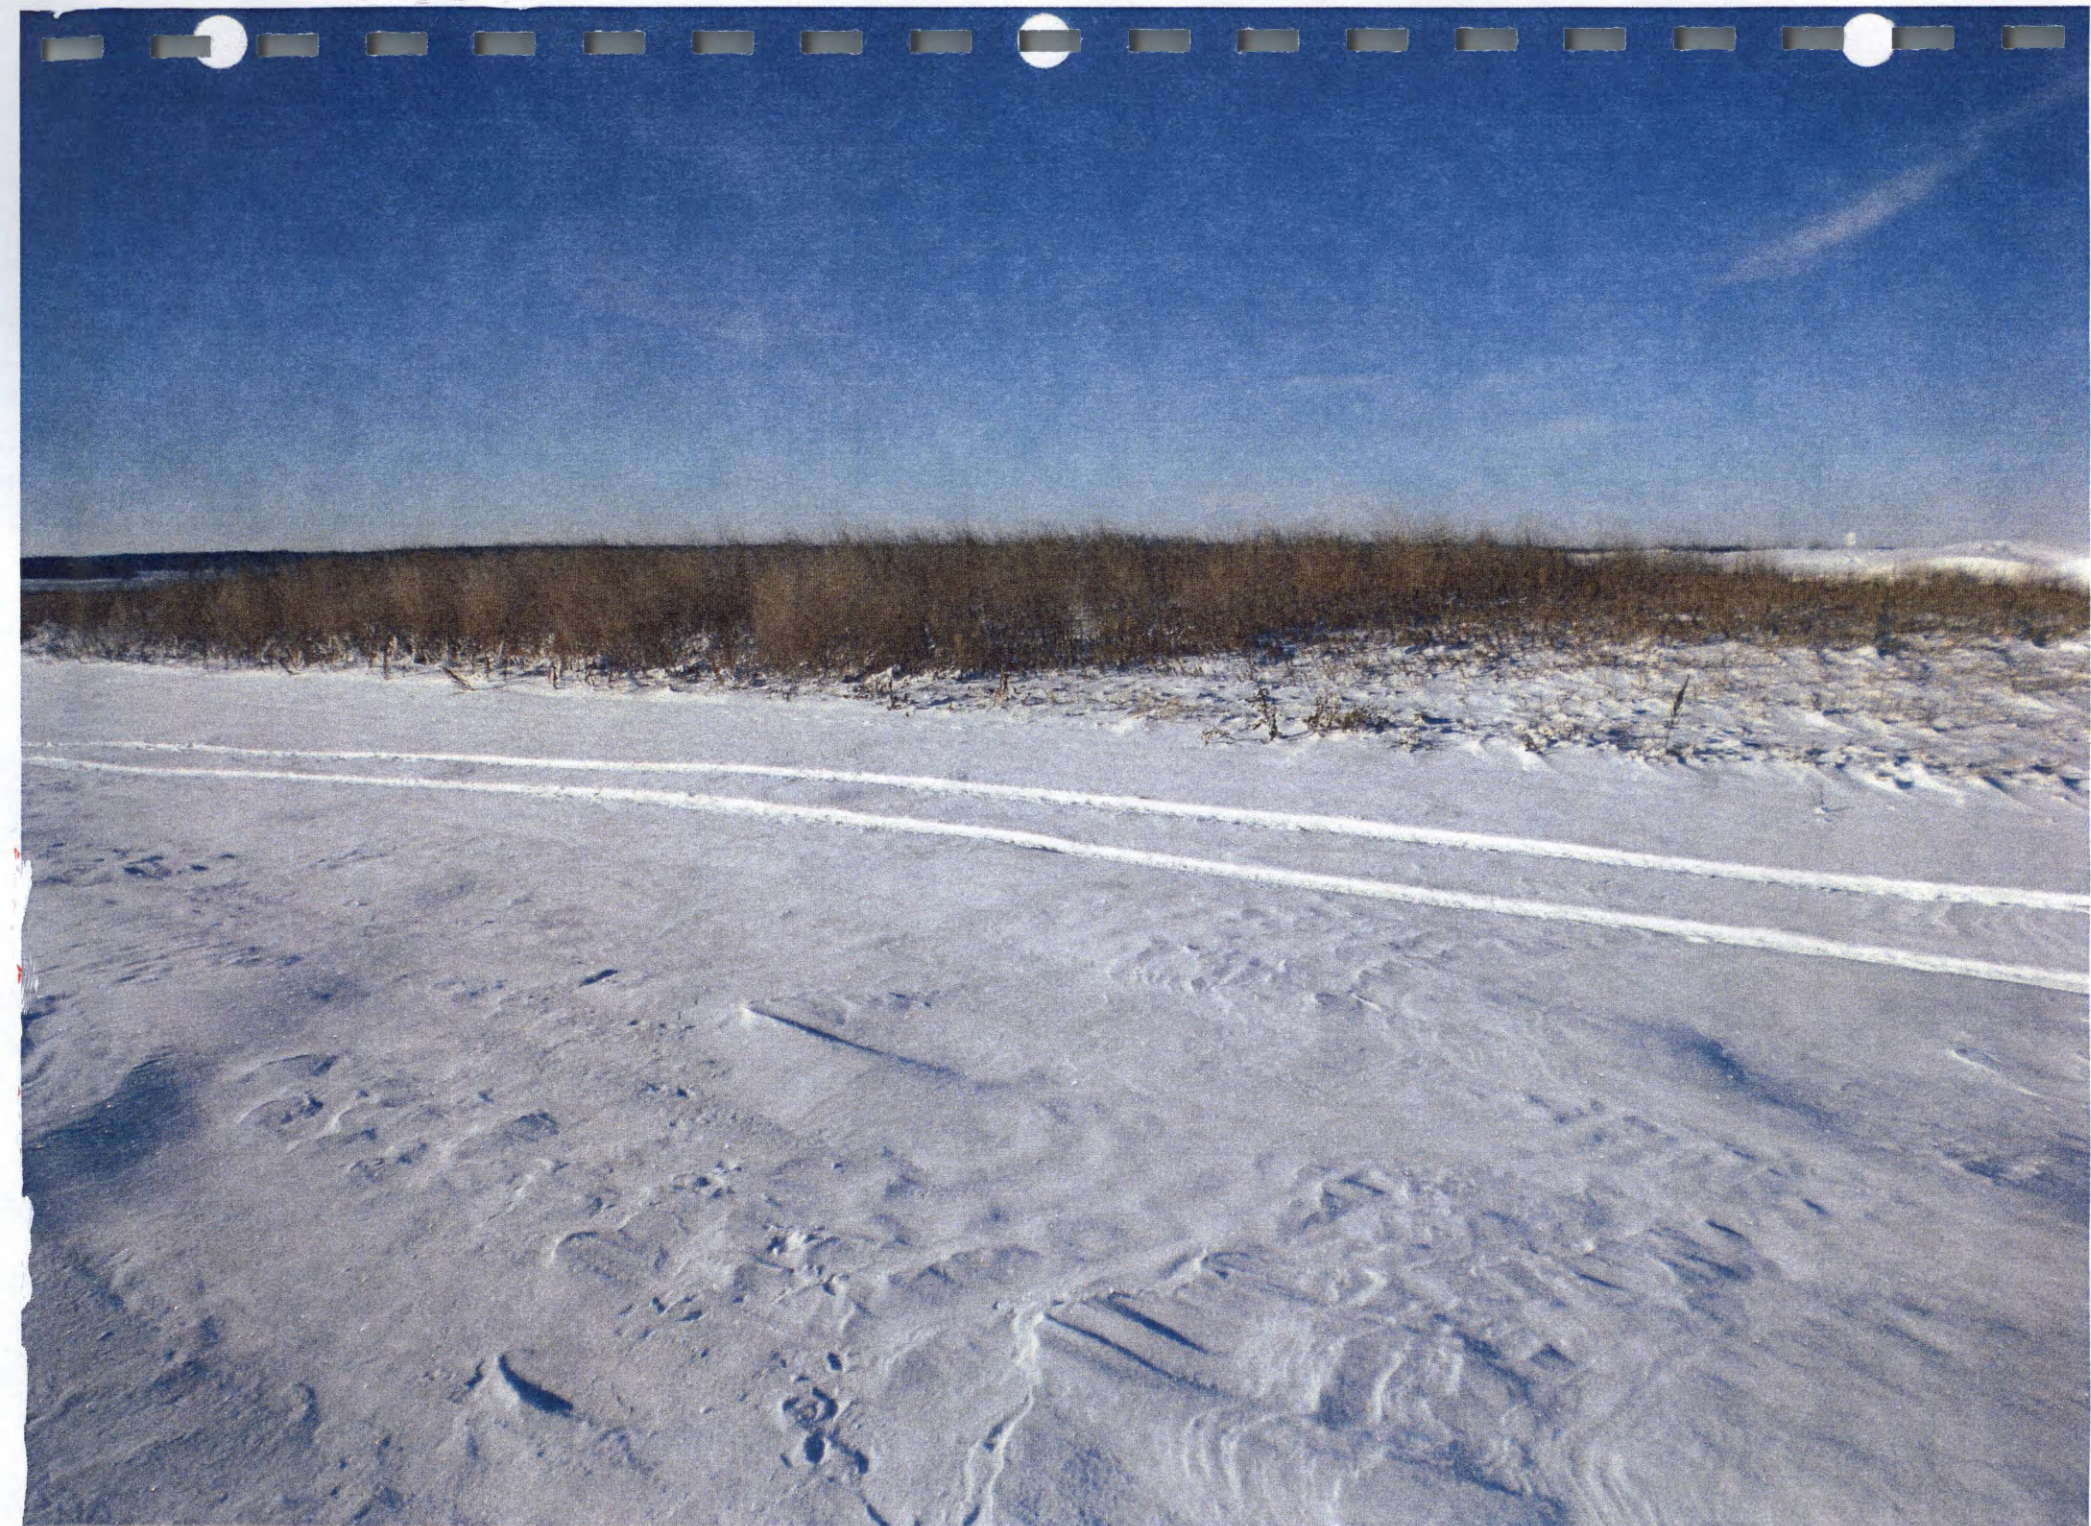
Picture #6 Drainage ditch on south side of road, no sign of erosion  
→ cover crop - well established 4' high, 1' high existing out side of work area  
is this cover crop the same as existing?

Picture # 6 established cover crop

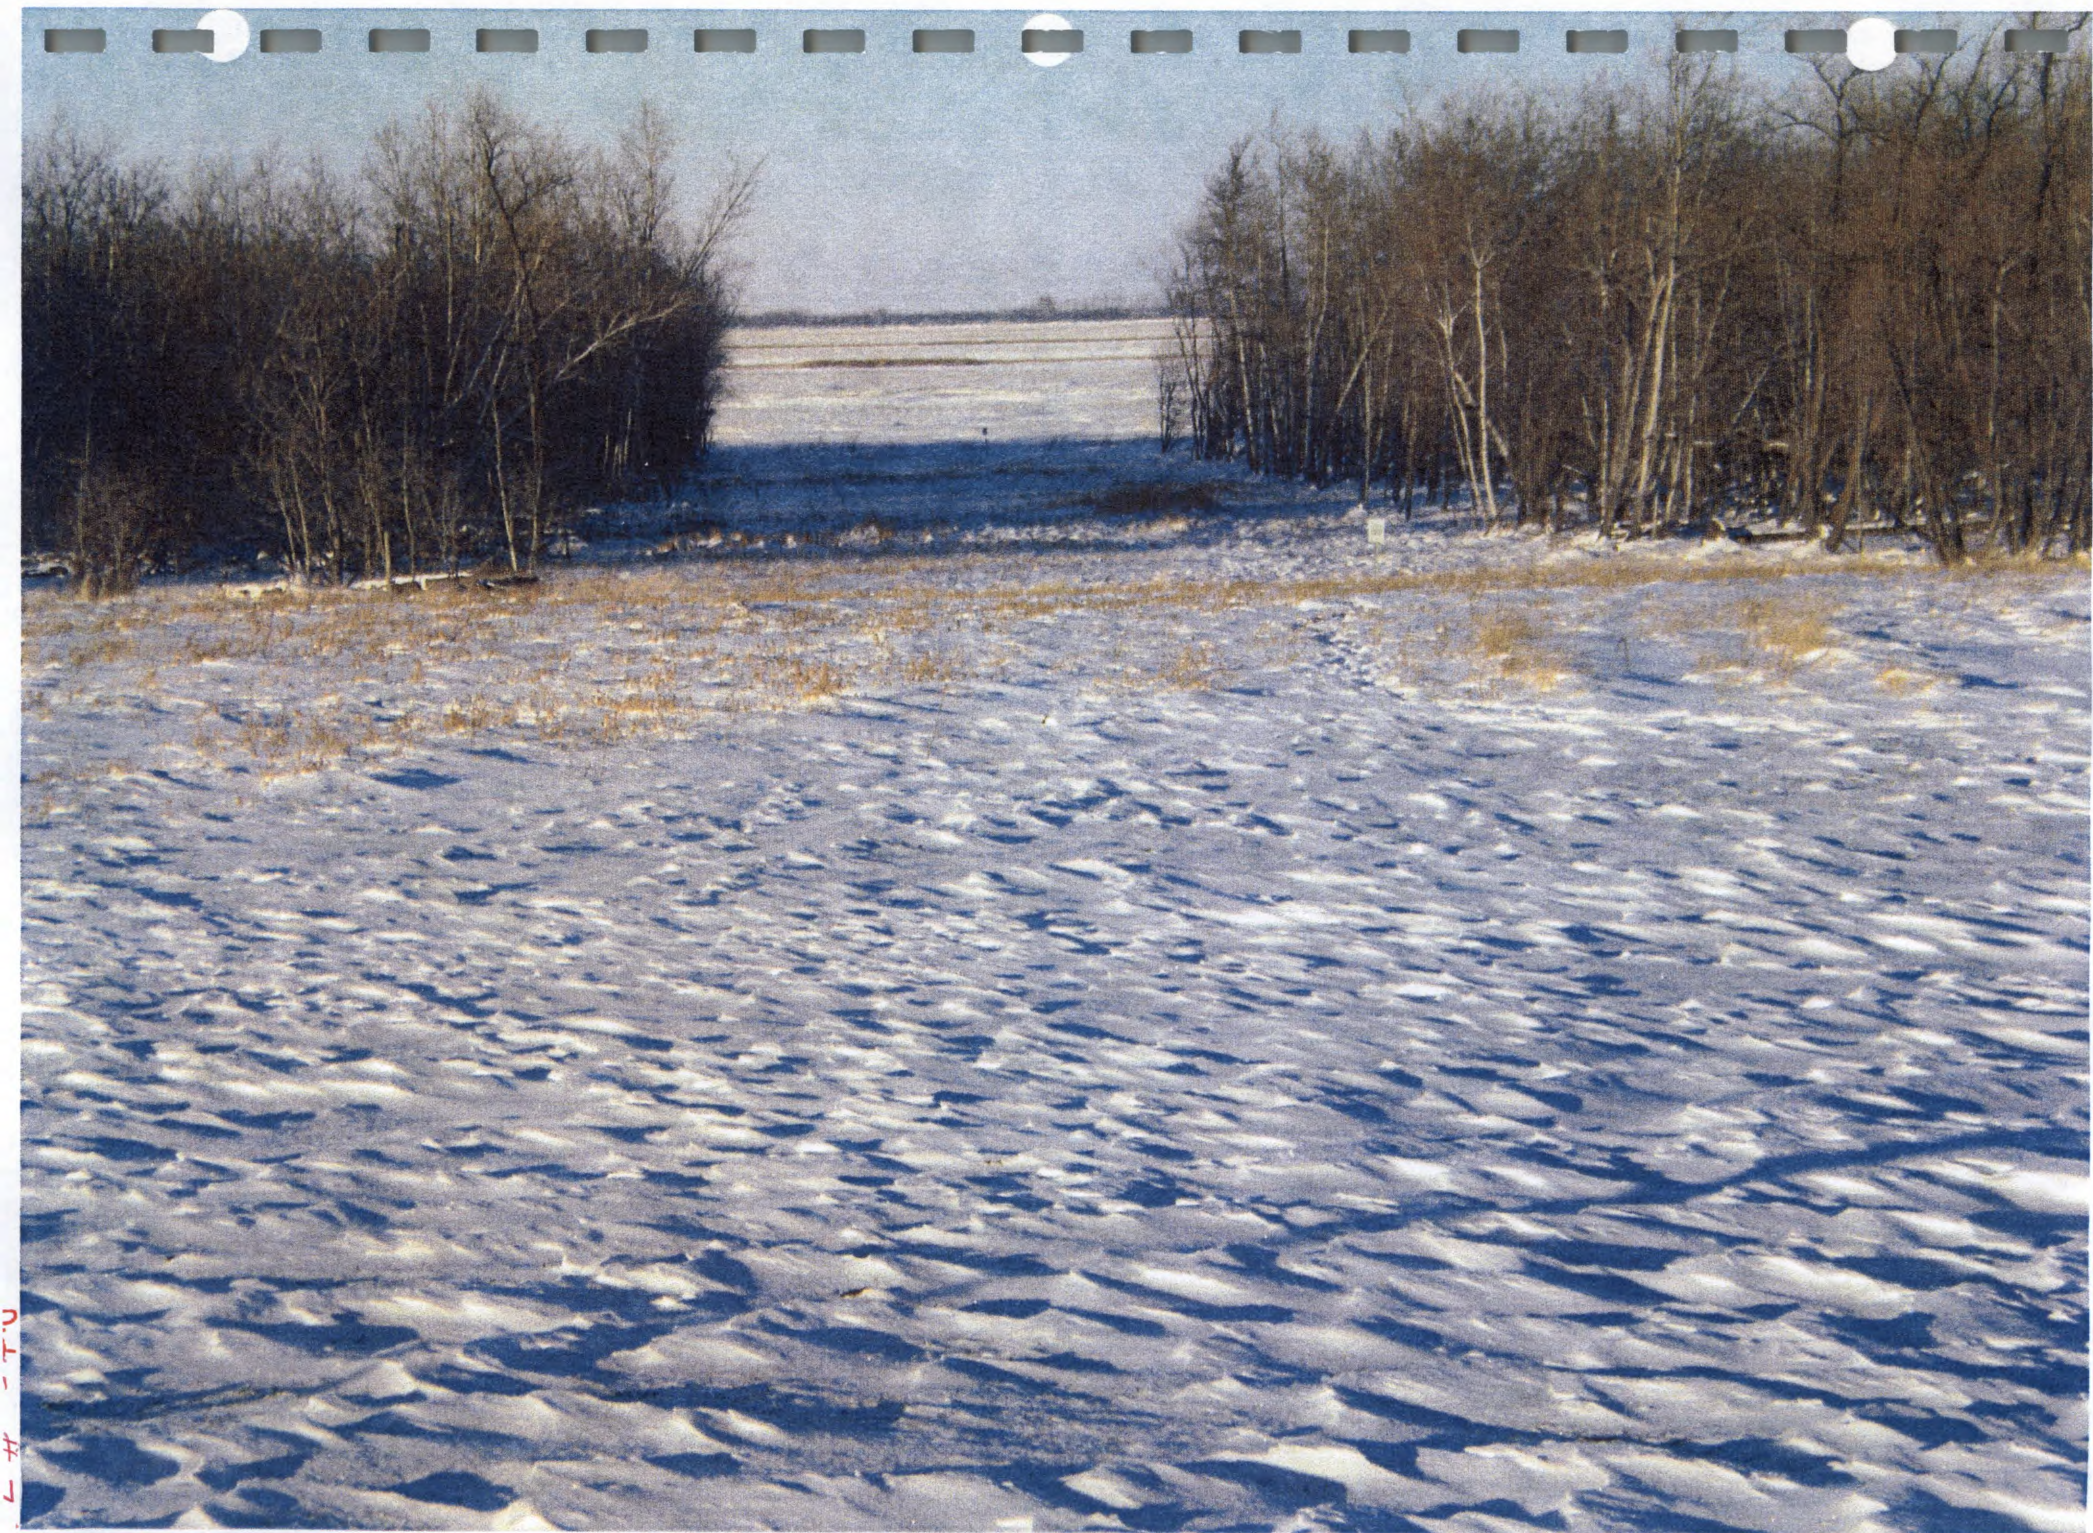
clearcut through about 1200' of woods at 85' width as per spec.  
Signs on both sides of clearcut

Clear cut through Woods 85', Noticed signs at both ends

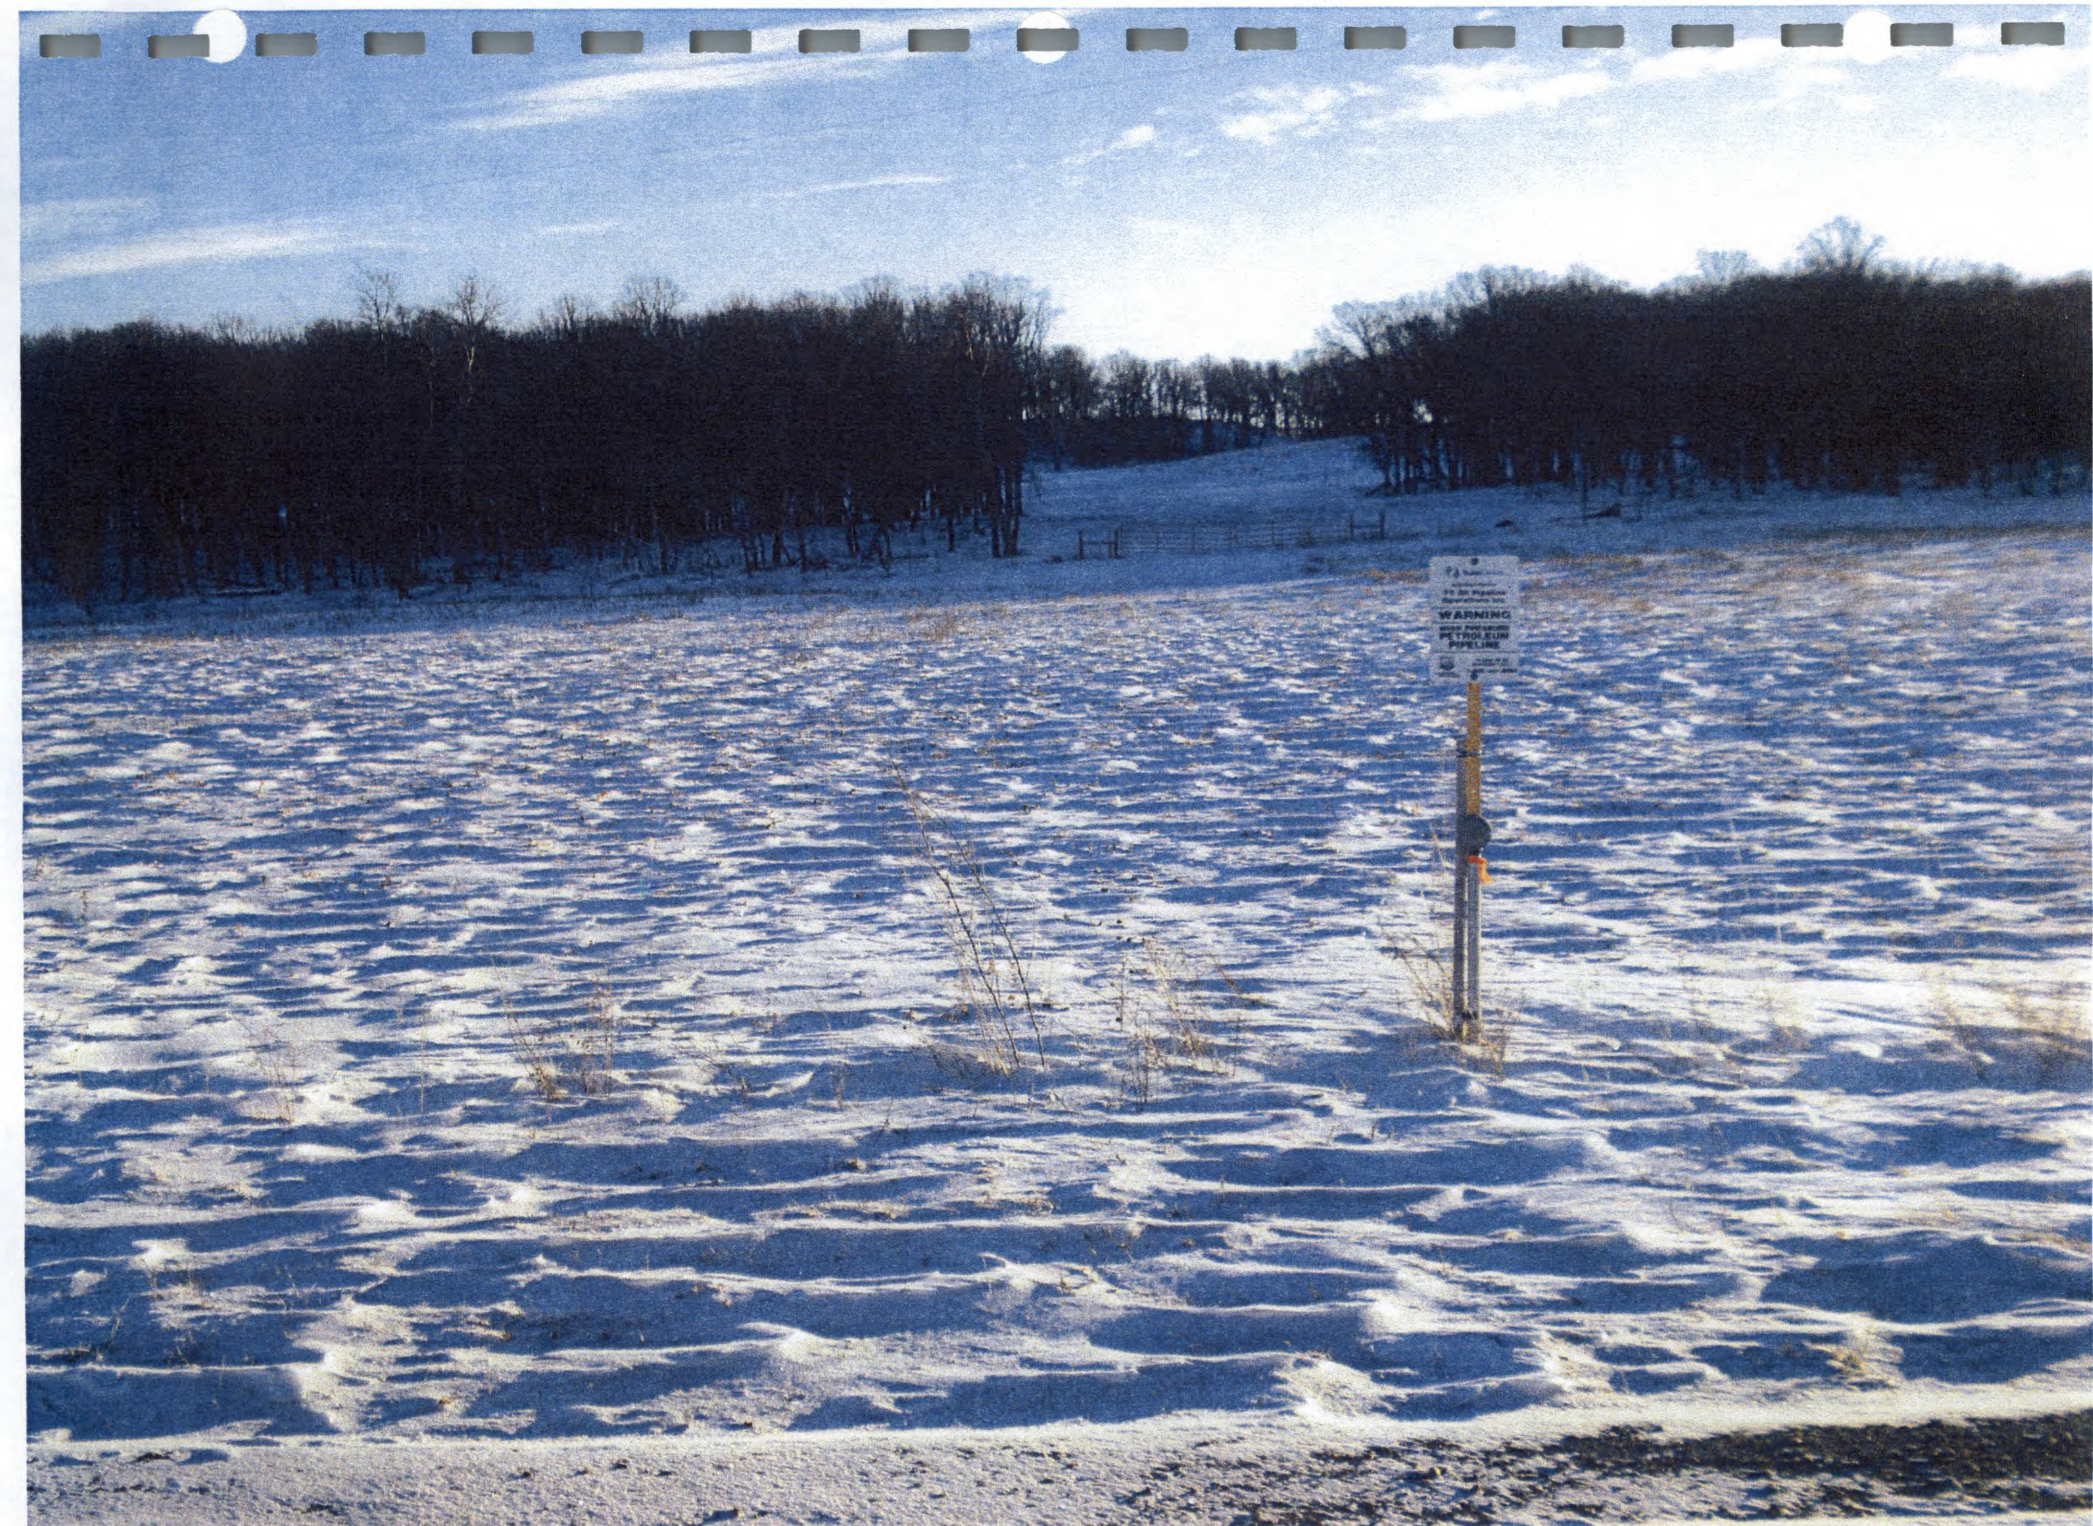
Picture #8 clear cut through woods 85', Fencing and Gates put back in place
