*Keystone*

**Final Inspection**

*1-5-2011*

PROJECT Keystone Pipeline - North Spread

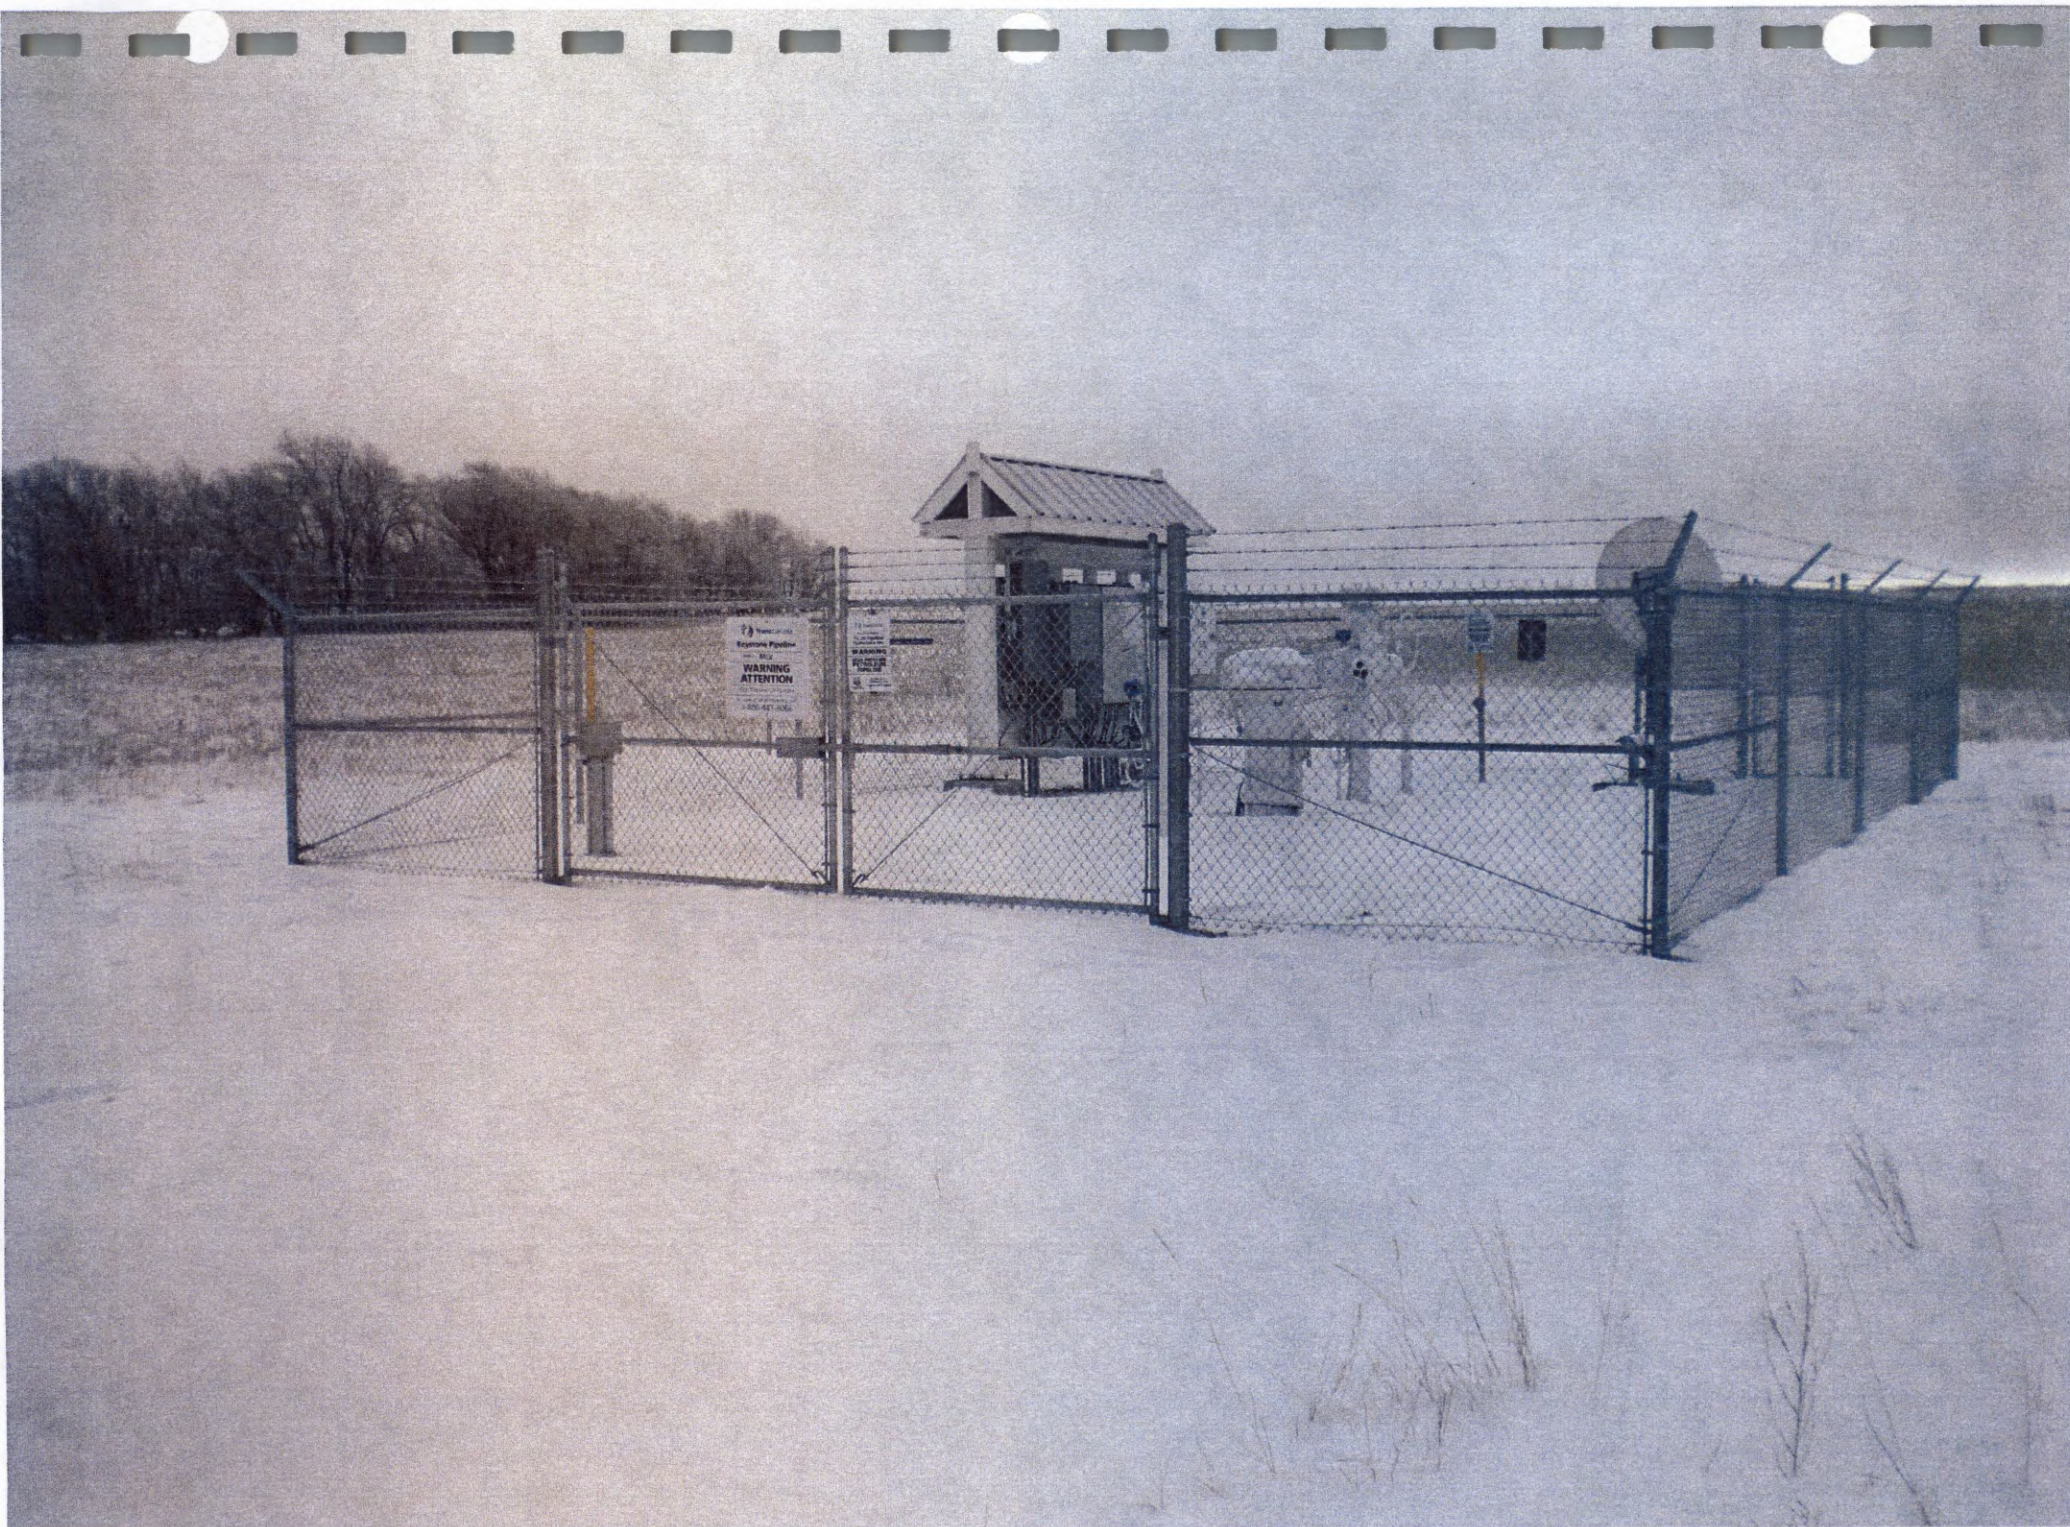
Picture # 9 → emergency shut of station on south side of CR55

30x40 enclosed, locked with barbed wire on top. 6' high fence

Picture #9 emergency shut off station South Side of CR 55 1st one

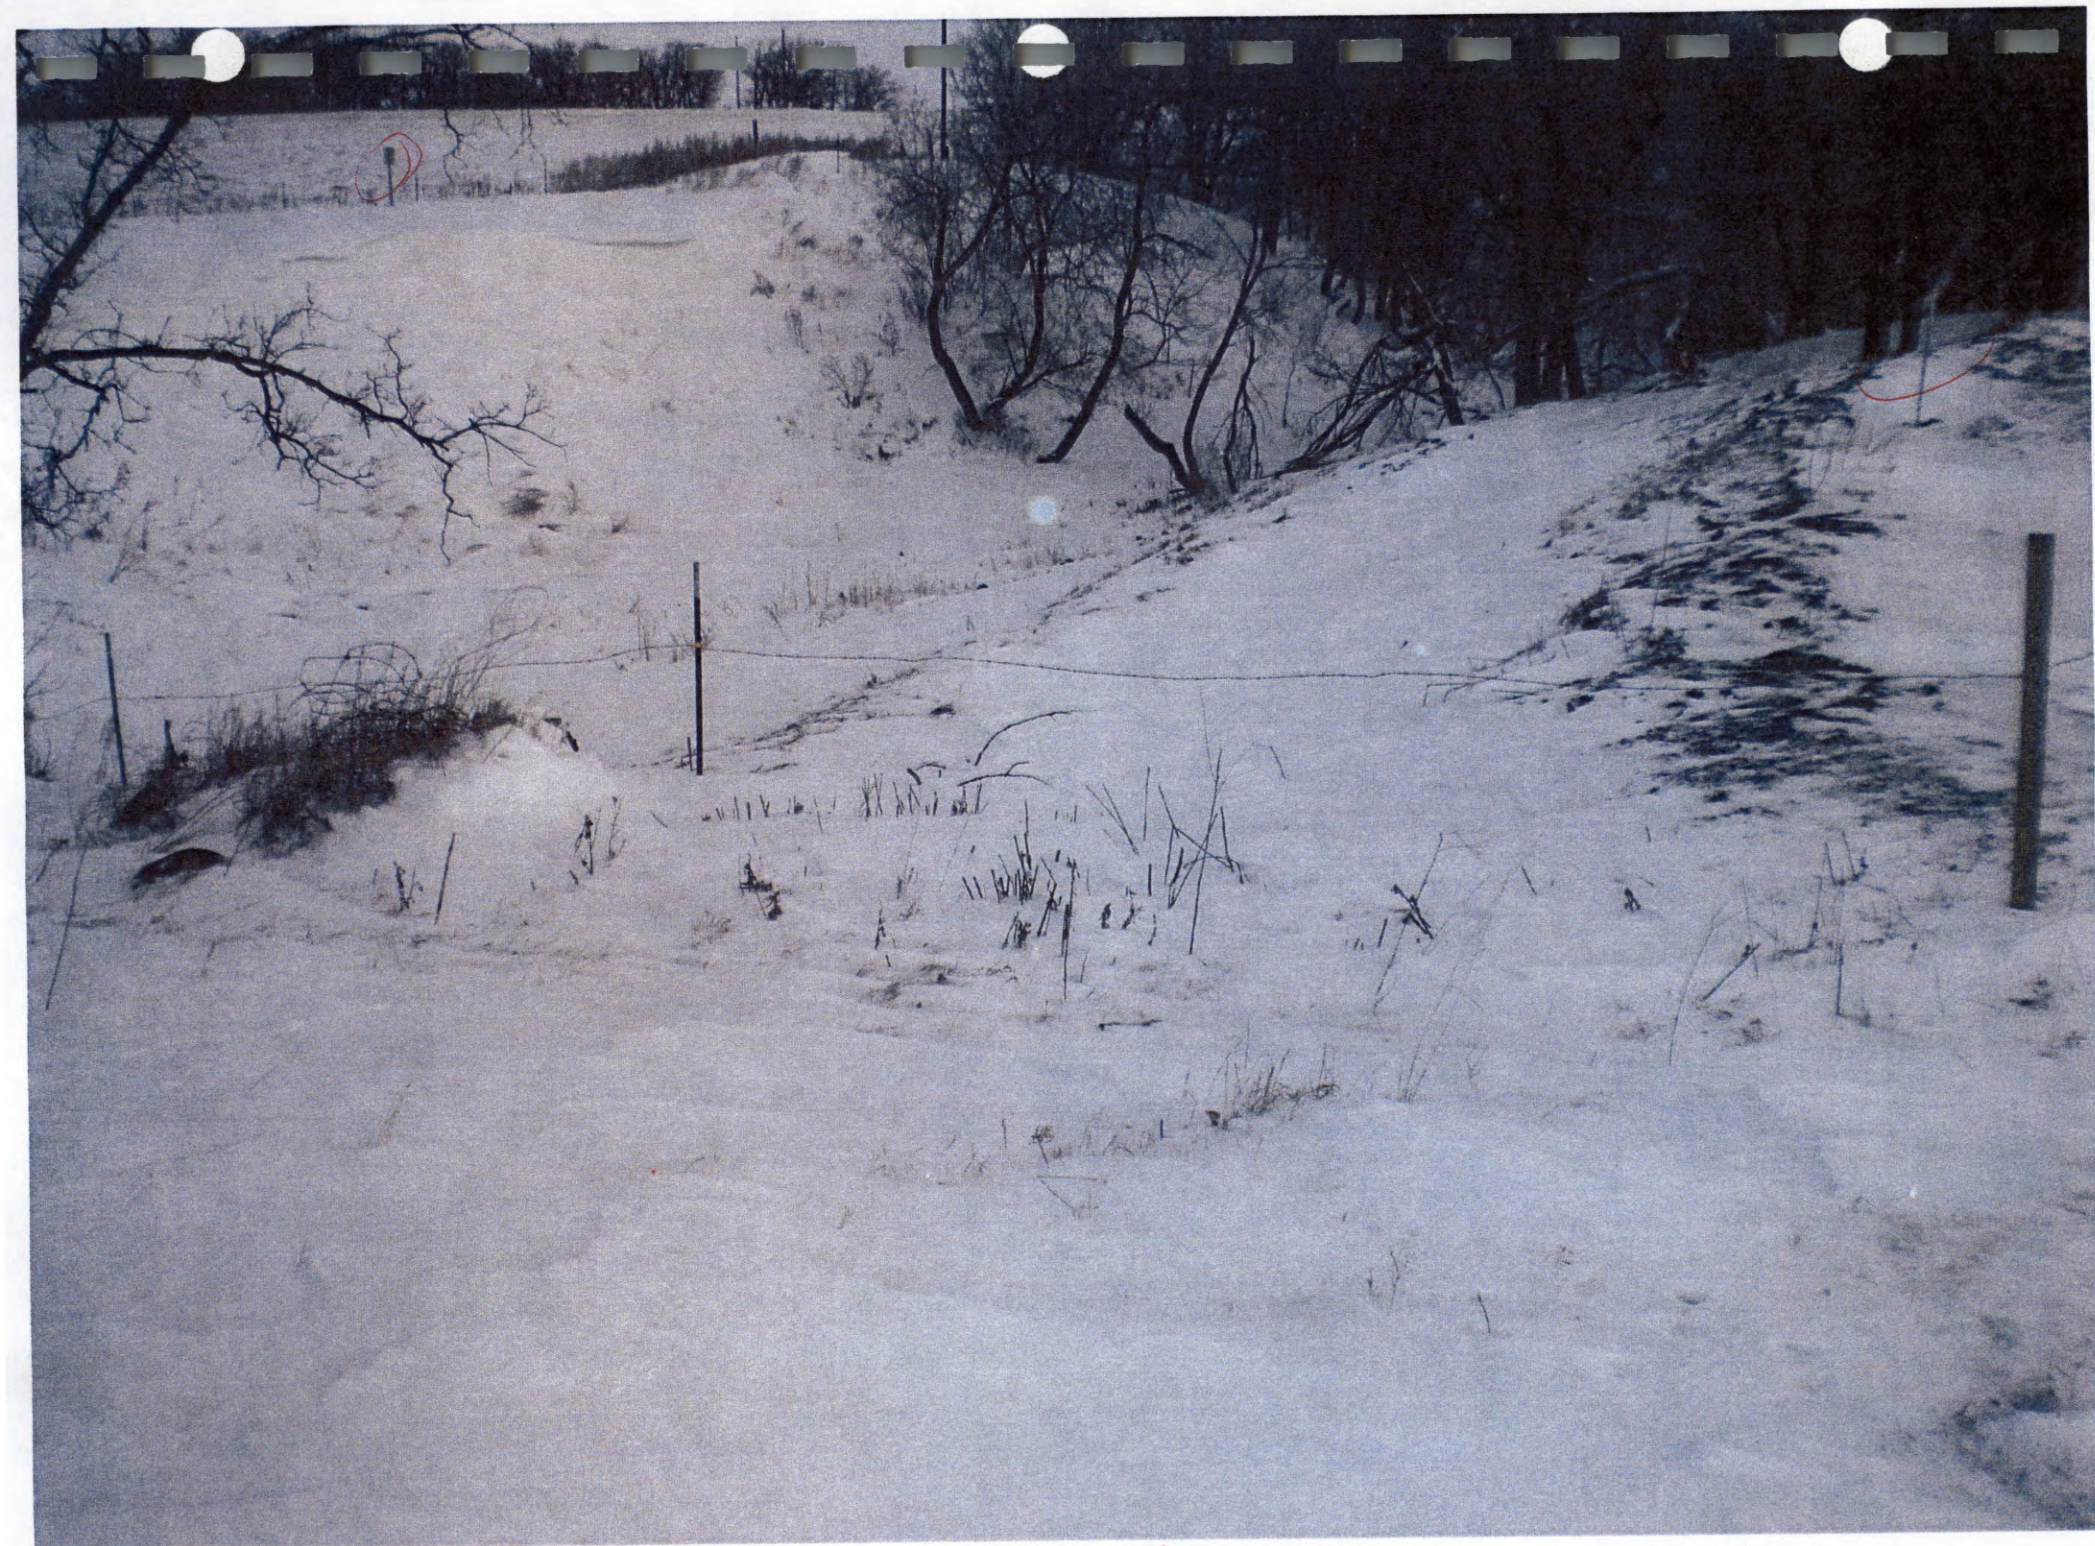
Picture # 10 → North of CR55. Small creek crossing 1/2 mile, embankment looks to be Terraced

Picture #10 Embankment Terraced, noticed signs on both sides

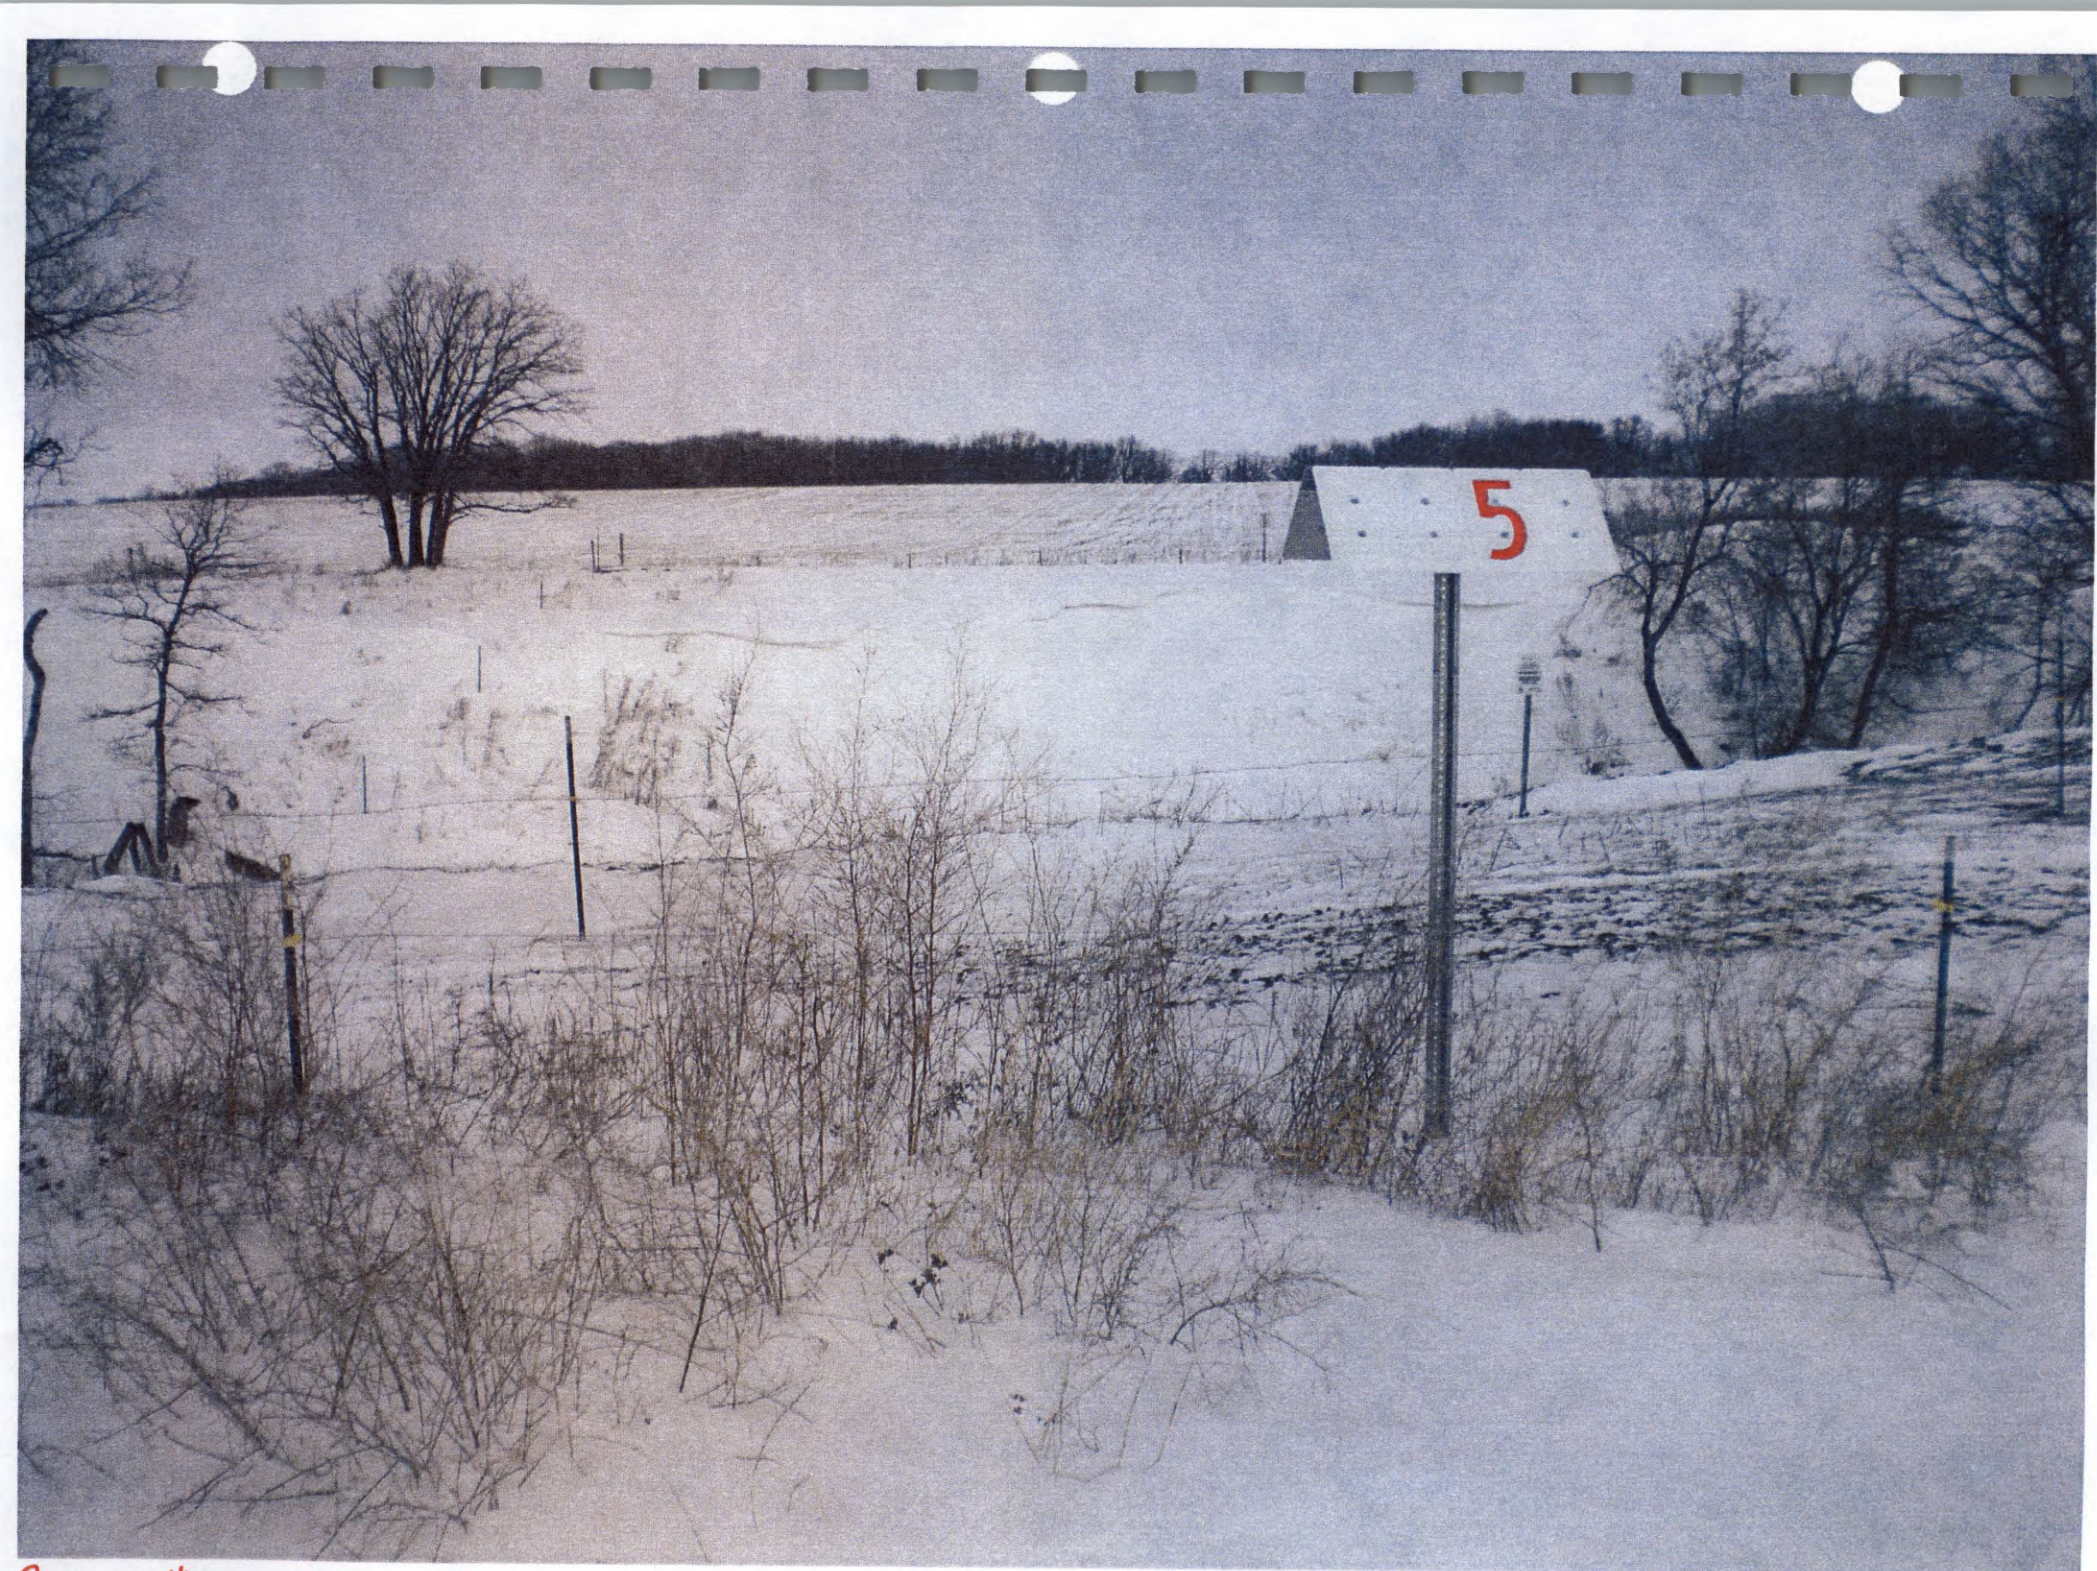
Picture # 11 → mile marker #5 - at edge of small creek South Side

Picture #11 mile markers every 5 miles, Aerial markers

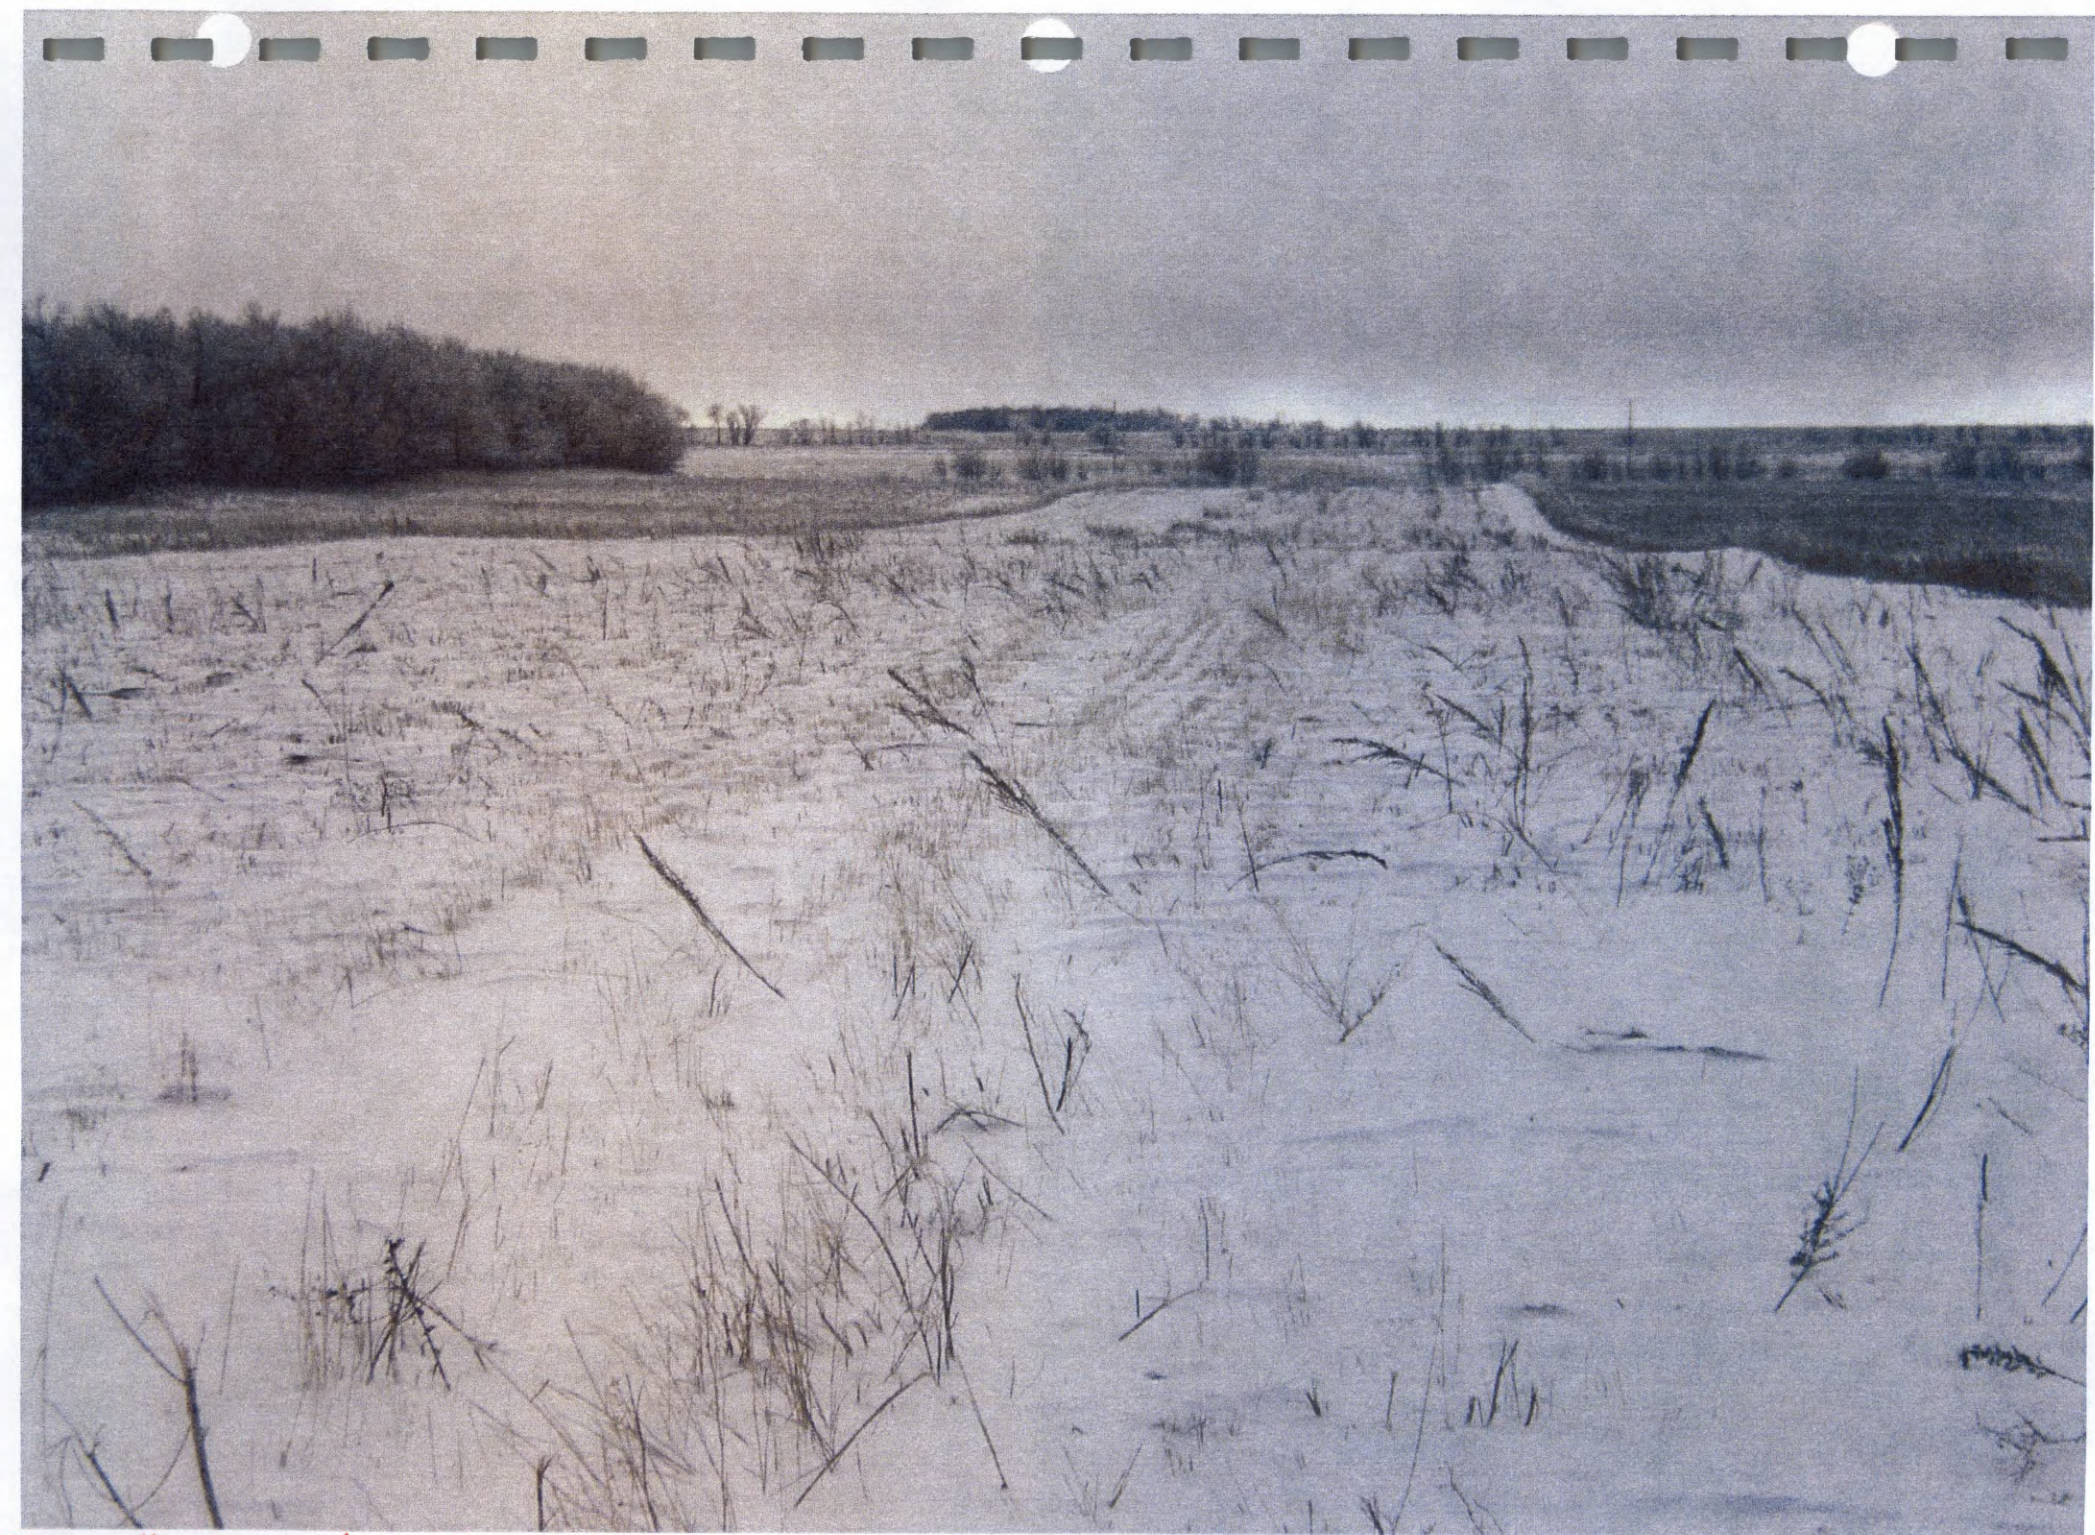
Picture # 12 - flow of land seems to match original

Picture #12 shows flow of land

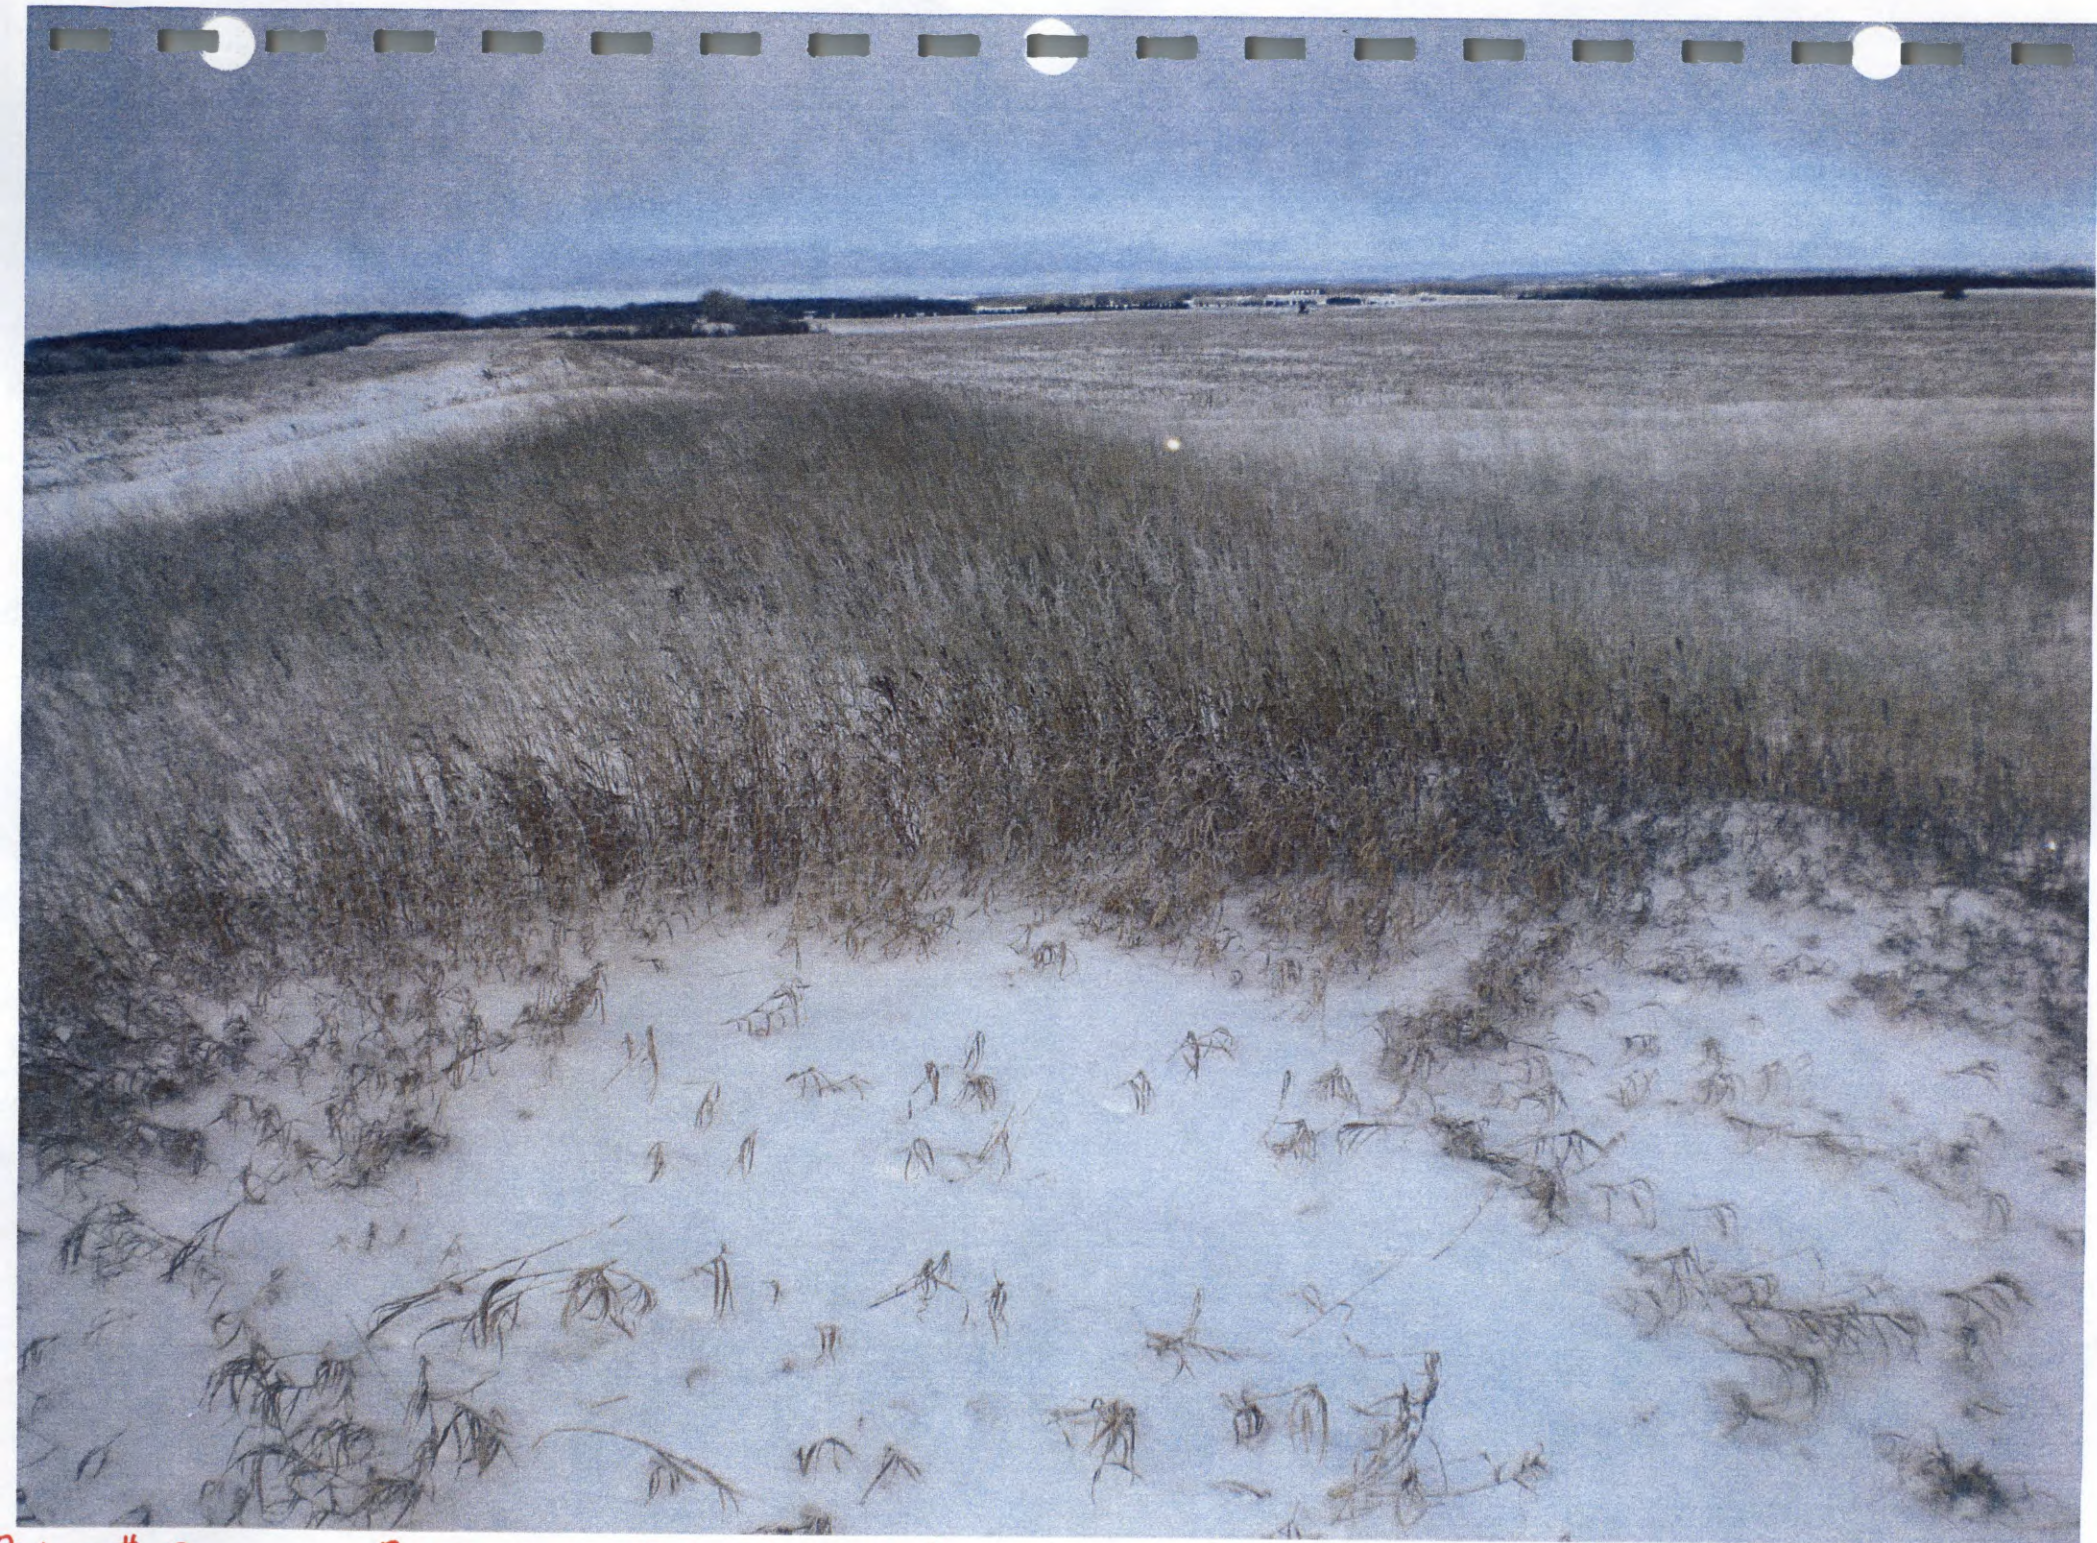
Picture # 13 - burms seem to match original

Burms seems to match originall

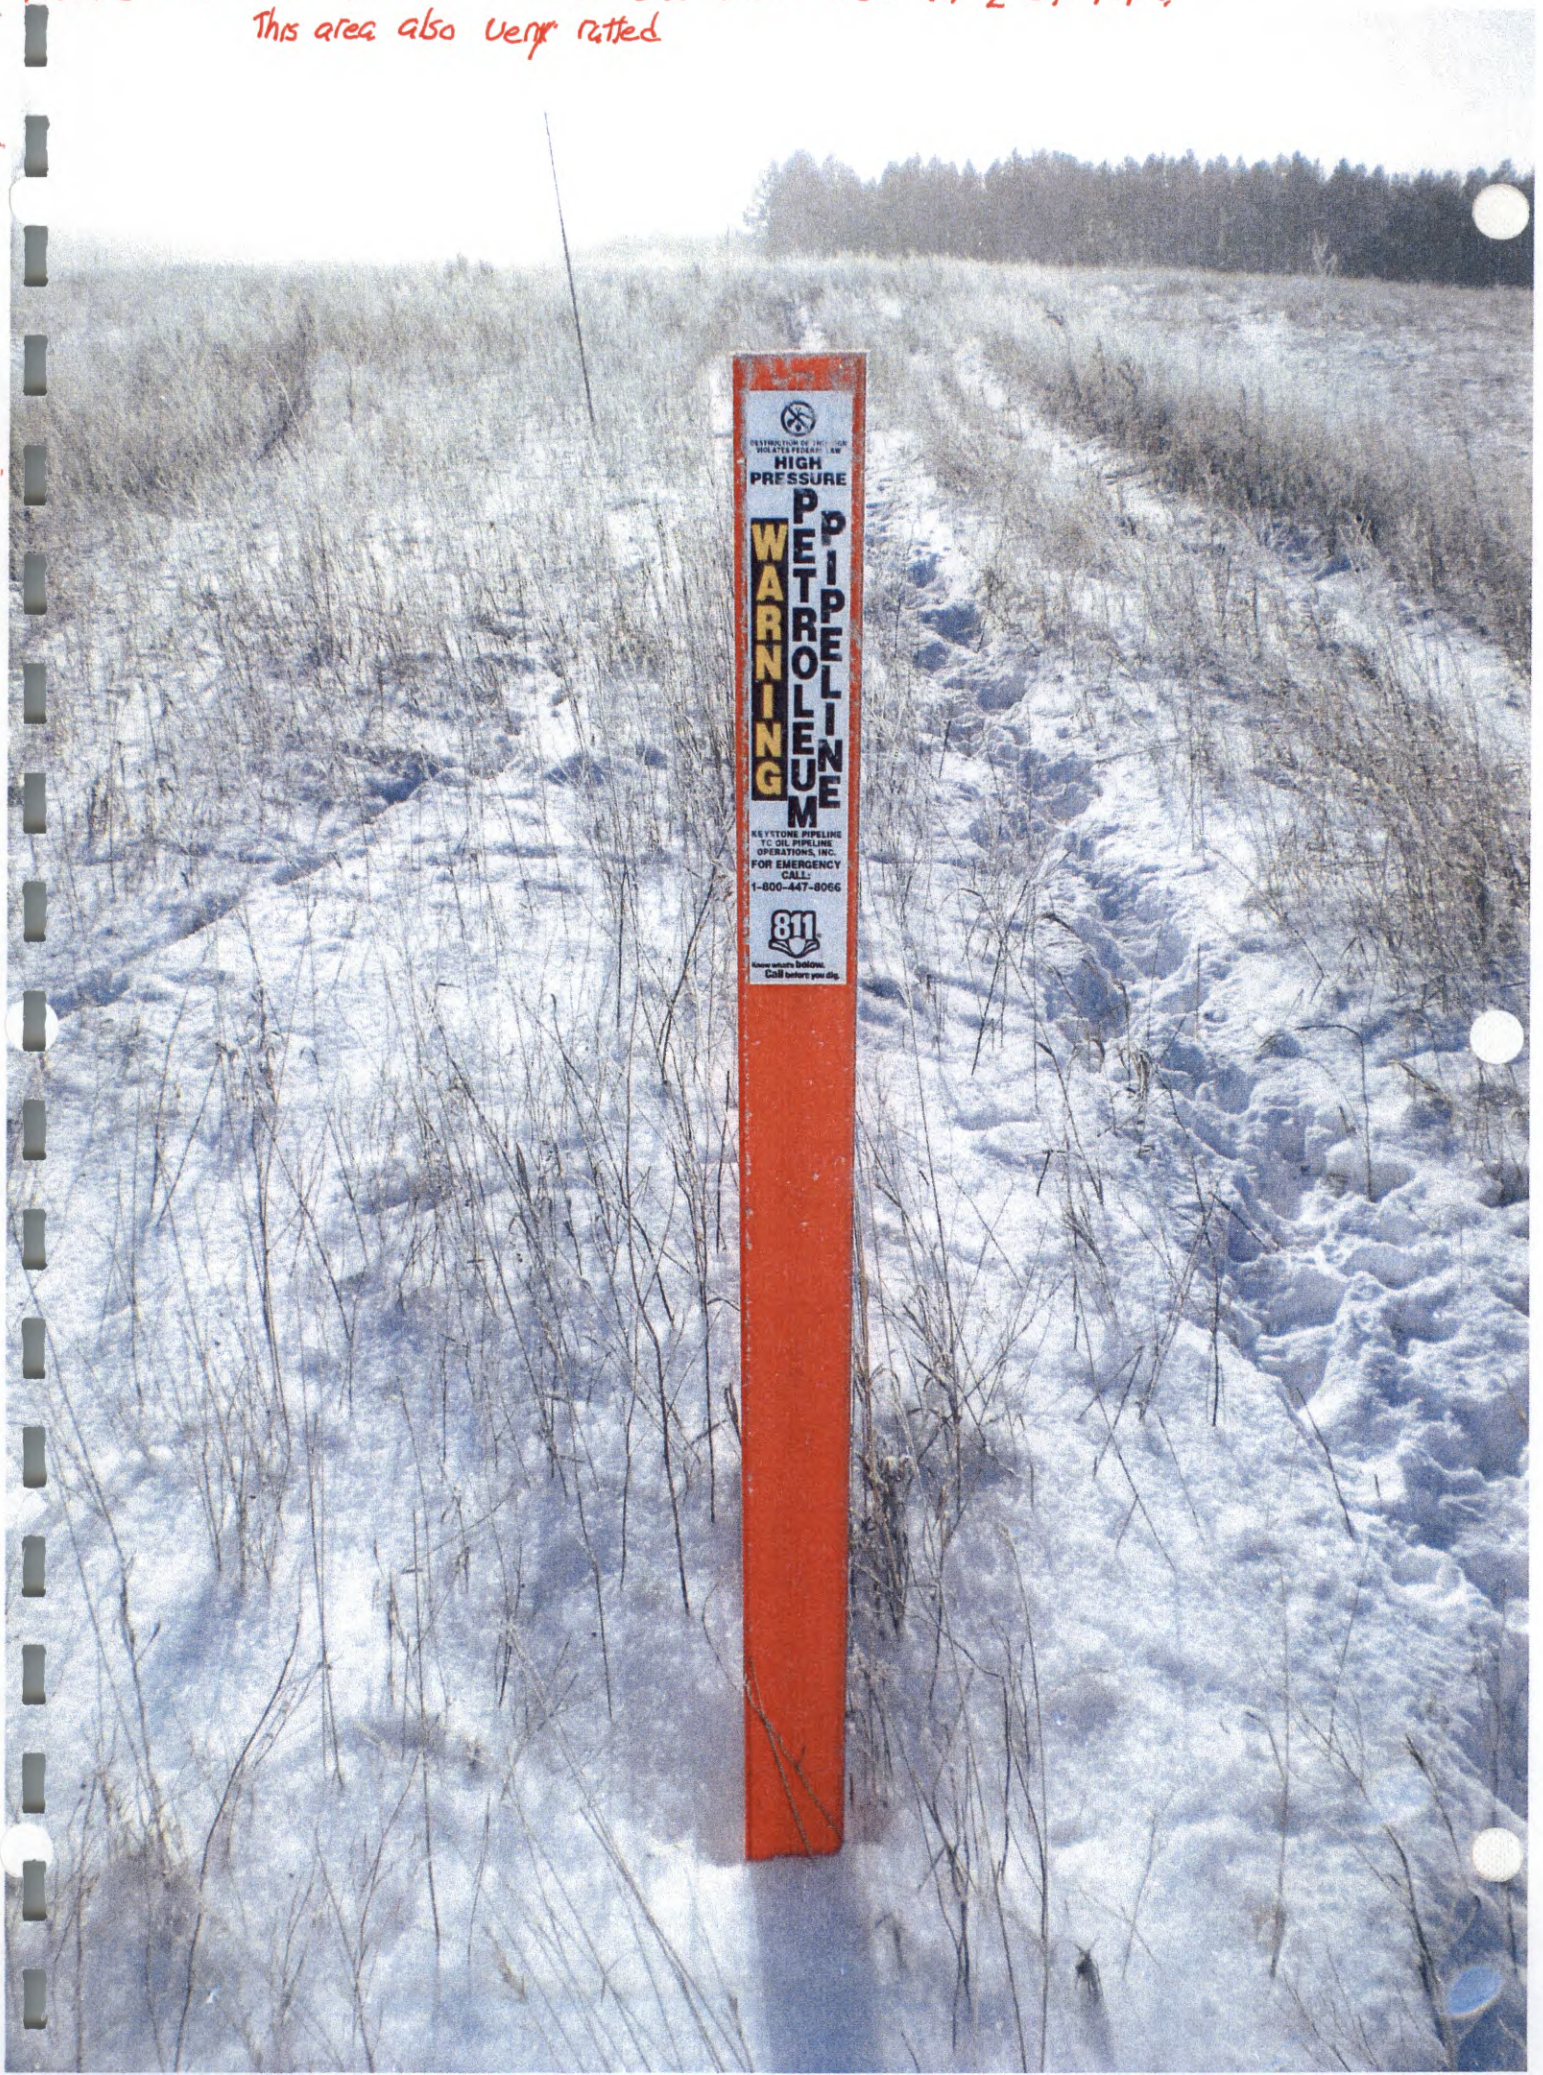
#14 → orange marker & of pipe line, south of 103st NE mm 7,

Picture # 14 This type of marker was also used for 2 of pipe.  
This area also very ratted

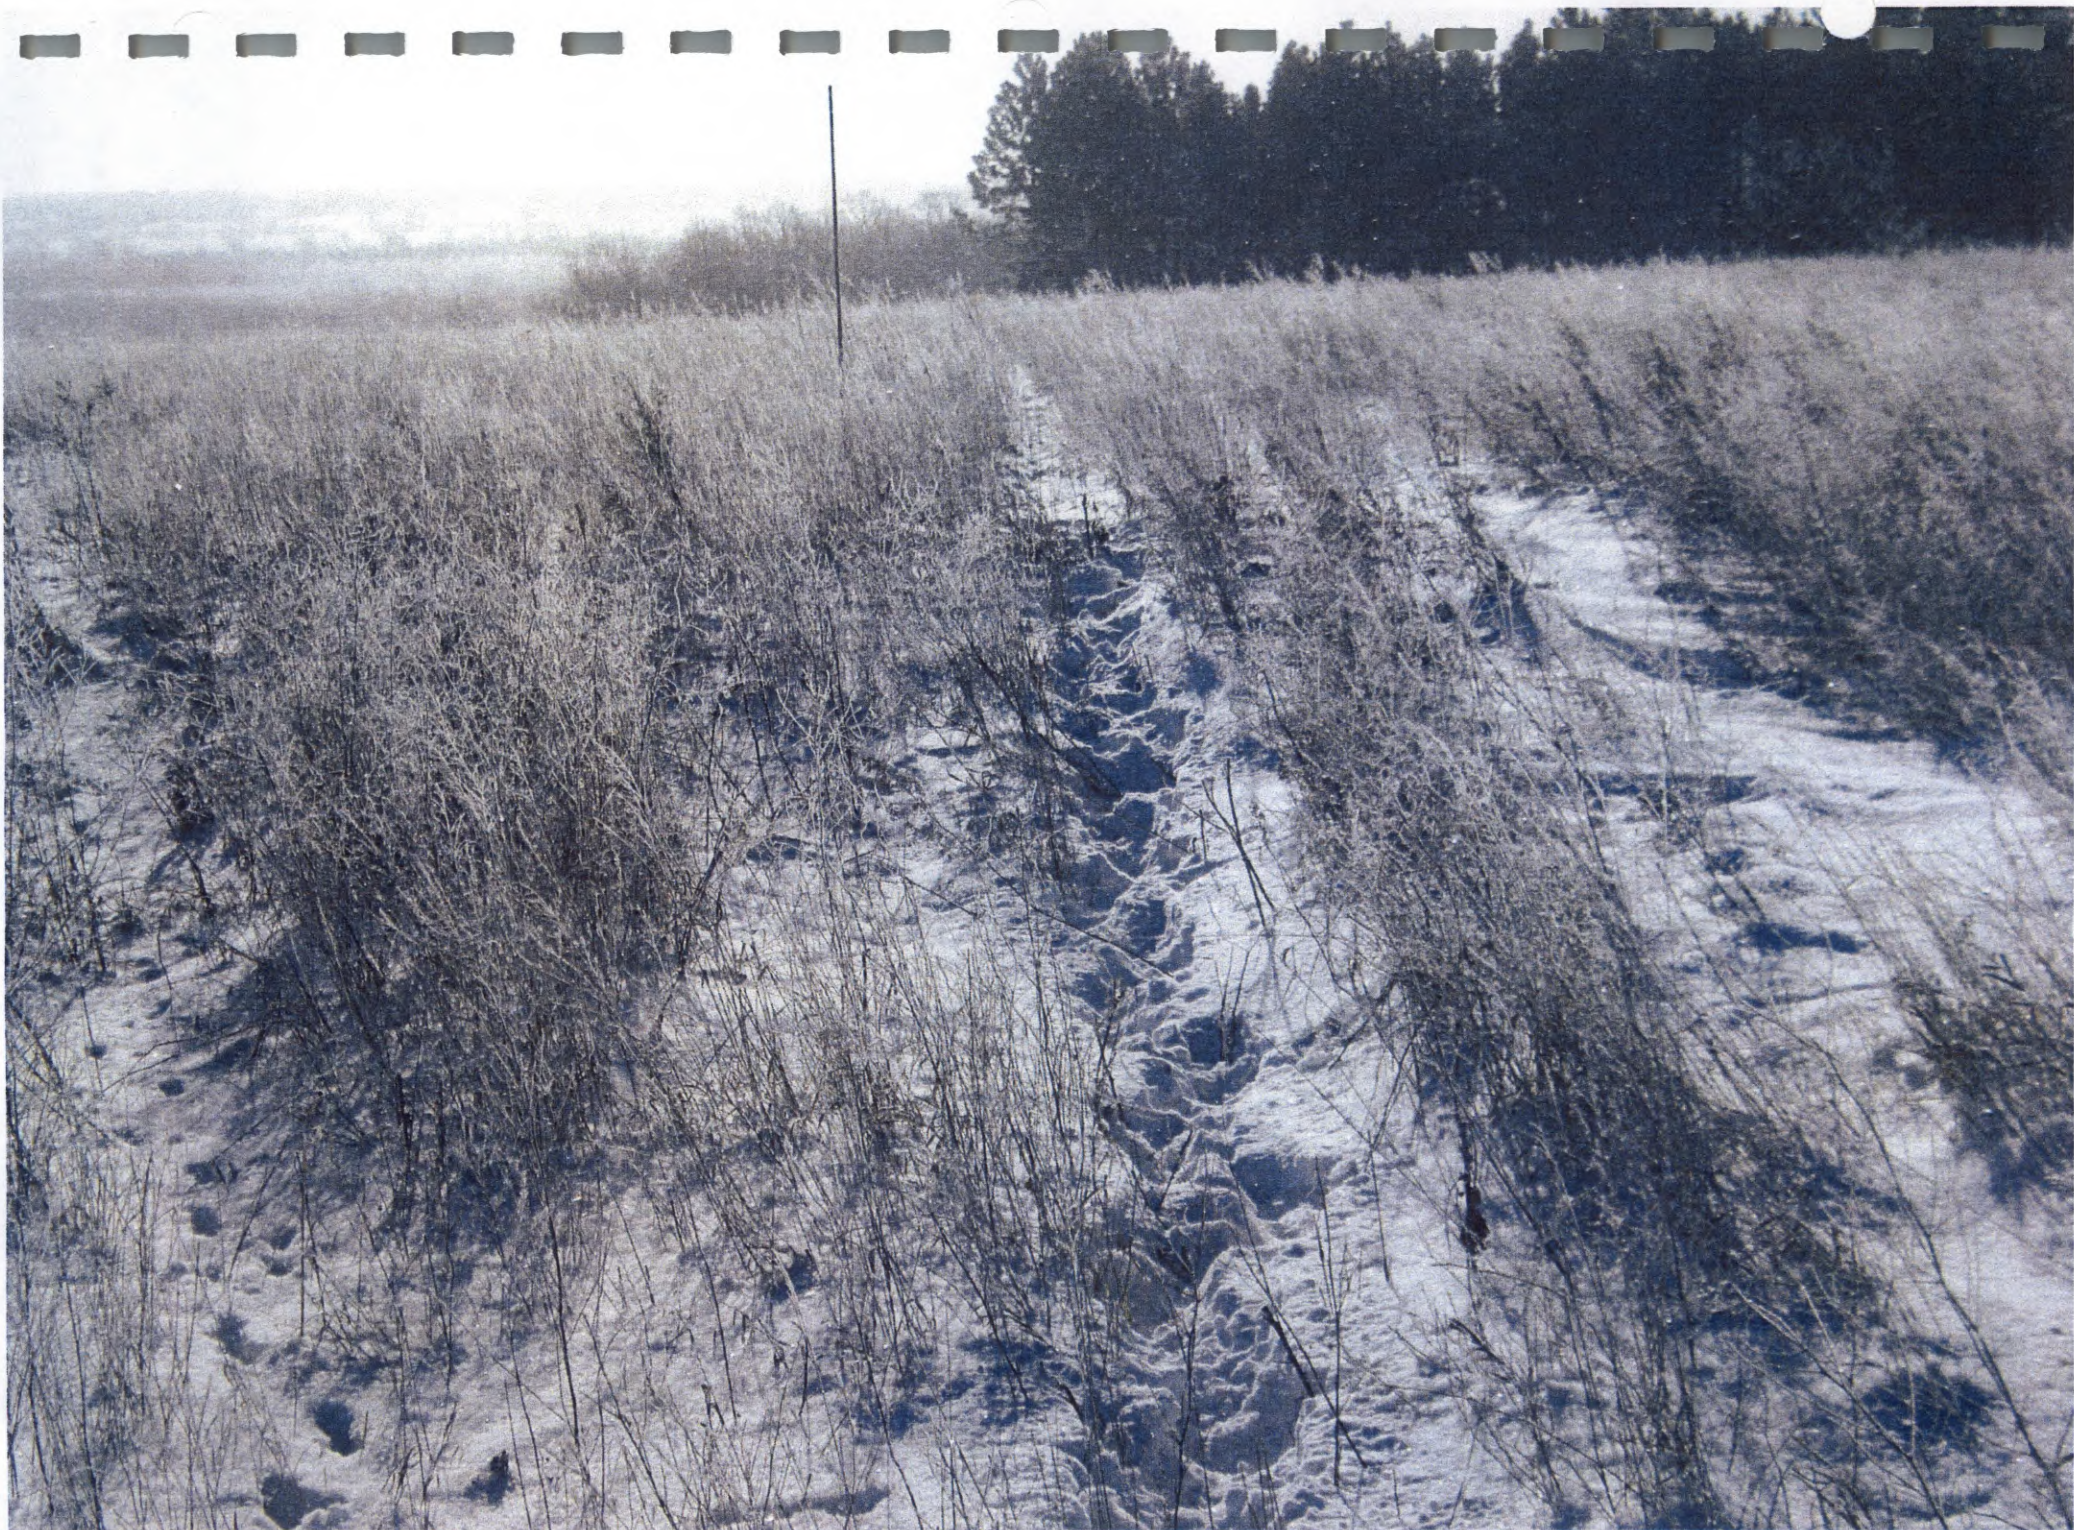
Picture  
#15 → This area has noticeable low spots and Ruts North Ridge of Pembina River Gorge

Picture #15 Metal Rods? North end of Pembina Gorge, Very rutted
