*Keystone*

**Final Inspection**

*1-5-2011*

PROJECT Keystone Pipeline - North Spread

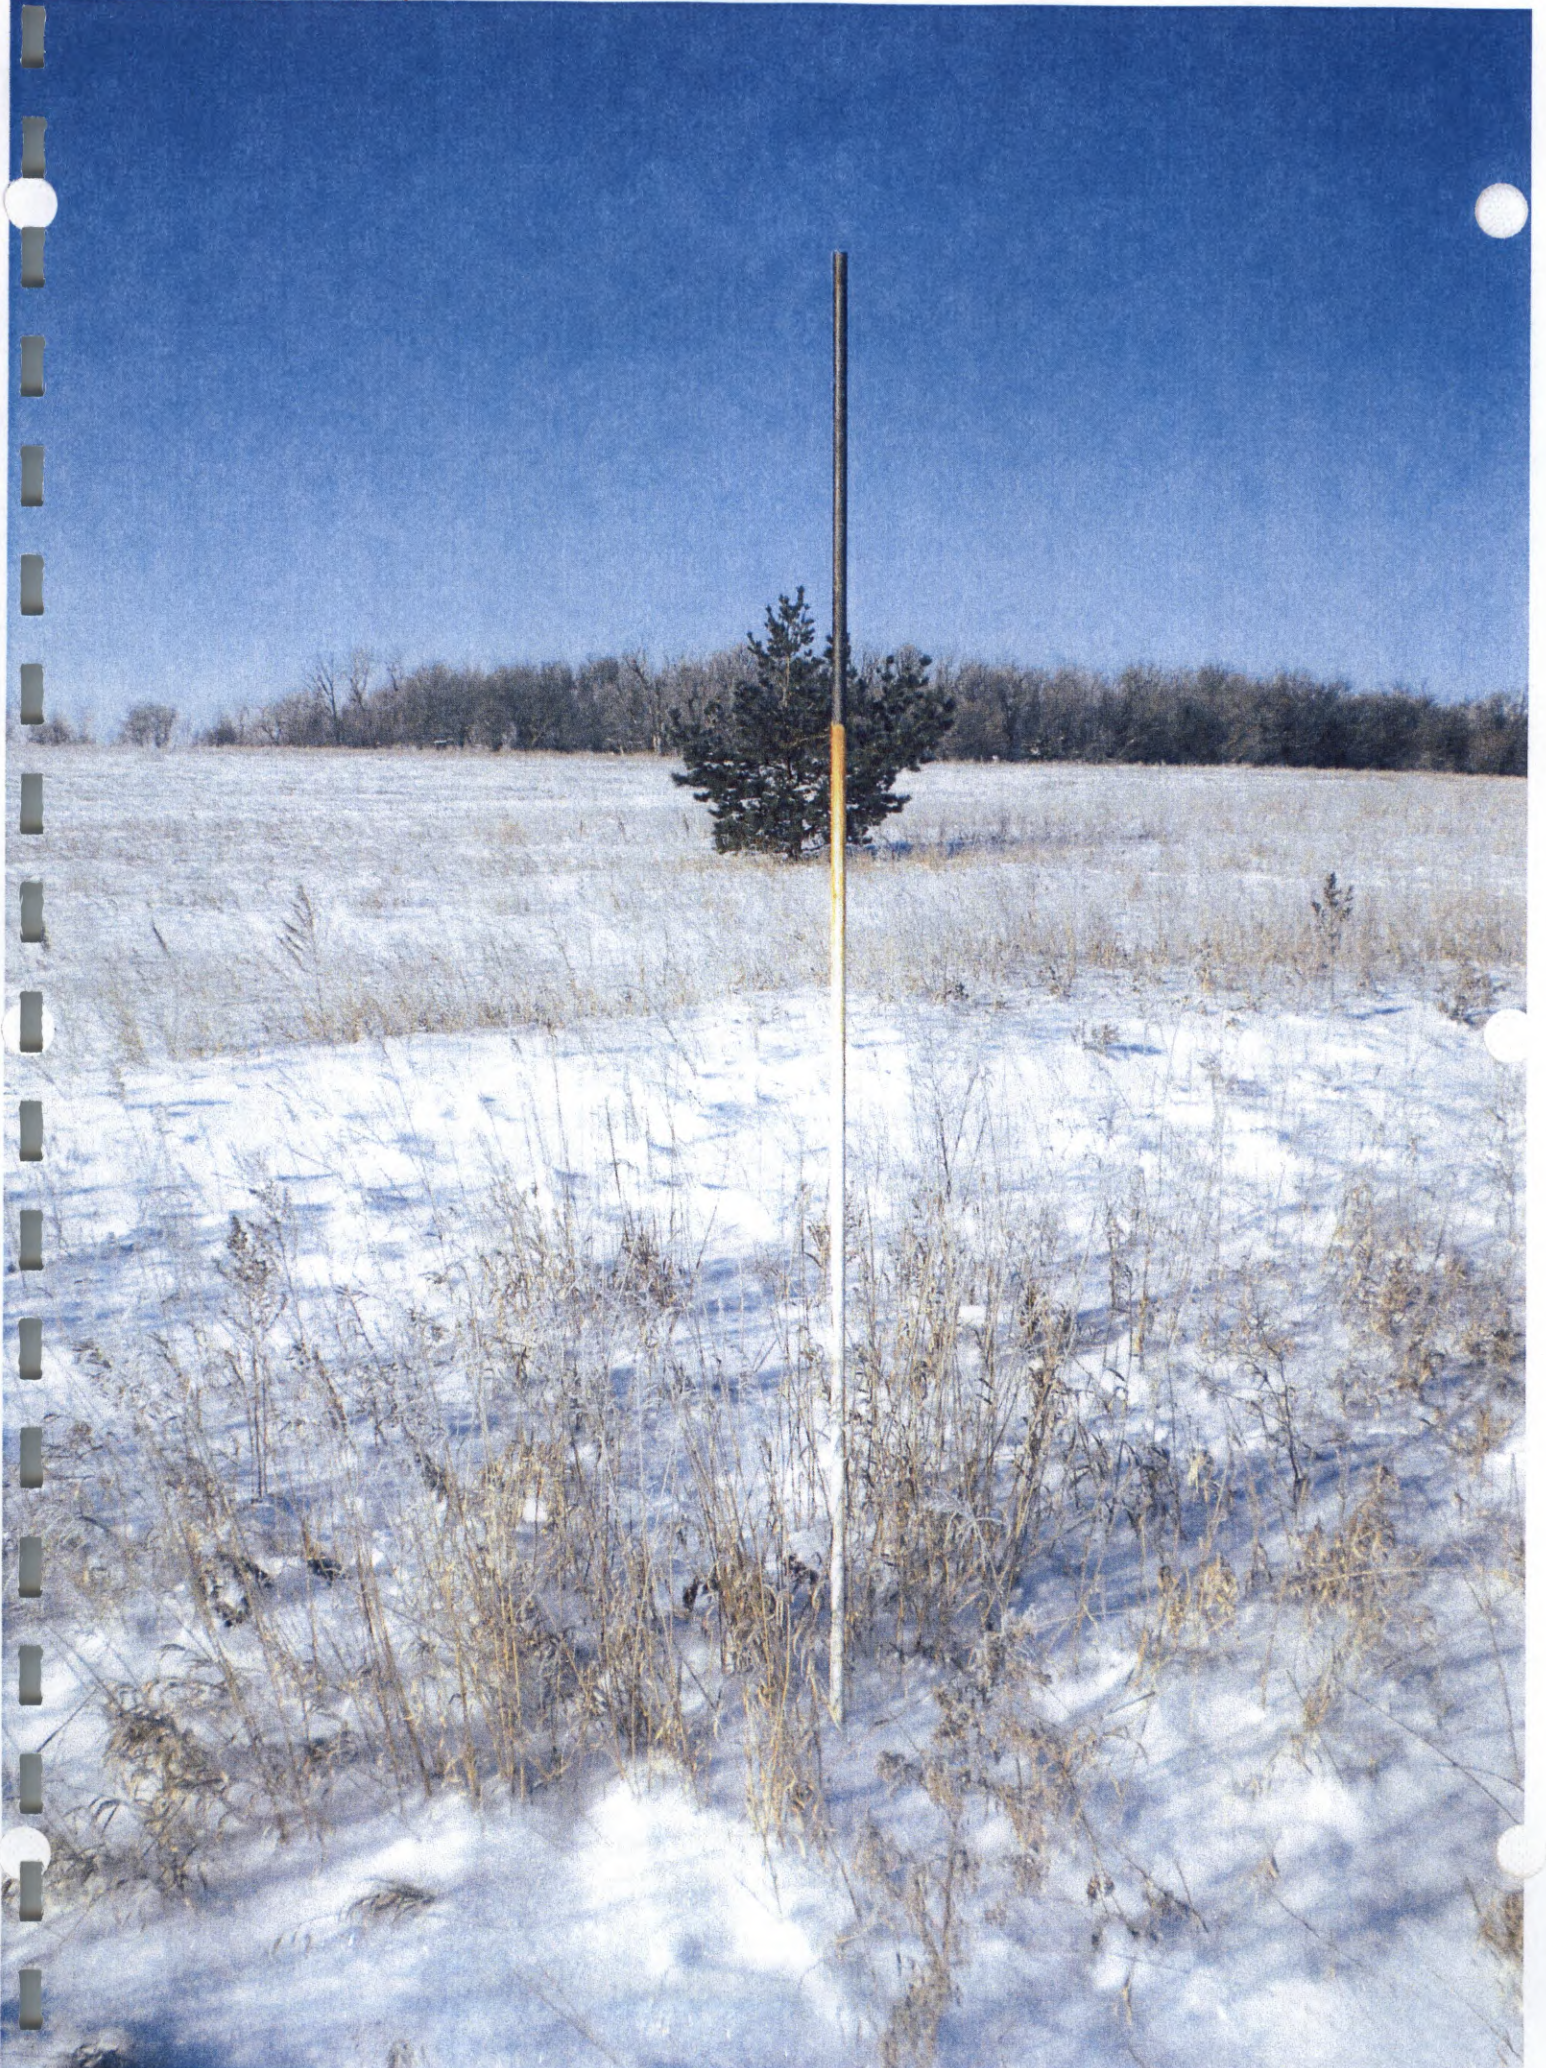
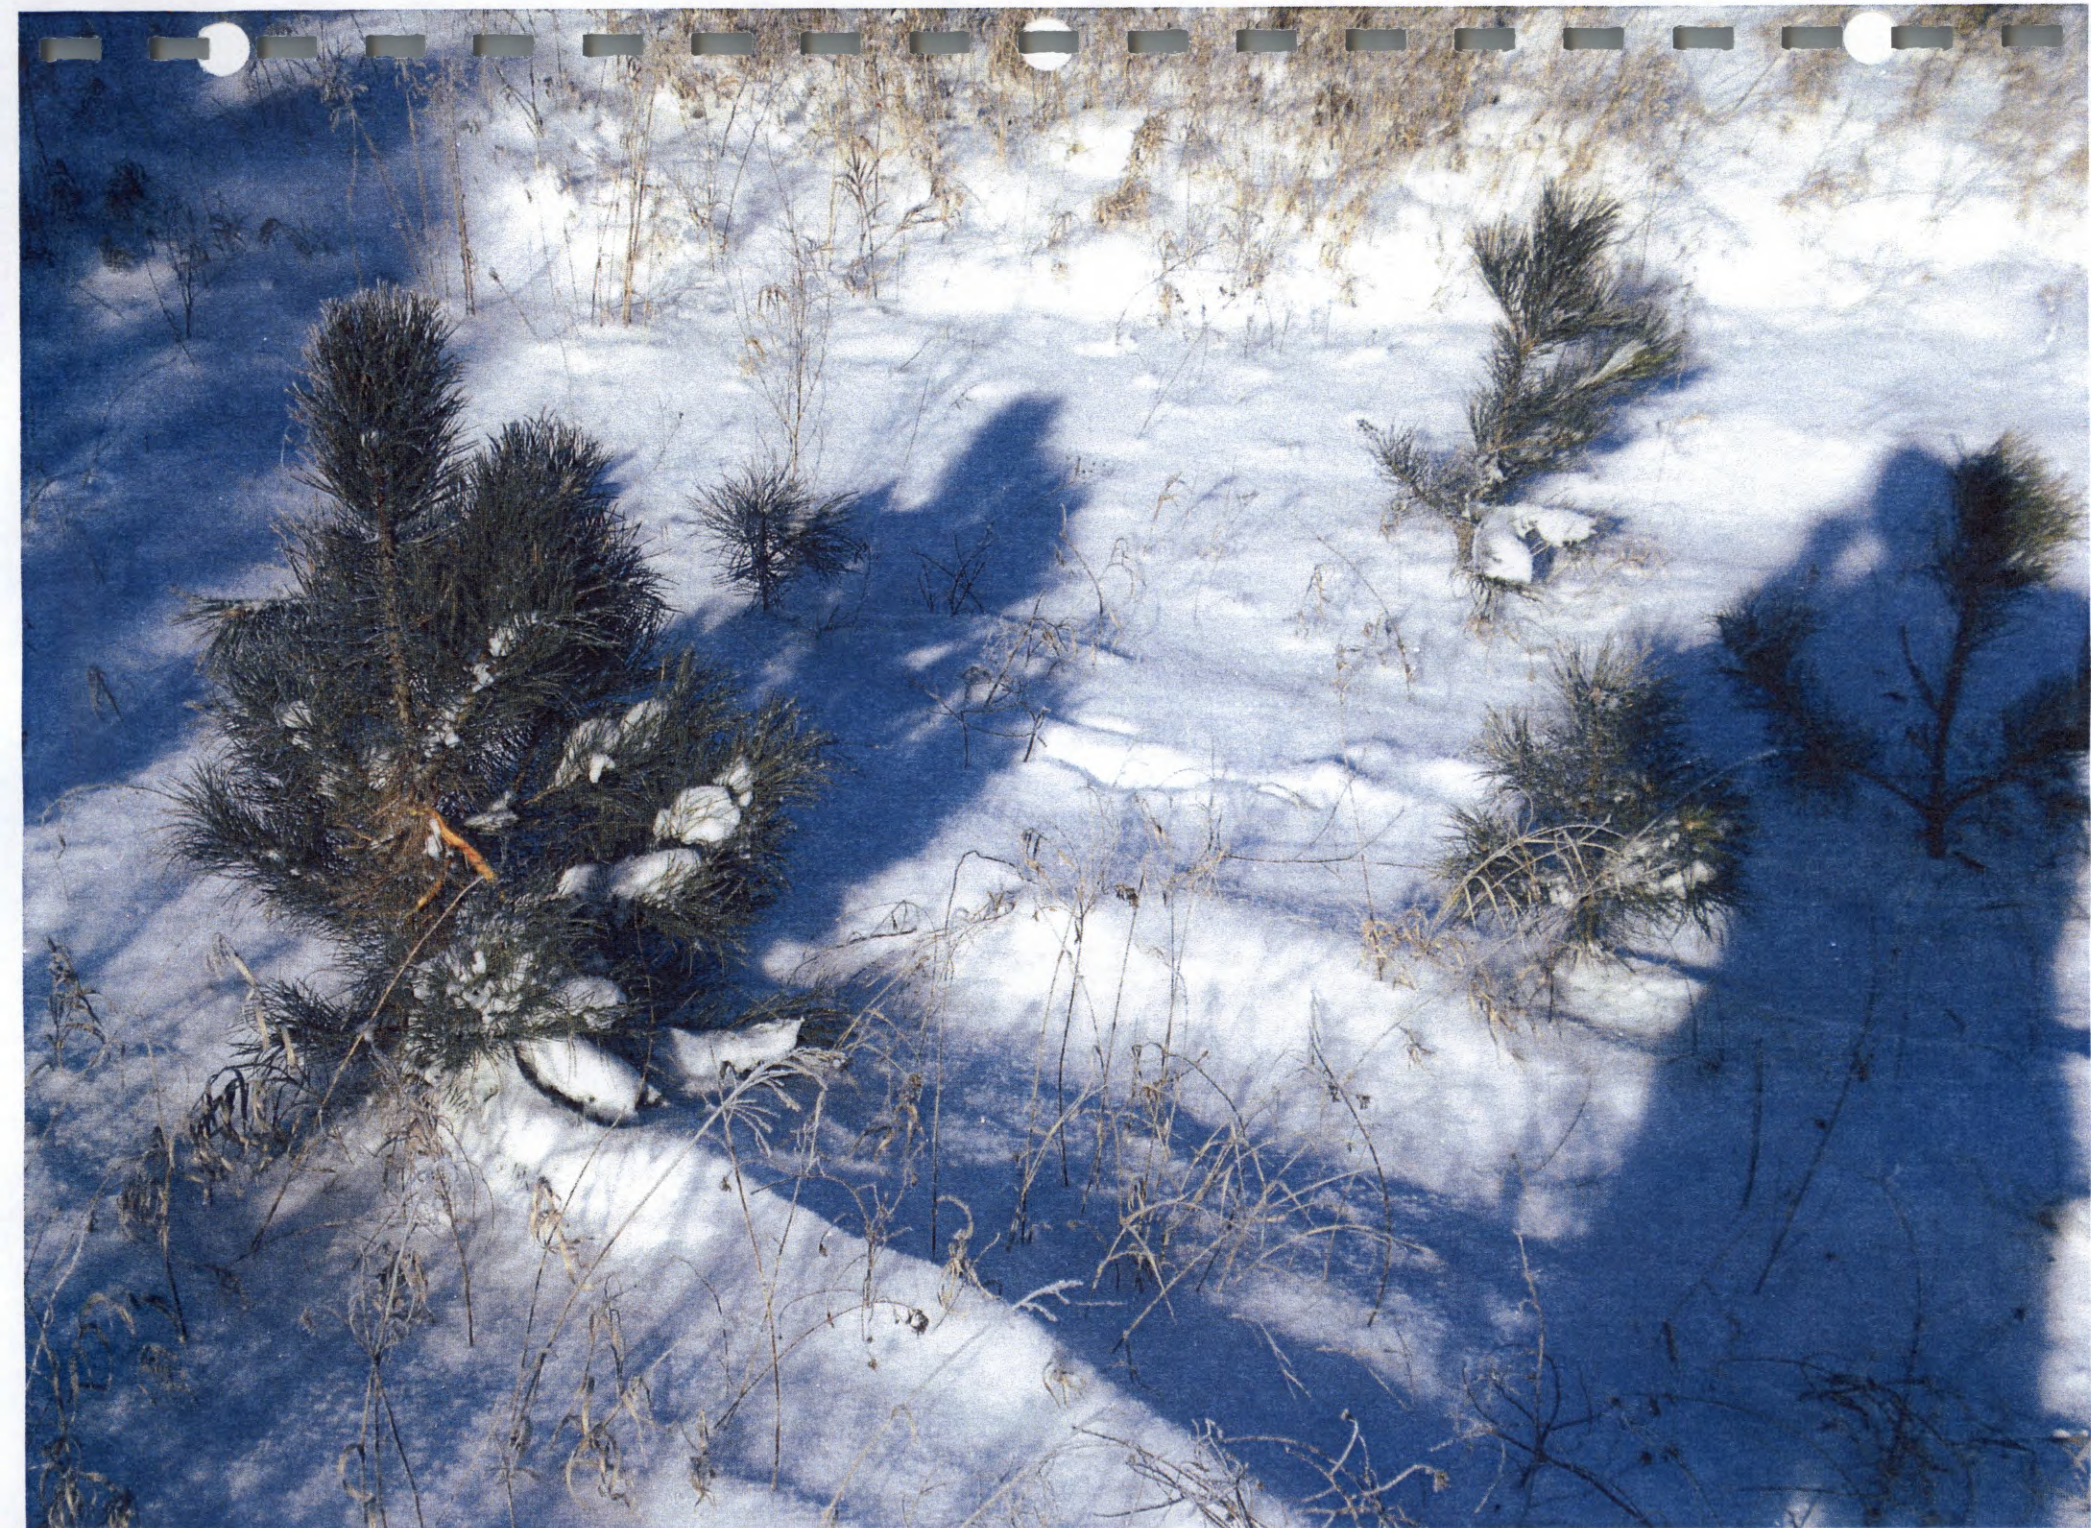
#16 → 2-12' Rods - 100' Apart - series of Rods 5.

Picture # 16 Metal Rods!

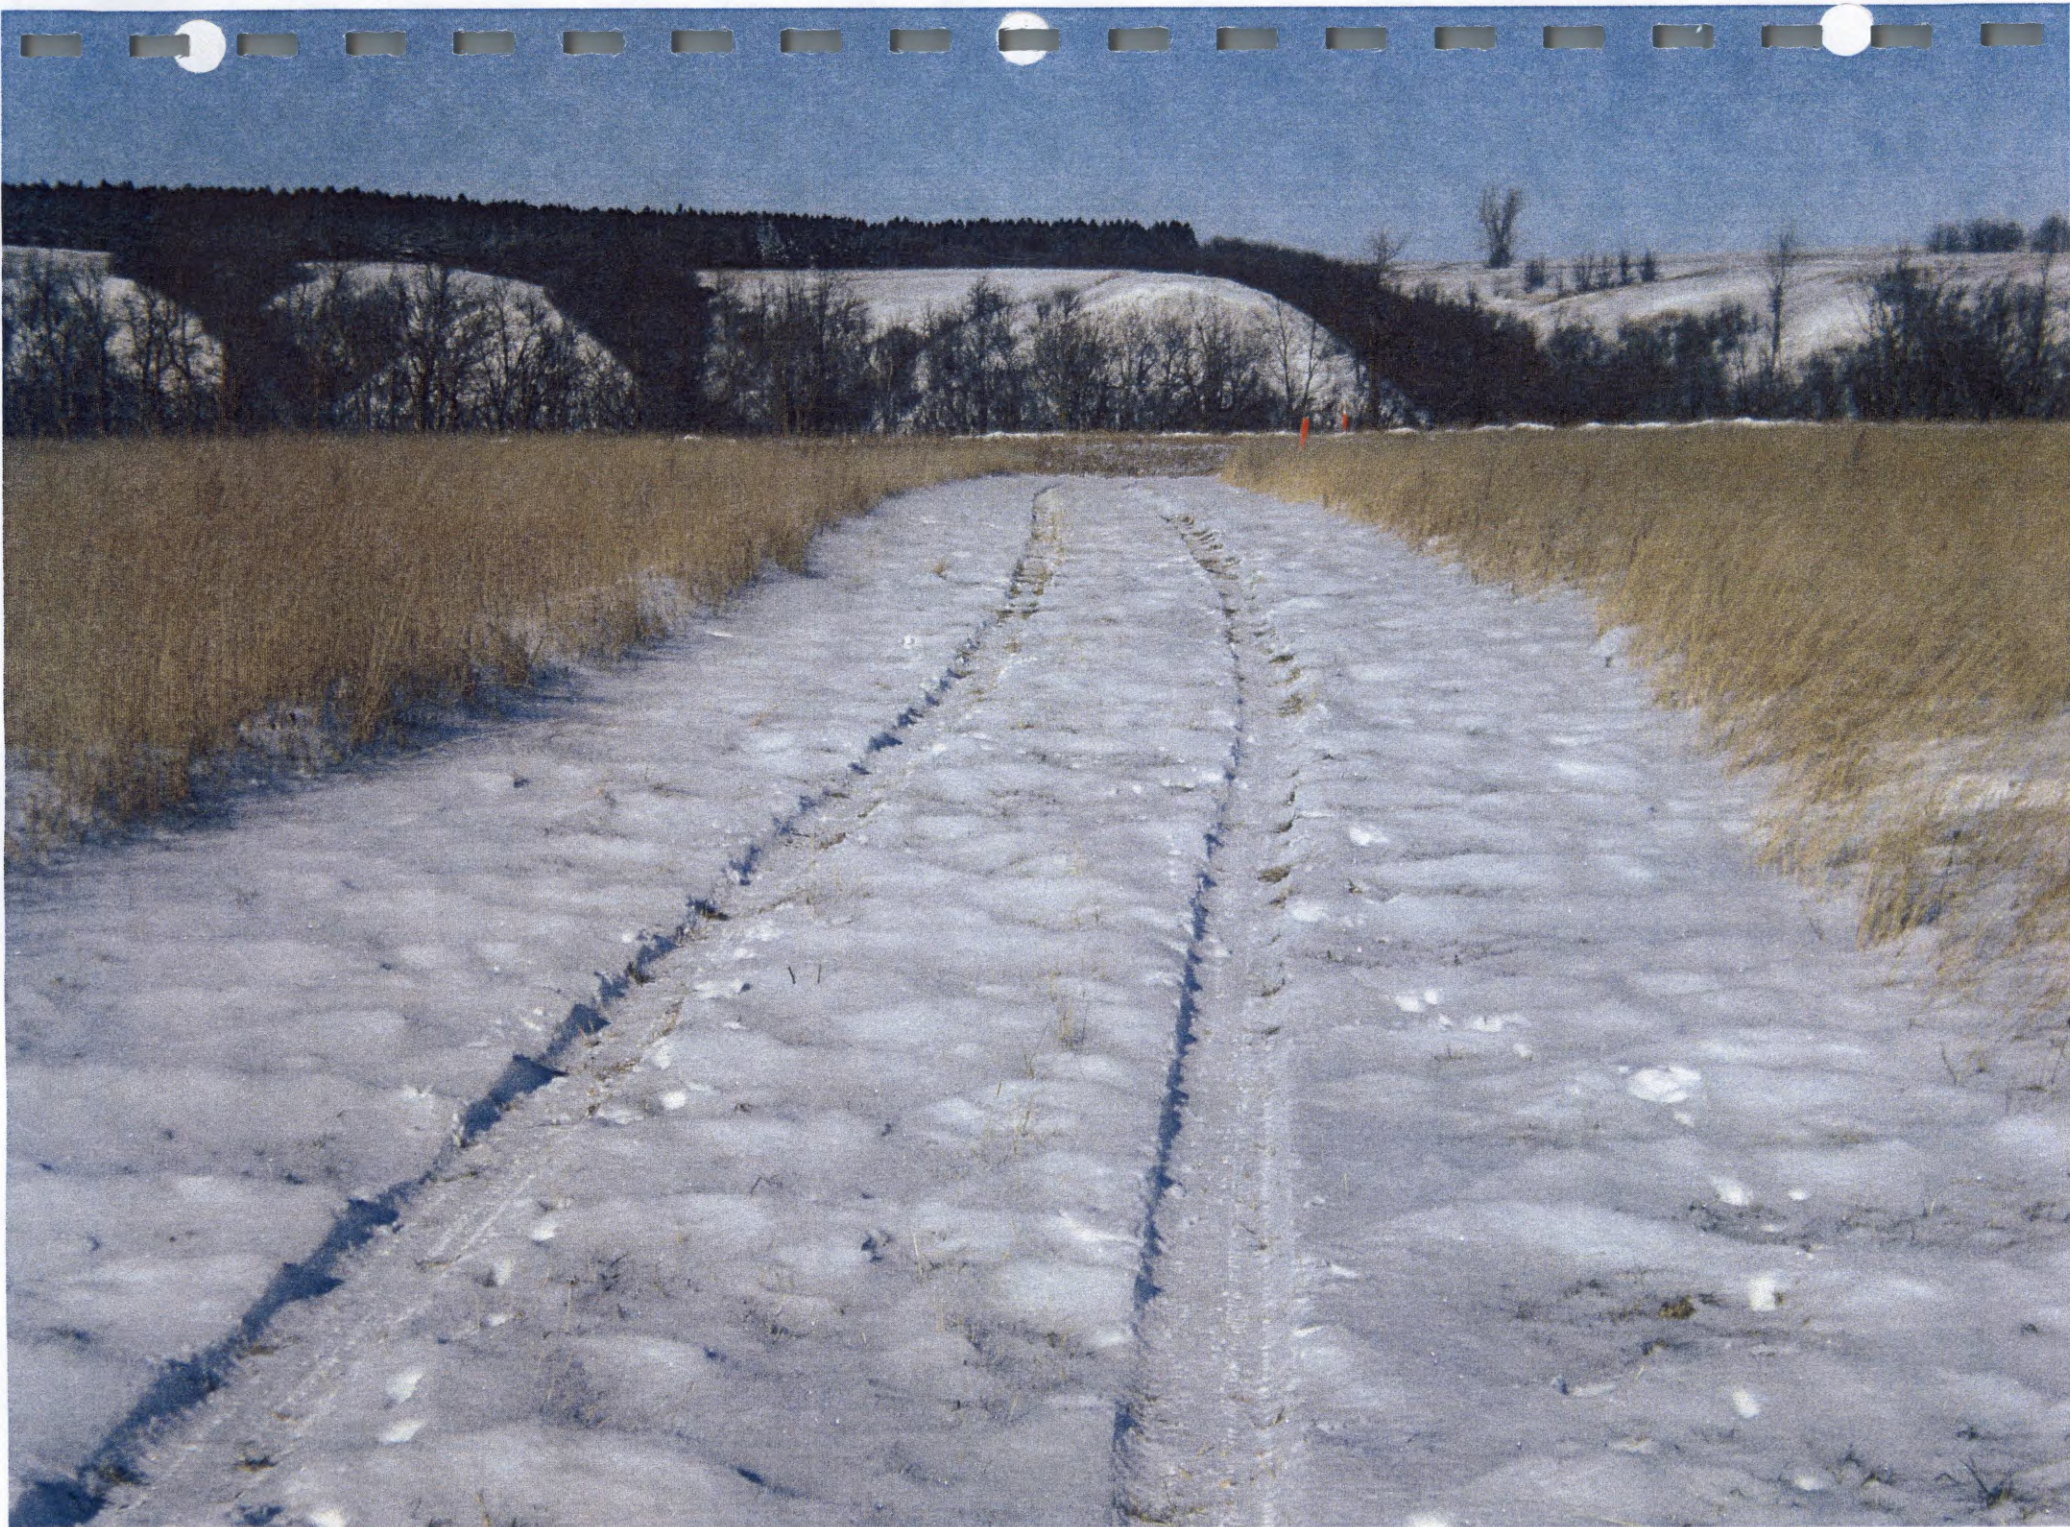
Picture  
#18 → Center of Cover crop looks like it was cut, for service Road

Picture #18 Center of Cover crop, looks to have been Oct.

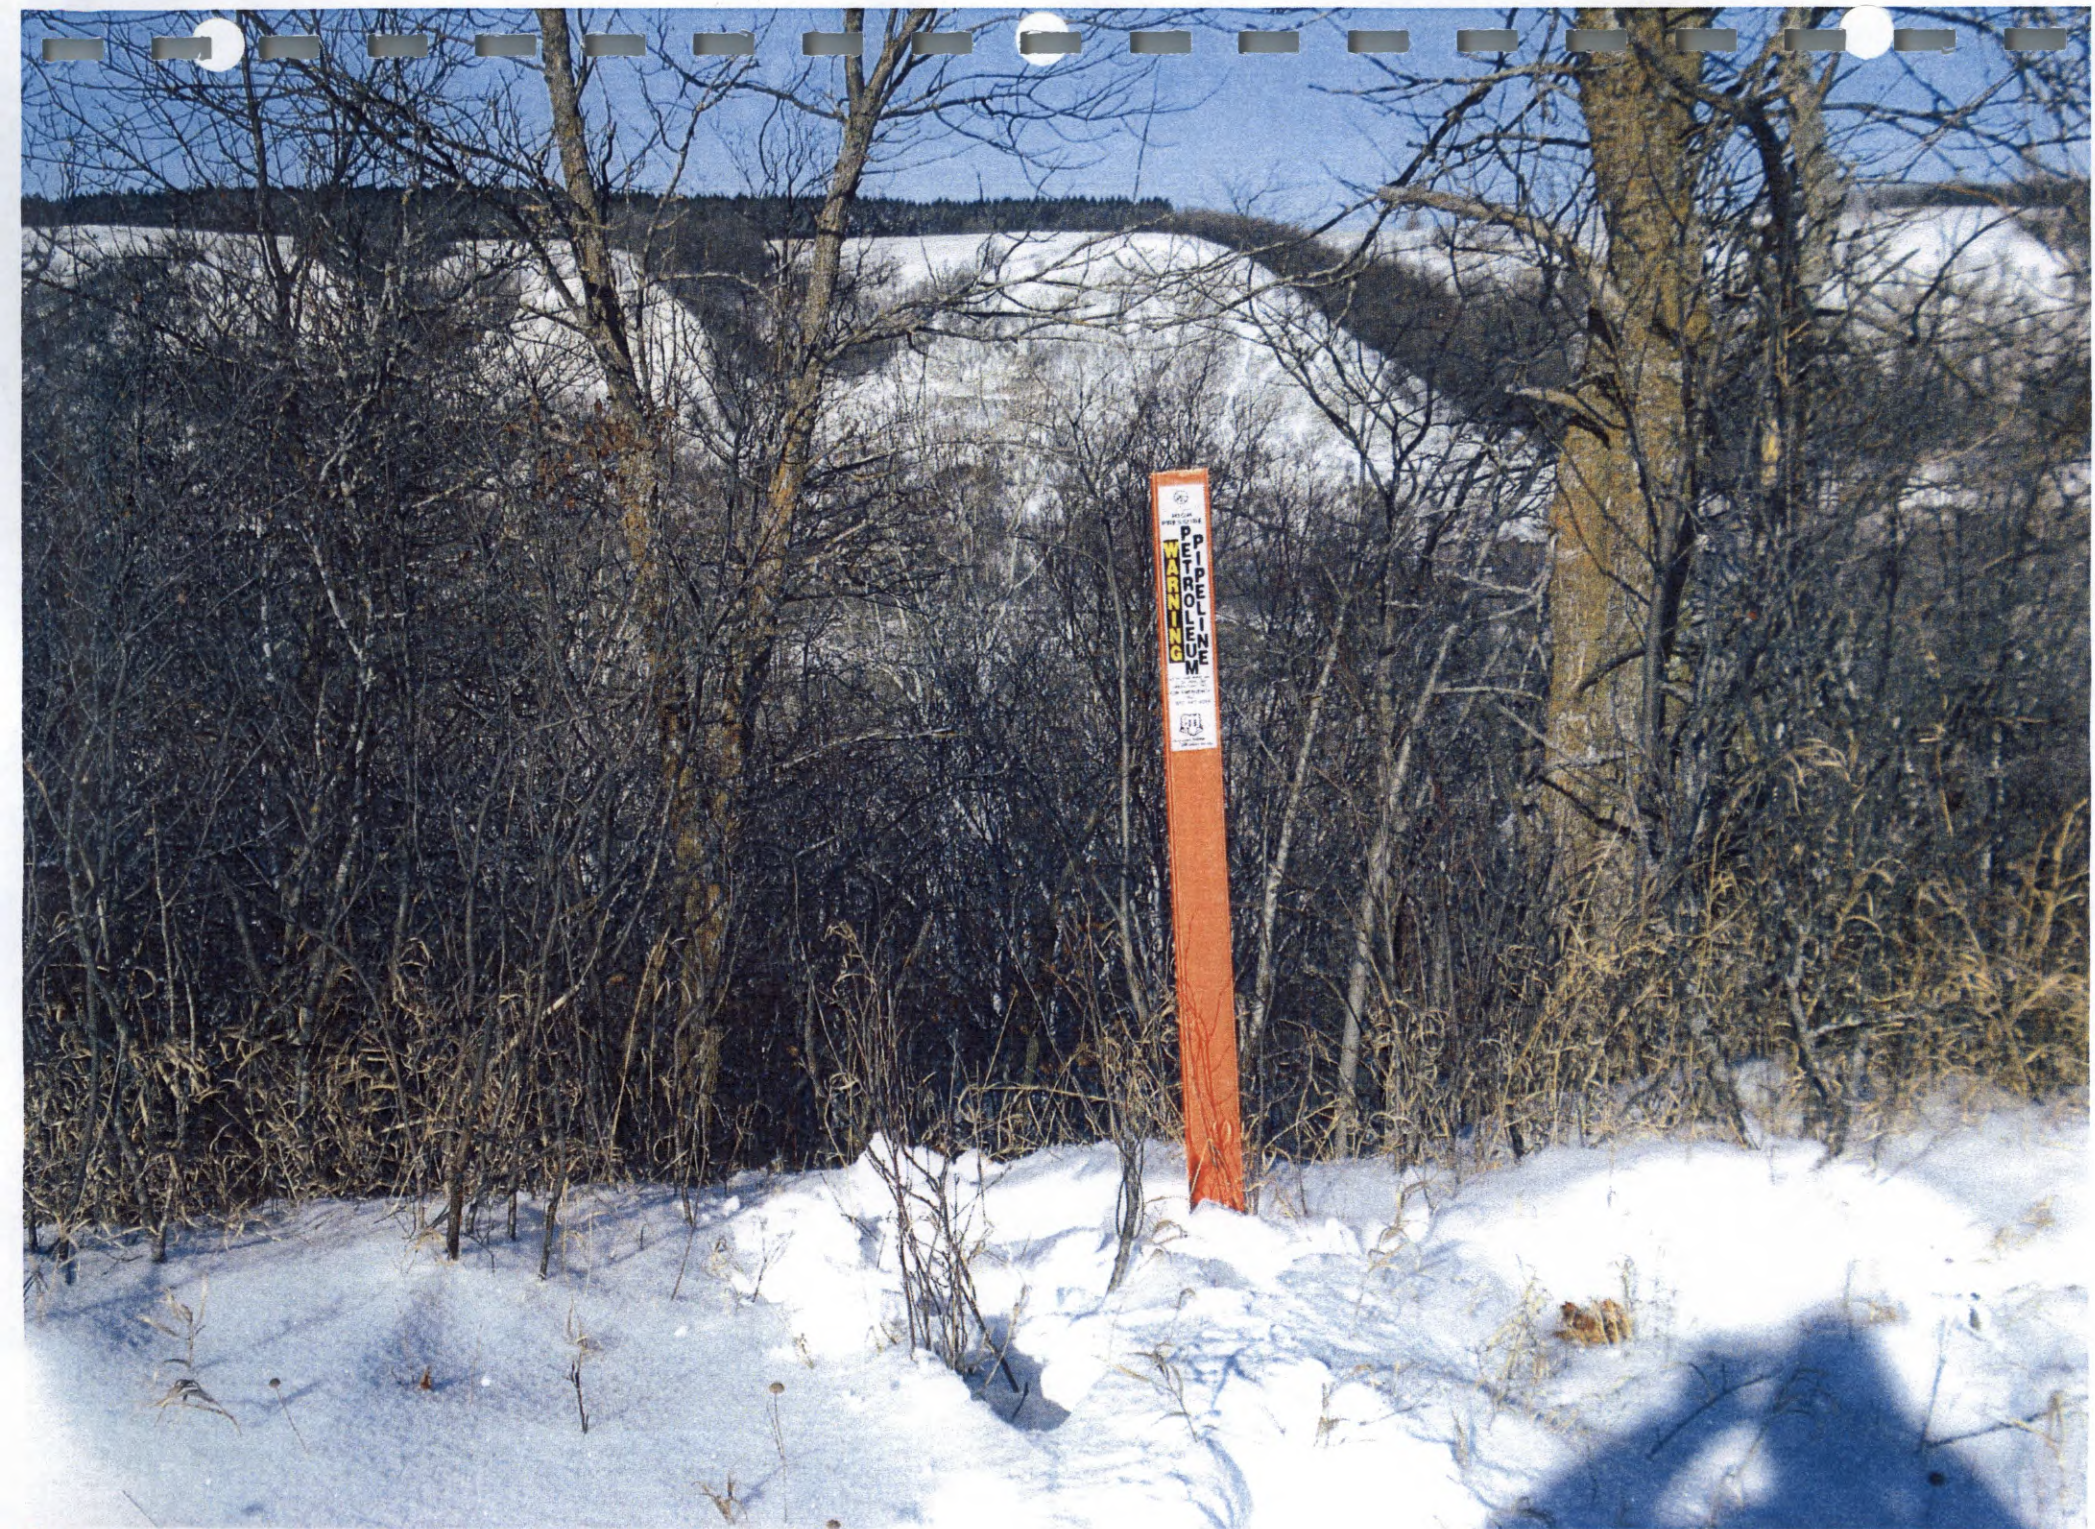
Picture  
#19 → Sign & - orange 2" wide - 5' long - edge South Ridge of Pembina River Gorge

Picture #19 South Ridge of Aembing Gorge

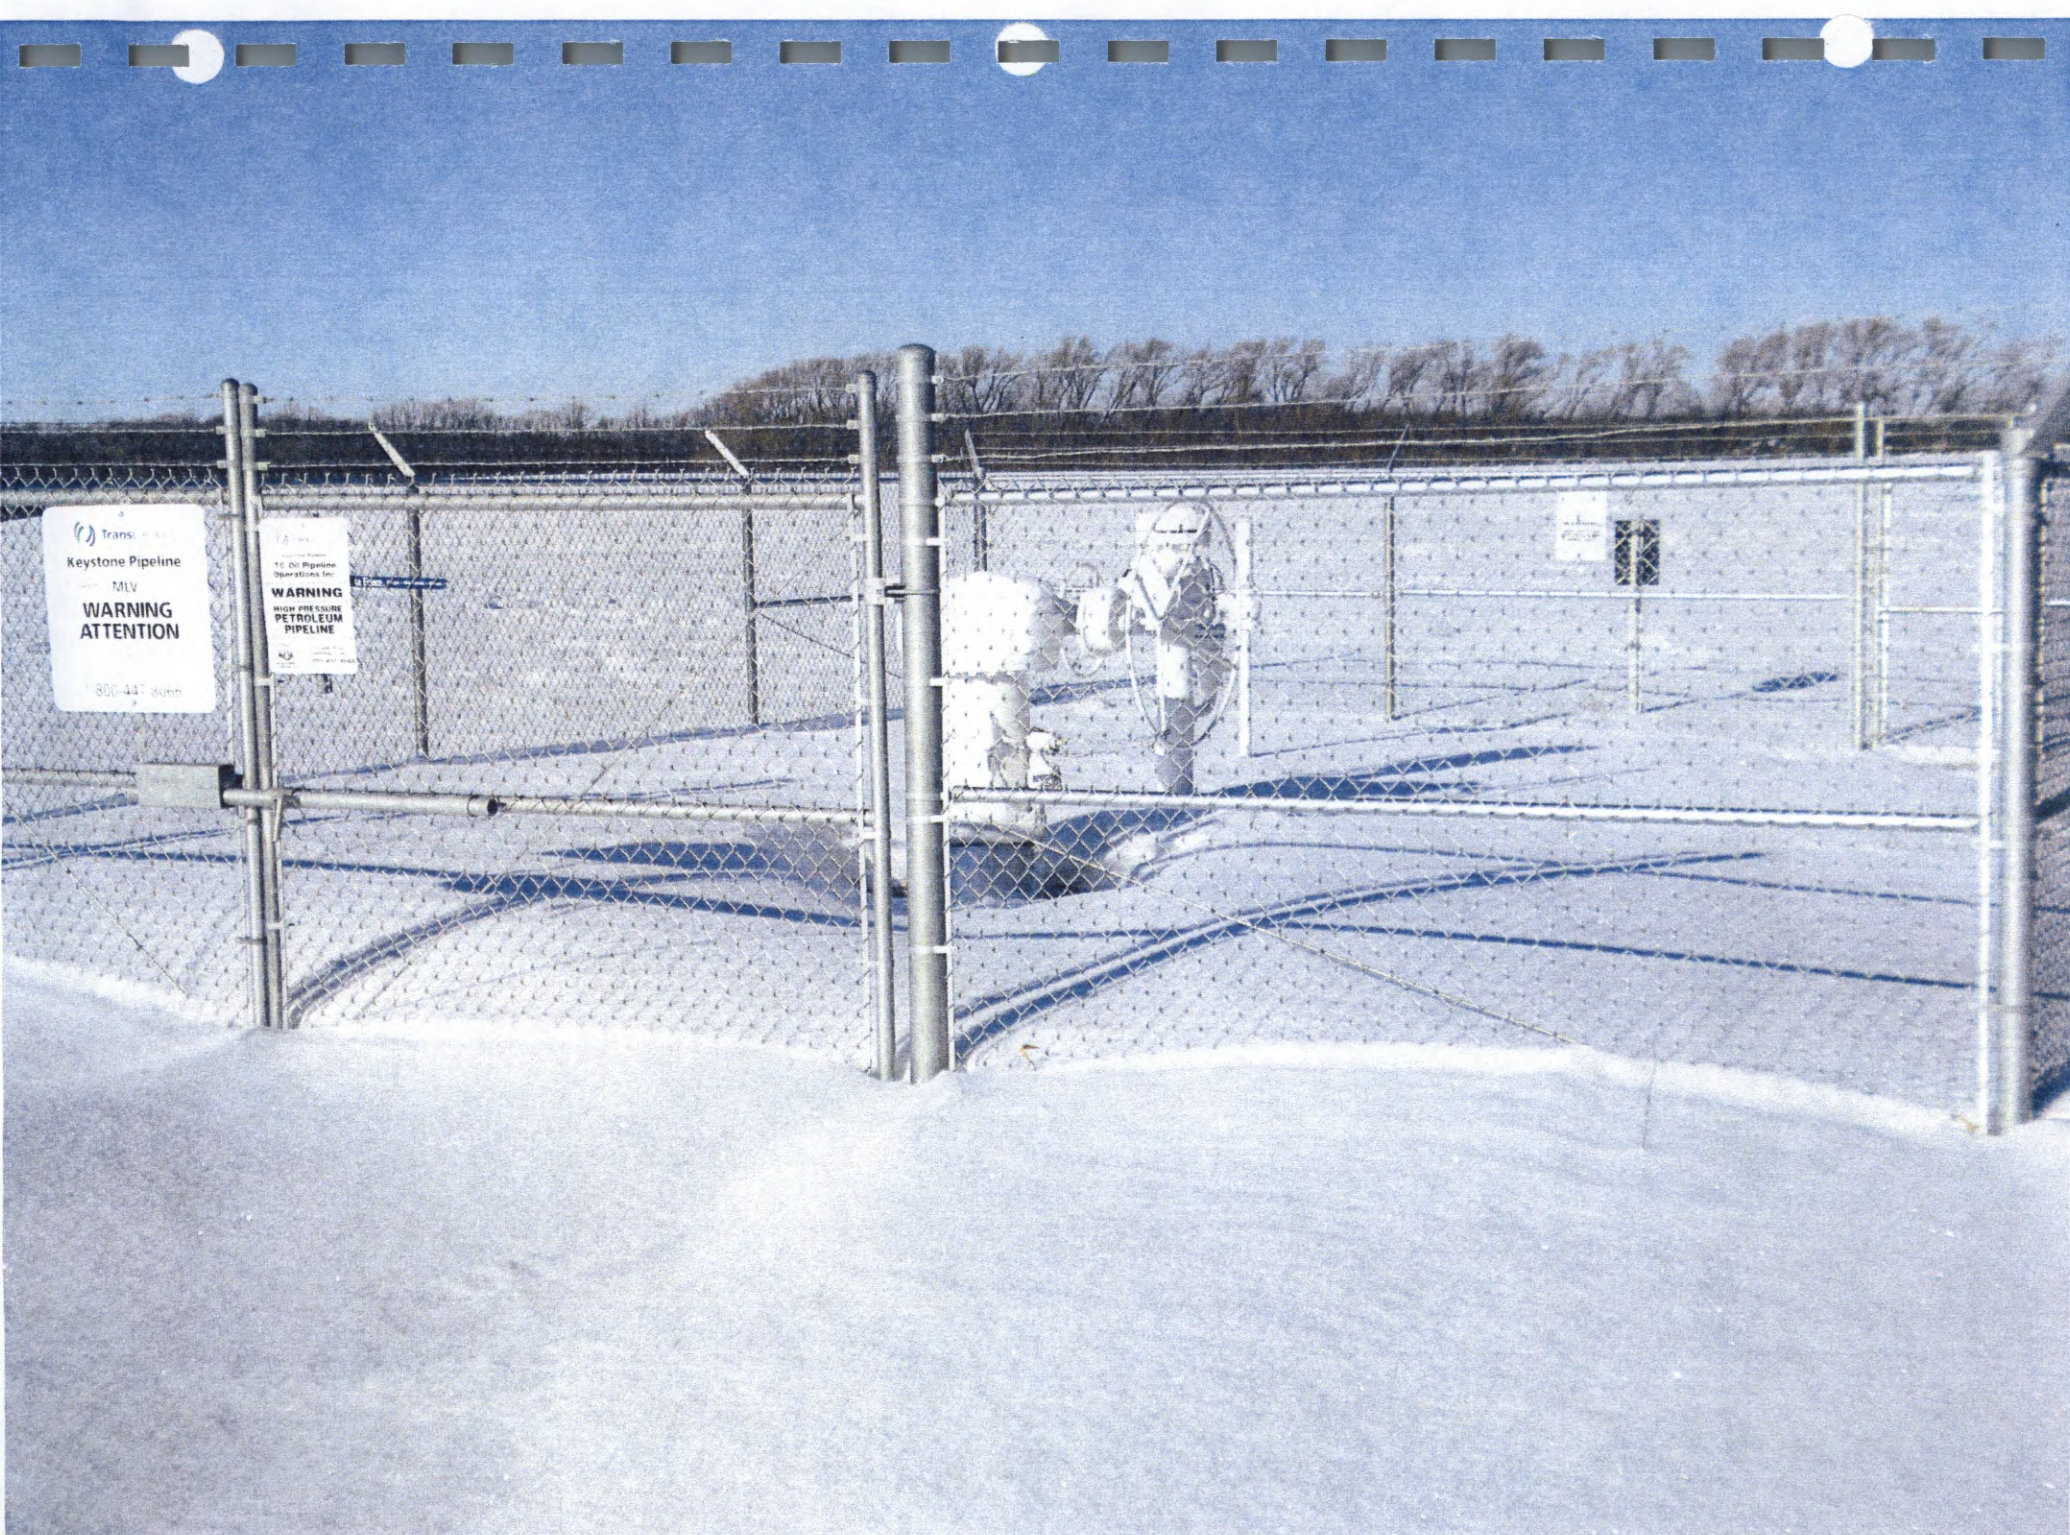
Picture # 20 - Value station (3) 30x40, Gates locked as are each value, North side of Rd. 200' off Road  
Signs for  $\text{E}$  of pipe on both sides of Road  
No subsidence on Roadway  
Field look to have natural flow, no subsidence

Picture #20 Valve station mile 9 1st one

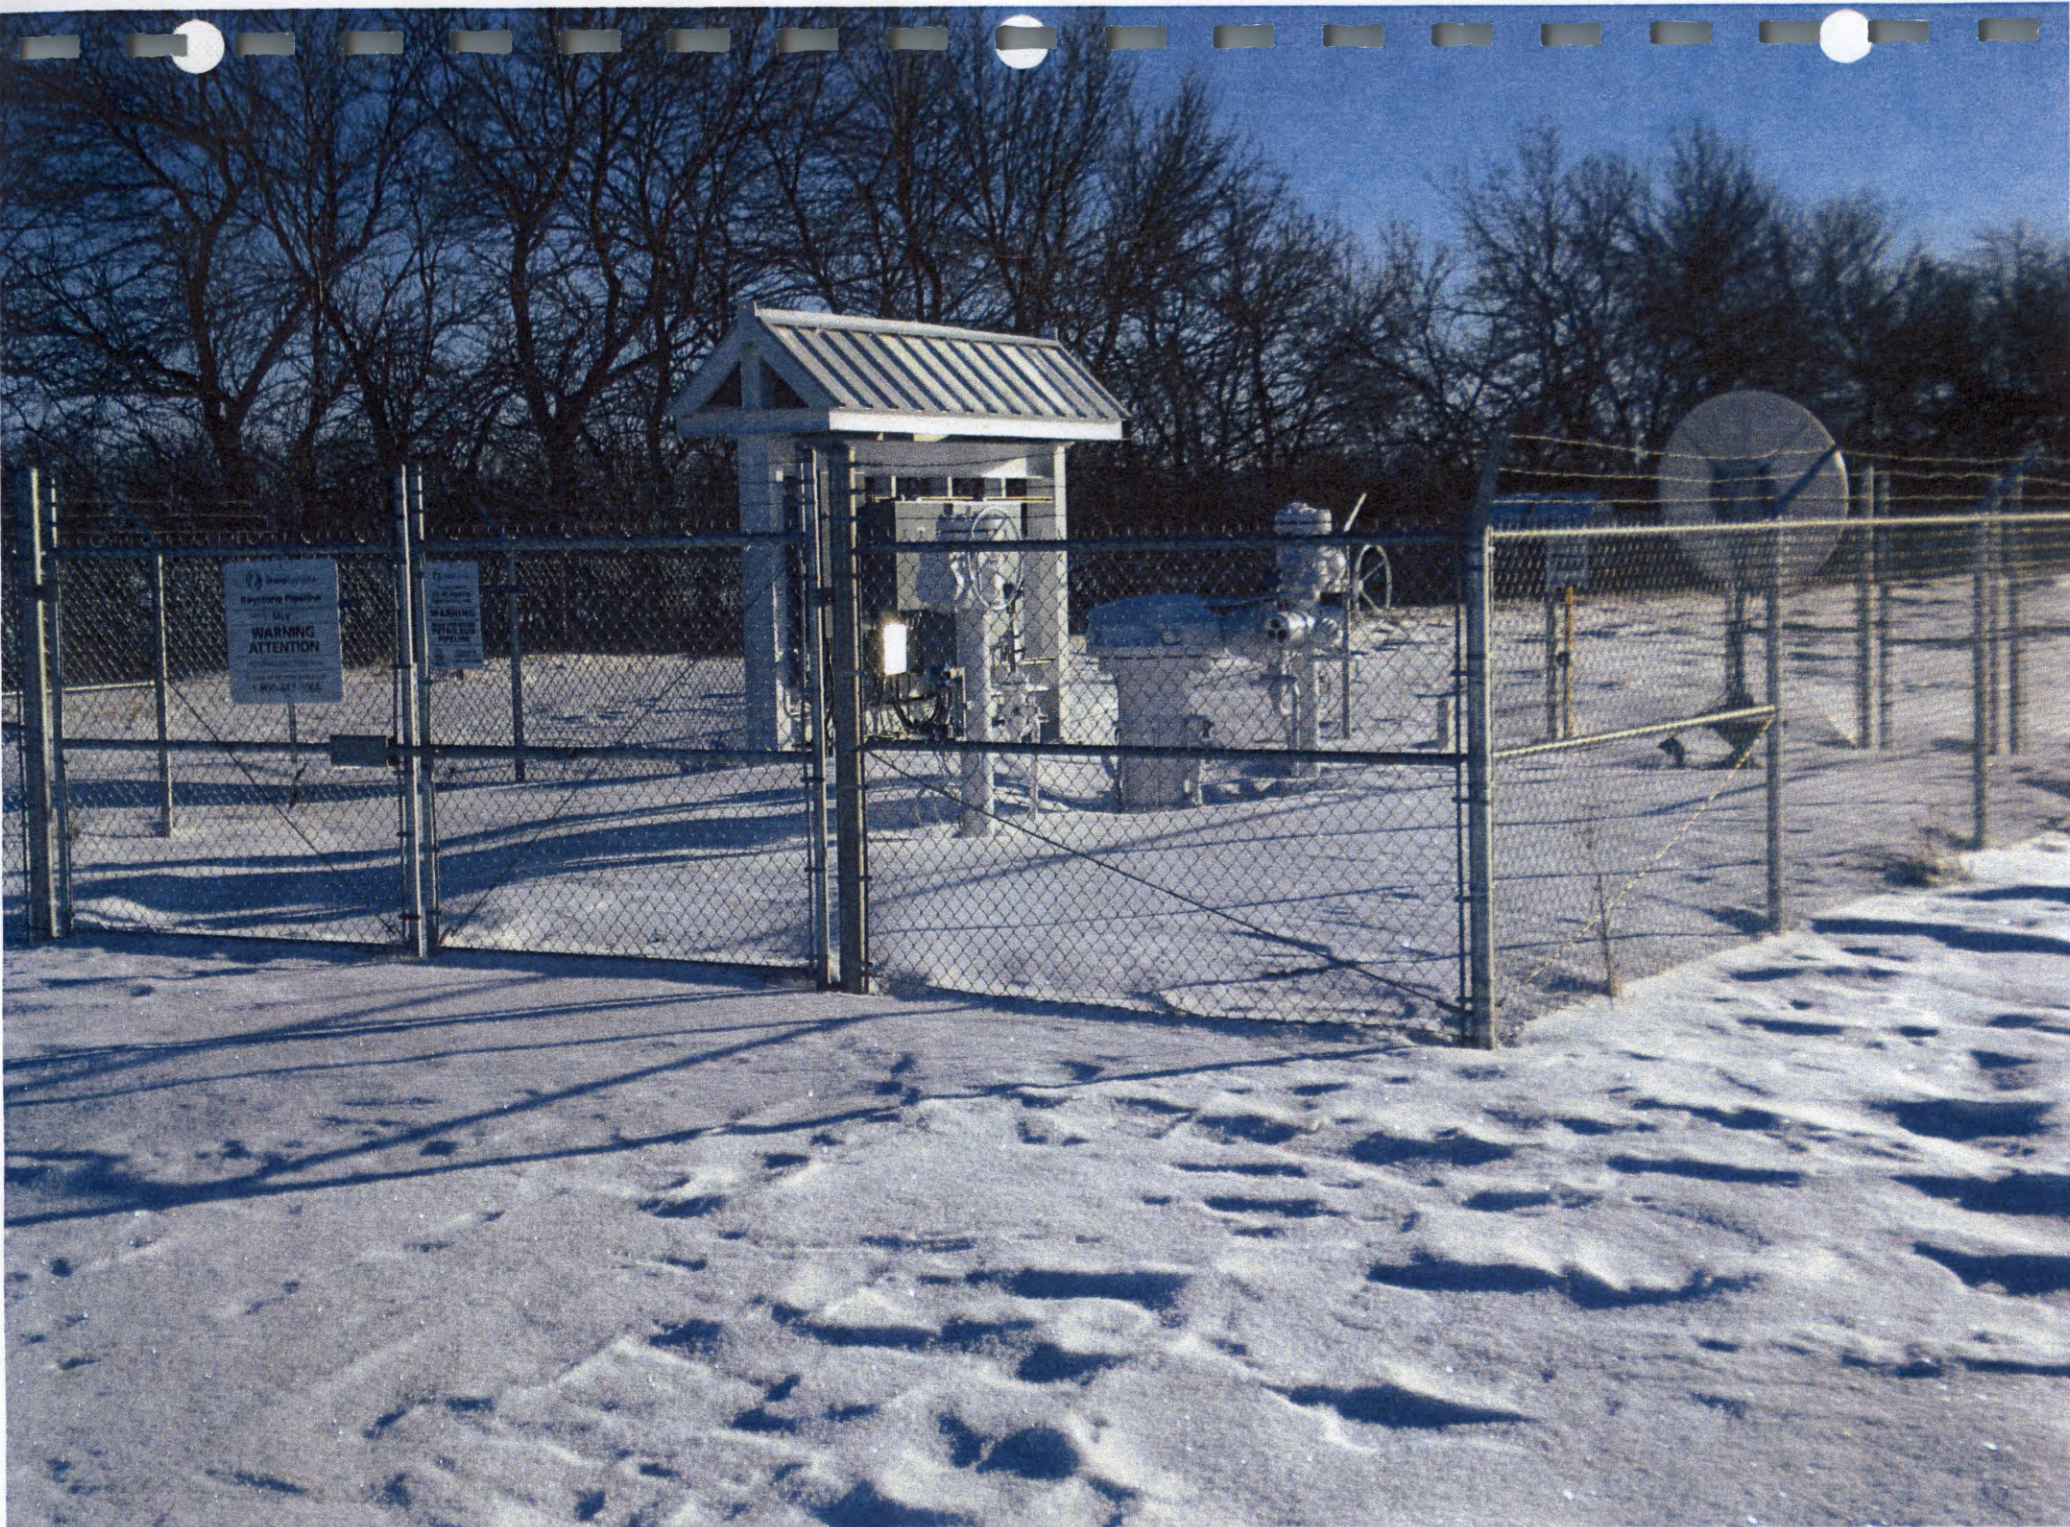
Picture # 01 → Automatic pressure emergency station on South side of Road 200' off Road, 6' chain link topped with barbed wire

Picture #21 Automatic pressure emergency station mile #15 (2nd one)

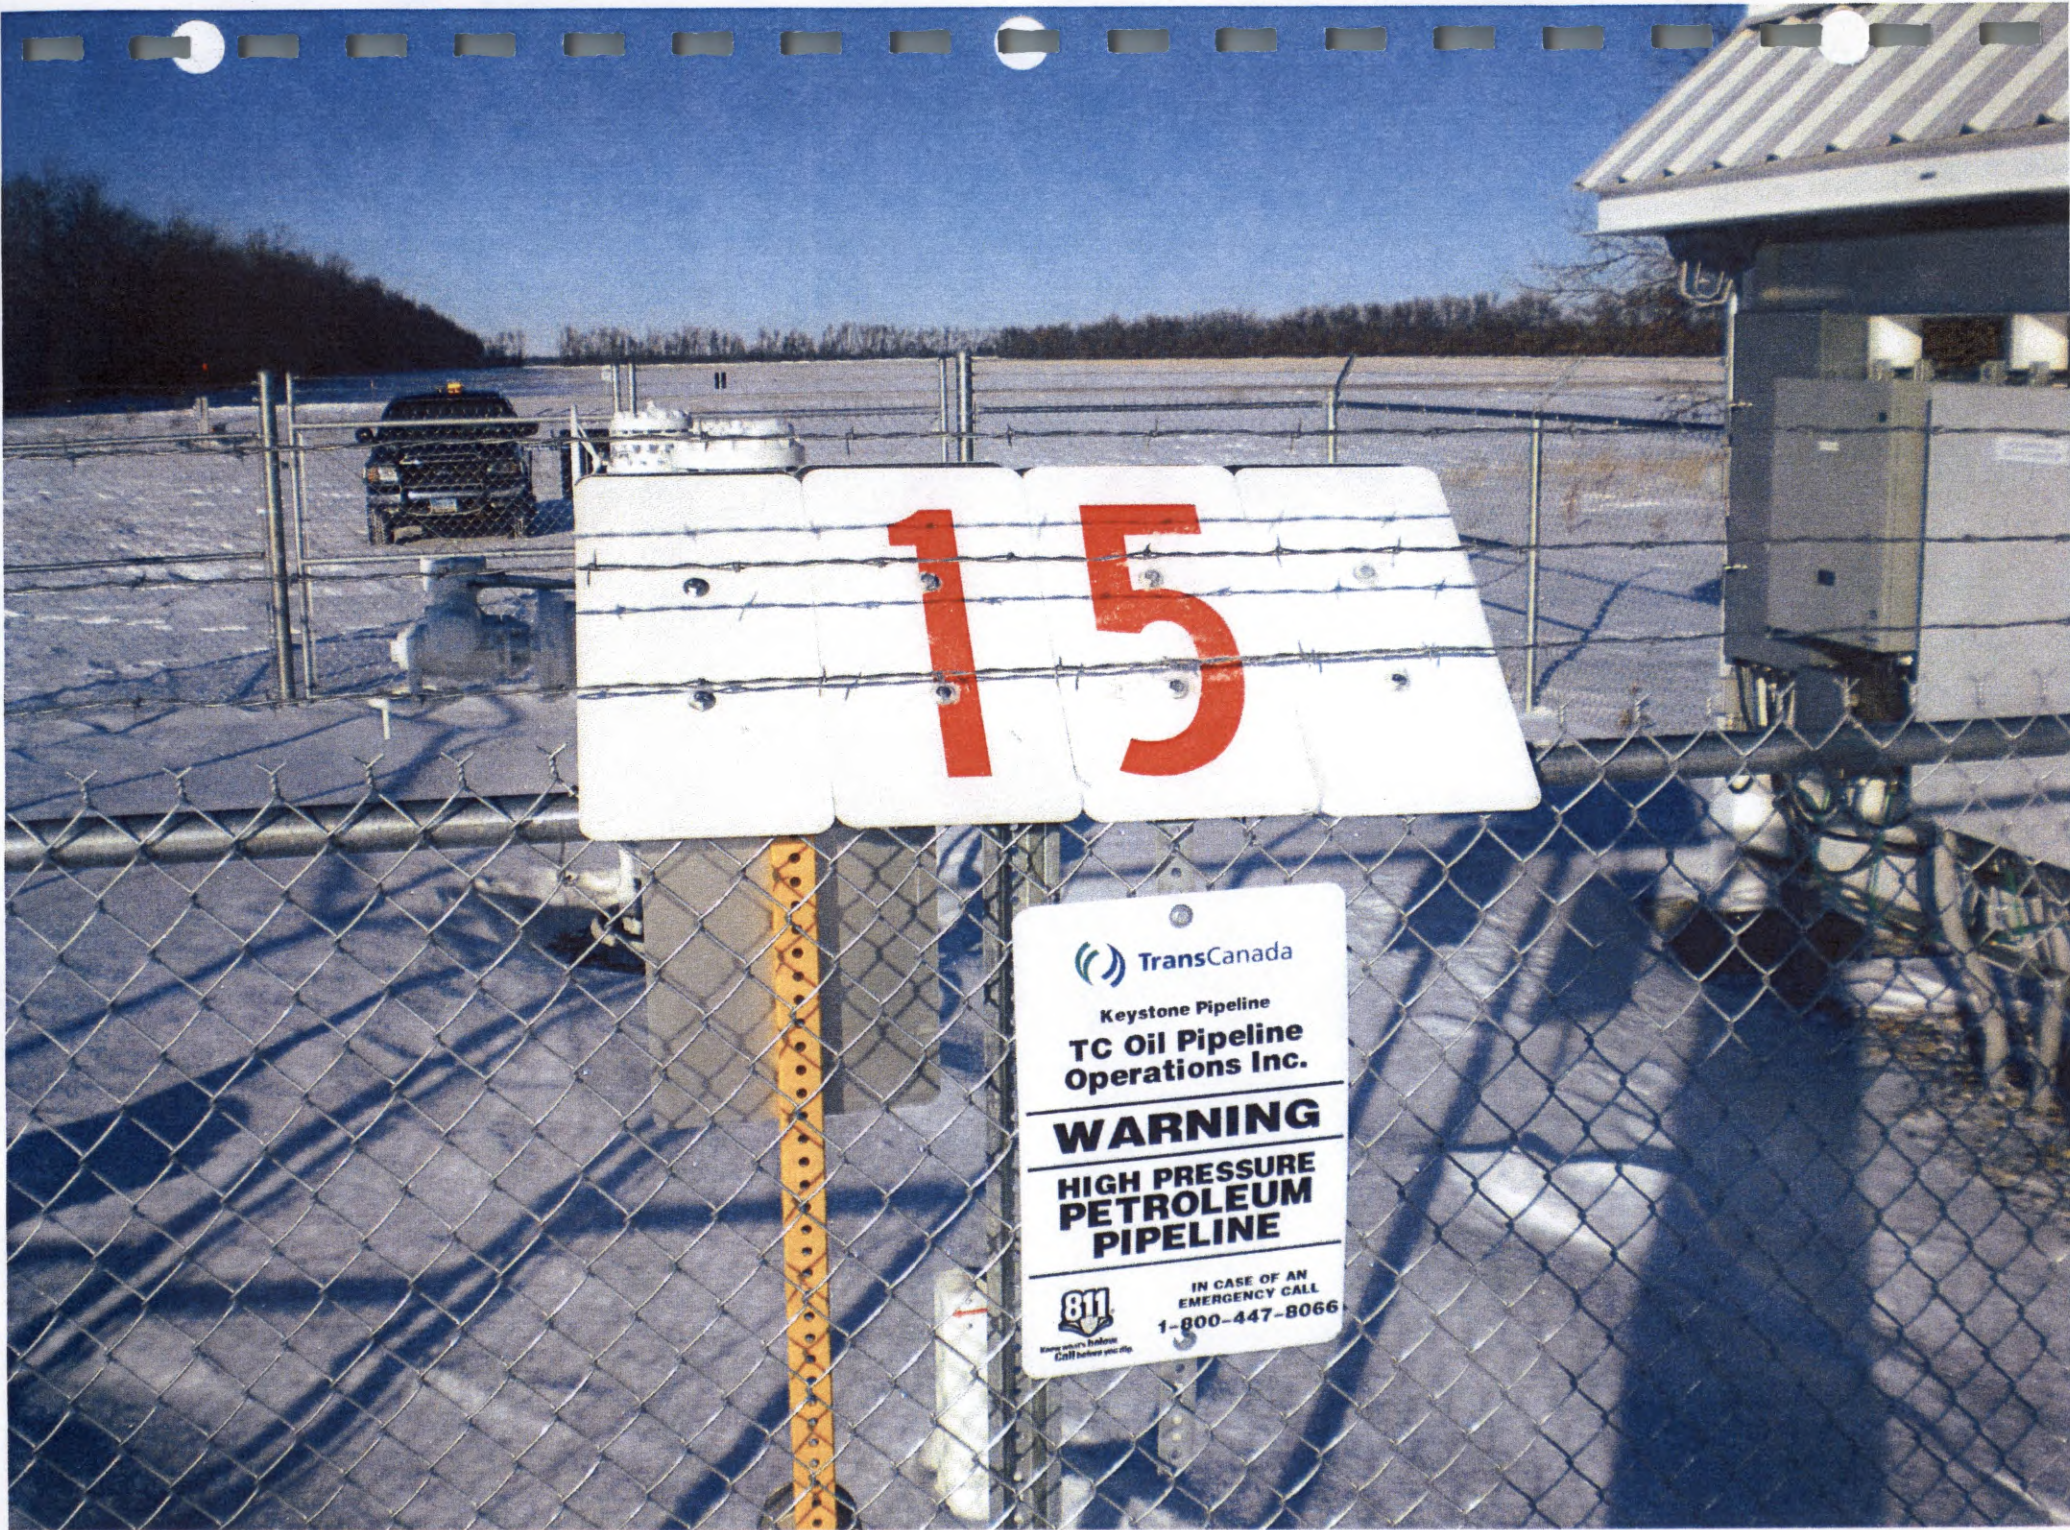
Picture # 02 → Mile marker 15 attached to back of fenced area, these are to be seen from the Air when they do there survey by plane

Picture # 22 mile marker 15 for Aerial Survey
