*Keystone*

**Final Inspection**

*1-5-2011*

PROJECT Keystone Pipeline - North Spread

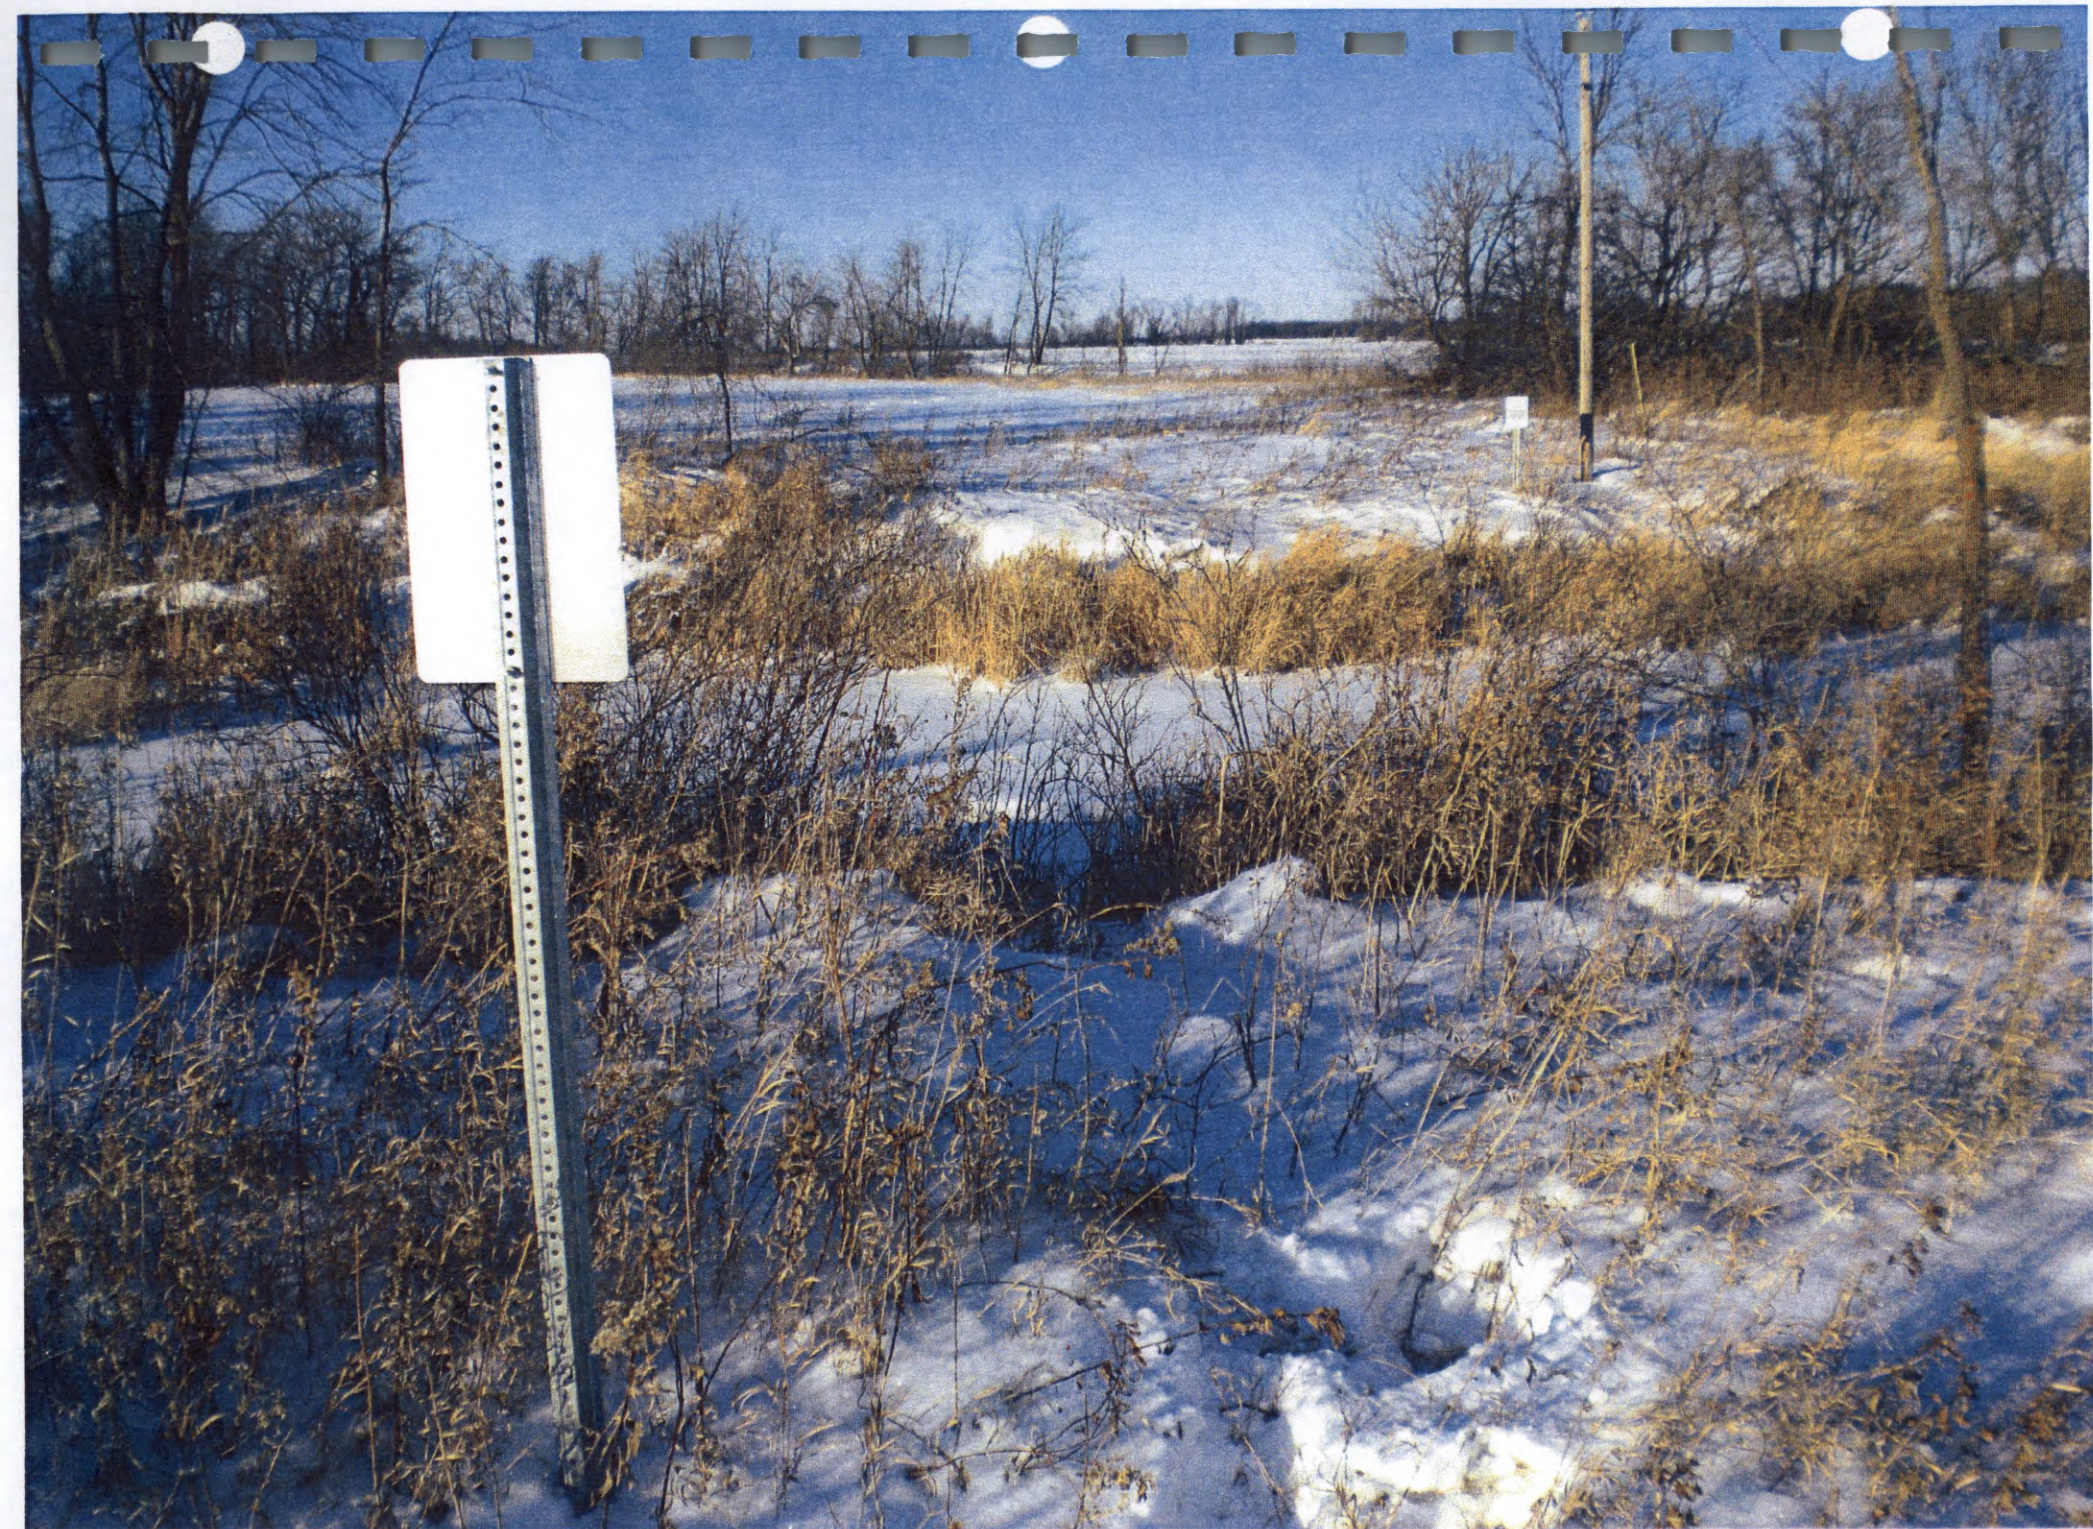
Picture #23 on North side of Hwy 5 Signs for  $\varnothing$  of pipe on both side of small creek about 250 yds from Hwy.

Picture # 23 North of Hwy 5

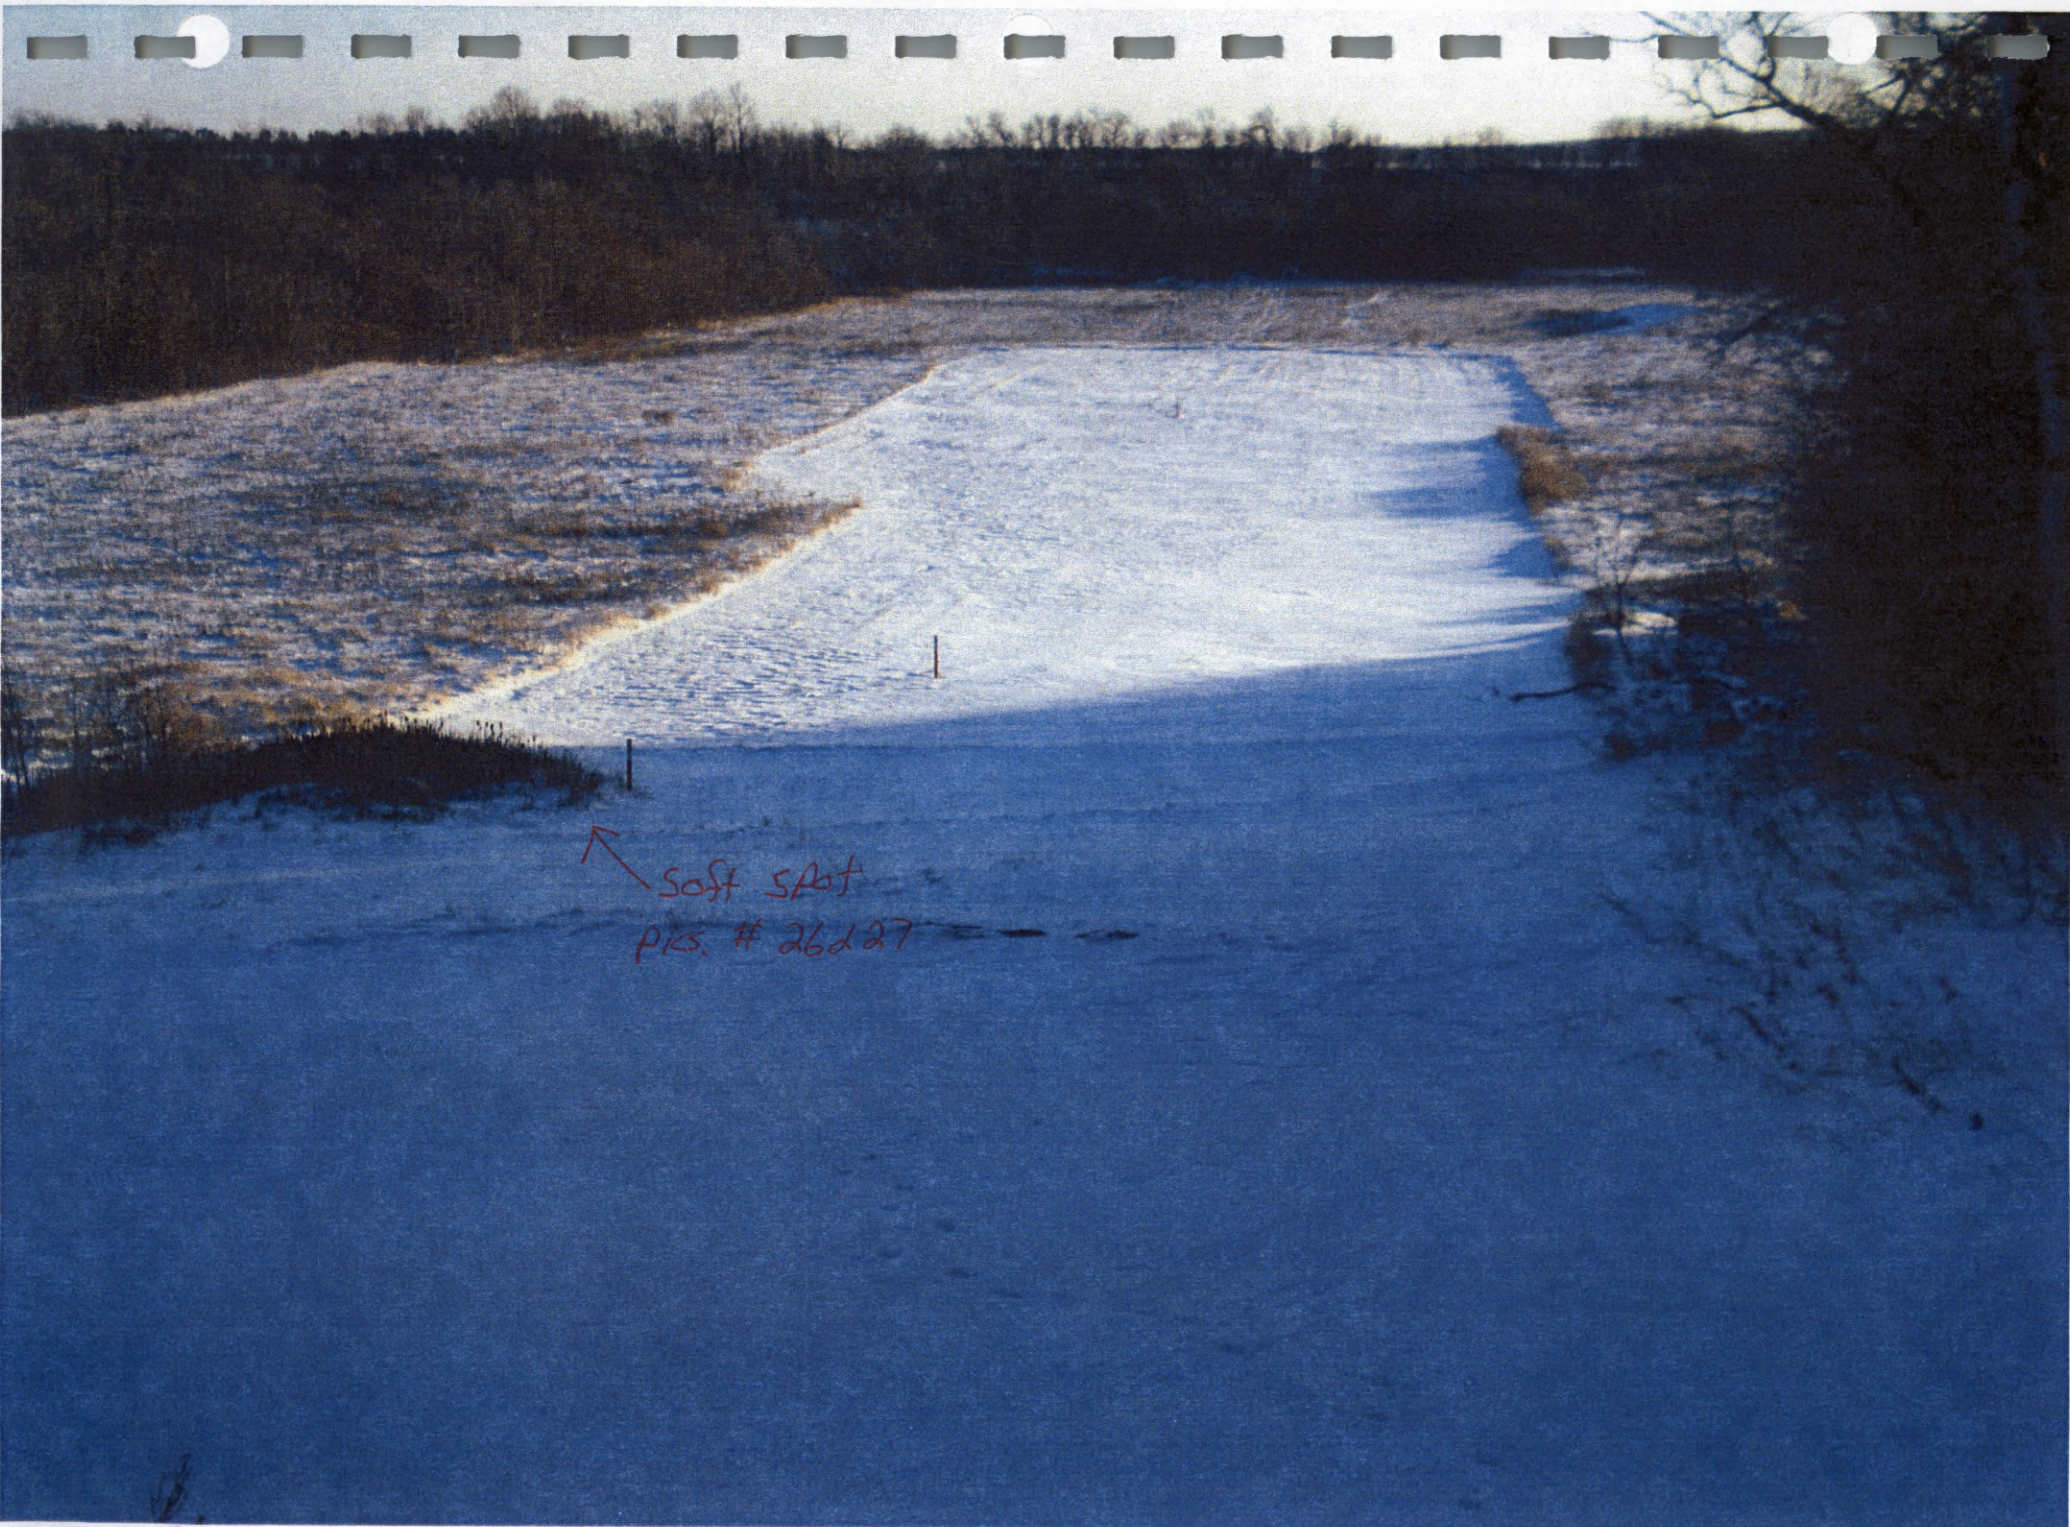
Picture #24 → looks to be a large area that needs to be replanted with cover crop, this area is north of the tongue River

Picture # 24 Needs Cover Crop?

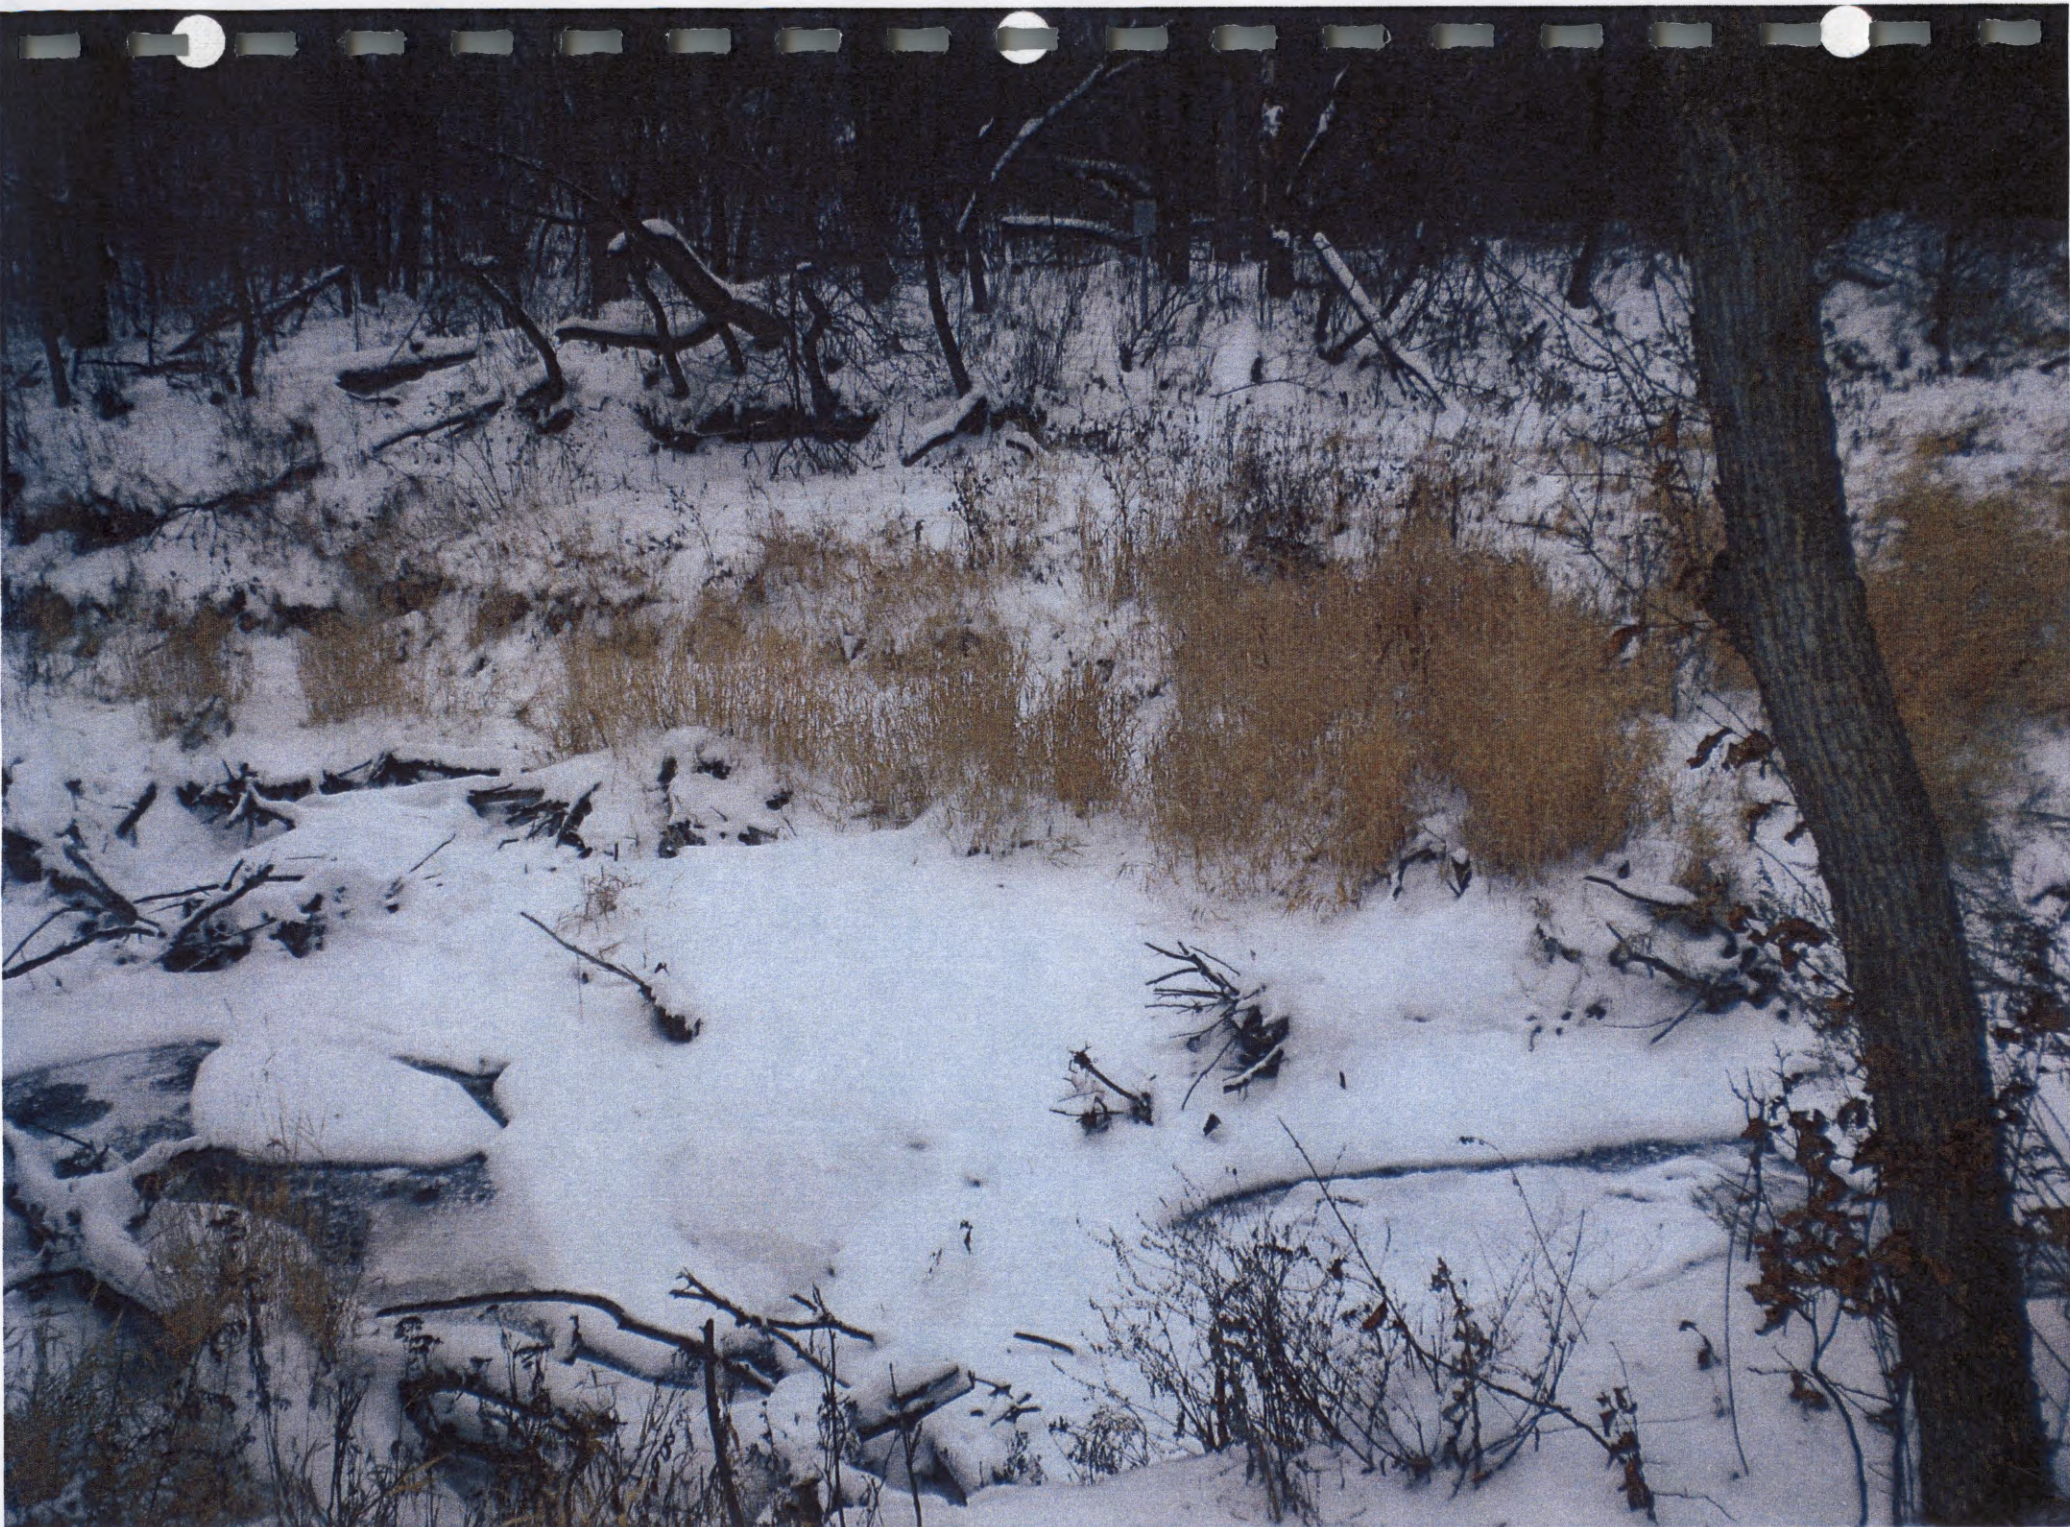
Picture #25 Hill leading down to this looks to be terraced, no washout visible

Picture # 25 Tongue River

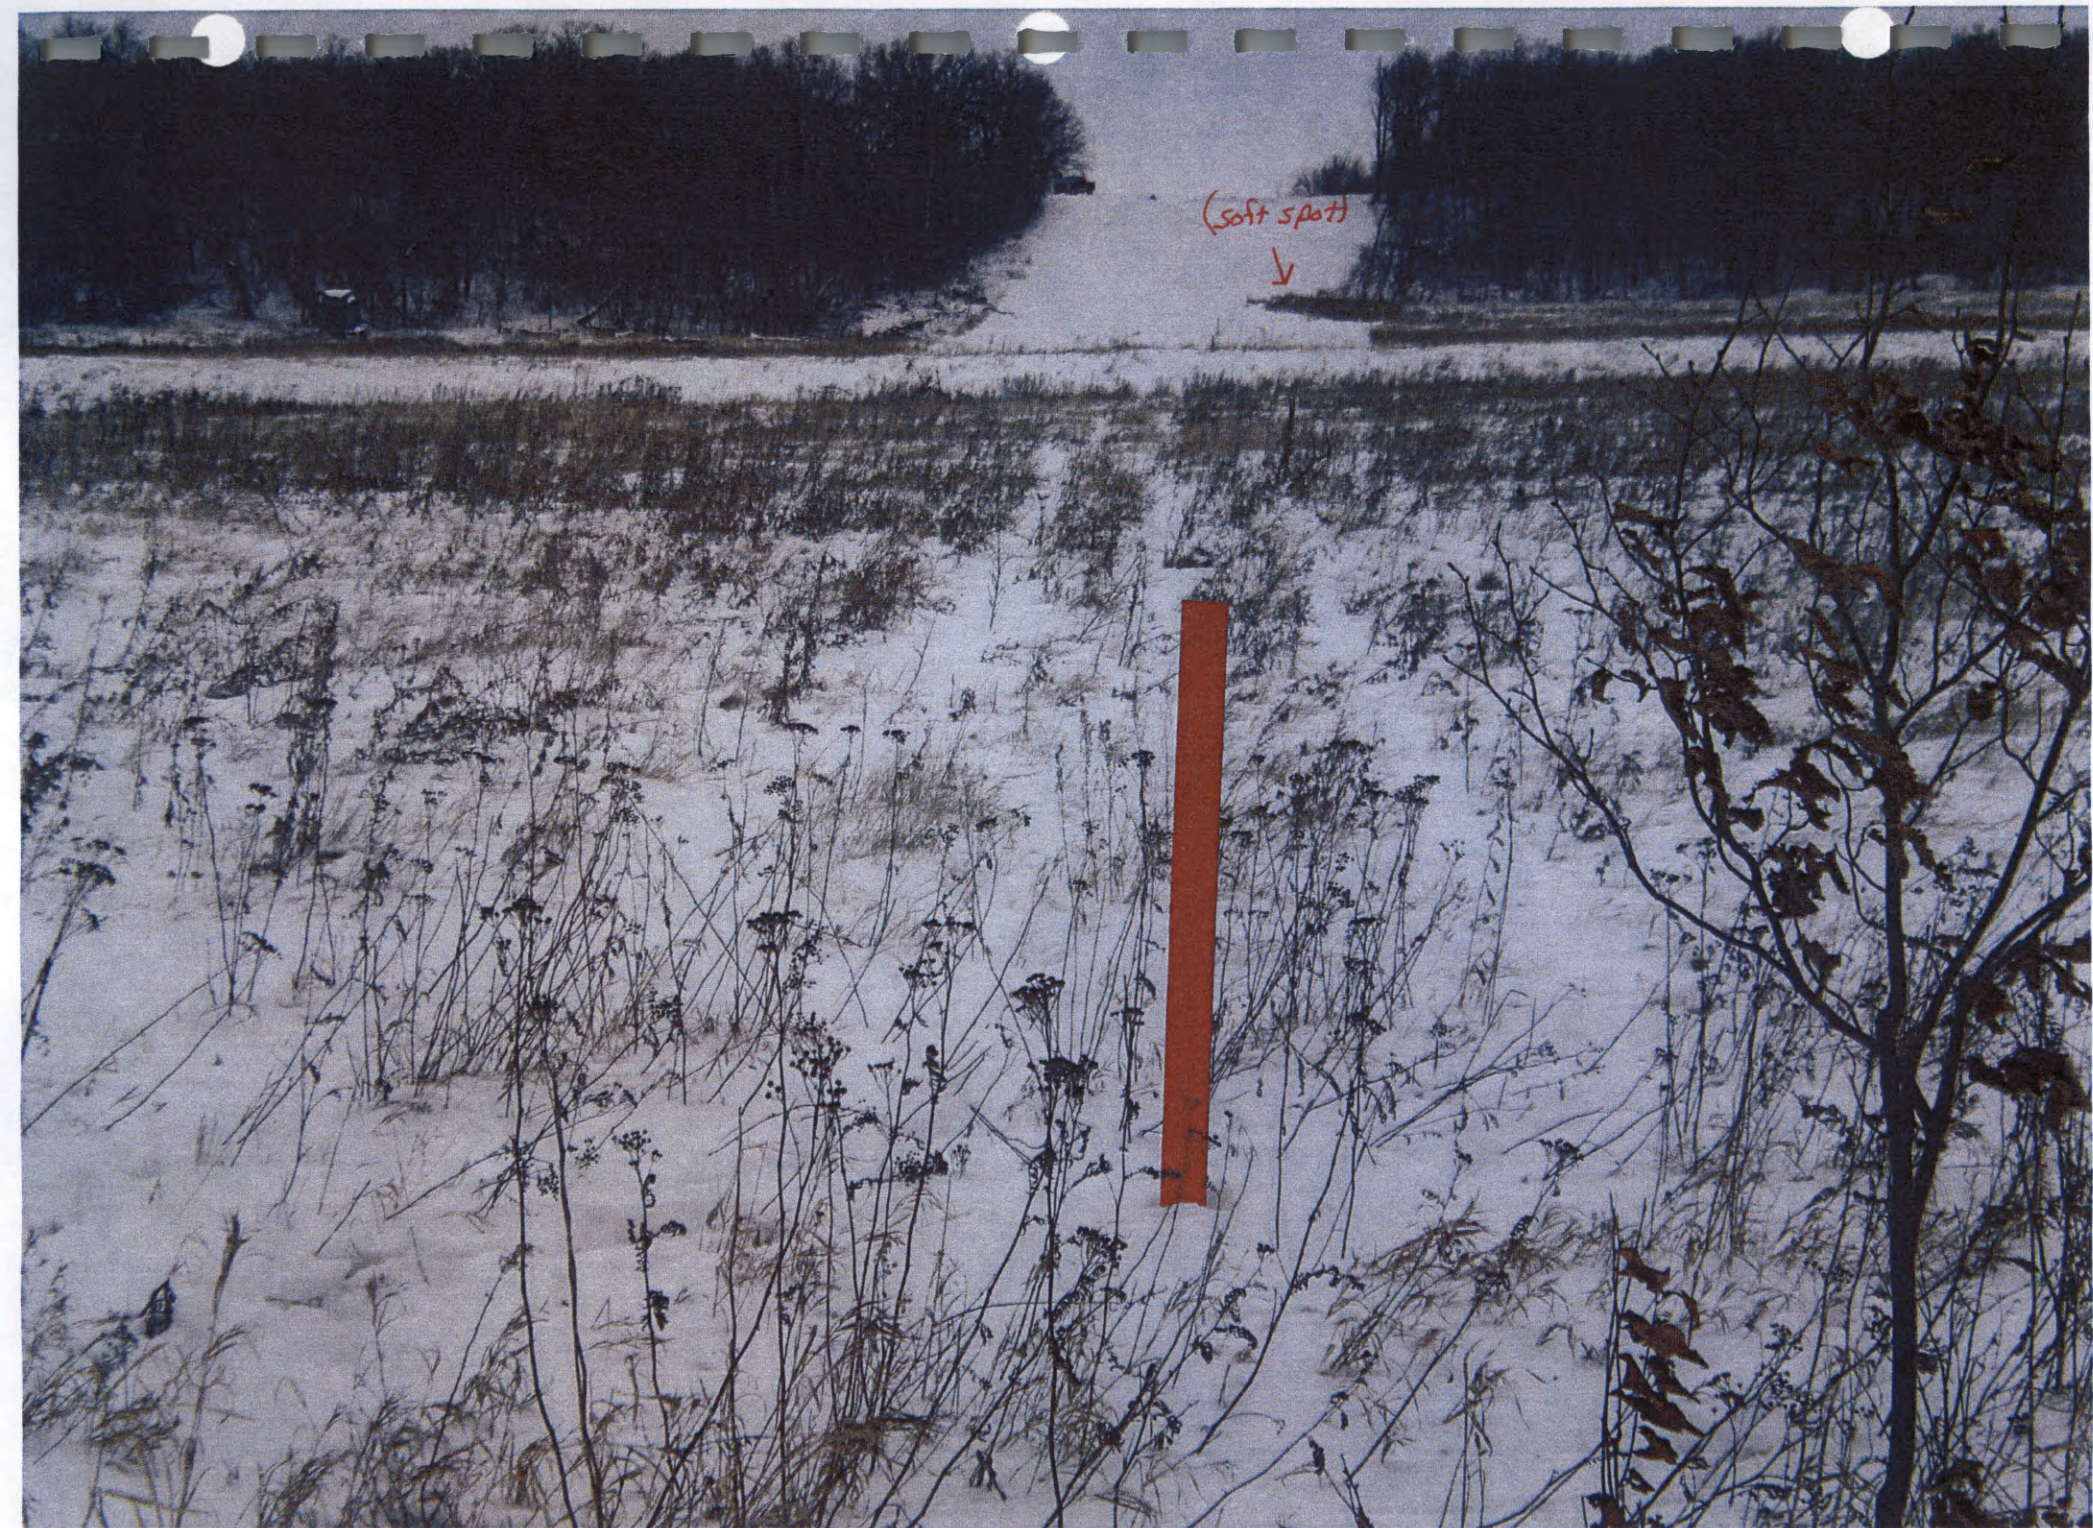
Picture #26 → looking back from tongue River

Picture #26 looking back from Tongue River (Refer to Picture #27)

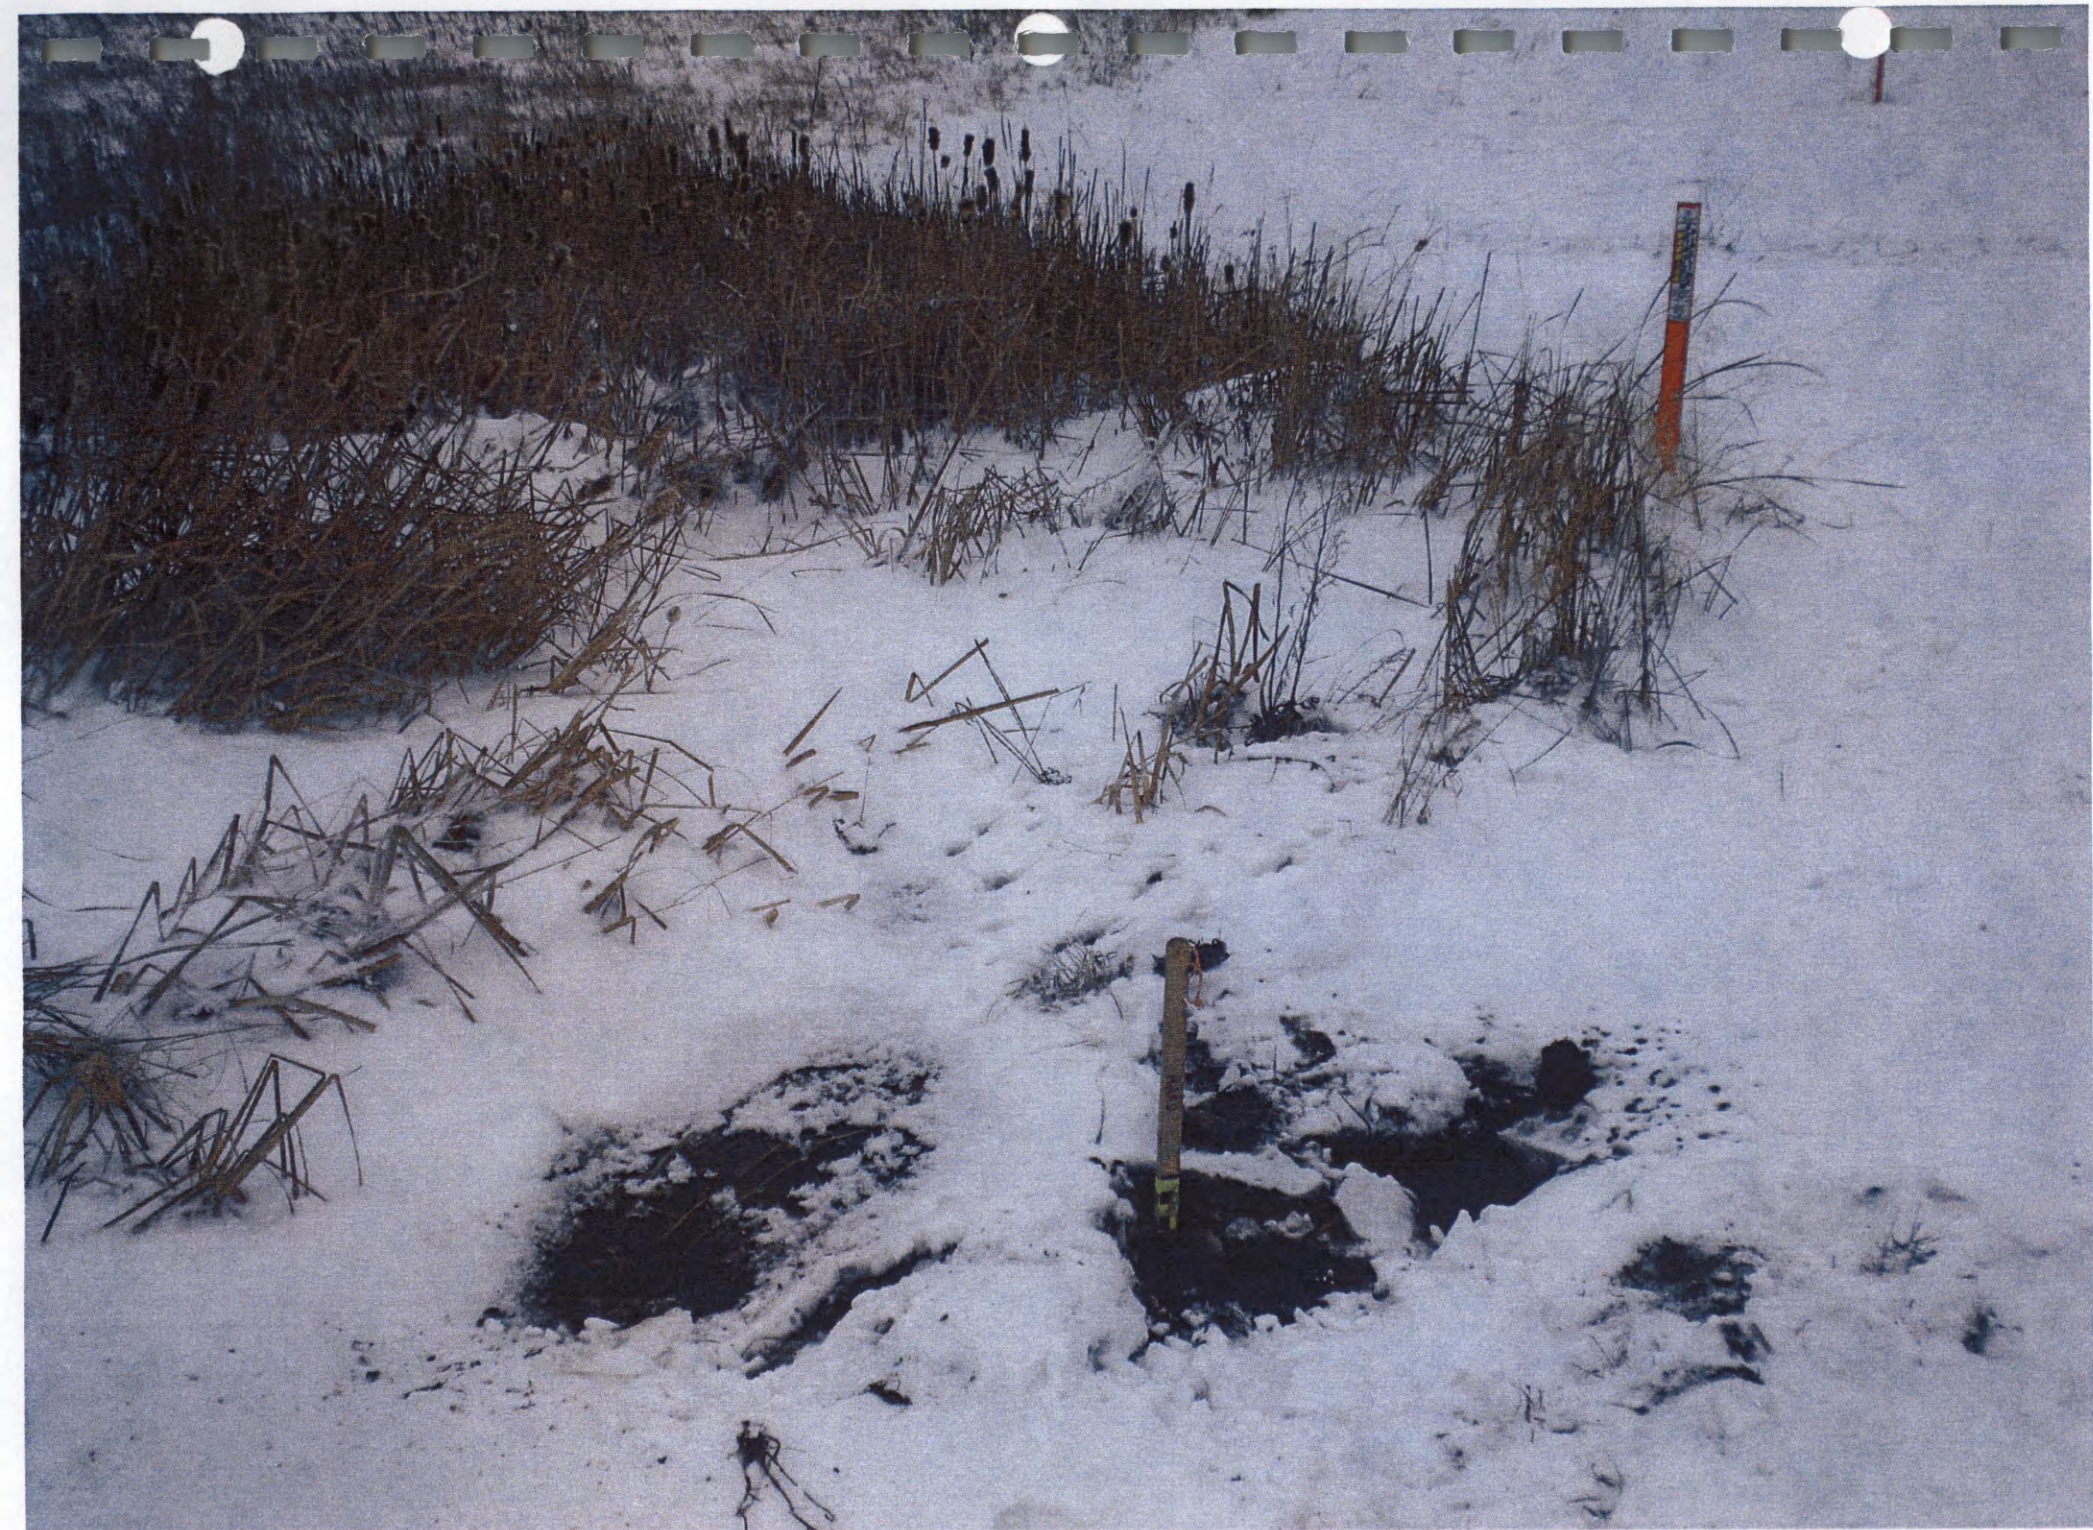
→ Noticed cattails growing slightly uphill, wet area on top of  $\varnothing$  of pipe

I pushed a 4' walking stick down 3' with ease, is this a concern?

Picture #27 Soft spot, pushed 4' stick down 3' with ease. ♀ of PIPC, Refer to Picture #26

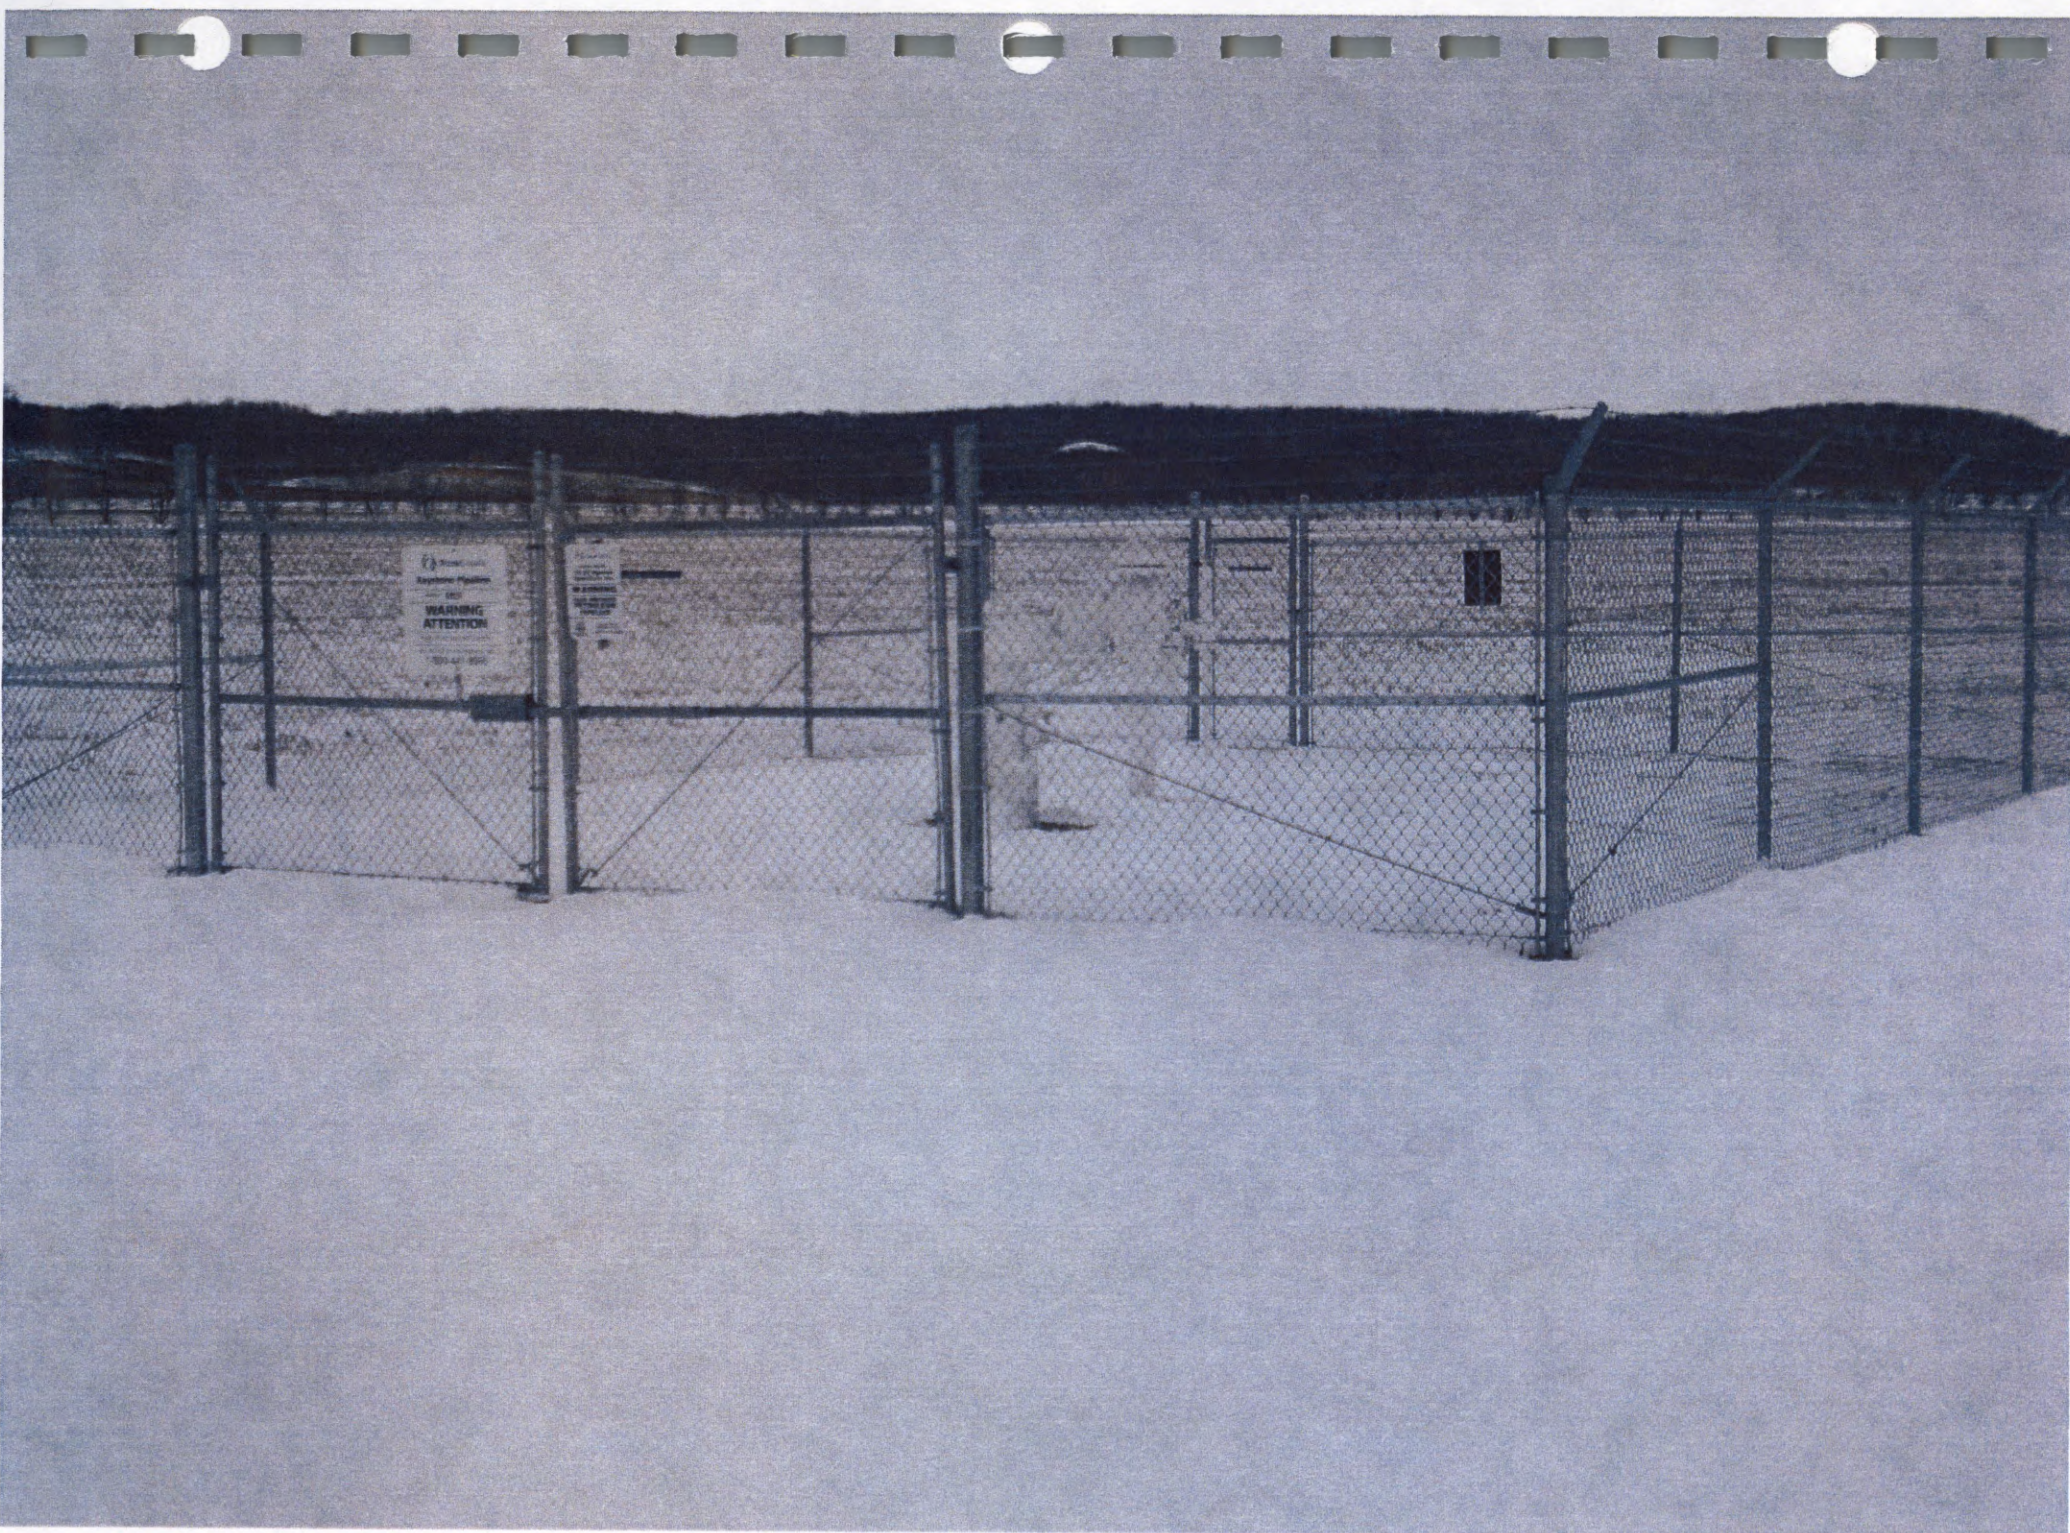
Picture # 8 → Valve station (3) inclosed in a 30 x 40 6' high topped with barbed wire, Gate and Valves all locked - about 200' off road.

Picture # 28 Valve Station mile 20 2<sup>nd</sup> one

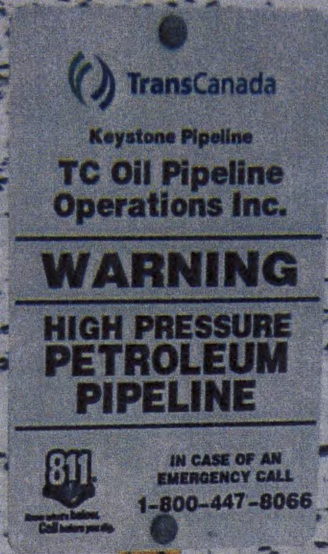
→ Signs on South side are on a 1 1/2" x 1 1/2" yellow tube post

Picture #29 example of Signs on South Sides of all Roads

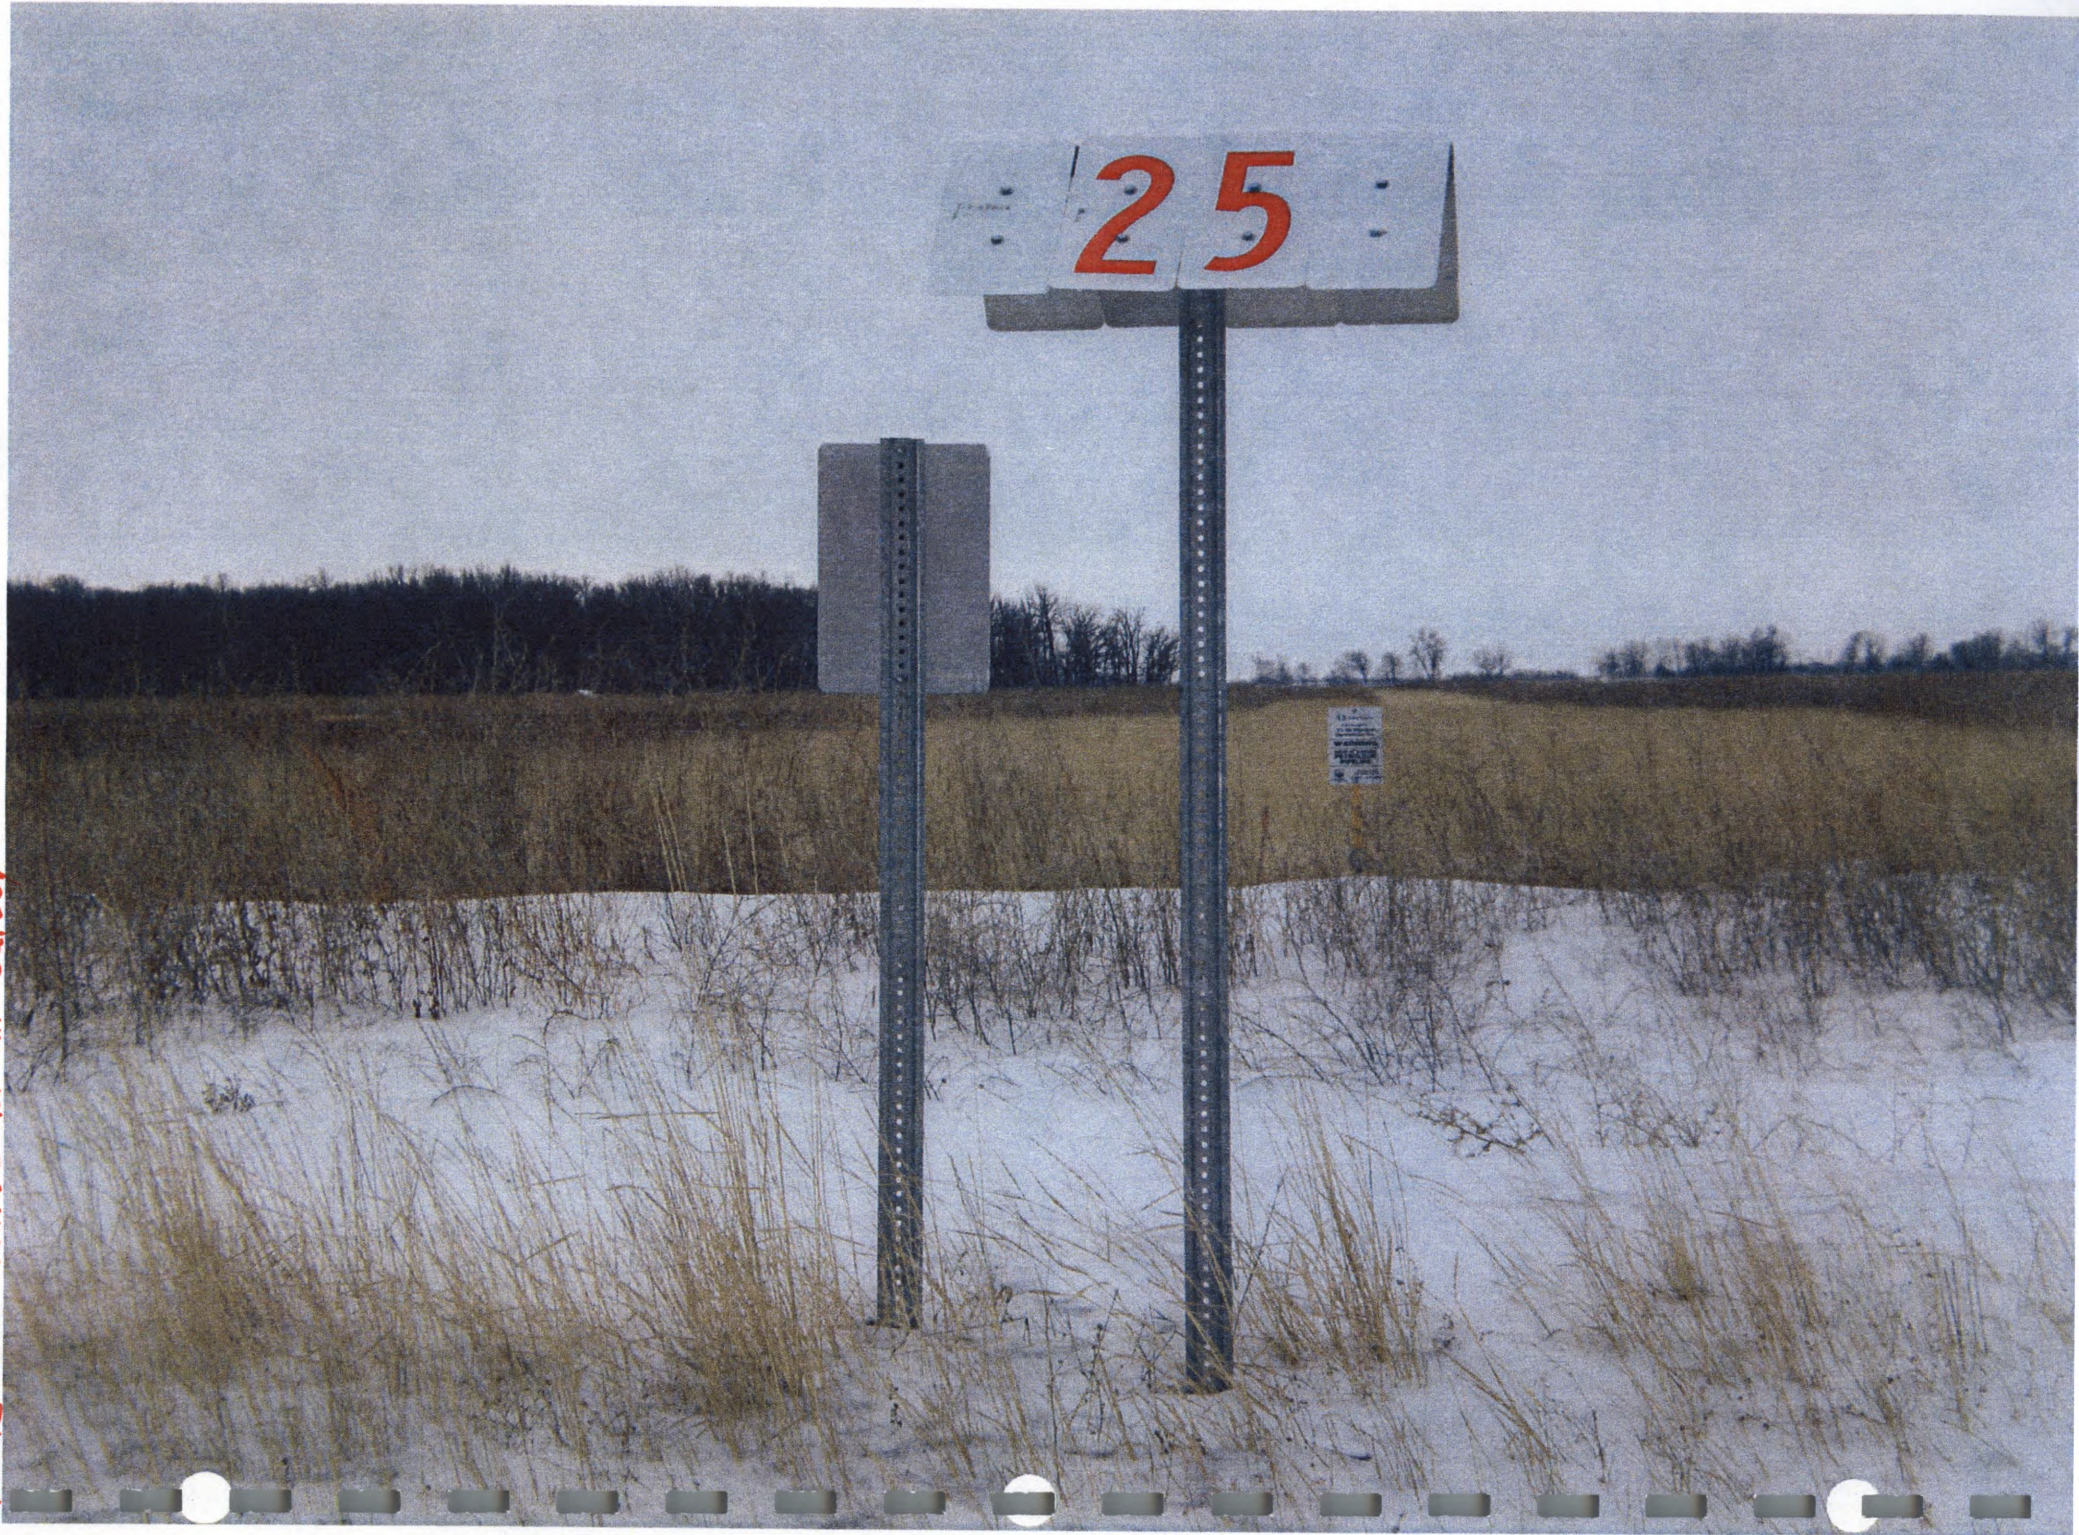
Signs for  $\Phi$  of Pipe on both sides of low maintenance Road  
- mile marker 25 on North Side of Road for Aircraft patrol  
No subsidence noted on Roadway or in fields  
Fields look to have natural flow. North  
Cover crop looks to be well established

Picture #30 Mill is for HIR Survey
