*Keystone*

**Final Inspection**

*1-5-2011*

PROJECT Keystone Pipeline - North Spread

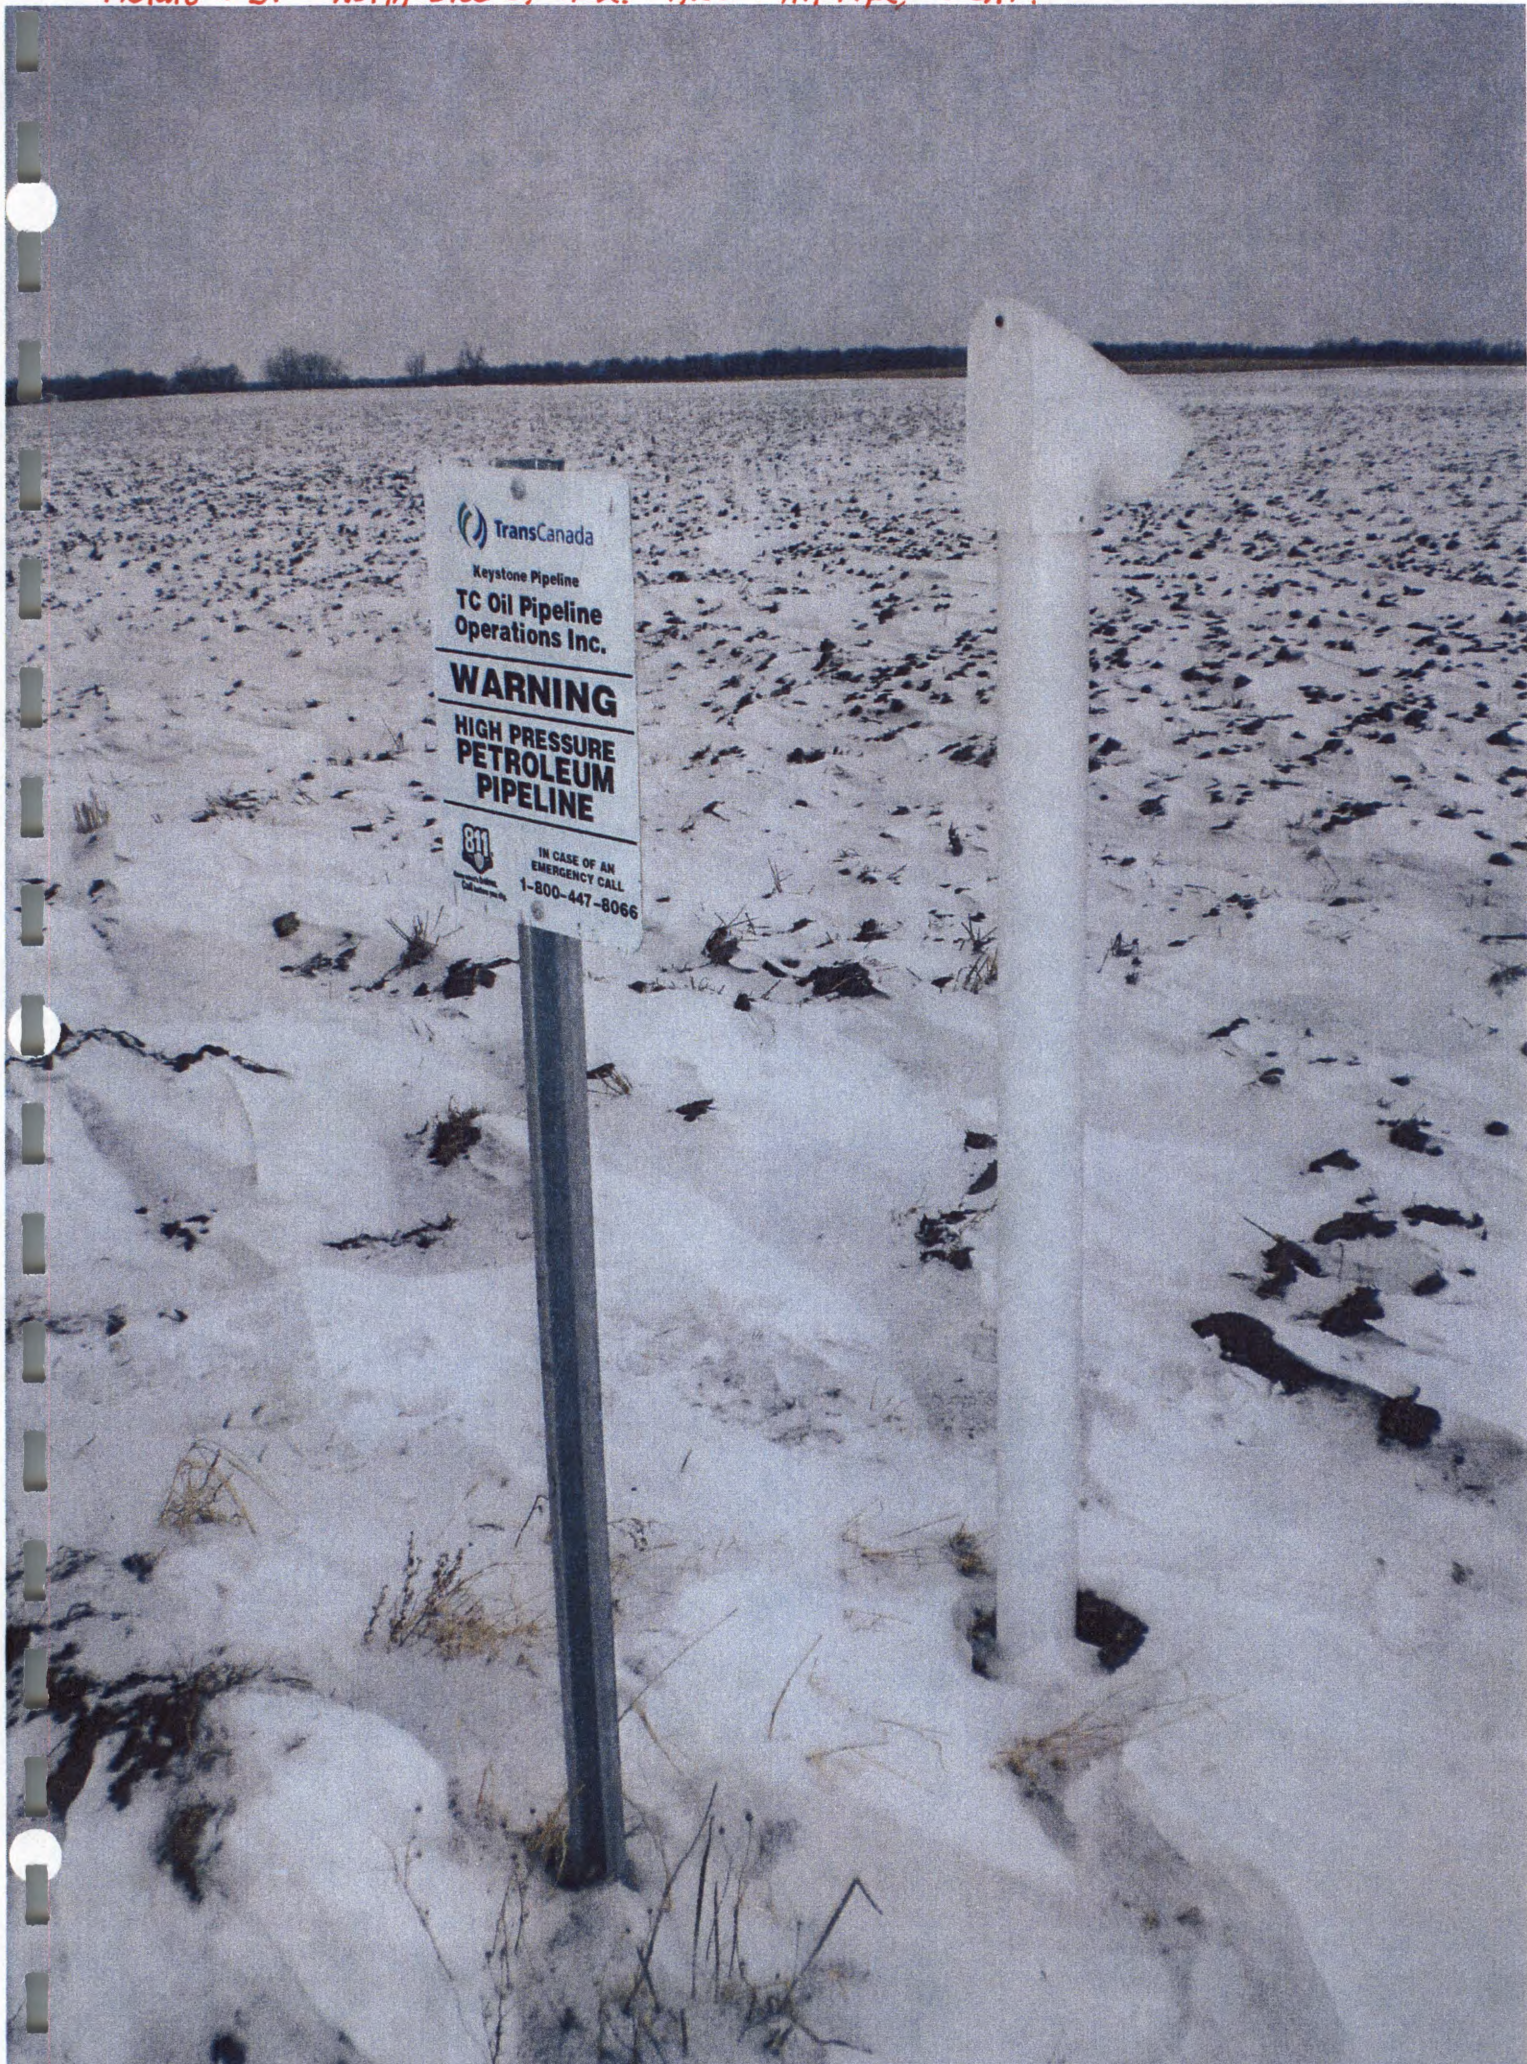
Picture # 31 North Side of Road. Also with Pipe, Vent?

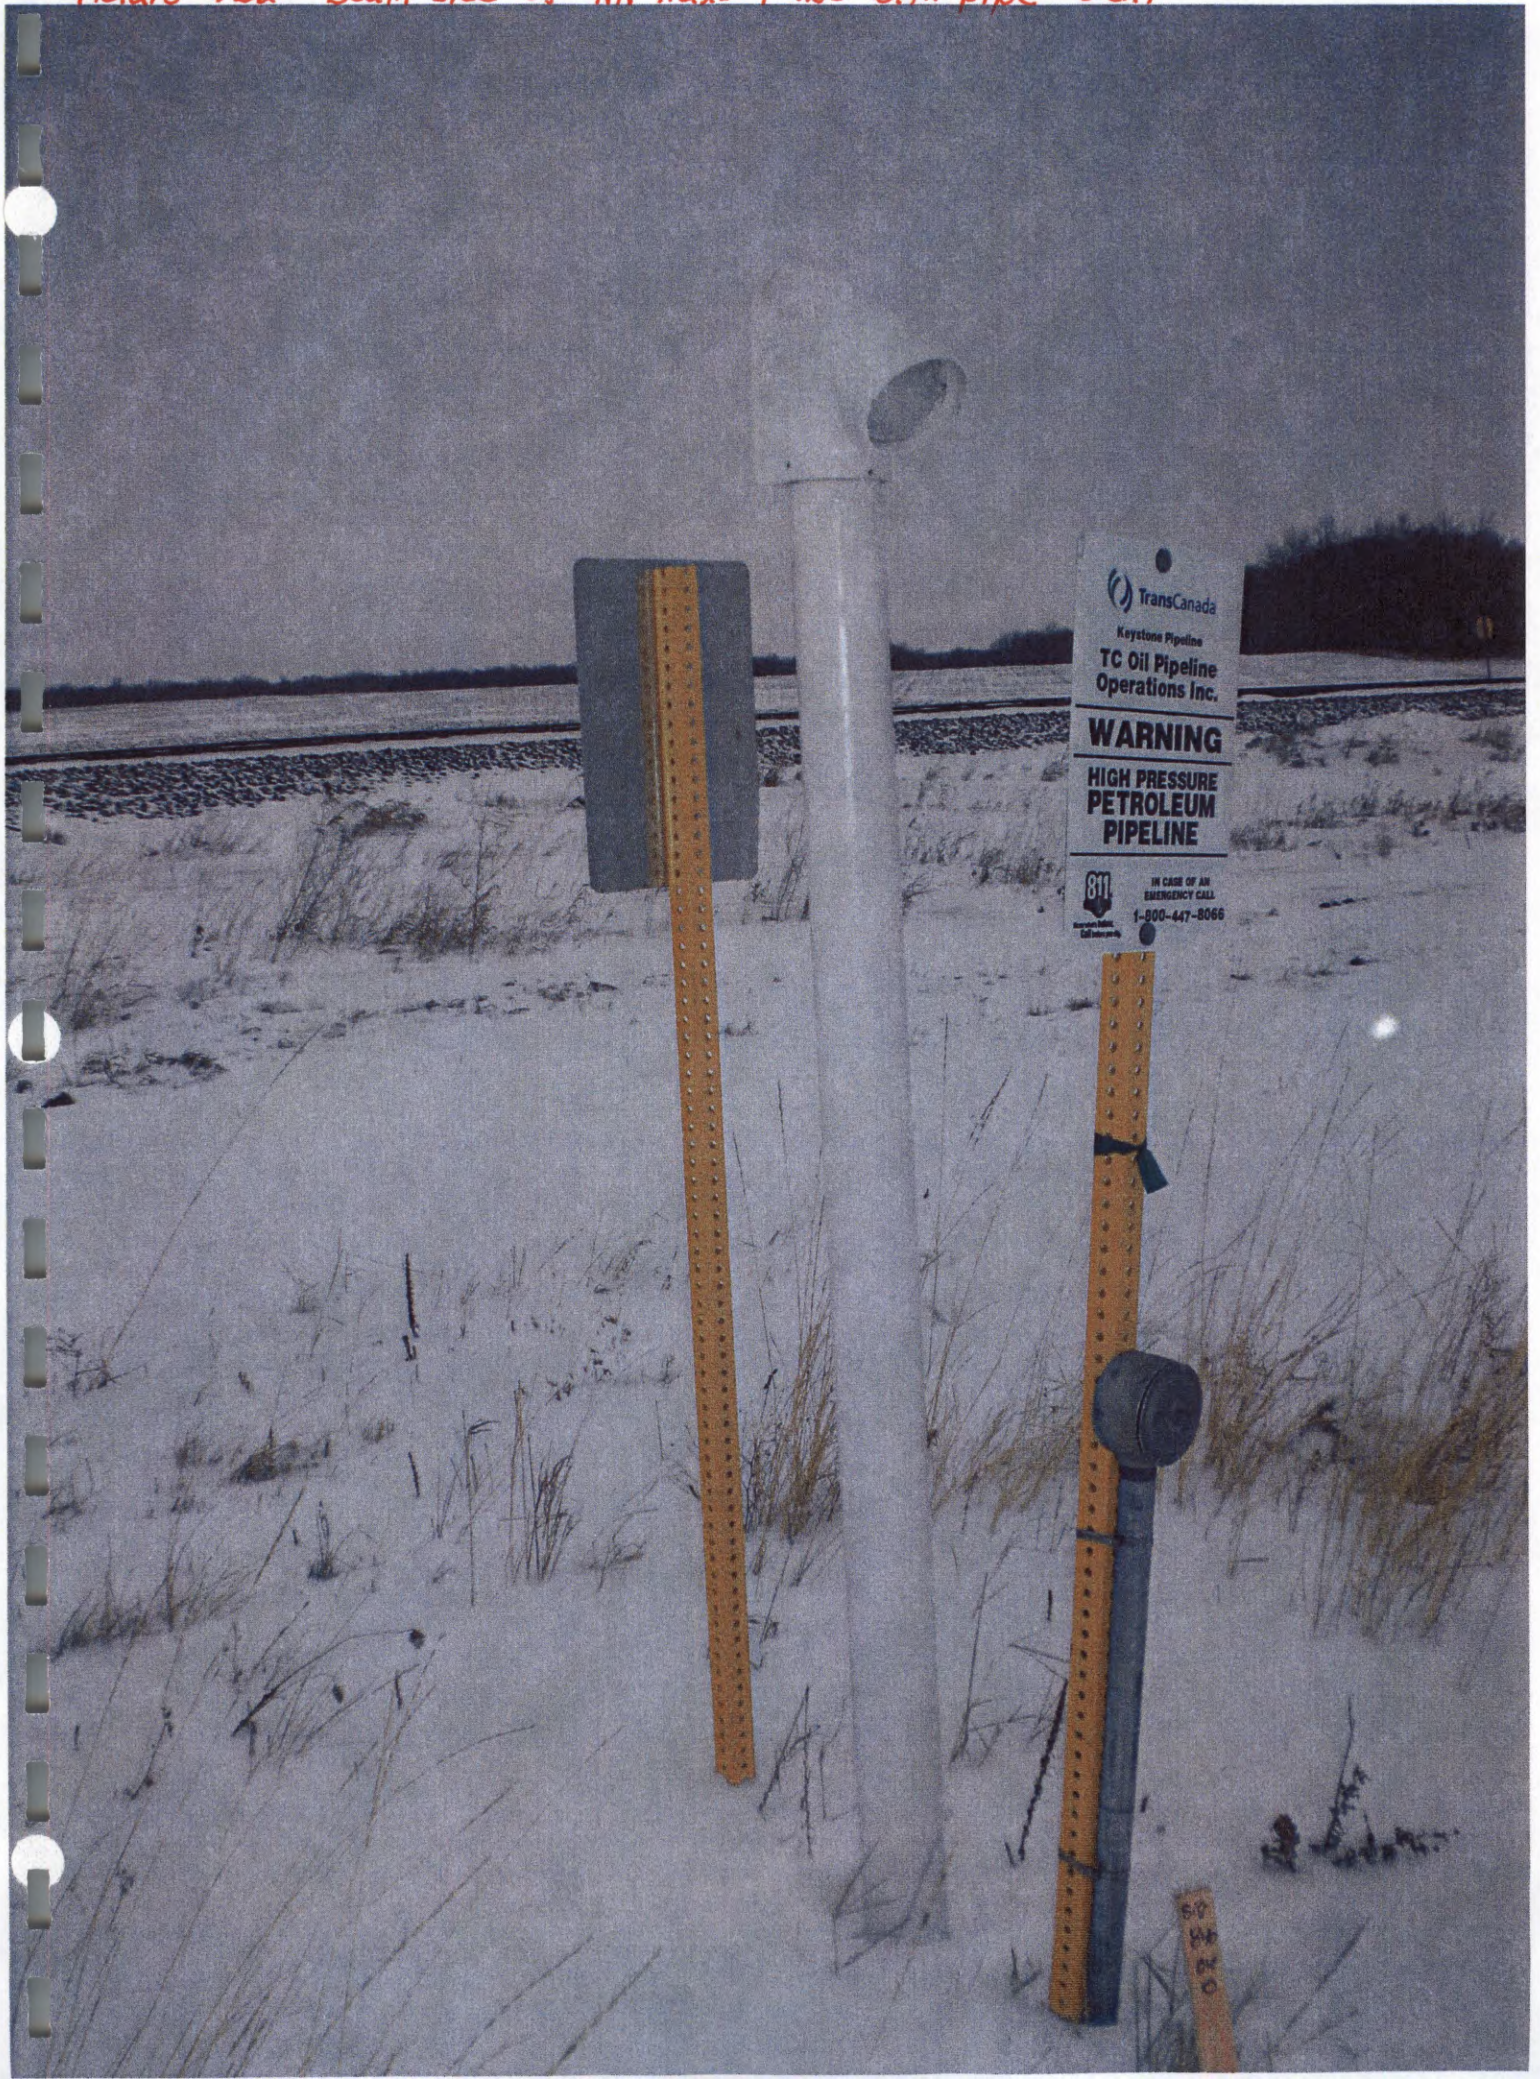
Picture #32 South Side of RR tracks, also with pipe vent

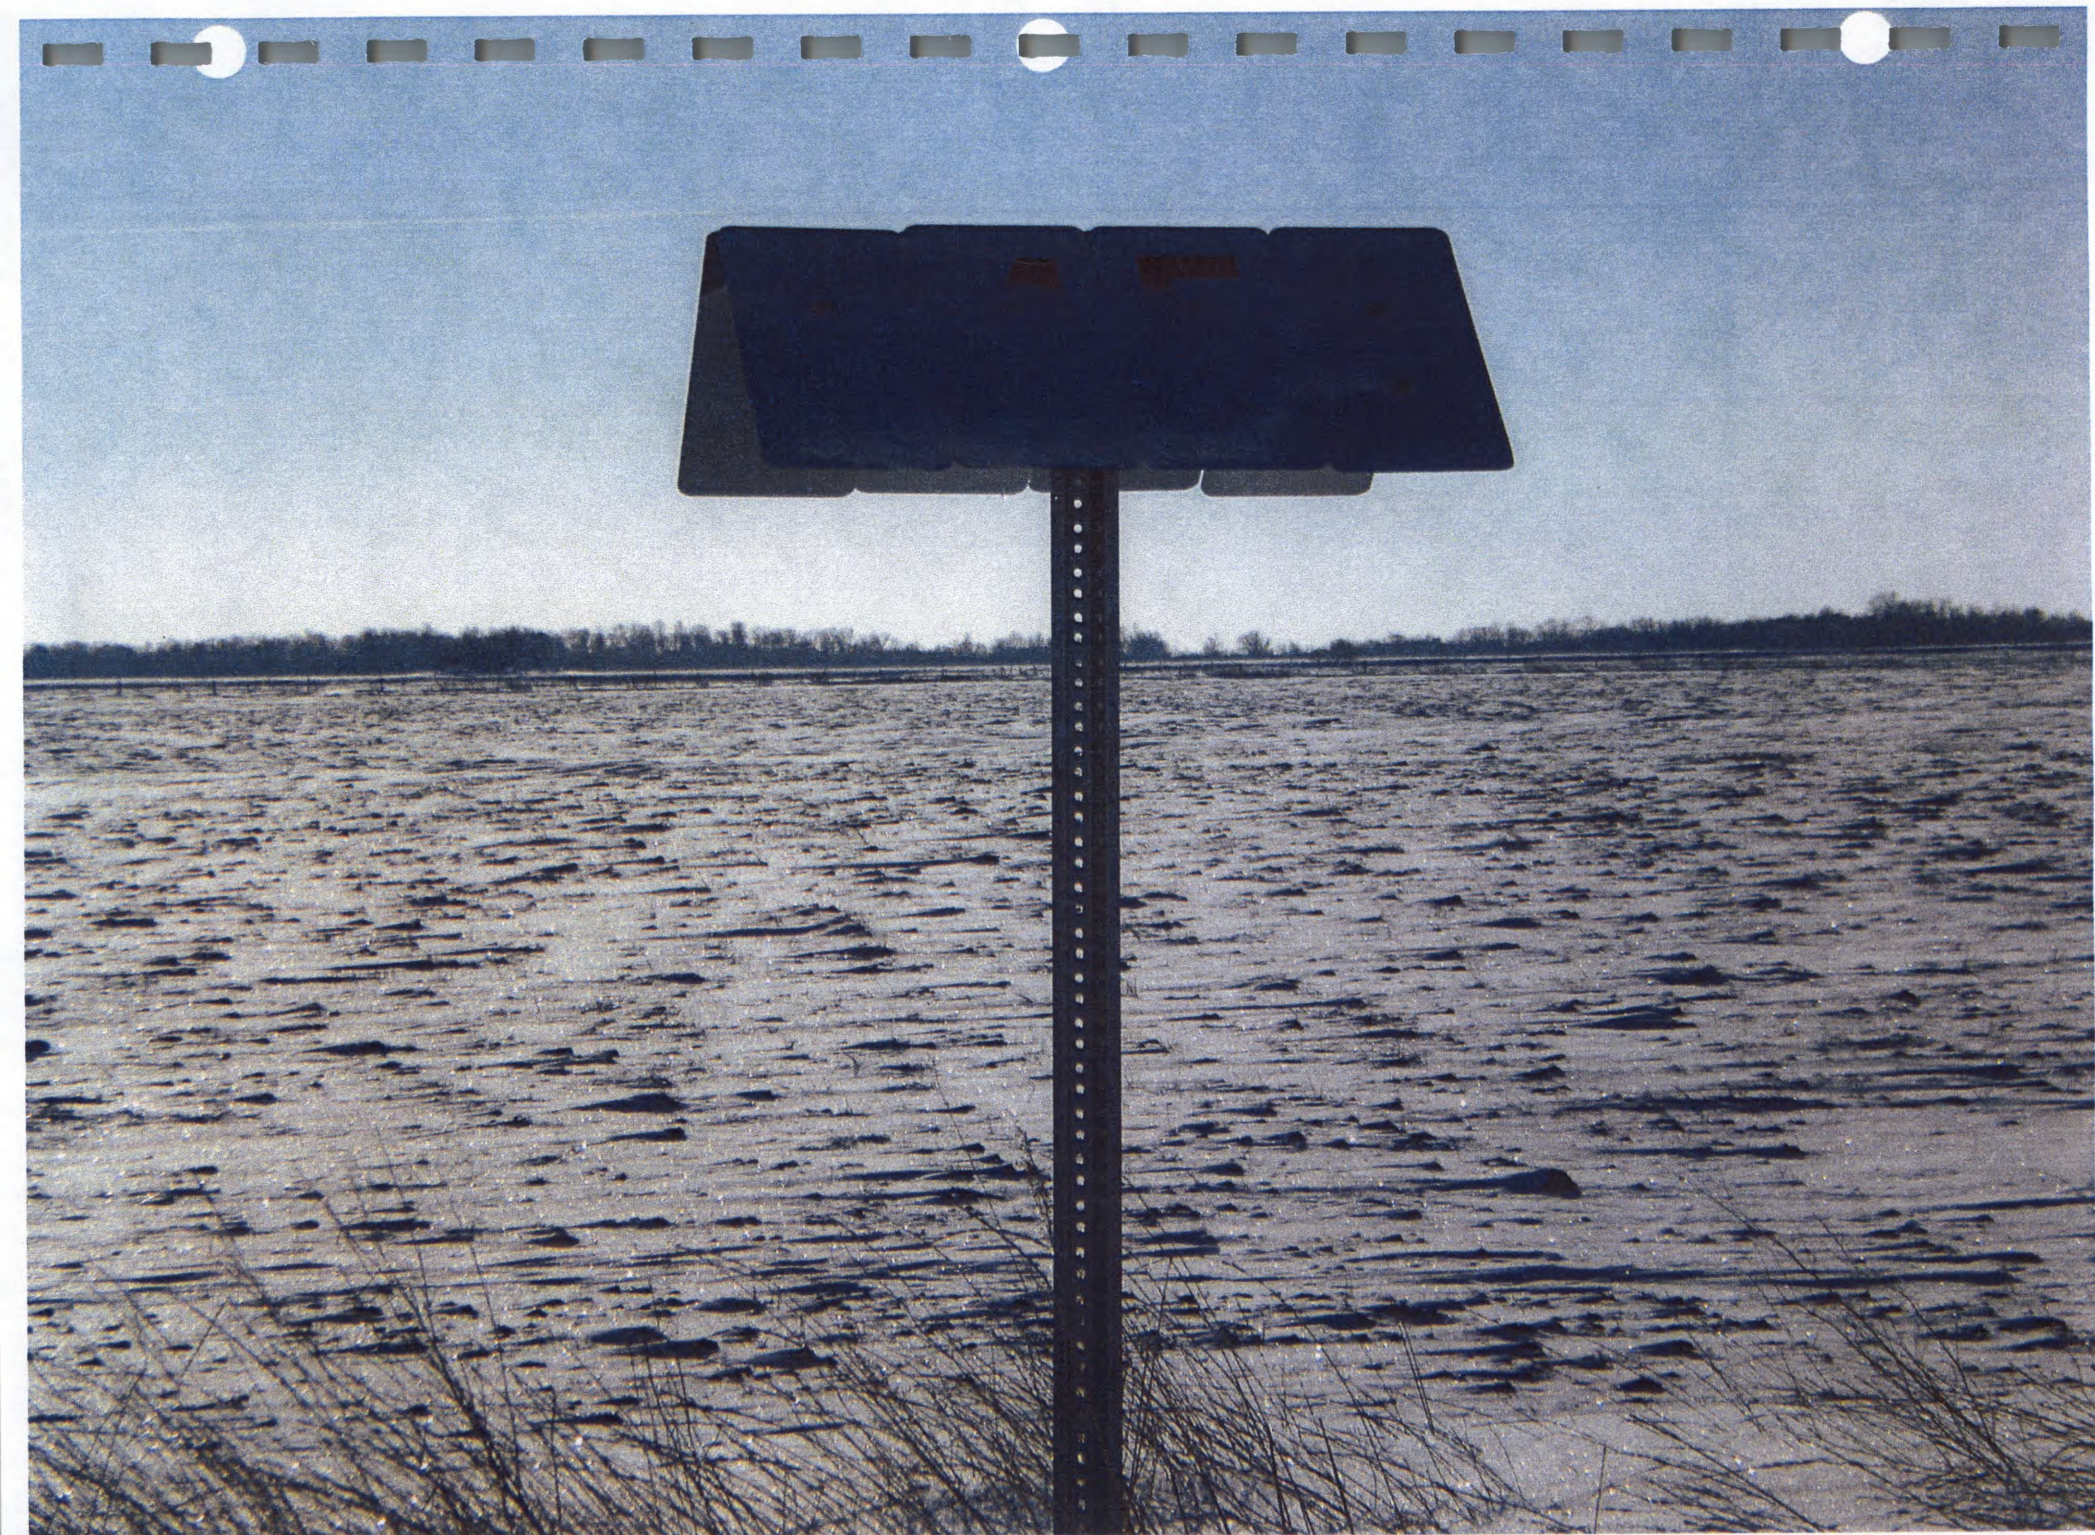
Signs for  $\varnothing$  of pipe on both sides of Roadway  
No subsidence noticed on Roadway  
Field on North side looks to have natural flow  
Field on south side cover crop looks to be well established  
no Subsidence noticed on either side  
mm 45 for Aircraft is on a fence line between mm 45 & 46  
Snow seems to stay on signs, blocks numbers

Picture #37 mm 45 for Air Survey, Snow seems to stick on signs

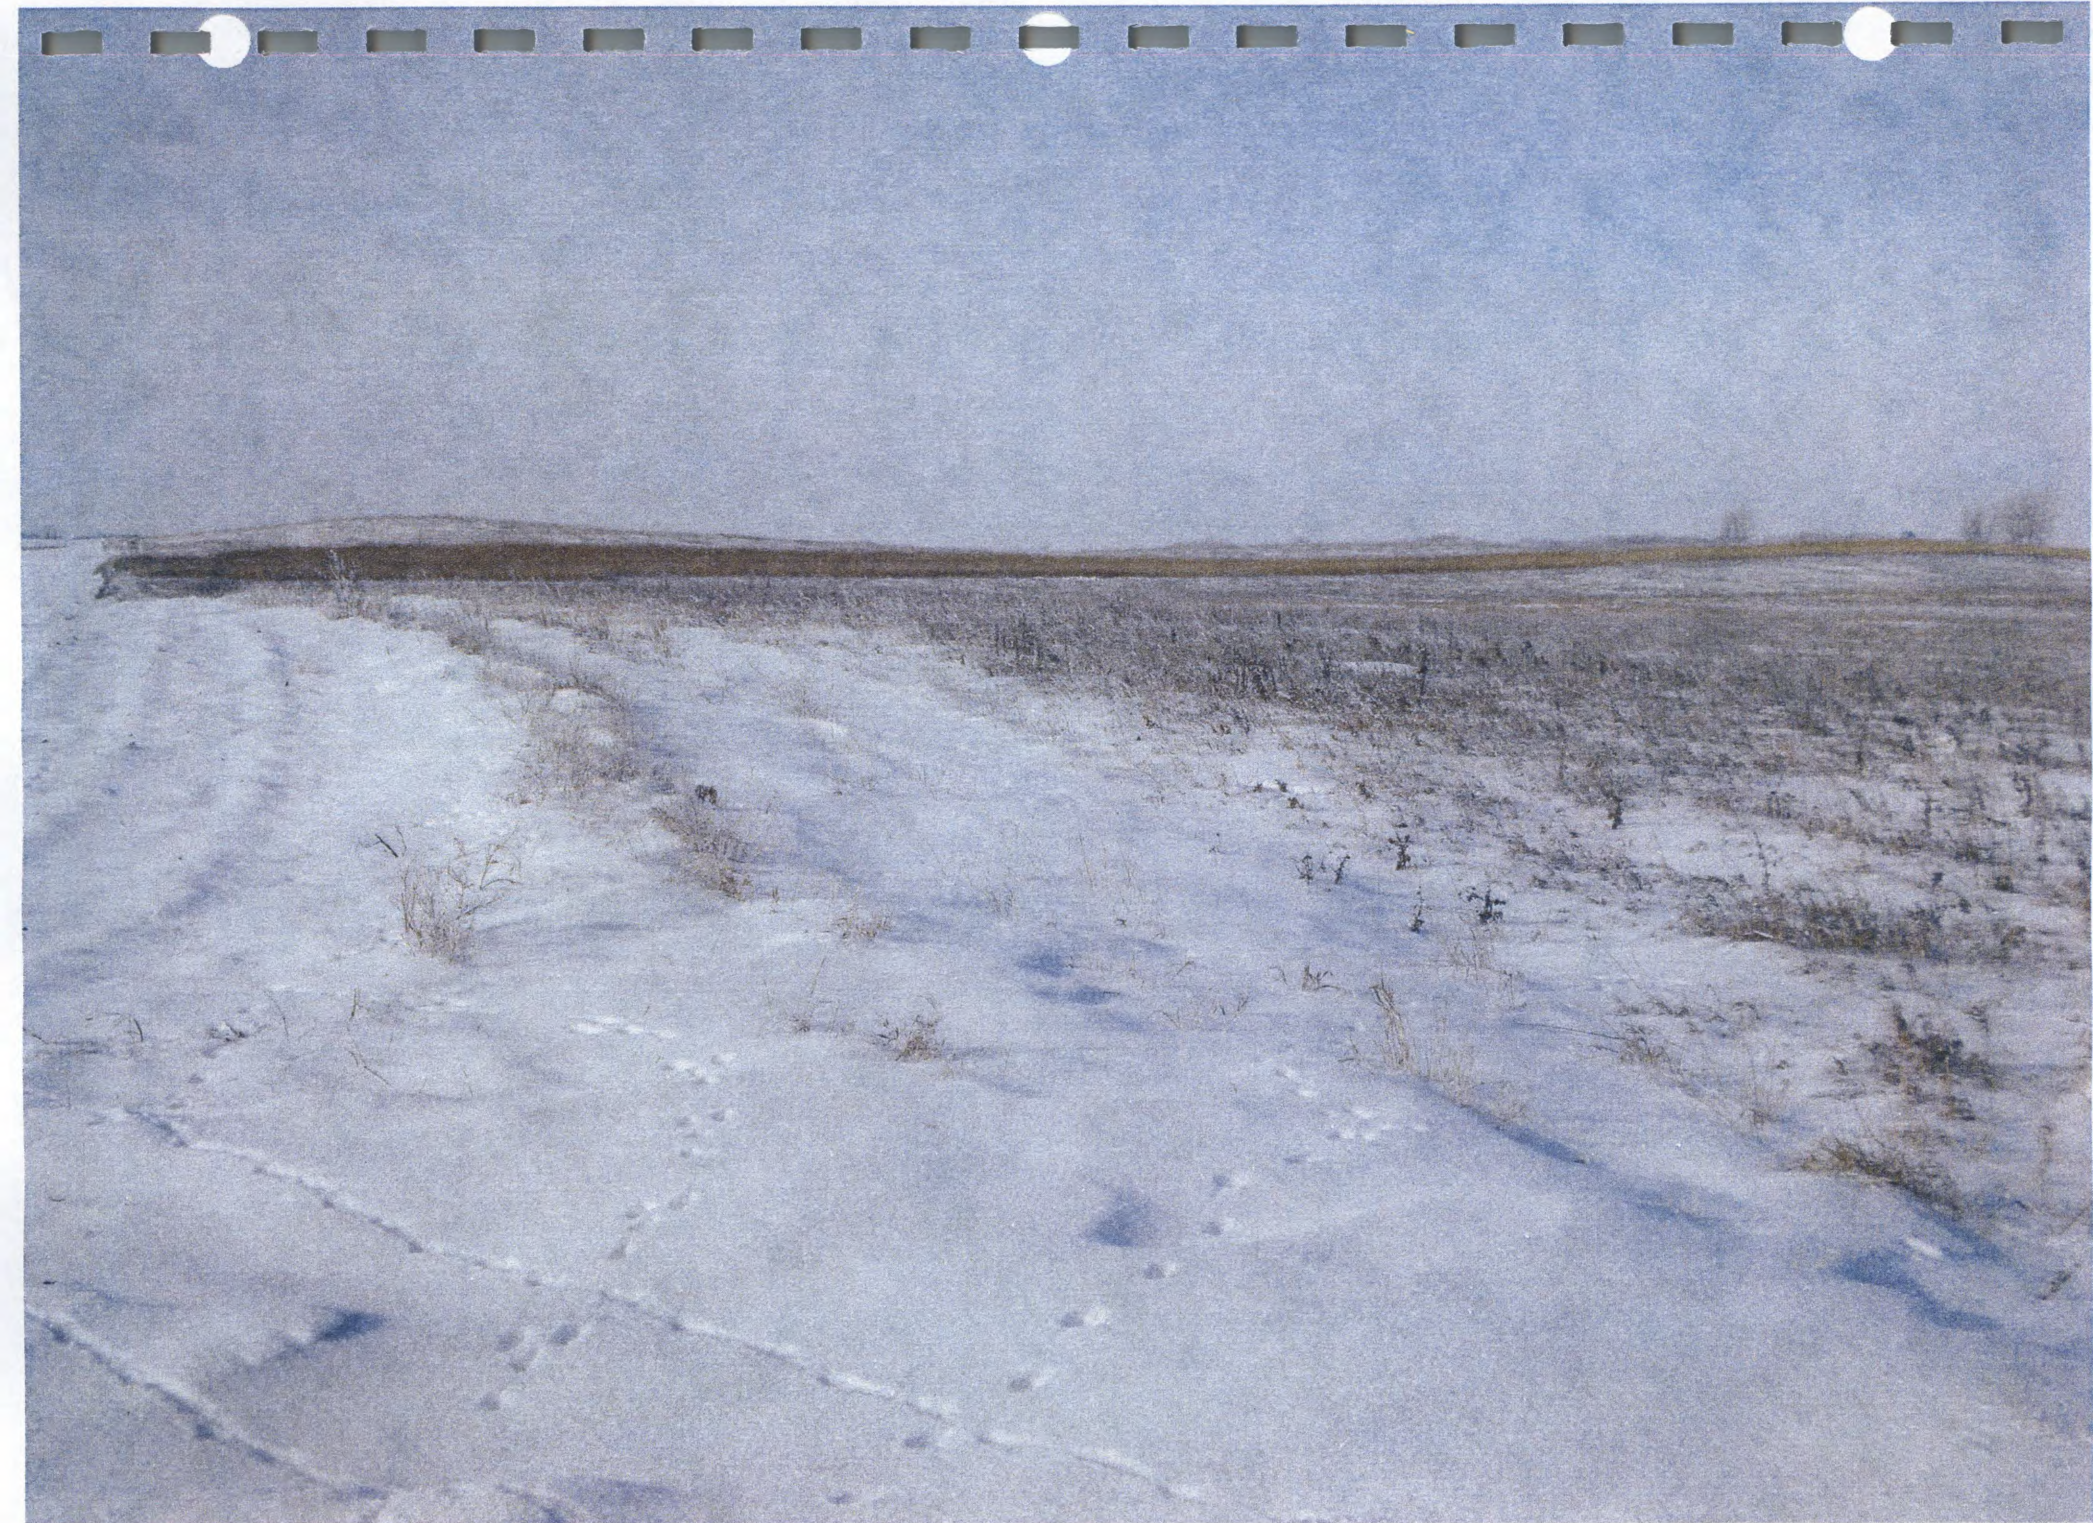
Picture # 48 example of how cover crop stands out mm84

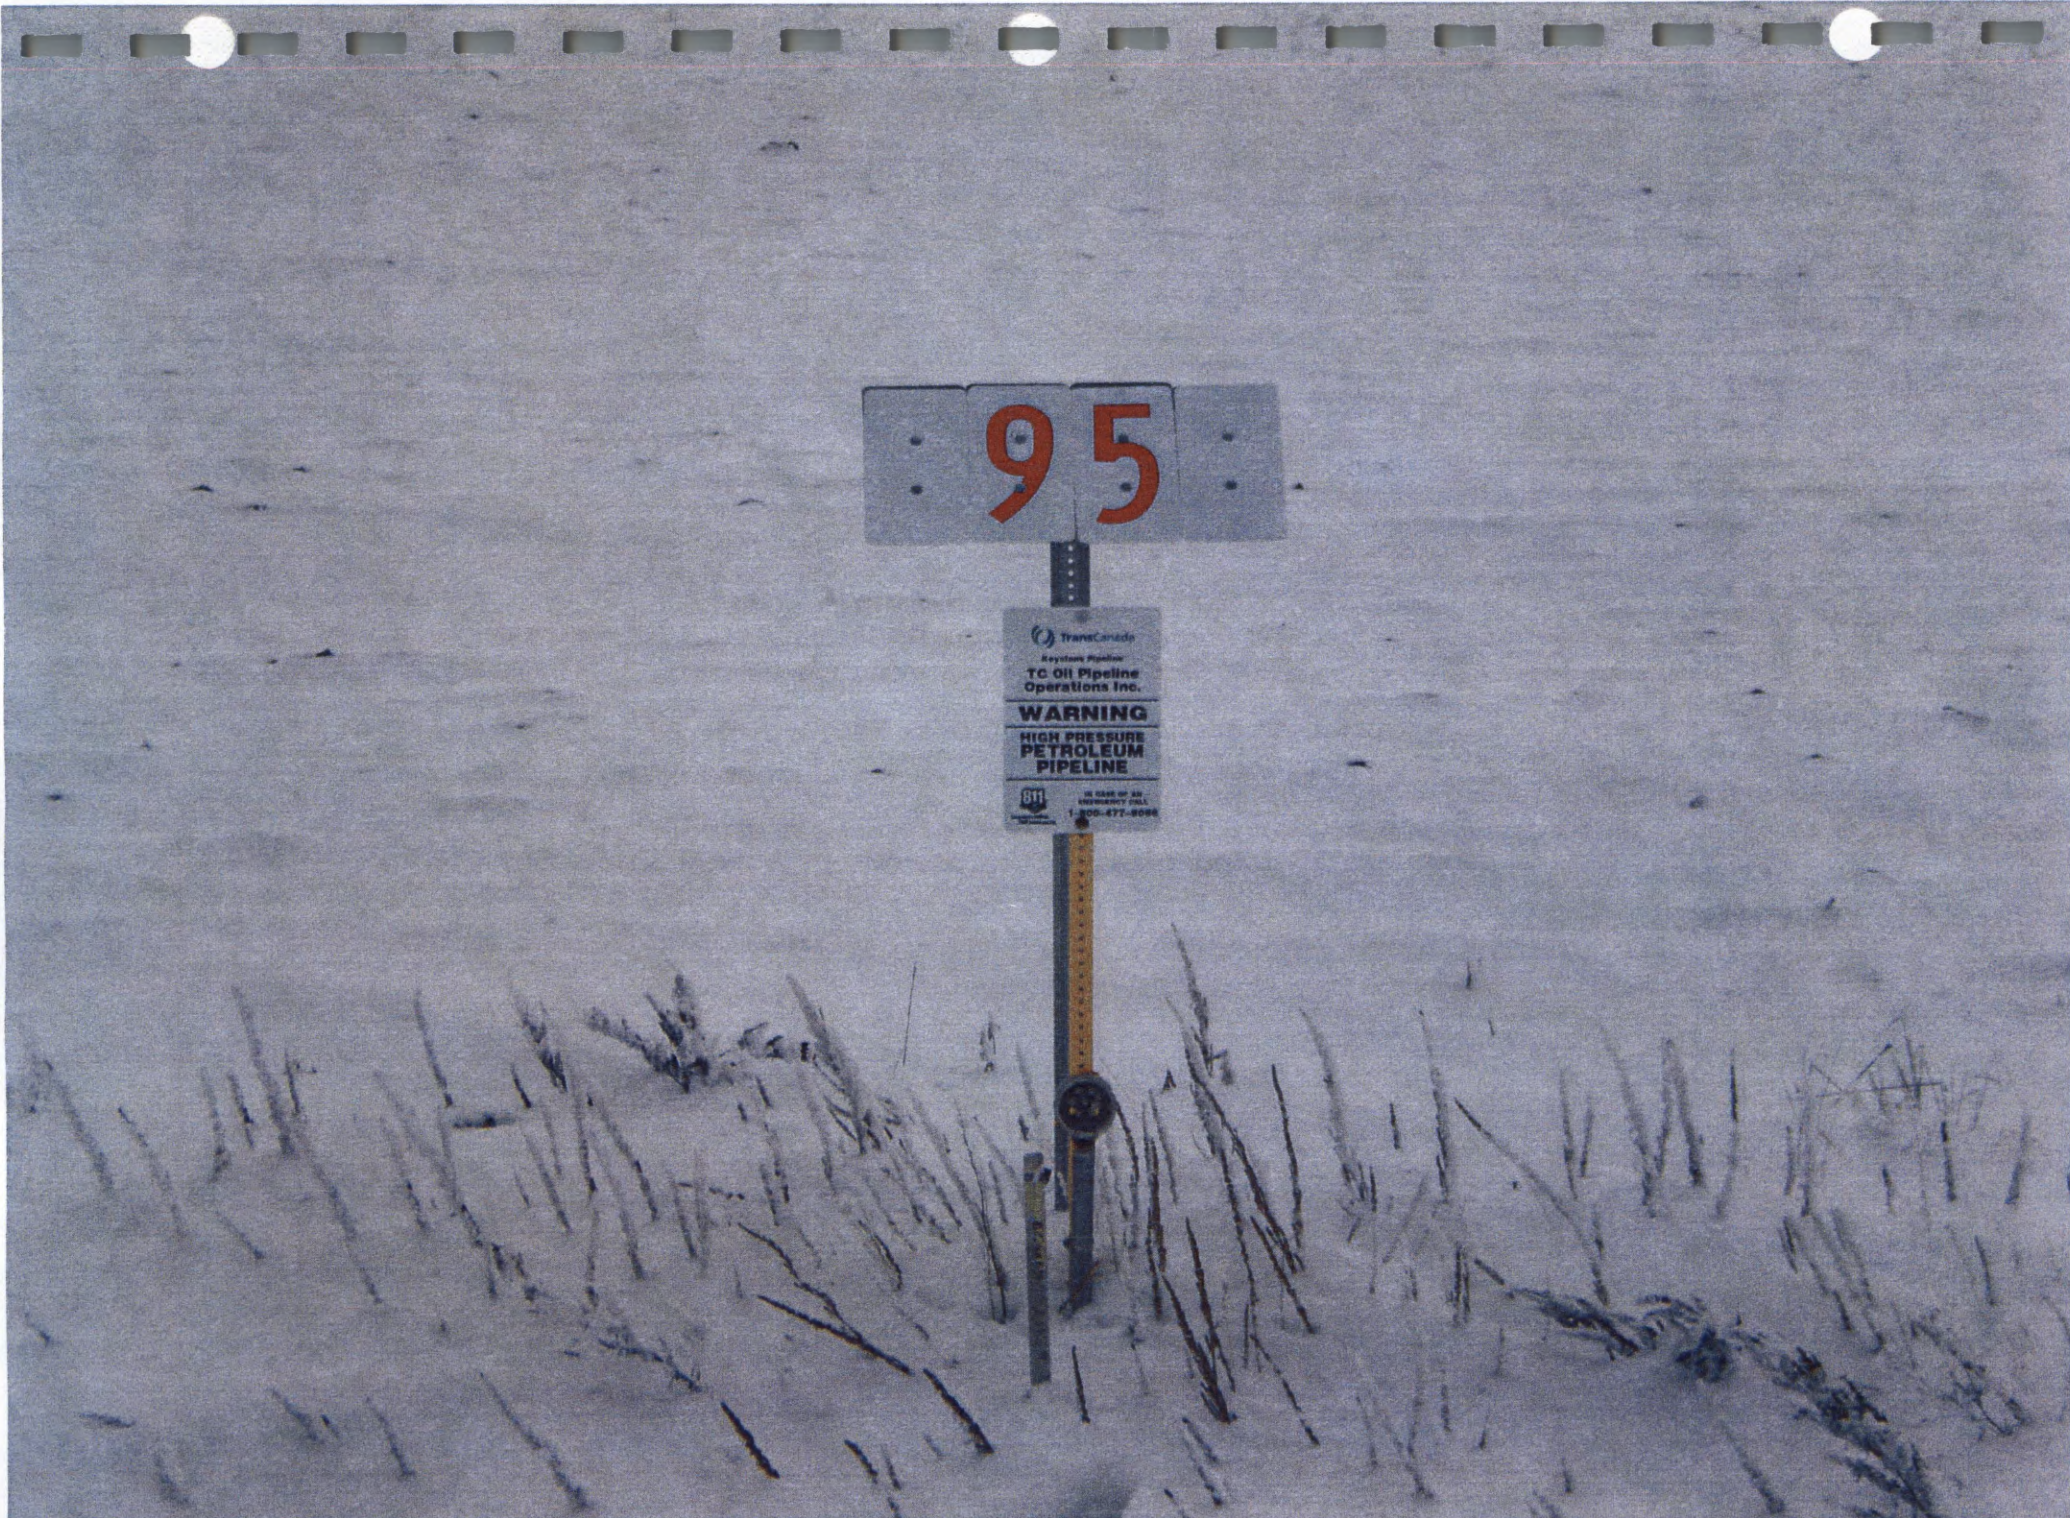
→ mm 95 on south side of Road for Aircraft Guide  
~~cap missing on post at mm 95 sign~~

Picture #.50 mm 95 for Air Survey 17<sup>th</sup> St/NE Notice Cap missing

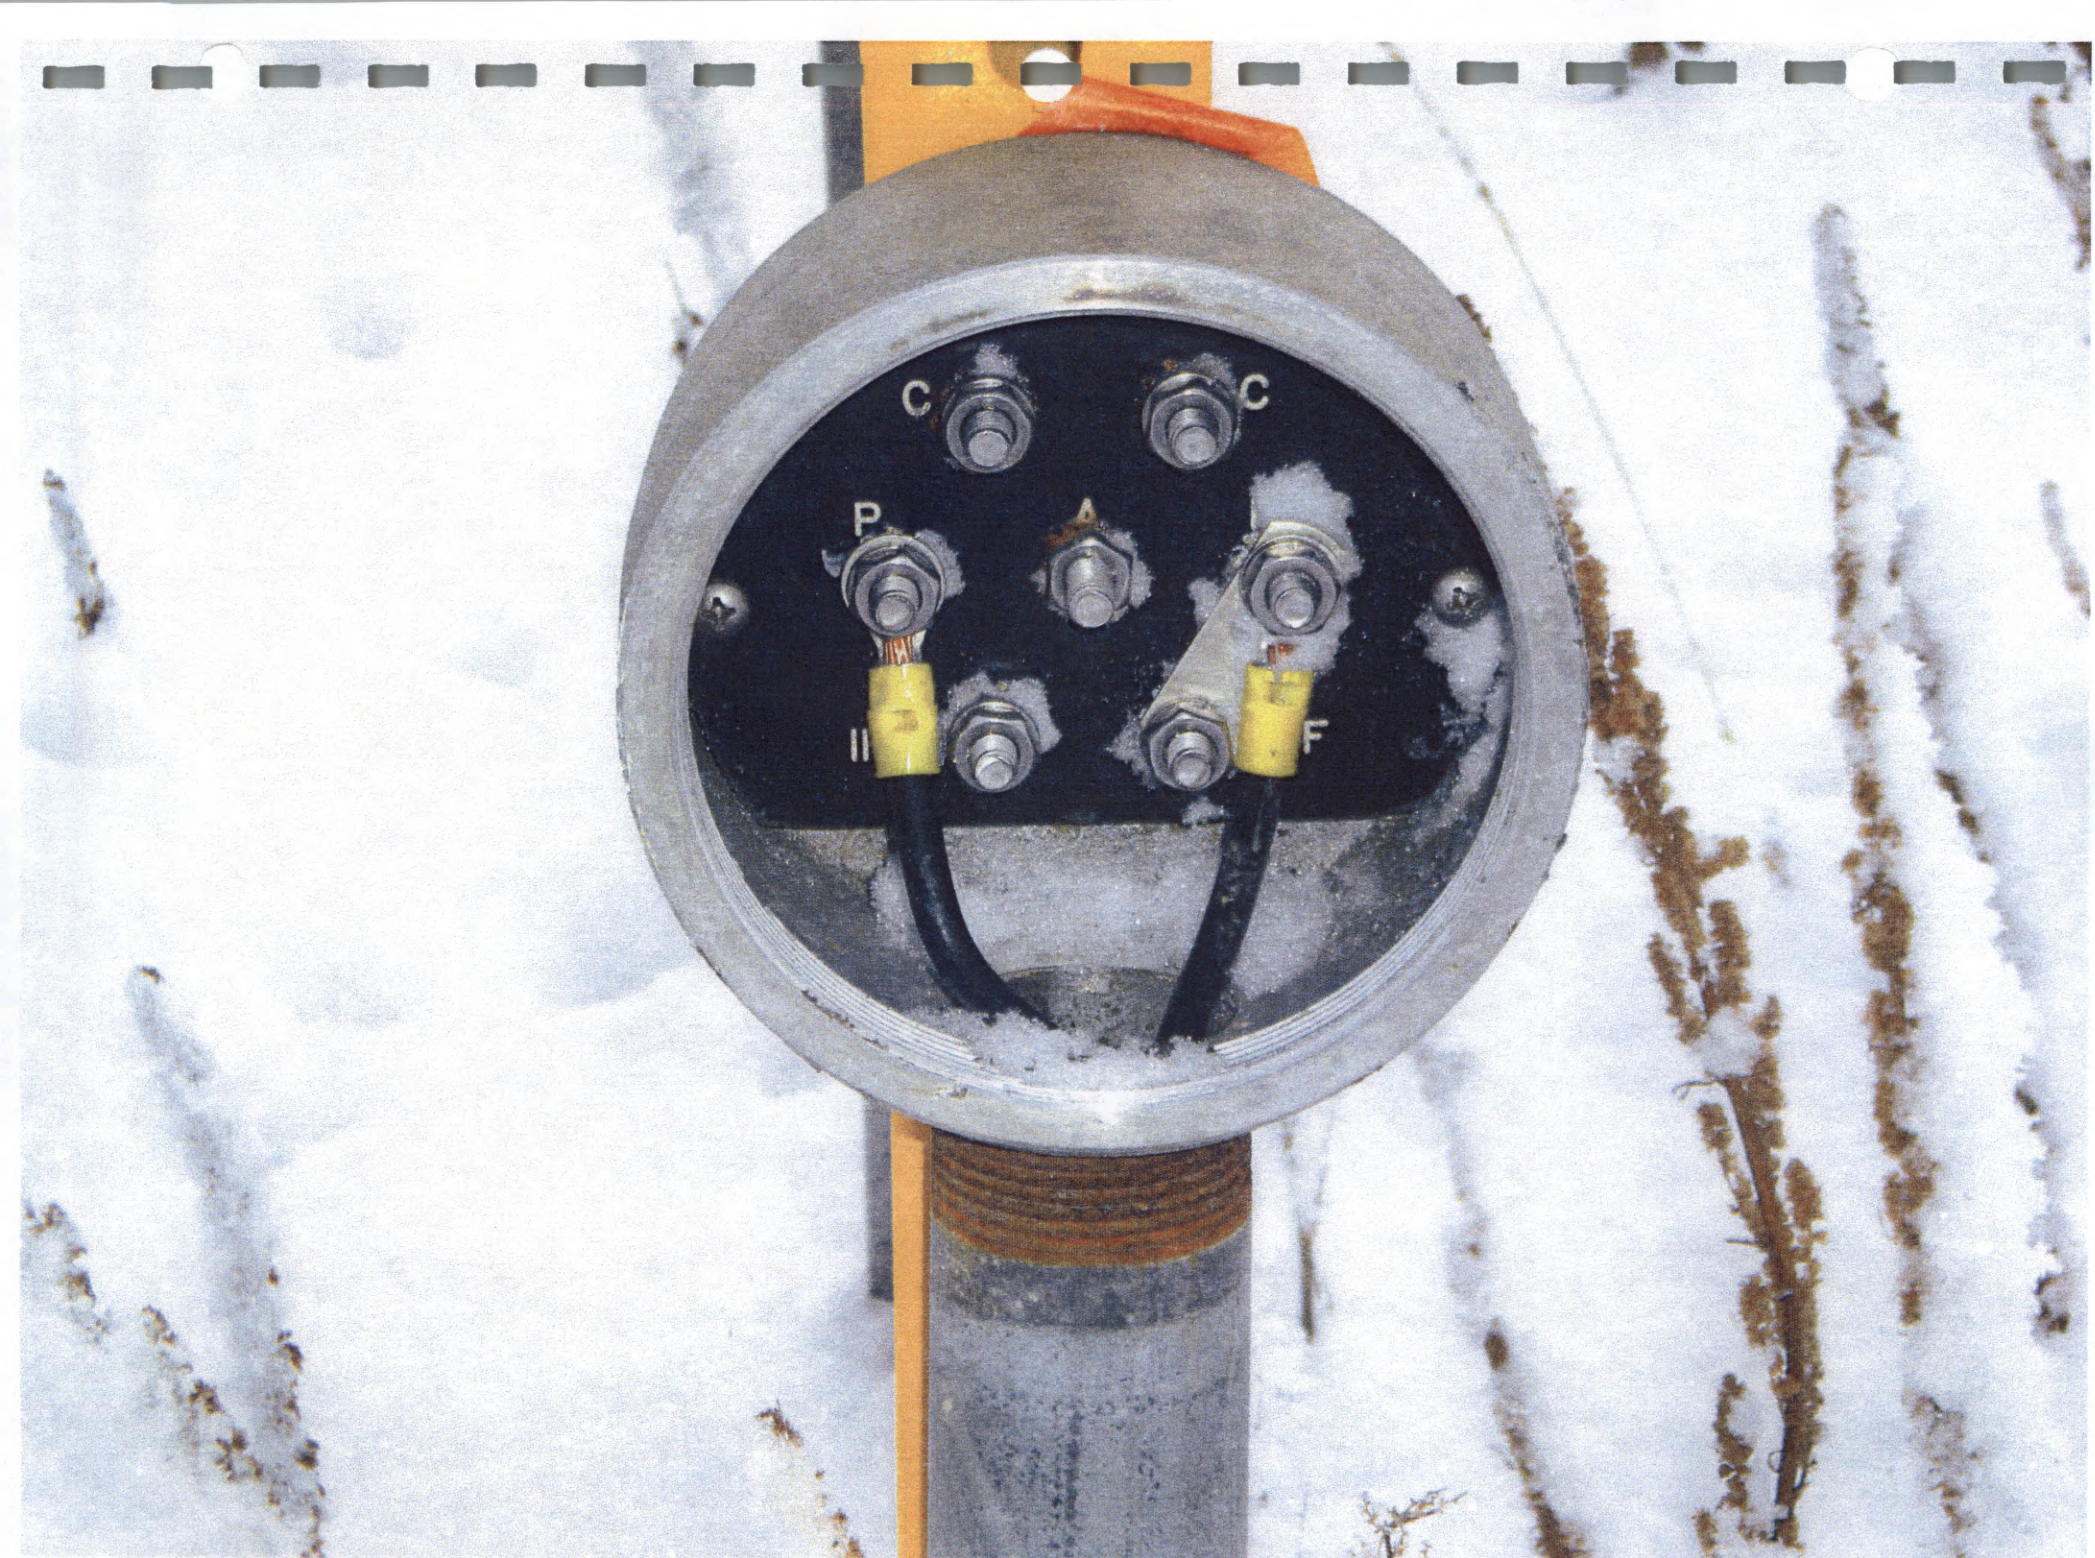
Picture # 51 Cap missing mm 95 17<sup>th</sup> St NE

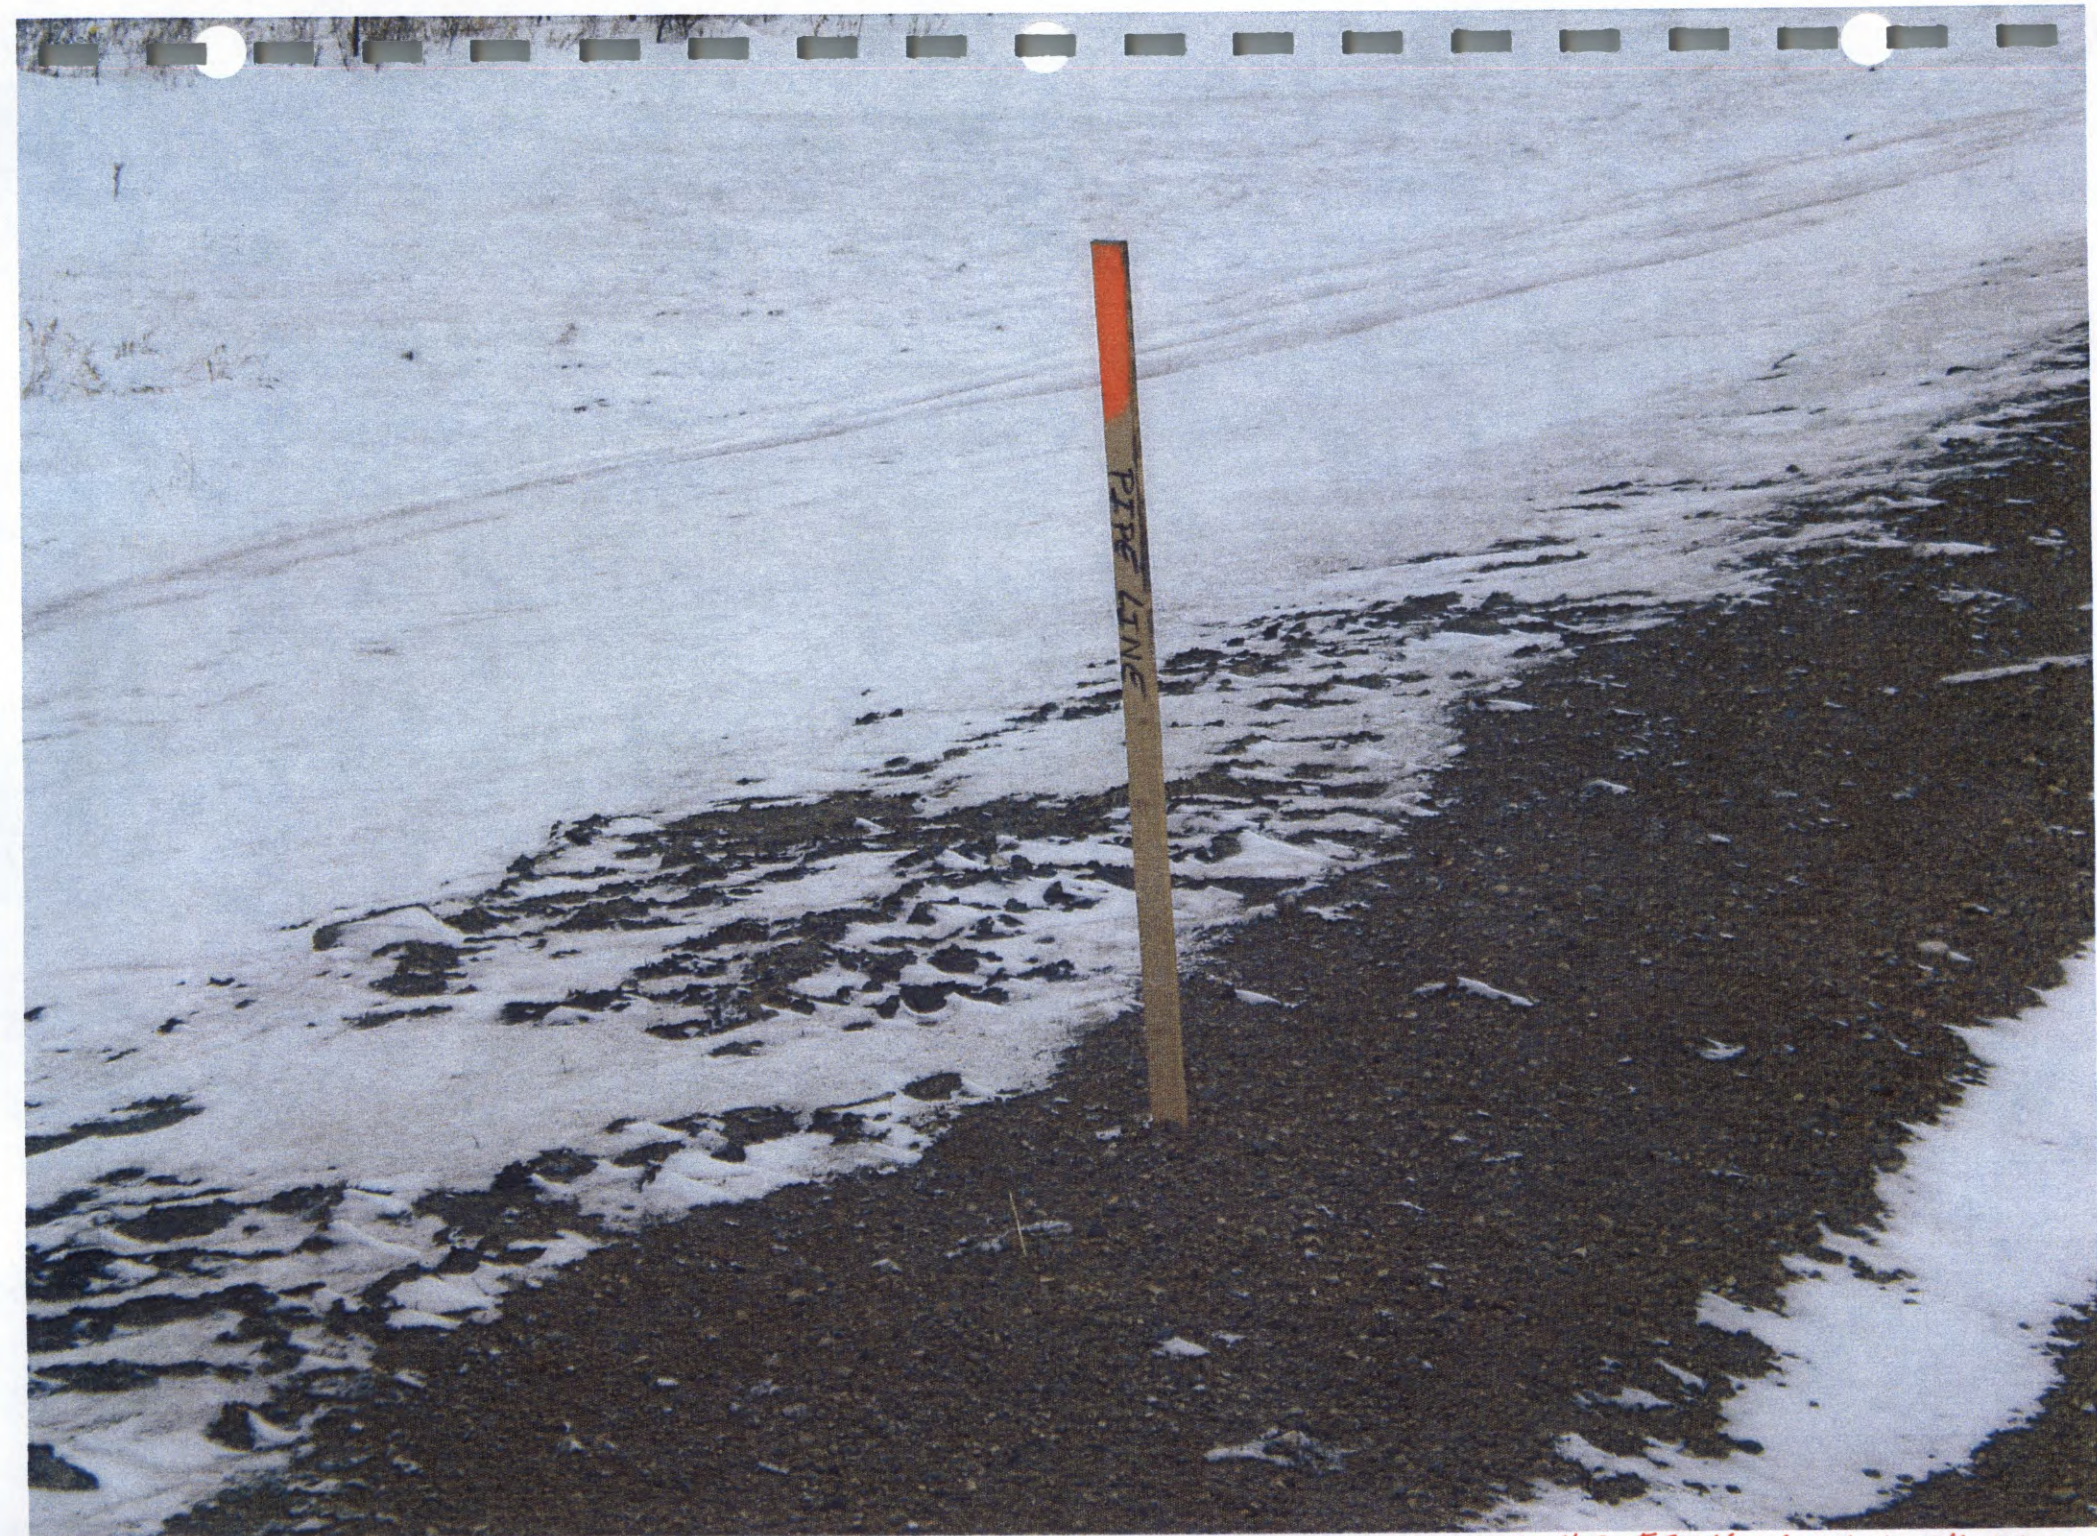
Picture #60 No signs, these are service roads to windmills./There could be more like this. I could not get to all service  
ADS
