*Keystone*

**Final Inspection**

*1-5-2011*

PROJECT Keystone Pipeline - North Spread

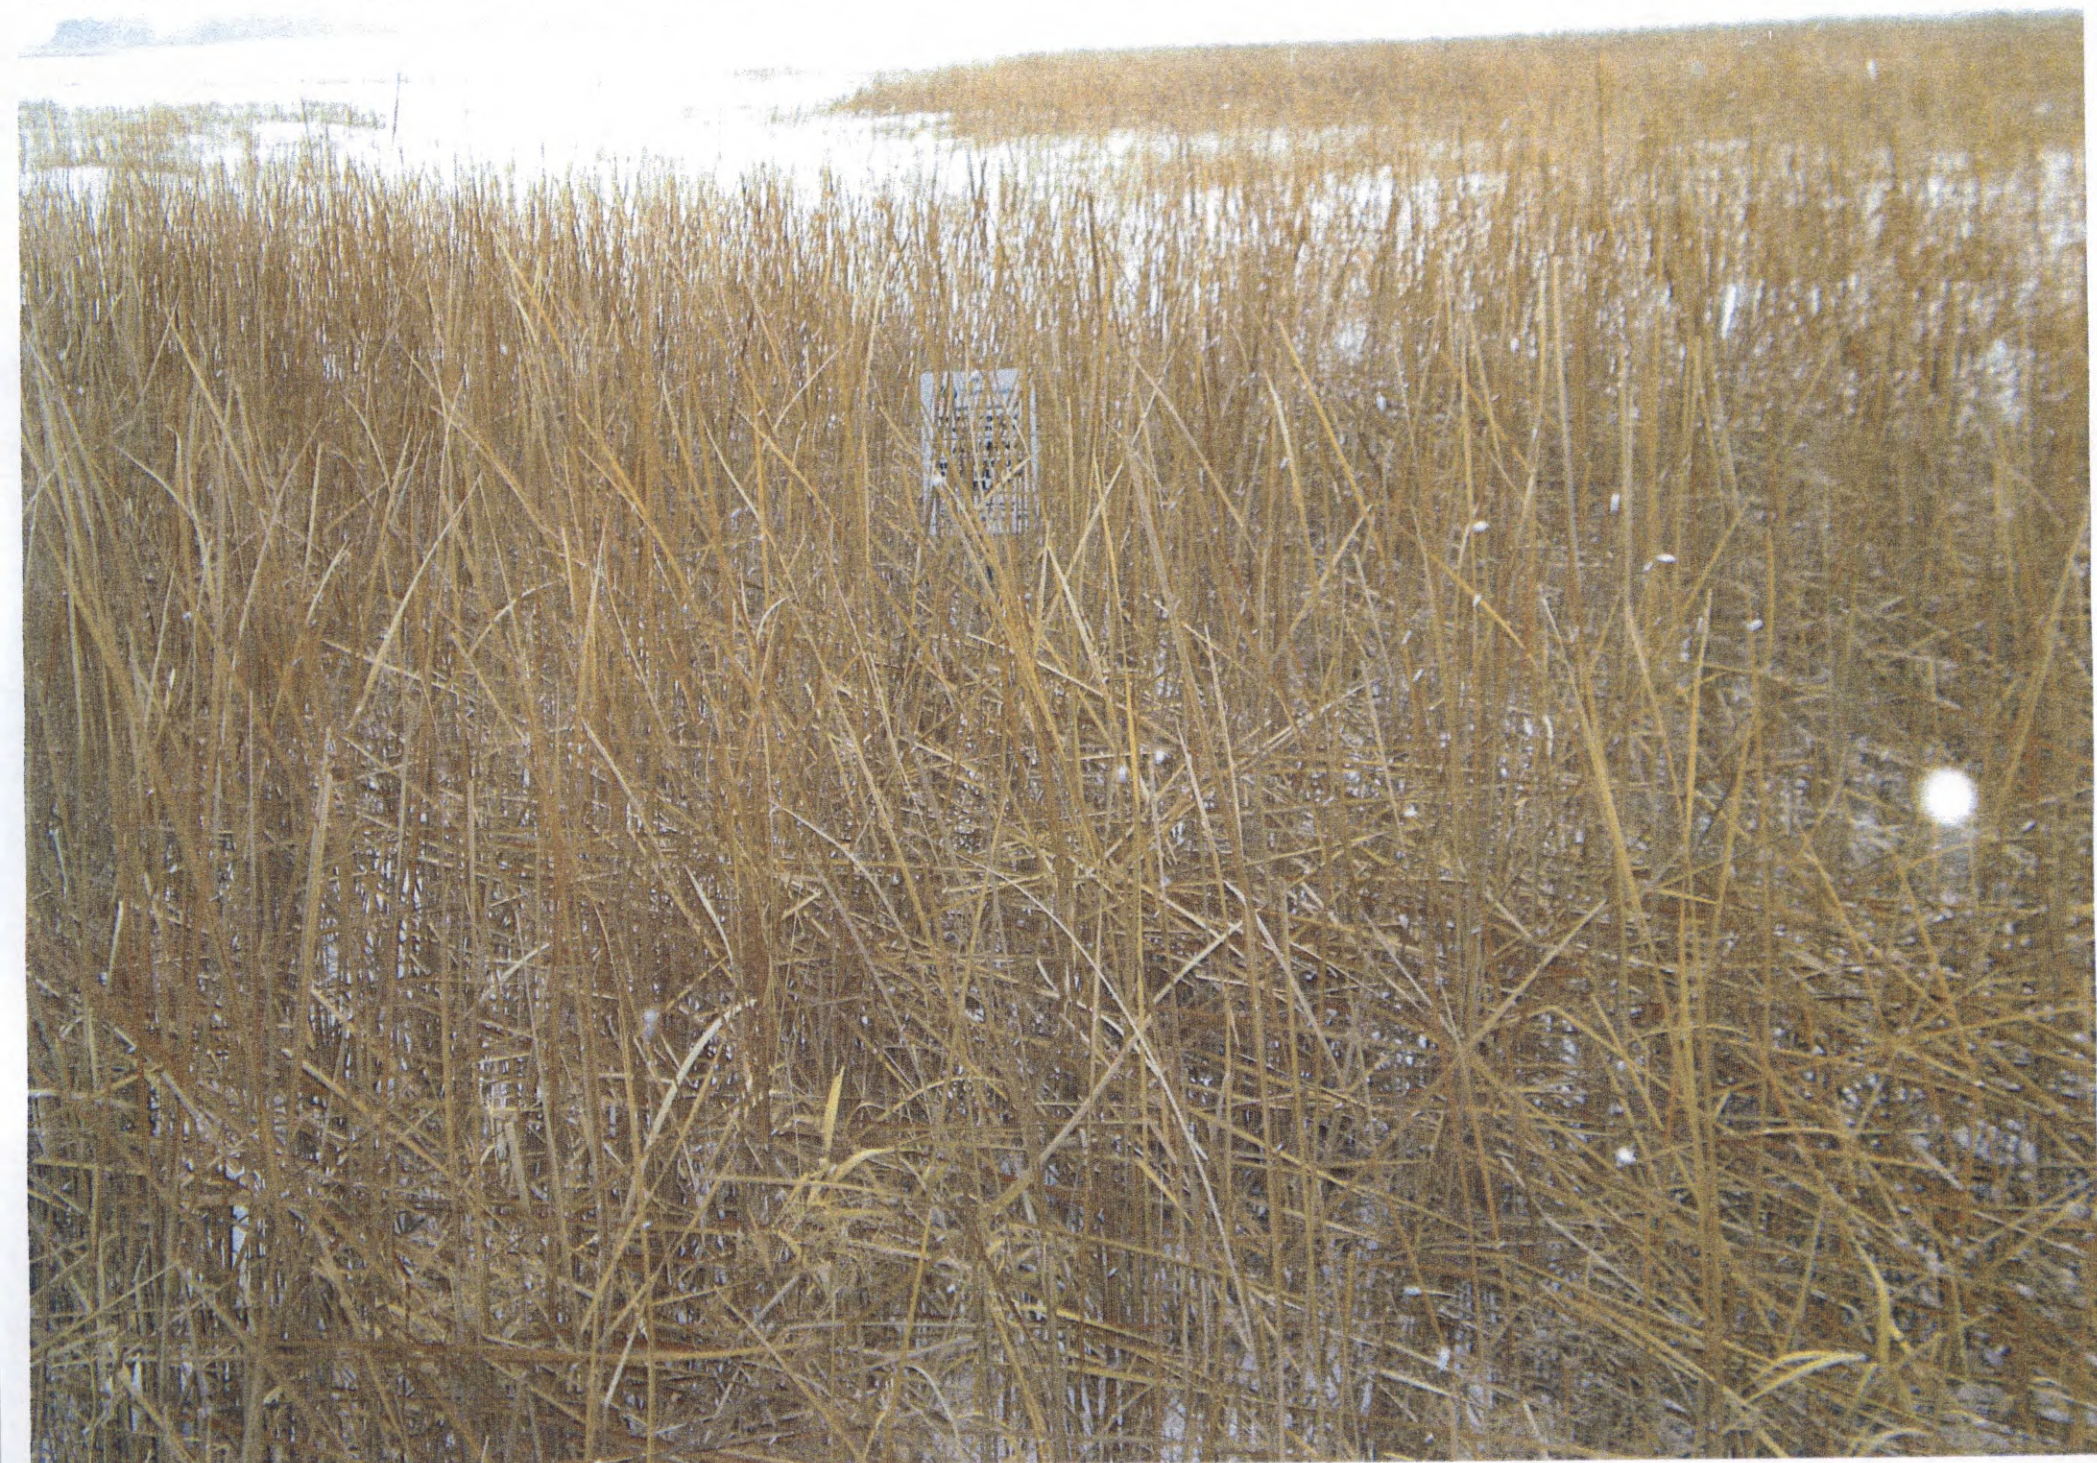
Picture # 64 Signs on both sides of Road 24<sup>th</sup> St SE are hard to See
