On July 29, 2008, the North Dakota Public Service Commission held a siting hearing in New England, North Dakota on Case No. PU07-169 regarding the Belfield to Rhame 230kv Transmission Line to be built by Basin Electric Power Cooperative. During the hearing, the Commission made a number of requests for additional information to be submitted as "late filed exhibits". The following is a list of the documents requested.

22 PU-07-169 Filed 09/10/2008 Pages: 285  
Late - filed Exhibits 9 to 14, Wetland Delineation  
and Cultural Resource Reports  
Basin Electric Power Coop Inc.

**Belfield to Rhame Transmission Project**

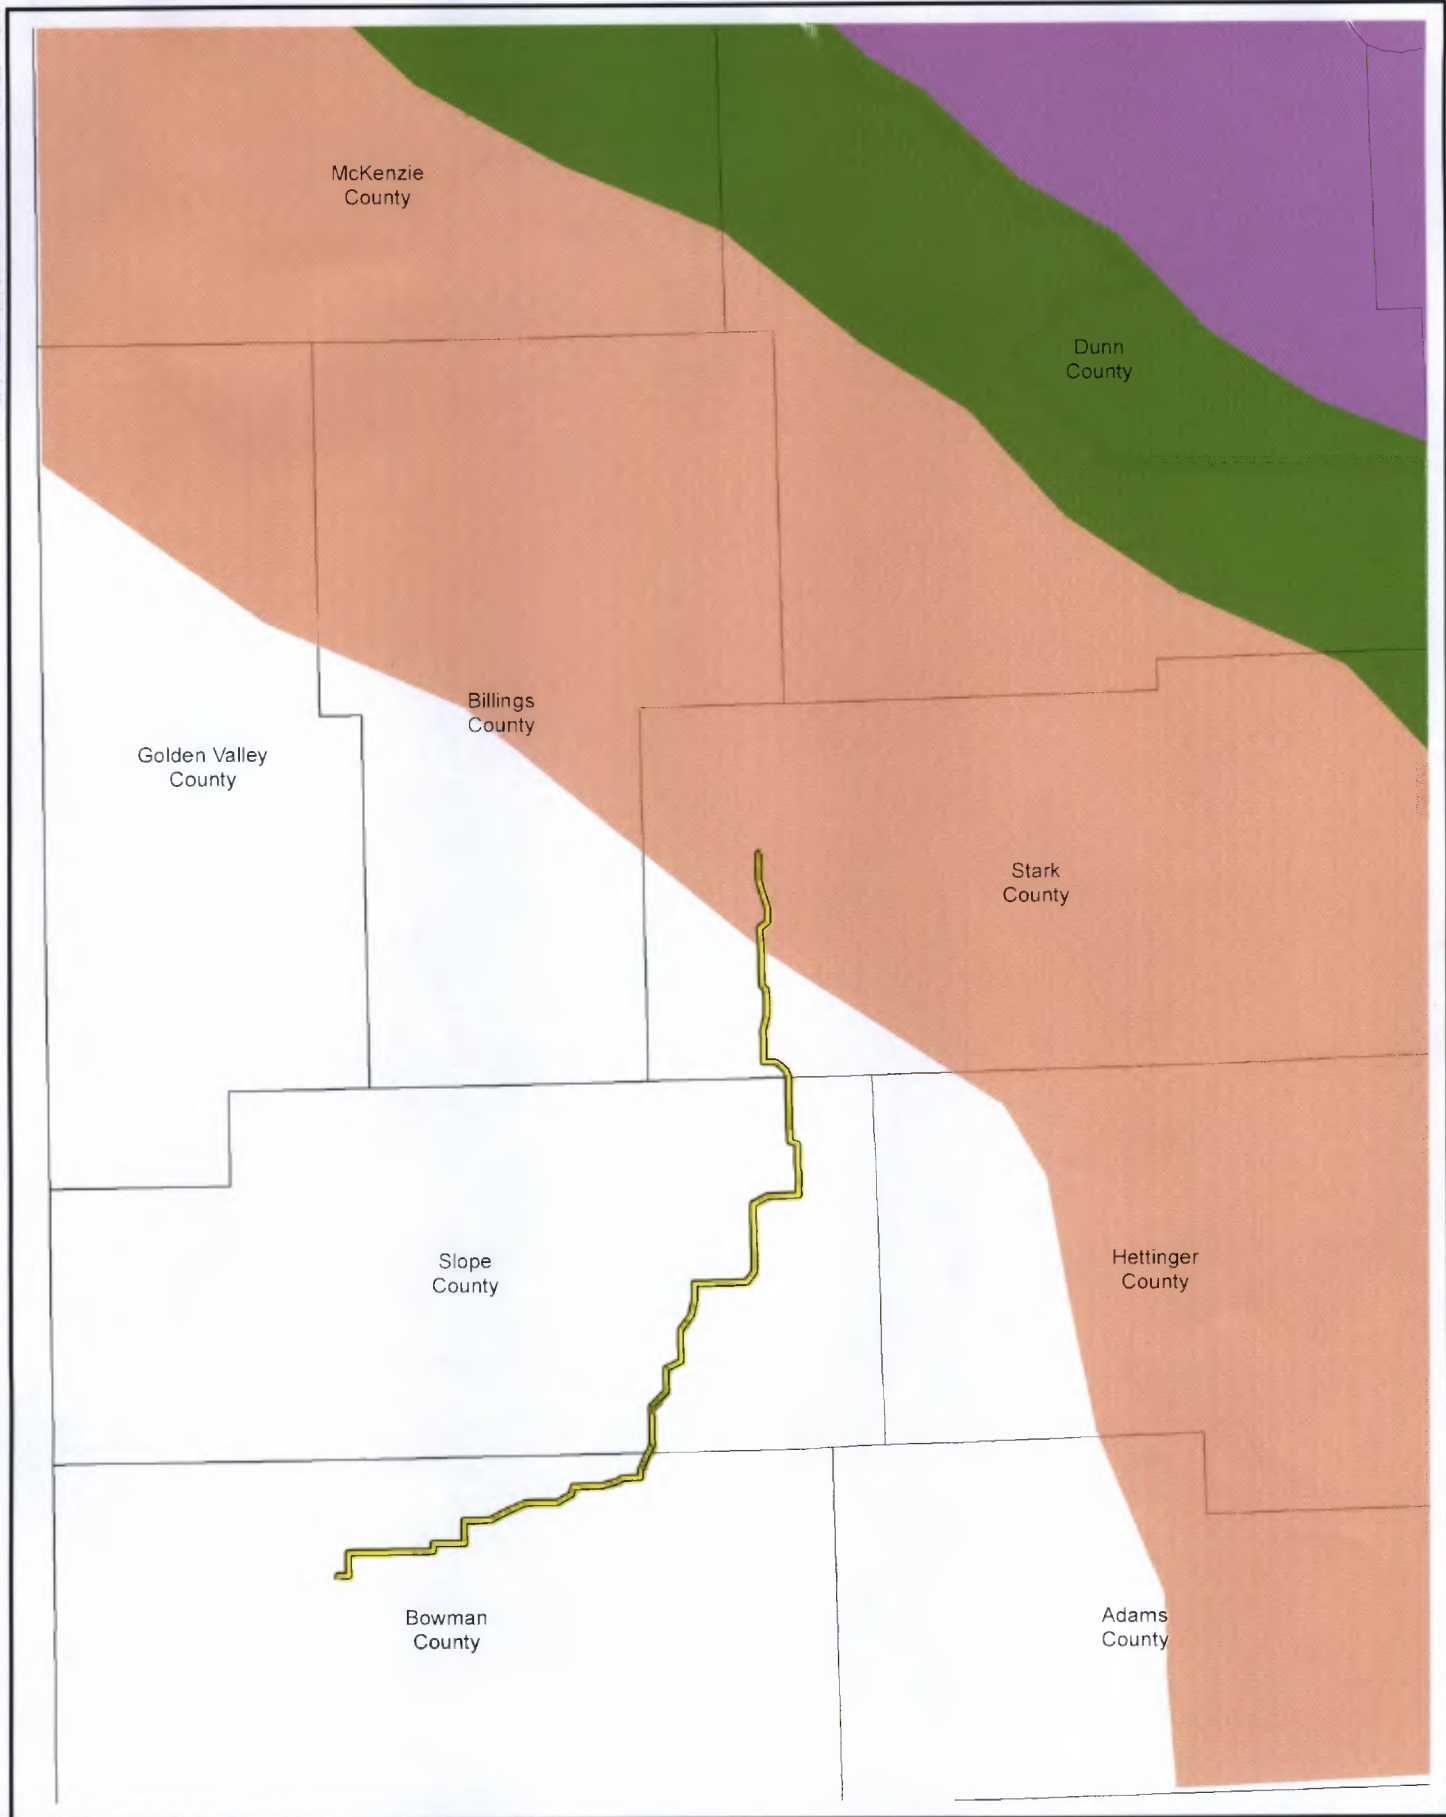
**Whooping Crane Corridors**

The map shows the proposed Belfield to Rhame transmission line with respect to the whooping crane migration flyway. The majority of the proposed transmission line route is outside the 180 mile wide migration flyway; however, a small segment of the route overlaps the outer fringe of the flyway.

Per the Commission's request for additional information regarding the relationship of the whooping crane migration flyway and the proposed route for the Belfield to Rhame 230kV transmission line on July 29, 2008, I have prepared a map (attached) that reflects the flyway and the proposed route.

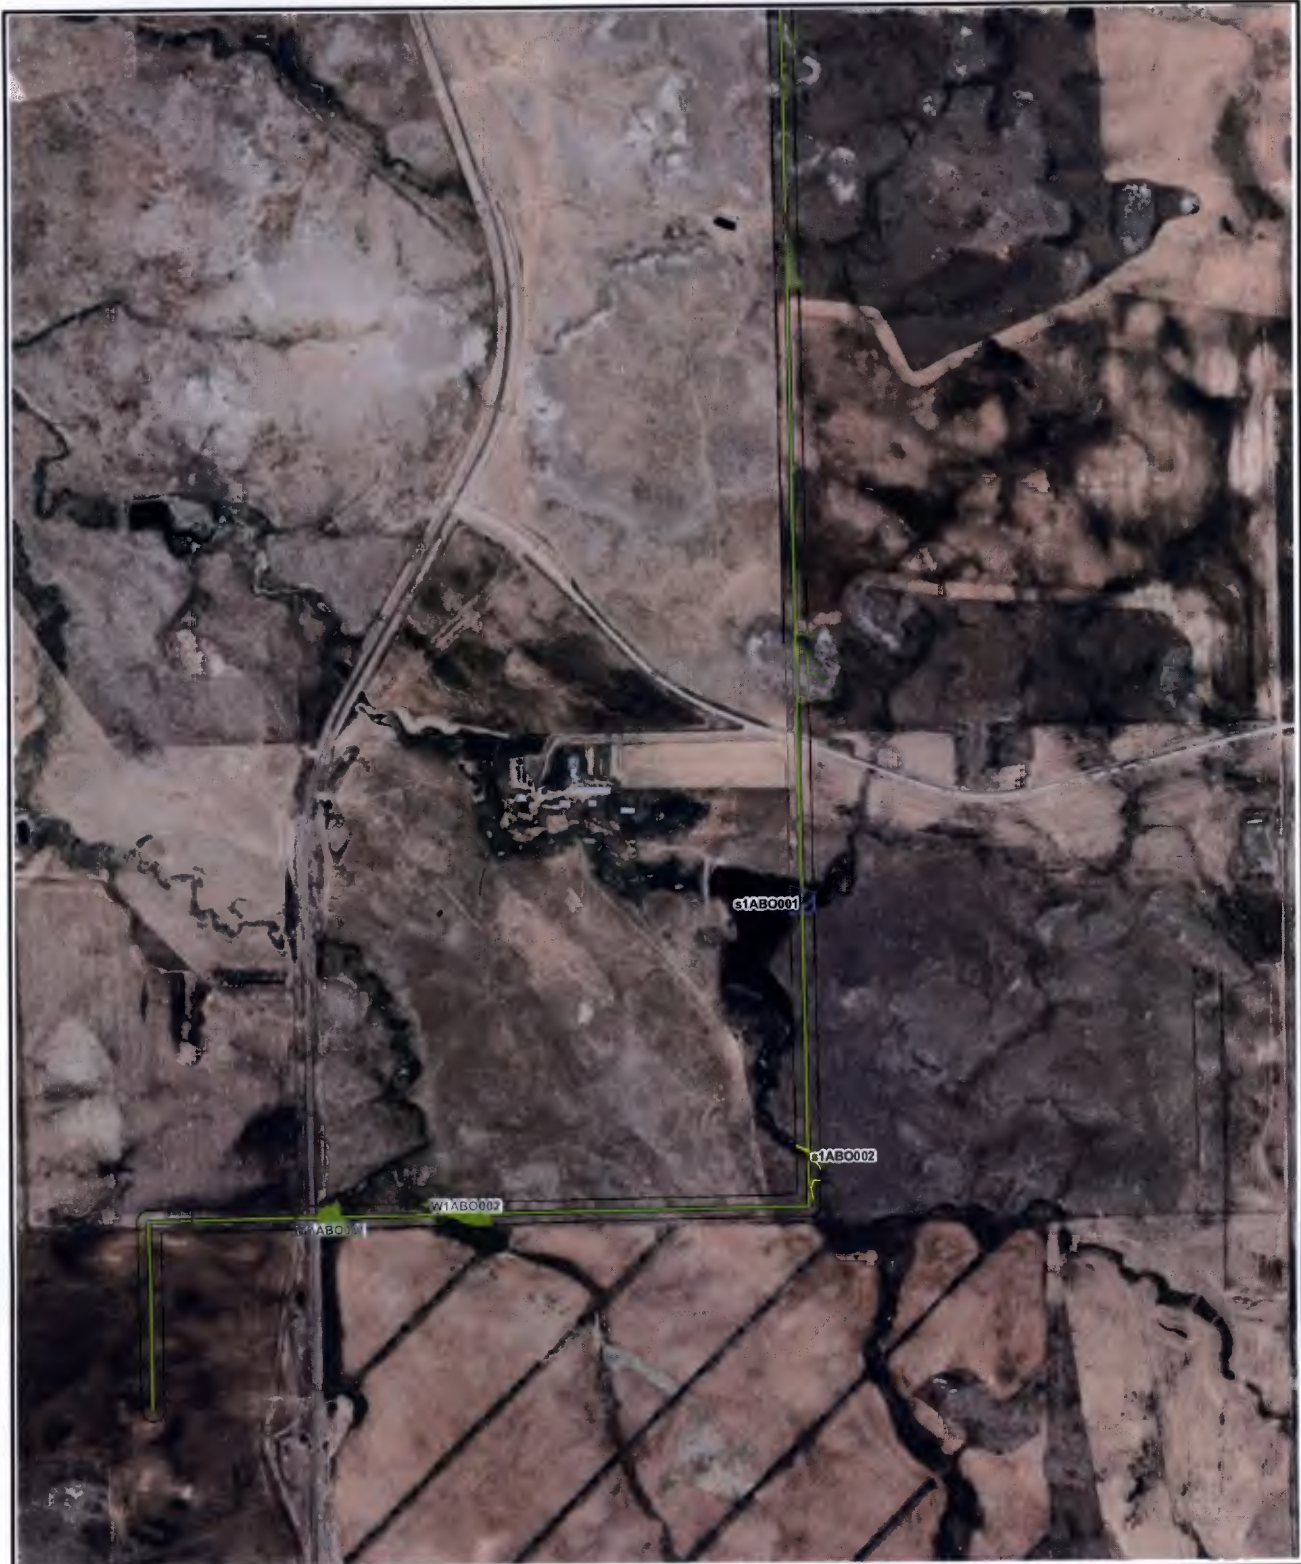
Map 01 of 26

**Wetlands and Waterbodies**

Project location maps provided in **Attachment A** show wetlands and waterbodies identified within the Project corridor. Wetlands identified and classified during the field surveys were not always illustrated on the National Wetland Inventory (NWI) maps. In addition, some areas illustrated on the NWI maps as wetland did not meet the criteria to be designated as wetland. Detailed information on each feature surveyed in the field is provided on the USACE Wetland Data Sheets that can be found in **Attachment B**.
