Enbridge Pipelines (North Dakota) L.L.C.

Phase 6 Expansion Project - Stations

Wetland Determination Report

October 2007

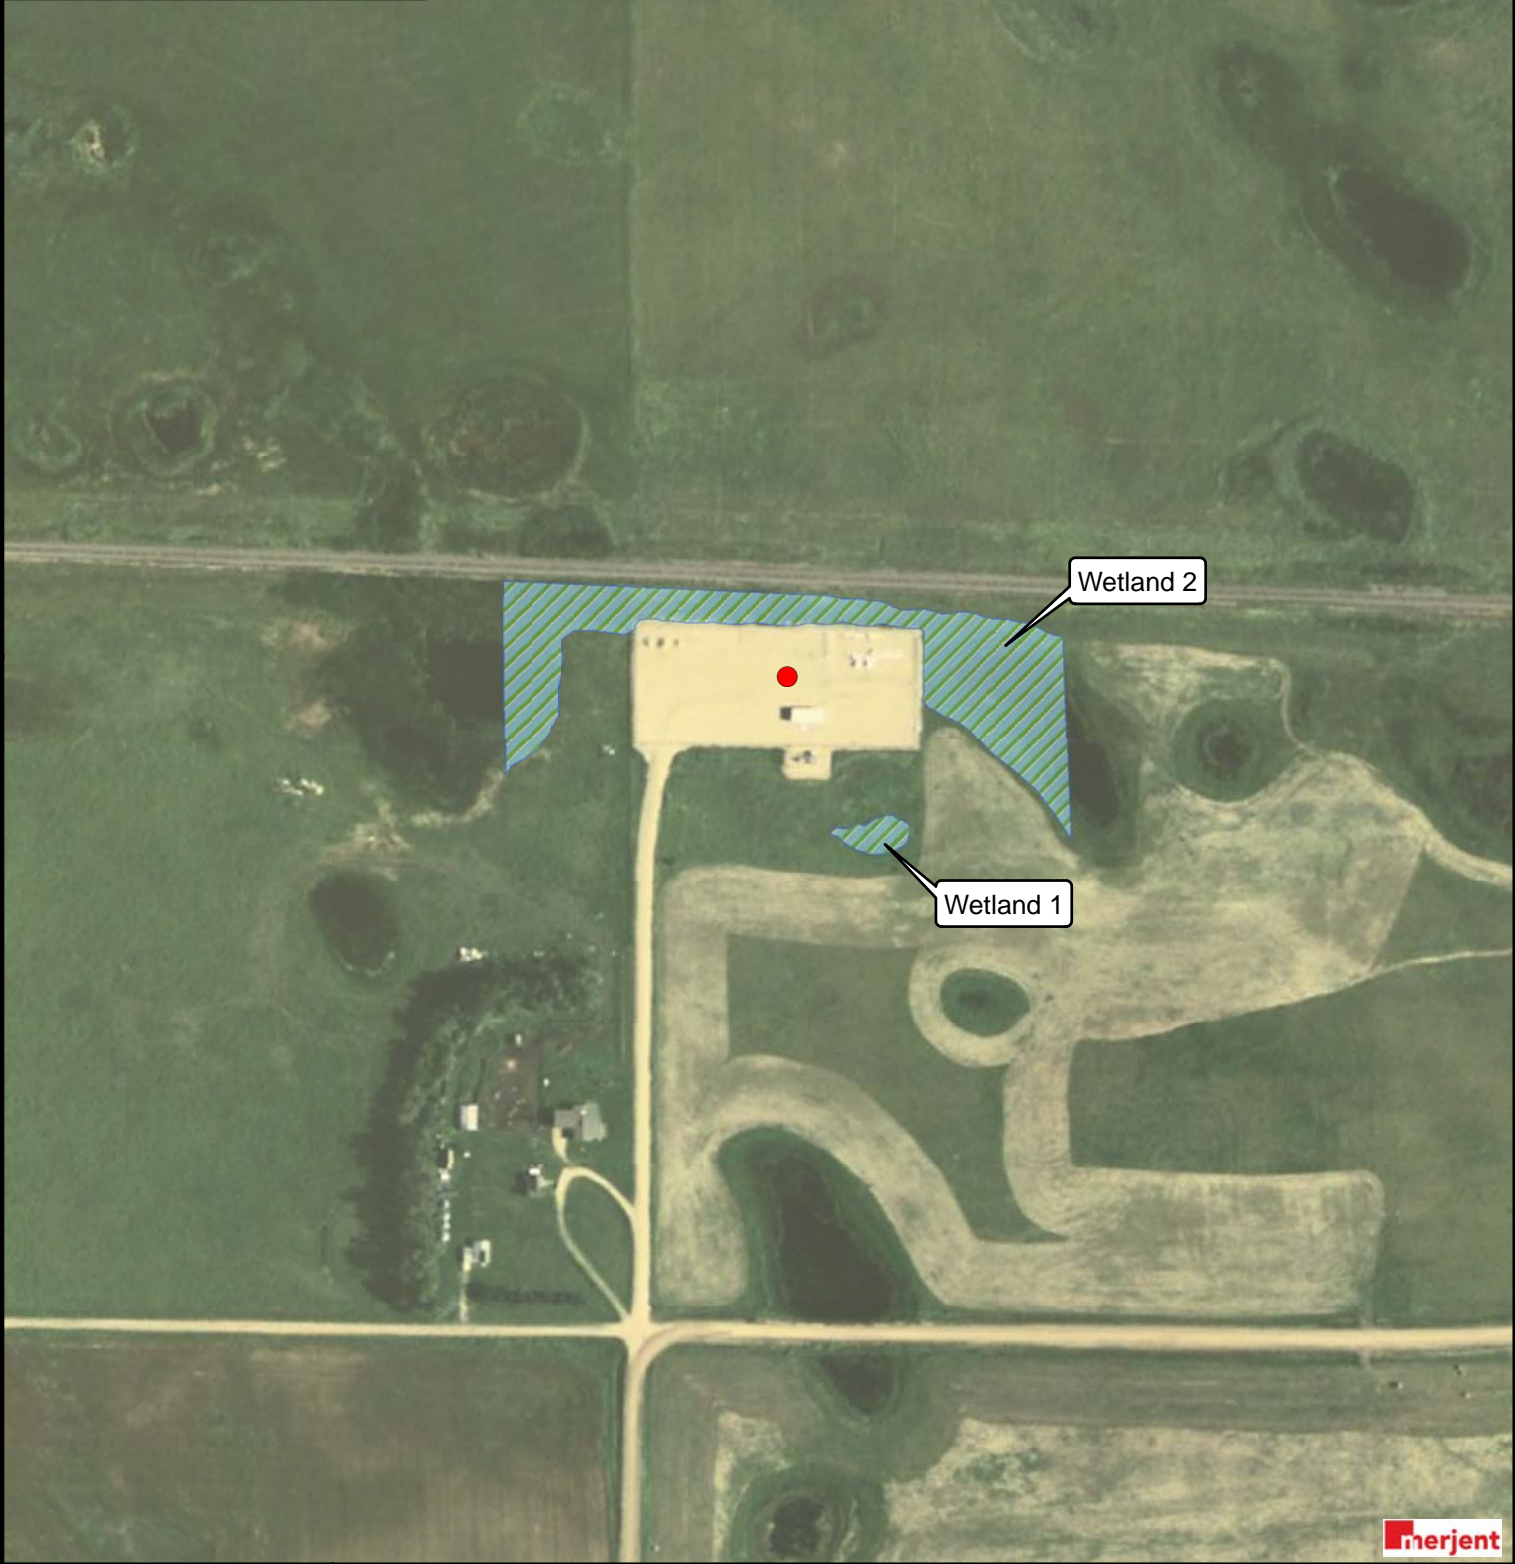
Wetland Location Map
(1:4,000 2003 Aerial Photography)

Two wetlands were identified and delineated at the Pleasant Lake Station. No wetlands were identified at the remaining stations. Wetland boundaries were recorded using a GPS unit rated for one-meter accuracy. The locations of the delineated wetlands and SSURGO soil data are presented on the attached 1:4,000 scale aerial-photograph based maps (see Appendix B and Appendix C, respectively). Information for each wetland is recorded in the attached Data Sheets (see Appendix D).

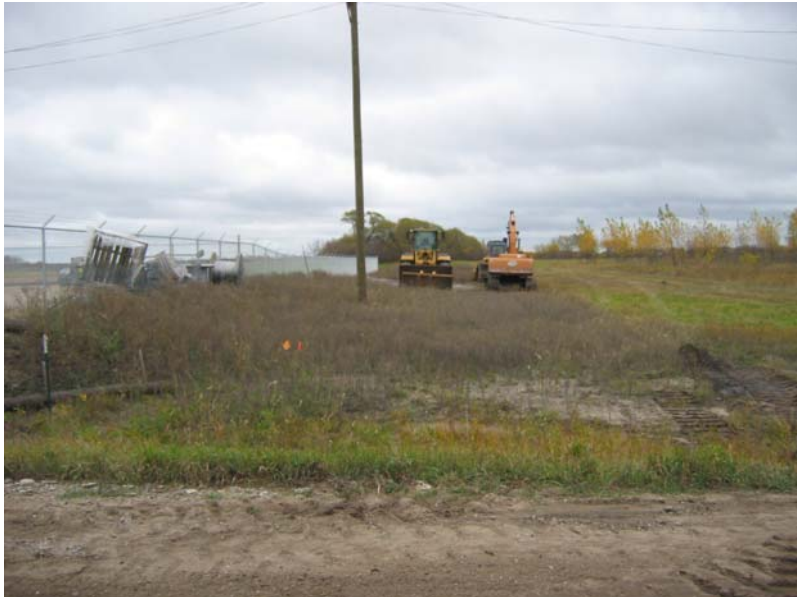
Brooks Station. View of southern fenced facility. Planted aspen occur south of facility. No wetlands present.

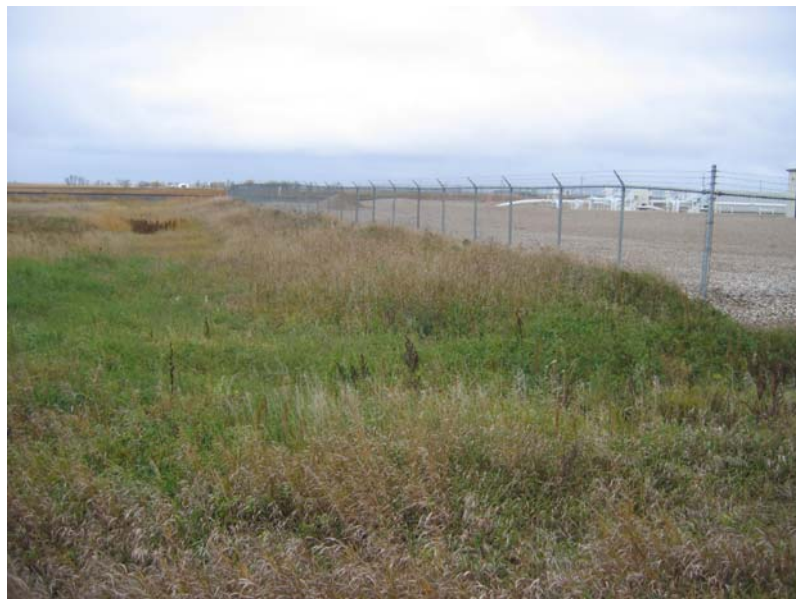
Bartlett Station. View of the western edge of the station. The small swale did not exhibit wetland characteristics.

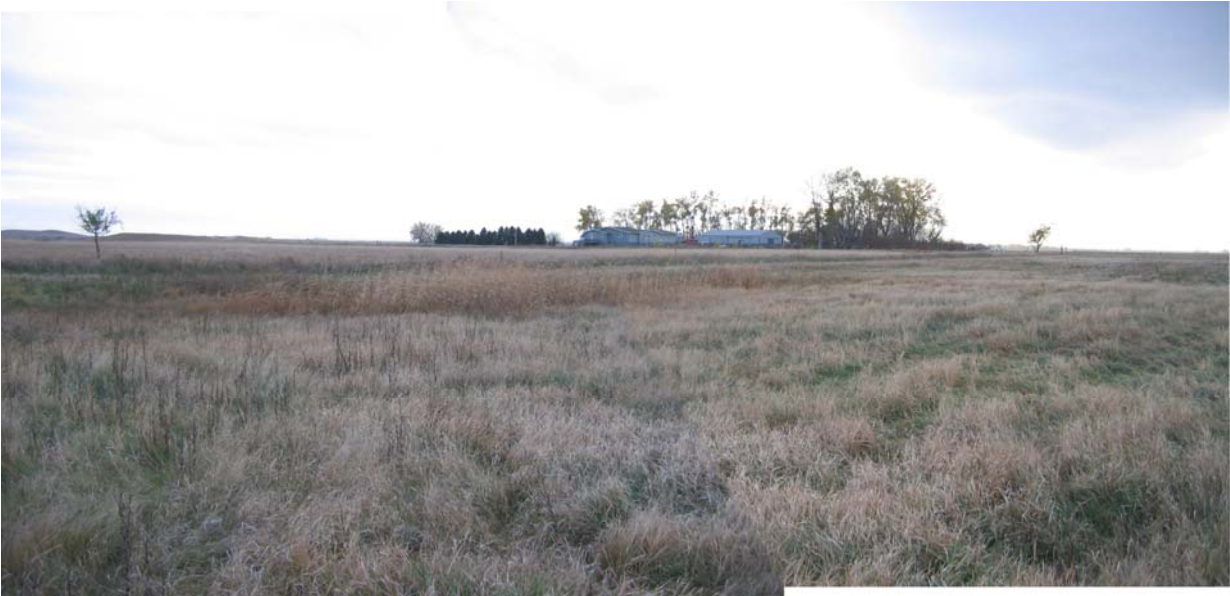
| Remarks: Small isolated recharge depression on the southwest side of the station. | |

| Remarks: Classified as a PEMA; Type 1 wetland. As stated in the vegetation section on Page 1, it is assumed the dominant sedge has an indicator status of OBL, FACW, or FAC (excluding FAC-). | | | | |

Pleasant Lake Station. View of Wetland 1 from the southeast corner of the existing substation.

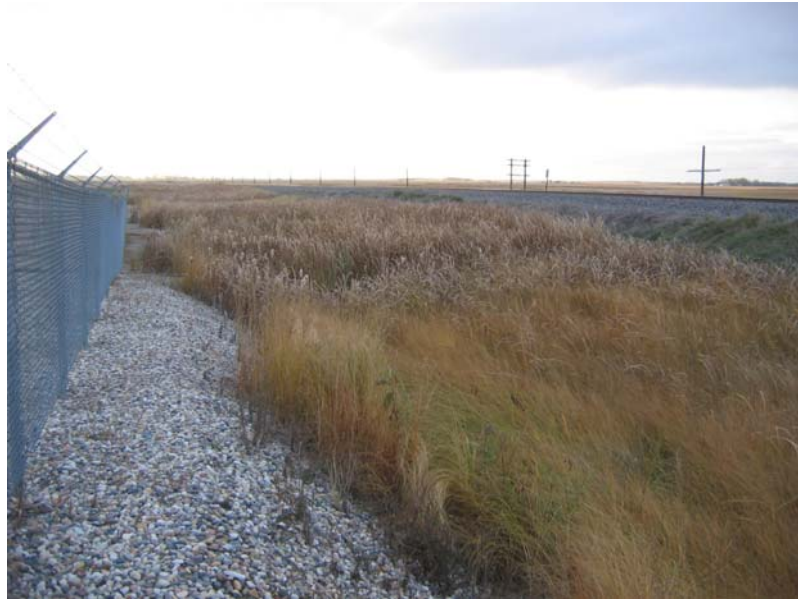
Pleasant Lake Station. View of the northern edge of the station and Wetland 2.

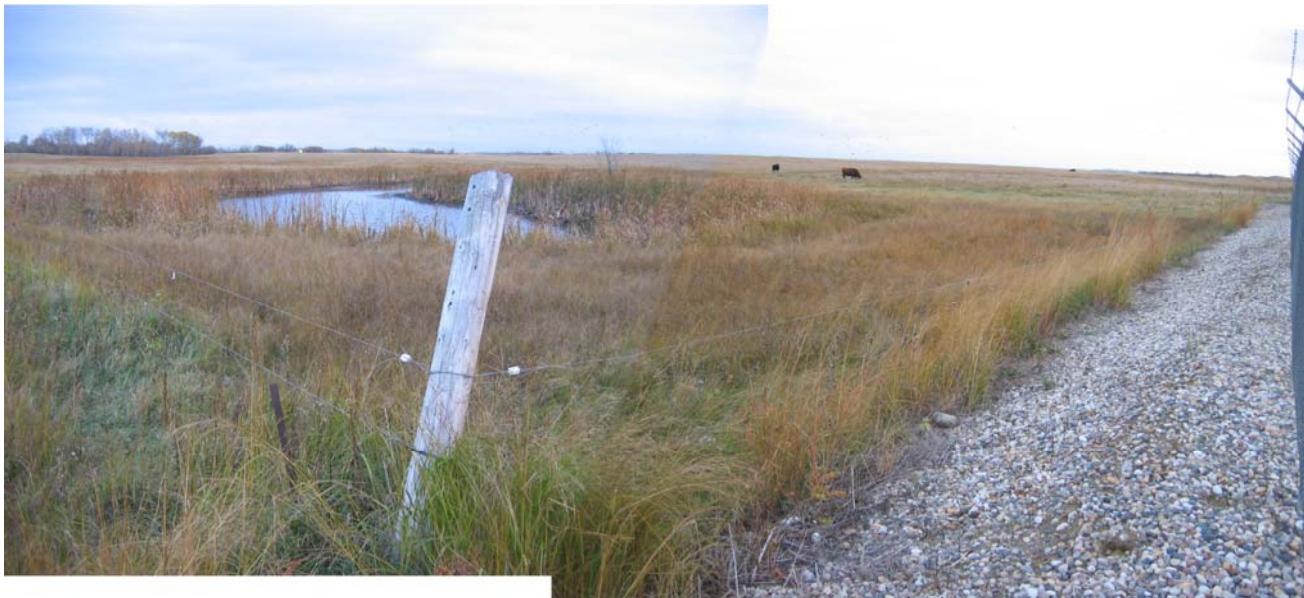
| Remarks: Isolated recharge wetland along the northern and eastern side of the station. | |

| Remarks: Classified as a PEMA and PUBGx; Type 1 wetland. A portion of this wetland was filled by the original station construction. The portion of the wetland east of the station is grazed. Railroad tracks bound the wetland to the north. There were no culverts observed underneath the railroad grade. | | | | |

Pleasant Lake Station. View of Wetland 2 from the northeast corner of the station.

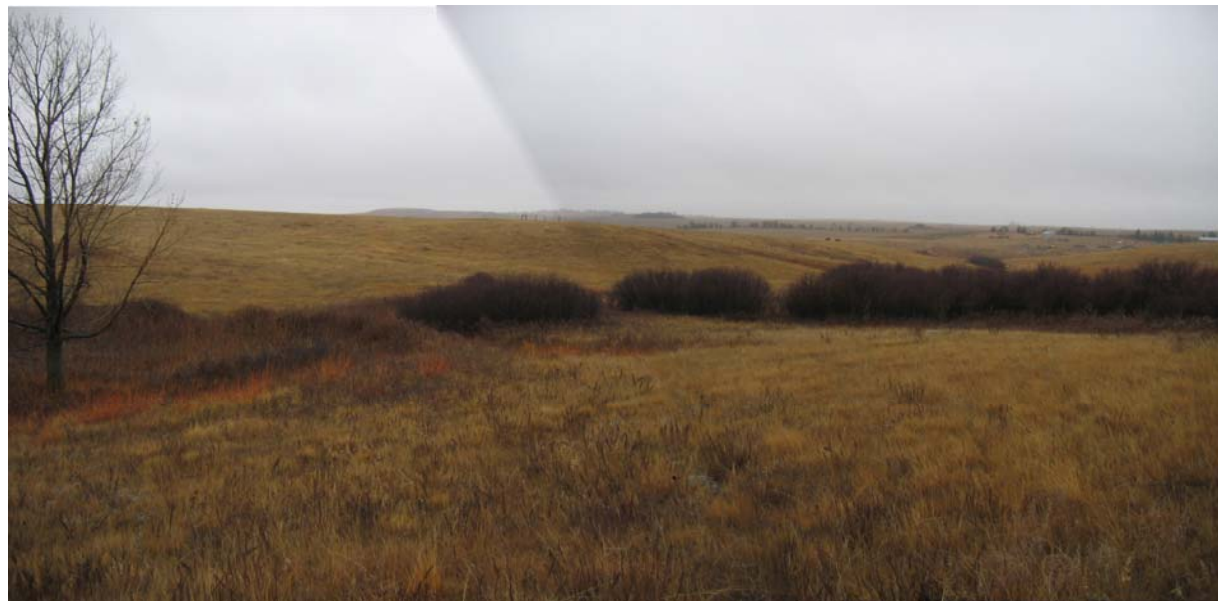
Beaver Lodge Station. View of intermittent waterbody 1,000 feet south of existing station. No wetland vegetation present.

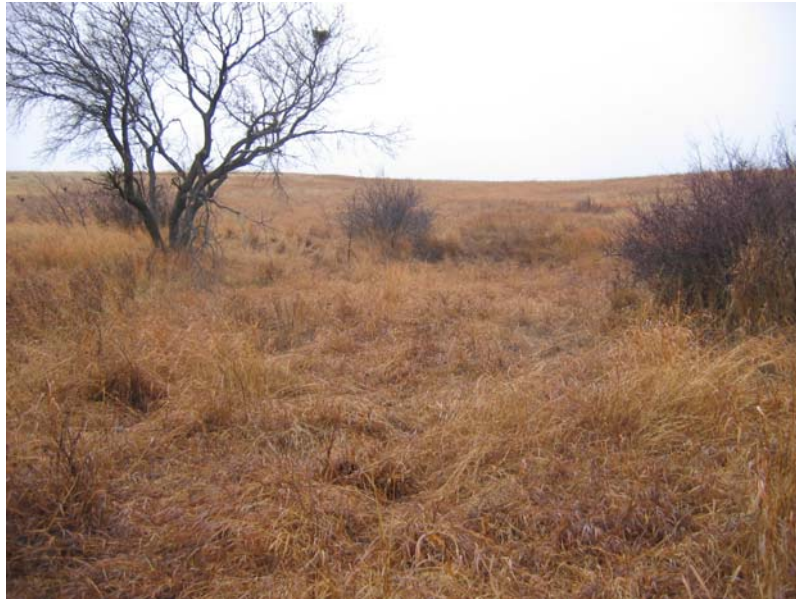
Beaver Lodge Station. View of the intermittent waterbody north of the existing station.
