Pillsbury-Fargo Transmission Line Construction Inspection Report

Minnkota Power Cooperative, Inc.

January 2012

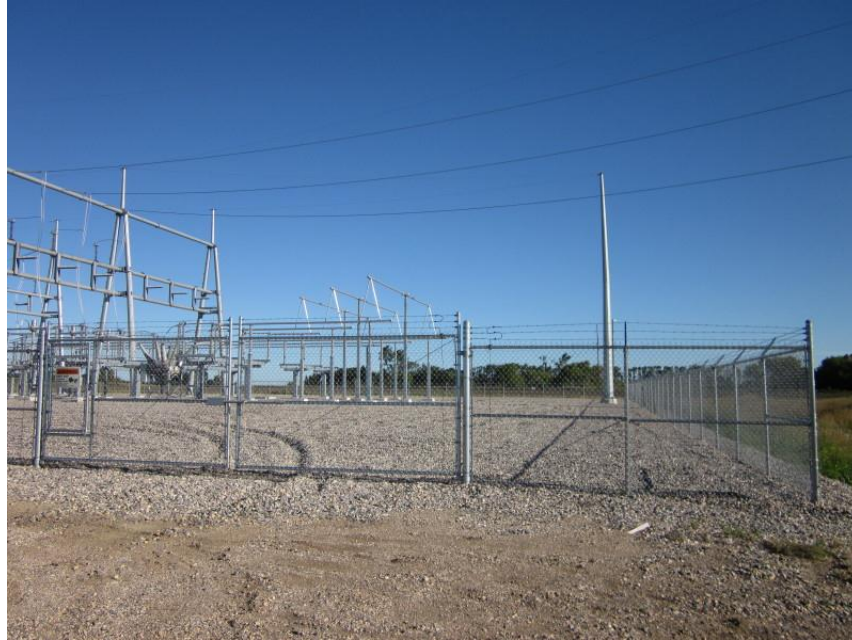
Photo 1. Direction: North. Entrance to the new Pillsbury Substation at the west end of the transmission line, about two miles west of the town of Pillsbury in the SW ¼ of Section 7, Township 143N, Range 56W, Barnes County, North Dakota.

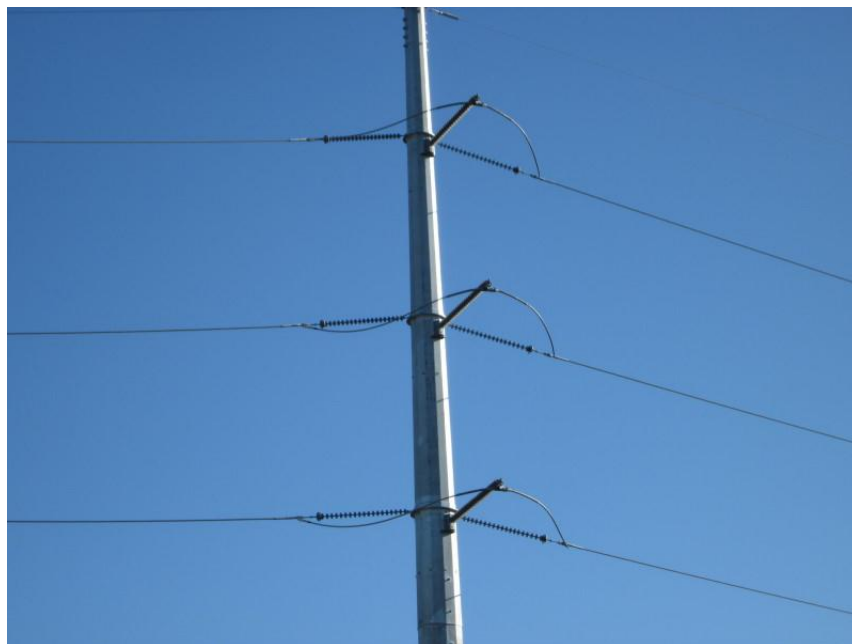
Photo 2. Direction: Northeast. First pole outside of the substation showing close-up of attachment of wires to the monopole structure. Monopoles were all self-supporting with no guy wires. Poles outside of substation fences and where the line changed directions had concrete footings, otherwise they were buried directly.

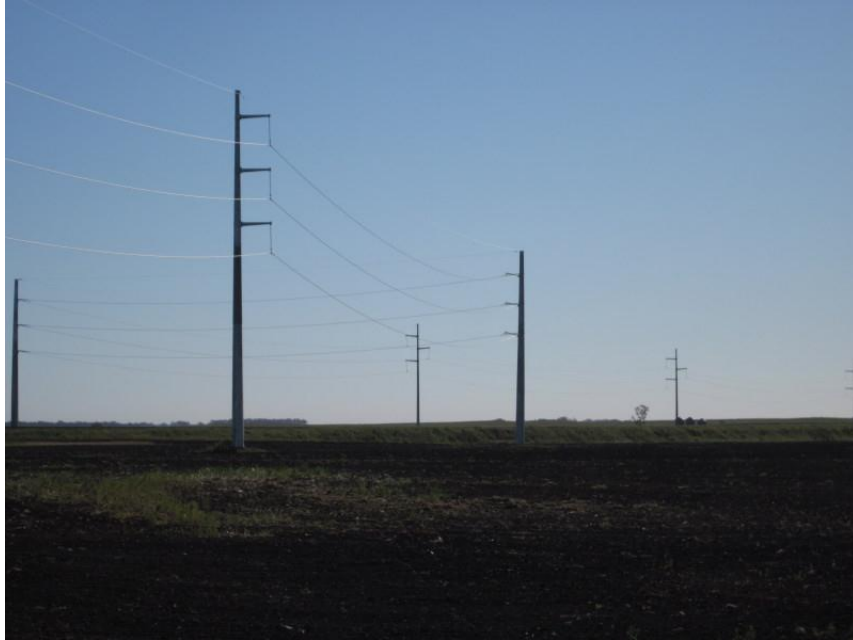
Photo 3. Direction: East. East from the Pillsbury substation where the transmission line paralleled a railroad.

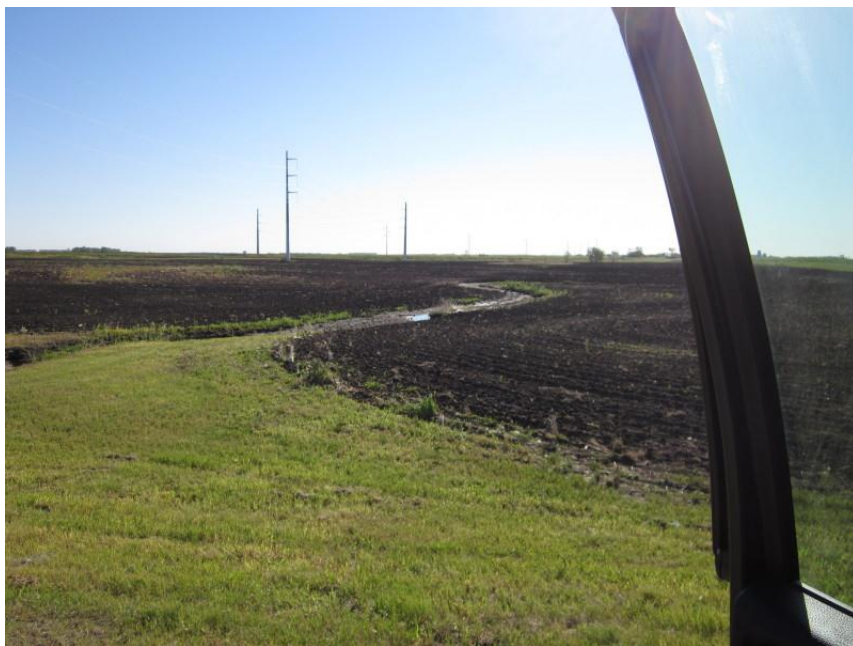
Photo 4. Direction: East. Intermittent drainage exiting underneath the approach for the Pillsbury substation entrance. According to Minnkota, the approach had been washed out and had to be reconstructed this past spring. There were no erosion control structures evident.

The approach at the entrance to the Pillsbury substation crossed an intermittent drainage which showed some signs of erosion (Section 3.2.1). Apparently the approach had been recently reconstructed but no erosion or sediment control structures were observed. Wenck recommends preventing future wash-outs by installation of BMPs or revegetation. This location should be monitored until erosion is stabilized.

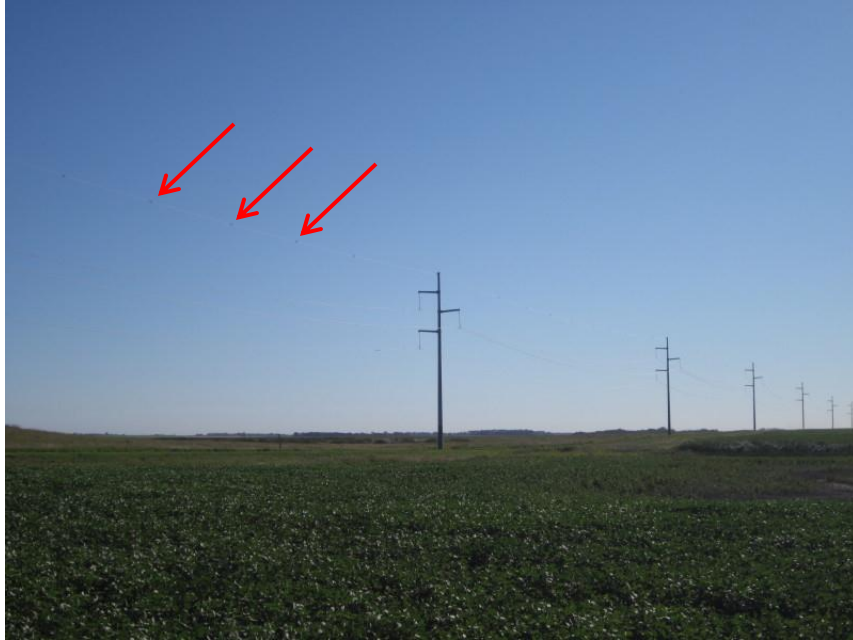
Photo 5. Direction: Northeast. Transmission line along 14th Street to the north of Pillsbury. There were bird deterrents on the top wire of this portion of the line (indicated by red arrows in photo, difficult to see against sky in background).

Though shield wires were marked with bird deterrents along many sections of the transmission line, it was unclear how decisions for marker placement were determined. Because of the well-studied potential for avian mortality from collision with transmission lines and the management and concern of these impacts by the USFWS, Wenck suggests clear documentation be obtained from Minnkota which explains rationale for the placement of markers for this Project, particularly how the placement relates to high avian use areas and proximity to wetlands.

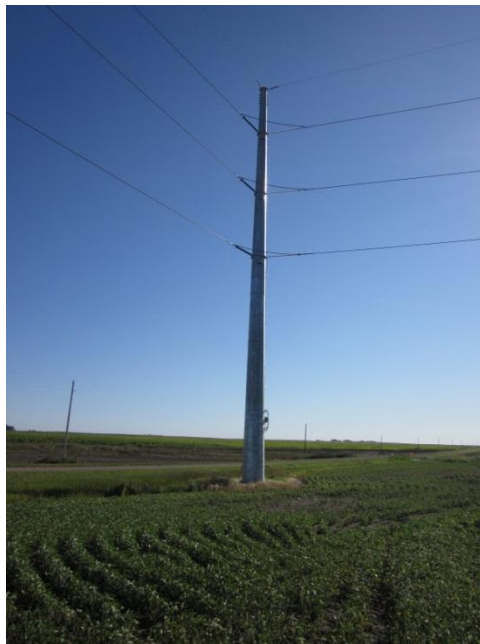
Photo 6. Direction: Northeast. Corner pole where transmission line turned from east to south at the intersection of 14th St and 129th Ave east of Pillsbury.

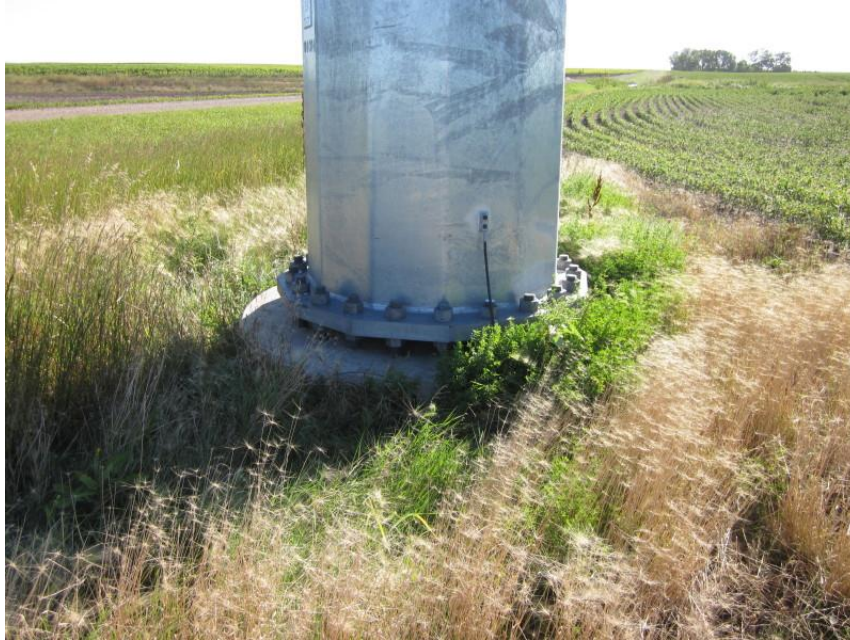
Photo 7. Close-up of pole in Photo 6 showing concrete footing of base, which is how all corner poles were constructed.

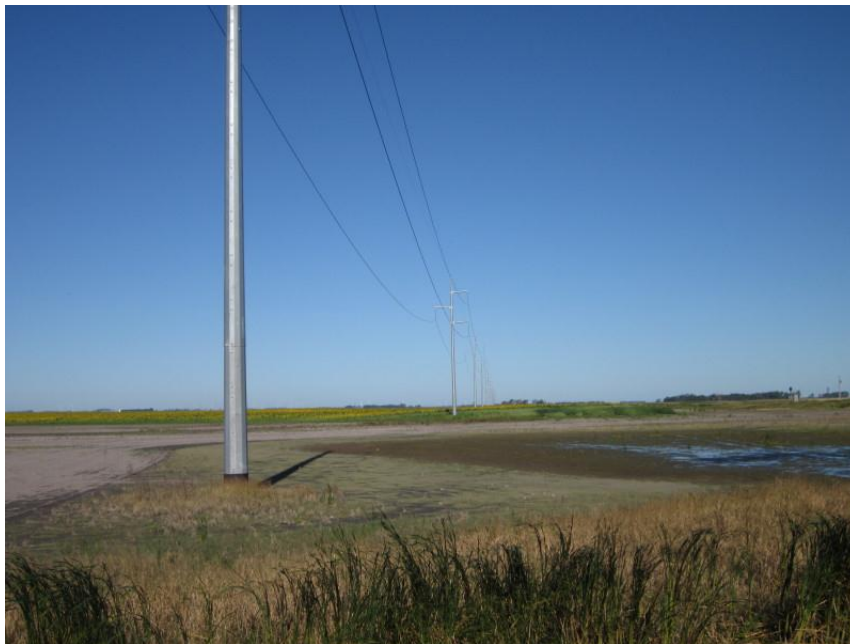
Photo 8. Direction: Northwest. Intersection of 133rd Ave and route of transmission line, looking to the northwest, where the line paralleled a railroad to the southeast of Pillsbury. Note the pole near the edge of a temporary wetland.

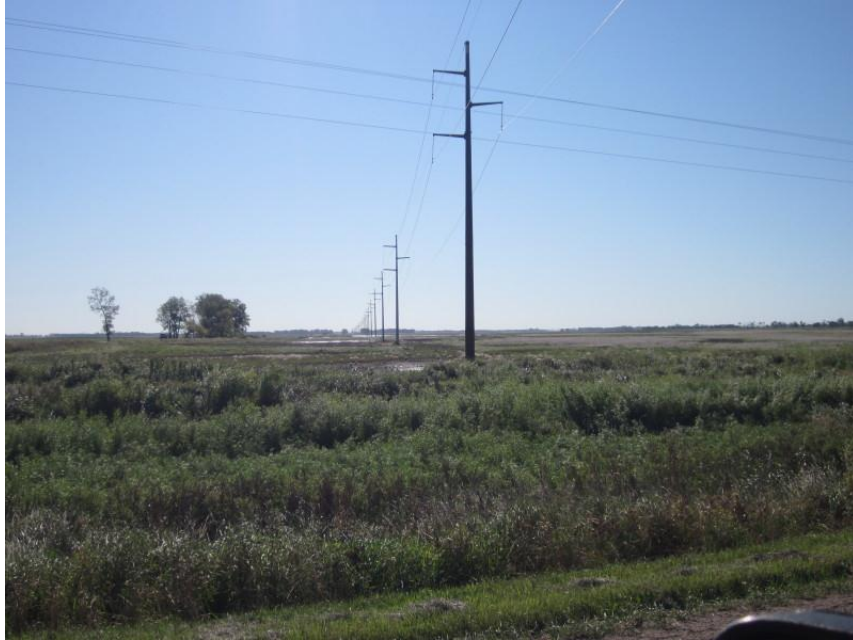
Photo 9. Direction: Southeast. Intersection of 133rd Ave and route of transmission line, looking to the southeast, where the line paralleled a railroad to the southeast of Pillsbury.

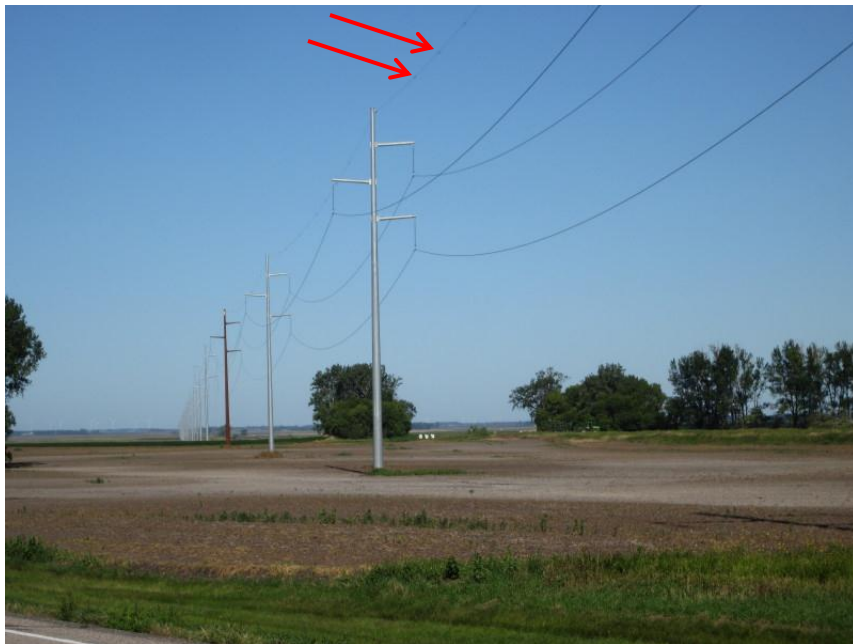
Photo 10. Direction: Northwest. Intersection of 18th St and route of transmission line, to the west of the town of Page. The line continued to parallel a railroad. There were bird deterrents in both directions on this portion of the line (indicated by red arrows in photo, difficult to see against sky in background).

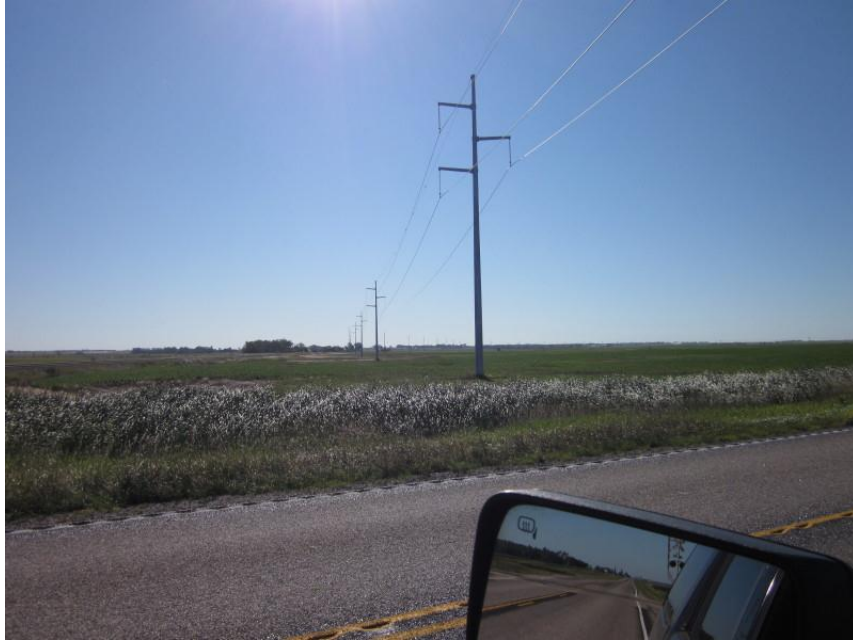
Photo 11. Direction: Southeast. Intersection of Highway 38 and route of transmission line, to the south of the town of Page. The line continued to parallel a railroad. There were bird deterrents in both directions on this portion of the line.

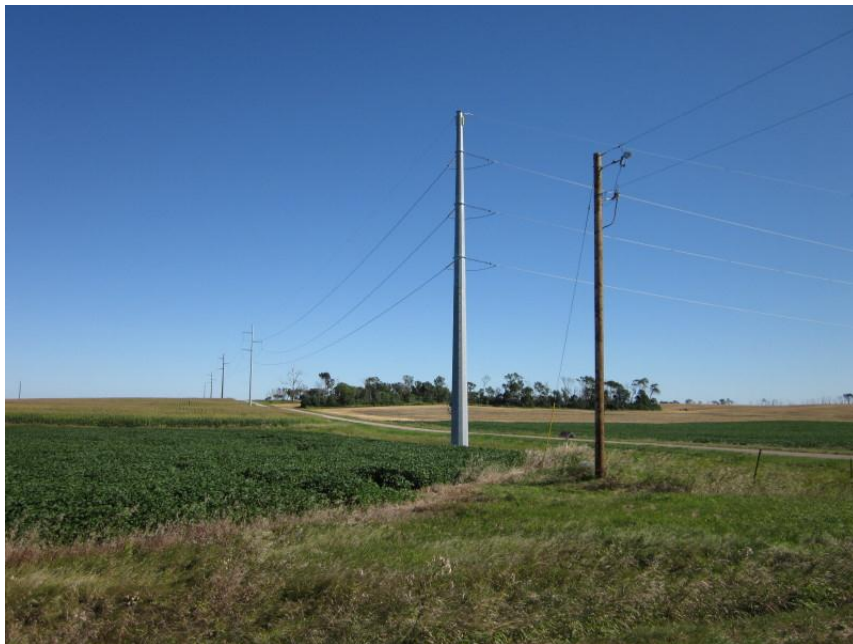
Photo 12. Direction: Northeast. Corner post at intersection of 143rd Ave and 23rd St. The line paralleled the west side of 143rd Ave to the north of this point (left-center of photo), then crossed 143rd Ave going east to parallel the north side of 23rd St.

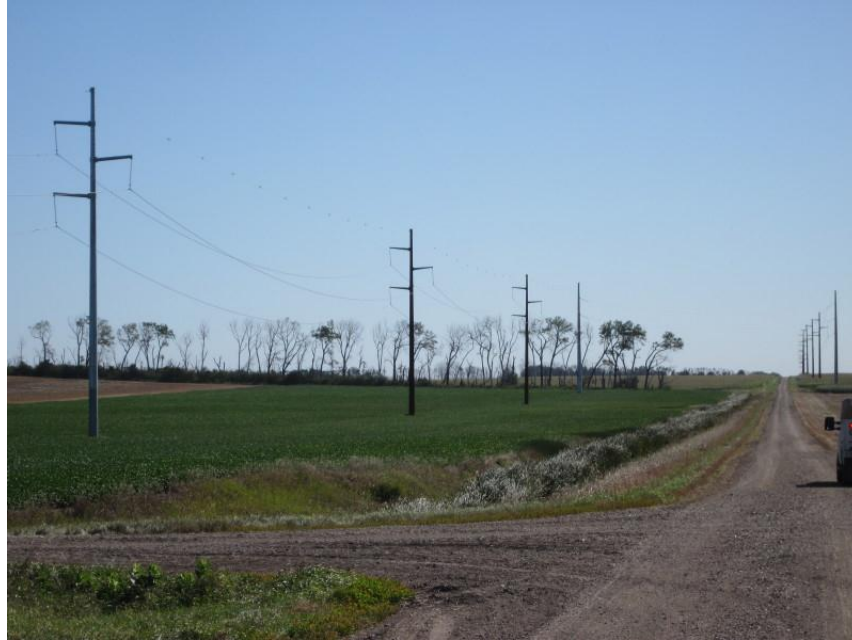
Photo 13. Direction: East. Transmission line along 23rd St, running parallel on its north side, then crossing it and continuing parallel on its south side (shown on distant right of photo).

- *Roads Restored to Previous Use.* The Application stated no permanent access roads would be constructed for the Project, but that temporary roads would be needed to access pole locations. It stated that when temporary roads were constructed they would be limited to 20ft width and would be located within farmed land. During the site visit, Wenck did not observe any remaining temporary roads or unreclaimed areas. Wenck noted that all minimum maintenance roads, county roads and highways within the Project area appeared to be in good condition and properly maintained (**Appendix A, Photos 11, 13, 15-16; Appendix B**).

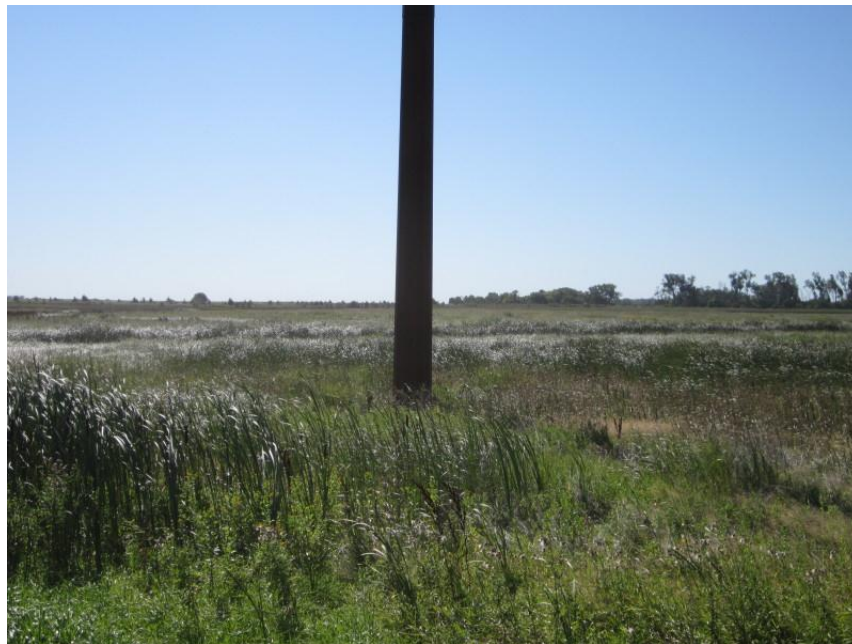
Photo 14. Direction: Southeast. Example of transmission line pole in the midst of a wetland, of which there were several noted along the route. Because of the past several wet years, the poles may not have been within wetland boundaries at the time of construction. However poles within wetland boundaries during construction of the line would have been covered under the Corps Nationwide Permit 12 for utility lines.

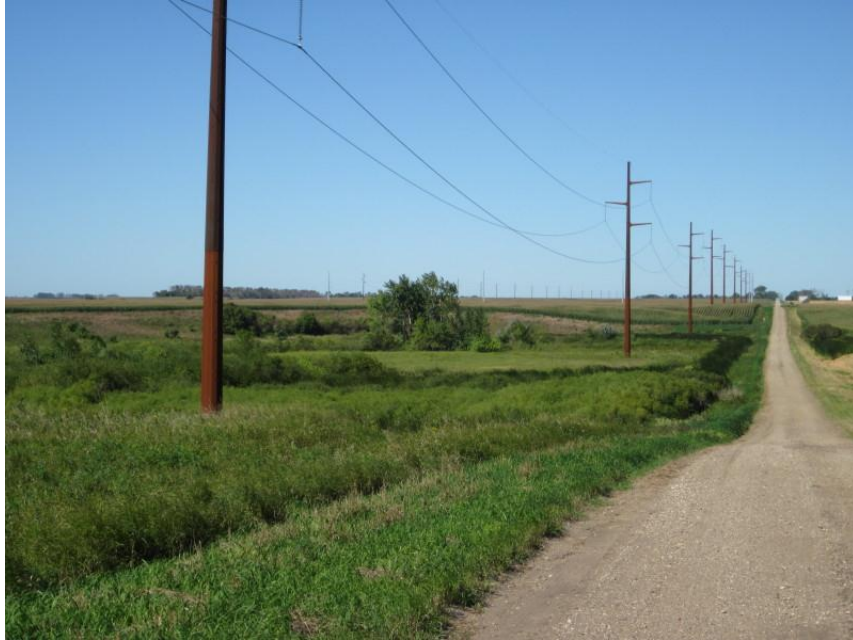
Photo 15. Direction: West. Example of wider spacing between poles to span the large wetland on the south side of the road (23rd St between 147th Ave and 148th Ave).

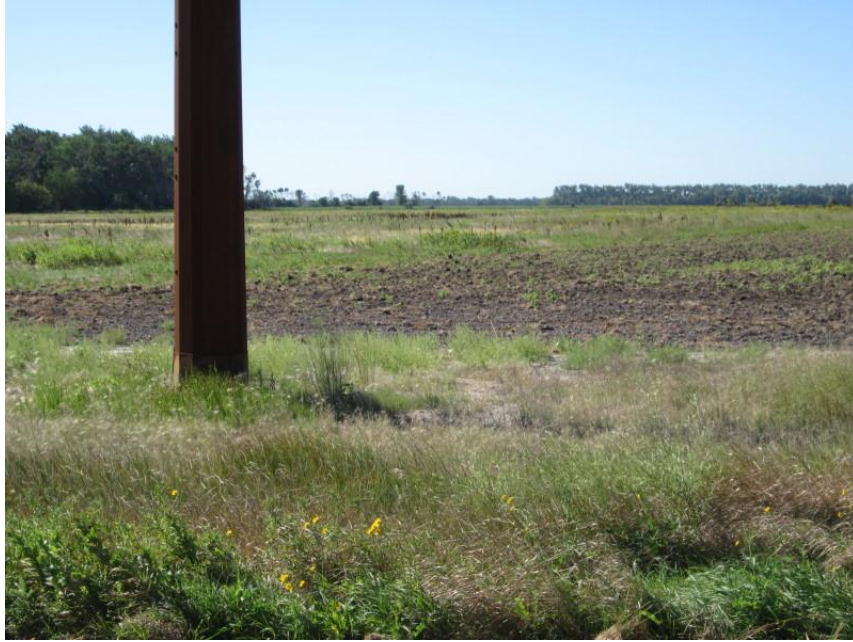
Photo 17. Direction: South. Example of pole in ditch on the edge of a field.

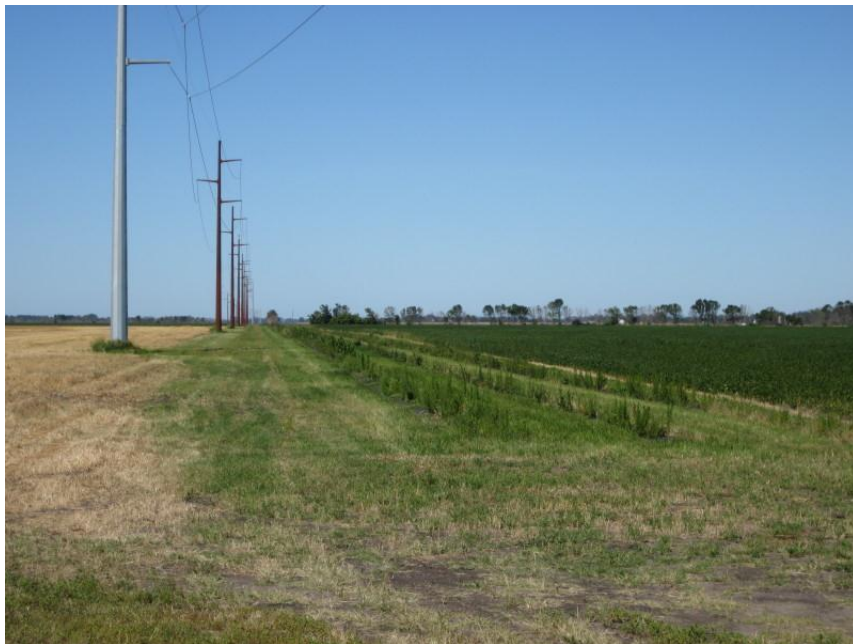
Photo 18. Direction: West. Intersection of transmission line with 153rd Ave. Note planted tree/shrub rows on right which was one of the replacement plantings for the Project. This was located through the center of Section 33, T142N, R52W and appeared to be in good condition.

A Tree/Shrub Replacement Plan was filed for the Project and Wenck confirmed plantings reported for 2009. Though planned for the Project, additional 2010 and 2011 plantings have not been documented with the PSC. Wenck recommends that the PSC request submission of the annual tree/shrub replacement report (typically required in October of each year) to include

confirmation of 2010 and 2011 plantings and survival information for 2009 and 2010 plantings. All plantings will require survival monitoring for three years following planting for fulfillment of the Order.

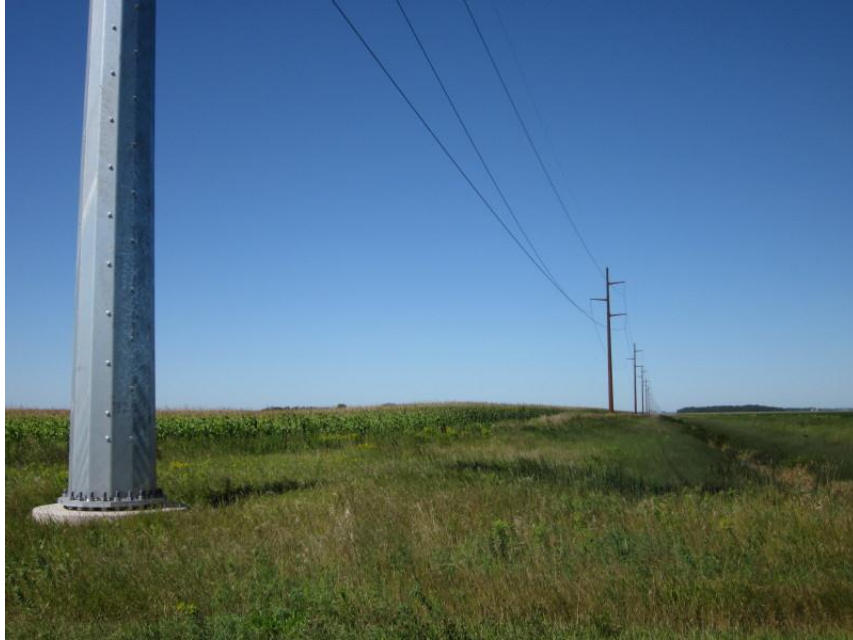
Photo 19. Direction: West. Transmission line where it paralleled 24th St for several miles. 24th St was a sectionline which had portions with no roads and portions with minimum maintenance two-track roads. This portion of the route primarily spanned active cropland.

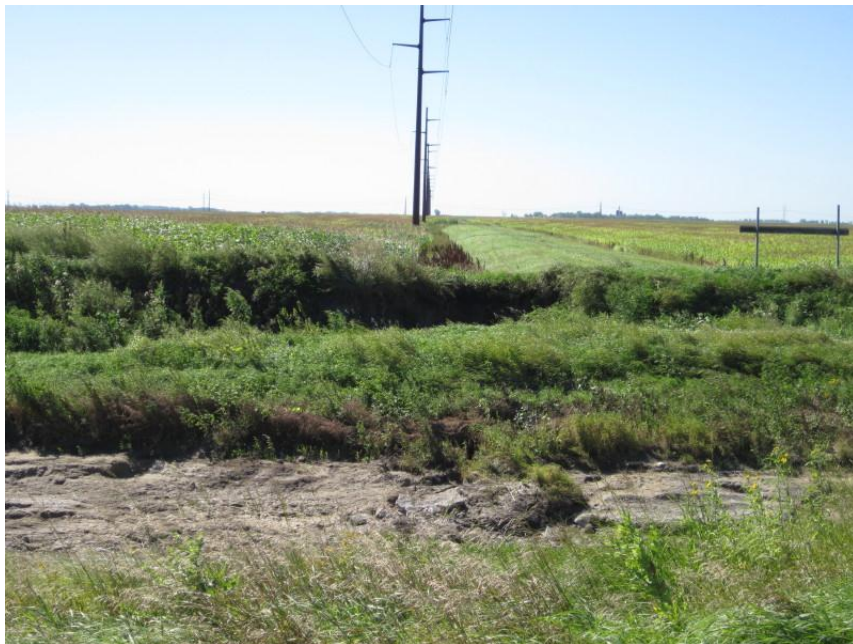
Photo 20. Direction: South. Transmission line crossing of the channelized Rush River along 162nd Ave to the south of its intersection with 30th St. The line spanned the channel and avoided disturbance of the waterway.

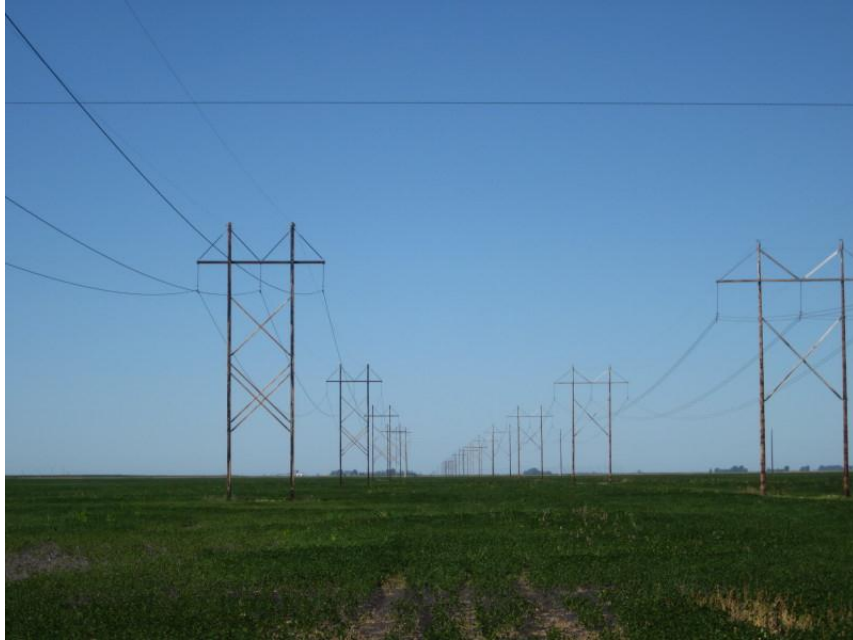
Photo 21. Direction: West. One mile in distance is where the line turned from north-south along 162nd Ave to east-west, about one-fourth of a mile north of, but parallel to, 32nd St. At the corner described, the use of monopoles shifted to the use of H-frame structures. Note the 345 kV line parallel to the 230 kV line to the north (on right in photo).

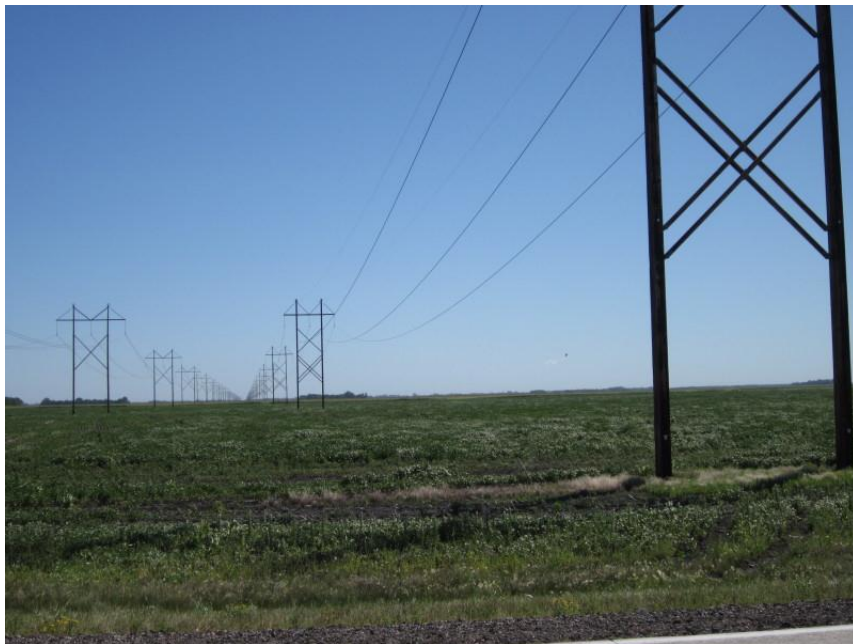
Photo 22. Direction: East. Intersection of transmission line with 163rd Ave, just to the north of 32nd St. There was cropland in both directions and no bird deterrents on the line.

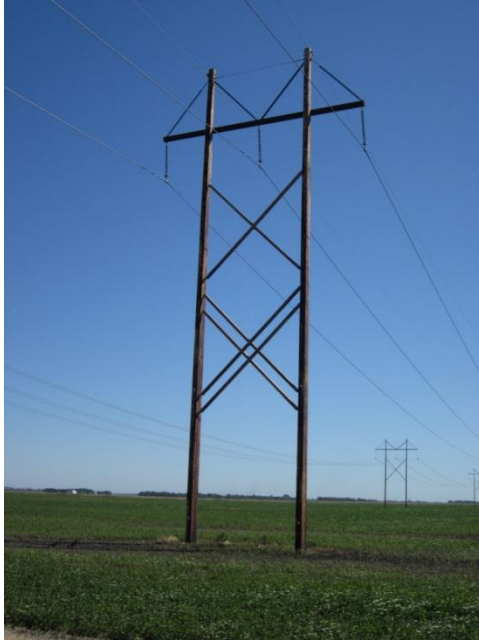
- *Avian Impacts Minimized by Bird-Safe Designs, Mirroring Structures, H-frame Suspension Insulation.* The Application identified avian mortality as a concern with construction of the transmission line. The following measures mitigation measures were outlined in the Application to be used when practicable to minimize impact on birds: use of H-frame structures; suspension insulators with 84in clearance; design according to “2006 Suggested Practices for Avian Protection on Power Lines”; marking shield wires in high use areas (within one mile of wetlands); pre-construction surveys for wetlands, native prairie, and woodlands; avoid or minimize disturbance of wetlands/drainages; replacement of unavoidable wetland loss with functionally equivalent wetlands; installation of erosion control measures; replacement of trees and shrubs removed at 2:1 ratio; soil and water conservation/BMPs; revegetation of non-cropland and pasture; control of noxious weeds. Though the majority of the transmission line consisted of monopoles, Wenck observed the use of H-frame structures along the portion of the route paralleling the 345kV transmission line; the 230kV poles mirrored the 345kV poles and the H-frames had suspension insulation

with required clearance (**Appendix A, Photos 21-25**). Wenck also confirmed the marking of shield wires with bird deterrents, though difficult to see in the photos (**Appendix A, Photos 5, 10-11**). The placement of markers in relation to high use areas was unclear. Because of the prevalence of wetlands in the area, it appeared the decision to mark the line was not based solely on a one-mile proximity to wetlands; however there were some areas where wetlands were uncommon and cropland was more prevalent where bird markers were not used (**Appendix B, Observation Notes**). The use of bird deterrents needs further documentation and indication on maps of the route. Minnkota submitted documentation of pre-construction surveys of wetlands, native prairie, and woodlands for the Project, which appeared to be avoided when possible (“Biological Assessment and Wetland Delineation Report, Pillsbury to Fargo Generation Outlet Project, May 20, 2008, McCain and Associates”, “Supplement to the Biological Assessment and Wetland Delineation Report, Pillsbury to Fargo Generation Outlet Project, Rush River Reroute, June 3, 2008, McCain and Associates”, “Tree and Shrub Inventory, McCain and Associates, March 19, 2009”). The remaining avian impact mitigation measures are discussed elsewhere in Section 3 of this report.

Photo 23. Direction: Northeast. Close-up view of H-frame structure on the 230 kV transmission line. The structures were laminated poles and had suspension insulation with required clearance.

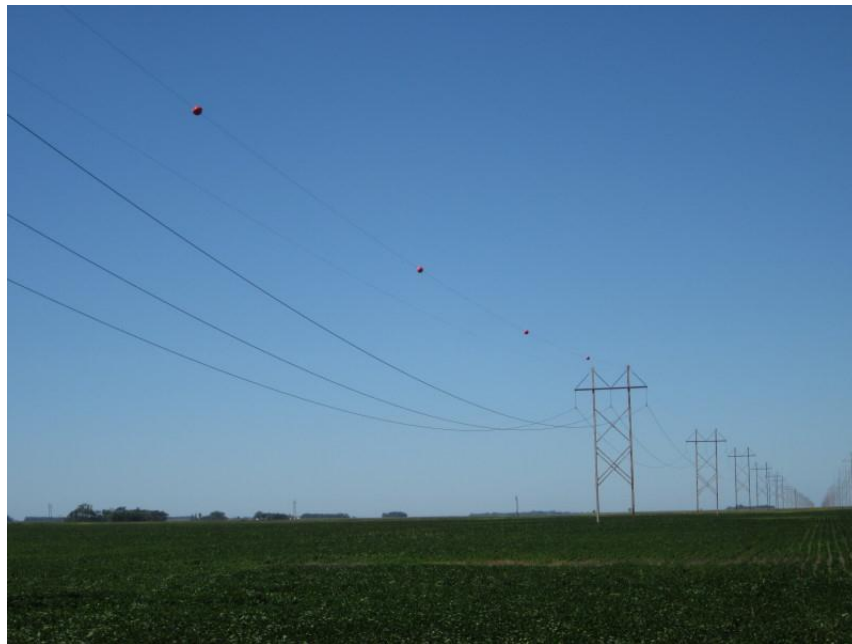
Photo 24. Direction: West. Intersection of transmission line with 81st St, just to the north of 52nd Ave, northwest of the city of West Fargo. The large orange balls on the line were presumably there for aircraft safety purposes.

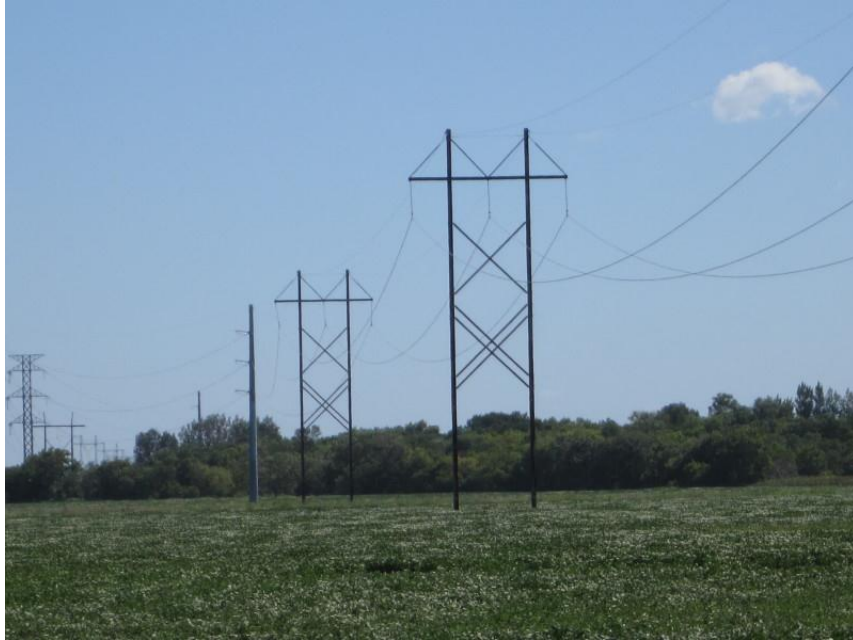
Photo 25. Direction: East. Intersection of transmission line with 81st St, just to the north of 52nd Ave, northwest of the city of West Fargo. Note the switch from H-frame structures to monopoles about ½ mile before the crossing of the Sheyenne River, which is indicated by the dense trees in the distance.

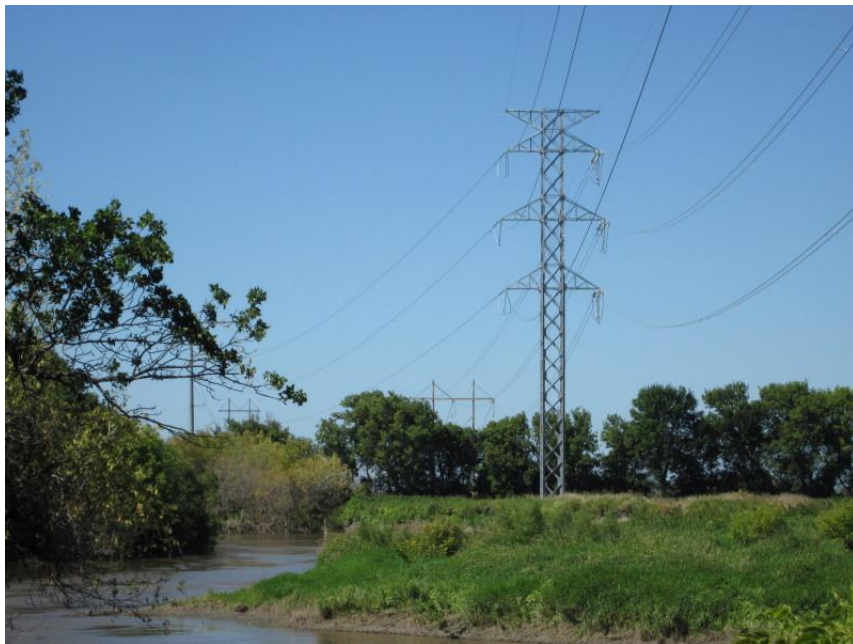
Photo 26. Direction: West. Crossing of the Sheyenne River northwest of West Fargo. At this point both the 230 kV line and the 345 kV line run together on the same structure (pole in foreground). Note there has been bank erosion on the Sheyenne due to spring flooding.

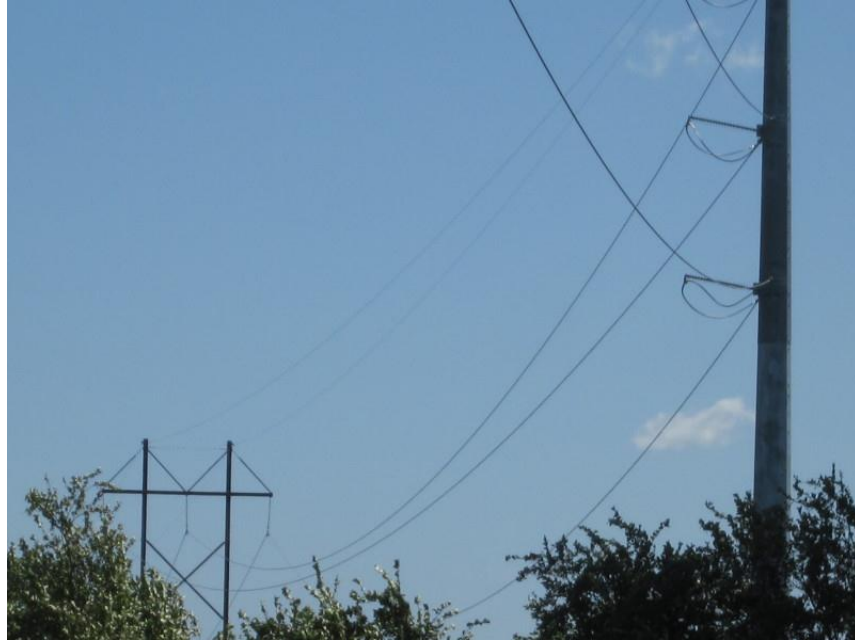
Photo 27. Direction: East. To the east of the crossing of the Sheyenne River, the 230 kV line runs back on a monopole structure (on right of photo), then to two H-frame structures (on left of photo), then back to monopoles. Note the trees in the photo appear to be close to the wires but this was due to the angle of the photo; they were not in need of clearing away from the line.

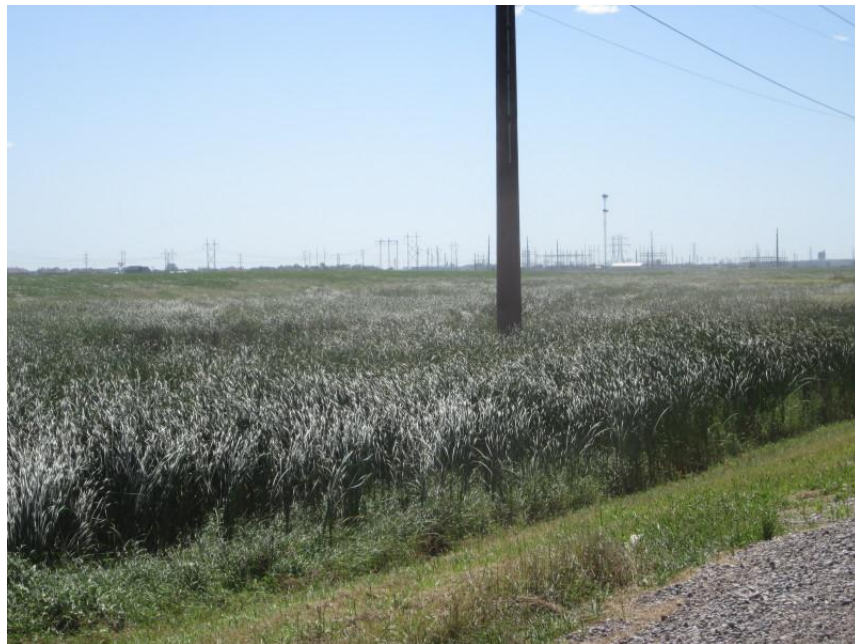
Photo 28. Direction: Southeast. Pole in midst of a wetland too large to span.

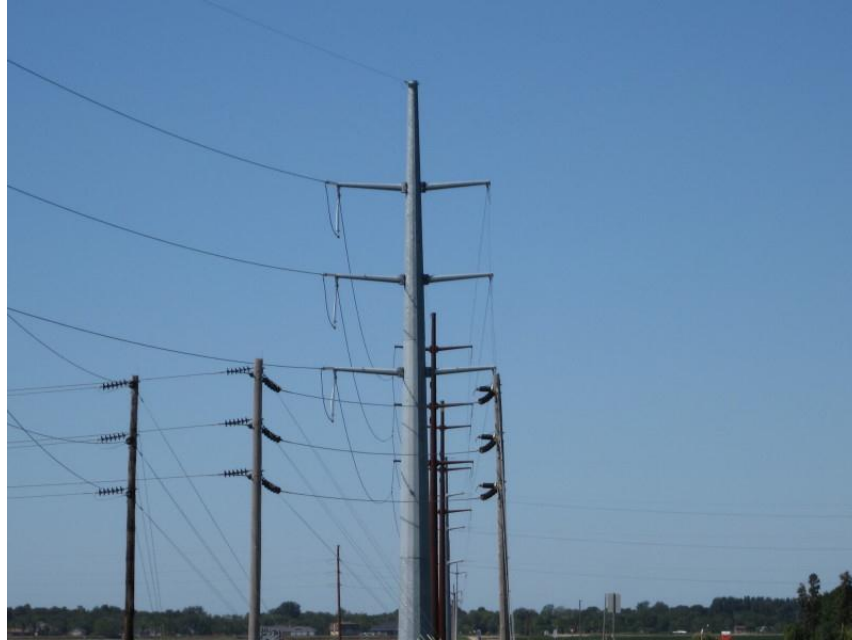
Photo 29. Direction: West. Monopole at end of transmission line as it entered the Maple River substation. The last portion of the line paralleled the south side of 32nd Ave to the west of the substation.

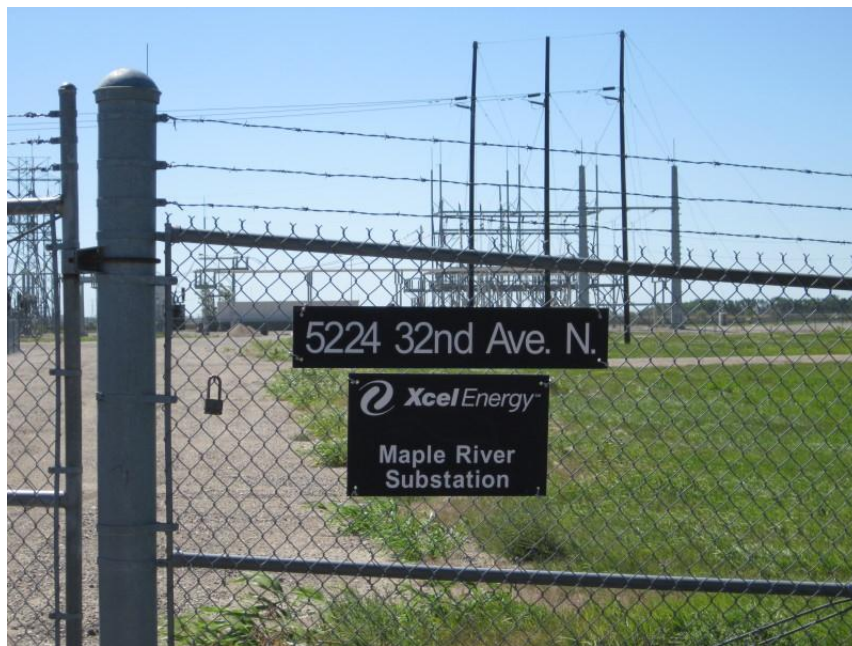
Photo 30. Direction: South. Entrance to Maple River Substation north of West Fargo. This was the east end of the 230 kV transmission line.
