Ashtabula Wind Transmission Line Post-Construction Inspection Report PU-08-073

NORTH DAKOTA PUBLIC SERVICE COMMISSION

WENCK ASSOCIATES, INC.

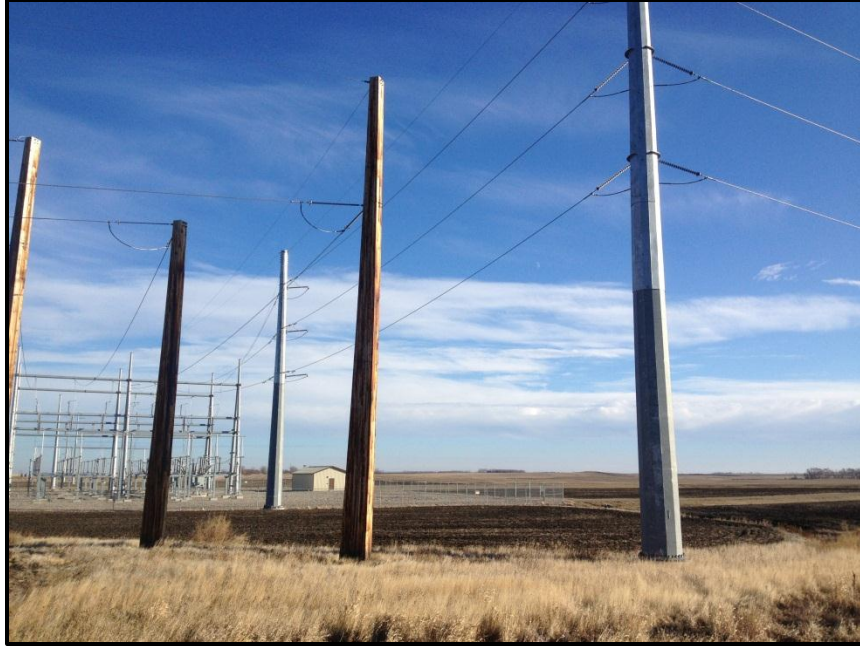
Photo 1. Direction: Southeast/East. North end of the transmission line (steel poles) at the Pillsbury substation.

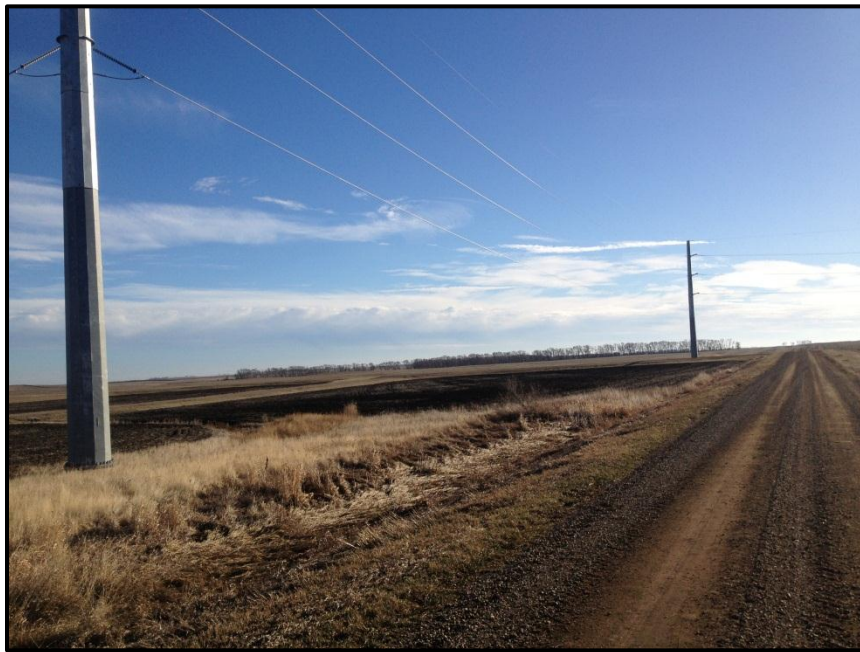
Photo 2. Direction: Southeast. View of the transmission line as it went north-south for approximately 1/4 mile on 126th Ave. SE.

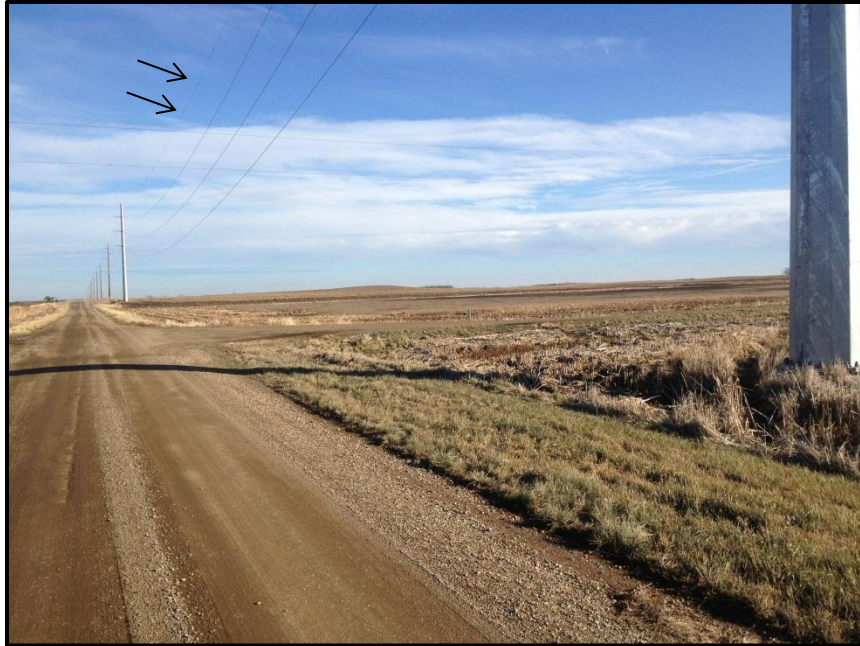
In the Revised Application, flight diverters were proposed where the transmission line crossed Goose Lake. Flight diverters were noted at this location (**Appendix A, Photos 3**), and at several other locations, notably nearby wetlands (**Appendix A, Photos 3, 5-7, 9, 10**). It appeared that these diverters were installed where planned, and at other areas not in the original Application. Based on this evidence, it appears that Ashtabula Wind considered avian protection as a part of the Project.

Photo 3. Direction: East/Southeast. View shows the transmission crossing nearby Goose Lake. The landowner appeared to have mowed the wetland vegetation prior to the inspection. The pole on the right of this photo is upland, with no apparent disturbance to wetland vegetation. There were flight diverters along this portion of the route (indicated by black arrows, but faintly visible).

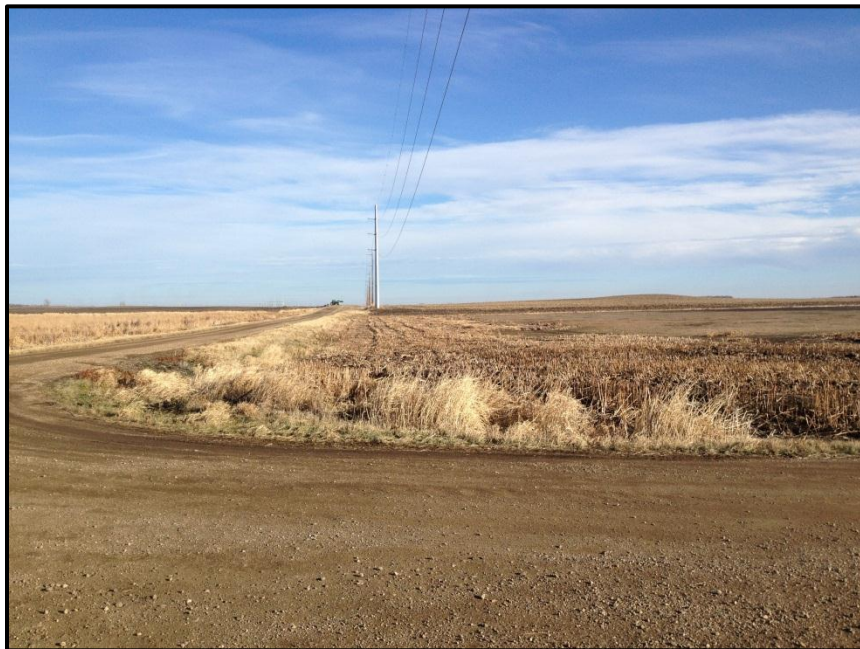
There were several areas along the transmission line route that crossed wetland areas (**Figure 1; Appendix A, Photos 3, 4, 7, 8, 9, 11**). It did not appear that vegetation along these wetland margins had been disturbed. No impacts were observed to surface drainage or groundwater flow patterns. The transmission line was located further than 0.25 miles from Wildlife Production Areas (WPAs) as described in the Application. It did not appear that any machine clearing of vegetation occurred near rivers or streams. It appeared that construction of the Project avoided impacts to wetland areas as specified in the Application.

Photo 4. Direction: East. Another view of the transmission line spanning the wetland area south of Goose Lake.

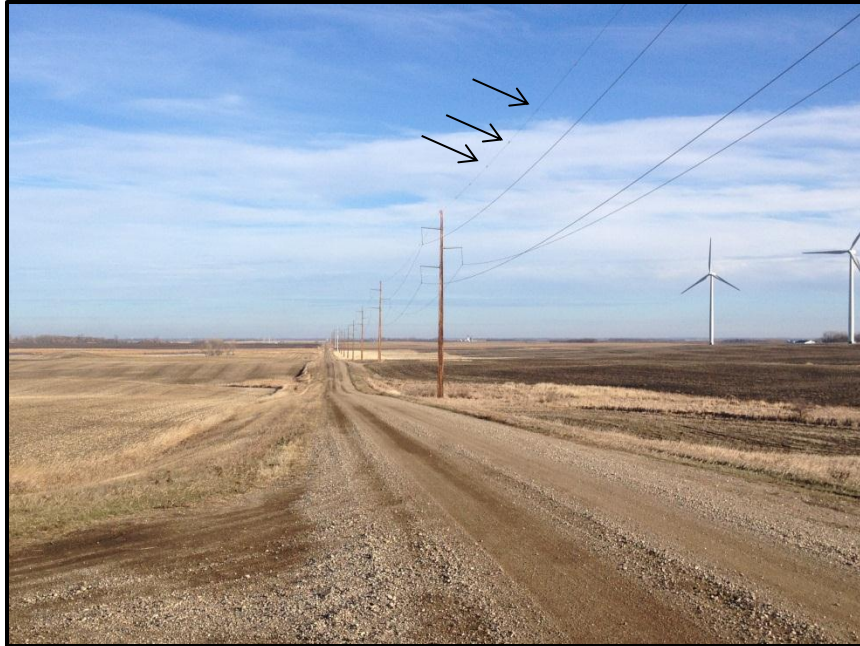
Photo 5. Direction: East. View of the transmission line as it went east-west down 14th St. SE. There were flight diverters along this portion of the route (indicated by black arrows).

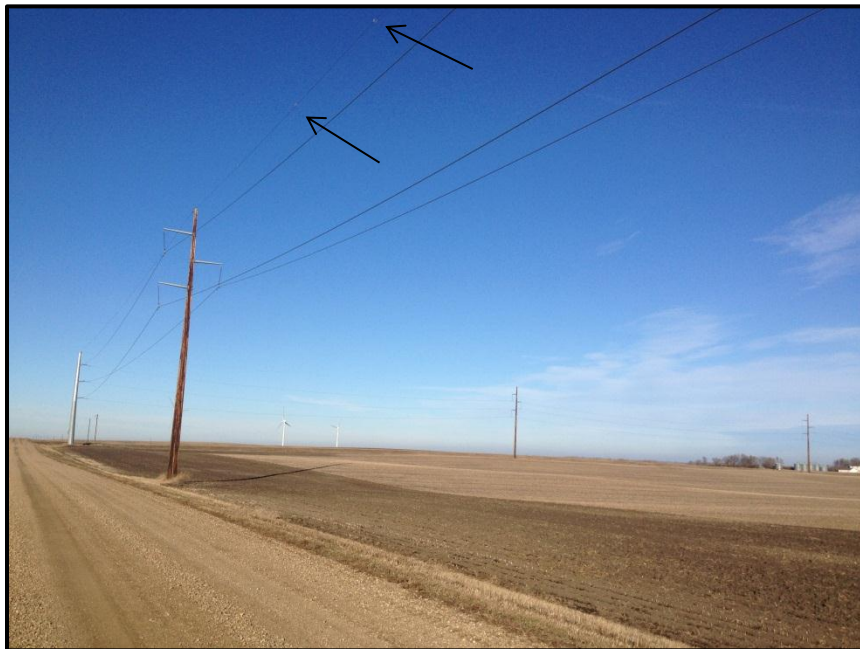
Photo 6. Direction: Northwest. View shows the transmission line as it turned north/south down 123rd Ave. SE. There were flight diverters along this portion of the route (indicated by black arrows).

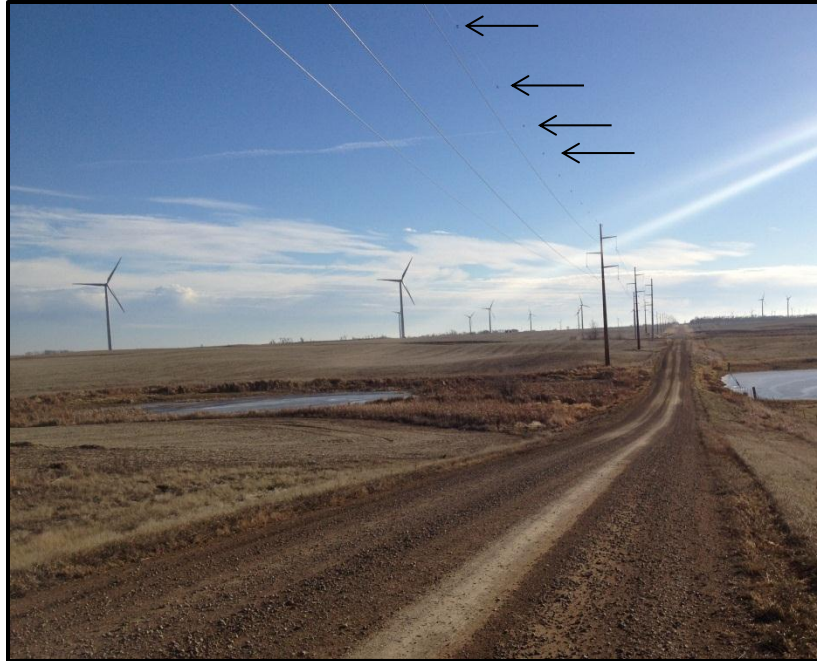
Photo 7. Direction: Southeast. View of wetland crossing along the transmission line route. It appeared the transmission line poles were in upland, with no apparent impacts to the wetland area. There were flight diverters along this portion of the route (indicated by black arrows).

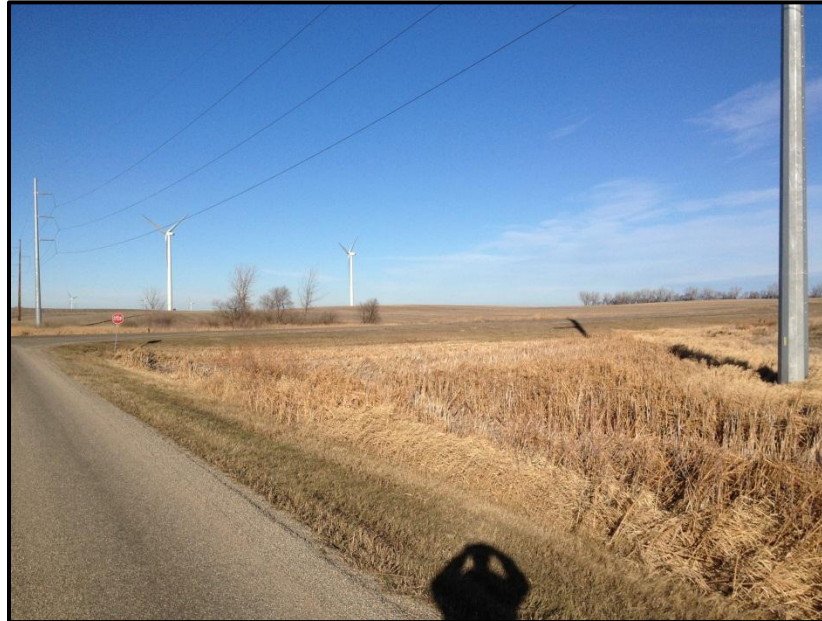
Photo 8. Direction: Northeast. At the intersection of ND Highway 26 and 123rd Ave. SE, two wetlands were spanned in the ditches north and south of the Highway. Poles were in upland with no impacts to the wetland area.

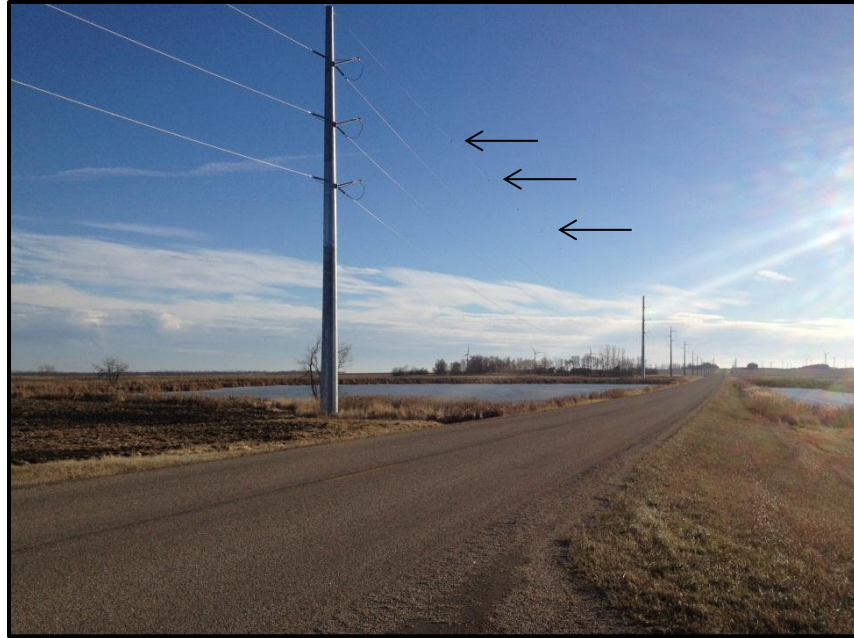
Photo 9. Direction: Southeast. View north of a water body crossing in Section 34, Township 143 North, Range 57 West. Structures were in upland with no impacts to the wetland area. There were flight diverters along this portion of the route (indicated by black arrows, but faintly visible).

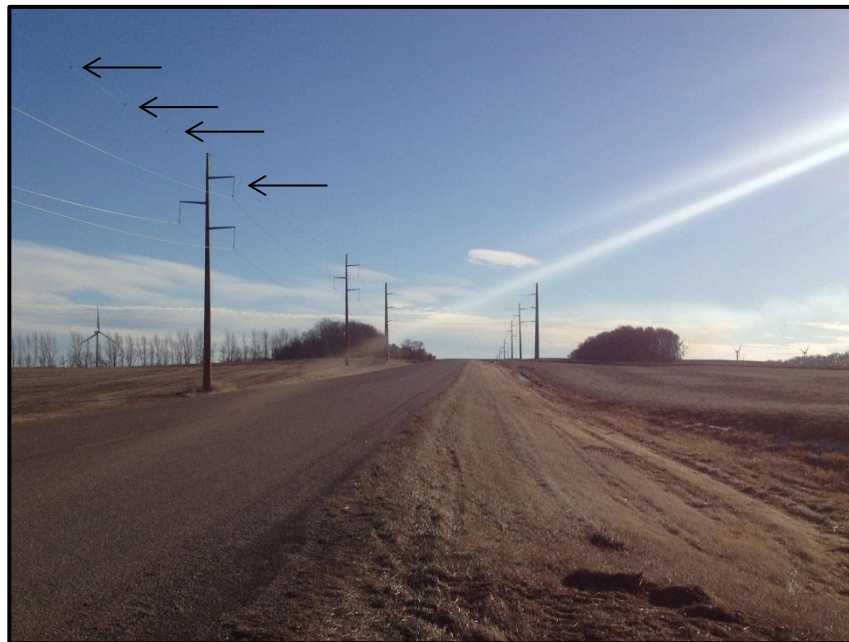
Photo 10. Direction: South. View of the transmission line crossing 123rd Ave. SE along 19th St. SE. There were flight diverters along this portion of the route (indicated by black arrows).

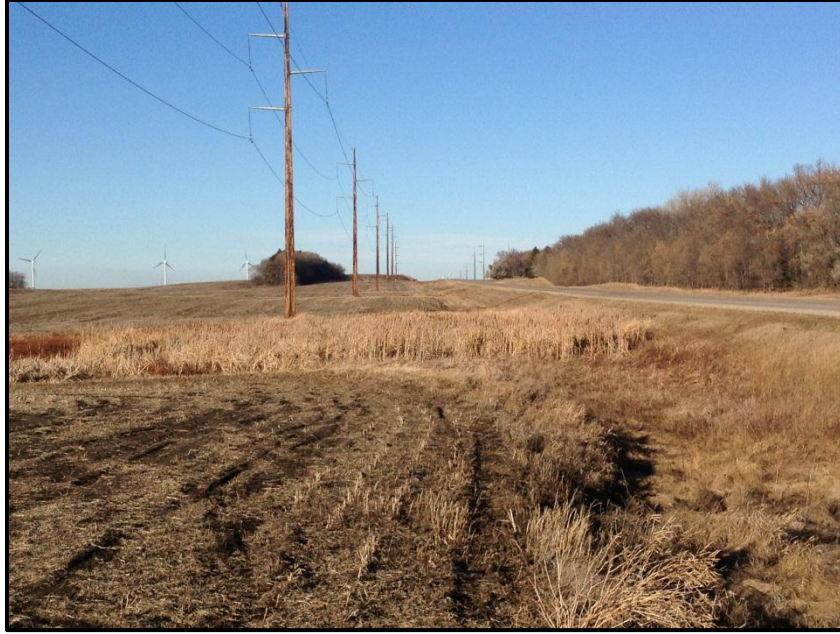
Photo 11. Direction: North. Another wetland crossing approximately ½ mile north of the Ashtabula Wind Energy Center Substation. The structure was in upland with no impacts to the wetland area.

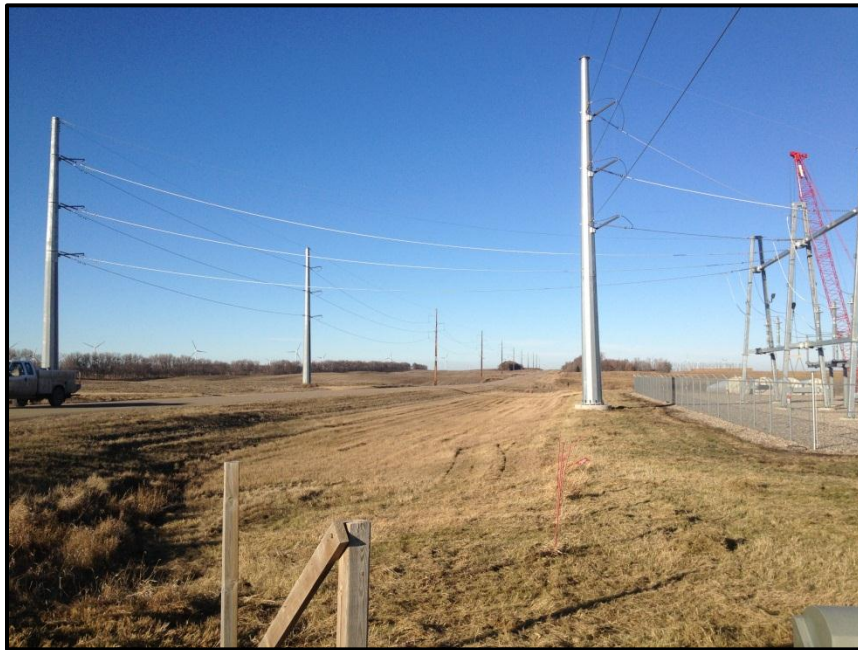
Photo 12. Direction: North. South end of the transmission line at the Ashtabula Wind Energy Center substation.
