Luverne to Pillsbury Transmission Line Post-Construction Inspection Report PU-08-107

NORTH DAKOTA PUBLIC SERVICE COMMISSION

WENCK ASSOCIATES, INC.

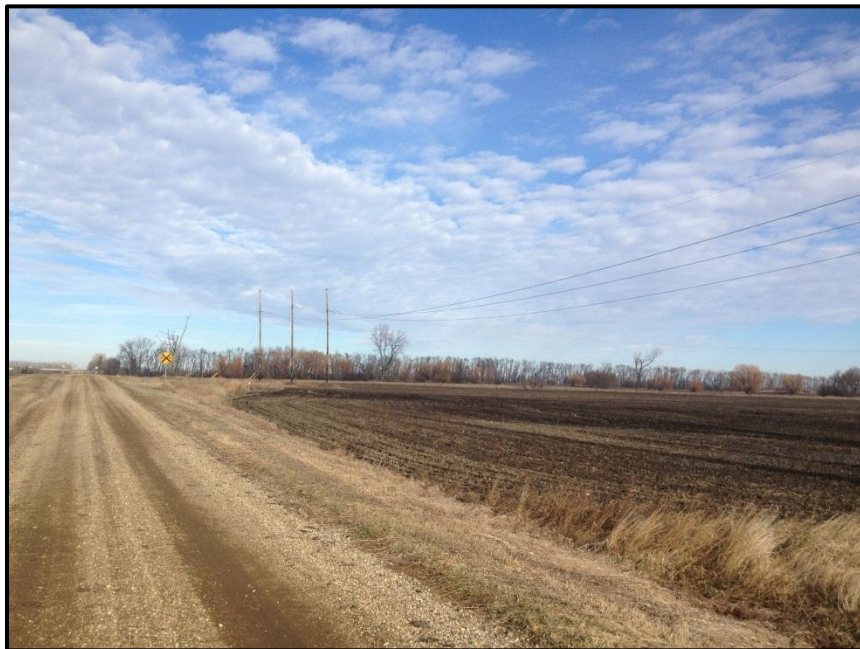
Preexisting roads appeared to have been restored and appeared in good condition (**Appendix A, Photos 2, 5, 7**). Temporary roads used during construction appeared to have been restored or retained by landowner request (**Appendix A, Photos 11, 12**).

Photo 2. Direction: North/Northeast. View shows the transmission line just north of the substation as it runs parallel to 126th Ave SE in Barnes County, ND.

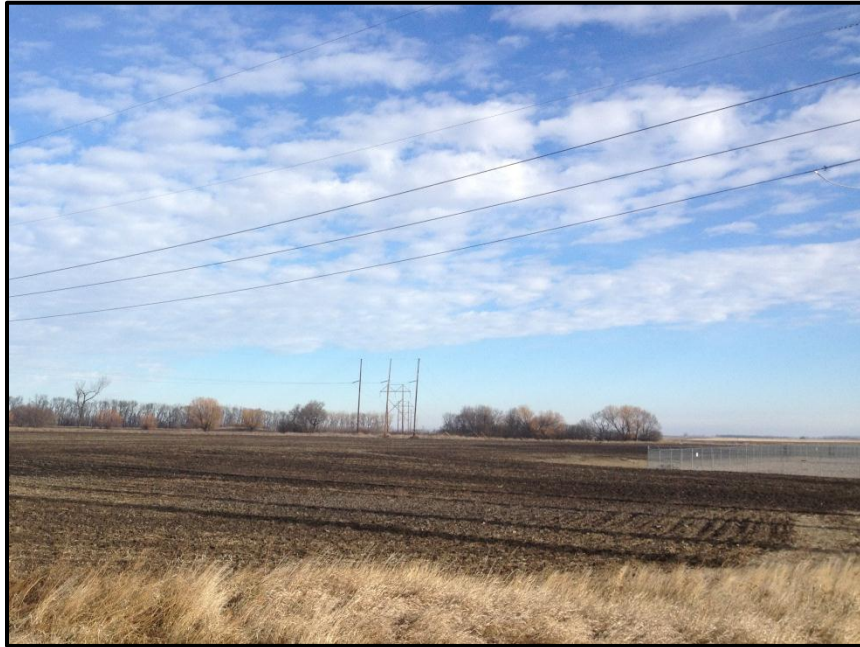
It appeared that no natural woodlands within the Project area were impacted by construction of the Project. There were several locations where trees or shrubs were removed from planted shelterbelts (**Appendix A, Photos 3, 9**). It appeared that disturbances to these areas were minimized to the width required for a safe buffer around the transmission line, yet within the 125ft maximum cut specified in the Order. The Otter Tail representative confirmed that trees and shrubs had been replaced at a 4:1 ratio, greater than what was specified in the Order. However, the representative stated that because the mitigation sites were on private land, inspecting these areas was not possible during the inspection. No Tree and Shrub Mitigation Plan or Survival Report was on file with the PSC. Wenck recommends the PSC request the Mitigation Plan from Otter Tail to confirm that trees and shrubs were replaced. If trees and shrubs have been planted, the PSC should request subsequent survival monitoring documentation.

Photo 3. Direction: South. View shows the transmission going through a shelterbelt in the distance. Cuts appeared to be minimized in these areas to only the width required for a safe buffer around the transmission line.

Trees and shrubs were removed during Project construction, and the Otter Tail representative stated that trees and shrubs had been replaced. However, no Tree and Shrub Mitigation Plan was on file with the PSC, and no Survival Monitoring Reports have been filed to date. Wenck recommends the PSC request documentation from Otter Tail to confirm that trees and shrubs have been replaced.

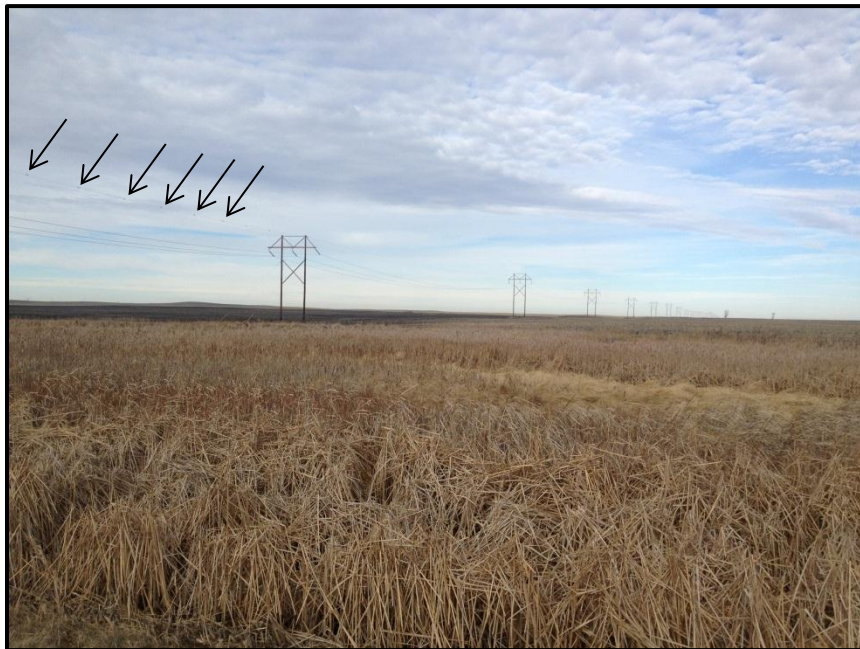
There were several areas along the transmission line route that crossed wetland areas (**Figure 1; Appendix A, Photos 4, 8**). The Otter Tail representative stated that during construction, BMPs were placed adjacent to wetland areas to prevent erosion or sedimentation to these areas and construction traffic avoided wetland margins to minimize disturbance. It did not appear that the vegetation along these wetland margins had been disturbed. Wenck also observed that no Project infrastructure disturbed wetlands on land under USFWS easements, of which two parcels were identified in the Application near the Project route. It appeared that construction of the Project avoided wetland areas as specified in the Application.

Photo 4. Direction: North/Northwest. View of the transmission line spanning a wetland area; no sedimentation or disturbance to the wetland was noted. Bird diverters were evident, although only faintly visible in this photo (shown by black arrows).

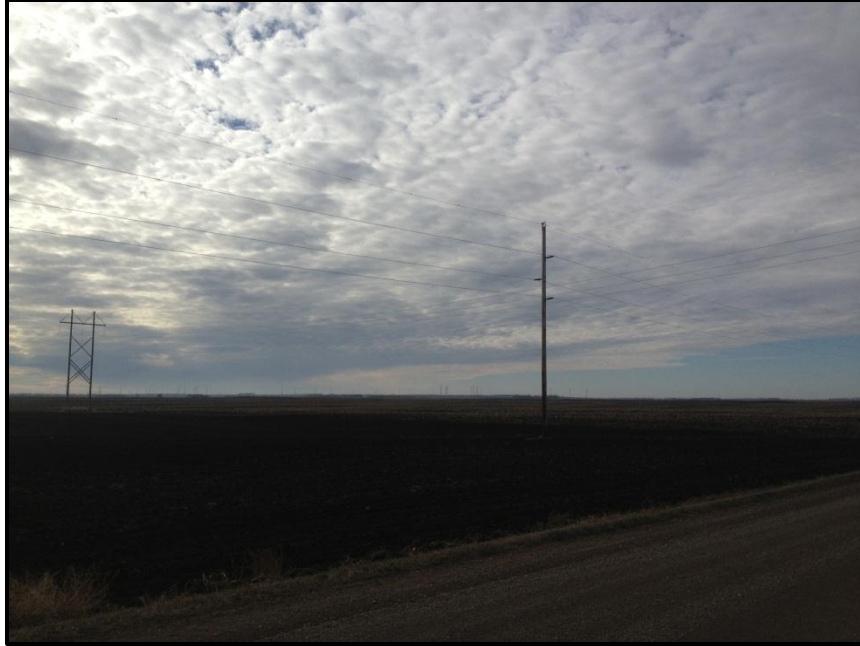
Photo 5. Direction: Southwest. View of the transmission line (H-frame structure on left) crossing Minnkota's Keystone line (single pole structure).

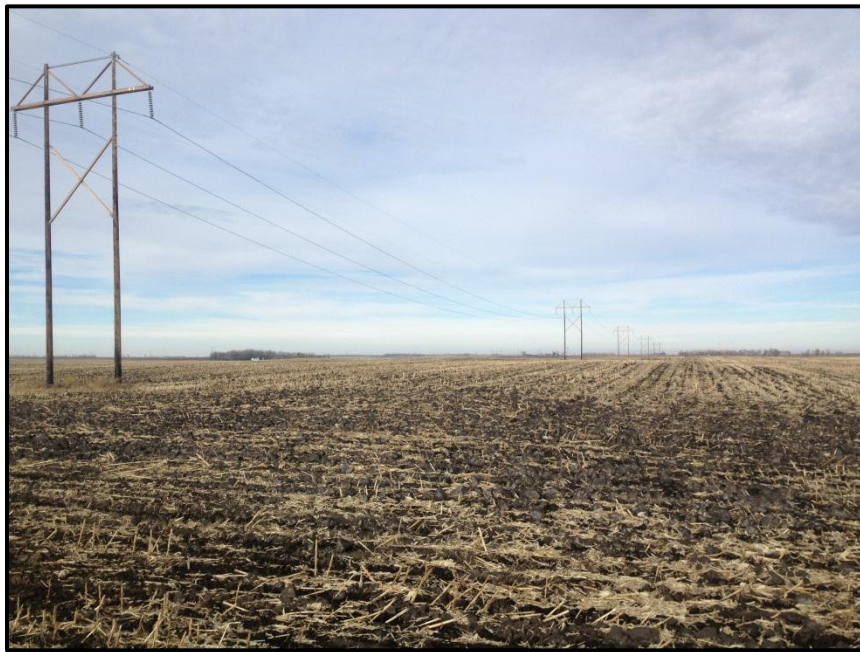
Photo 6. Direction: Northwest. View shows typical span and structure design of the transmission line. No impacts to agricultural land or crop production were noted.

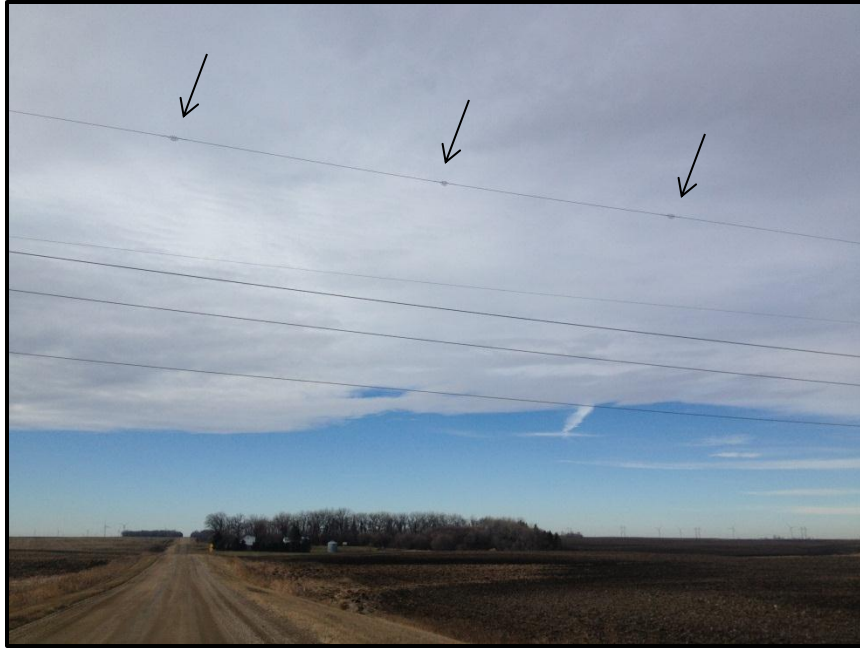
In the Application, several mitigation efforts to protect avian species from colliding with the transmission line were noted. Mitigation measures related to design specifications included using H-Frame structures, marking the transmission line in areas of potential aerial hazard of whooping crane movement (e.g. wetlands and stream crossings), and designing suspension insulators with a clearance of 84in. These measures coincided with requests made by the US Fish and Wildlife Service (USFWS) to mark the line near wetlands and at stream crossings and to space the electrical lines (60in or greater) to prevent raptor electrocution. Structure design is discussed in Section 3.2.1. Wenck observed several areas along the transmission line route that had been marked to prevent avian collisions (**Appendix A, Photos 4, 7, 9**). These areas were typically near wetlands or USFWS wetland easements and appeared to correspond with plan drawings specifying the location of marking devices. The suspended insulators appeared to be spaced as specified with a span greater than 60 inches. It appeared the mitigation measures in the Application and those requested by the USFWS were installed as specified.

Photo 7. Direction: Northwest. View shows typical bird diverters installed at several areas along the transmission line (indicated by black arrow).

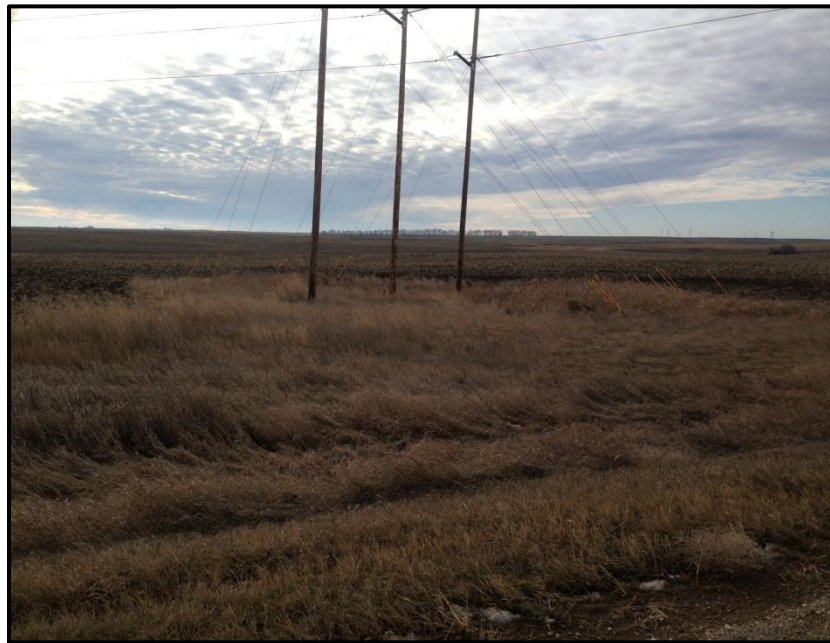
Photo 8. Direction: Southwest. View of a transmission pole structure adjacent to a wetland basin. No impacts to the basin were noted, and bird diverters were in place (not visible).

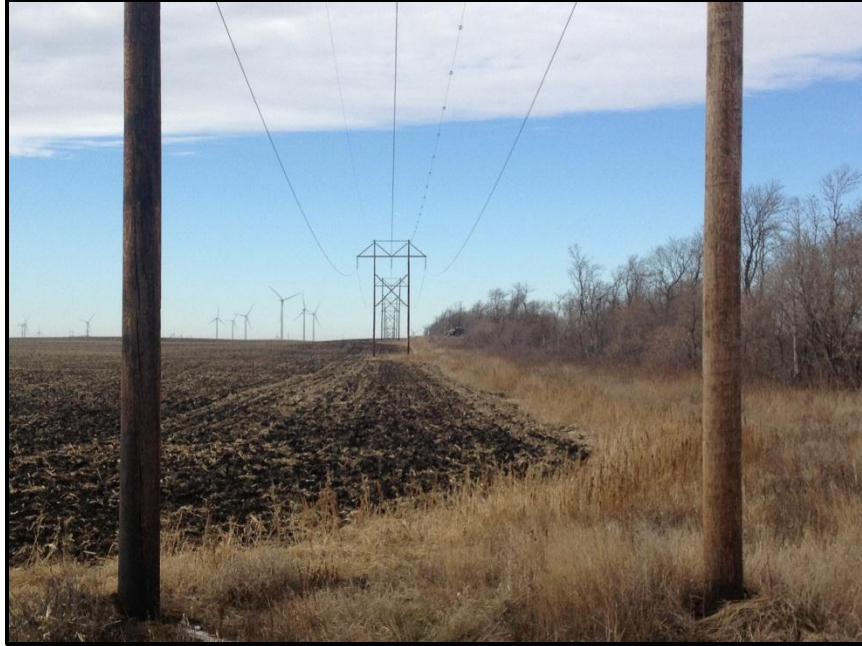
Photo 9. Direction: West. The tree row to the right had been cut to accommodate the transmission line and it appeared impacts to the area had been minimized. Note the flight diverters that were installed in this area.

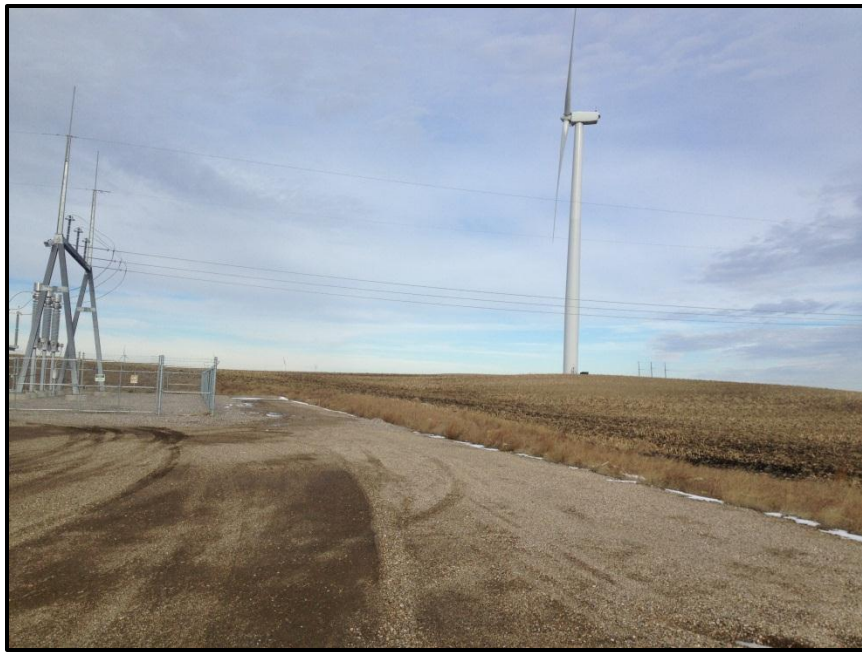
Photo 10. Direction: North. View of the transmission line as it interconnects with the Luverne substation.

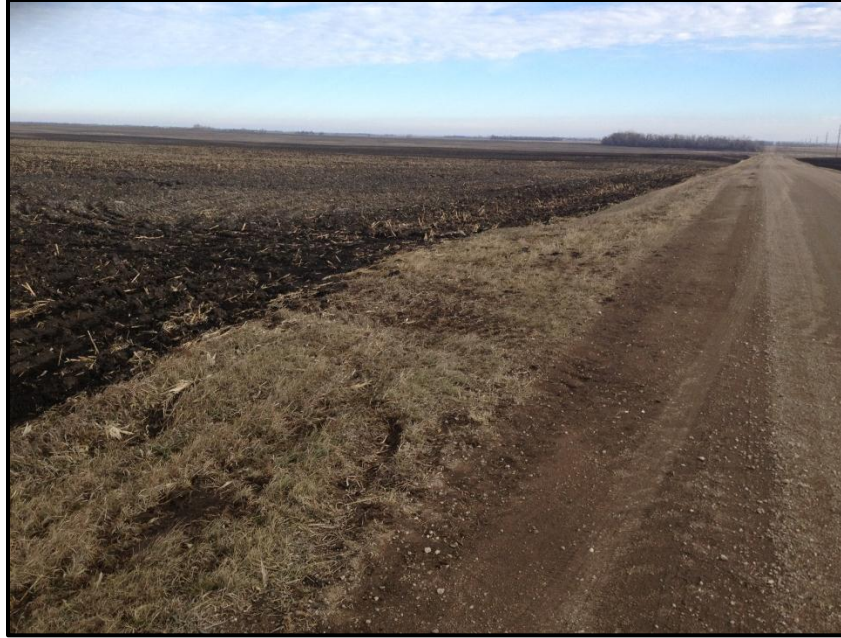
Photo 11. Direction: Northeast. View of a typical reclaimed access road used for the Project. Vegetation had established along the road ditch. No disturbance was noted in the agricultural field.

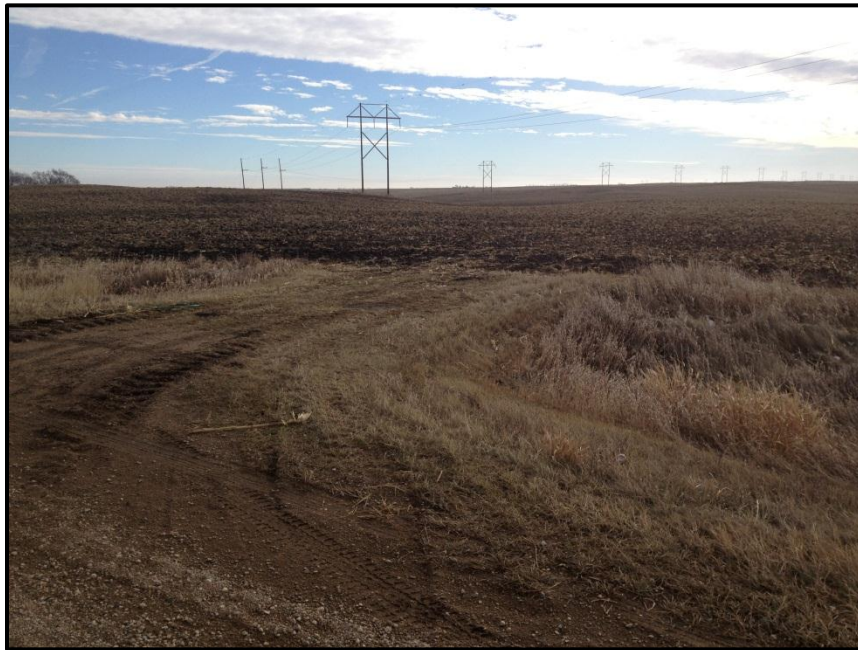
Photo 12. Direction: Southeast. This access road had been retained by the landowner for access to the agricultural field. No disturbance from access road construction was noted in the agricultural field.
