Minnkota Power Cooperative, Inc. 250 mile 345 kV line from Center to Grand Forks, North Dakota (PSC Case No. PU-09-670)

Permit Compliance Review

NDPUC Contract No.: PU-668-12

Reporting Period: March 20th, 2013 – August 16th, 2013Prepared By: Houston Engineering, Inc. / Emmy Baskerville, Environmental Scientist and Bart Schultz, Project Manager

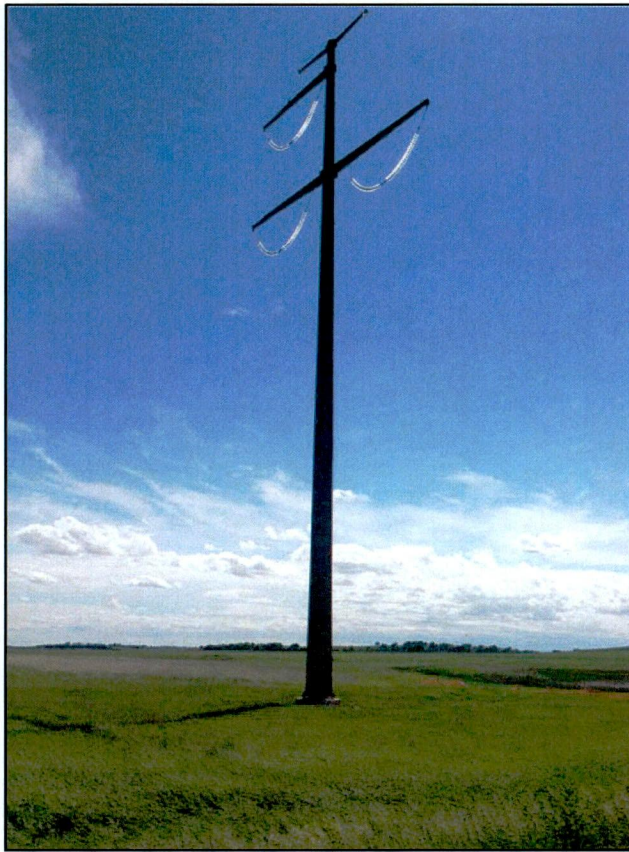
Photo 1: Example observed silt fencing around wetland resources (Pole 953)

Wetland delineation data was used to identify poles that were constructed within wetlands. US Fish and Wildlife Service easement parcel data was used to identify potential wetland impacts within easement parcels. A total of 160 poles were inspected to determine wetland impact compliance. Twelve poles were placed within wetlands, including 1272, 1264, 1261, 1204, 1087, 1086, 1077, 1058, 966, 965, 920, 880, 866, 863. Temporary impacts from construction rutting or bridge material was observed on poles 920, 1065, 1077, 1079, 1080, 1272 (see **Photo 3 and Photo 4** for example) and will need to be returned to pre-construction condition, as outlined within the Permit SWPPP implementation was observed on all construction close to and within wetland areas, including the installation of silt fencing. (See **Photo 1** for example).

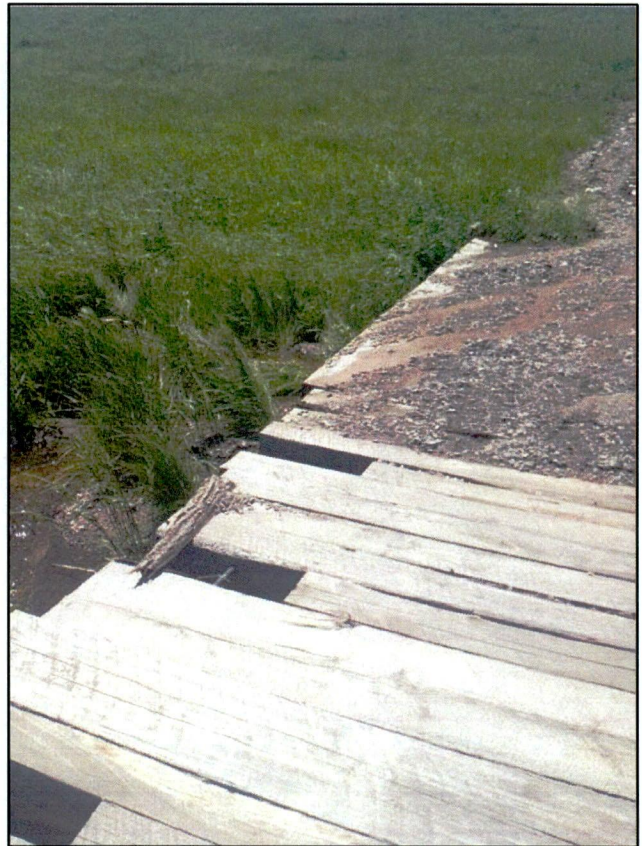
Photo 2: Erosion and sedimentation within intermittent stream (Pole 996)

GIS location data was received from Minnkota and utilized to identify poles which may be constructed within a river, stream or drainage way, as outlined within the Selection Criteria of the permit. No poles were observed to be constructed directly within rivers/streams or drainage ways. Poles 1317, 1318 and 1244 are within the floodplains of the English Coulee. Poles 1295, 1272, 1174, 1130, 1093, 1092, 1007 and 1001 were constructed within the floodplains of intermittent streams. Pole 1159, 1153 and 1152 were constructed within the floodplains of the Little Goose River. Pole 1091 was constructed within the floodplain of Goose Creek. Pole 1045 was constructed within the floodplain of the Pickerel Lake Creek. Poles 993-991 were constructed within the floodplain of the Sheyenne River. Installations of the Stormwater Pollution Prevention Plan items were observed, including the placement of silt fences around water resources (See **Photo 1**). In-between Pole 996 and 997, erosion was present and siltation was observed in the intermittent stream (See **Photo 2**).

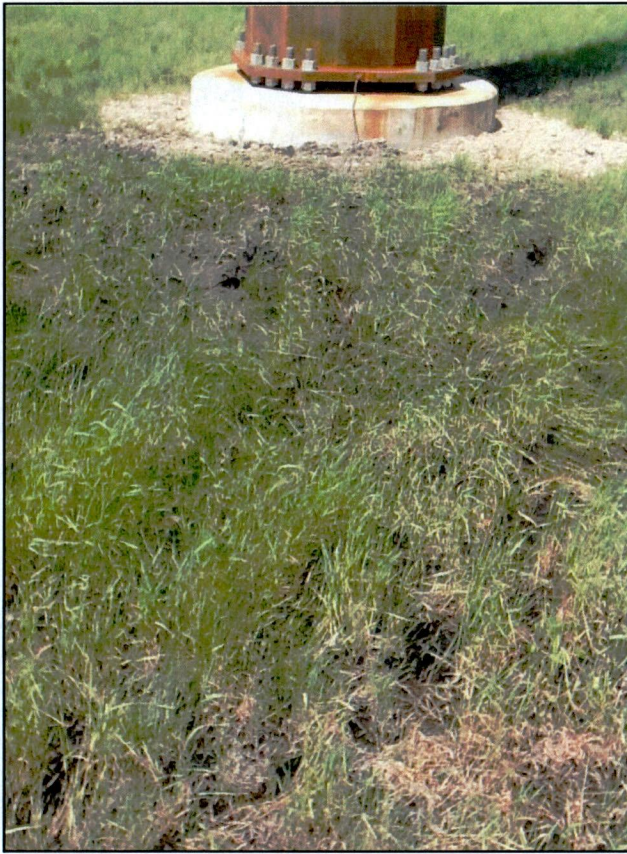
Photo 3: Example construction rutting (Pole 1272)

Conditions identified within the Special Use Permit include receiving final approval from the PSC, and the roads and lands damaged during construction of the line shall be repaired. Equipment rutting, grading impacts and bridging material was observed within an intermittent stream by Pole 1273.

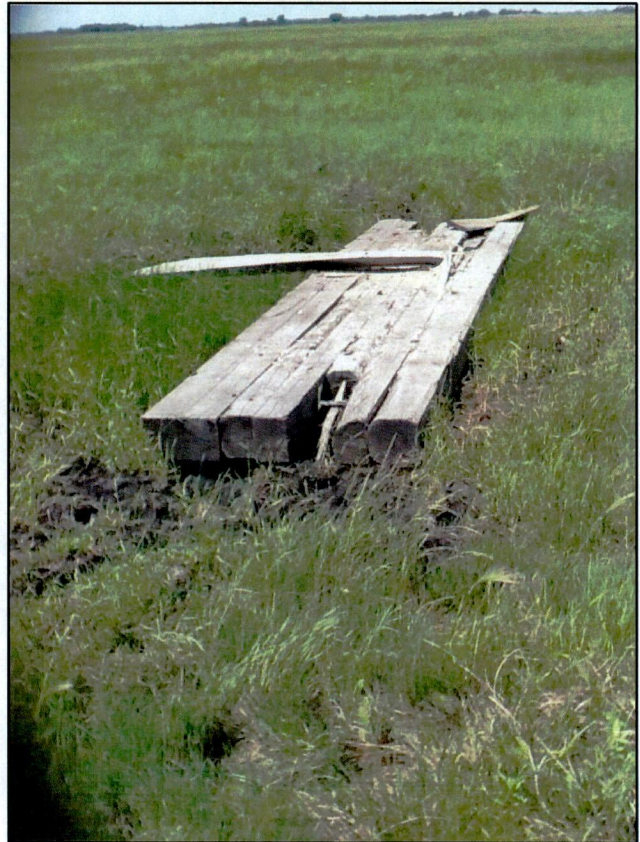
Photo 4: Example construction debris (Pole 1272)

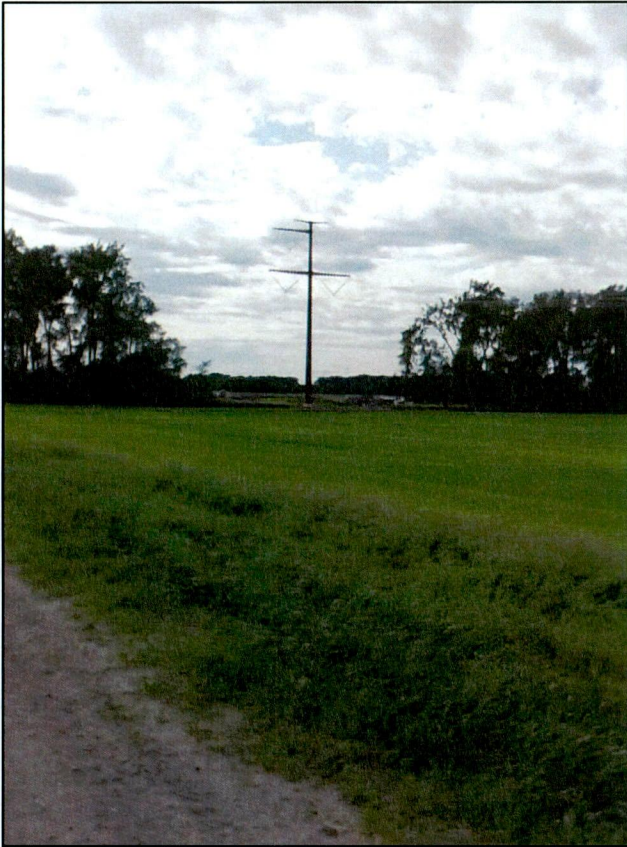
Photo 5: Example tree clearing activities (Pole 1214)

Permanent impacts to plant life, which included tree clearing operations, were observed within several pole areas, including Poles 1313, 1312, 1311, 1310, 1309, 1308, 1214, 1155, 1117, and 968 (See **Photo 5** for example).

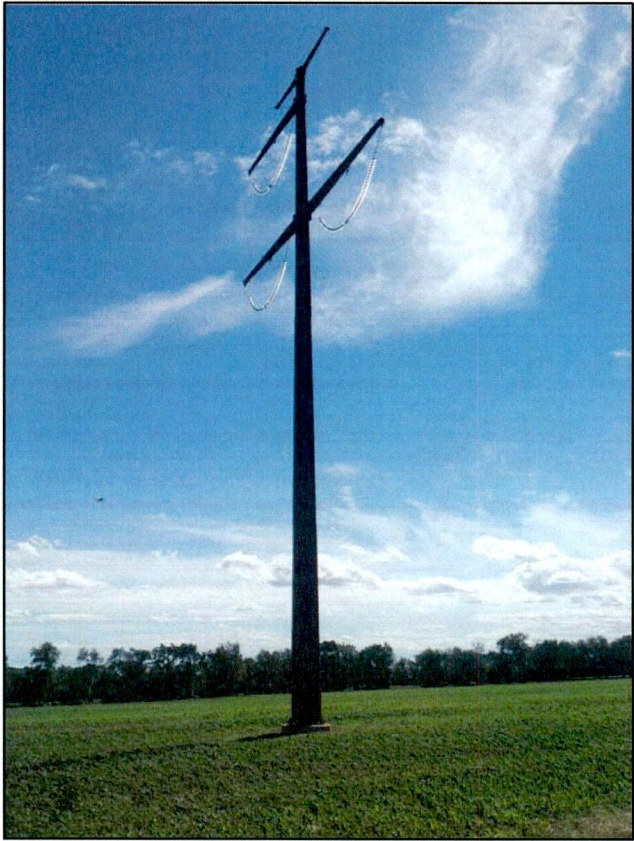
Photo 6: Example agricultural land construction (Pole 955)

The majority of the observed poles were located within agricultural areas (See **Photo 6**). Cultivation and planting avoidance was observed in areas where poles were actively under construction. Agricultural areas were tilled and planted where construction of the poles had been completed.

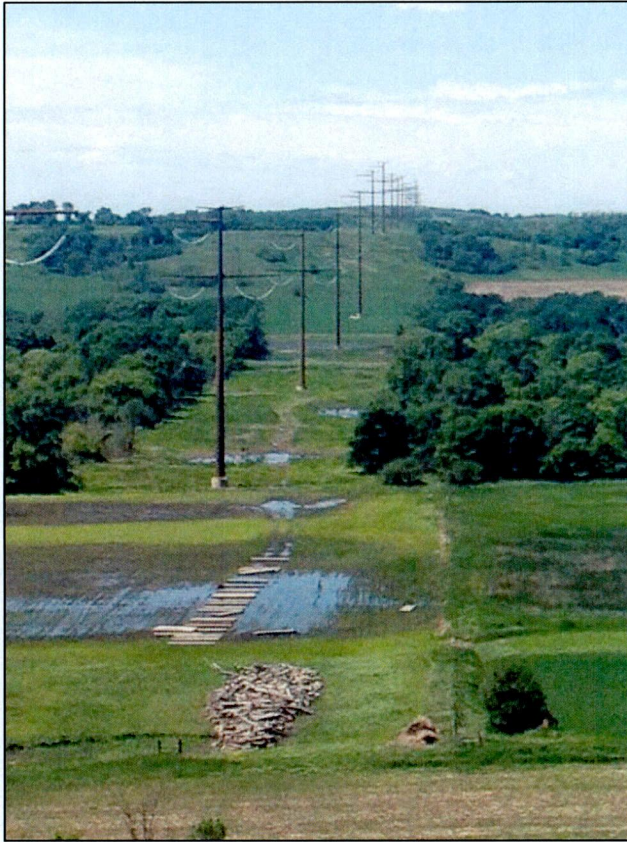
*Photo 7: Sheyenne River Pole Span.
(Poles 991-993)*

Poles were inspected crossing the Sheyenne River. Three poles were observed (991-993, **Photo 7**), and are within compliance of the Sovereign Land Permit No. S-1758 and the PSC Permit.
- Conditional Use Permit Griggs County
Pole construction within Griggs County complies with the PSC Permit, Findings of Fact, and Conclusions of Law and Order, therefore is compliant with the Conditional use Permit.
- Conditional Use Permit Foster County
No conditions were identified within the Conditional use Permit for Foster County. Pole construction is in compliance of the Conditional Use Permit.
- Conditional Use Permit Nelson County
No conditions were identified within the Conditional use Permit for Nelson County. Pole construction is in compliance of the Conditional Use Permit.
- Special Use Permit Grand Forks County
