NORTH DAKOTA PUBLIC SERVICE COMMISSION  
CENTER-GRAND FORKS 345KV TRANSMISSION LINE INSPECTION  
DATE: 8-12-2014

PRELIMINARY INSPECTION REPORT

DATES OF INSPECTION: AUGUST 4 THRU AUG 6, 2014  
INSPECTOR: KEVIN J. BERRETH, MBN ENGINEERING, INC.

Houston Engineering, Inc. and MBN Engineering were contractually hired by the North Dakota Public Service Commission to complete the construction inspection activities, as part of the Minnkota Power Cooperative Center-Grand Forks 345kV transmission line construction project(PU-09-670). The following is a summary of the work completed to date by MBN Engineering.

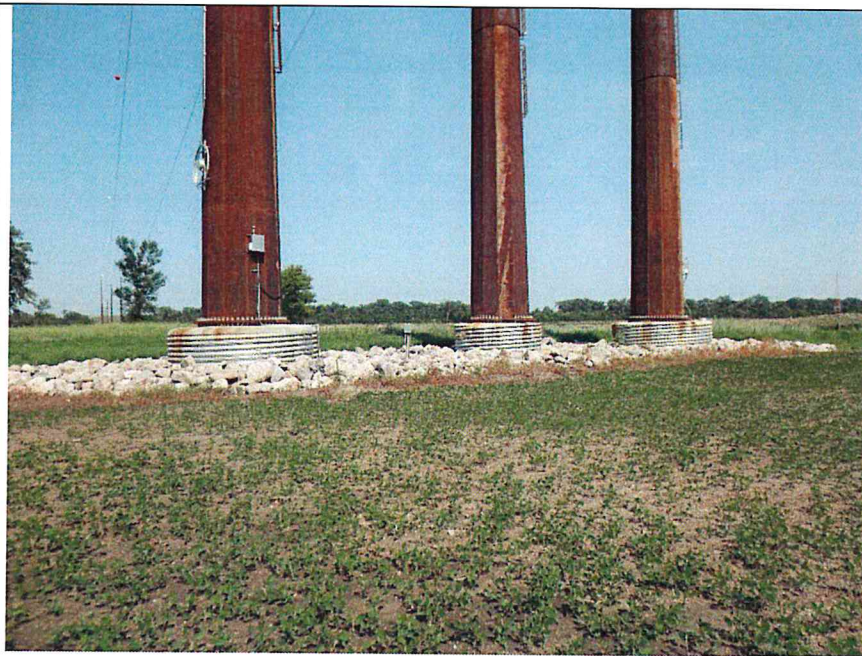
SOVEREIGN LAND PERMIT NO. S-1755 - Permit to construct transmission line across the Missouri River in Oliver and Burleigh Counties. Poles 68 and 69 were inspected on the west side of the river. Construction activities were complete in this area. See picture "STR 69 BASE LOOKING EAST MISSOURI RIVER.JPG". It appears that all material excavated for the drilled pier foundations has been removed from the site. The drilled piers were backfilled by rip-rap just above normal grade, and the area seems to be graded uniformly. See picture "STR 70 LOOKING EAST ACROSS MISSOURI RIVER.JPG". Marker balls were installed on the shield wires. It appears spacers were installed on the conductors. Plan and profile drawing state that they are maintaining 30' of clearance over the river above the 100 year flood elevation. This could not be verified as would require extensive survey. The west side of the river appears to be in compliance with the sovereign land permit No. S-1755. The east side of the river was not inspected at close range due to access.

Photo 1: Pole 69 base, looking east across the Missouri River.

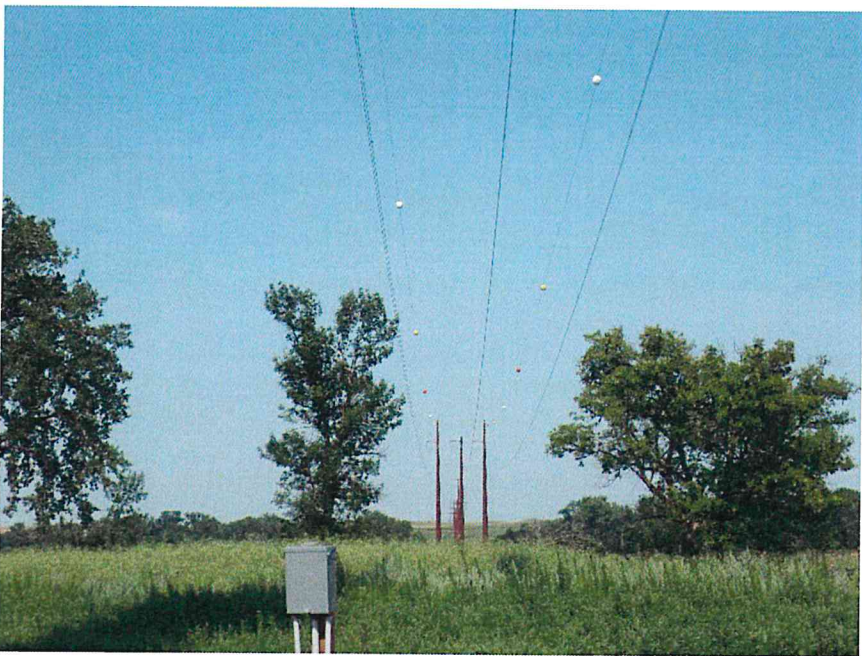
Photo 2: Pole 70, looking east across Missouri River.

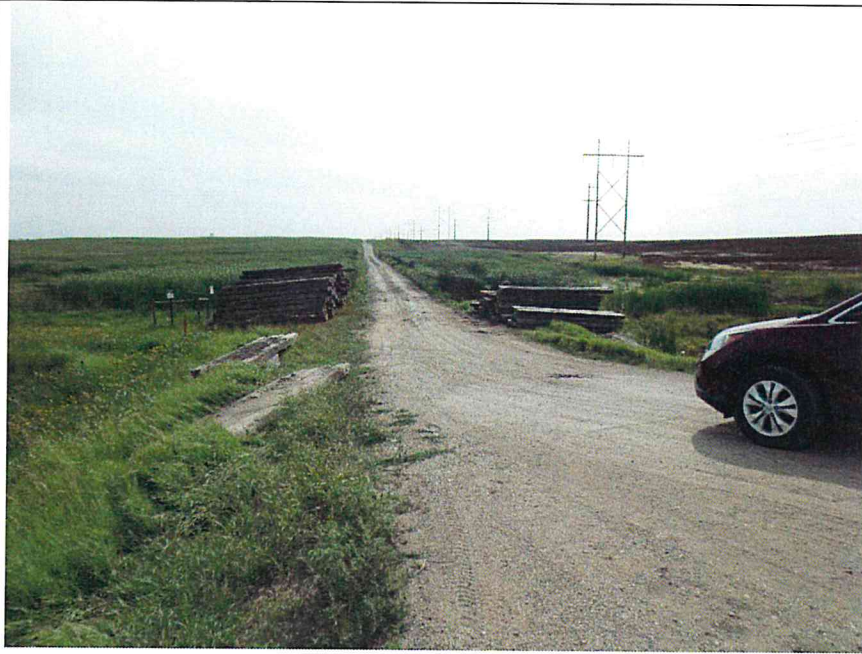
STRUCTURE #256: See picture "STR 256 JUST NORTH OF-CONSTR MATTING LOOK E.JPG". Just north of structure #256 on the east west minimum maintenance road, construction matting is still layed out in the low areas of the road and some is stacked up along side the road.

Photo 3: Pole 256 showing construction matting, looking east.

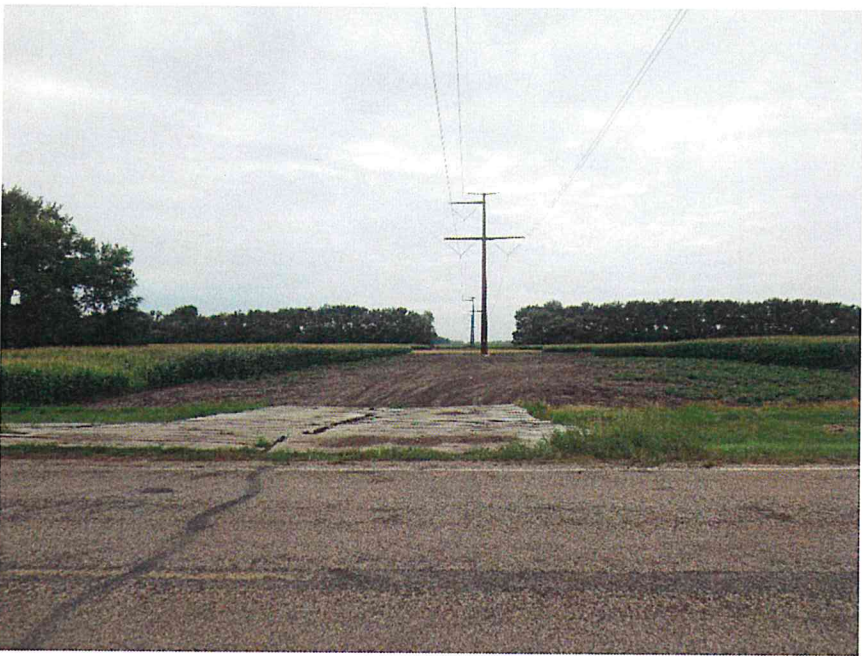
STRUCTURE #753; See picture "STR 753 LOOK E CONSTR MATTING.JPG"; On both sides of the road in the ditches, there still remains construction matting.

Photo 4: Pole 753, showing construction matting, looking east.
