FINAL COMPLIANCE MONITORING REPORT
Minnkota Power Cooperative, Inc. Center to Grand Forks 345 kV Transmission Line
North Dakota Public Service Commission Case No. PU-09-670
Route Permit Number 144

Minnkota Power Cooperative, Inc. 250 mile 345 kV line from Center to Grand Forks, North Dakota (PSC Case No. PU-09-670)

Permit Compliance Review

CENTER-GRAND FORKS 345KV TRANSMISSION LINE
 MBN INSPECTION REPORT
 DATE: 09/05/2014

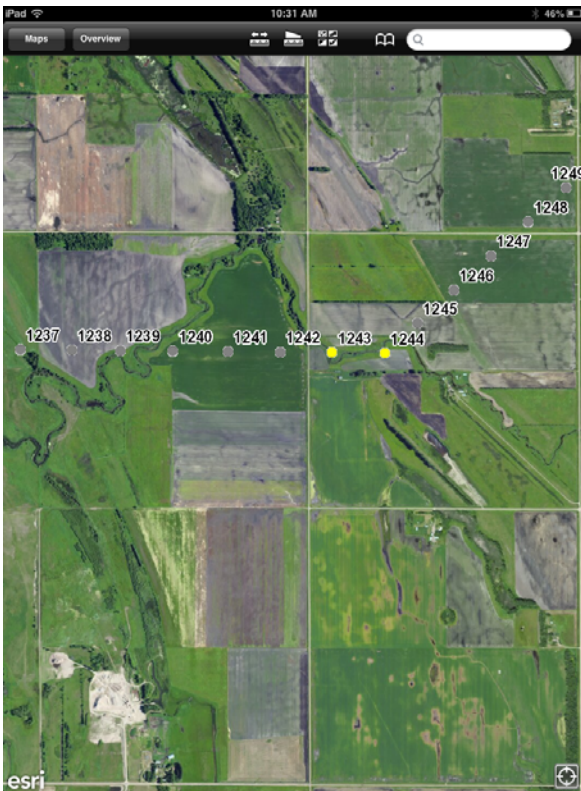
Photos 3 & 4 show the ArcGIS for iPad mapping application. In these example screenshots, the geodatabase that has been created allows us to map the location and track the environmental and permitting details that are specific to individual poles. The poles are color coded to indicate if they have been constructed and what stage of construction they are currently in.

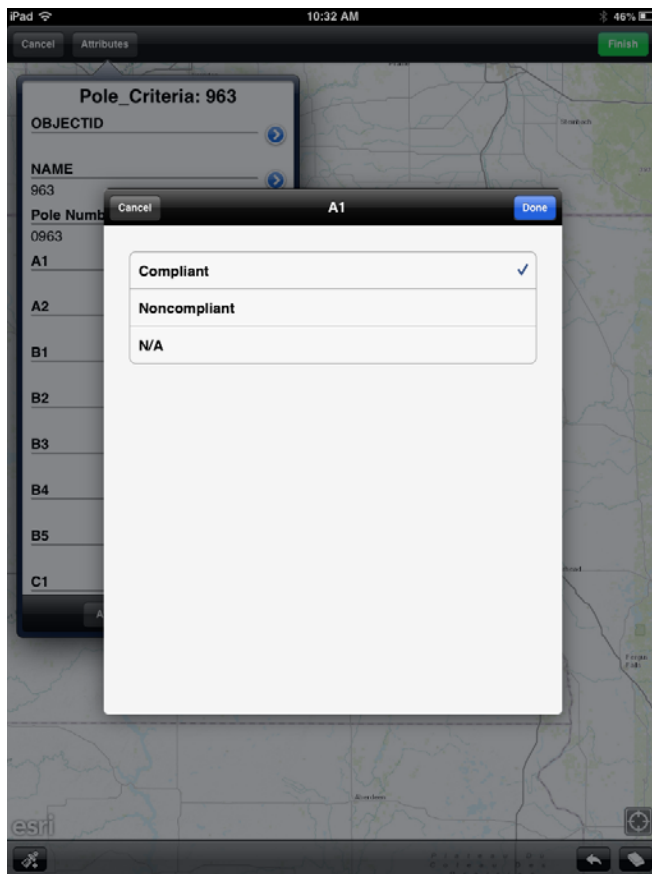
Photo 5: Example screen shot of the data collection feature of the geodatabase in ArcMap for iPad. This will allow us to travel to the pole, collect compliance data, take a photo and notes, and simultaneously update the database to the server in real-time.

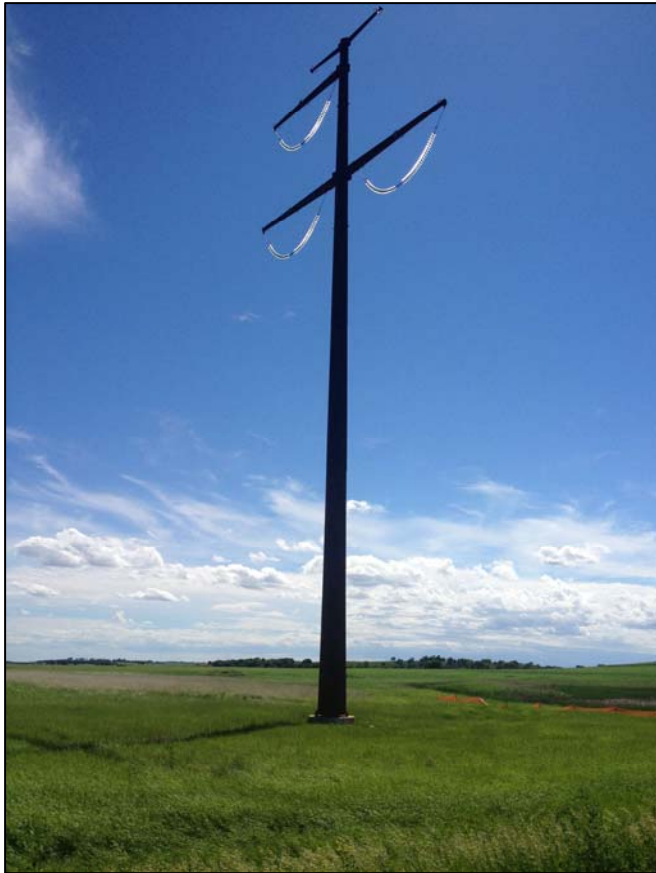
Wetland delineation data was used to identify poles that were constructed within wetlands. US Fish and Wildlife Service easement parcel data was used to identify potential wetland impacts within easement parcels. A total of 160 poles were inspected to determine wetland impact compliance. Twelve poles were placed within wetlands, including 1272, 1264, 1261, 1204, 1087, 1086, 1077, 1058, 966, 965, 920, 880, 866, 863. Temporary impacts from construction rutting or bridge material was observed on poles 920, 1065, 1077, 1079, 1080, 1272 (see **Photo 3 and Photo 4** for example) and will need to be returned to pre-construction condition, as outlined within the Permit SWPPP implementation was observed on all construction close to and within wetland areas, including the installation of silt fencing. (See **Photo 1** for example).

Photo 1: Example observed silt fencing around wetland resources (Pole 953)

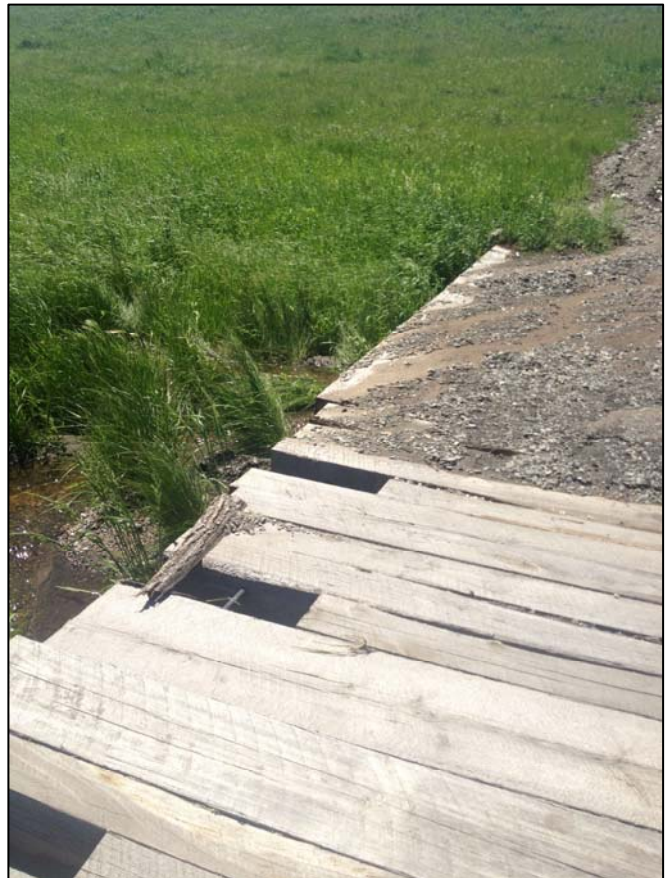
GIS location data was received from Minnkota and utilized to identify poles which may be constructed within a river, stream or drainage way, as outlined within the Selection Criteria of the permit. No poles were observed to be constructed directly within rivers/streams or drainage ways. Poles 1317, 1318 and 1244 are within the floodplains of the English Coulee. Poles 1295, 1272, 1174, 1130, 1093, 1092, 1007 and 1001 were constructed within the floodplains of intermittent streams. Pole 1159, 1153 and 1152 were constructed within the floodplains of the Little Goose River. Pole 1091 was constructed within the floodplain of Goose Creek. Pole 1045 was constructed within the floodplain of the Pickerel Lake Creek. Poles 993-991 were constructed within the floodplain of the Sheyenne River. Installations of the Stormwater Pollution Prevention Plan items were observed, including the placement of silt fences around water resources (See **Photo 1**). In-between Pole 996 and 997, erosion was present and siltation was observed in the intermittent stream (See **Photo 2**).

Photo 2: Erosion and sedimentation within intermittent stream (Pole 996)

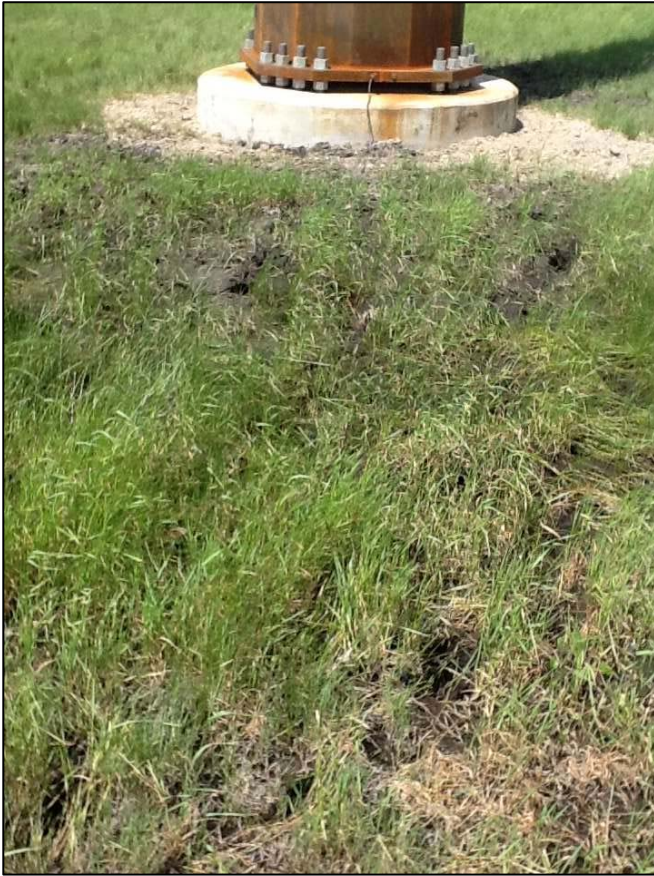
Photo 3: Example construction rutting (Pole 1272)

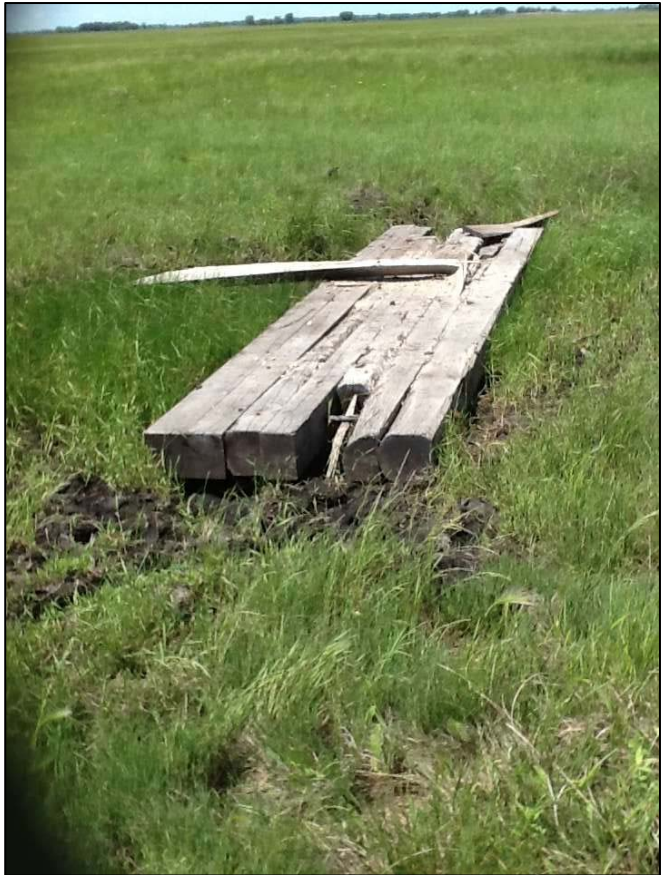
Photo 4: Example construction debris (Pole 1272)

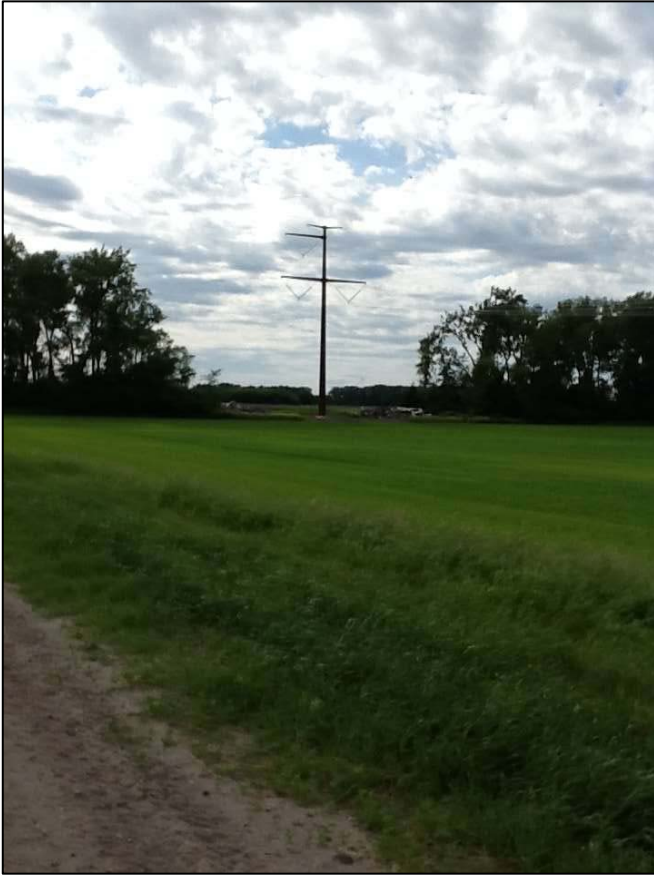
Permanent impacts to plant life, which included tree clearing operations, were observed within several pole areas, including Poles 1313, 1312, 1311, 1310, 1309, 1308, 1214, 1155, 1117, and 968 (See **Photo 5** for example).

Photo 5: Example tree clearing activities (Pole 1214)

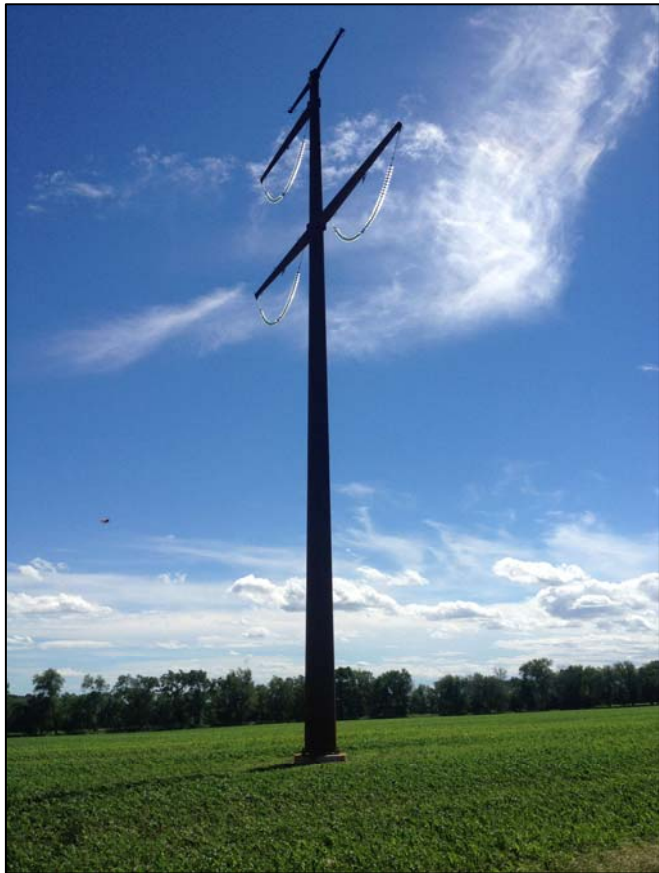
The majority of the observed poles were located within agricultural areas (See **Photo 6**). Cultivation and planting avoidance was observed in areas where poles were actively under construction. Agricultural areas were tilled and planted where construction of the poles had been completed.

Photo 6: Example agricultural land construction (Pole 955)

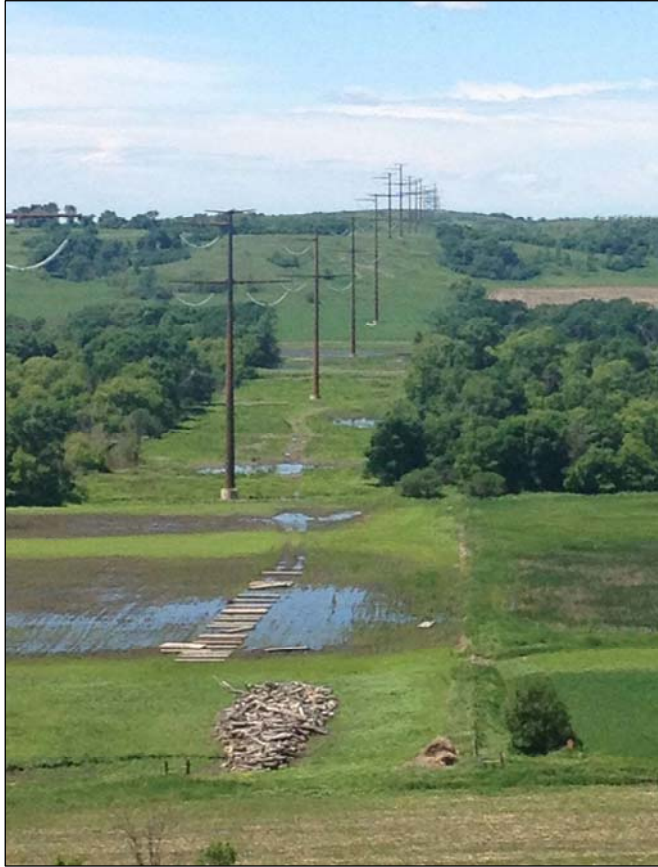
Poles were inspected crossing the Sheyenne River. Three poles were observed (991-993, **Photo 7**), and are within compliance of the Sovereign Land Permit No. S-1758 and the PSC Permit.

*Photo 7: Sheyenne River Pole Span.
(Poles 991-993)*

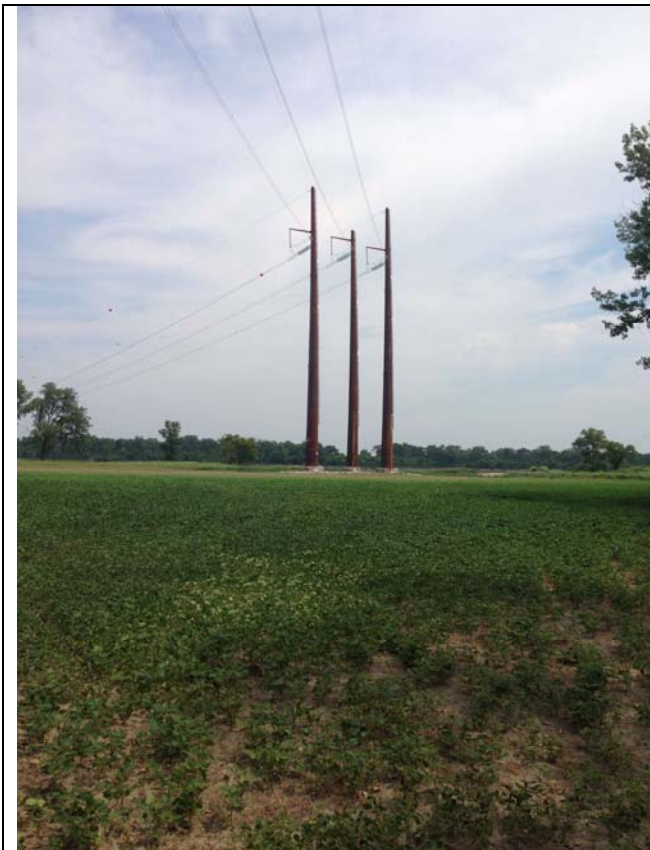
Photo 1: Pole 69 on the west side of the Missouri River. Shield markers have been installed, and can be seen in this photo.

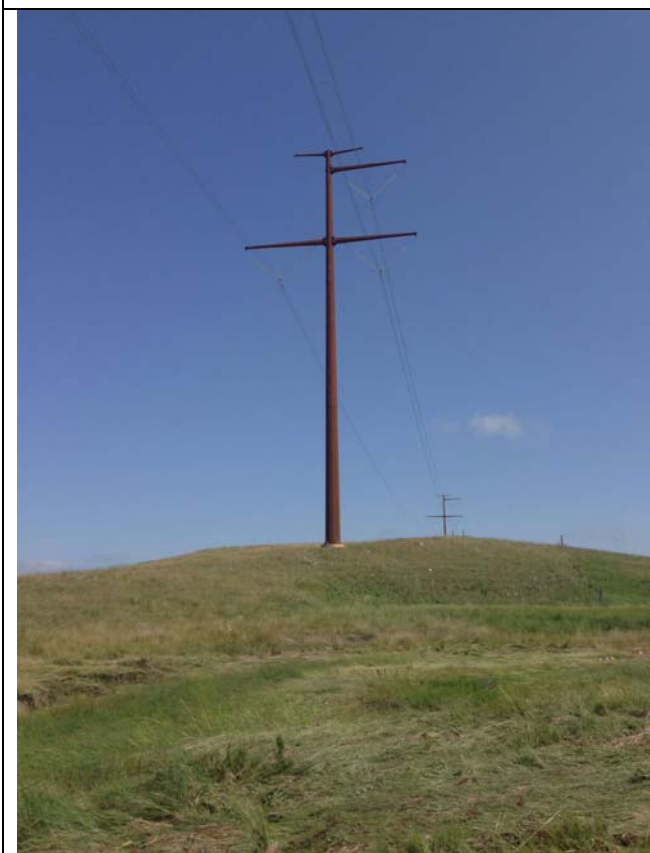
Photo 2: Pole 119, showing avoidance of an archaeological / historic site. Posting of archaeological / historic site can be faintly observed in the foreground.

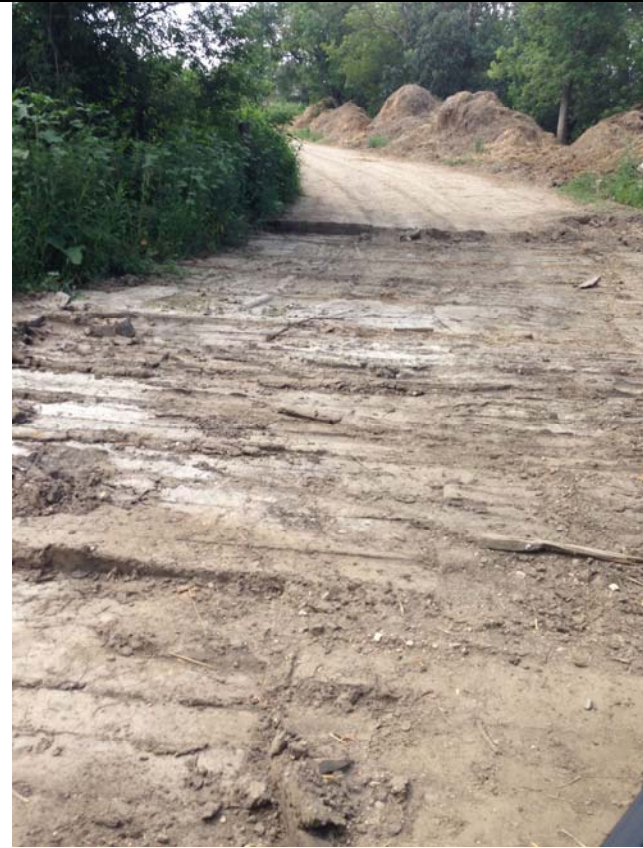
Photo 3: Adjacent to pole 68, showing rutting from recently removed construction matting within a wetland. This area will require further restoration.

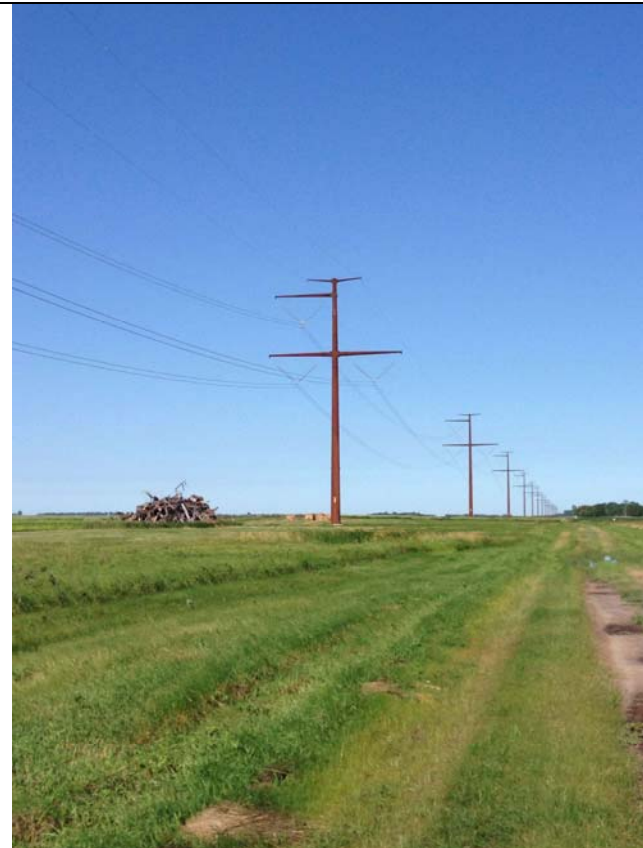
One land owner discussed with us during the site visit that his field access road was damaged and was expecting further restoration activities. This was in and around the area of pole 552.

Permanent impacts to plant life, which included tree clearing operations, were observed within several pole areas, including Poles 503, 504, 522, 553, 554, 555, 562, 631, 633, 634, 647, 648, 658 (See **Photo 4** for example).

Photo 4: Pole 552, showing tree clearing areas and remnant debris.

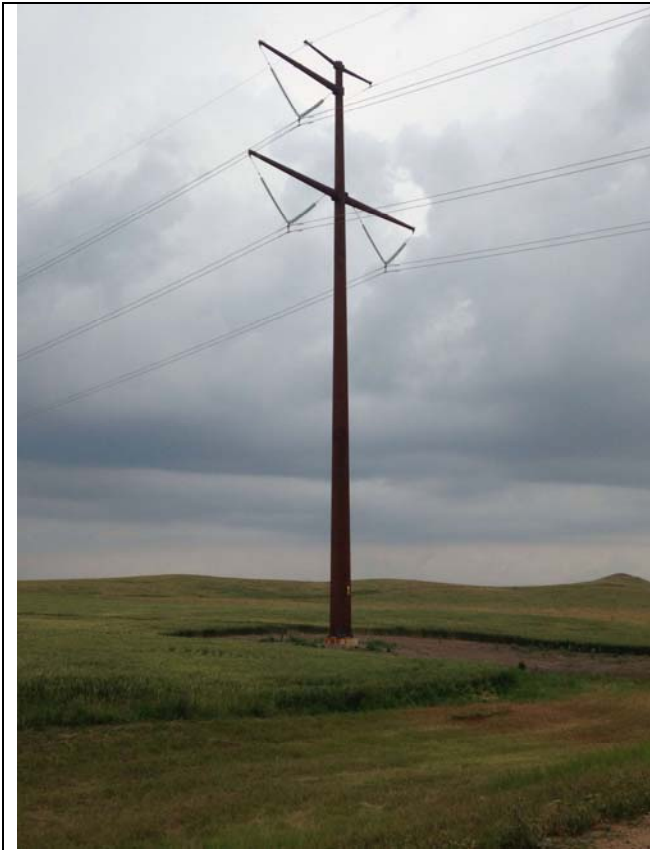
The majority of the observed poles were located within agricultural areas (See **Photo 5**). Cultivation and planting avoidance was observed in areas where poles were actively under construction. Agricultural areas were tilled and planted where construction of the poles had been completed.

Photo 5: Typical photo of a pole constructed in agriculture land. Pole 86.

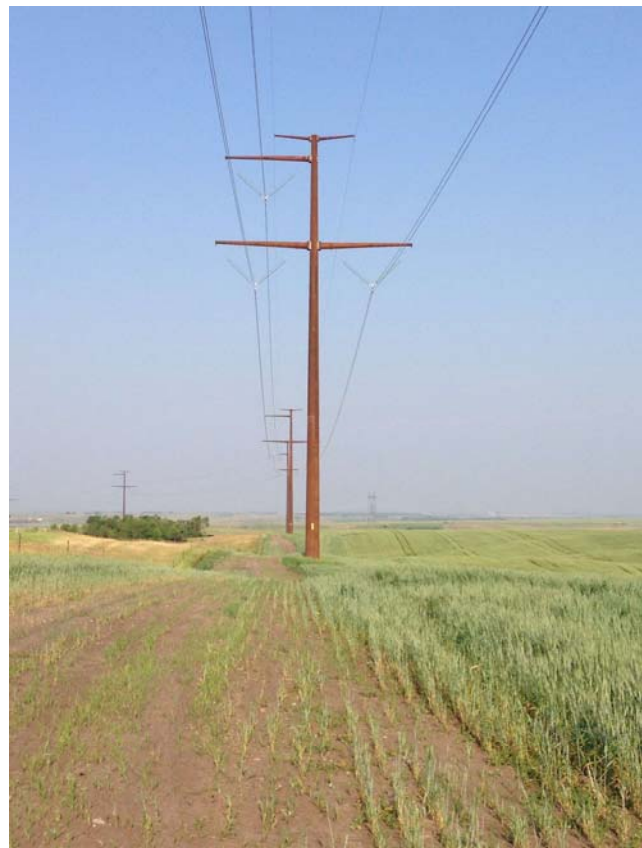
Photo 6: Pole 8, showing avoidance of a Wildlife Management Area (WMA). The Wilbur Boldt WMA is on the left side of this photograph.

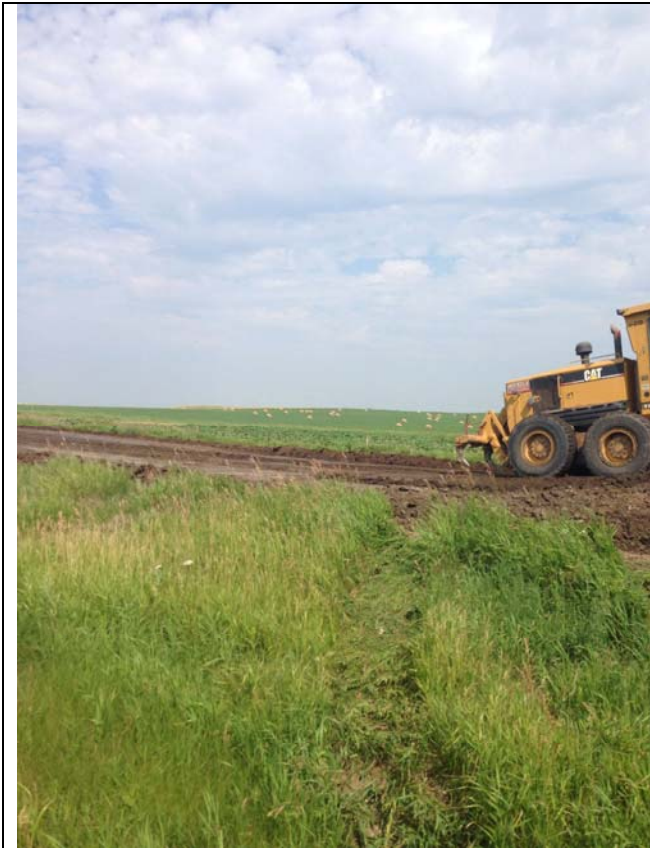
Photo 7: Road restoration activities as observed adjacent to Pole 31.

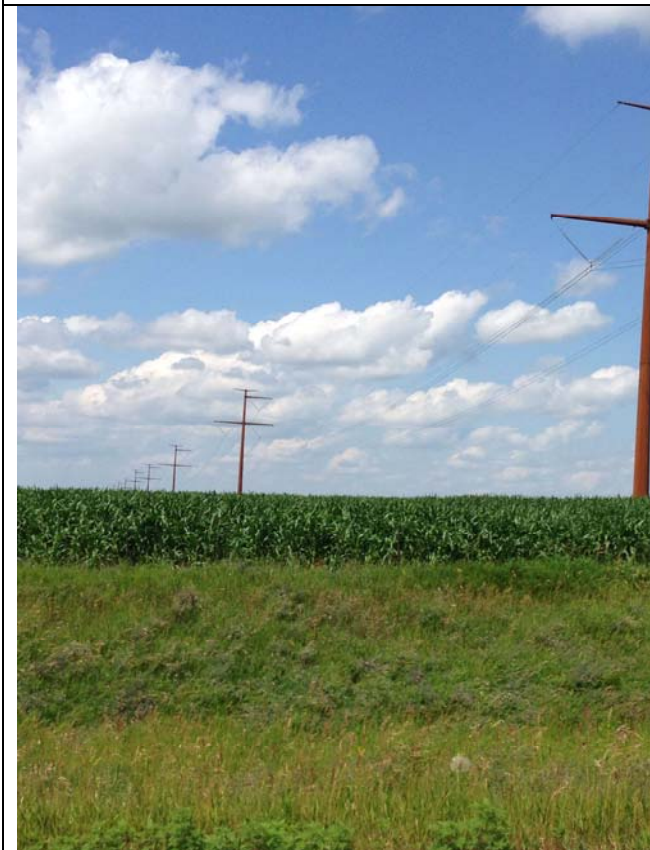
Photo 8: Several areas were identified as USFWS easement lands, however upon field inspection it was clear that these areas had been removed from easement, as shown in this photo of poles 186-188.

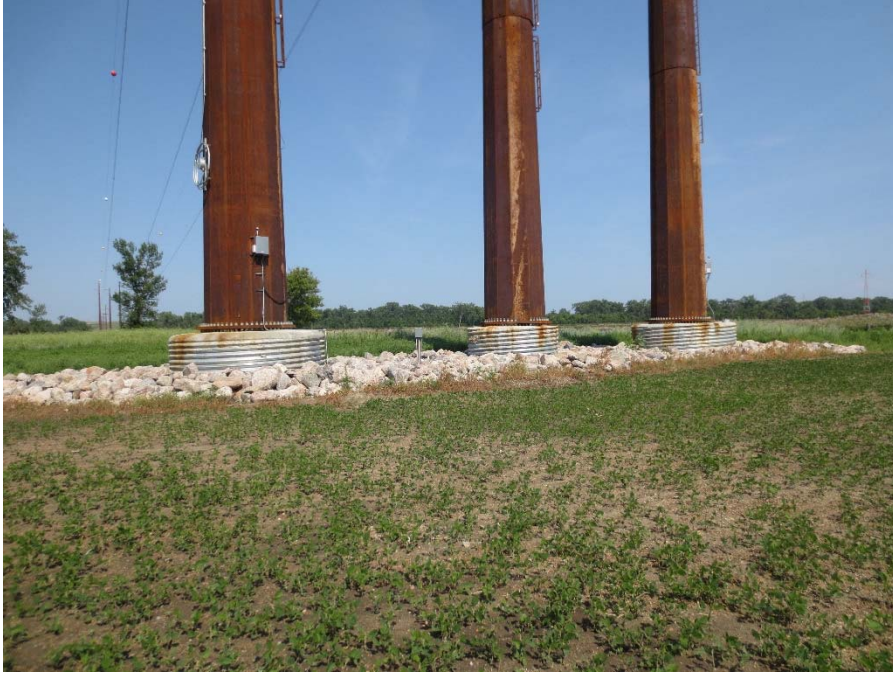
Poles 68 and 69 were inspected on the west side of the river. Construction activities were complete in this area. See picture "STR 69 BASE LOOKING EAST MISSOURI RIVER.JPG". It appears that all material excavated for the drilled pier foundations has been removed from the site. The drilled piers were backfilled by rip-rap just above normal grade, and the area seems to be graded uniformly. See picture "STR 70 LOOKING EAST ACROSS MISSOURI RIVER.JPG". Marker balls were installed on the shield wires. It appears spacers were installed on the conductors. Plan and profile drawing state that they are maintaining 30' of clearance over the river above the 100 year flood elevation. This could not be verified as would require extensive survey. The west side of the river appears to be in compliance with the sovereign land permit No. S-1755. The east side of the river was not inspected at close range due to access.

Photo 1: Pole 69 base, looking east across the Missouri River.

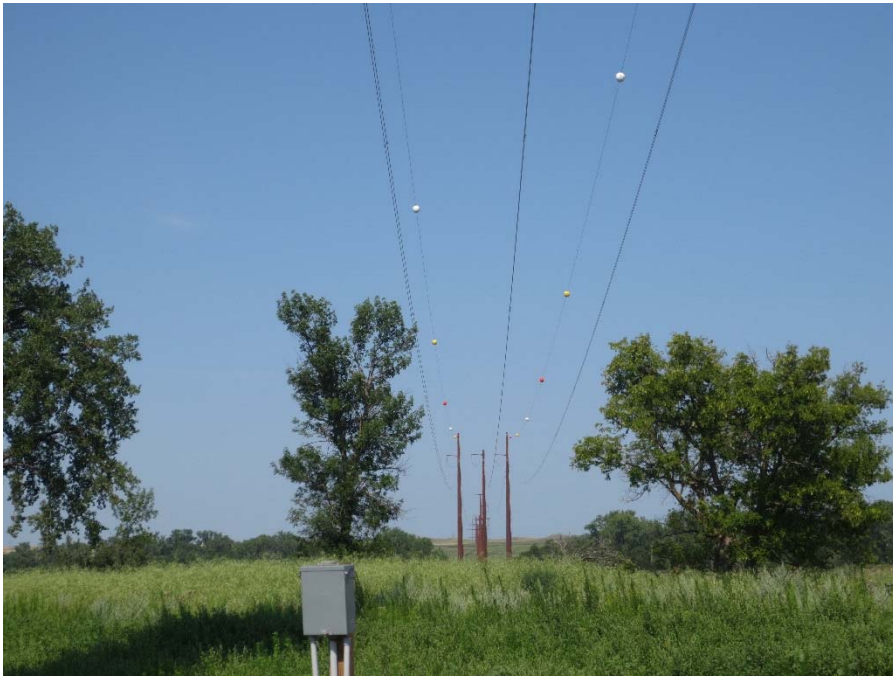
Photo 2: Pole 70, looking east across Missouri River.

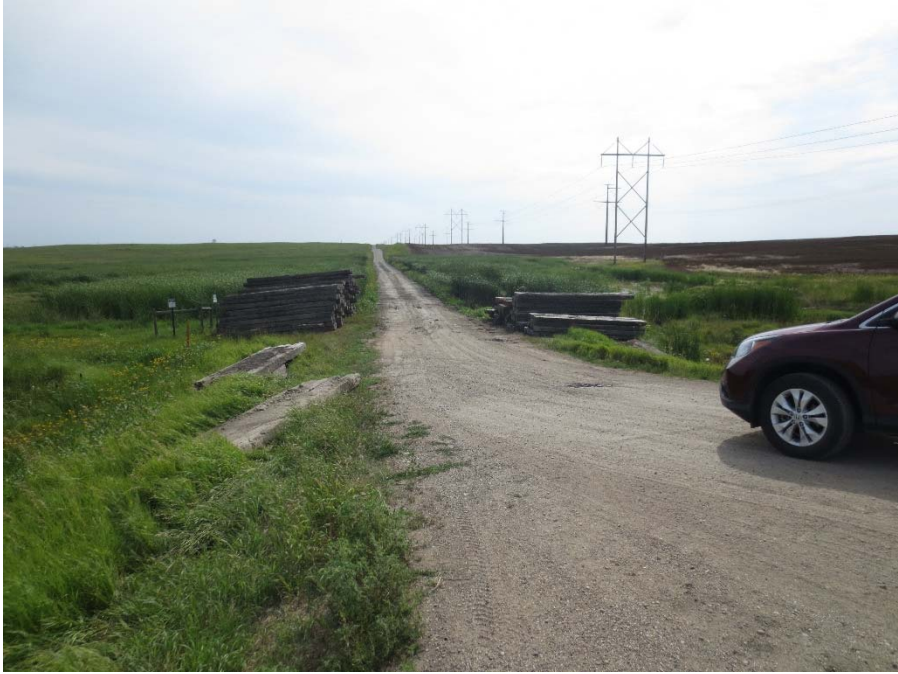
Photo 3: Pole 256 showing construction matting, looking east.

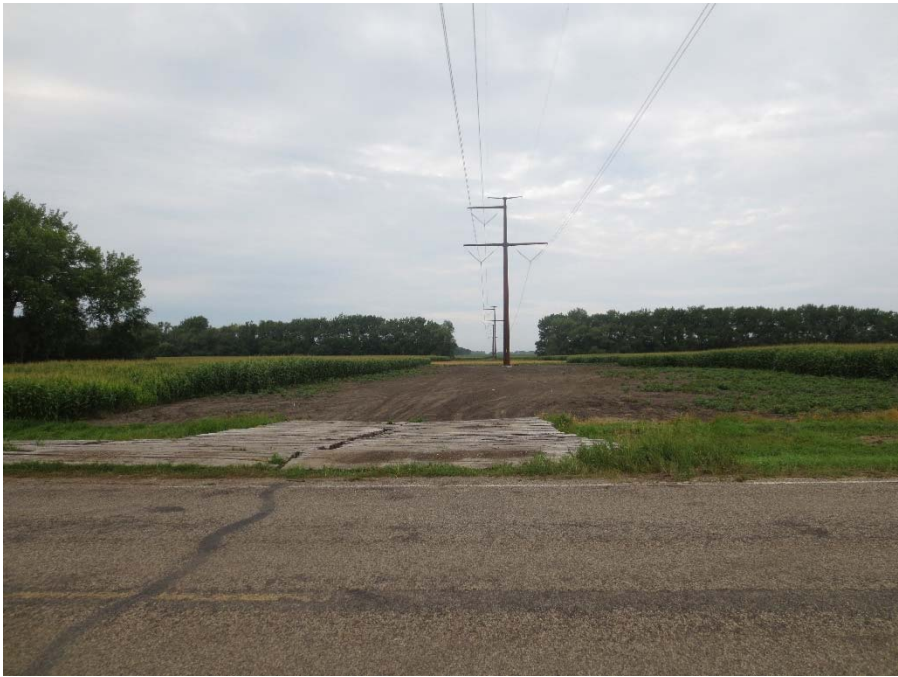
Photo 4: Pole 753, showing construction matting, looking east.
