Hankinson-Ellendale Transmission Line Reroute Post-Construction Inspection Report PU-09-674

NORTH DAKOTA PUBLIC SERVICE COMMISSION

WENCK ASSOCIATES, INC.

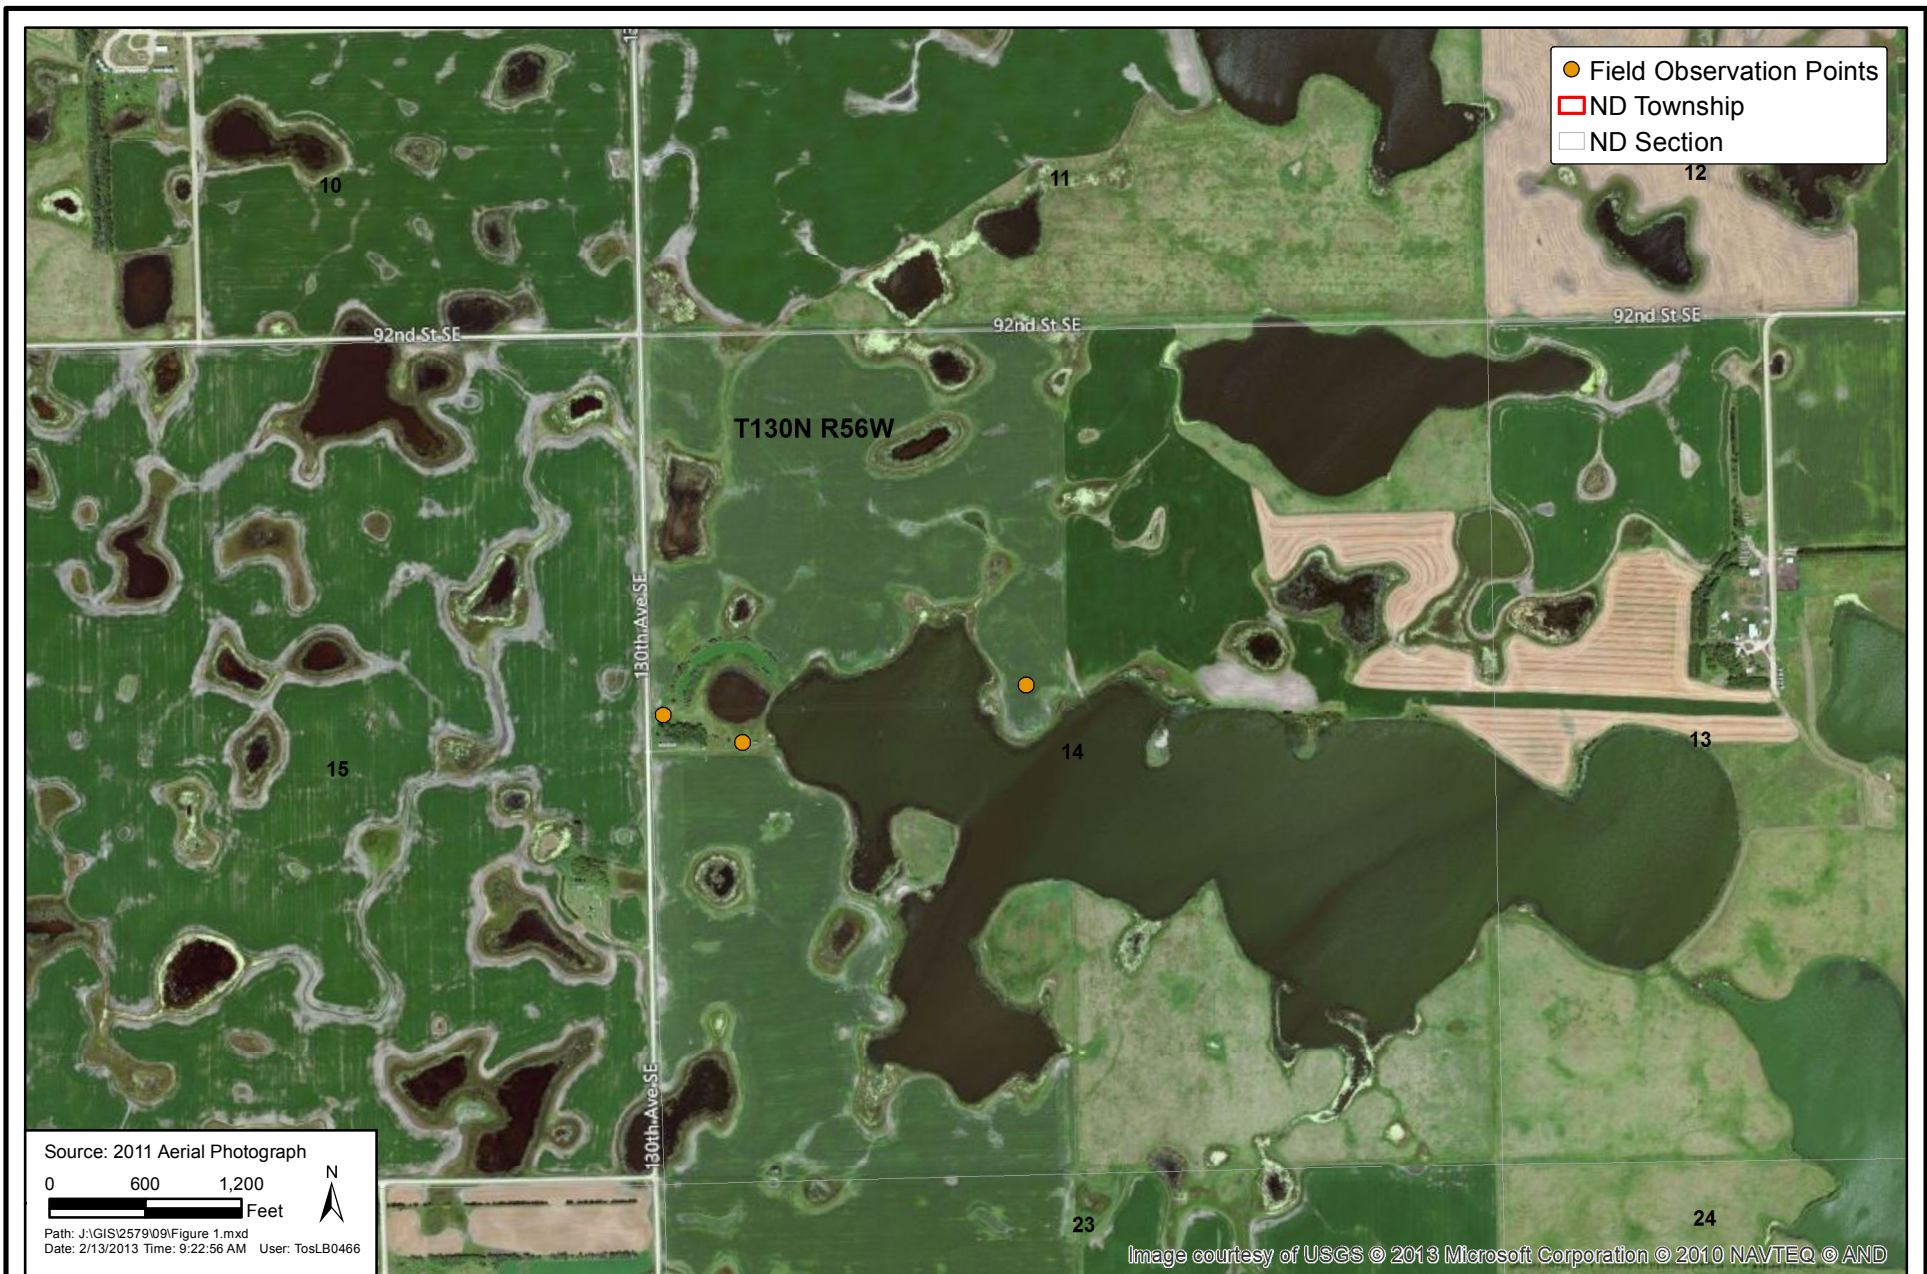
Figure 1

Hankinson-Ellendale 0.53 mile Transmission Line Reroute
Section 14, T130N, R56W - Sargent County, ND

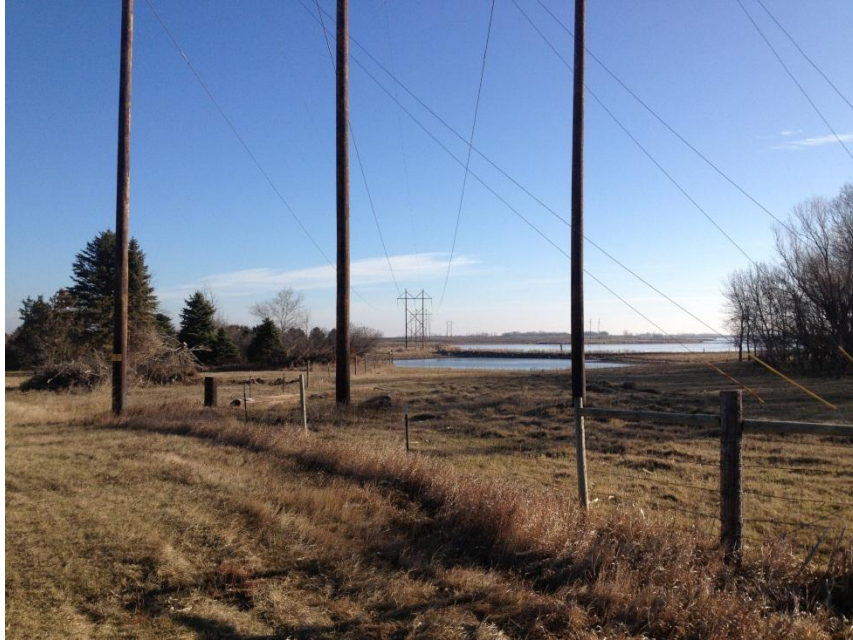
Photo 1. Direction: East. View of the first transmission structure installed for the reroute just east of 130th Ave. SE in Section 14, Township 130 North, Range 56 West (**Figure 1**).

The Project was built as proposed in the designated Project area described in the Application and Order (**Figure 1**). Maps of the approved corridor and observations of on-the-ground infrastructure during the inspection appeared to coincide (**Appendix A, Photos 1-3**).

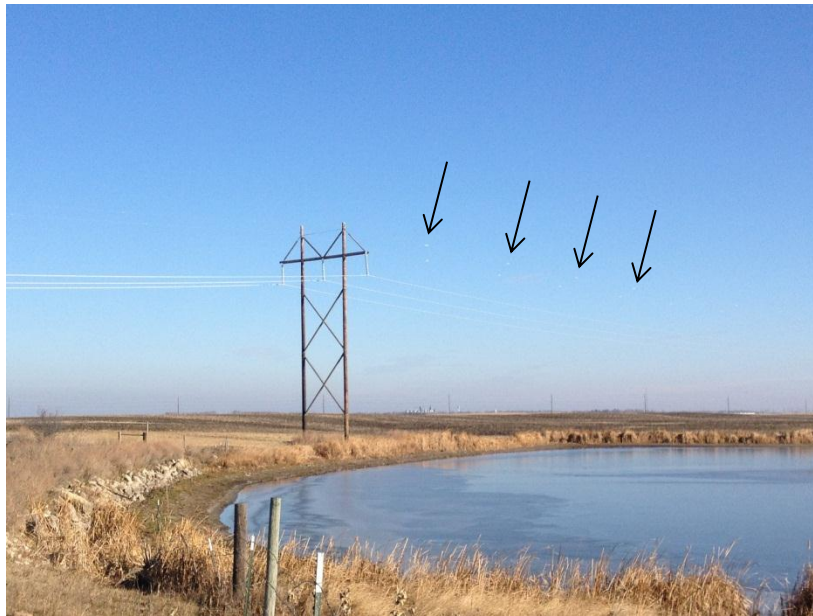
The US Fish and Wildlife Service (USFWS) and ND Game and Fish Department (NDGF) requested that overhead powerlines be marked to prevent collisions from whooping cranes and other migratory birds. Wenck observed that overhead power lines were marked where requested (**Appendix A, Photo 2**).

Photo 2. Direction: Northeast. View of the transmission line showing bird diverters along the line, which are faintly visible (indicated by black arrows).

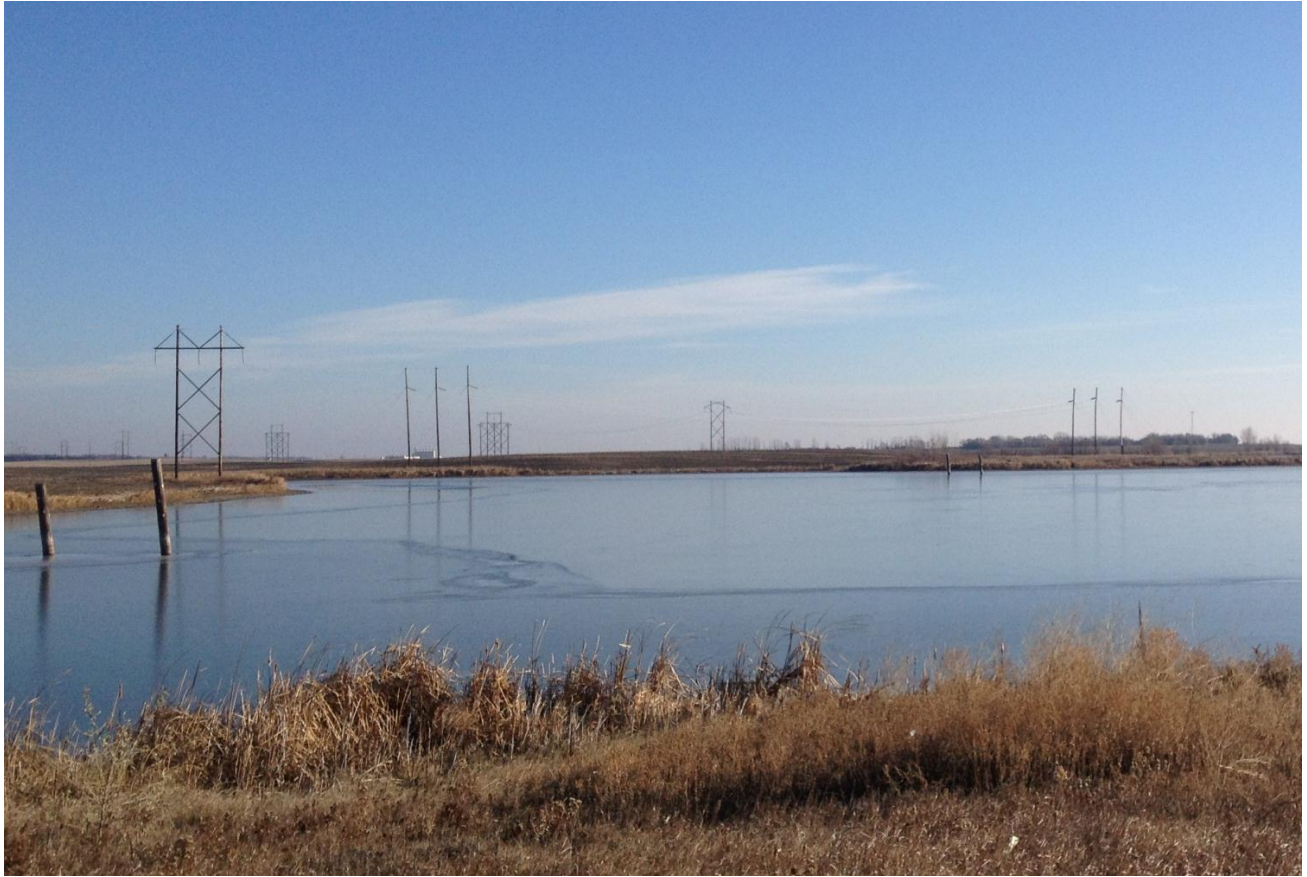
The old structure bases were still in the lake during the site inspection (**Appendix A, Photo 3**). However, the landowner requested them for personal use and would collect them when they float to the surface.

Photo 3. Direction: Northwest. View across Fiala Lake towards the rerouted transmission line. Two tangents were used to route the transmission line; both were located nearby the Lake, but only one was within close proximity, and it had riprap installed to prevent erosion and to protect the structure. No erosion or sedimentation was observed to the Lake. By request, the landowner will remove the old poles when they float to the surface (seen to the left and across the lake to the right).
