**WETLAND DELINEATION REPORT  
OLIVER III TRANSMISSION LINE**

**MORTON & OLIVER COUNTIES  
NORTH DAKOTA**

**December 17, 2010**

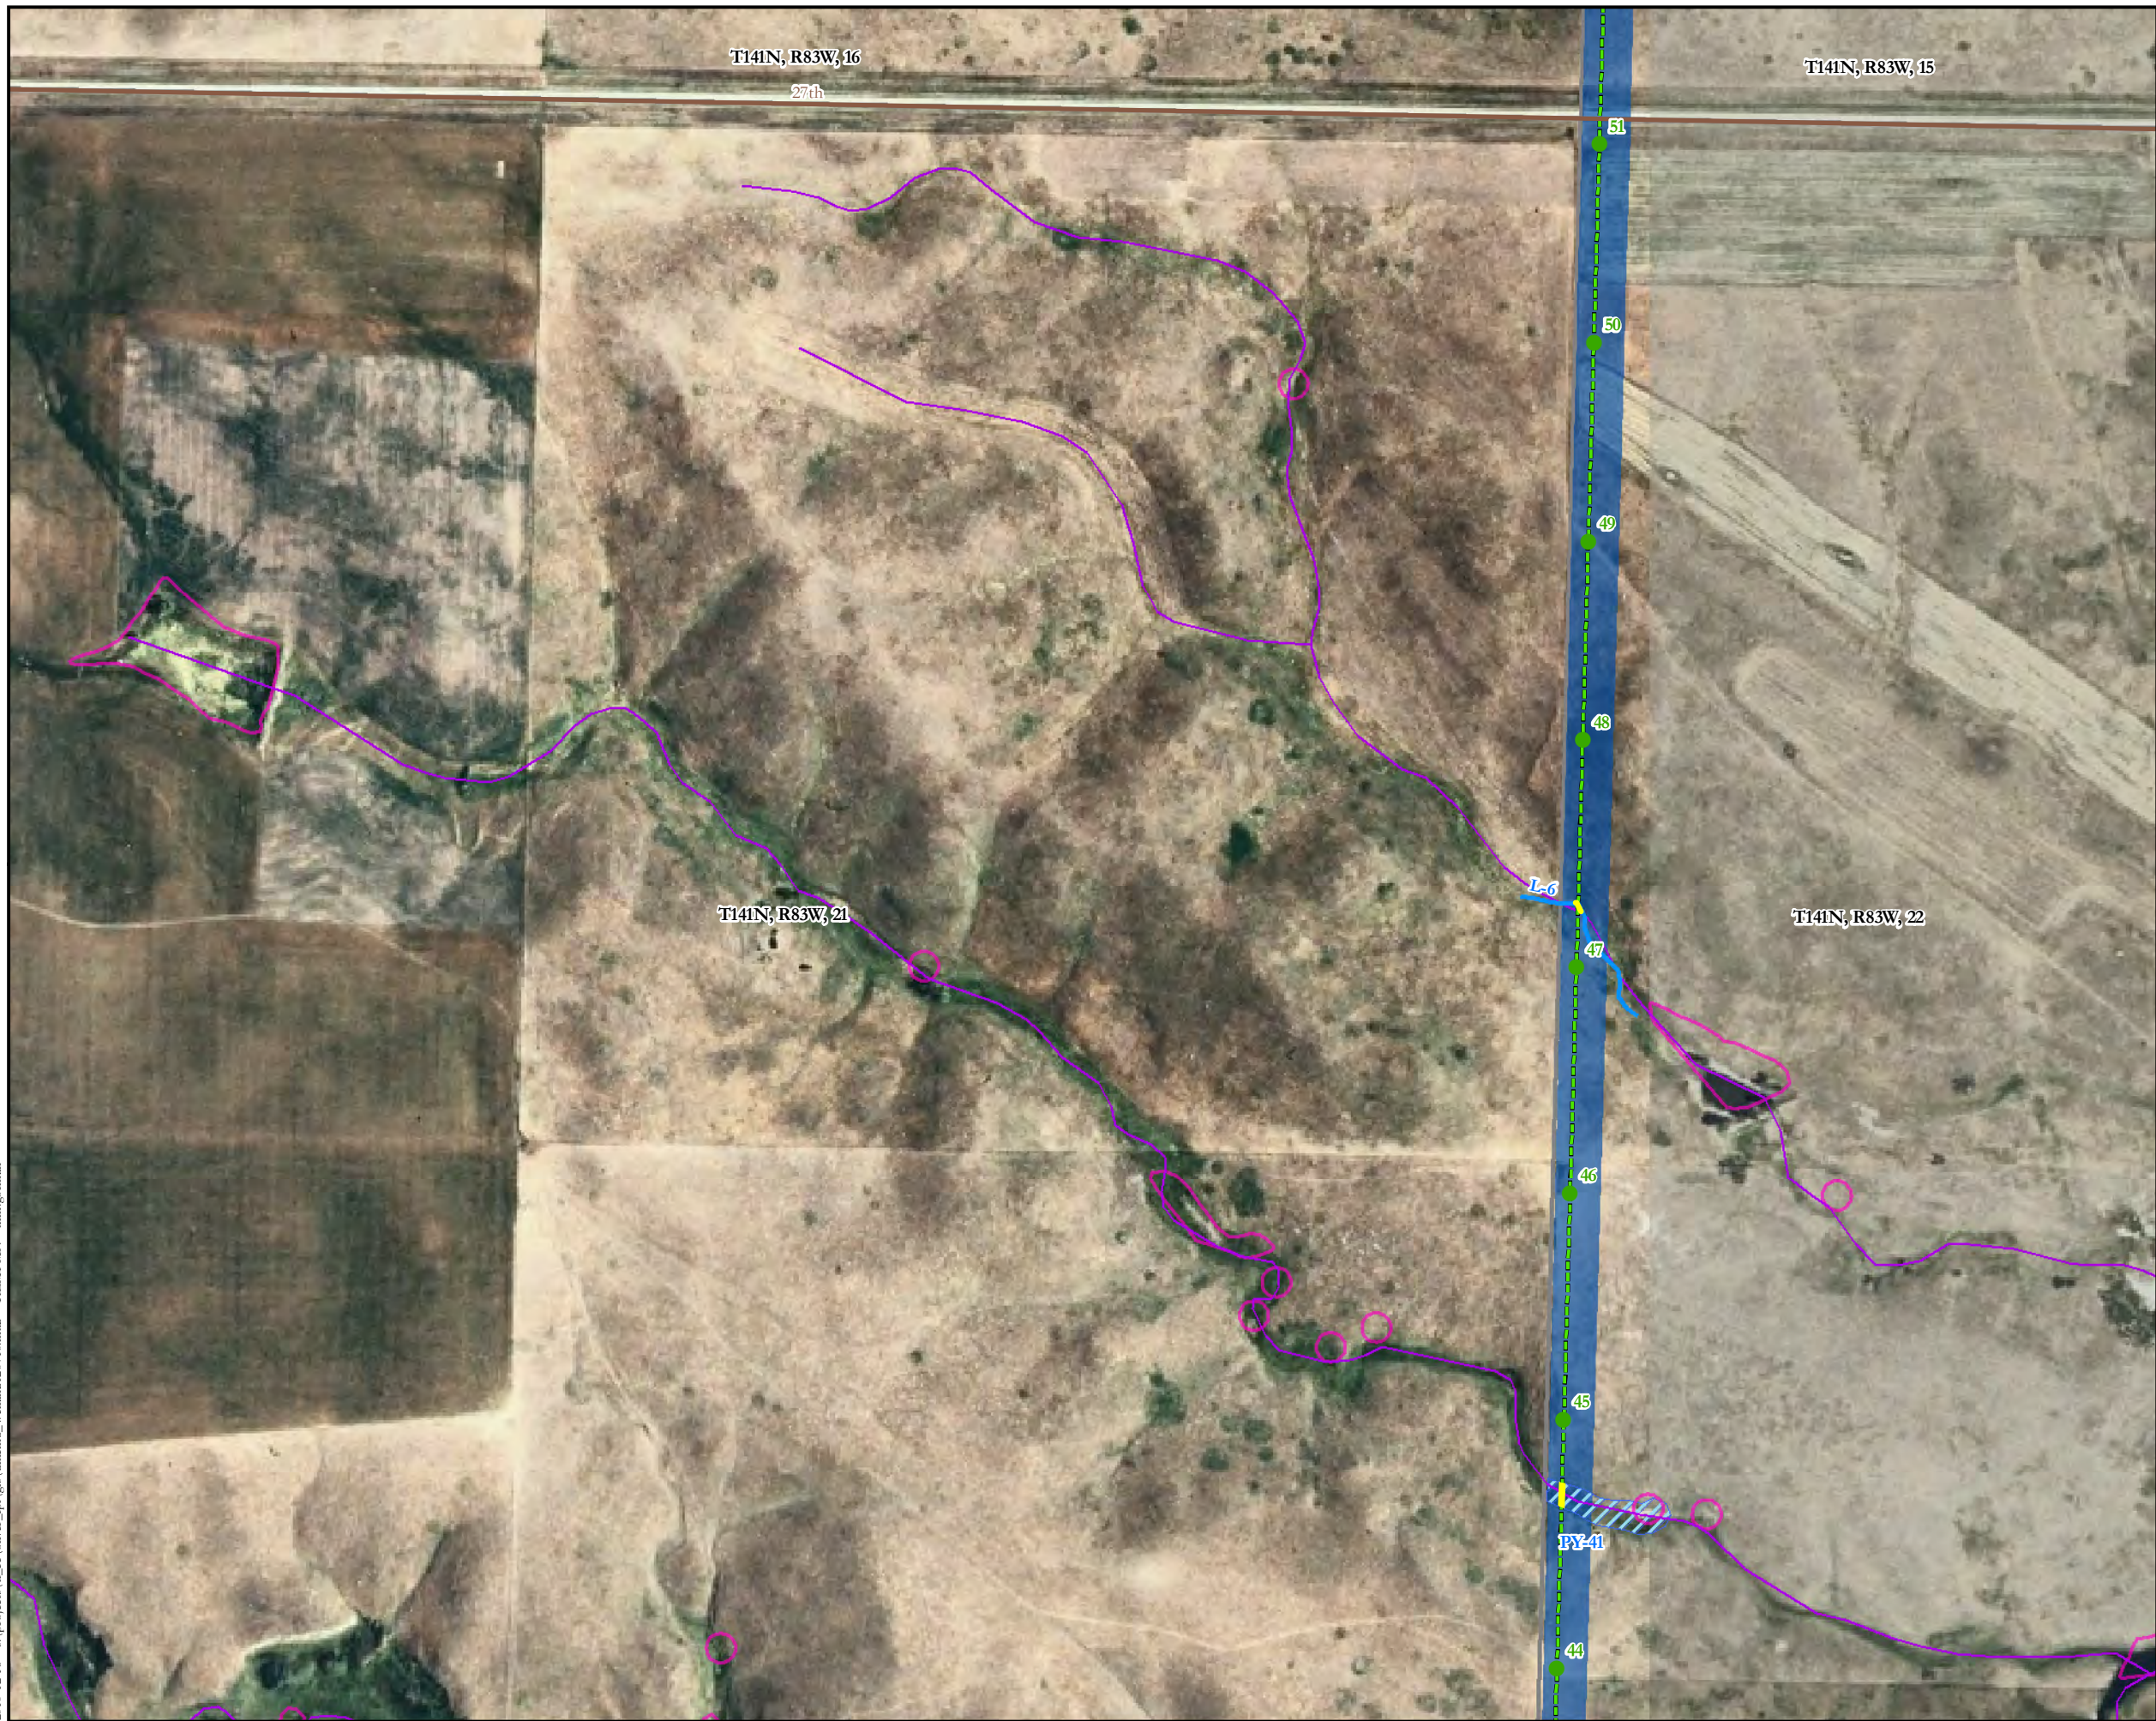
# E01

L-6	E01	Sections 21 & 22, T141N, R83W	Drainage swale	None	0	The feature is a drainage swale and was identified on a NHD line. The swale was not observed to have characteristics of an OHWM and likely only transports water during periods of heavy rainfall. The USACE typically does not assert jurisdiction to swales that are characterized by low volume, infrequent, and short duration of flow. The feature was observed to contain upland vegetation typical of non-wetland areas. It is Tetra Tech's opinion that a significant nexus does not exist and the swale is not a jurisdictional water of the U.S.
PY-41	E01	Section 22, T141N, R83W	Intermittent stream, NRPW	USACE	0.023	The feature is an intermittent stream identified on a NHD line. Tetra Tech classified the stream as a NRPW due to the observation of a bed and bank characteristic of an OHWM and assumed flow of less than three months. To determine jurisdiction of NRPWs the USACE makes a significant nexus determination. A significant nexus exists if the tributary has more than a speculative or insubstantial effect on the chemical, physical, and/or biological integrity of a traditional navigable water. It is Tetra Tech's opinion that a significant nexus exists and the stream is jurisdictional. Tetra Tech recommends avoidance of this feature. If avoidance cannot be achieved, minimization and/or mitigation methods that reduce impacts on the aquatic resource should be implemented.

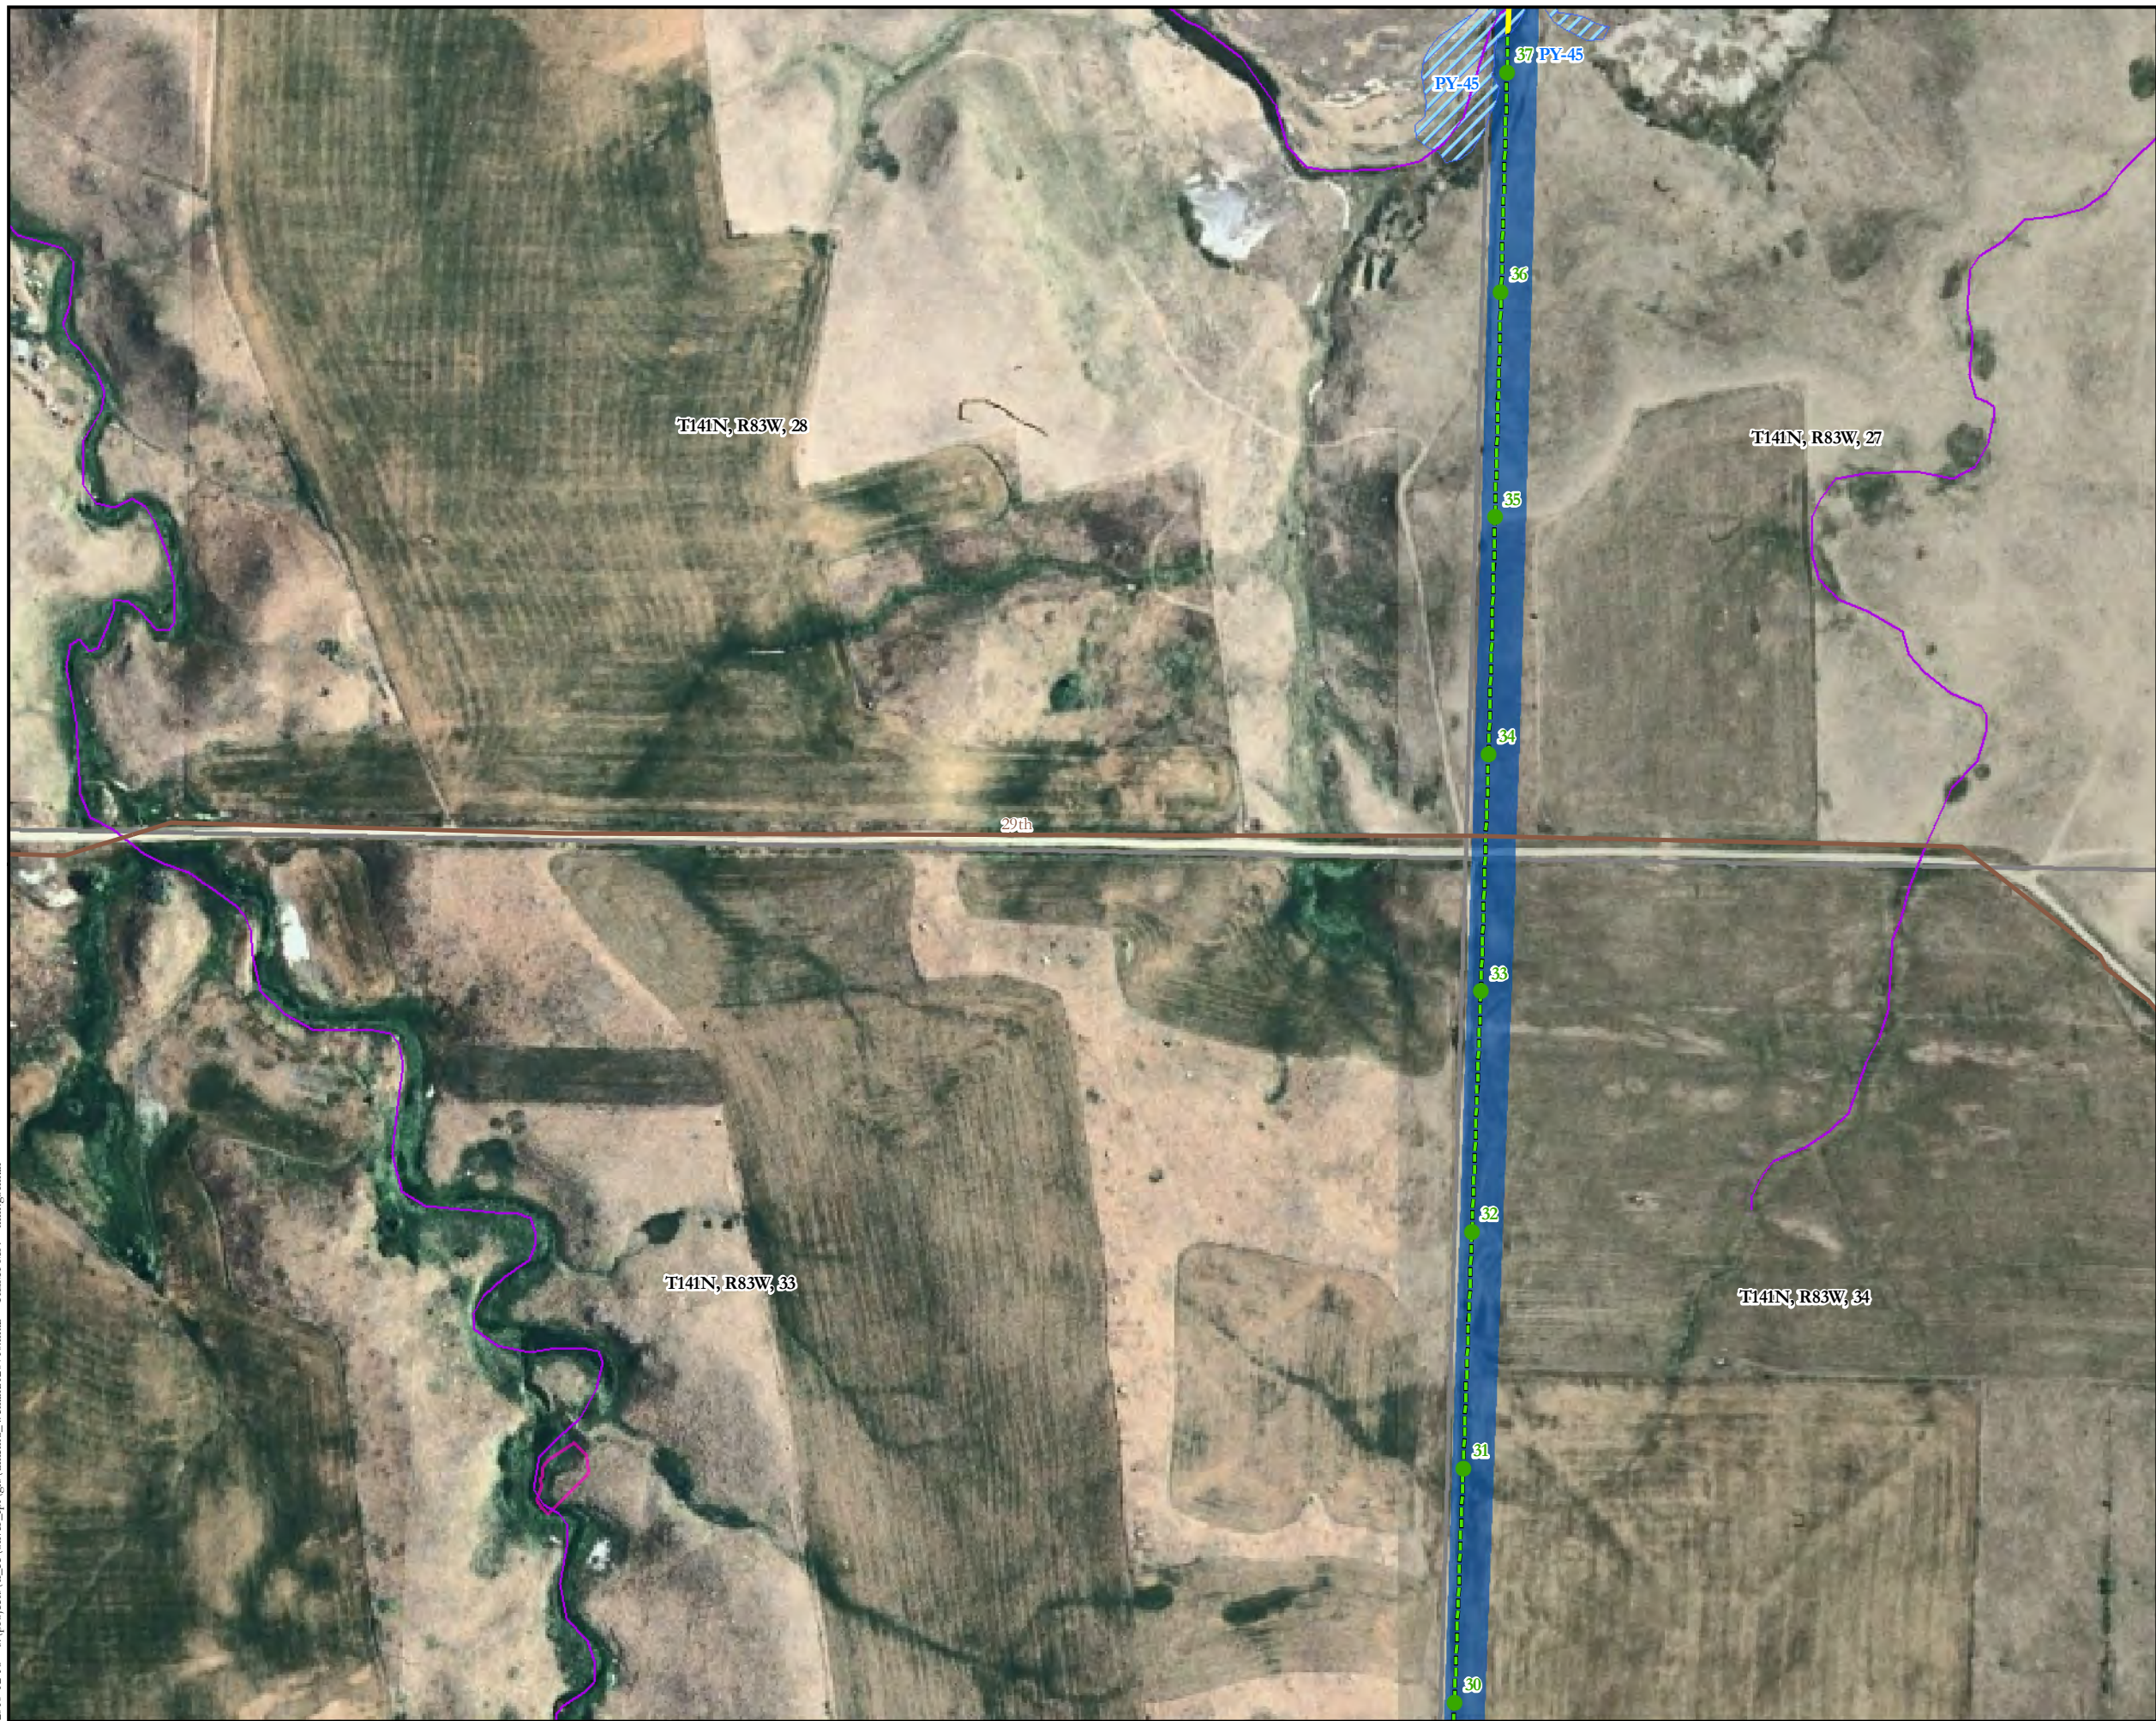
# G01

PY-45	F01 & G01	Section 27, T141N, R83W	Perennial stream, RPW	USACE	0.068	The feature is a perennial stream observed to contain flowing water. The stream was identified on an NHD line. Tetra Tech classified the stream as a RPW due to the observation of a bed and bank characteristic of an OHWM. This feature was collected downstream of feature PY-39 and along the same channel. The USACE typically asserts jurisdiction to RPWs as waters of the U.S.; therefore, Tetra Tech recommends avoidance of this area. If avoidance cannot be achieved, minimization and/or mitigation methods that reduce impacts on the aquatic resource should be implemented.
PY-32	H01	Sections 33 & 34, T141N, R83W	Drainage swale	None	0	The feature is within the survey corridor but not within the impact analysis area and no temporary impacts area anticipated. The drainage swale was not observed to have characteristics of an OHWM and likely only transports water during periods of heavy rainfall. The USACE typically does not assert jurisdiction to swales that are characterized by low volume, infrequent, and short duration of flow. It is Tetra Tech's opinion that a significant nexus does not exist and the swale is not a jurisdictional water of the U.S.

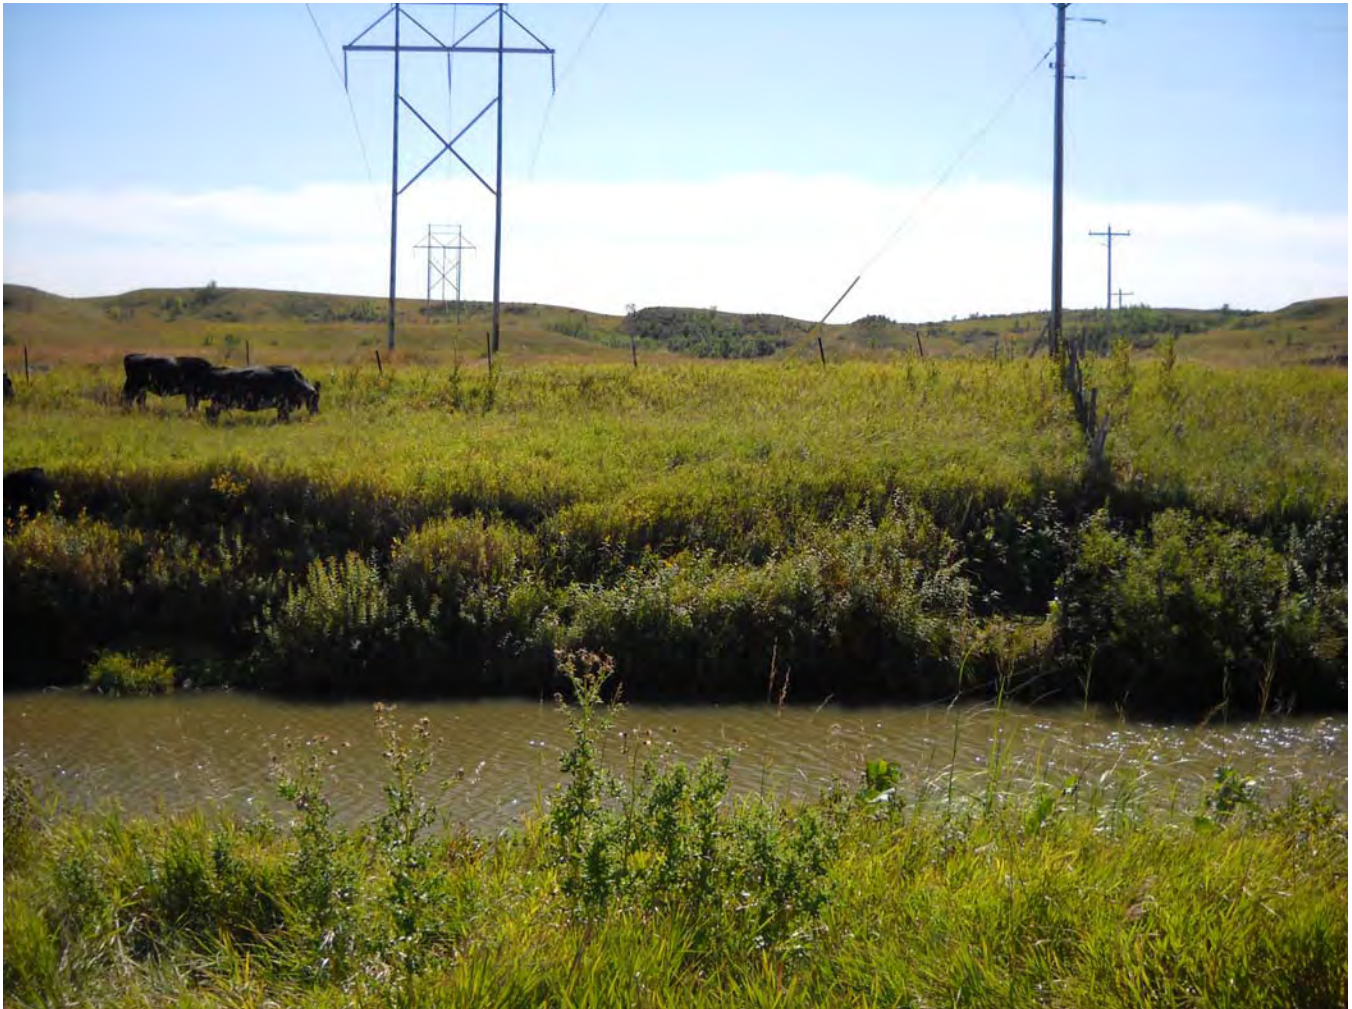
TETRA TECH PROJECT NO. 103I0979  Direction: South	Feature ID	PY-46	Date 9/10/10
	Description	Square Butte Creek is a perennial stream. Tetra tech identified this feature as a RPW. This is the most northern crossing.	
	CLIENT	NextEra Energy	
	PHOTOGRAPHER	John Kinny

Feature ID	Map Book Page	Section Location	Feature Type <sup>a</sup>	Jurisdiction <sup>b</sup>	Potential Temporary Impacts <sup>c</sup> (acres)	Recommendations and Comments <sup>a</sup>
PY-46	B01	T141N, R83W, Section 3 & 4	Perennial stream, RPW	USACE	0.122	The stream is Square Butte Creek and is a Tributary to the Missouri River. This feature was documented in four locations where the proposed transmission line intersects the creek. Square Butte Creek is a perennial stream observed to contain flowing water. The feature was identified on a NHD line and corresponds to a feature in the NWI. Tetra Tech classified the stream as a relatively permanent water (RPW) due to the observation of a bed and bank characteristic of an OHWM. The USACE typically asserts jurisdiction to RPWs as being waters of the U.S. Tetra Avoidance of this feature is recommended. If avoidance cannot be achieved, minimization and/or mitigation methods that reduce impacts on the aquatic resource should be implemented.

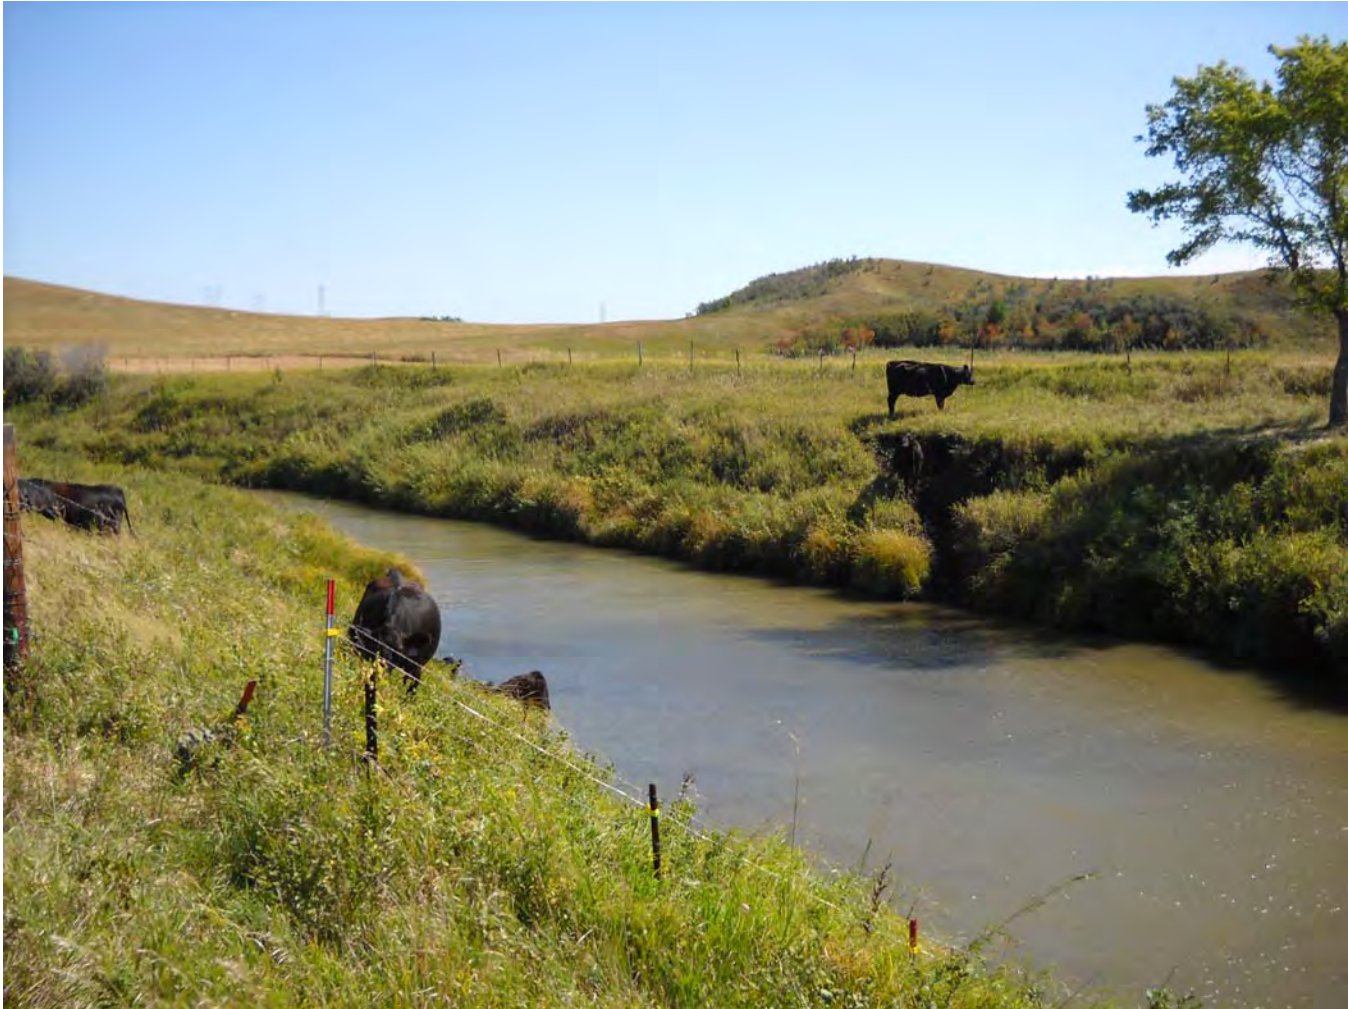
TETRA TECH PROJECT NO. 103IP10979  Direction: Southeast	Feature ID	PY-46	Date 9/10/10
	Description	Square Butte Creek is a perennial stream identified as an RPW. This location is the second and middle crossing.	
	CLIENT	NextEra Energy	
	PHOTOGRAPHER	John Kinny

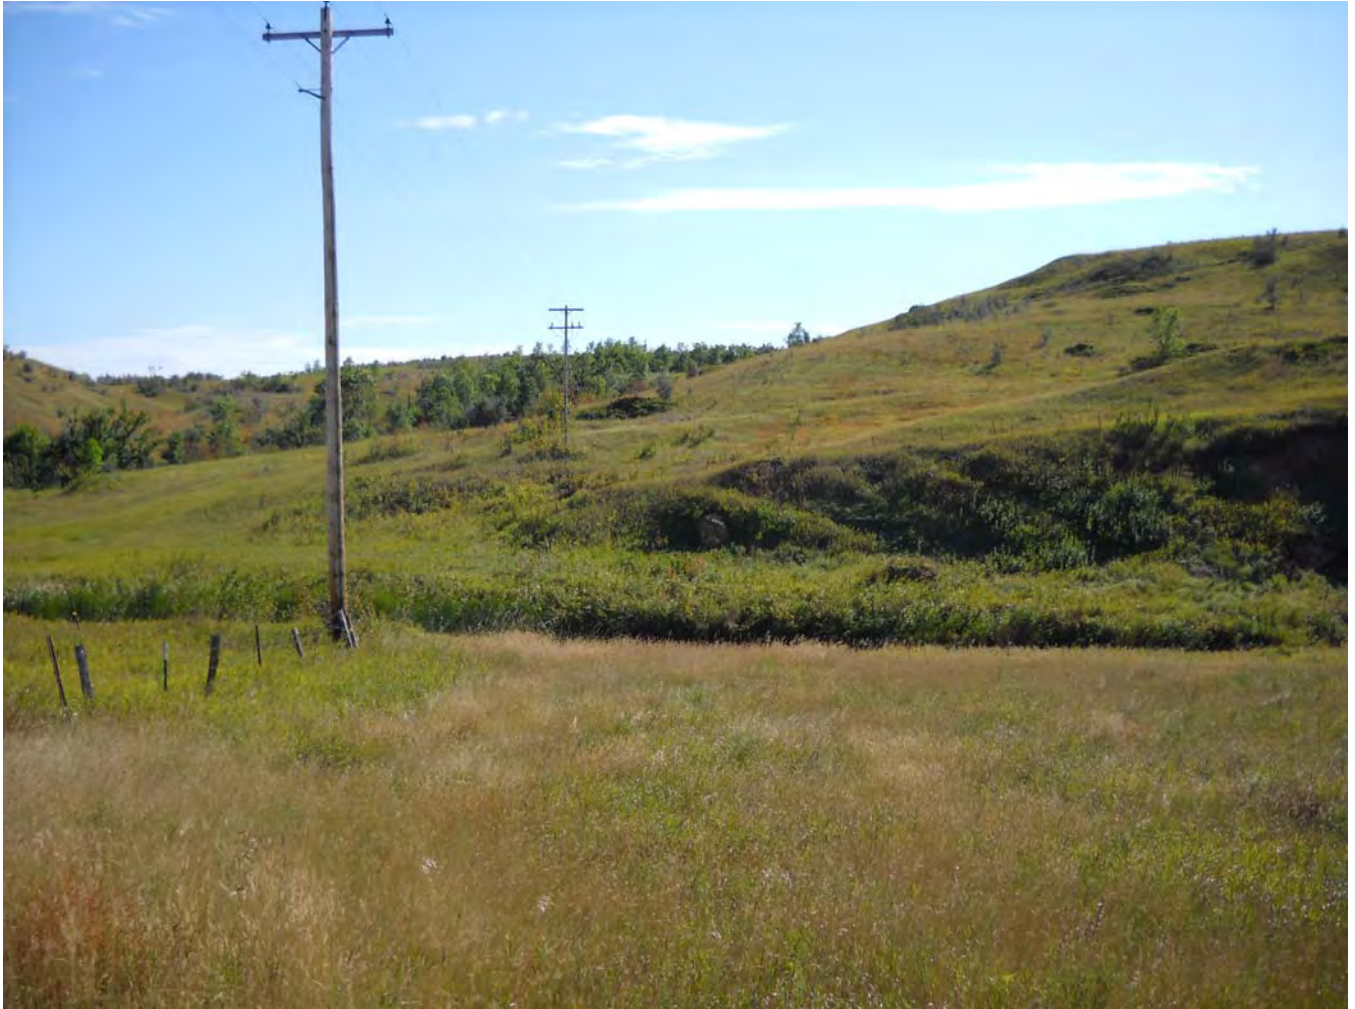
TETRA TECH PROJECT NO. 103IP10979  Direction: South	Feature ID	PY-46	Date 9/10/10
	Description	Square Butte Creek is a perennial stream identified as an RPW. This location is the first and most southern crossing.	
	CLIENT	NextEra Energy	
	PHOTOGRAPHER	John Kinny

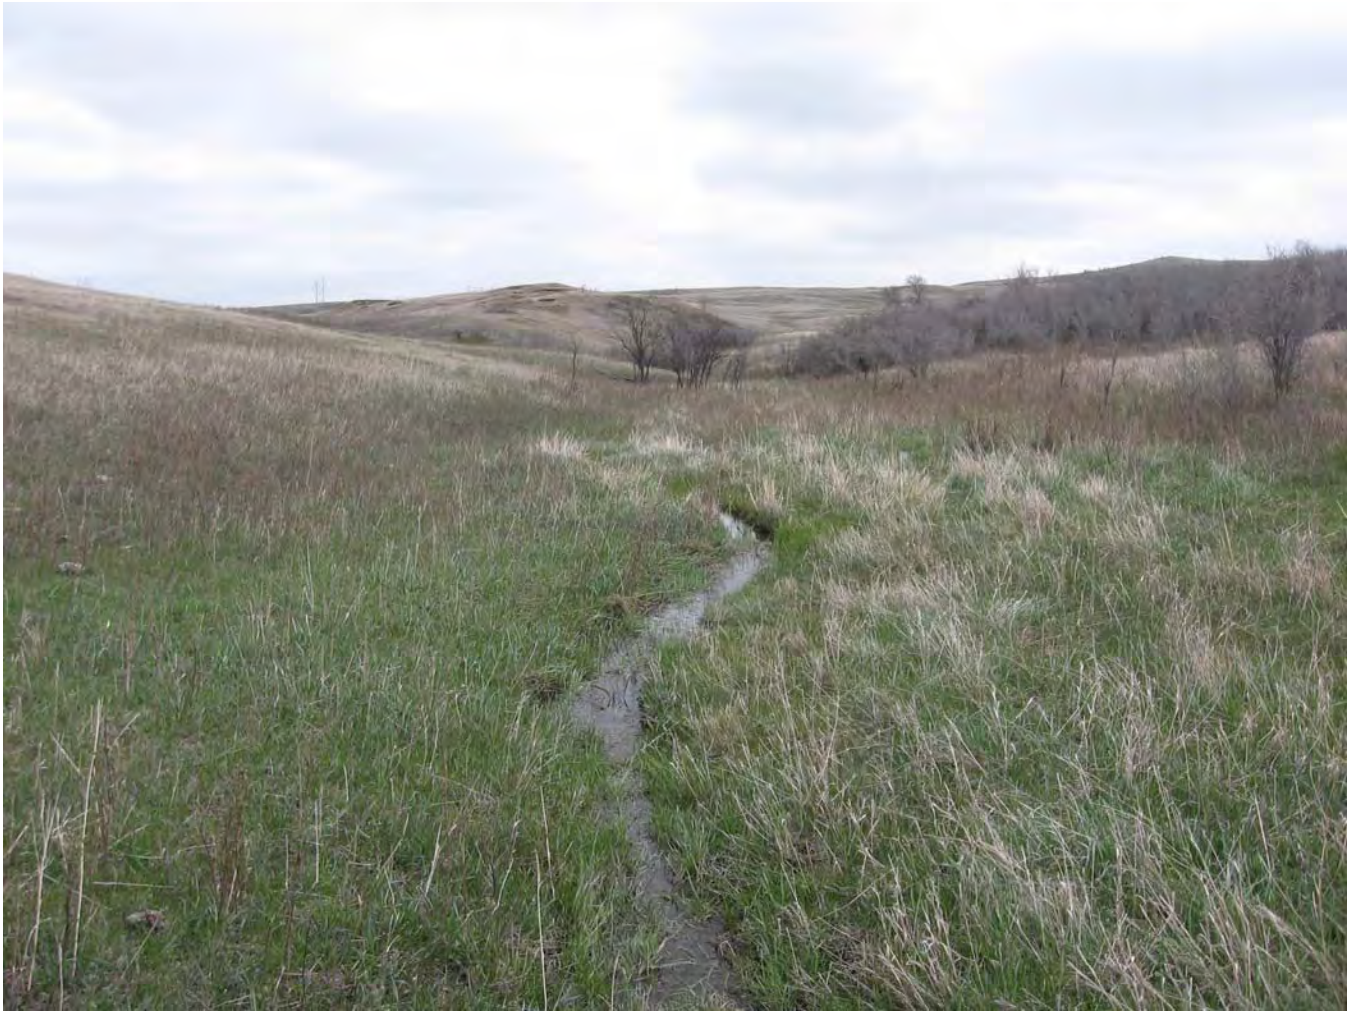
TETRA TECH PROJECT NO. 103IP10979  Direction: Southeast	Feature ID	PY-44	Date 5/5/10
	Description	The feature was identified as an intermittent stream. Tetra Tech classified the stream as and NRPW.	
	CLIENT	NextEra Energy	
	PHOTOGRAPHER	John Kinny

PY-44	C01	T141N, R83W, Section 9 & 10	Intermittent stream, NRPW	USACE	0.021	The feature is an intermittent stream identified on a NHD line. Tetra Tech classified the stream as a NRPW due to the observation of a bed and bank characteristic of an OHWM and assumed flow less than three months. It is Tetra Tech's opinion that a significant nexus exists and the stream is jurisdictional. Avoidance of this feature is recommended. If avoidance cannot be achieved, minimization and/or mitigation methods that reduce impacts on the aquatic resource should be implemented.
L-8	C01	T141N, R83W, Section 9 & 10	Drainage swale	None	0	The drainage swale was not observed to have characteristics of an OHWM and likely only transports water during periods of heavy rainfall. The USACE typically does not assert jurisdiction to swales that are characterized by low volume, infrequent, and short duration of flow. The feature was observed to contain upland vegetation typical of non-wetland areas. It is Tetra Tech's opinion that a significant nexus does not exist and the swale is not a jurisdictional water of the U.S. If avoidance cannot be achieved, minimization and/or mitigation methods that reduce impacts on the aquatic resource should be implemented.

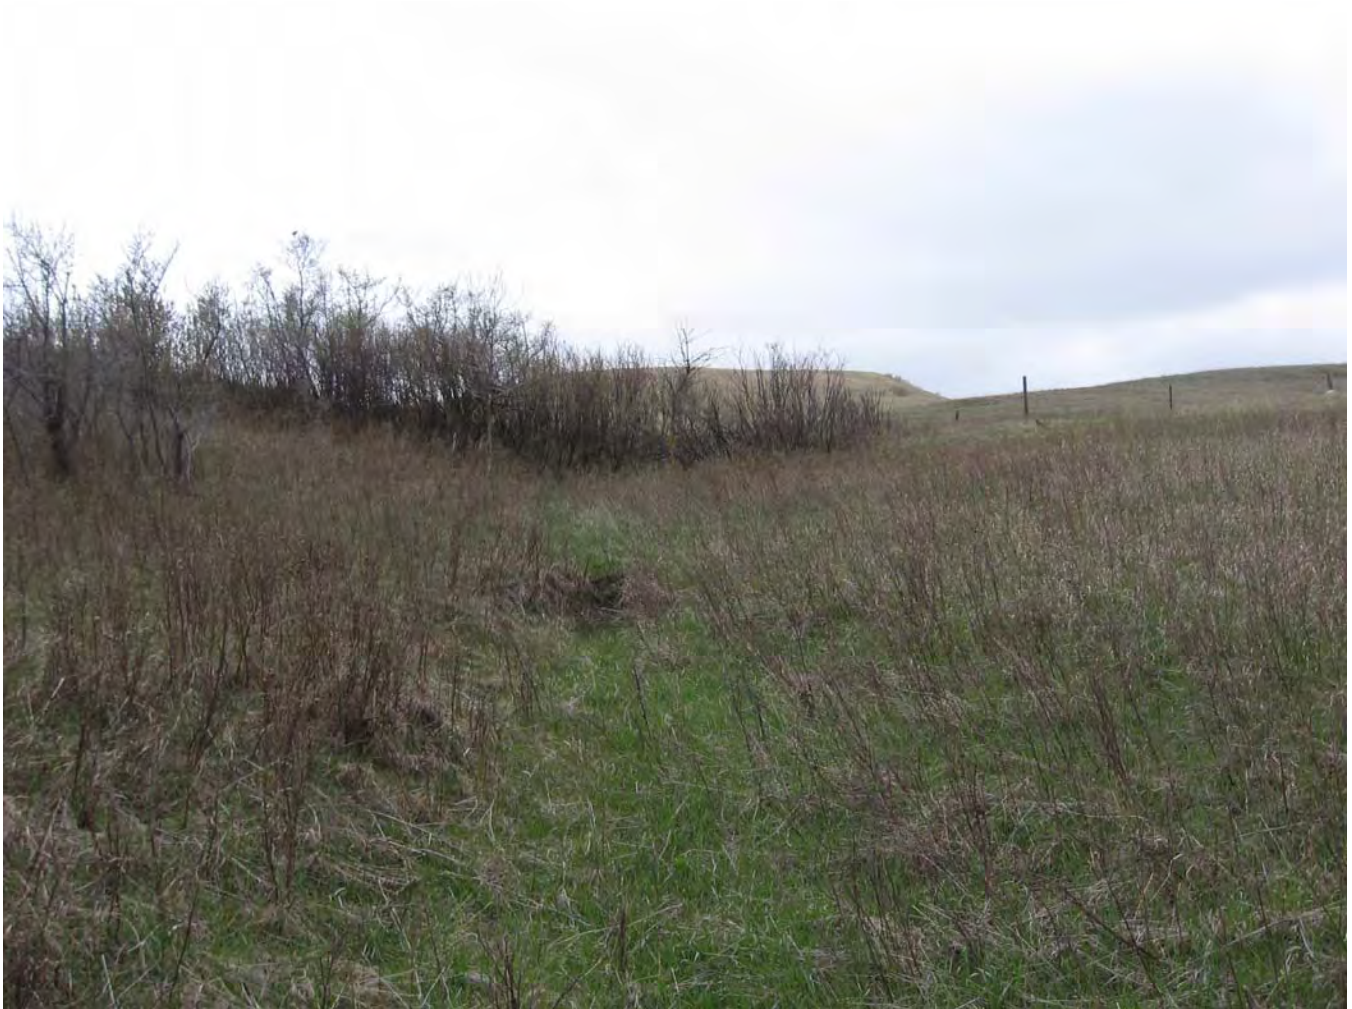
TETRA TECH PROJECT NO. 103IP10979  Direction: West	Feature ID	L-8	Date 5/5/10
	Description	The feature was identified as a drainage swale with no significant nexus.	
	CLIENT	NextEra Energy	
	PHOTOGRAPHER	John Kinny

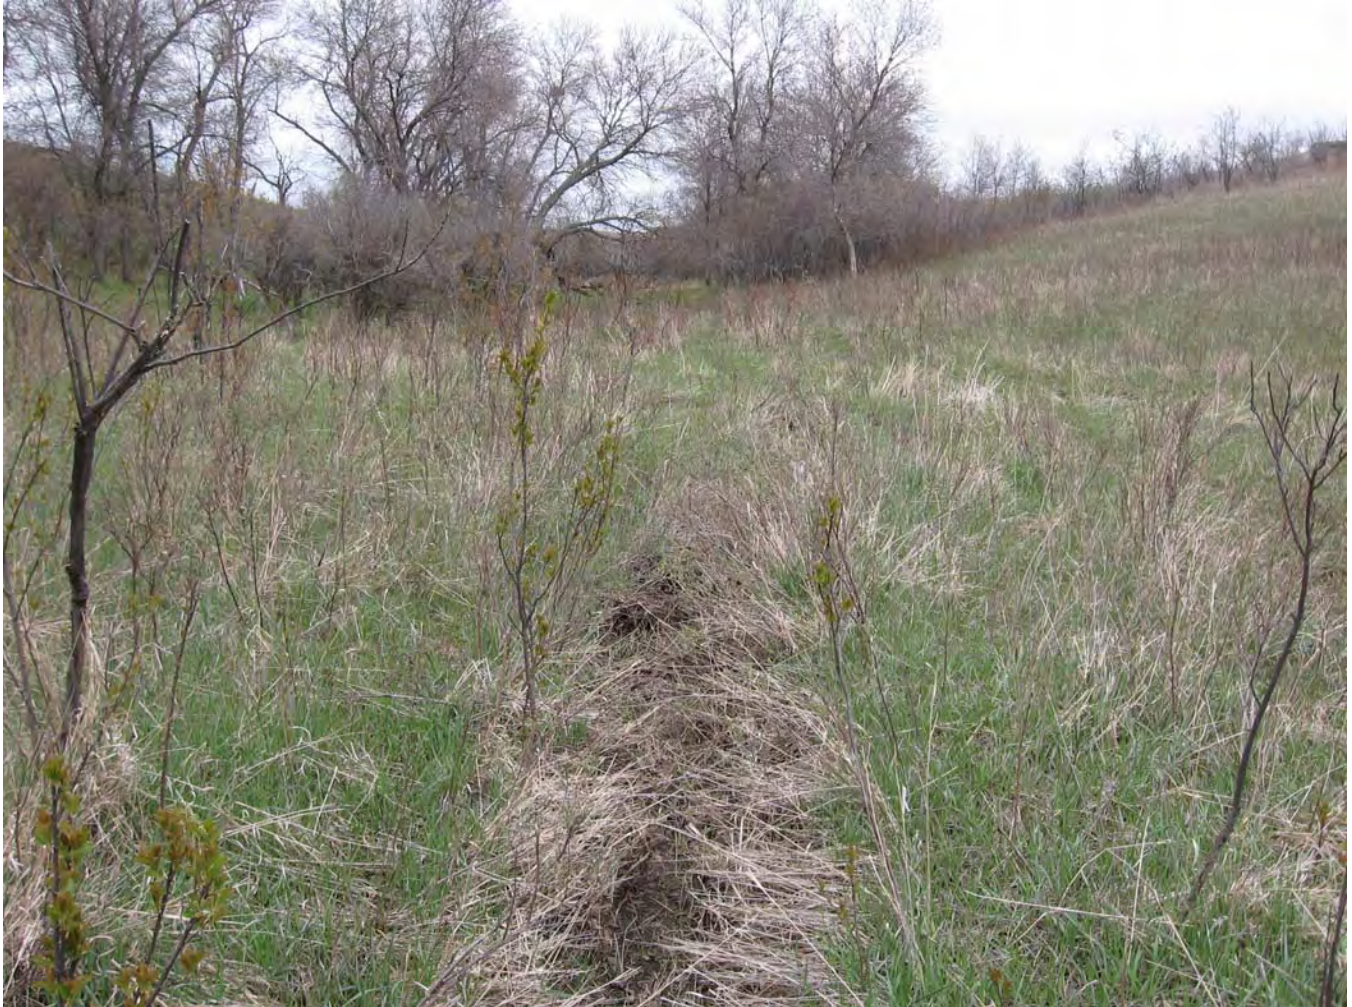
TETRA TECH PROJECT NO. 103IP10979  Direction: Southwest	Feature ID	L-7	Date 5/5/10
	Description	The feature was identified as an intermittent stream. Tetra Tech classified the stream as a NRPW.	
	CLIENT	NextEra Energy	
	PHOTOGRAPHER	John Kinny

L-7	C01	Section 10, T141N, R83W	Intermittent stream, NRPW	USACE	0.001	The feature is an intermittent stream and was identified on a NHD line. Tetra Tech classified the stream as a NRPW due to the observation of a bed and bank characteristic of an OHWM and assumed flow less than three months. The narrow stream channel was observed to be located in a much larger ravine with steep banks containing upland vegetation. It is Tetra Tech's opinion that a significant nexus exists and the stream is a jurisdictional water of the U.S.; therefore, avoidance of the feature is recommended. If avoidance cannot be achieved, minimization and/or mitigation methods that reduce impacts on the aquatic resource should be implemented.

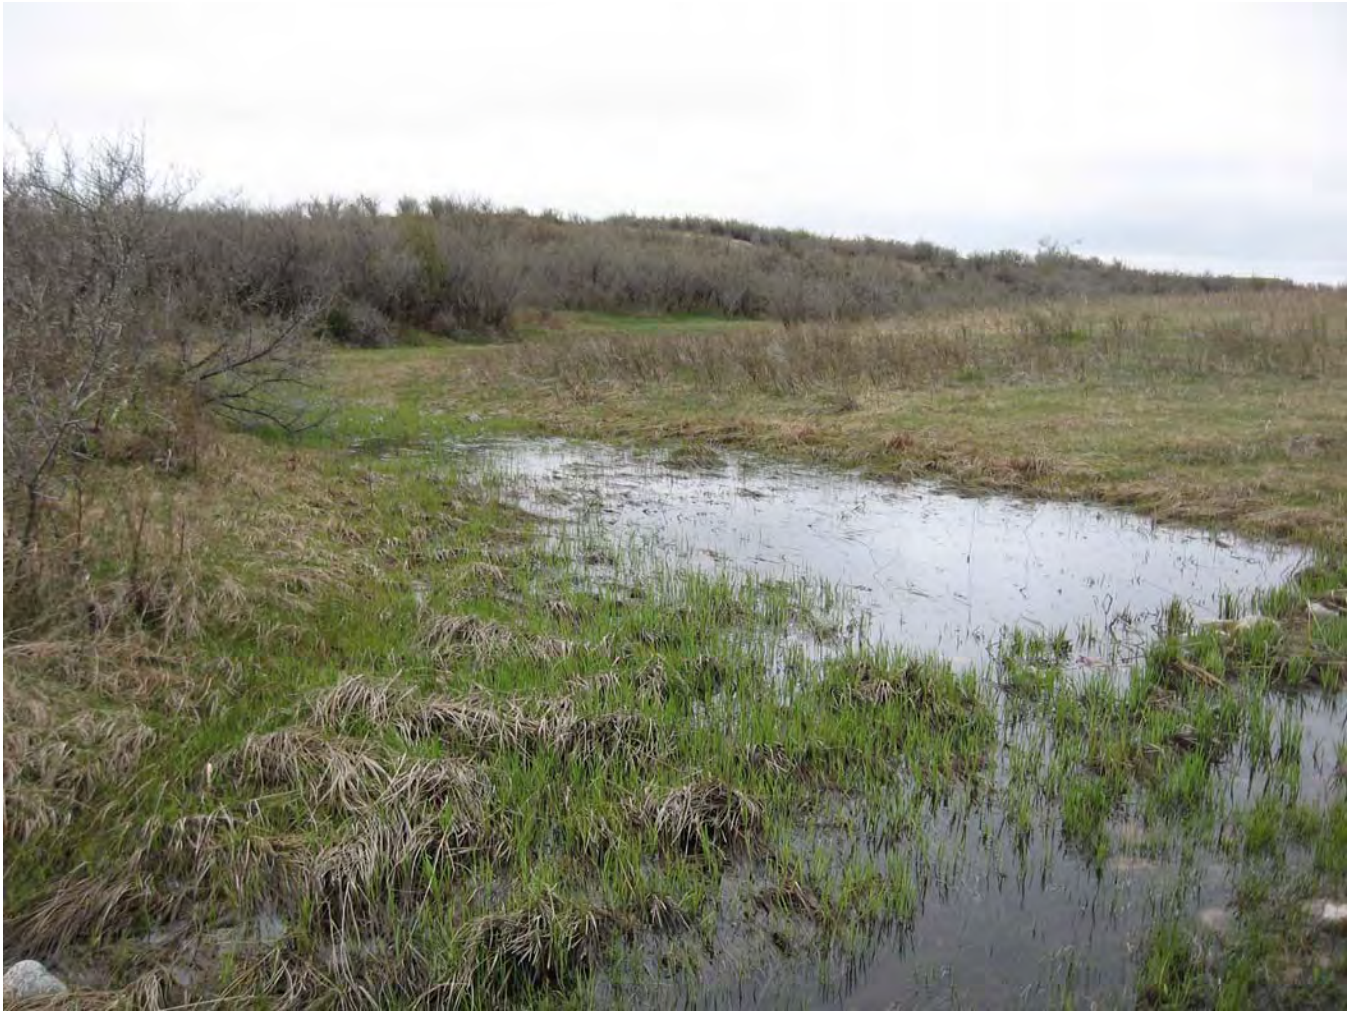
TETRA TECH PROJECT NO. 103IP10979  Direction: West	Feature ID	PY-43	Date 5/5/10
	Description	The feature was identified as an intermittent stream. Tetra Tech classified the stream as a NRPW.	
	CLIENT	NextEra Energy	
	PHOTOGRAPHER	John Kinny

Feature ID	Map Book Page	Section Location	Feature Type <sup>a</sup>	Jurisdiction <sup>b</sup>	Potential Temporary Impacts <sup>c</sup> (acres)	Recommendations and Comments <sup>a</sup>
PY-43	D01	Sections 15 & 16, T141N, R83W	Intermittent stream, NRPW	USACE	0.015	The feature is an intermittent stream identified on a NHD line. Tetra Tech classified the stream as a NRPW due to the observation of a bed and bank characteristic of an OHWM and assumed flow of less than three months. It is Tetra Tech's opinion that a significant nexus exists and the stream is jurisdictional. Avoidance of this feature is recommended. If avoidance cannot be achieved, minimization and/or mitigation methods that reduce impacts on the aquatic resource should be implemented.
PY-42	D01	Sections 15 & 16, T141N, R83W	Intermittent stream, NRPW	USACE	0.039	The feature is an intermittent stream identified on a NHD line. Tetra Tech classified the stream as a NRPW due to the observation of a bed and bank characteristic of an OHWM and assumed flow less than three months. It is Tetra Tech's opinion that a significant nexus exists and the stream is jurisdictional and, therefore, should be avoided. If avoidance cannot be achieved, minimization and/or mitigation methods that reduce impacts on the aquatic resource should be implemented.

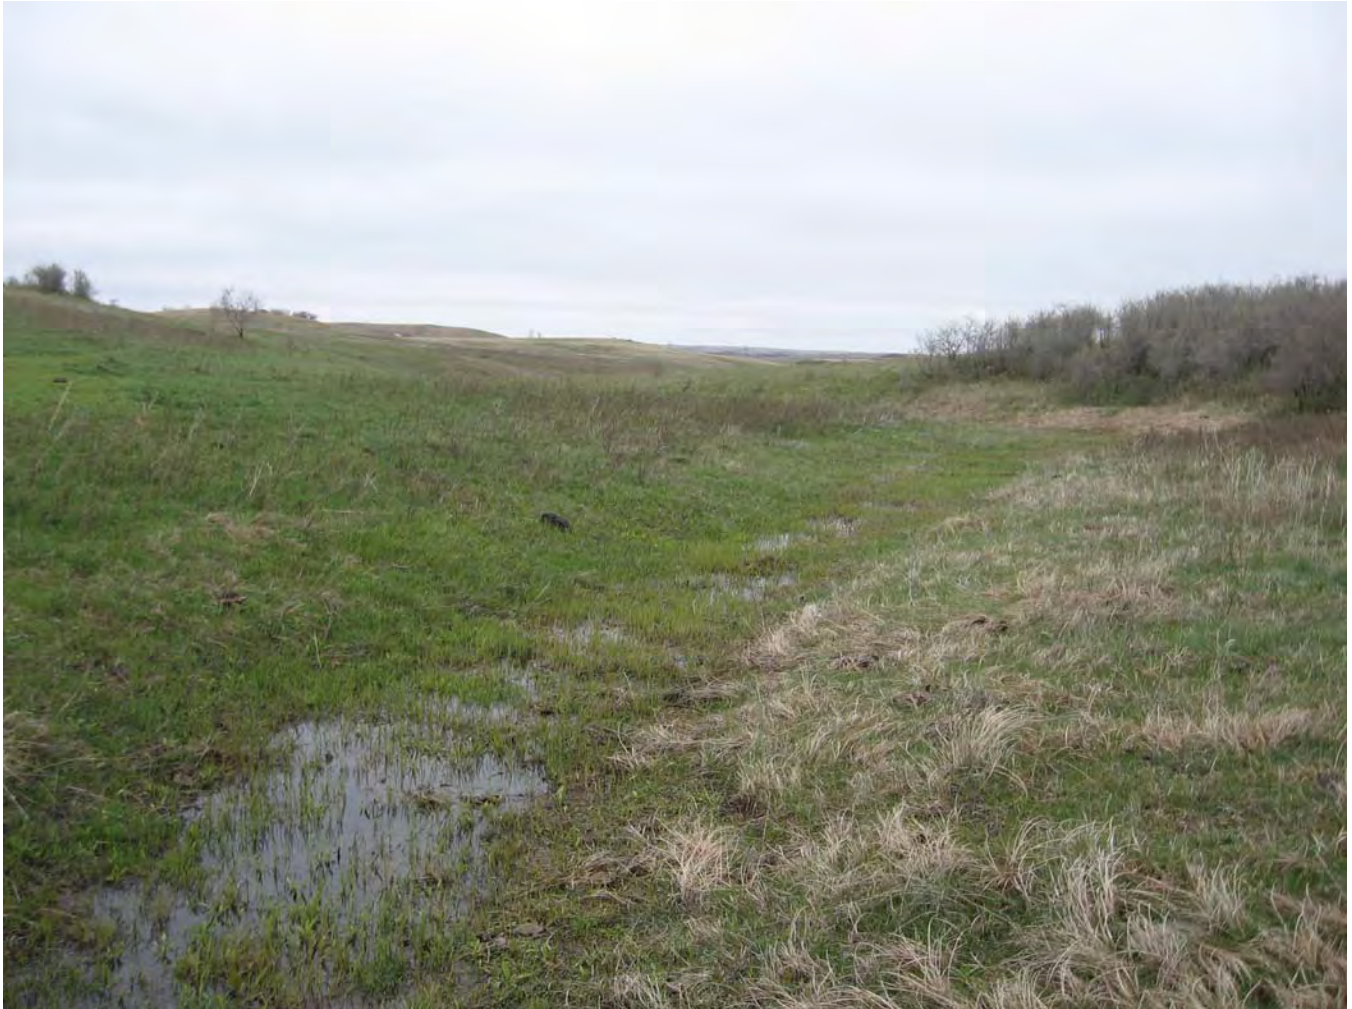
TETRA TECH PROJECT NO. 103IP10979  Direction: Northeast	Feature ID	PY-42	Date 5/5/10
	Description	The feature was identified as an intermittent stream. Tetra Tech classified the stream as a NRPW. A portion of this feature was observed to be an excavated farm pond.	
	CLIENT	NextEra Energy	
	PHOTOGRAPHER	John Kinny

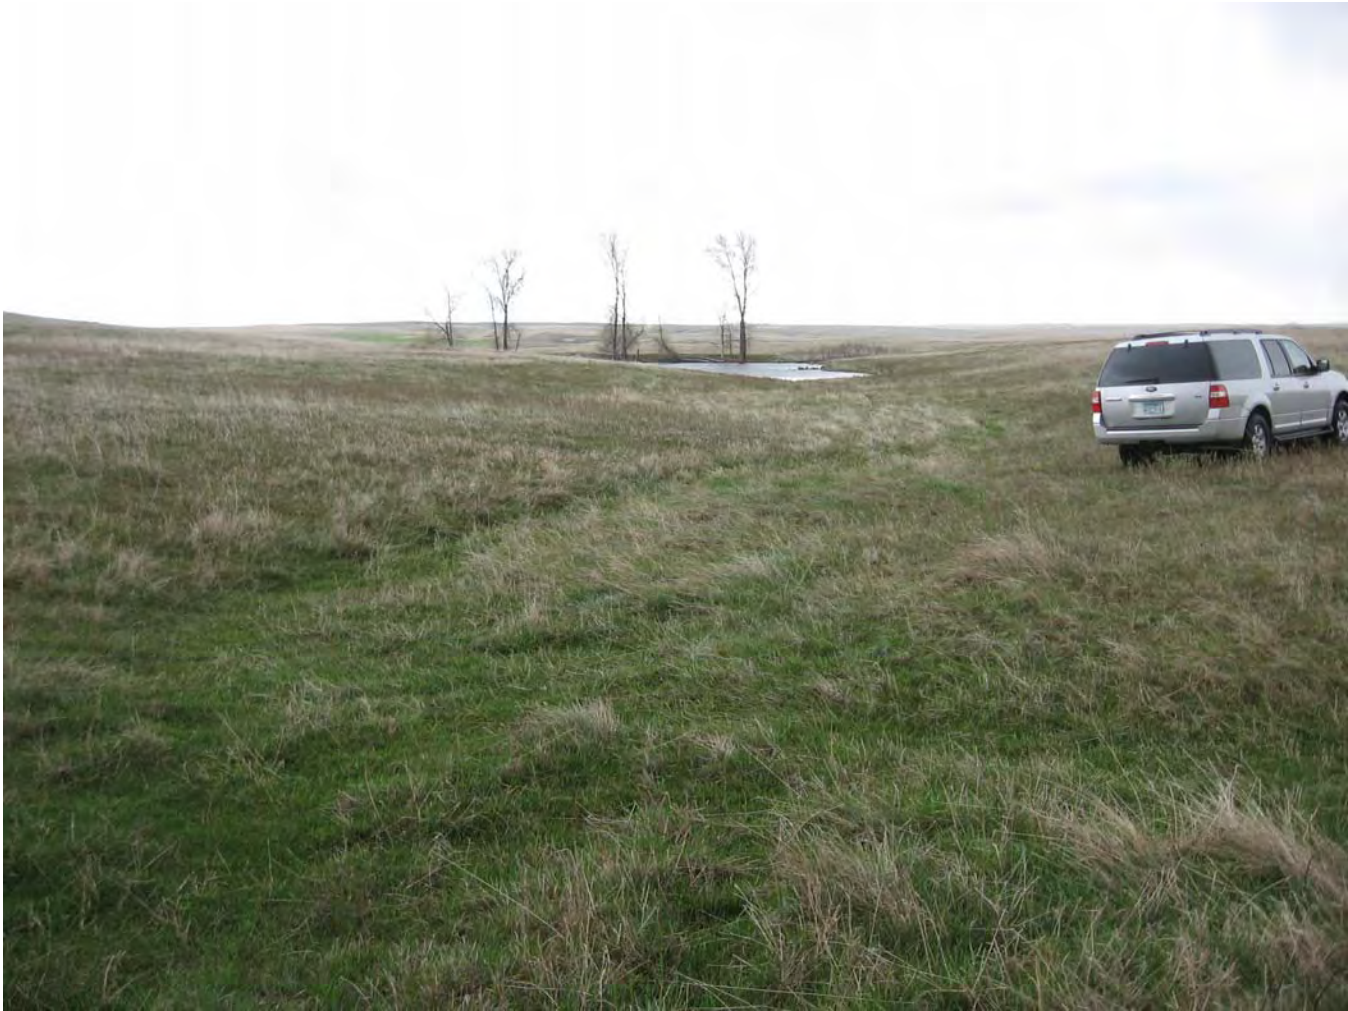
TETRA TECH PROJECT NO. 103IP10979  Direction: East	Feature ID	L-6	Date 5/4/10
	Description	The feature was identified as a drainage swale with no significant nexus. An excavated farm pond can be seen in the back ground.	
	CLIENT	NextEra Energy	
	PHOTOGRAPHER	John Kinny
