**WETLAND DELINEATION REPORT  
OLIVER III TRANSMISSION LINE**

**MORTON & OLIVER COUNTIES  
NORTH DAKOTA**

**December 17, 2010**

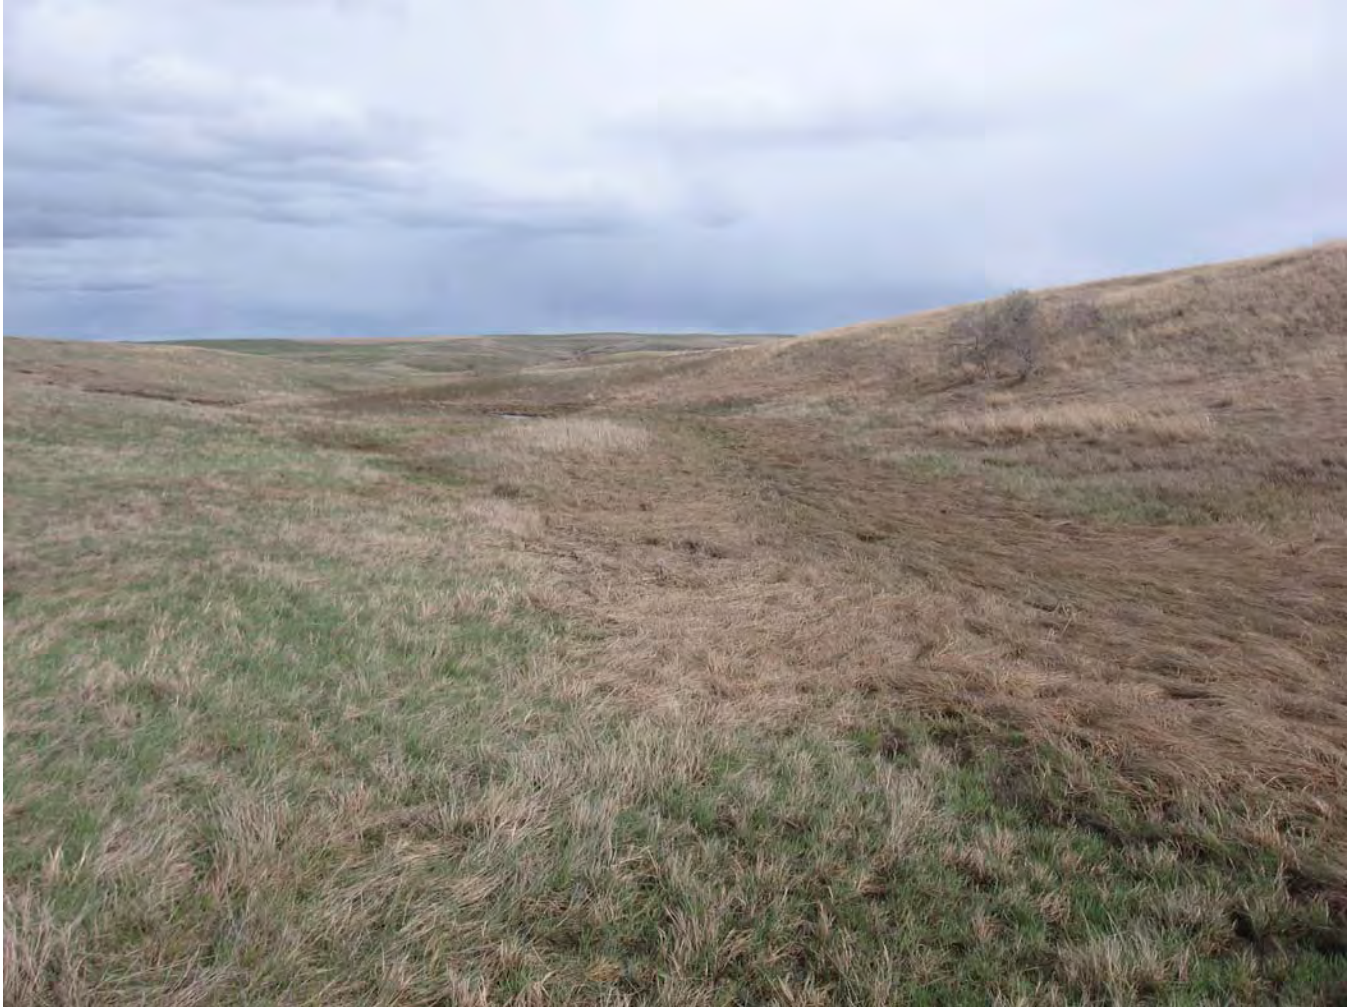
TETRA TECH PROJECT NO. 103IP10979  Direction: Southeast	Feature ID	PY-41	Date 5/4/10
	Description	The feature was identified as an intermittent stream. Tetra Tech classified the stream as a NRPW.	
	CLIENT	NextEra Energy	
	PHOTOGRAPHER	John Kinny

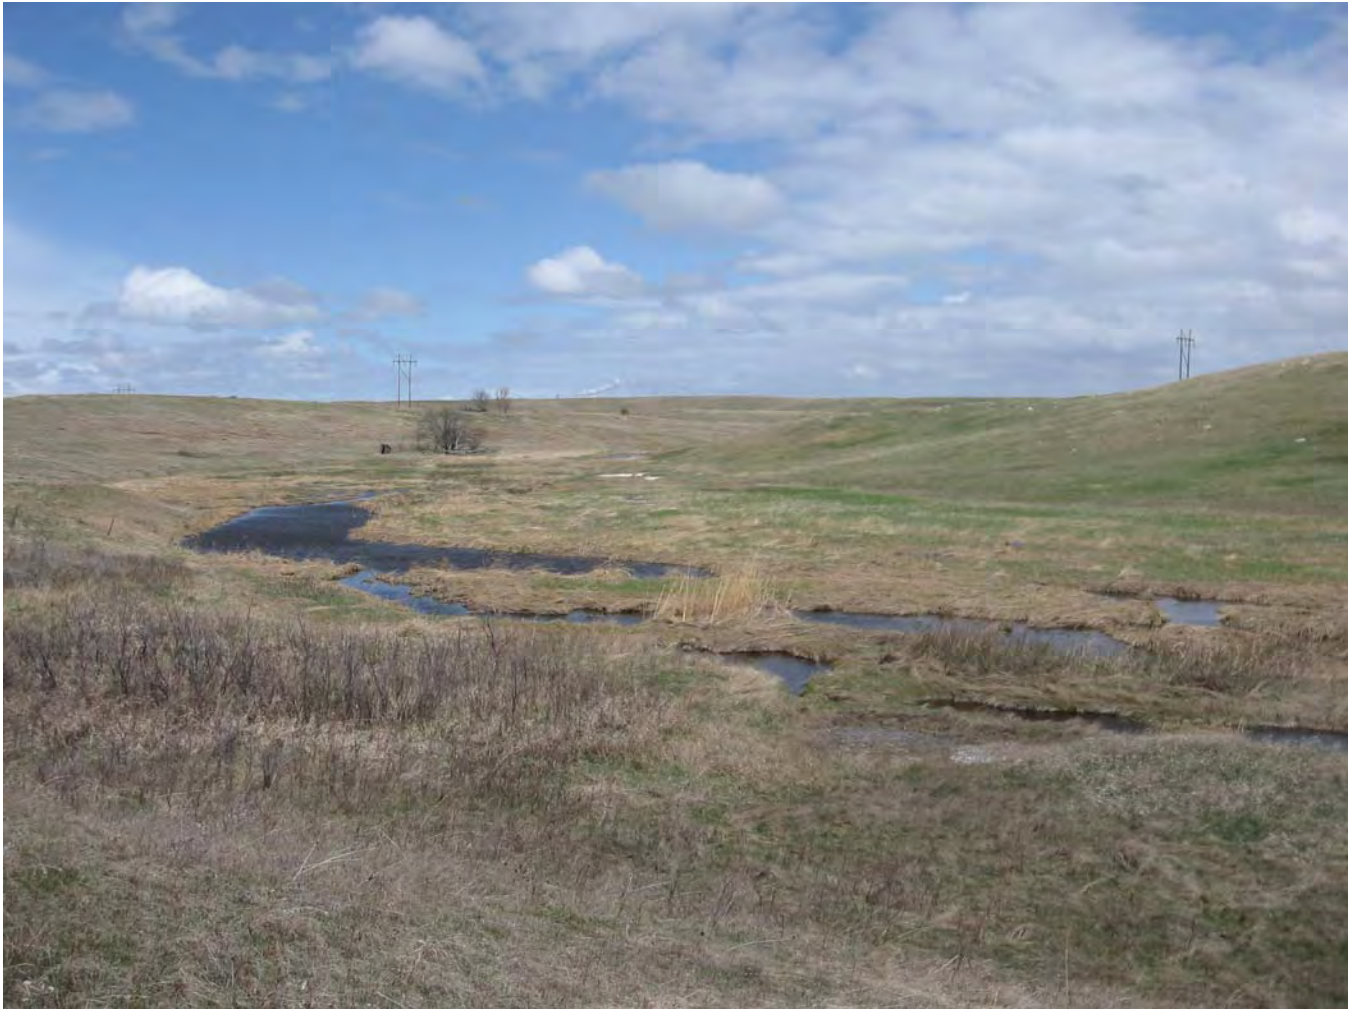
<b>TETRA TECH PROJECT NO. 103IP10979</b>  Direction: North	Feature ID	PY-39 & PY-40	Date 5/4/10
	Description	The feature was identified as perennial stream. Tetra Tech classified the stream as a RPW.	
	CLIENT	NextEra Energy	
	PHOTOGRAPHER	John Kinny

PY-40	F01	Sections 21, 22, 27, & 28, T141N, R83W	Perennial stream, RPW	USACE	0.073	The feature is a perennial stream observed to contain flowing water. The feature was identified on a NHD line and corresponds to a feature in the NWI. Tetra Tech classified the stream as a RPW due to the observation of a bed and bank characteristic of an OHWM. The stream is a tributary to feature PY-39. The USACE typically asserts jurisdiction to RPWs as being waters of the U.S. and Tetra Tech recommends avoidance of this area. If avoidance cannot be achieved, minimization and/or mitigation methods that reduce impacts on the aquatic resource should be implemented.

Feature ID	Map Book Page	Section Location	Feature Type <sup>a</sup>	Jurisdiction <sup>b</sup>	Potential Temporary Impacts <sup>c</sup> (acres)	Recommendations and Comments <sup>a</sup>
PY-39	F01	Section 27 & 28, T141N, R83W	Perennial stream, RPW	USACE	0.301	The feature is a perennial stream observed to contain flowing water. The feature was identified on a NHD line and corresponds to a feature in the NWI. Tetra Tech classified the stream as a RPW due to the observation of a bed and bank characteristic of an OHWM. The stream was observed to contain flowing water. This feature was collected upstream of feature PY-45 along the same channel. The USACE typically asserts jurisdiction to RPWs as being waters of the U.S. and Tetra Tech recommends avoidance of this area. If avoidance cannot be achieved, minimization and/or mitigation methods that reduce impacts on the aquatic resource should be implemented.

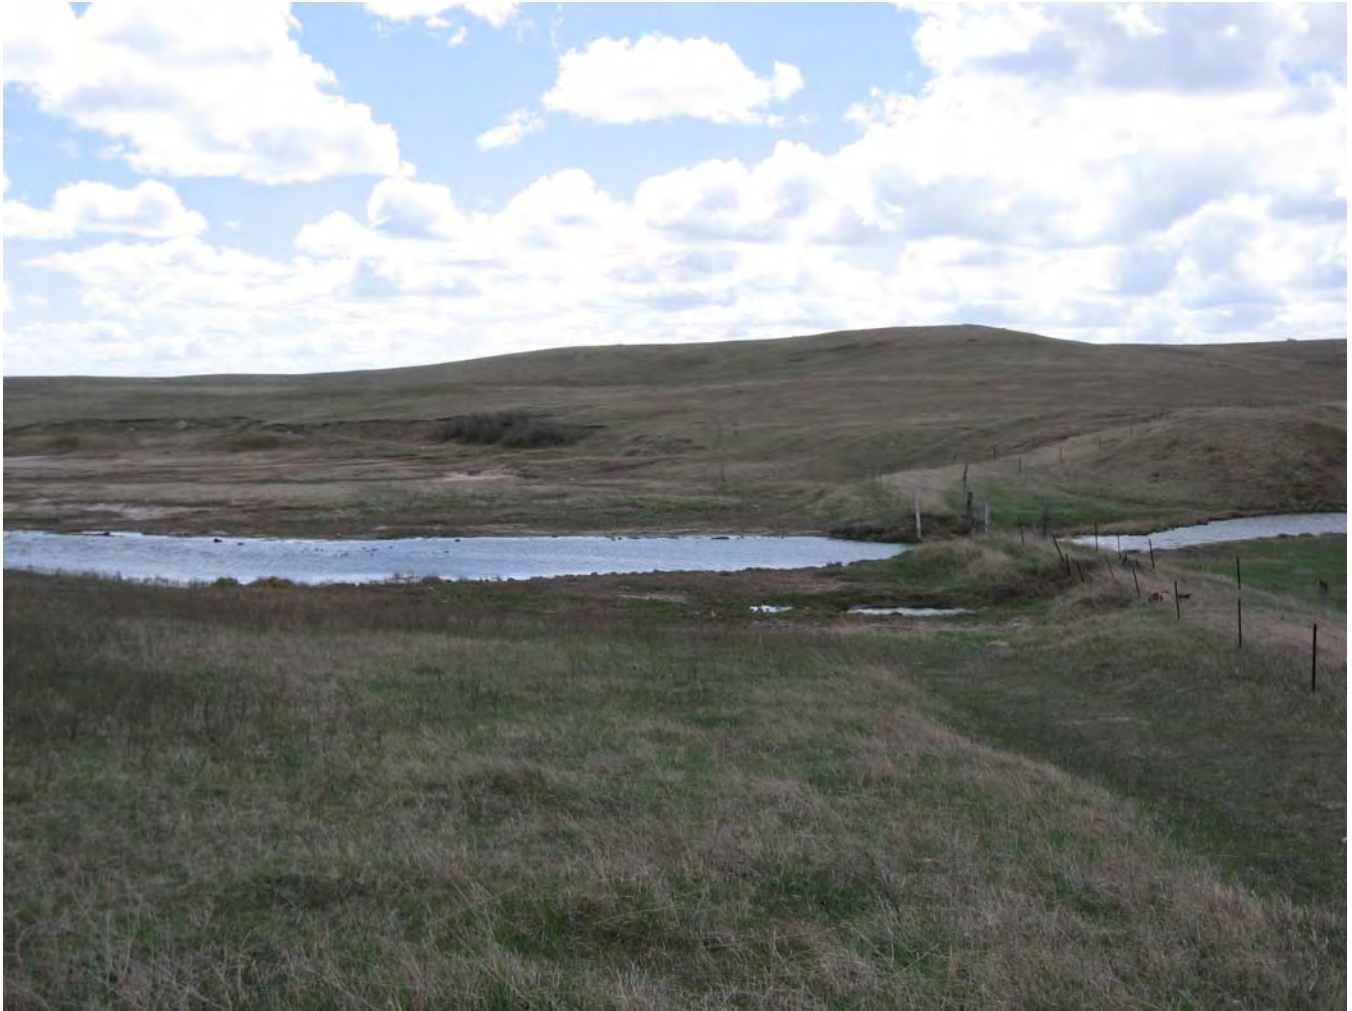
TETRA TECH PROJECT NO. 103IP10979  Direction: South	Feature ID	PY-45	Date 5/4/10
	Description	The feature was identified as perennial stream. Tetra Tech classified the stream as a RPW. The feature connects to PY-39 upstream and to the north.	
	CLIENT	NextEra Energy	
	PHOTOGRAPHER	John Kinny

PY-45	F01 & G01	Section 27, T141N, R83W	Perennial stream, RPW	USACE	0.068	The feature is a perennial stream observed to contain flowing water. The stream was identified on an NHD line. Tetra Tech classified the stream as a RPW due to the observation of a bed and bank characteristic of an OHWM. This feature was collected downstream of feature PY-39 and along the same channel. The USACE typically asserts jurisdiction to RPWs as waters of the U.S.; therefore, Tetra Tech recommends avoidance of this area. If avoidance cannot be achieved, minimization and/or mitigation methods that reduce impacts on the aquatic resource should be implemented.
PY-32	H01	Sections 33 & 34, T141N, R83W	Drainage swale	None	0	The feature is within the survey corridor but not within the impact analysis area and no temporary impacts area anticipated. The drainage swale was not observed to have characteristics of an OHWM and likely only transports water during periods of heavy rainfall. The USACE typically does not assert jurisdiction to swales that are characterized by low volume, infrequent, and short duration of flow. It is Tetra Tech's opinion that a significant nexus does not exist and the swale is not a jurisdictional water of the U.S.

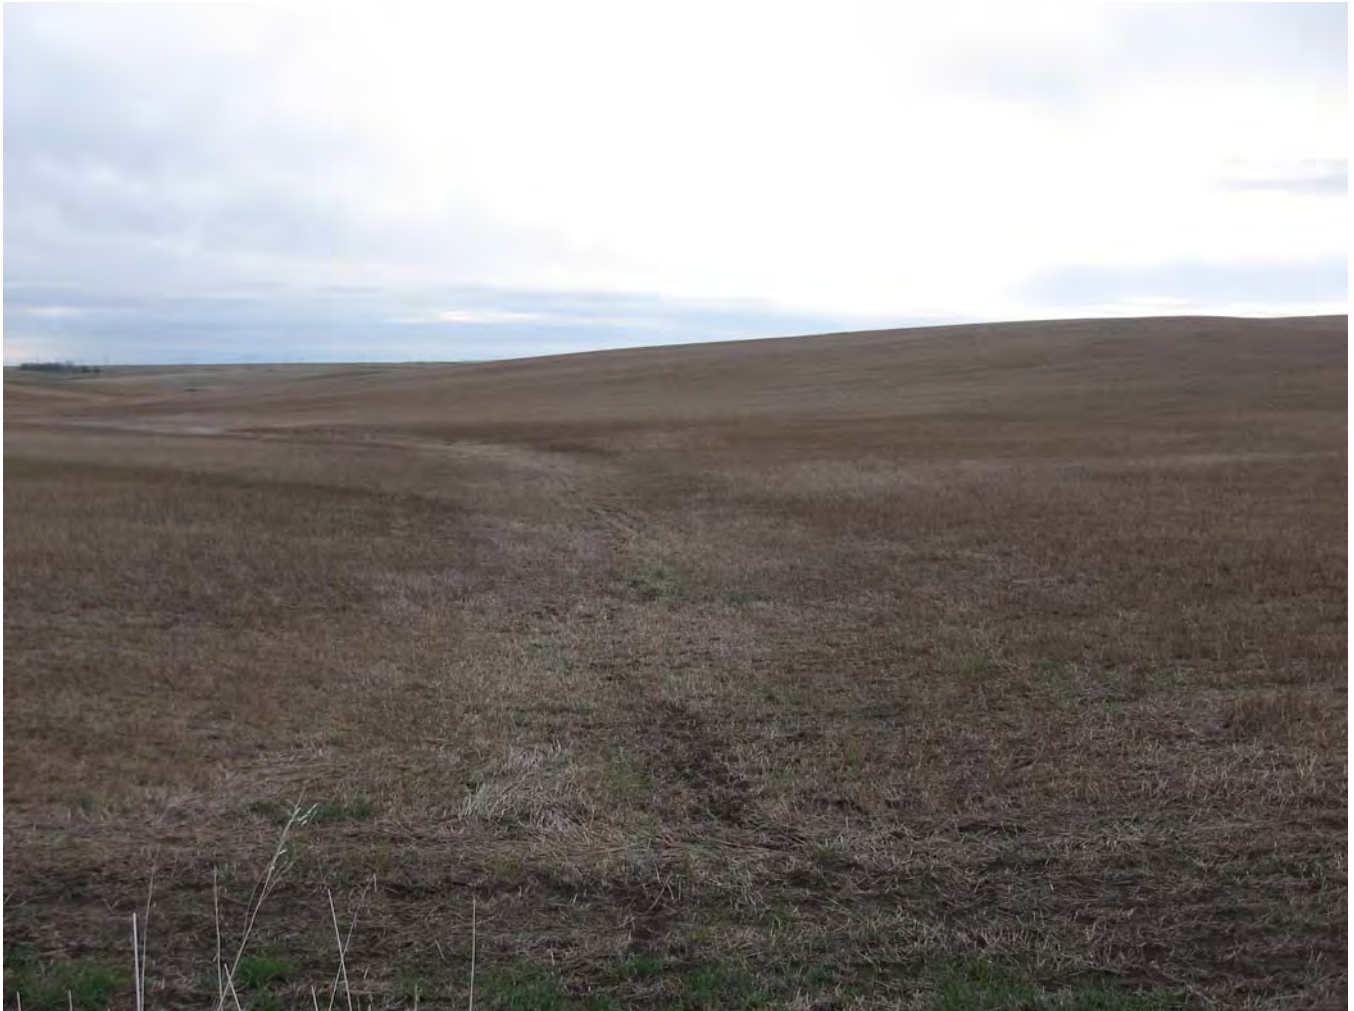
TETRA TECH PROJECT NO. 103IP10979  Direction: East	Feature ID	PY-32 & L-5	Date 5/4/10
	Description	The feature was identified as a drainage swale with no significant nexus.	
	CLIENT	NextEra Energy	
	PHOTOGRAPHER	John Kinny

L-5	H01	Section 34, T141N, R83W	Drainage swale	None	0	The drainage swale was not observed to have characteristics of an OHWM and likely only transports water during periods of heavy rainfall. The USACE typically does not assert jurisdiction to swales that are characterized by low volume, infrequent, and short duration of flow. It is Tetra Tech's opinion that a significant nexus does not exist and the swale is not a jurisdictional water of the U.S.
PY-33	H01	Section 5, T140N, R83W, Section 34, T141N, R83	Perennial stream, RPW	USACE	0	An adjacent road exists and no temporary impacts are anticipated. The feature is a perennial stream observed to contain flowing water. The feature was identified on a NHD line. Tetra Tech classified the stream as a RPW due to the observation of a bed and bank characteristic of an OHWM. The USACE typically asserts jurisdiction to RPWs as being waters of the U.S. and Tetra Tech recommends avoidance of this area. If avoidance cannot be achieved, minimization and/or mitigation methods that reduce impacts on the aquatic resource should be implemented.

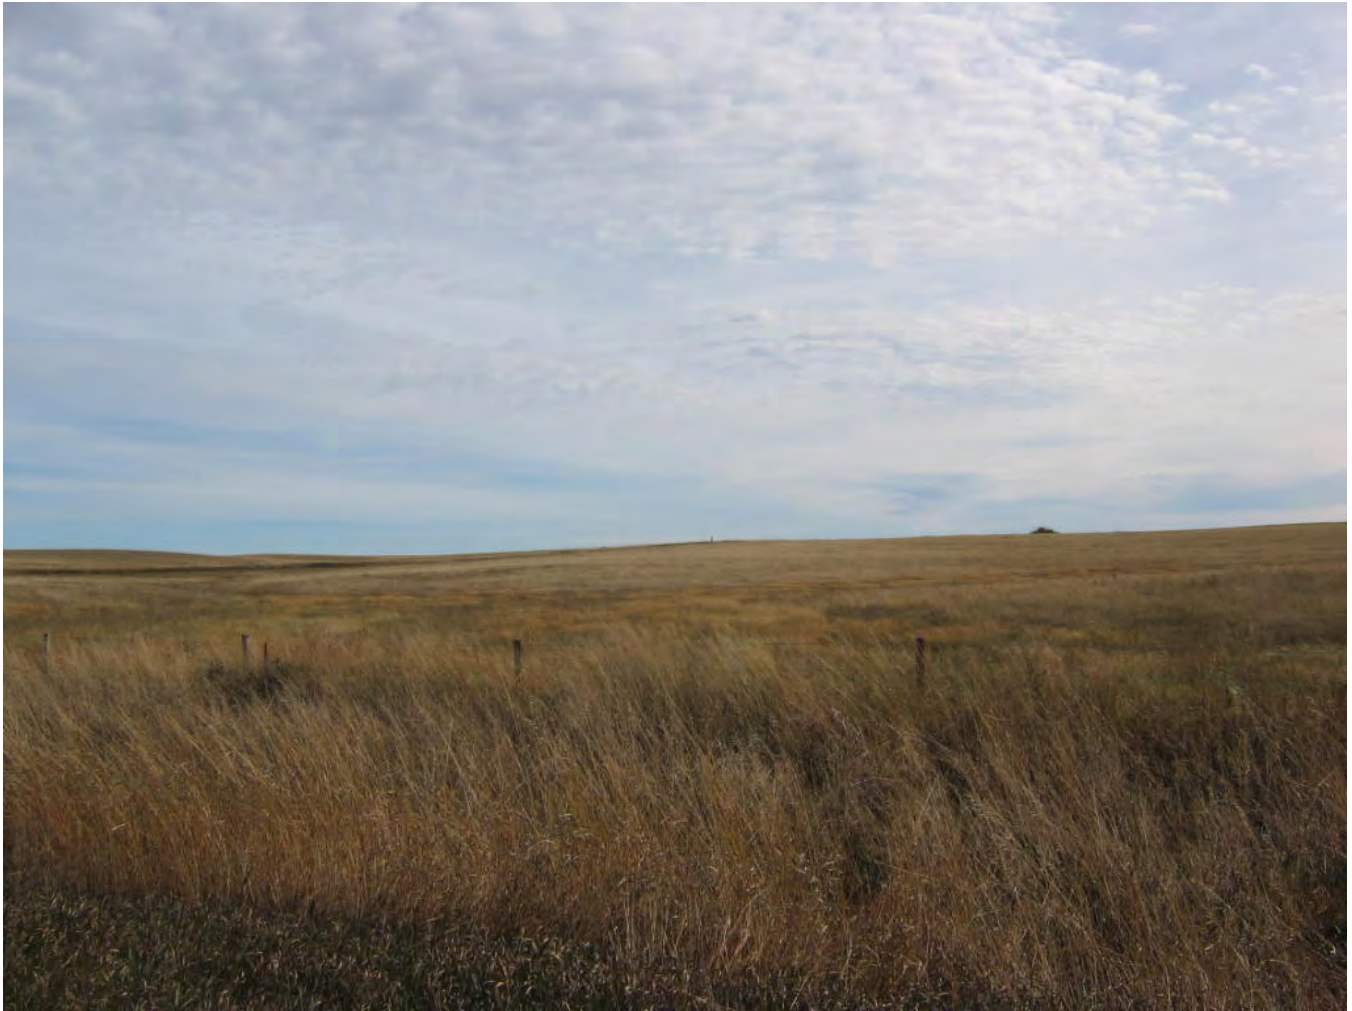
TETRA TECH PROJECT NO. 103IP10979  Direction: East	Feature ID	PY-33	Date 10/17/09
	Description	The feature was identified as an intermittent stream. Tetra Tech classified the stream as a NRPW.	
	CLIENT	NextEra Energy	
	PHOTOGRAPHER	Kali Pace-Graczyk

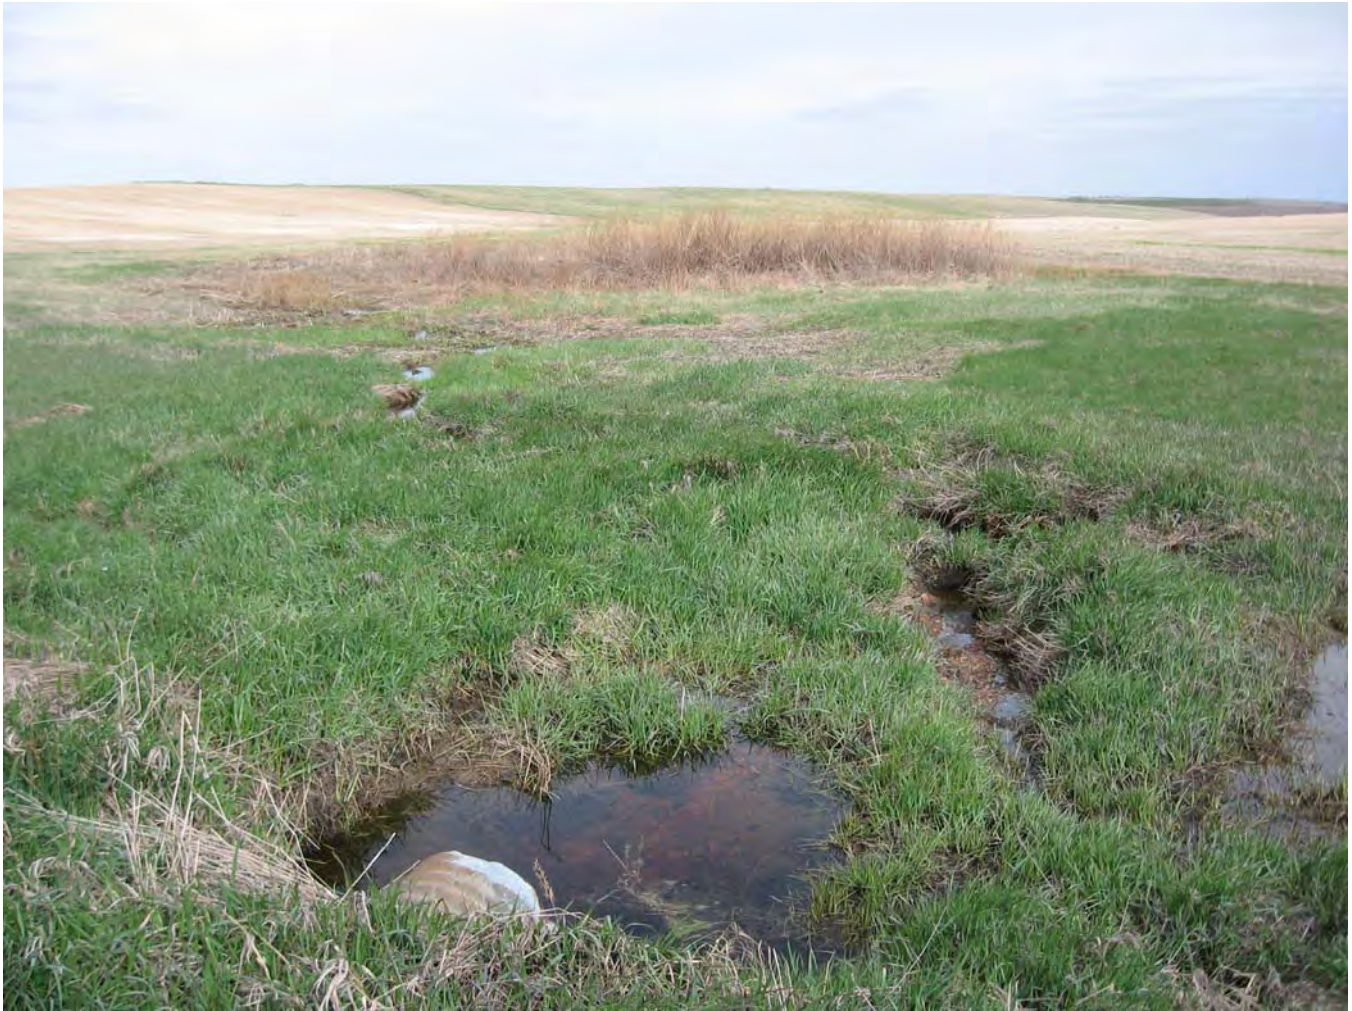
TETRA TECH PROJECT NO. 103IP10979  Direction: North	Feature ID	PY-34	Date 10/17/09
	Description	The feature was identified as an intermittent stream. Tetra Tech classified the stream as a NRPW.	
	CLIENT	NextEra Energy	
	PHOTOGRAPHER	Kali Pace-Graczyk

PY-34	H02	Section 5, T140N, R83W, Section 34, T141N,	Intermittent stream, NRPW	USACE	0	An adjacent road exists and no temporary impacts are anticipated. The feature is an intermittent stream identified on a NHD line. Tetra Tech classified the stream as a NRPW due to the observation of a bed and bank characteristic of an OHWM and assumed flow less than three months. It is Tetra Tech's opinion that a significant nexus exists and the stream is jurisdictional. Avoidance of this feature is recommended. If avoidance cannot be achieved, minimization and/or mitigation methods that reduce impacts on the aquatic resource should be implemented.

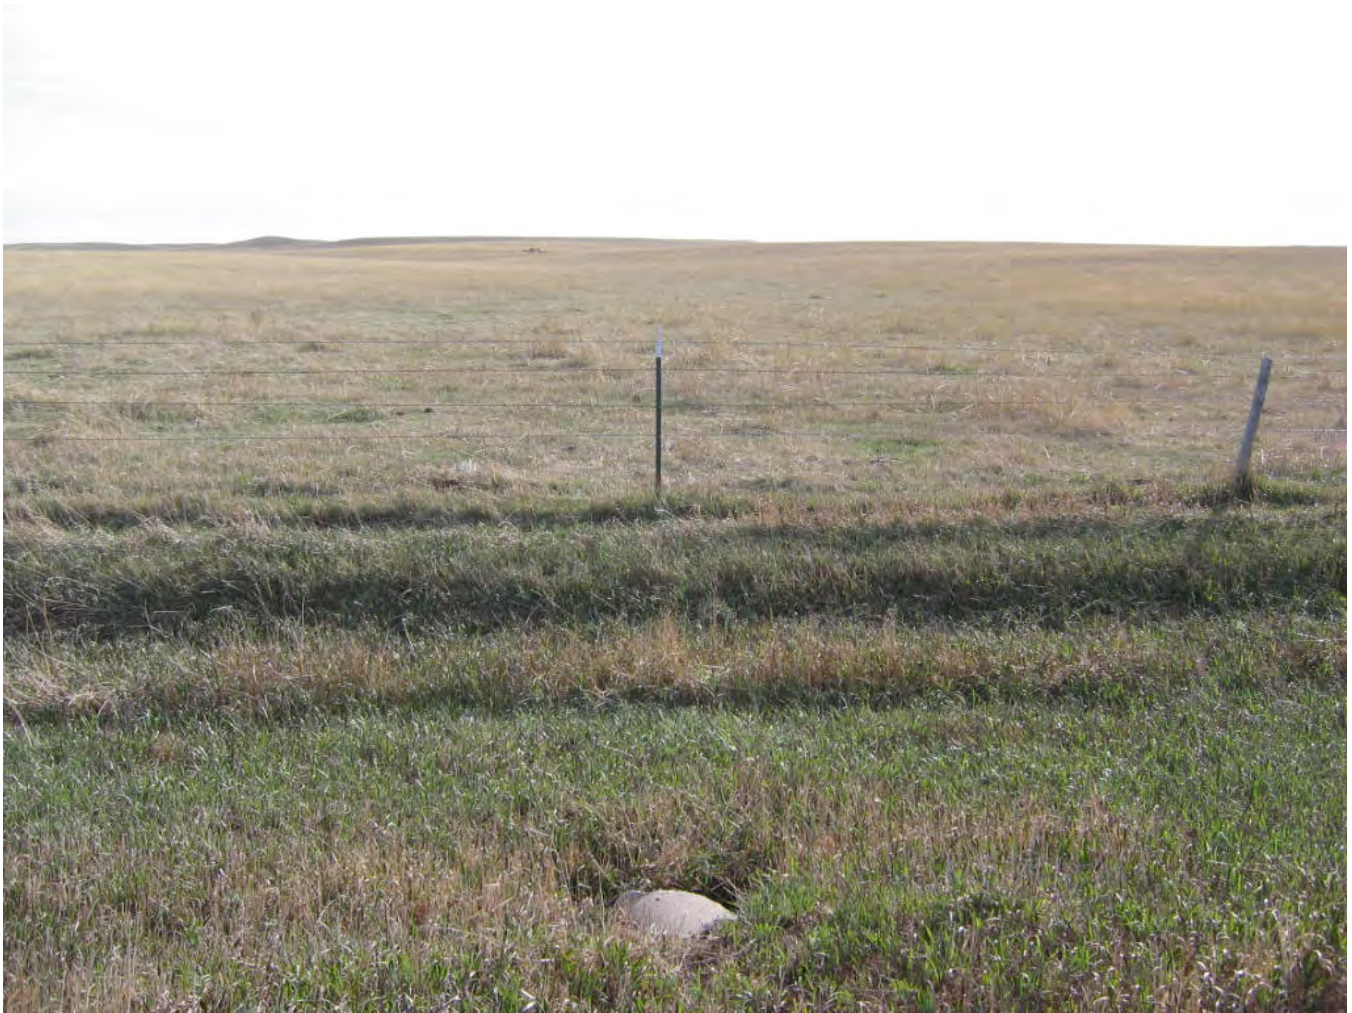
<b>TETRA TECH PROJECT NO. 103IP10979</b>  Direction: South	Feature ID	PY-35	Date 10/17/09
	Description	The feature was identified as a drainage swale with no significant nexus.	
	CLIENT	NextEra Energy	
	PHOTOGRAPHER	Kali Pace-Graczyk

Feature ID	Map Book Page	Section Location	Feature Type <sup>a</sup>	Jurisdiction <sup>b</sup>	Potential Temporary Impacts <sup>c</sup> (acres)	Recommendations and Comments <sup>a</sup>
		R83				
PY-35	H02	Section 35, T141N, R83W, Section 4, T140N, R83	Drainage swale	None	0	The drainage swale was not observed to have characteristics of an OHWM and likely only transports water during periods of heavy rainfall. The USACE typically does not assert jurisdiction to swales that are characterized by low volume, infrequent, and short duration of flow. It is Tetra Tech's opinion that a significant nexus does not exist and the swale is not a jurisdictional water of the U.S.
PY-36	H03	Section 35, T141N, R83W, Section 4, T140N, R83	Intermittent stream, NRPW	USACE	0	An adjacent road exists and no temporary impacts are anticipated. The feature is an intermittent stream identified on a NHD line. Tetra Tech classified the stream as a NRPW due to the observation of a bed and bank characteristic of an OHWM and assumed flow less than three months. This feature was previously classified as a drainage swale. It is Tetra Tech's opinion that a significant nexus exists and the stream is jurisdictional. Avoidance of this feature is recommended. If avoidance cannot be achieved, minimization and/or mitigation methods that reduce impacts on the aquatic resource should be implemented.

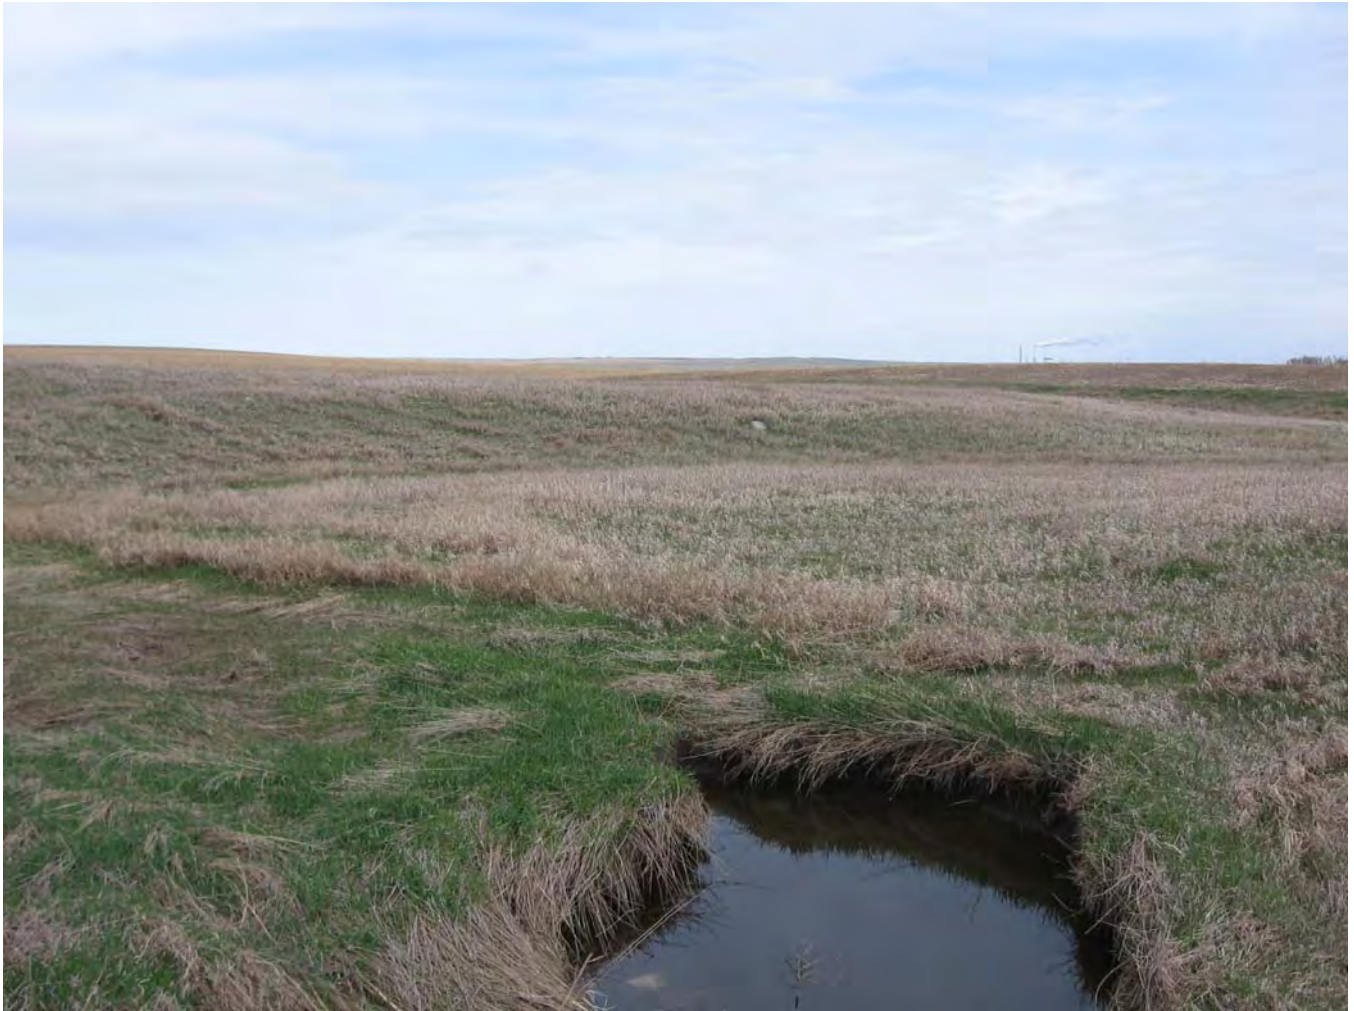
TETRA TECH PROJECT NO. 103IP10979  Direction: North	Feature ID	PY-36	Date 10/17/09
	Description	The feature was identified as an intermittent stream. Tetra Tech classified the stream as a NRPW.	
	CLIENT	NextEra Energy	
	PHOTOGRAPHER	Kali Pace-Graczyk

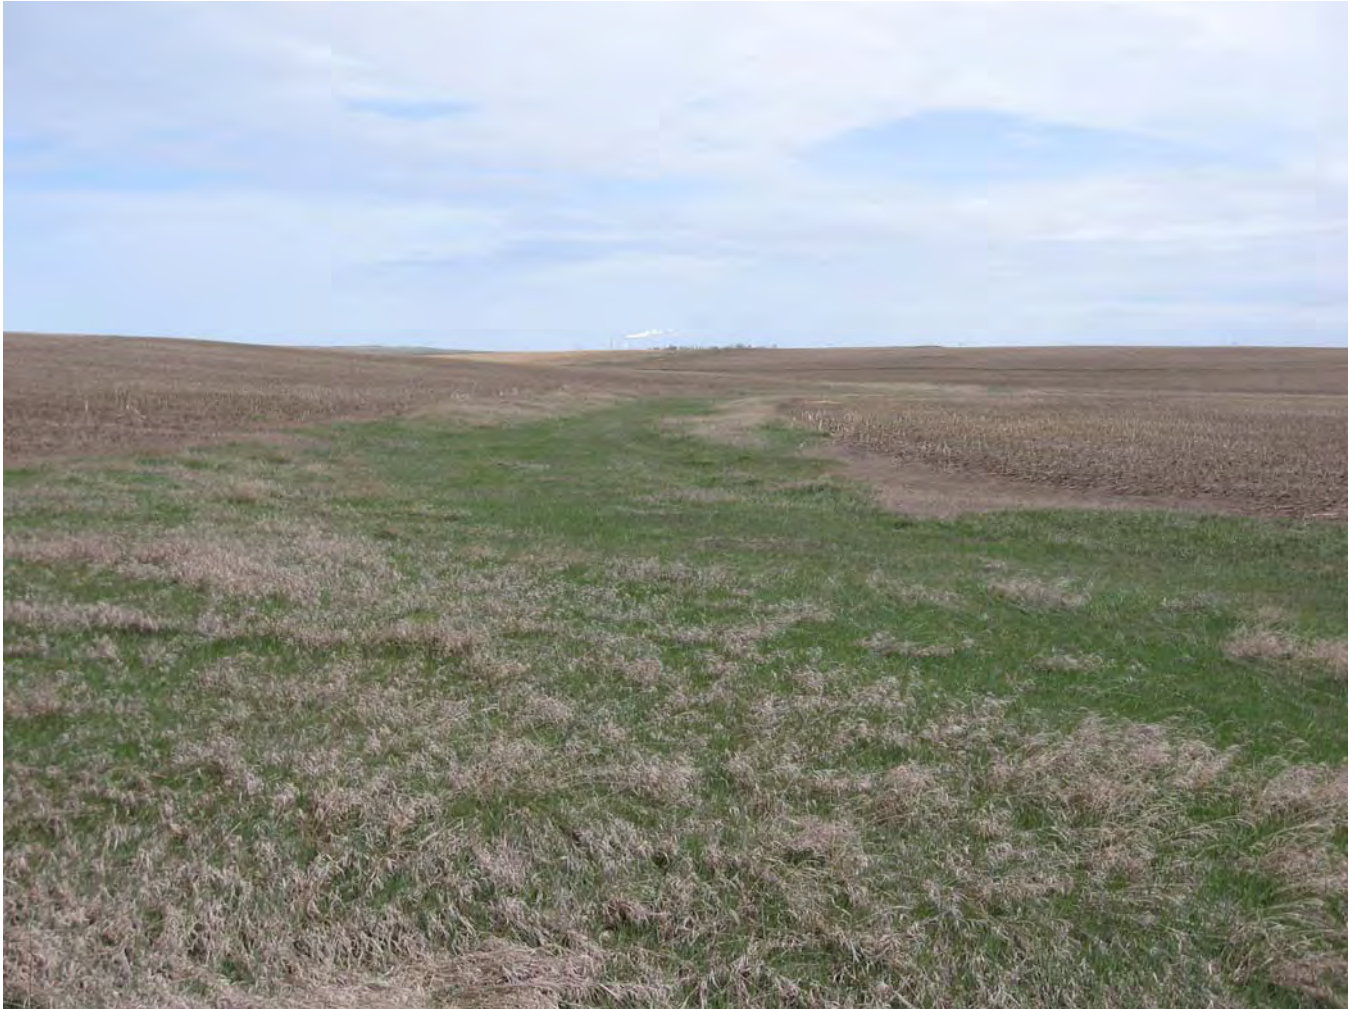
<b>TETRA TECH PROJECT NO. 103IP10979</b>  Direction: North	Feature ID	PY-37	Date 10/17/09
	Description	The feature was identified as a drainage swale with no significant nexus.	
	CLIENT	NextEra Energy	
	PHOTOGRAPHER	Kali Pace-Graczyk

PY-37	H03	Section 35, T141N, R83W, Section 4, T140N, R83	Drainage swale	None	0	The drainage swale was not observed to have characteristics of an OHWM and likely only transports water during periods of heavy rainfall. The USACE typically does not assert jurisdiction to swales that are characterized by low volume, infrequent, and short duration of flow. It is Tetra Tech's opinion that a significant nexus does not exist and the swale is not a jurisdictional water of the U.S.
<b>Total Potential Temporary Impacts for Project</b>					<b>0.663</b>
