74 **PU-10-120** Filed: 11/29/2012 Pages: 12
On-site inspection report of Hess Tioga Gas Plant Expansion

Carlson McCain, Inc (CMI) conducted an on-site inspection of the Hess Corporation (Hess) Tioga Gas Plant (TGP) Expansion (Case No. PU-10-120) on November 15, 2012. CMI Inspector Ryan Krapp met with Hess TGP Expansion Construction Manager, Mr. Scott Wright and Environmental Compliance Manager, Mr. Greg Lee at the Hess TGP field office. Permits and records were reviewed, construction progress was discussed and a construction site tour was conducted.

Construction Inspection Summary
Hess Corporation, Tioga Gas Plant Expansion – Williams County
PSC Case No. PU-10-120

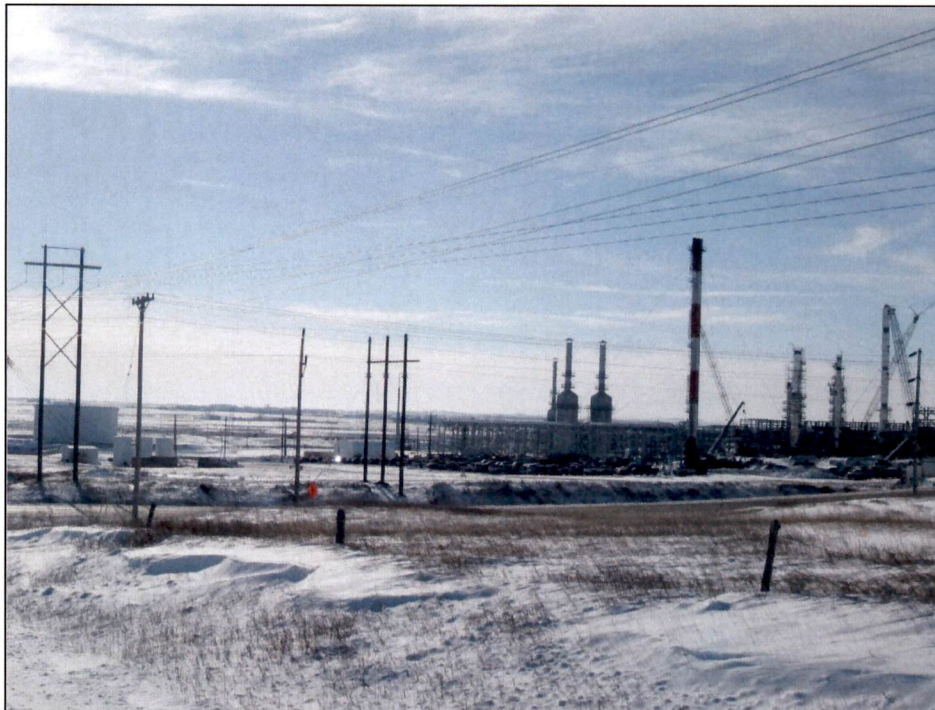
Figure 1. Hess TGP Expansion overview. Photo taken northeast of site facing south-southwest.

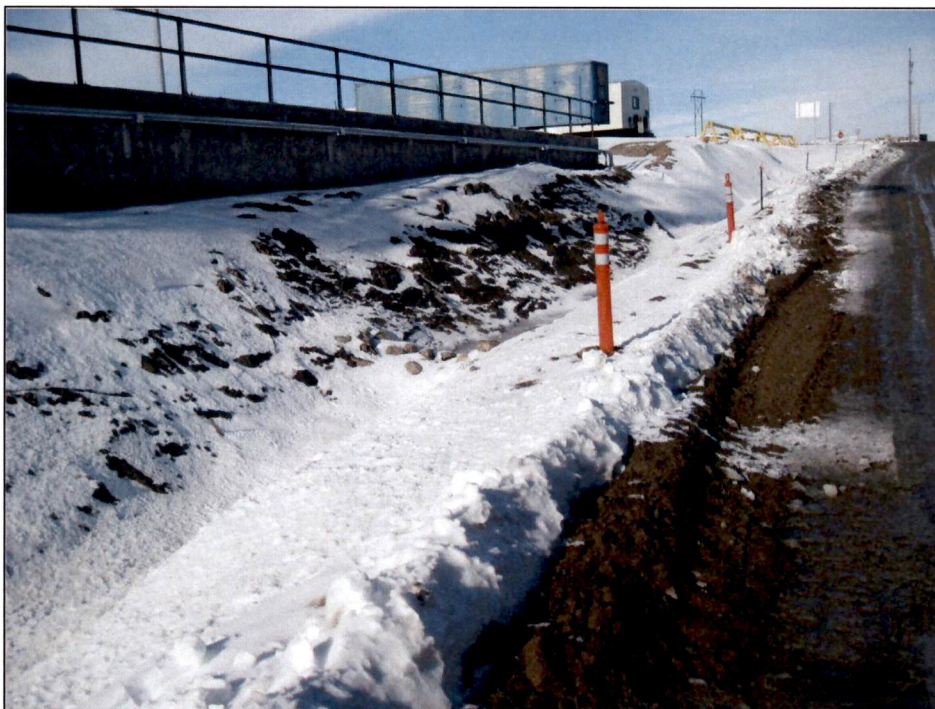
Figure 2. Diversion ditch separating existing site from construction expansion zone. Water is diverted from the existing facility grounds south to containment ponds through ditch. Silt fence and straw wattles are used occasionally in bottom and around culverts.

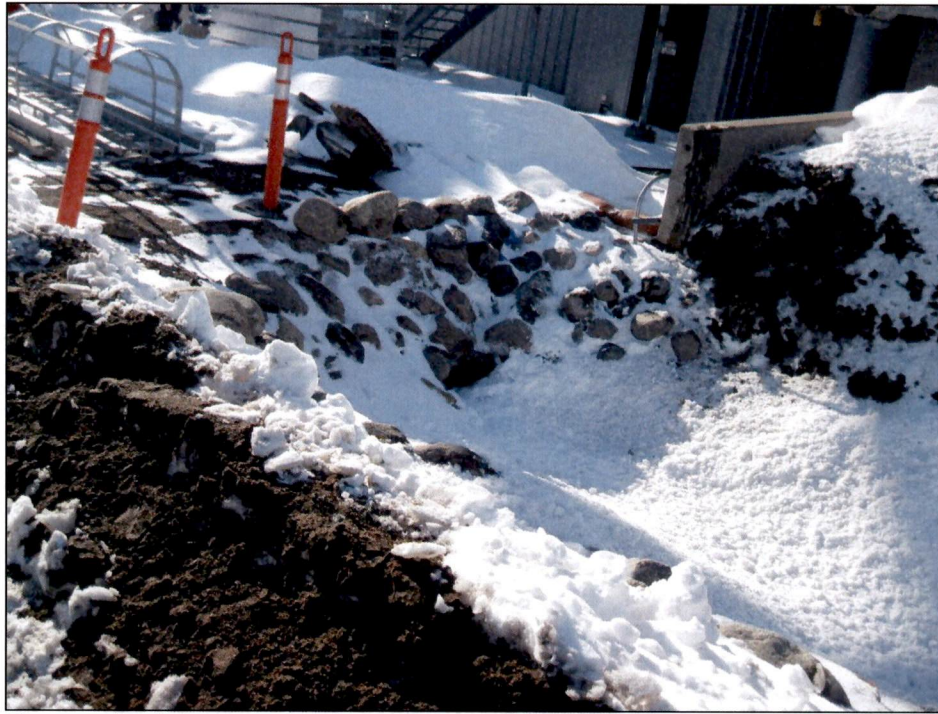
Figure 3. Rock rip-rapped culvert entrance within diversion ditch. Silt fence is also in place in bottom of ditch (currently covered by snow).

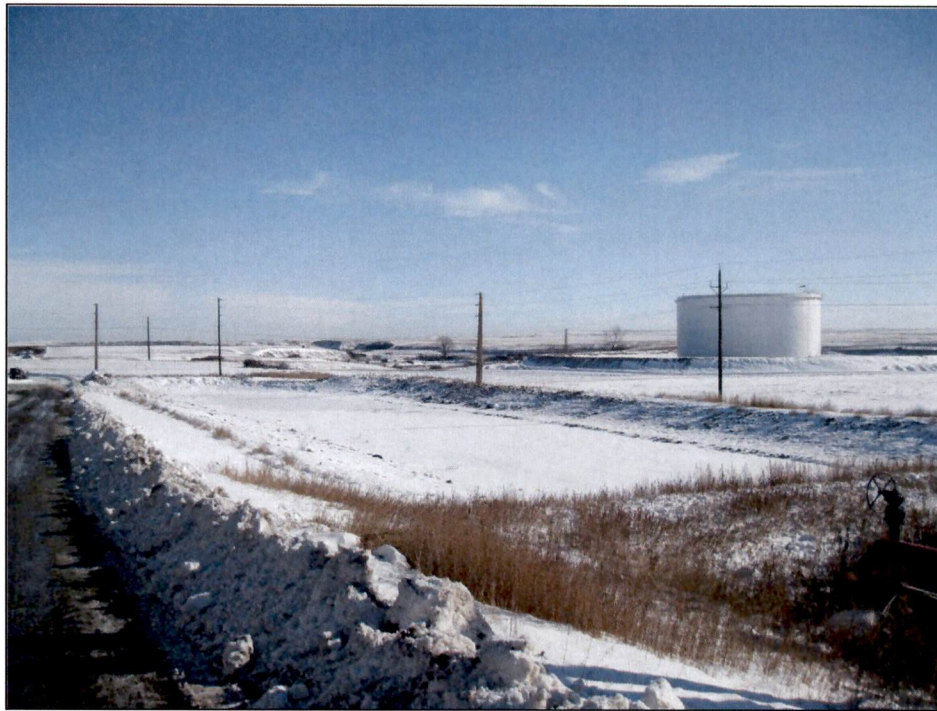
Figure 4. Storm water retention pond #3 located on south side of expansion site. The pond is rock rip-rapped with two inlet culverts from the construction site. The pond is also equipped with an evacuation pump system (pictured in lower right) and an emergency spillway for major runoff event.

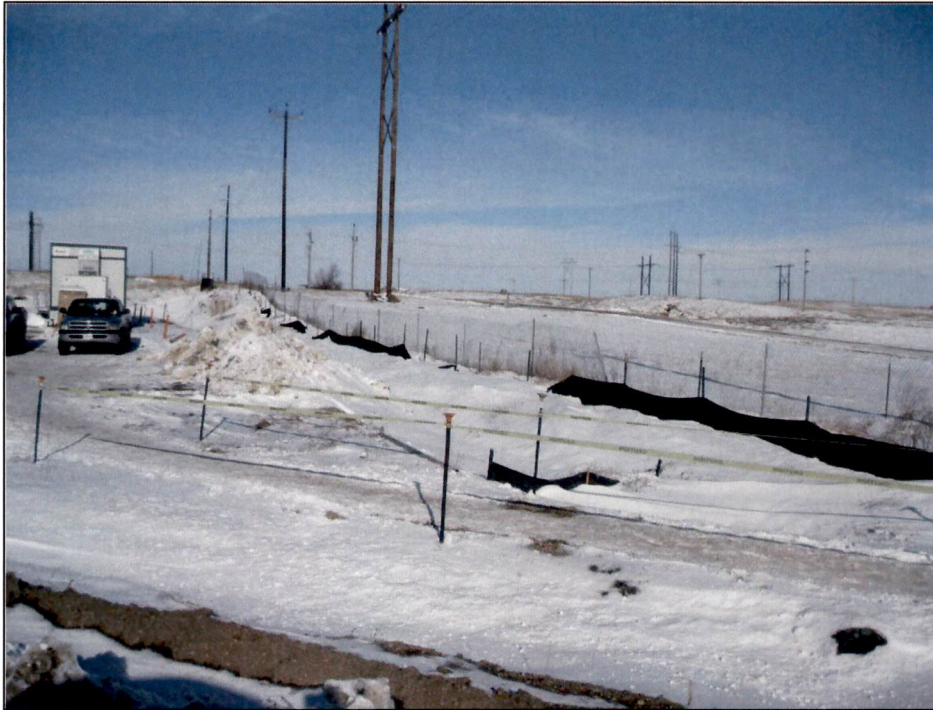
Figure 5. Water diversion ditch on east side of TGP expansion site. Silt fence in place with minor damage from heavy snow. Fencing will be repaired as conditions allow.

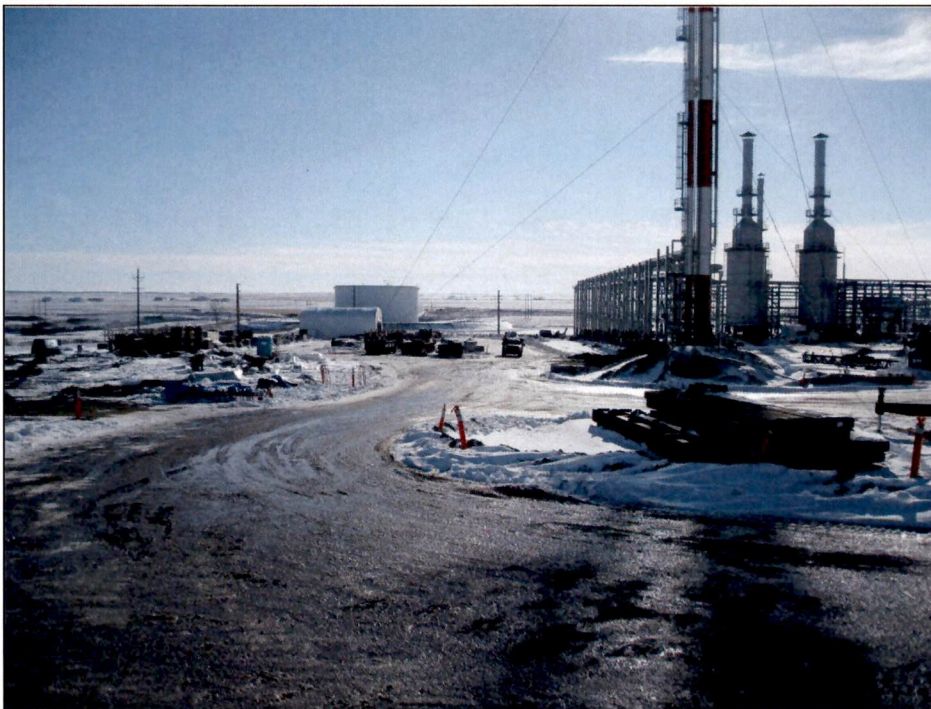
Figure 6. Photo taken facing south near the center of the TGP Expansion.

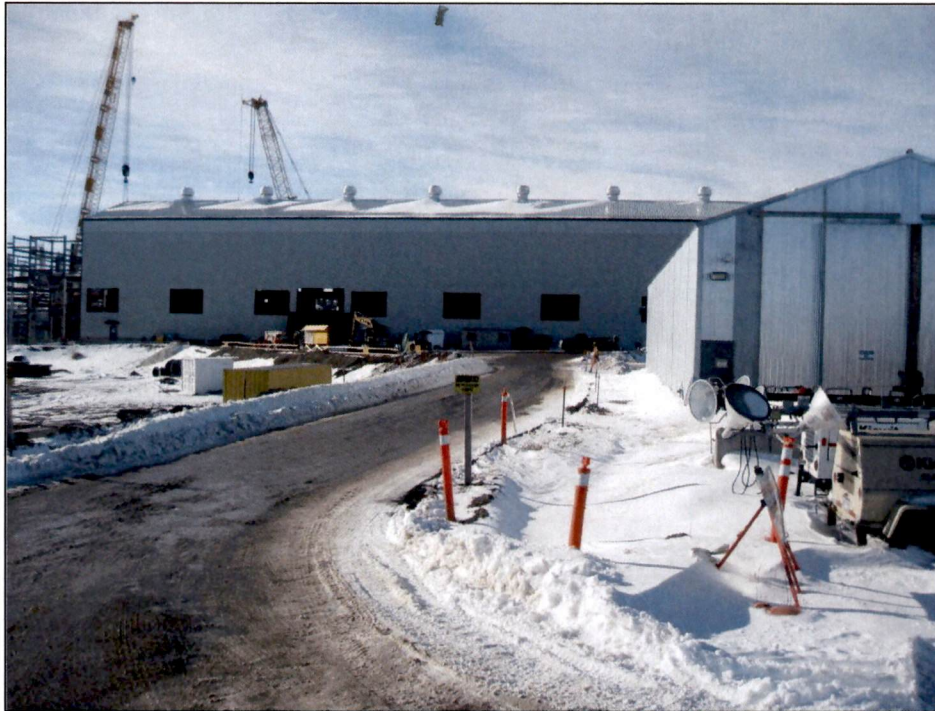
Figure 7. Photo taken facing west near the center of the TGP Expansion. Pictured is access road above tiered construction site. Water diversion ditch to culvert under road currently snow filled (marked by orange pylons).

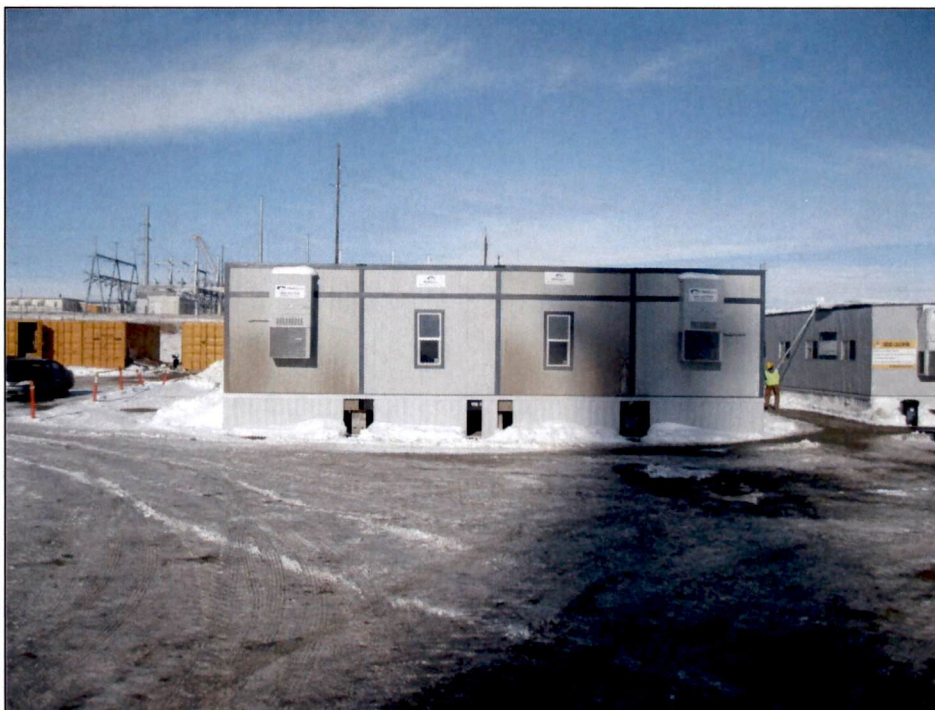
Figure 8. Photo taken facing north near the center of the TGP Expansion. Temporary office buildings set on-site.

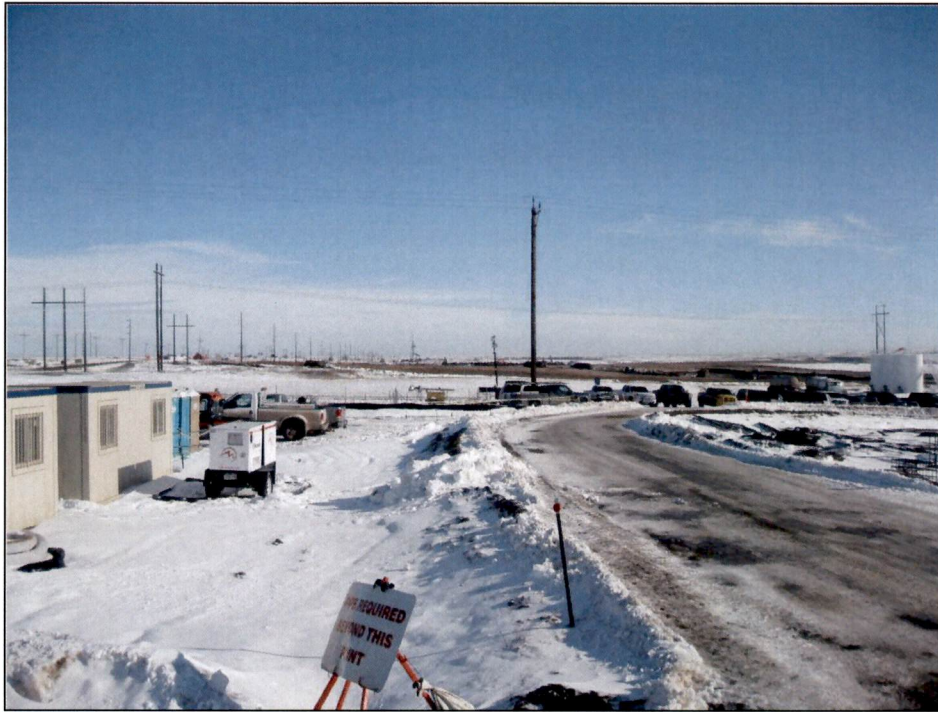
Figure 9. Photo taken facing north near the center of the TGP Expansion. Secondary containment in place under portable generator.
