Carlson McCain, Inc. (CMI) conducted a second on-site inspection of the Hess Corporation (Hess) Tioga Gas Plant (TGP) Expansion (Case No. PU-10-120) on October 2, 2013. Ryan Krapp, CMI Inspector, met with Mr. Scott Wright, Hess TGP Expansion Construction Manager; Mr. Greg Lee, Hess Environmental Compliance Manager; and Mr. Brandon Bell, Kiewit Infrastructure Group (Kiewit) Project Environmental Coordinator, at the Hess TGP field office. Permits and records were reviewed, construction progress was discussed and a construction site tour was conducted.

Construction Inspection Summary
Hess Corporation, Tioga Gas Plant Expansion - Williams County
PSC Case No. PU-10-120

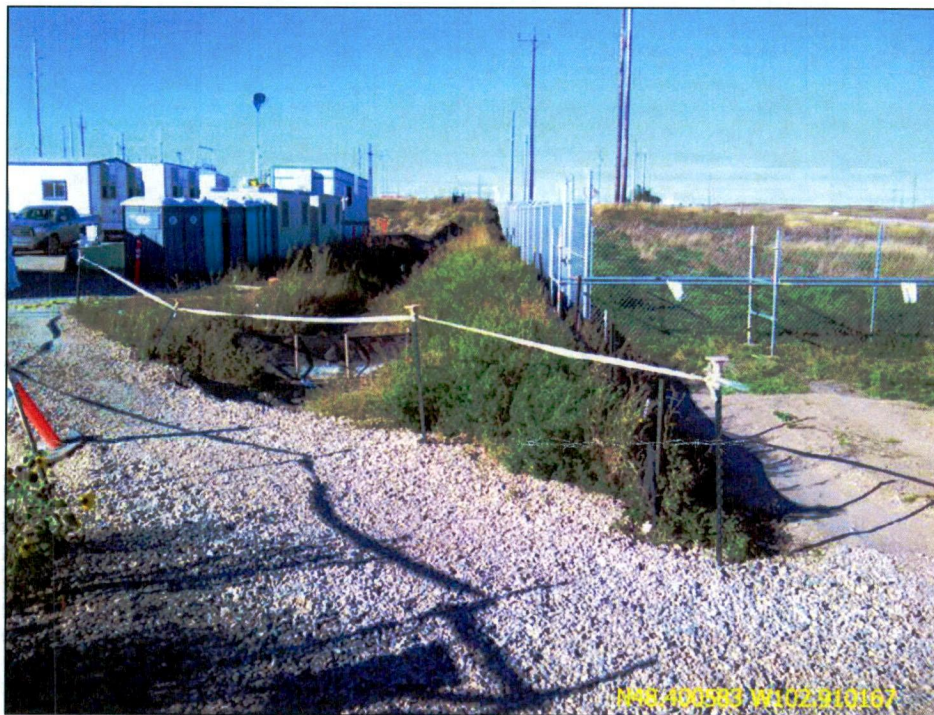
Figure 1. Eastern border of the Hess TGP Expansion site. Photo taken facing north showing established vegetation and silt fencing functioning properly.

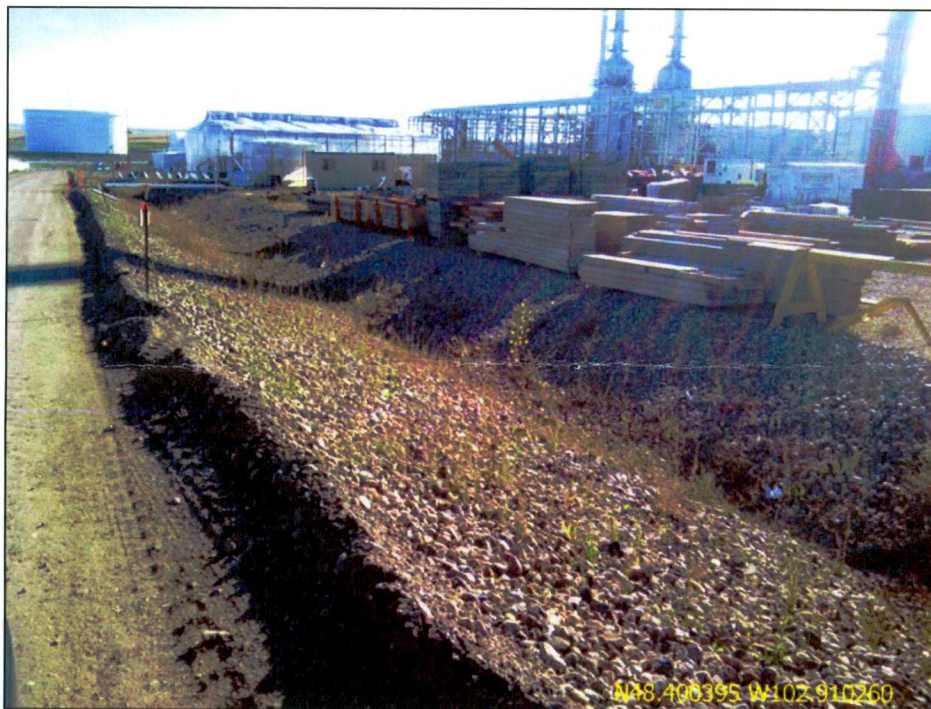
Figure 2. Diversion ditch established at eastern edge of site. Surface water runoff from the site is collected and diverted south to the storm water retention pond through the ditch.

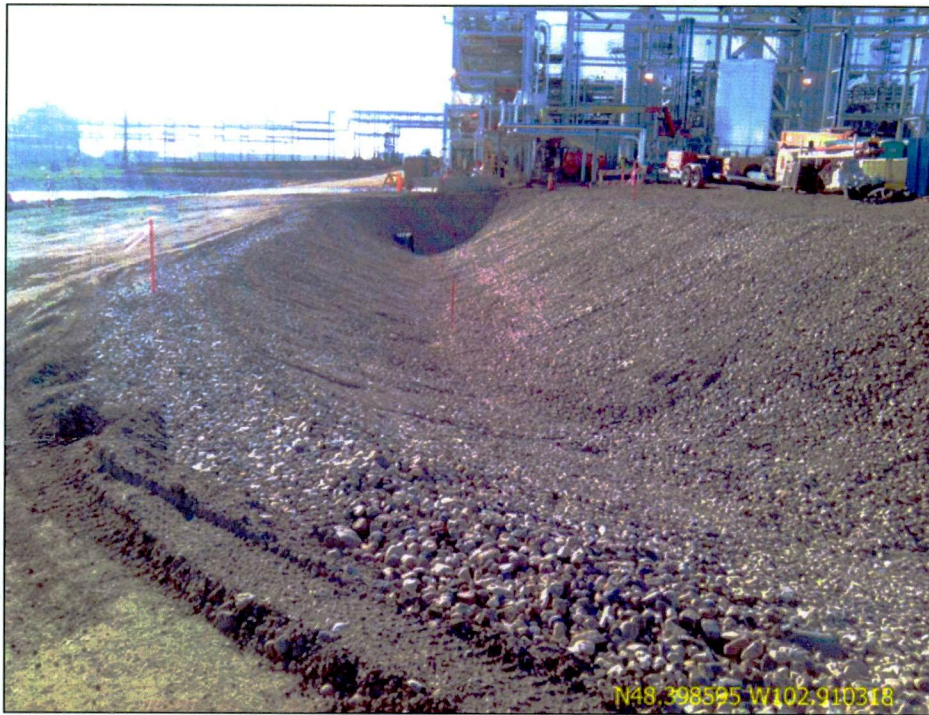
Figure 3. Recently refurbished water conveyance ditch leading directly to the storm water retention. Rock rip-rapped after pipeline (staked) was installed.

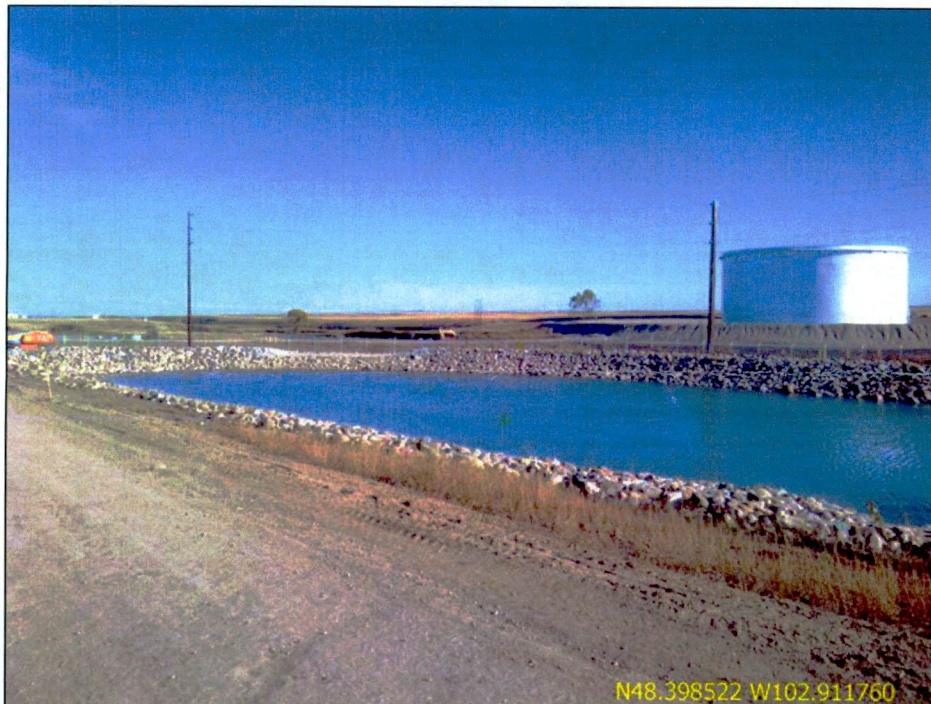
Figure 4. Storm water retention pond located on south side of expansion site. All on-site water is collected here and sediments settle out. Mr. Lee stated that the majority of this water is reused on-site for dust control and various construction activities.

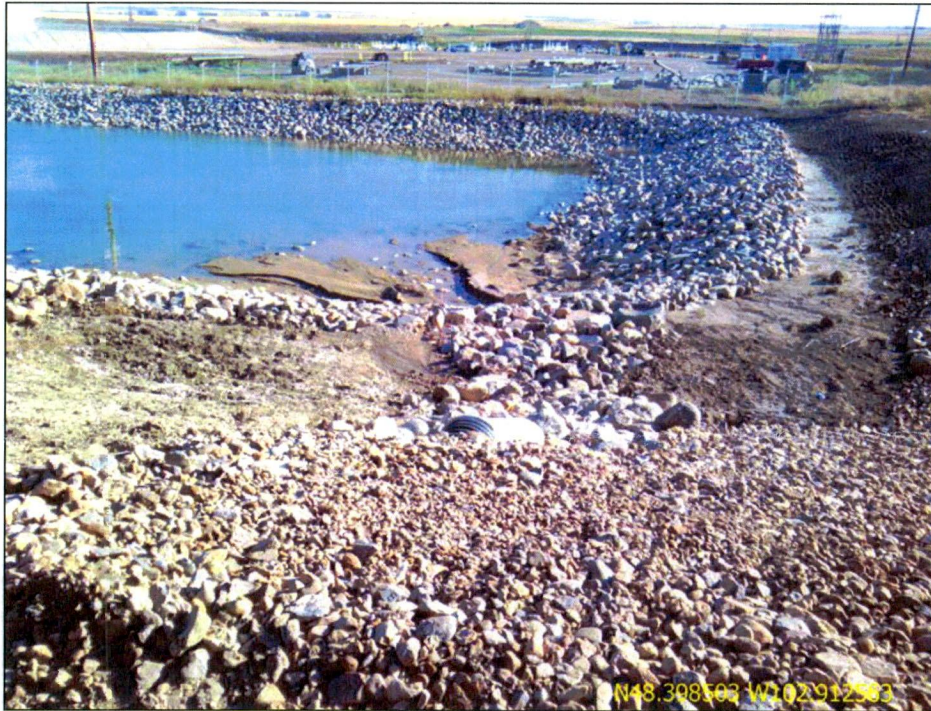
Figure 5. Storm water retention pond is rock rip-rapped with two inlet culverts from the construction site.

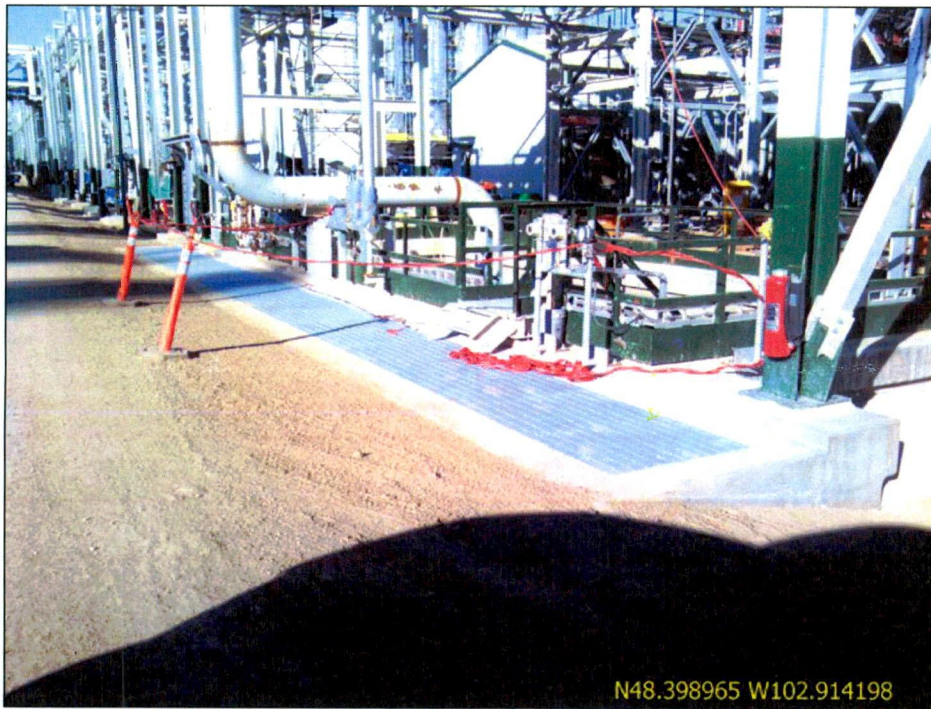
Figure 6. Concrete water collection drain in the interior of the plant site. Concrete conveyances and pipelines direct the water through the site to the pond.

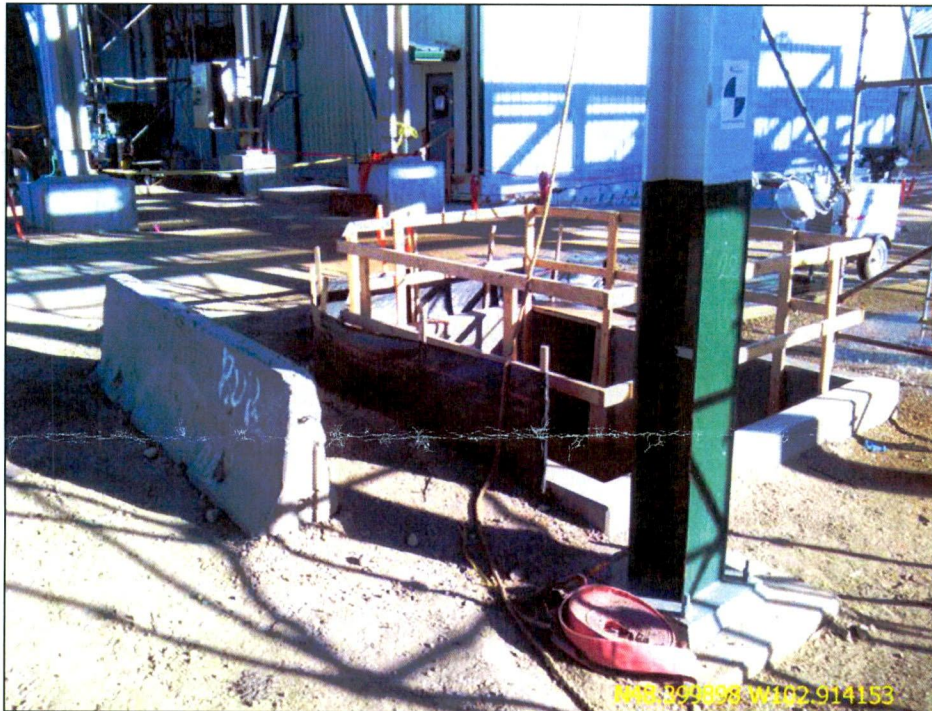
Figure 7. Concrete drain and conveyance being established to permanently direct surface water through the site to the pond.

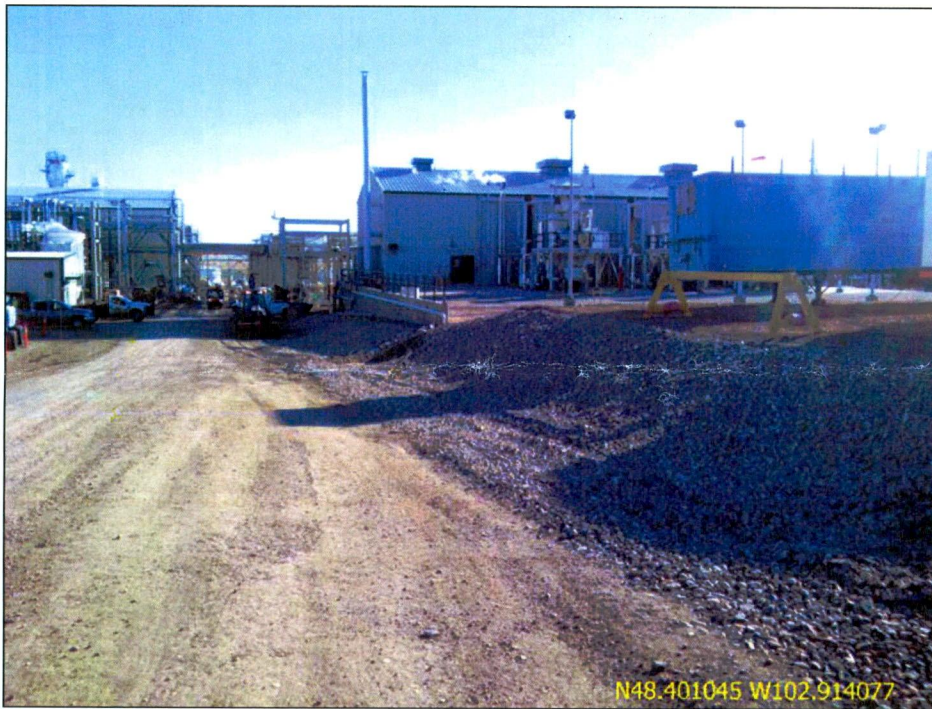
Figure 8. Diversion ditch separating existing site from construction expansion zone. Silt fencing and straw wattles were previously used, but has been stabilized with erosion control matting and rocked.

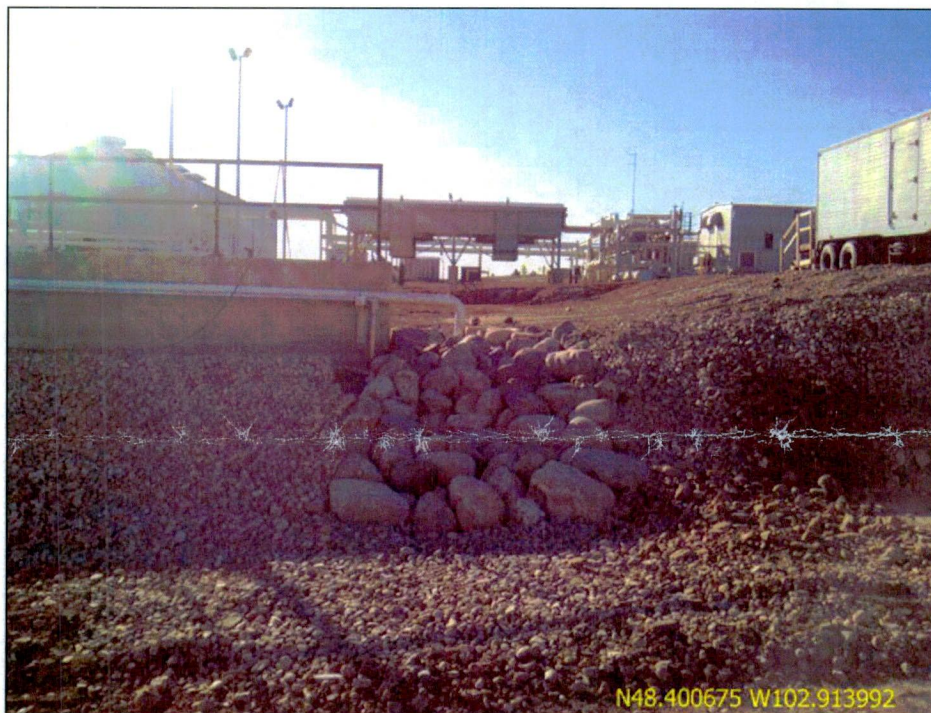
Figure 9. Photo taken facing west of drainage from original plant site. Large rocks placed to dissipate energy of flow water from overland and a downspout of adjacent building.

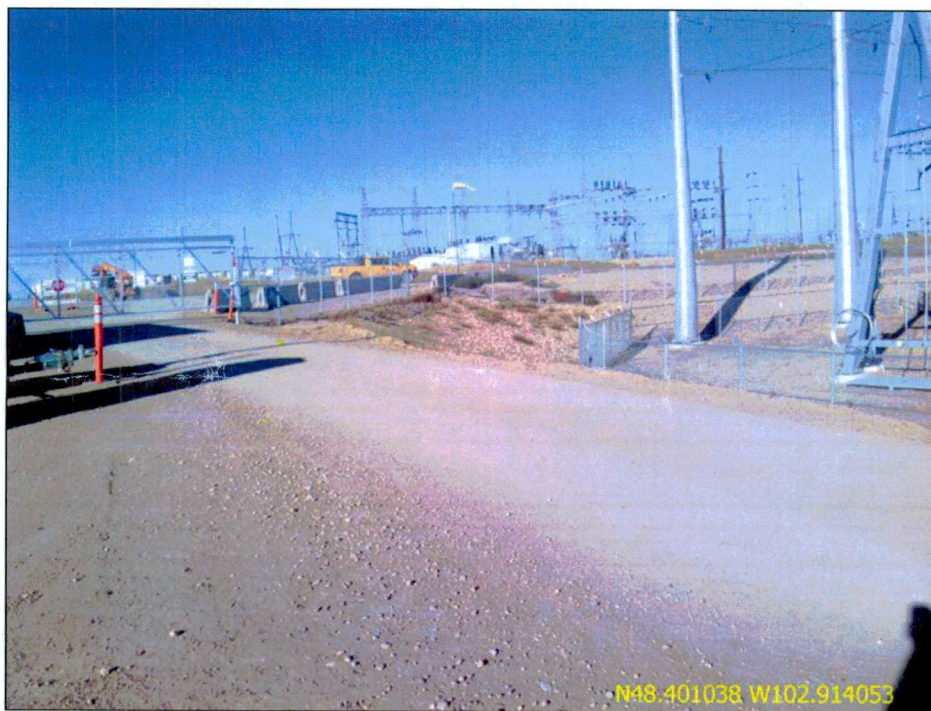
Figure 10. Photo taken facing north at the entrance of the TGP Expansion site. Permanent slopes have been matted and rocked.
