WETLAND DELINEATION AND WATERBODY CROSSING REPORT

BakkenLink Pipeline

Billings, Dunn, McKenzie, Stark and Williams Counties
North Dakota

BakkenLink Pipeline LLC

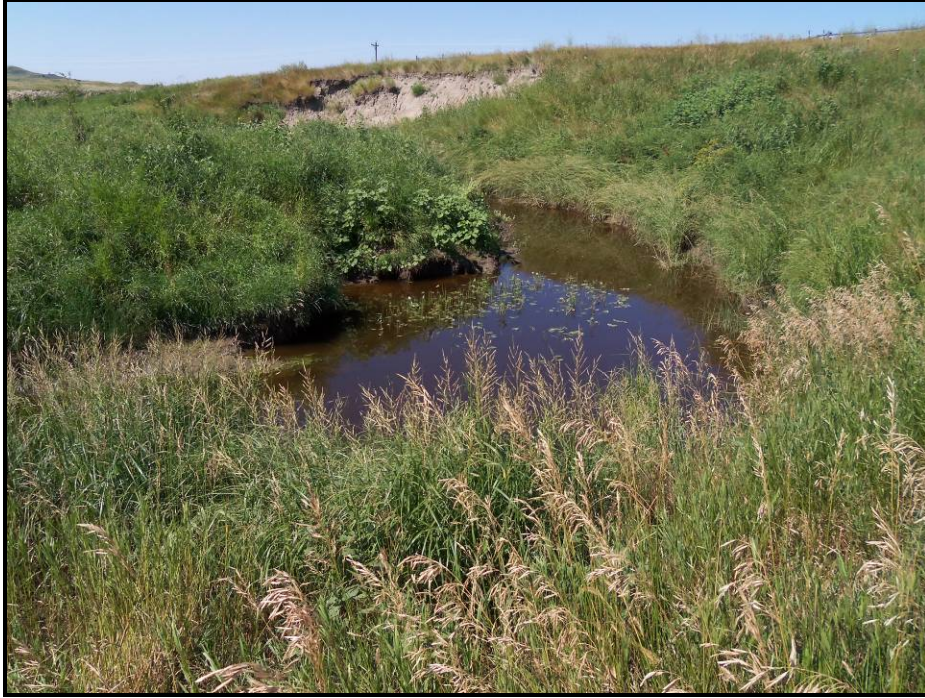
Photograph 1. Representative photograph of perennial stream crossing (North Fork Creek). Prairie cordgrass (*Spartina pectinata*) is most typically found along stream banks along route.

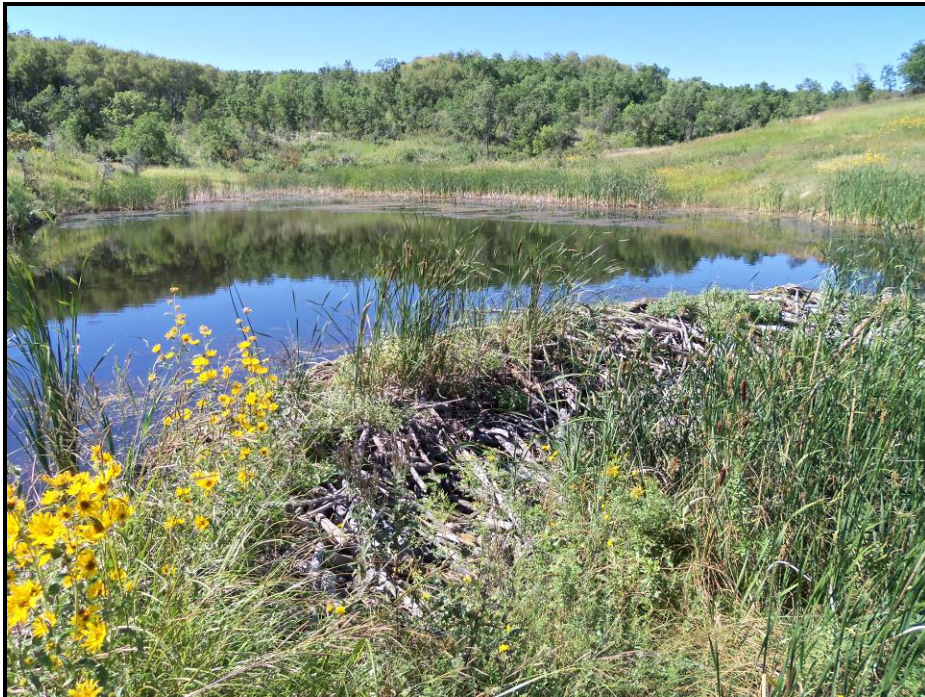
Photograph 2. Representative photo of beaver dam backing up an intermittent drainage creating wetland. Narrow leaf cattail (*Typha angustifolia*) surrounds wetland edge.

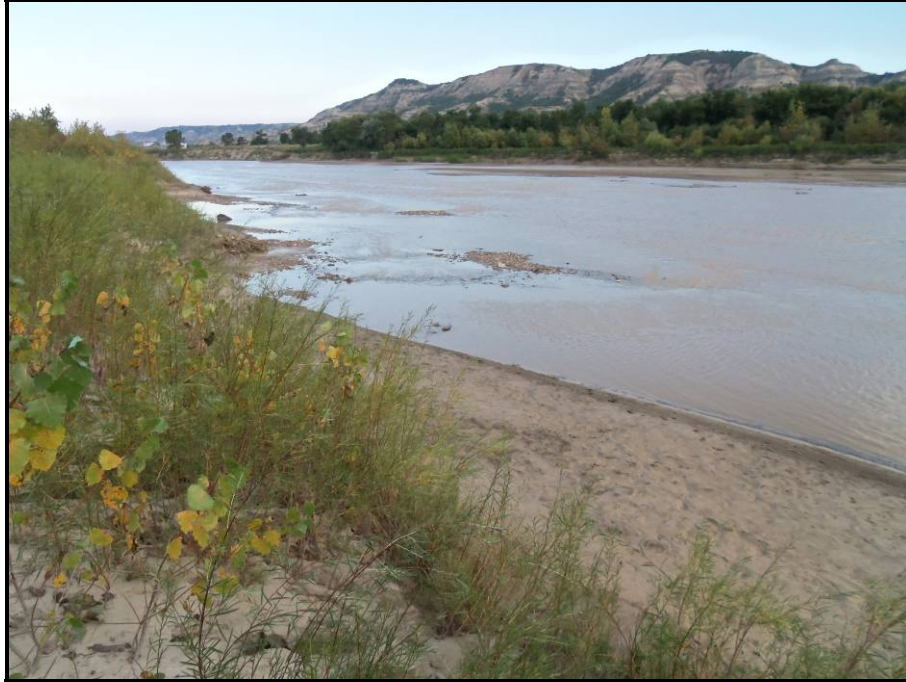
Photograph 3. Little Missouri River crossing. Photo taken from north shore facing southeast. Cottonwood and Willows line sandy banks. Little Missouri Badlands breaks visible in background.

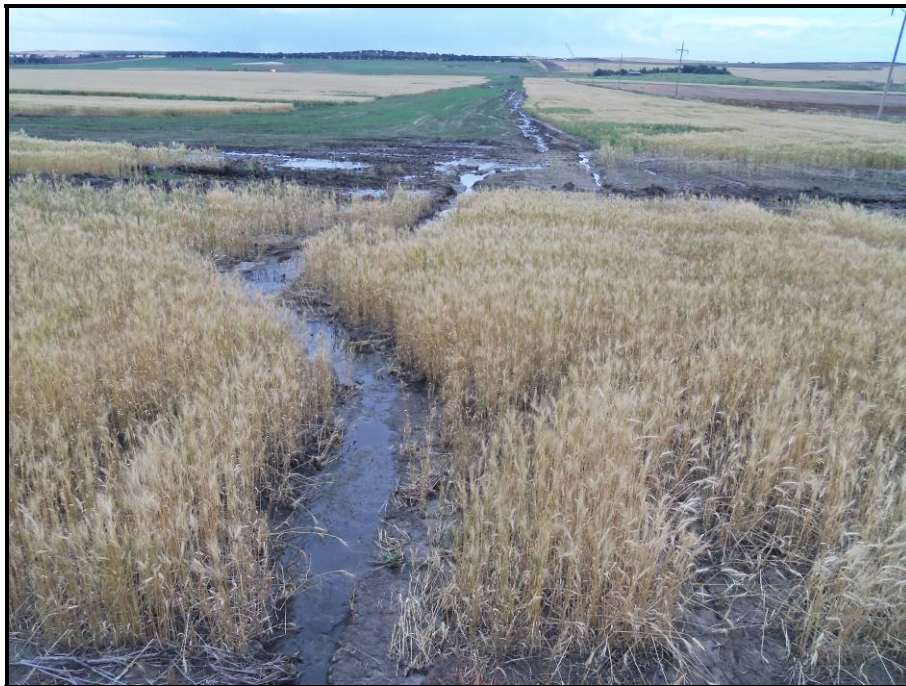
Photograph 4. A representative photo of a spring-fed intermittent drainage that is cultivated.

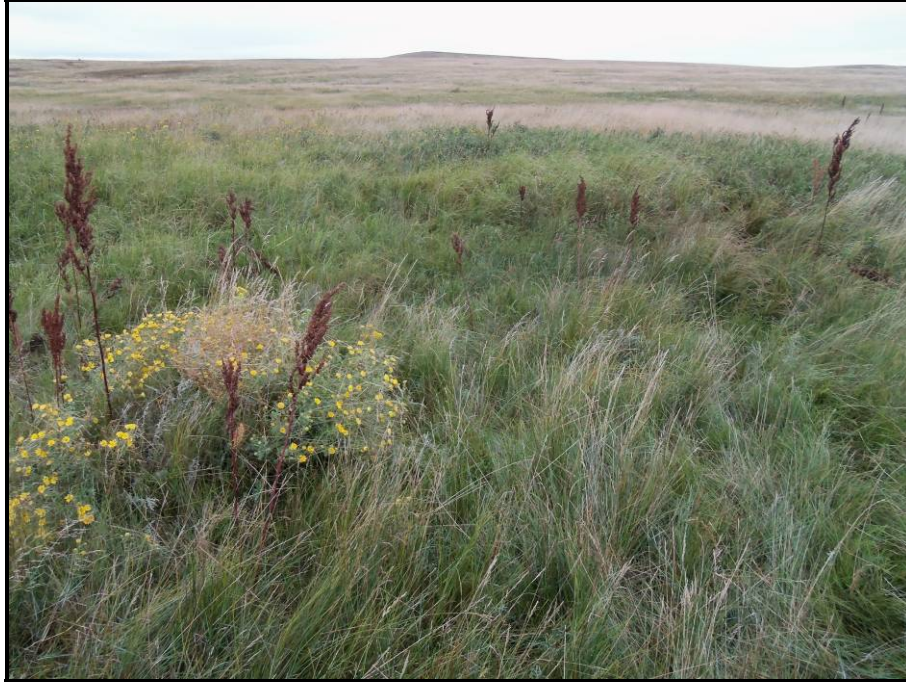
Photograph 5. Representative shallow depression wetland located in native prairie pasture. This is a typical pothole wetland located in the Missouri Coteau Region.

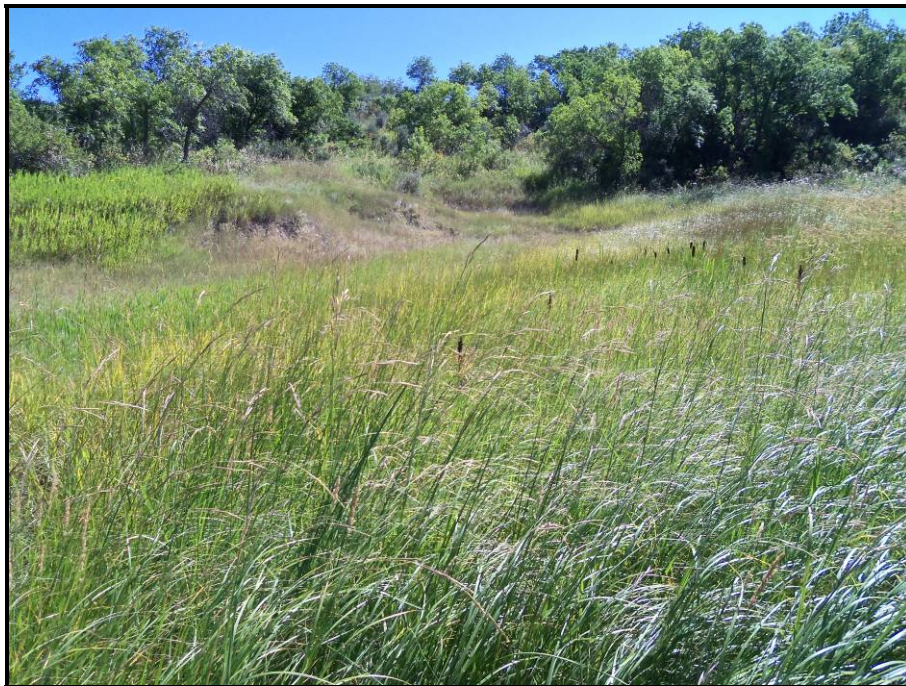
Photograph 6. Sedge that flows through a swale into a dammed drainage. Ground water flows to the ground surface on a sideslope and creates a shallow slope wetland. Sedge species and Prairie cordgrass are present in the slope wetland area.

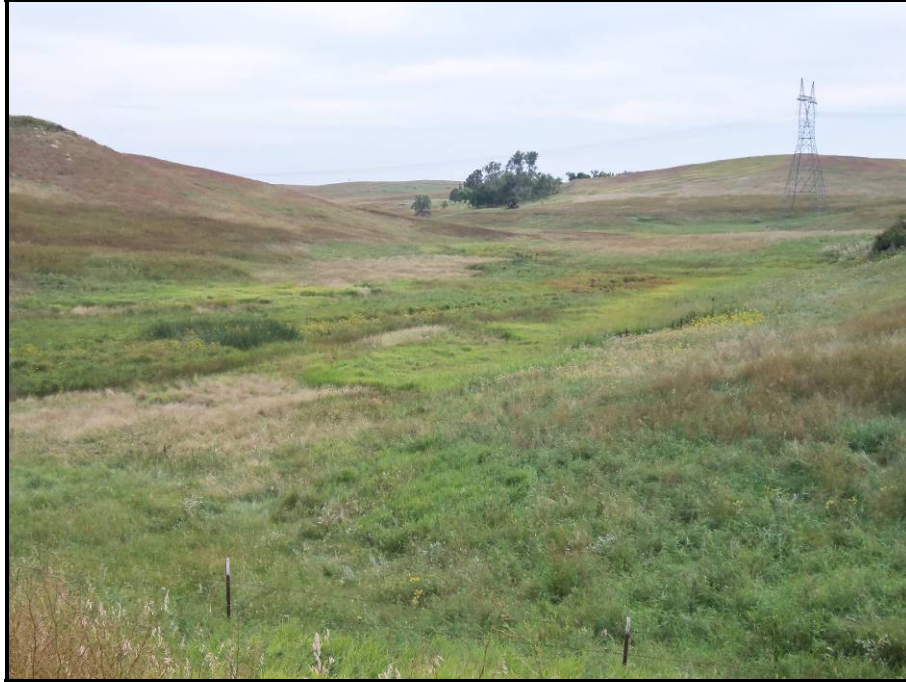
Photograph 7. Typical intermittent stream crossing in well-drained sloping landscape. Baltic rush (*Juncus balticus*) is common in shallow drainage pools.

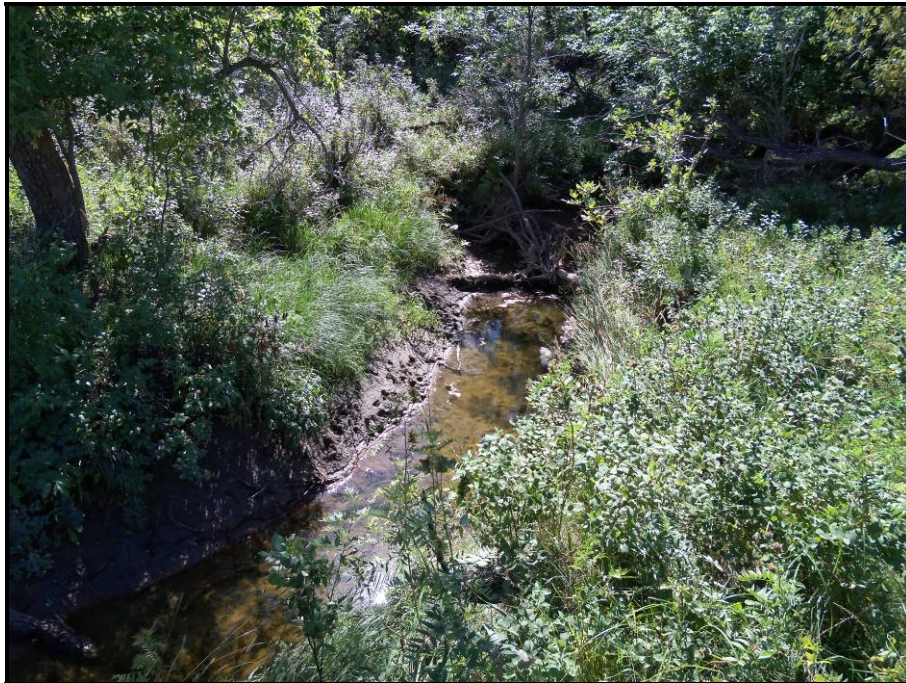
Photograph 8. Intermittent stream crossing in bottom of steep treed drainage. Many intermittent drains were dry at time of survey. Prairie cordgrass is typically found along stream banks.
