Project Inspection Report

Project Name: Hiland Operating LLC 8-inch Natural Gas Liquids Pipeline, McKenzie County ND

PSC Case Number: PU-10-554

Date: 1/25/2013

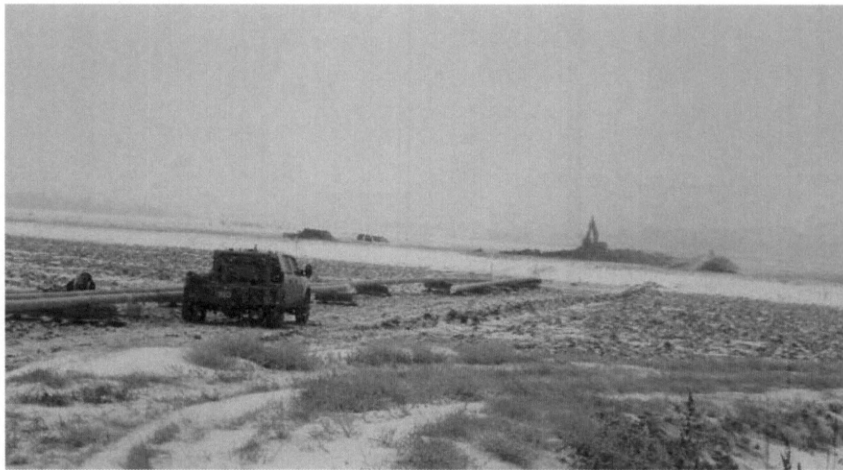
Photo 1: Looking southwest from 36th ST NW at Project ROW, notice pipe strung in preparation installation via open trench method.

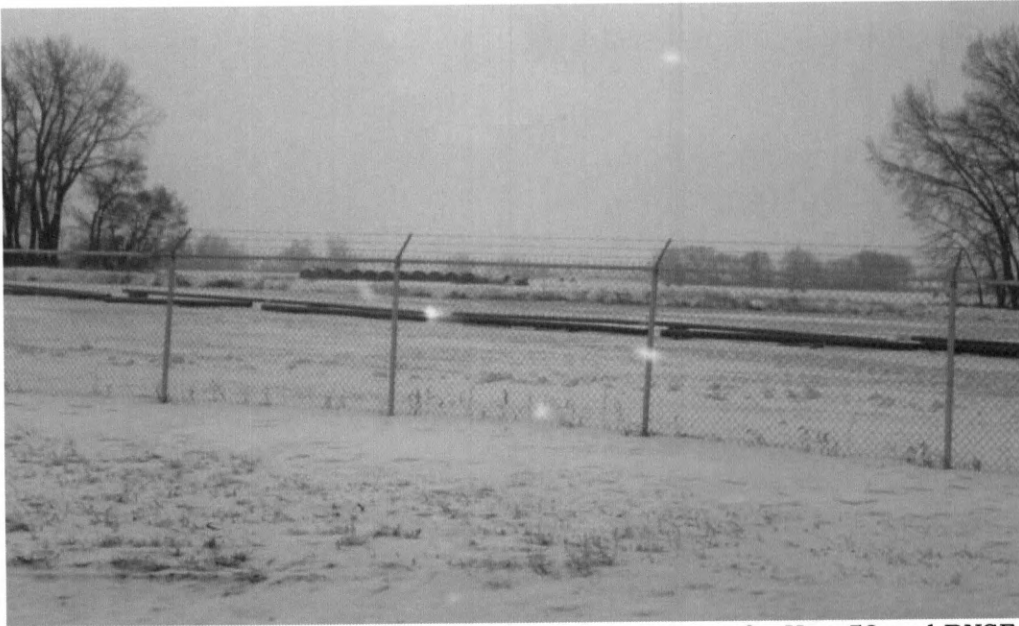
Photo 2: Looking south from Hiland Rail Terminal at pipe strung for Hwy 58 and BNSF Railroad HDD and installation of pipeline into facility.

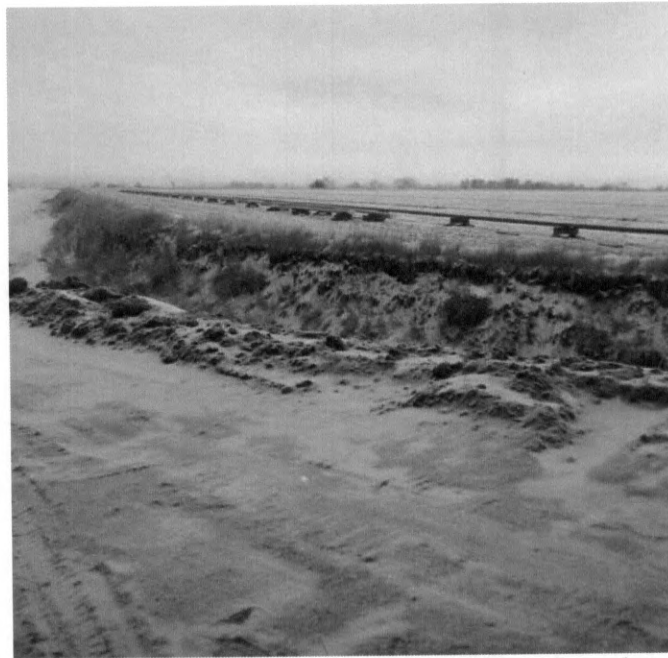
Photo 3: Looking east at pipe strung for HDD of irrigation channels and existing creek and ditches.

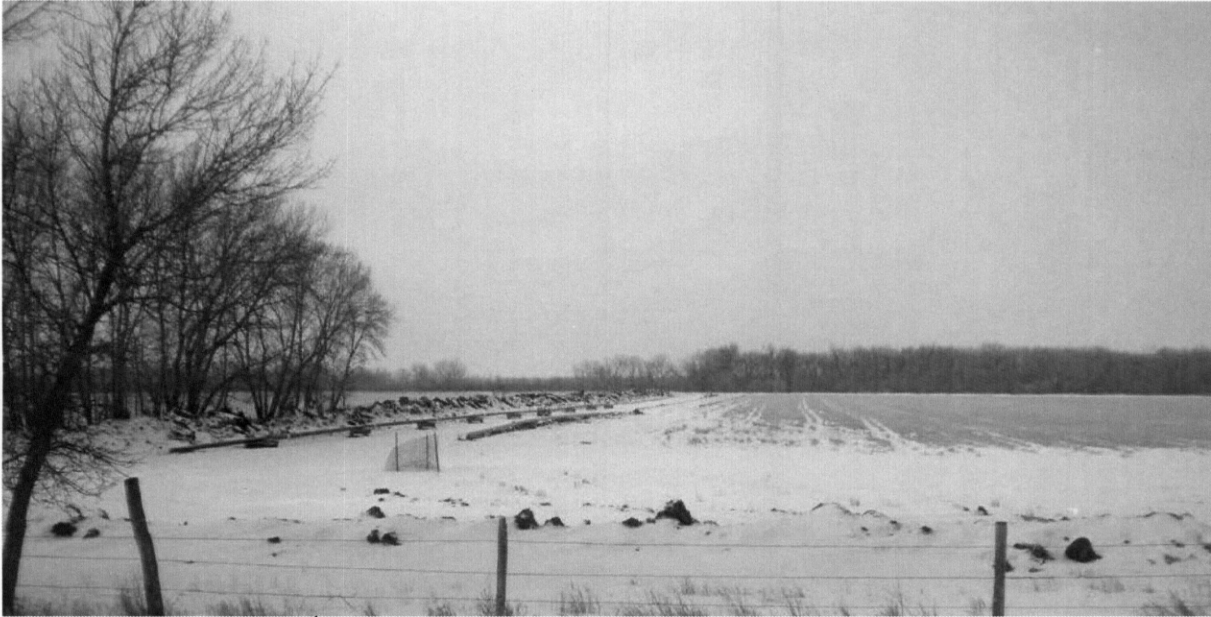
Photo 4: Looking west from 157th Ave. NW at pipe strung for installation up to eastern side of Yellowstone River and tie-in into Yellowstone River HDD.

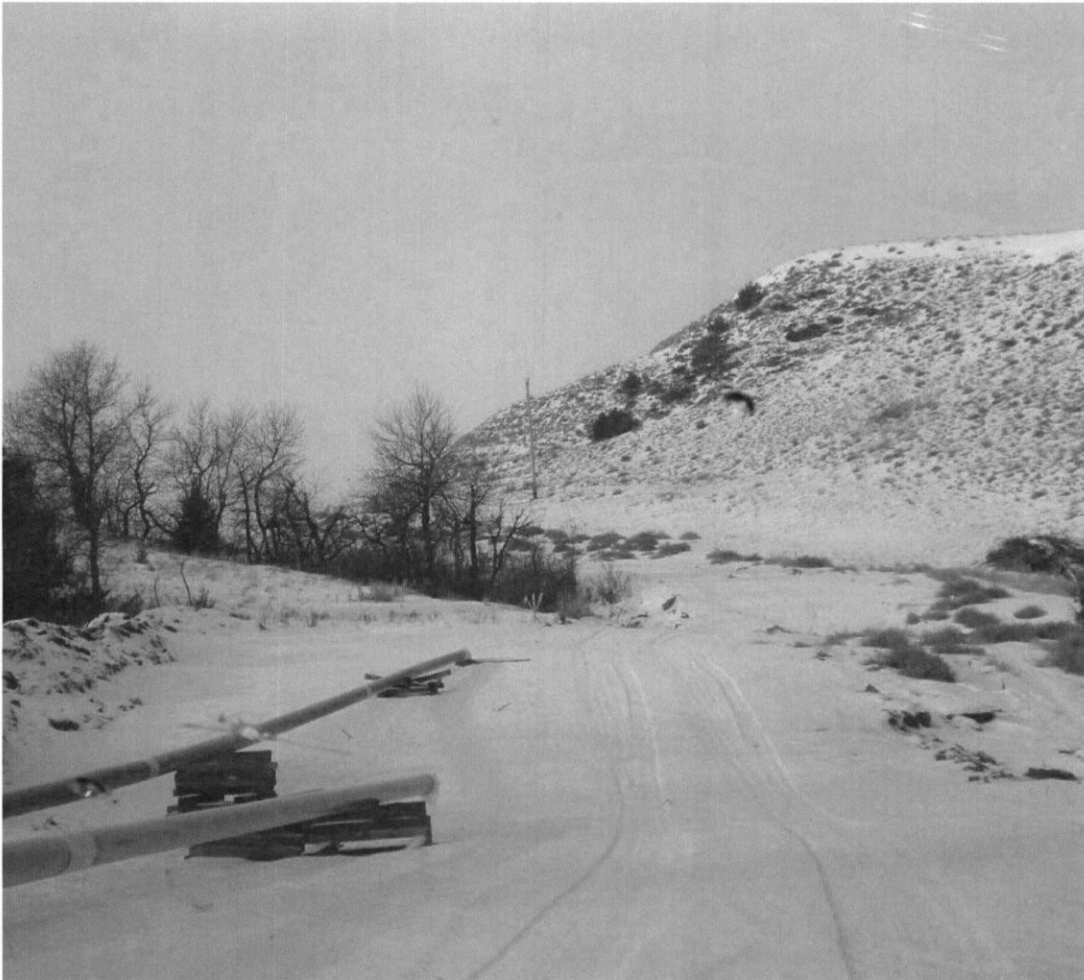
Photo 5: Looking west from Project ROW just north of 36th Street NW; orange 3 piece flags mark entrance/exit points of planned HDDs to avoid trees, cultural site and protected plant. The majority of this hill will be HDD to avoid the rough terrain including the aforementioned sensitive features. No Trees will be removed during construction.
