## Project Inspection Report

**Project Name:** Hiland Operating LLC 8-inch Natural Gas Liquids Pipeline, McKenzie County ND

**PSC Case Number:** PU-10-554

**Date:** 1/25/2013

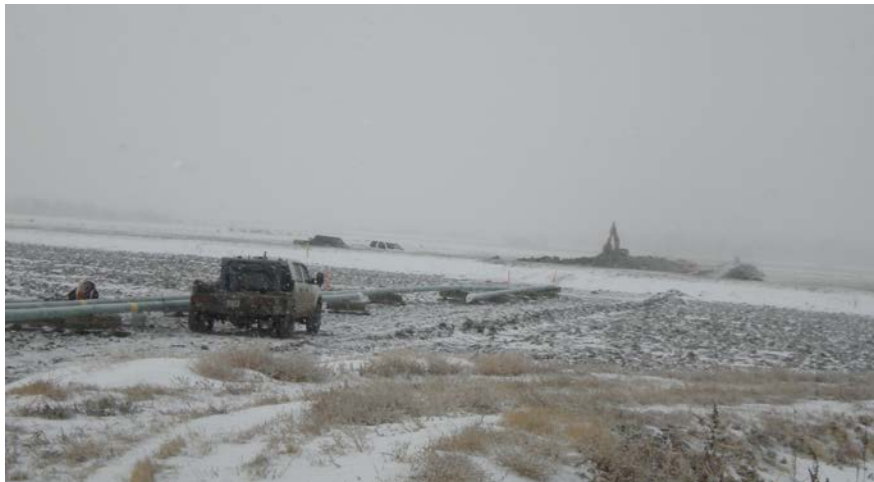
**Photo 1:** Looking southwest from 36<sup>th</sup> ST NW at Project ROW, notice pipe strung in preparation installation via open trench method.

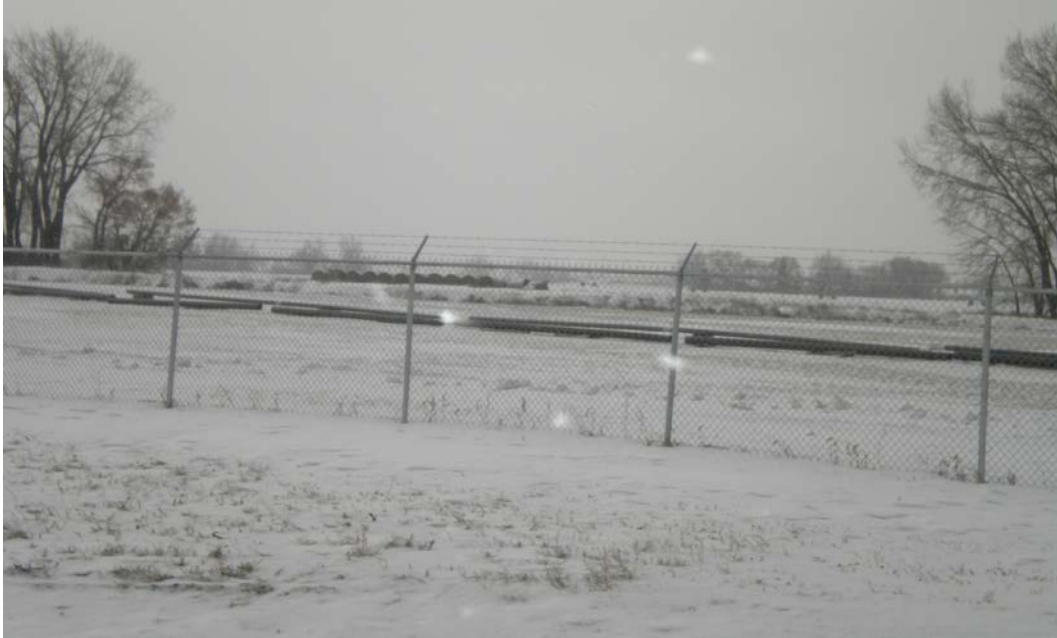
**Photo 2:** Looking south from Hiland Rail Terminal at pipe strung for Hwy 58 and BNSF Railroad HDD and installation of pipeline into facility.

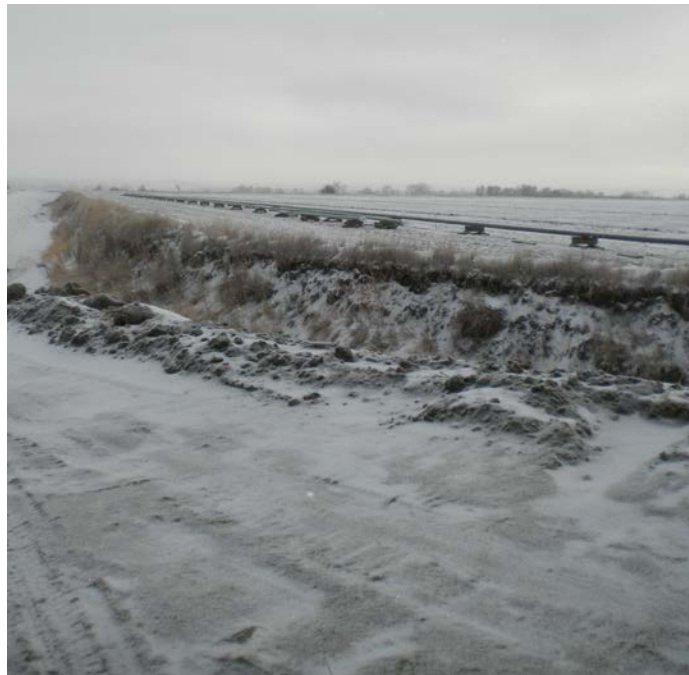
**Photo 3:** Looking east at pipe strung for HDD of irrigation channels and existing creek and ditches.

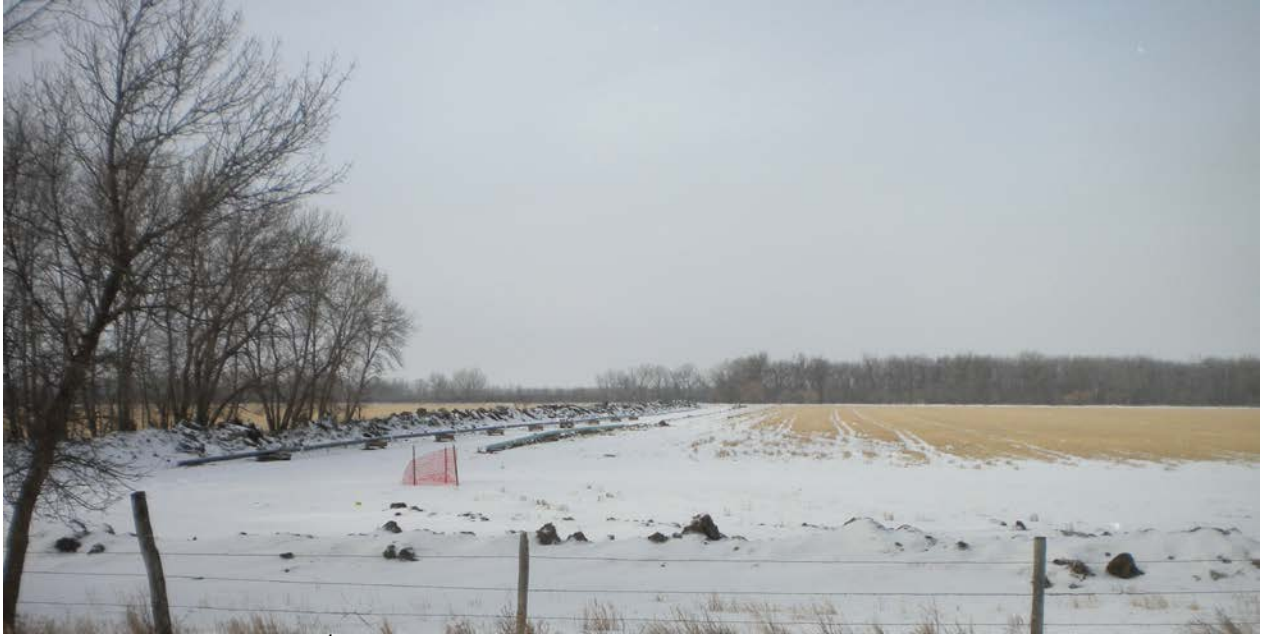
**Photo 4:** Looking west from 157<sup>th</sup> Ave. NW at pipe strung for installation up to eastern side of Yellowstone River and tie-in into Yellowstone River HDD.

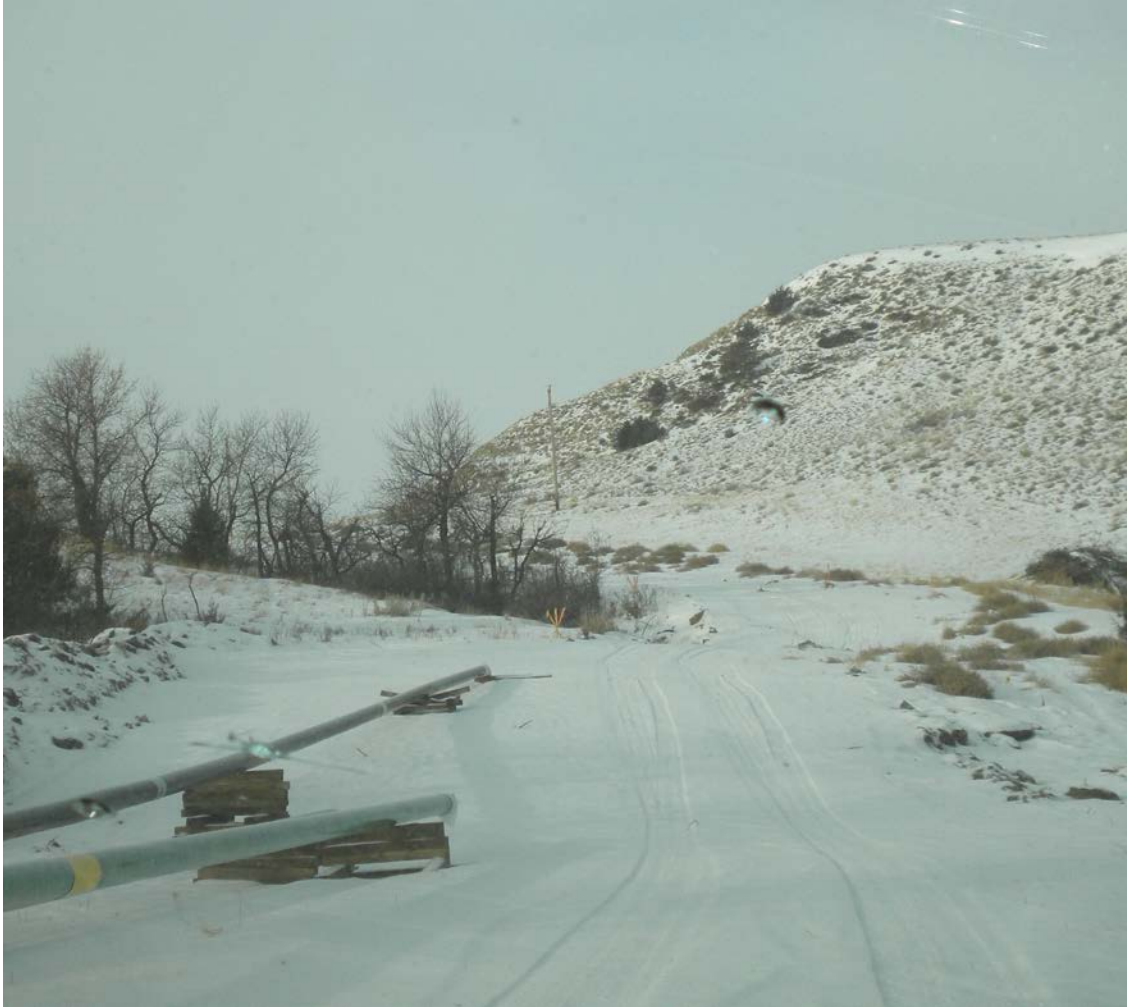
**Photo 5:** Looking west from Project ROW just north of 36<sup>th</sup> Street NW; orange 3 piece flags mark entrance/exit points of planned HDDs to avoid trees, cultural site and protected plant. The majority of this hill will be HDD to avoid the rough terrain including the aforementioned sensitive features. No Trees will be removed during construction.
