In re: Enbridge Pipelines (North Dakota) LLC  
Bakken Pipeline Project US  
Ward & Burke Counties  
Case No. PU-10-612  
Our File No. 31-411-004

Enclosed for filing in the above captioned matter please find two copies of responses to Mr. Patrick Fahn's request dated August 19, 2015, regarding Final Construction Inspection Reports.

### 4.1 Berthold Station Mitigation Wetland

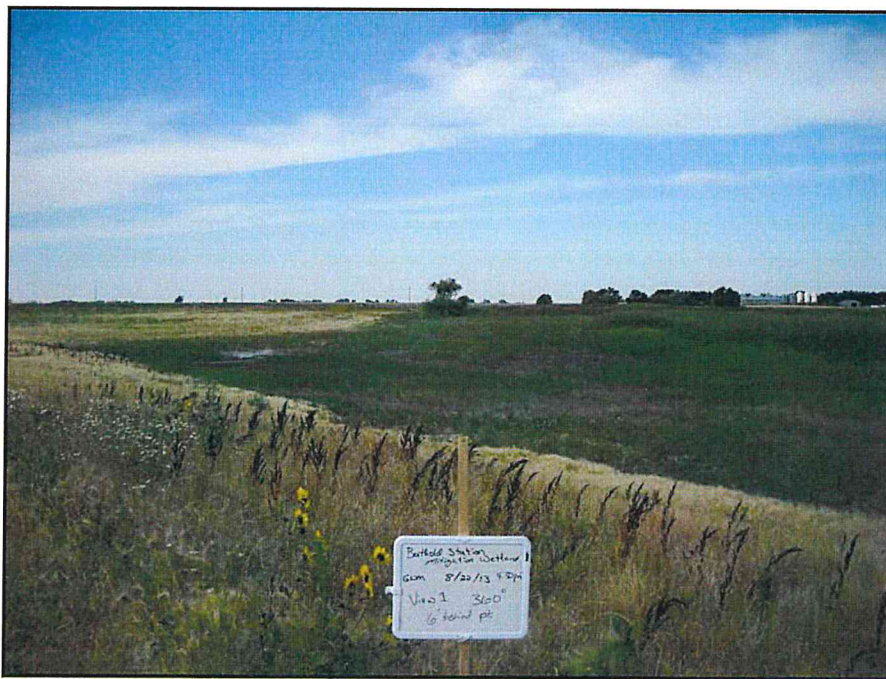
Photograph 1. 2013 view of the Berthold Station Mitigation Wetland from photopoint 1. The mitigation wetland contained hydrophytic vegetation and indications of wetland hydrology. Photograph taken facing north.

Photographs 1 and 2 depict the 2013 conditions of the mitigation wetland. Indication of wetland hydrology was present throughout the mitigation wetland. Sediment deposits, salt crusts, and surface soil cracks were present in the mitigation wetland as well as inundation within a small area near the entrance of the storm drain. Wetland hydrology was determined to be present within the mitigation wetland.

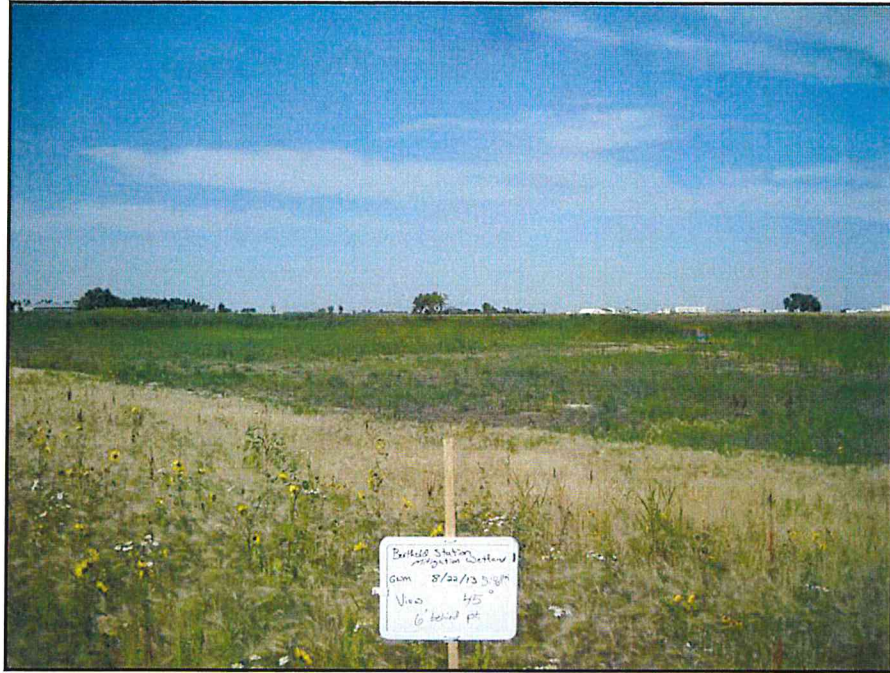
Photograph 2. 2013 view of the Berthold Station Mitigation Wetland from photopoint 2. The mitigation wetland contained hydrophytic vegetation and indications of wetland hydrology. Photograph taken facing northeast.

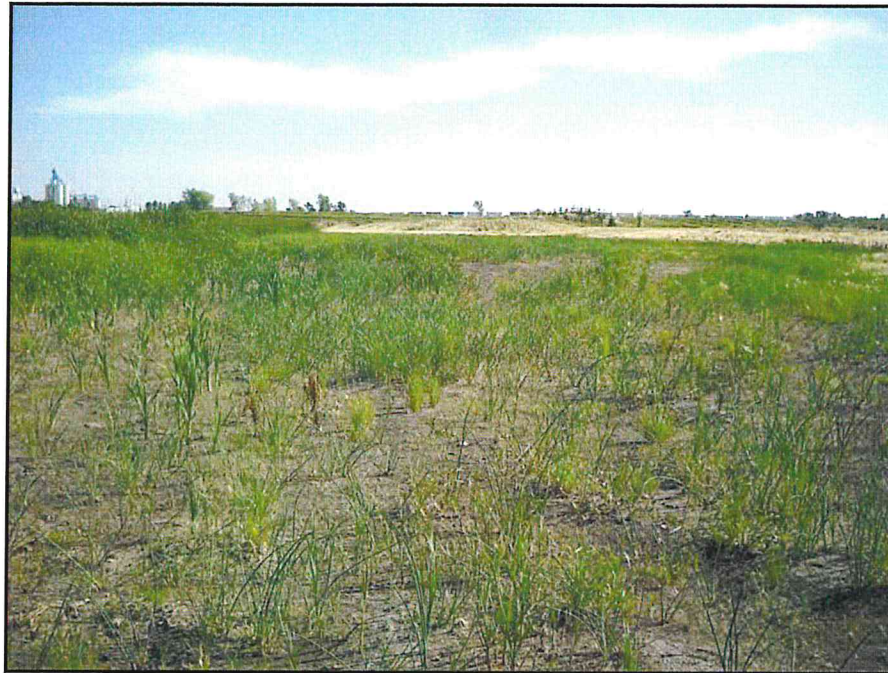
Photograph 3. Sporadic hydrophytic vegetation was established within the mitigation wetland; however, there was also a prevalence of areas of exposed bare soil.

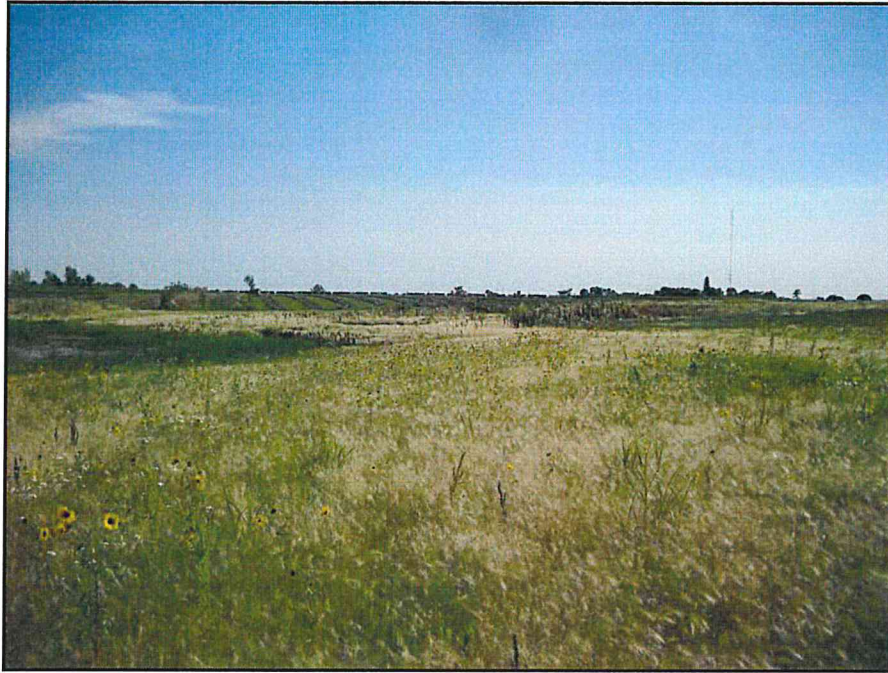
Four observation points were sampled within the established upland buffer that is located along the west side of the mitigation wetland. The upland buffer is 50-foot wide and is currently dominated with with foxtail barley (*Hordeum jubatum*) and annual sunflower (*Helianthus annuus*) (Photograph 4). Other species observed with less canopy coverage include black-eyed susan (*Rudbeckia hirta*) and blanket flower (*Gaillardia aristata*). Few of the planted species were documented within the upland buffer but additional time will allow these species to outcompete foxtail barley. The amount of bare ground cover was insignificant in the upland buffer. A few sporadic noxious weeds were documented and they comprise less than a single percent of the overall areal coverage. More years are needed for the planted species to out-compete the existing vegetation and become the dominant species.

Photograph 4. Vegetation in the upland buffer is well established but does not comprise the planted species.

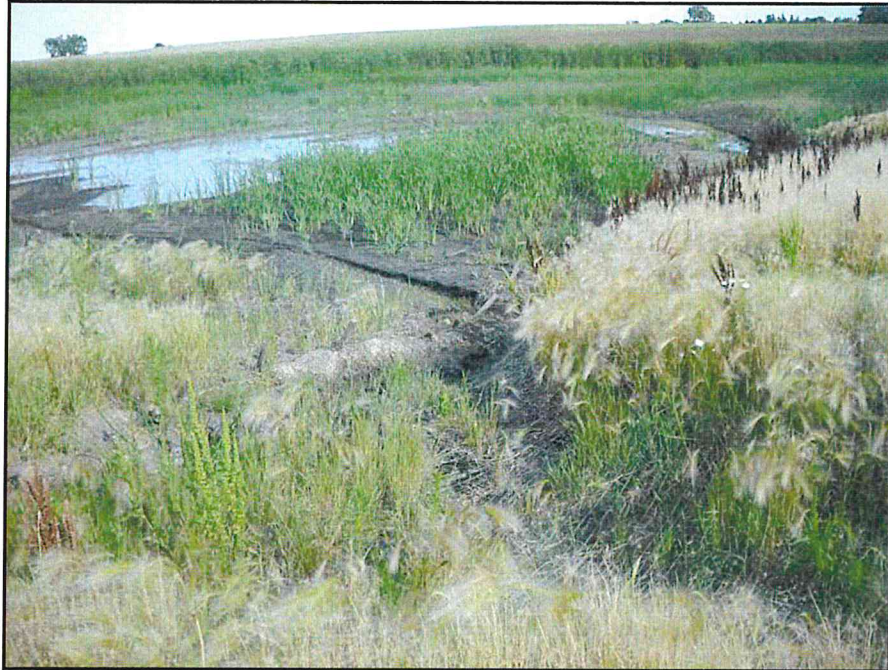
Overall, few problem areas exist within the mitigation wetland. A small area of erosion was noted near the retention pond at the end of the storm drain (Photographs 5 and 6). The eroded cut is quite small at this time but should be filled in to keep from washing out the upland buffer and placing sediment in the mitigation wetland. Further, Enbridge will replace coconut logs to slow down the flow and evaluate methods to prevent future erosion events.

Photograph 5. An erosion area located near the retention pond at the end of the storm water drain has cut through the upland buffer and washed sediment into the mitigation wetland.

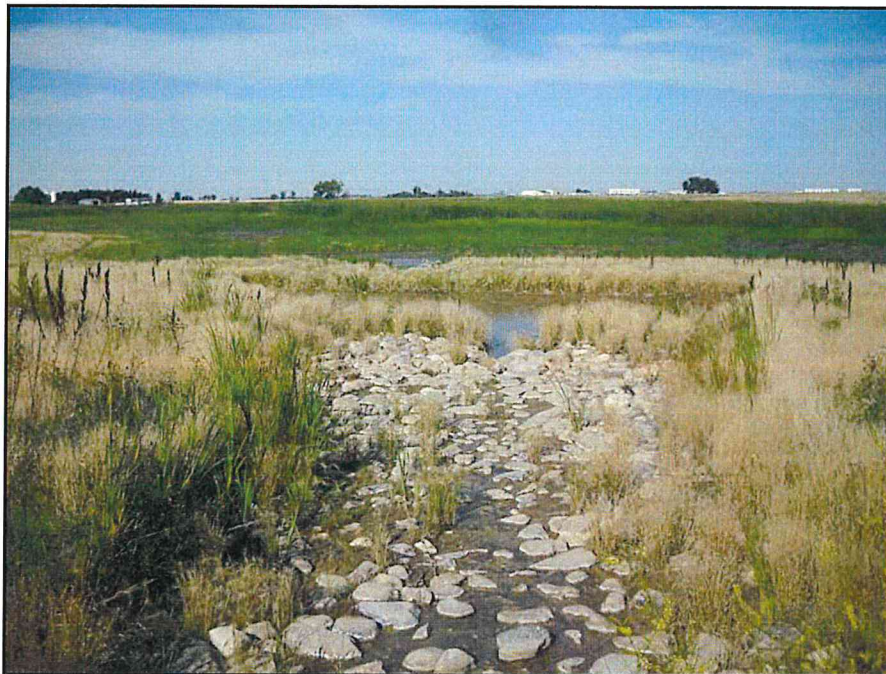
Photograph 6. A storm water drain from the BTUL flows into a retention pond before the mitigation wetland. Excessive runoff caused water to flow out of the retention pond and erode the upland buffer.

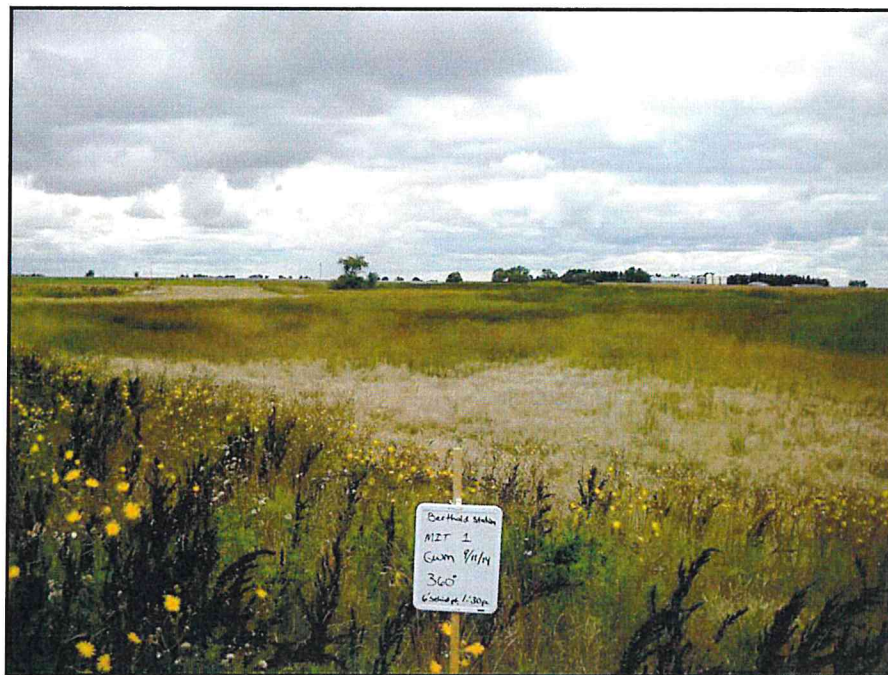
Photograph 1. 2014 view of the Berthold Station Mitigation Wetland from photo point 1. Hydrophytic vegetation and indicators of hydrology have increased within the mitigation wetland. Photograph taken facing north.

Photographs 1 and 3 depict the 2014 conditions of the mitigation wetland. Indication of wetland hydrology was present throughout the mitigation wetland. Sediment deposits, salt crusts, and surface soil cracks were present in the mitigation wetland as well as inundation across the southern half of the mitigation wetland. Indicators of wetland hydrology were determined to be present throughout the mitigation wetland.

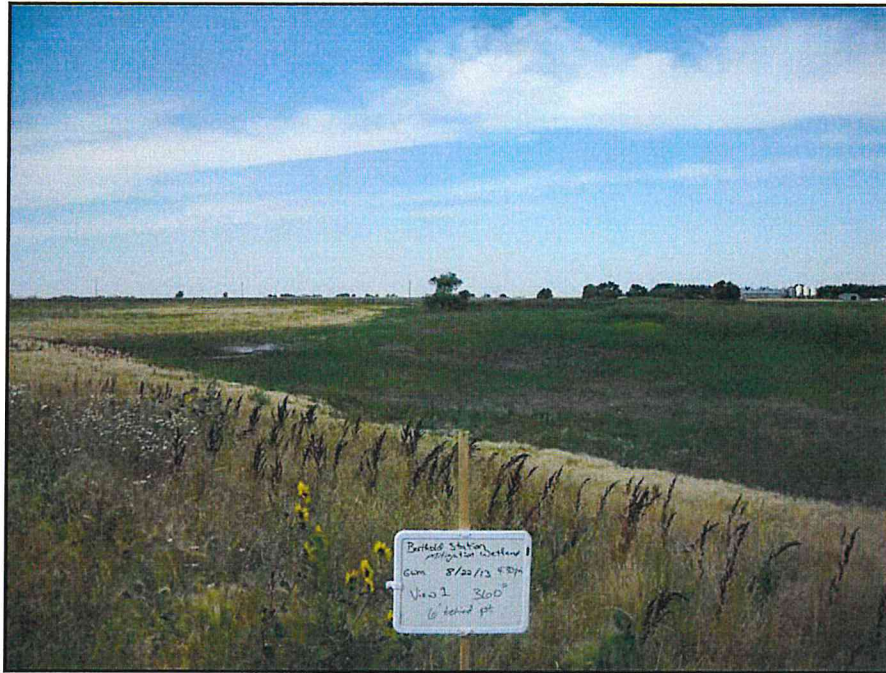
Photograph 2. 2013 view of the Berthold Station Mitigation Wetland from photo point 1. The mitigation wetland contained hydrophytic vegetation and indications of wetland hydrology. Photograph taken facing north.

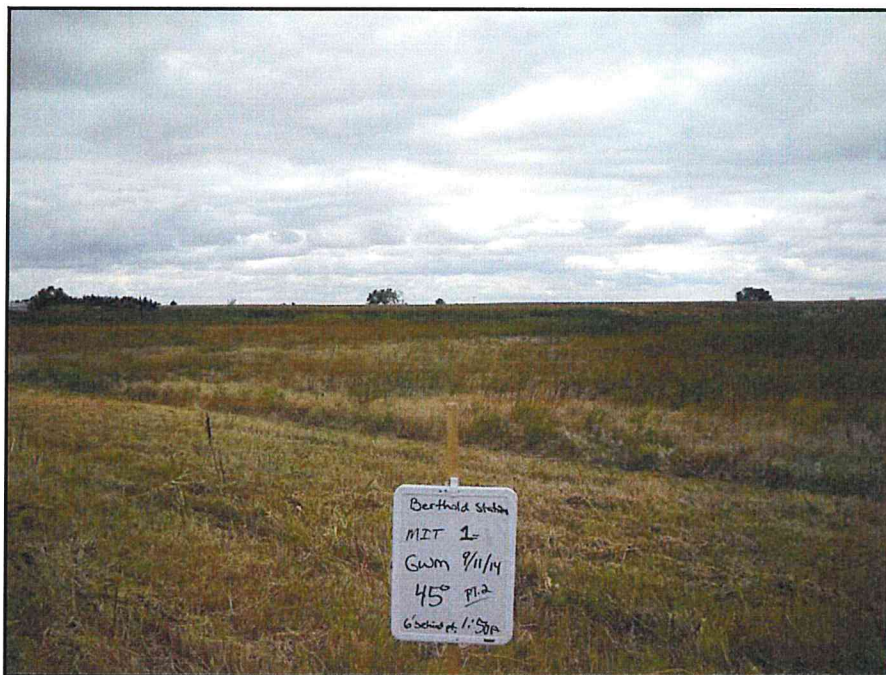
Photograph 3. 2014 view of the Berthold Station Mitigation Wetland from photo point 2. Hydrophytic vegetation has increased within the mitigation wetland. The adjacent buffer was mowed prior to the monitoring visit. Photograph taken facing northeast.

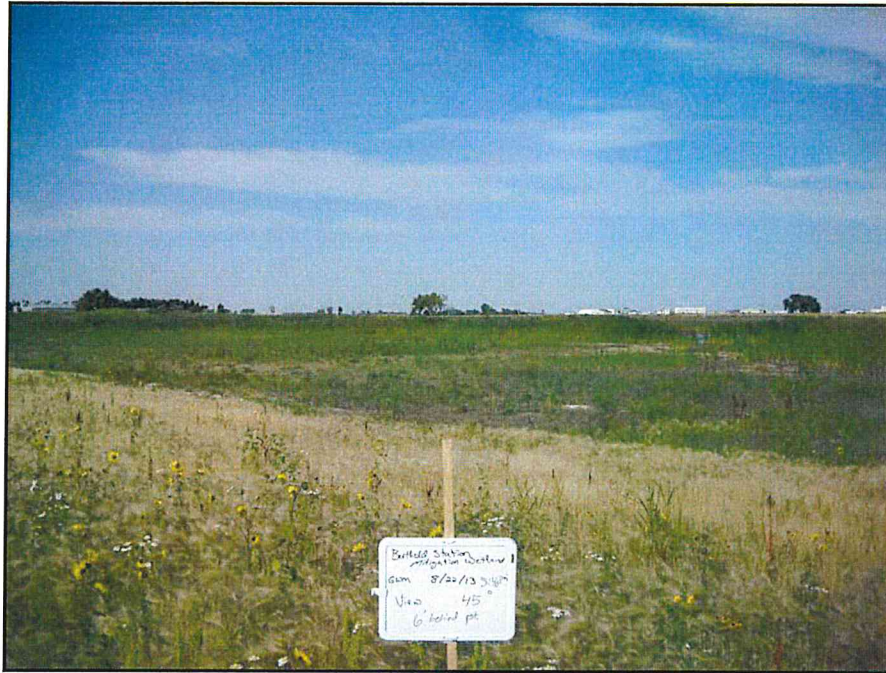
Photograph 4. 2013 view of the Berthold Station Mitigation Wetland from photo point 2. The mitigation wetland contained hydrophytic vegetation and indications of wetland hydrology. Photograph taken facing northeast.

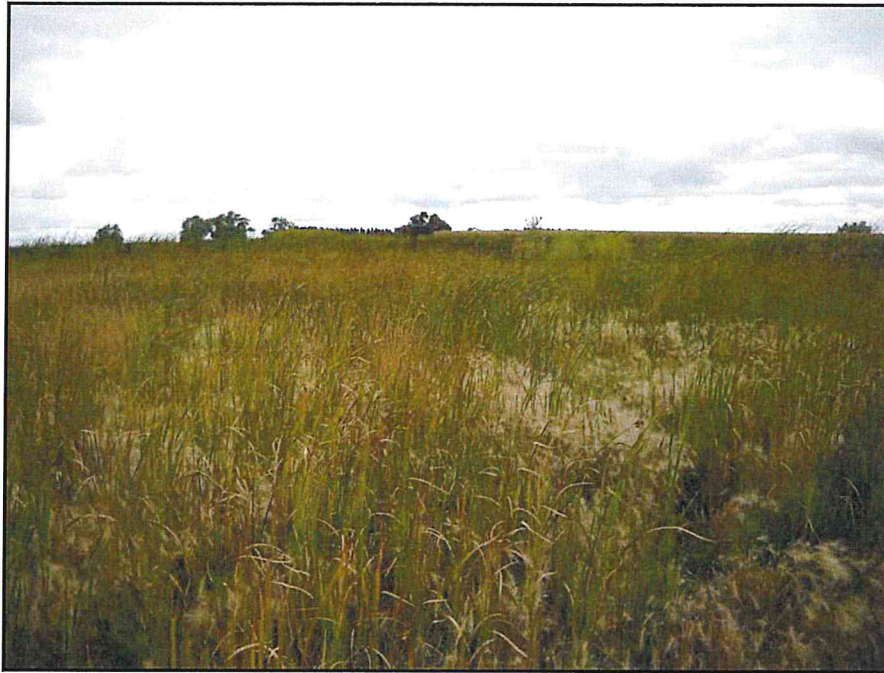
Photograph 5. Hydrophytic vegetation has increased significantly since the 2013 monitoring visit.

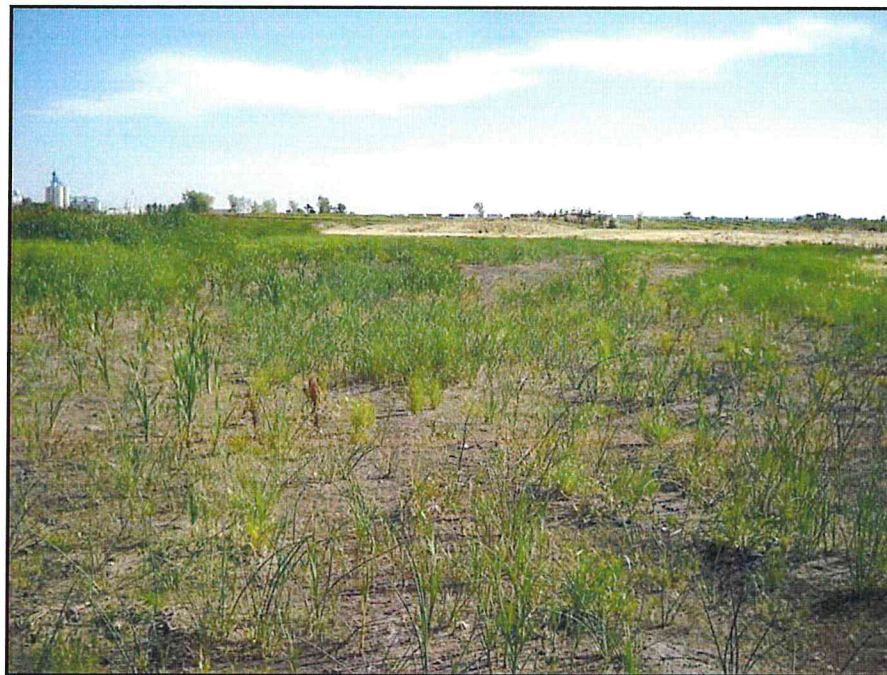
Photograph 6. Sporadic hydrophytic vegetation was established within the mitigation wetland; however, there was also a prevalence of areas of exposed bare soil. Photograph taken in 2013.

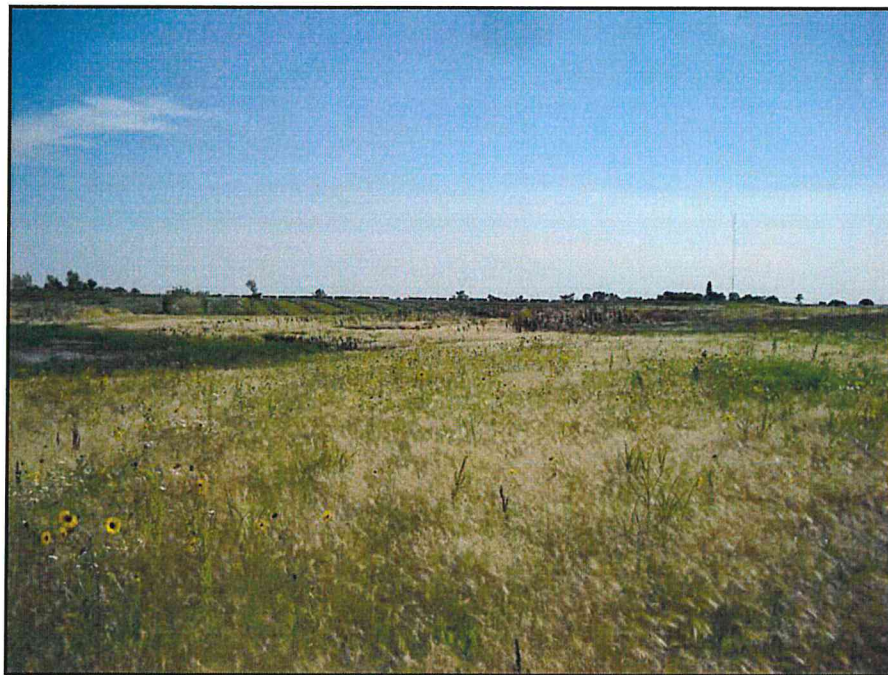
Four observation points were sampled within the established upland buffer that is located along the west side of the mitigation wetland. The upland buffer is 50-foot wide and is currently dominated with with foxtail barely (*Hordeum jubatum*), slender wheatgrass (*Elymus trachycaulus*), and annual sunflower (*Helianthus annuus*) (Photograph 4). Other species observed with less canopy coverage include black-eyed susan (*Rudbeckia hirta*) and sow thistle (*Sonchus arvensis*). More of the planted species were observed during the 2014 monitoring visit than during last year's visit. The amount of bare ground cover was insignificant in the upland buffer. Overall few sporadic noxious weeds were documented and they comprise approximately two percent of the overall areal coverage; however, a large patch of Canada thistle (*Cirsium arvense*) is located near photo point 1. More years are needed for the planted species to out-compete the existing vegetation and become the dominant species.

Photograph 7. 2013 view of vegetation in the upland buffer is well established but does not comprise the planted species. Additional planted species were observed during the 2014 monitoring visit.

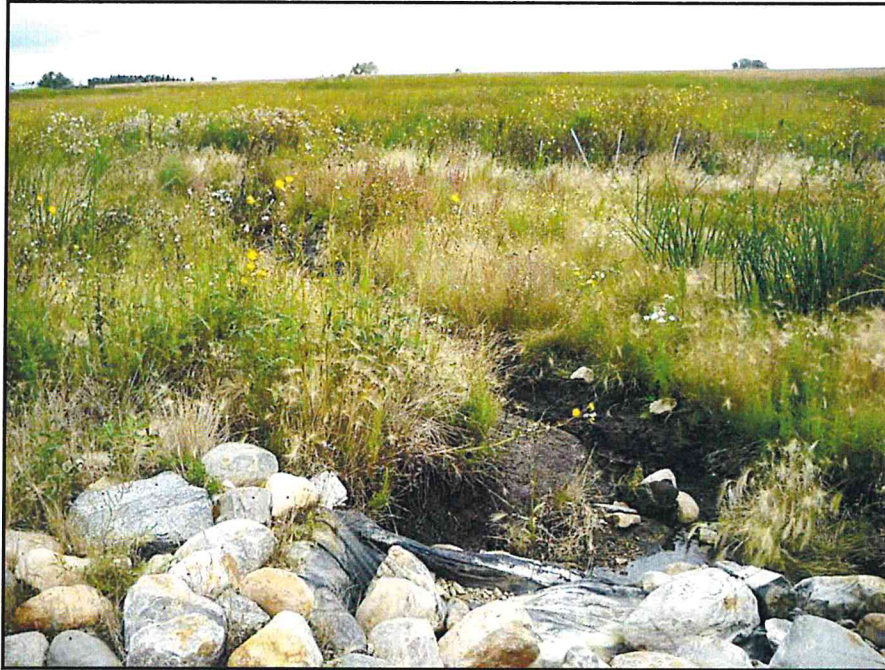
Overall, few problem areas exist within the mitigation wetland. An erosion cut was noted near the retention pond at the end of the storm drain (Photographs 8 and 9). The eroded cut is sizeable and should be filled in to keep from washing out the upland buffer and placing sediment in the mitigation wetland. Rocks or a culvert should be placed in the erosion cut to minimize any further erosion.

Photograph 8. An erosion area located near the retention pond at the end of the storm water drain has cut through the upland buffer and washed sediment into the mitigation wetland.

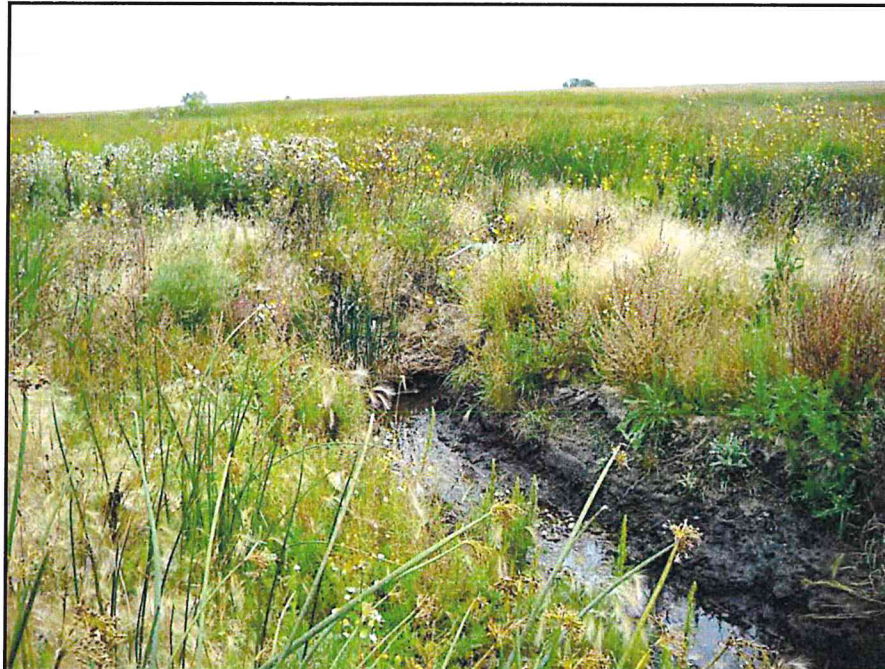
Photograph 9. Close-up of erosion cut located at the end of the stormwater drain.
