Appendix C

Representative Photographs

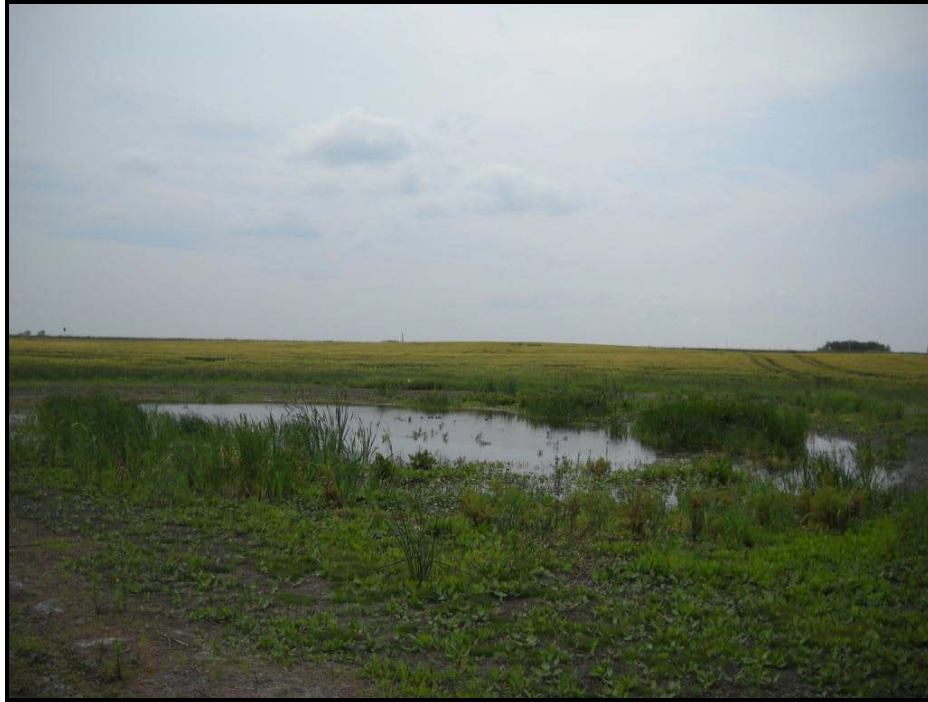
Photograph 1. Representative depression wetland located in cultivated field. Field was planted to canola. Many of the wetlands located in the pipeline corridor were inundated with water due to wet conditions. Wetland is located near Berthold, North Dakota.

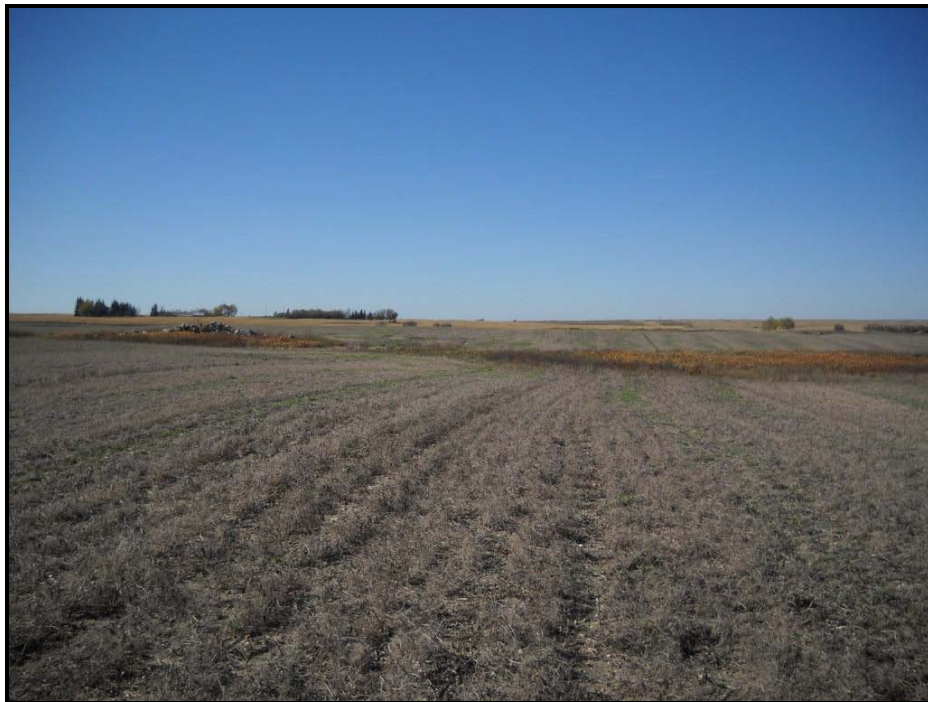
Photograph 2. Representative cultivated wetland found in the Project Area. Photograph was taken in October after harvest. The edges of the wetland were cultivated and planted to peas.

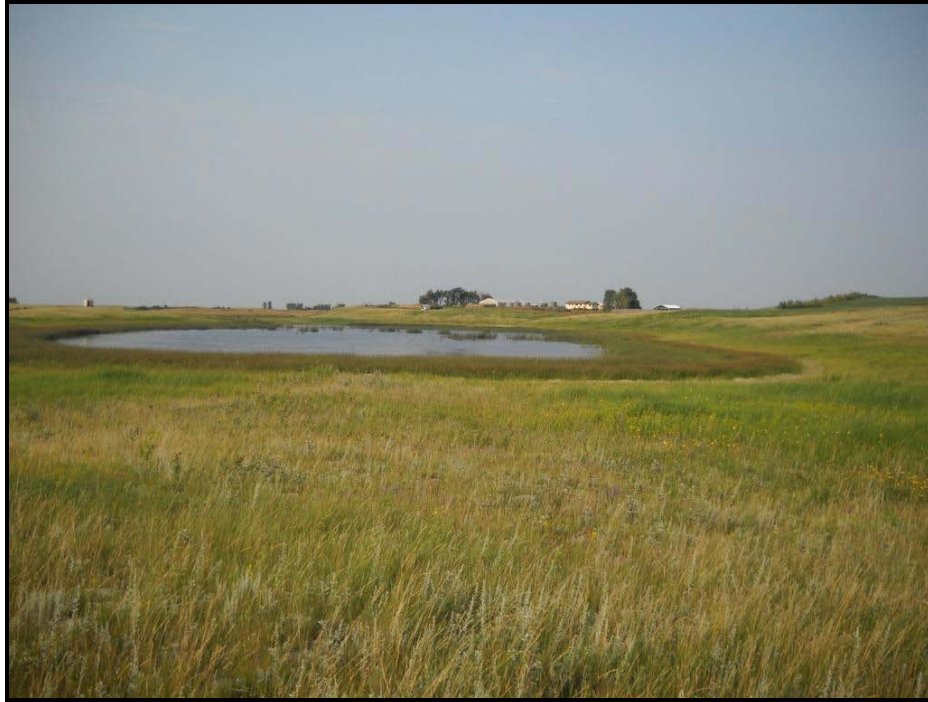
Photograph 3. Large depression wetland with expansive open water located in a native prairie area. Livestock graze the native prairie pasture. Fowl bluegrass and woolly sedge are prevalent along the edge of the wetland boundary.

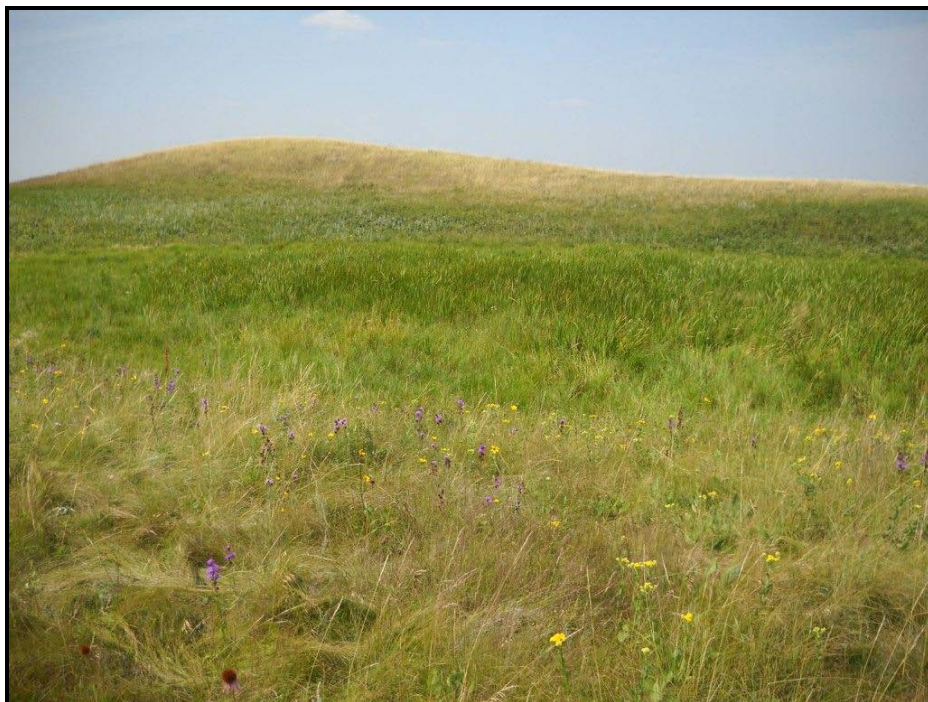
Photograph 4. A representative pothole wetland located in native prairie pastures. The wetland has a NWI designation of PEMC. Giant burreed (*Sparganium eurycarpum*) is present in the wetland interior. Native wildflowers are present in the foreground of the photograph.

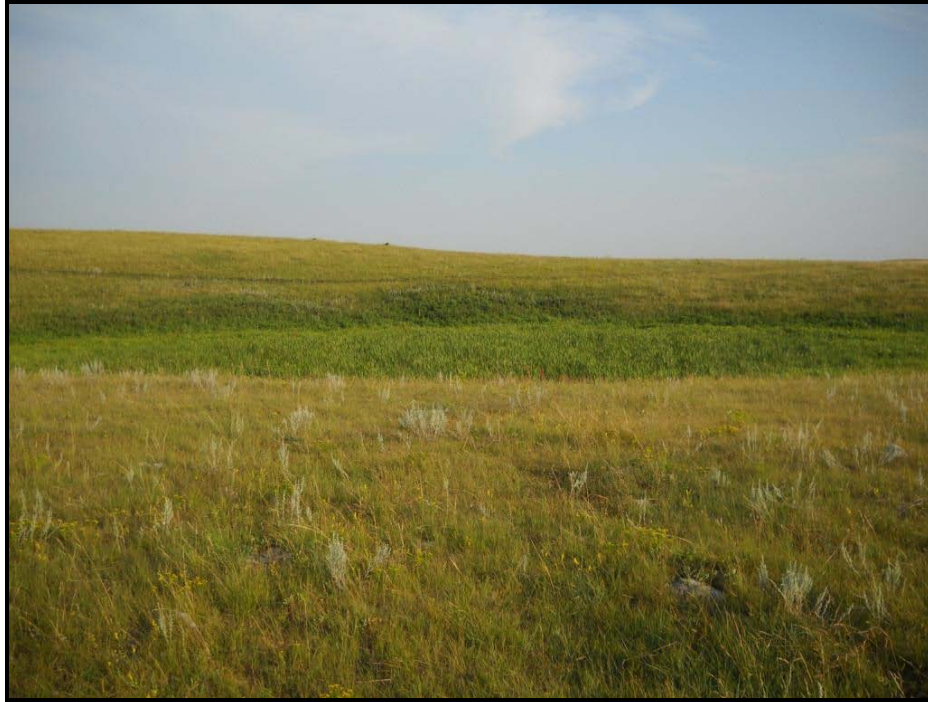
Photograph 5. Representative shallow depression wetland located in native prairie pasture. This is a typical pothole wetland located in the Missouri Coteau Region.

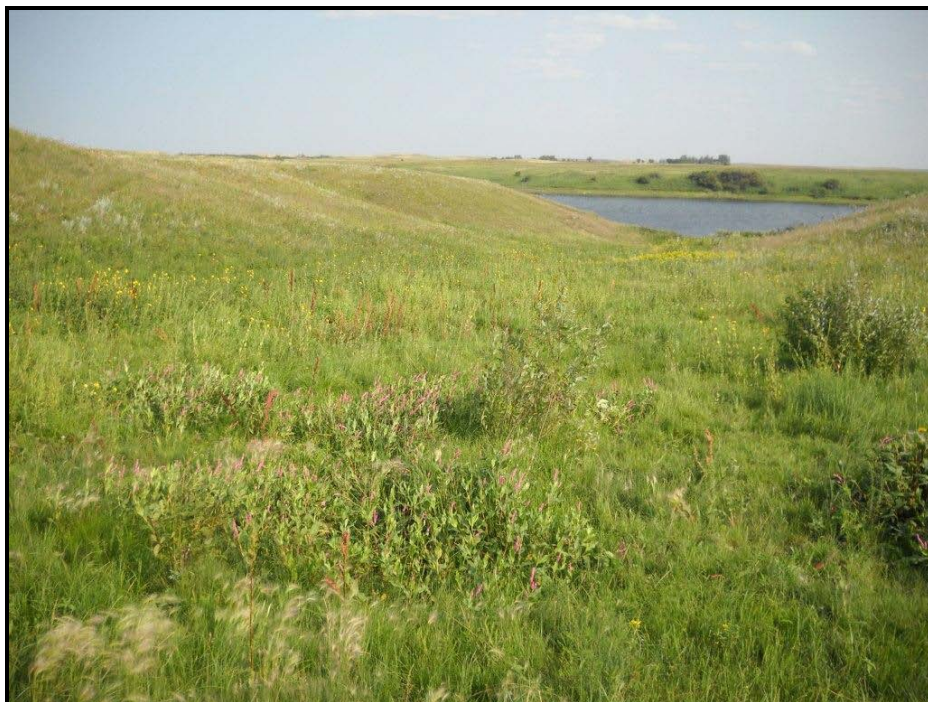
Photograph 6. Sloped wetland that flows through a swale into a large lake. Ground water flows to the ground surface at on a sideslope and creates a shallow slope wetland. Water smartweed and woolly sedge is present in the wetland area.

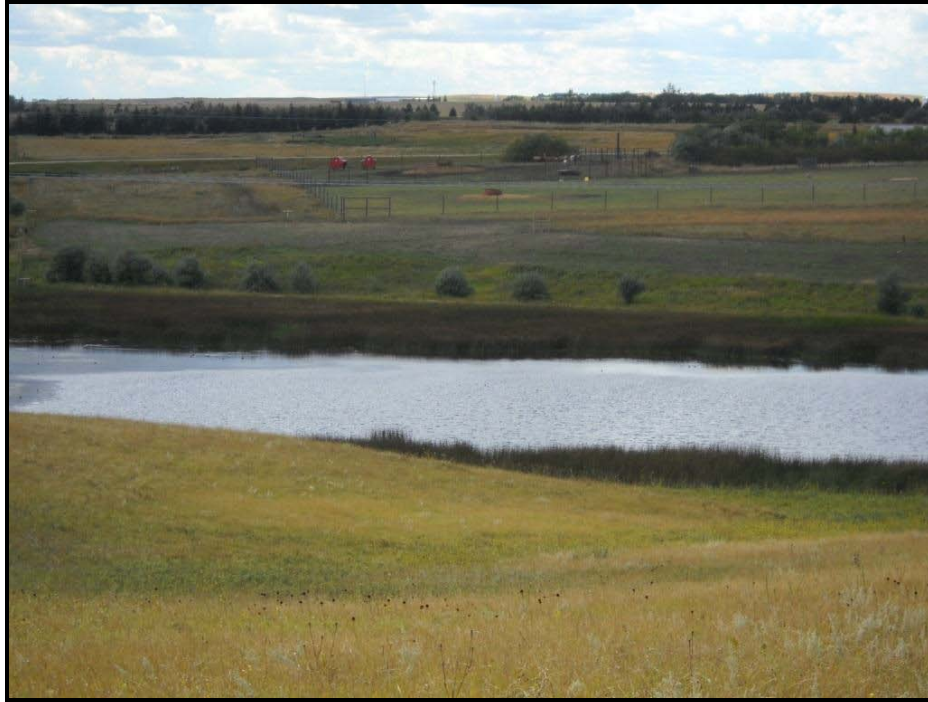
Photograph 7. Stanley Reservoir located east of Stanley, North Dakota. This wetland is part of the Little Knife River system. Bulrush is prevalent between the shoreline and the deep water area of the reservoir. Photograph taken facing west. North Dakota Highway 8 is visible in the background of the photograph.

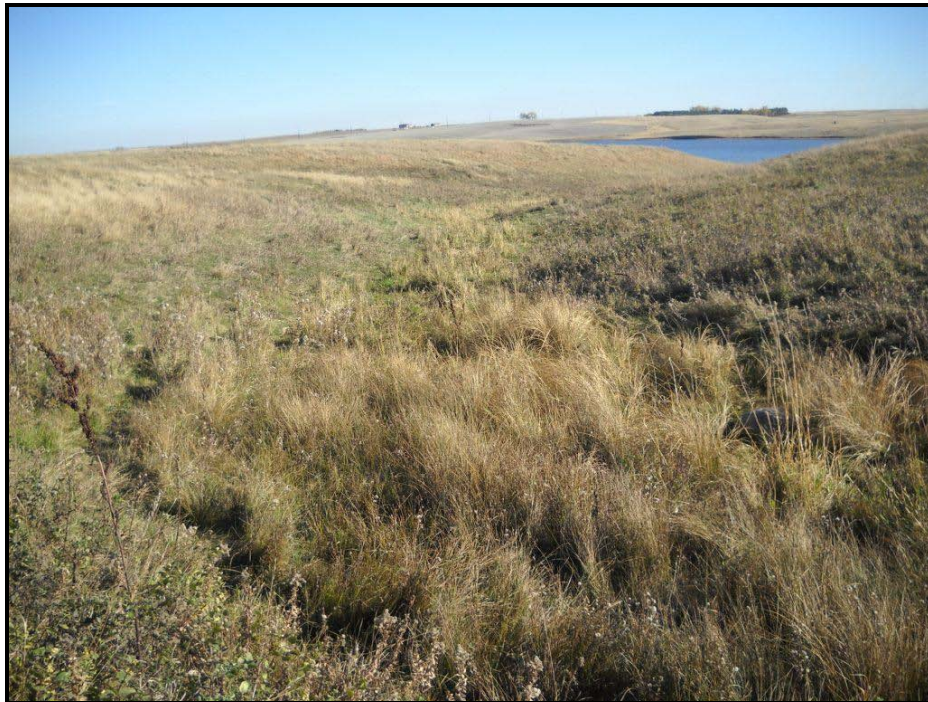
Photograph 8. Swale wetland that flows into the Stanley Reservoir. Stanley Reservoir is visible in the background. Prairie cordgrass is prevalent in the swale.
