**Memorandum**

To: Bill Behling, Joe Griffiths, Bob Evans, Capital Power Corporation, Inc.  
From: Steve Yarbrough, Sarah McCall, Tetra Tech, Inc.  
Date: May 2, 2018  
Project: New Frontier Wind Energy Project  
Subject: Evaluation of Wetlands within Previously Un-Surveyed Areas of Project Layout

**To:** Bill Behling, Joe Griffiths, Bob Evans, Capital Power Corporation, Inc.  
**From:** Sarah McCall, Chris Ansari, Karen Brimacombe, Tetra Tech, Inc.  
**Date:** November 27, 2017  
**Project:** New Frontier Wind Energy Project  
**Subject:** Evaluation of Wetlands within Previously Un-surveyed Areas of Project Layout

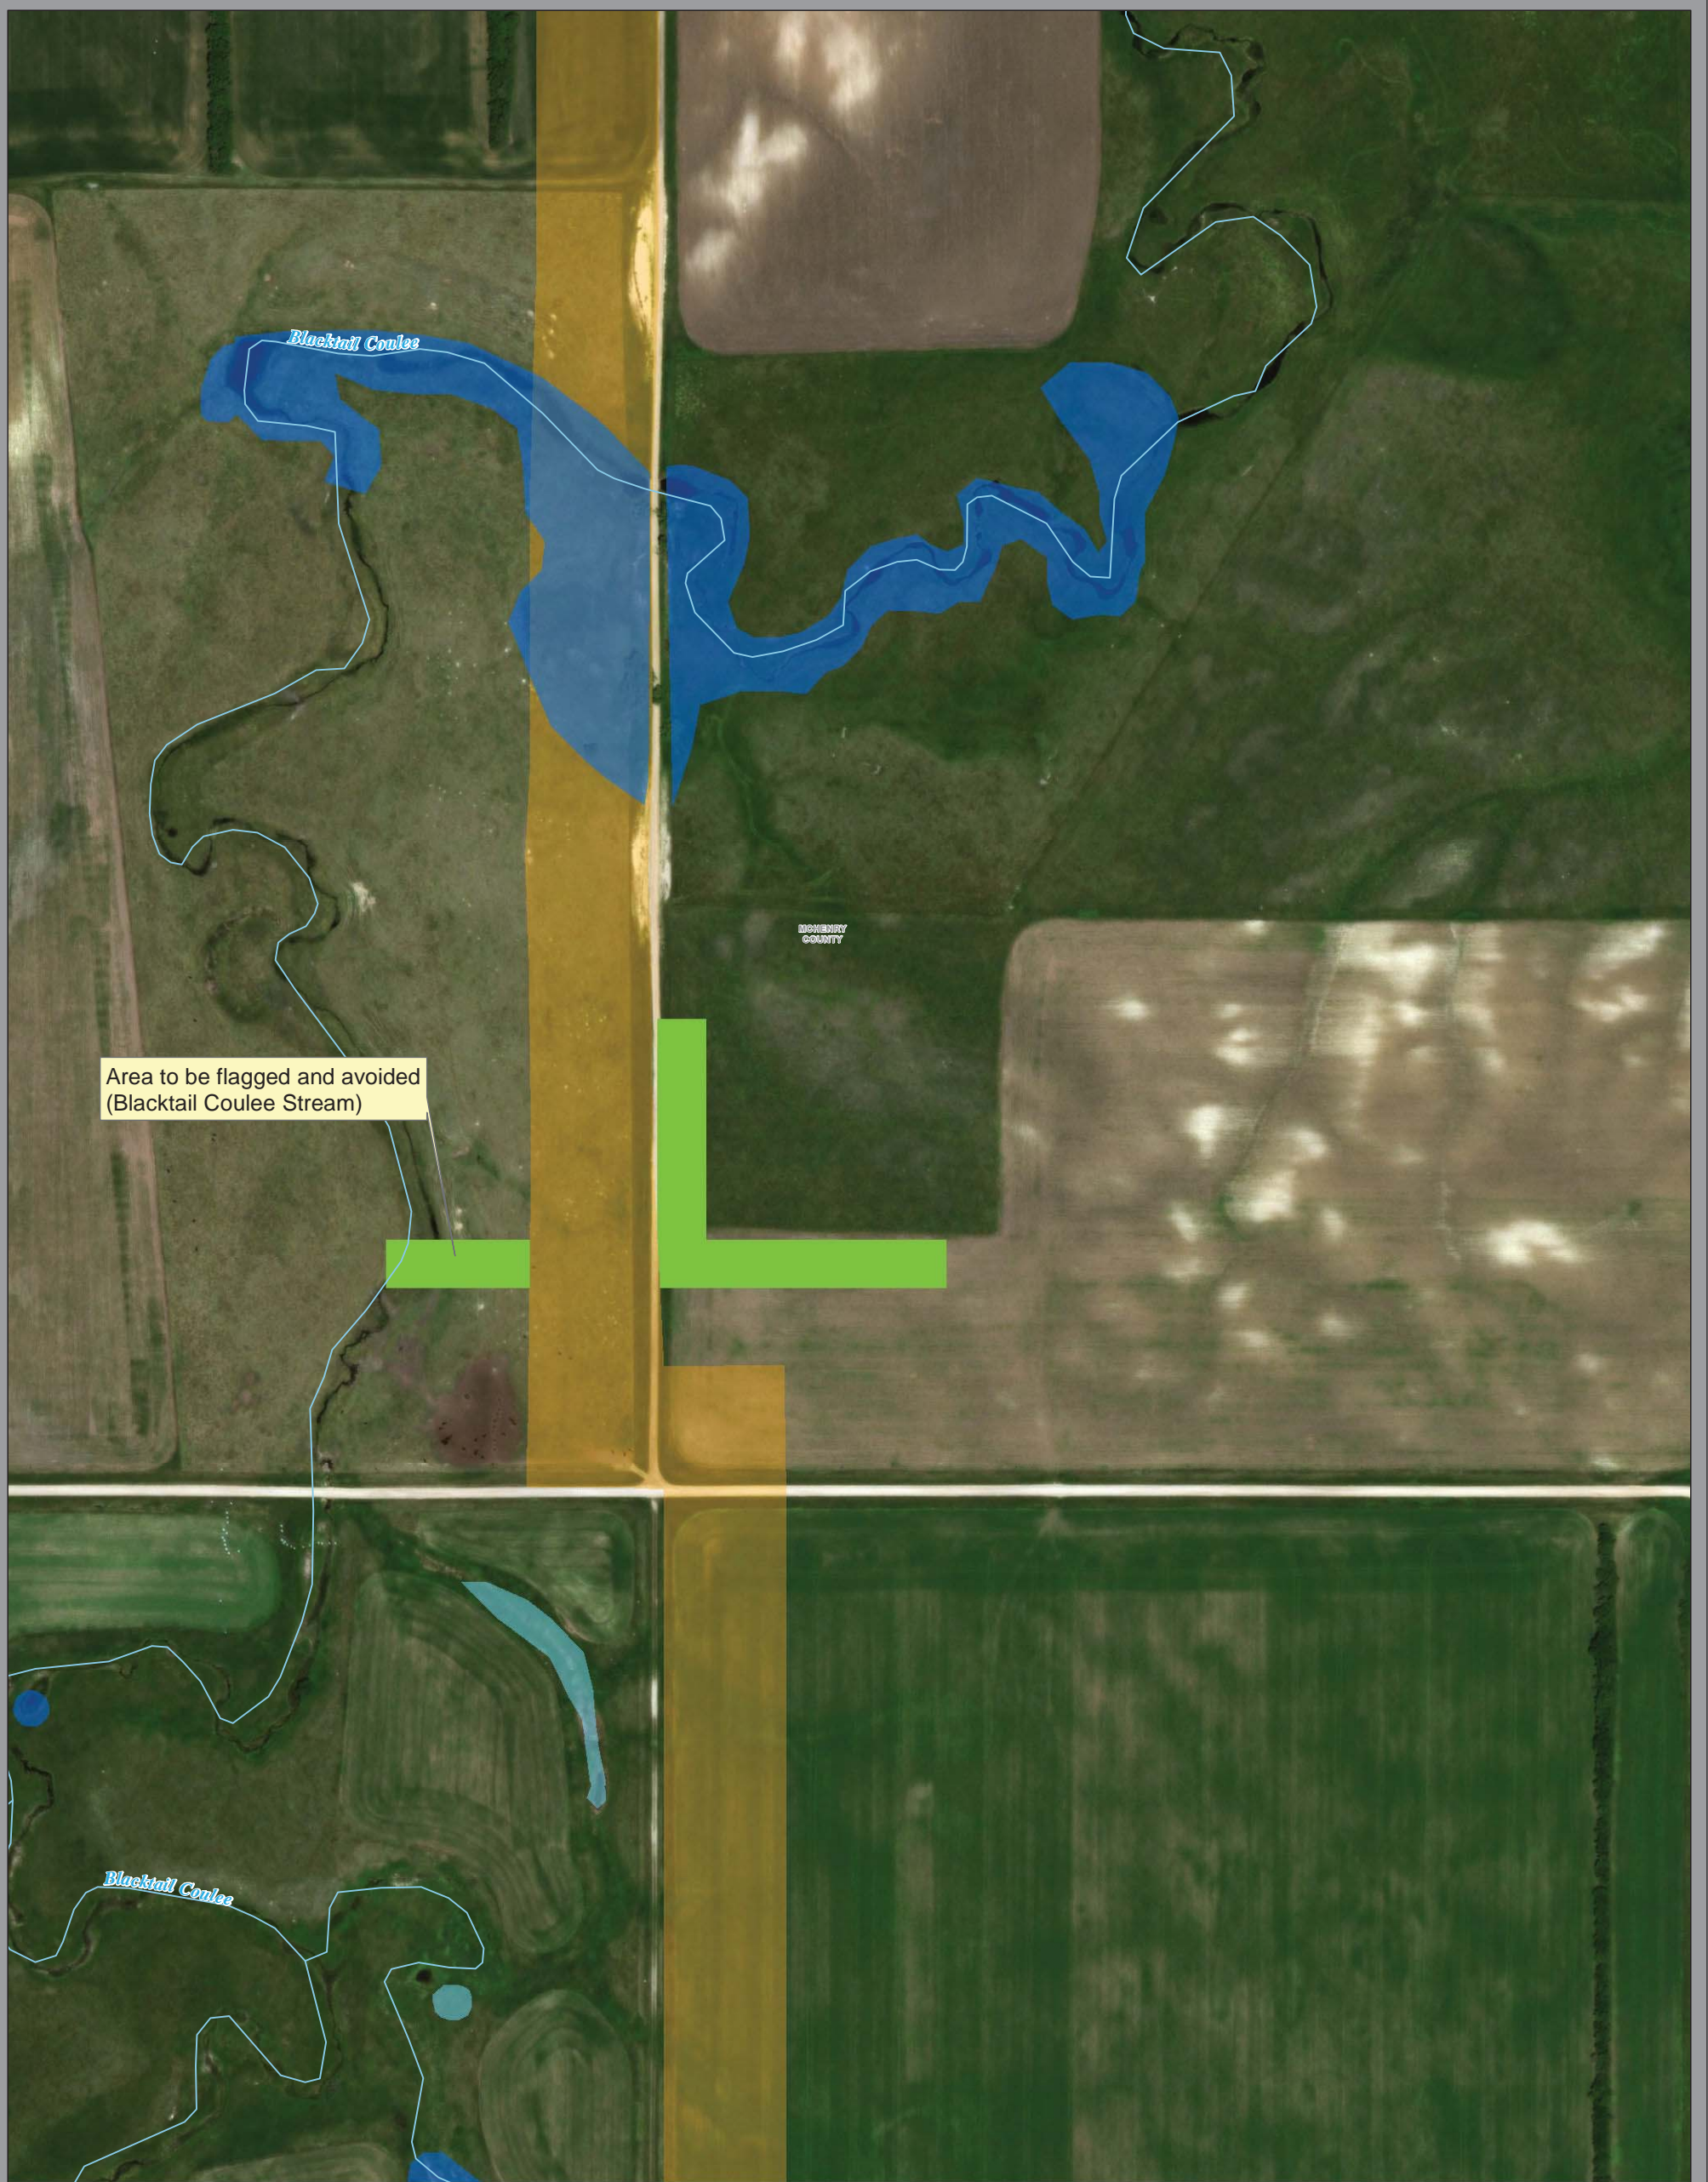
## Stream ST-B-01

**Stream ST-B-01**—The observation point on this stream (Blacktail Coulee) is located at latitude 47.96560893, longitude -100.88844079. This location is near a planned pulling site for the transmission line north of the Project (Figure Stream ST-B-01). The stream will be flagged along its ordinary high water mark prior to construction, and impacts will be avoided in this surface water feature. Observations of this stream were documented using wetland determination forms (Attachment 1).

Area to be flagged and avoided  
(Blacktail Coulee Stream)

OB-B-64			X		Wetland will be flagged prior to construction. Access road to Turbine 19 will avoid any impact to the USACE Jurisdictional Wetland.
ST-B-01				X	Blacktail Coulee. Stream's ordinary high water mark will be flagged prior to construction and the stream will be avoided by activity associated with the transmission line pulling site.

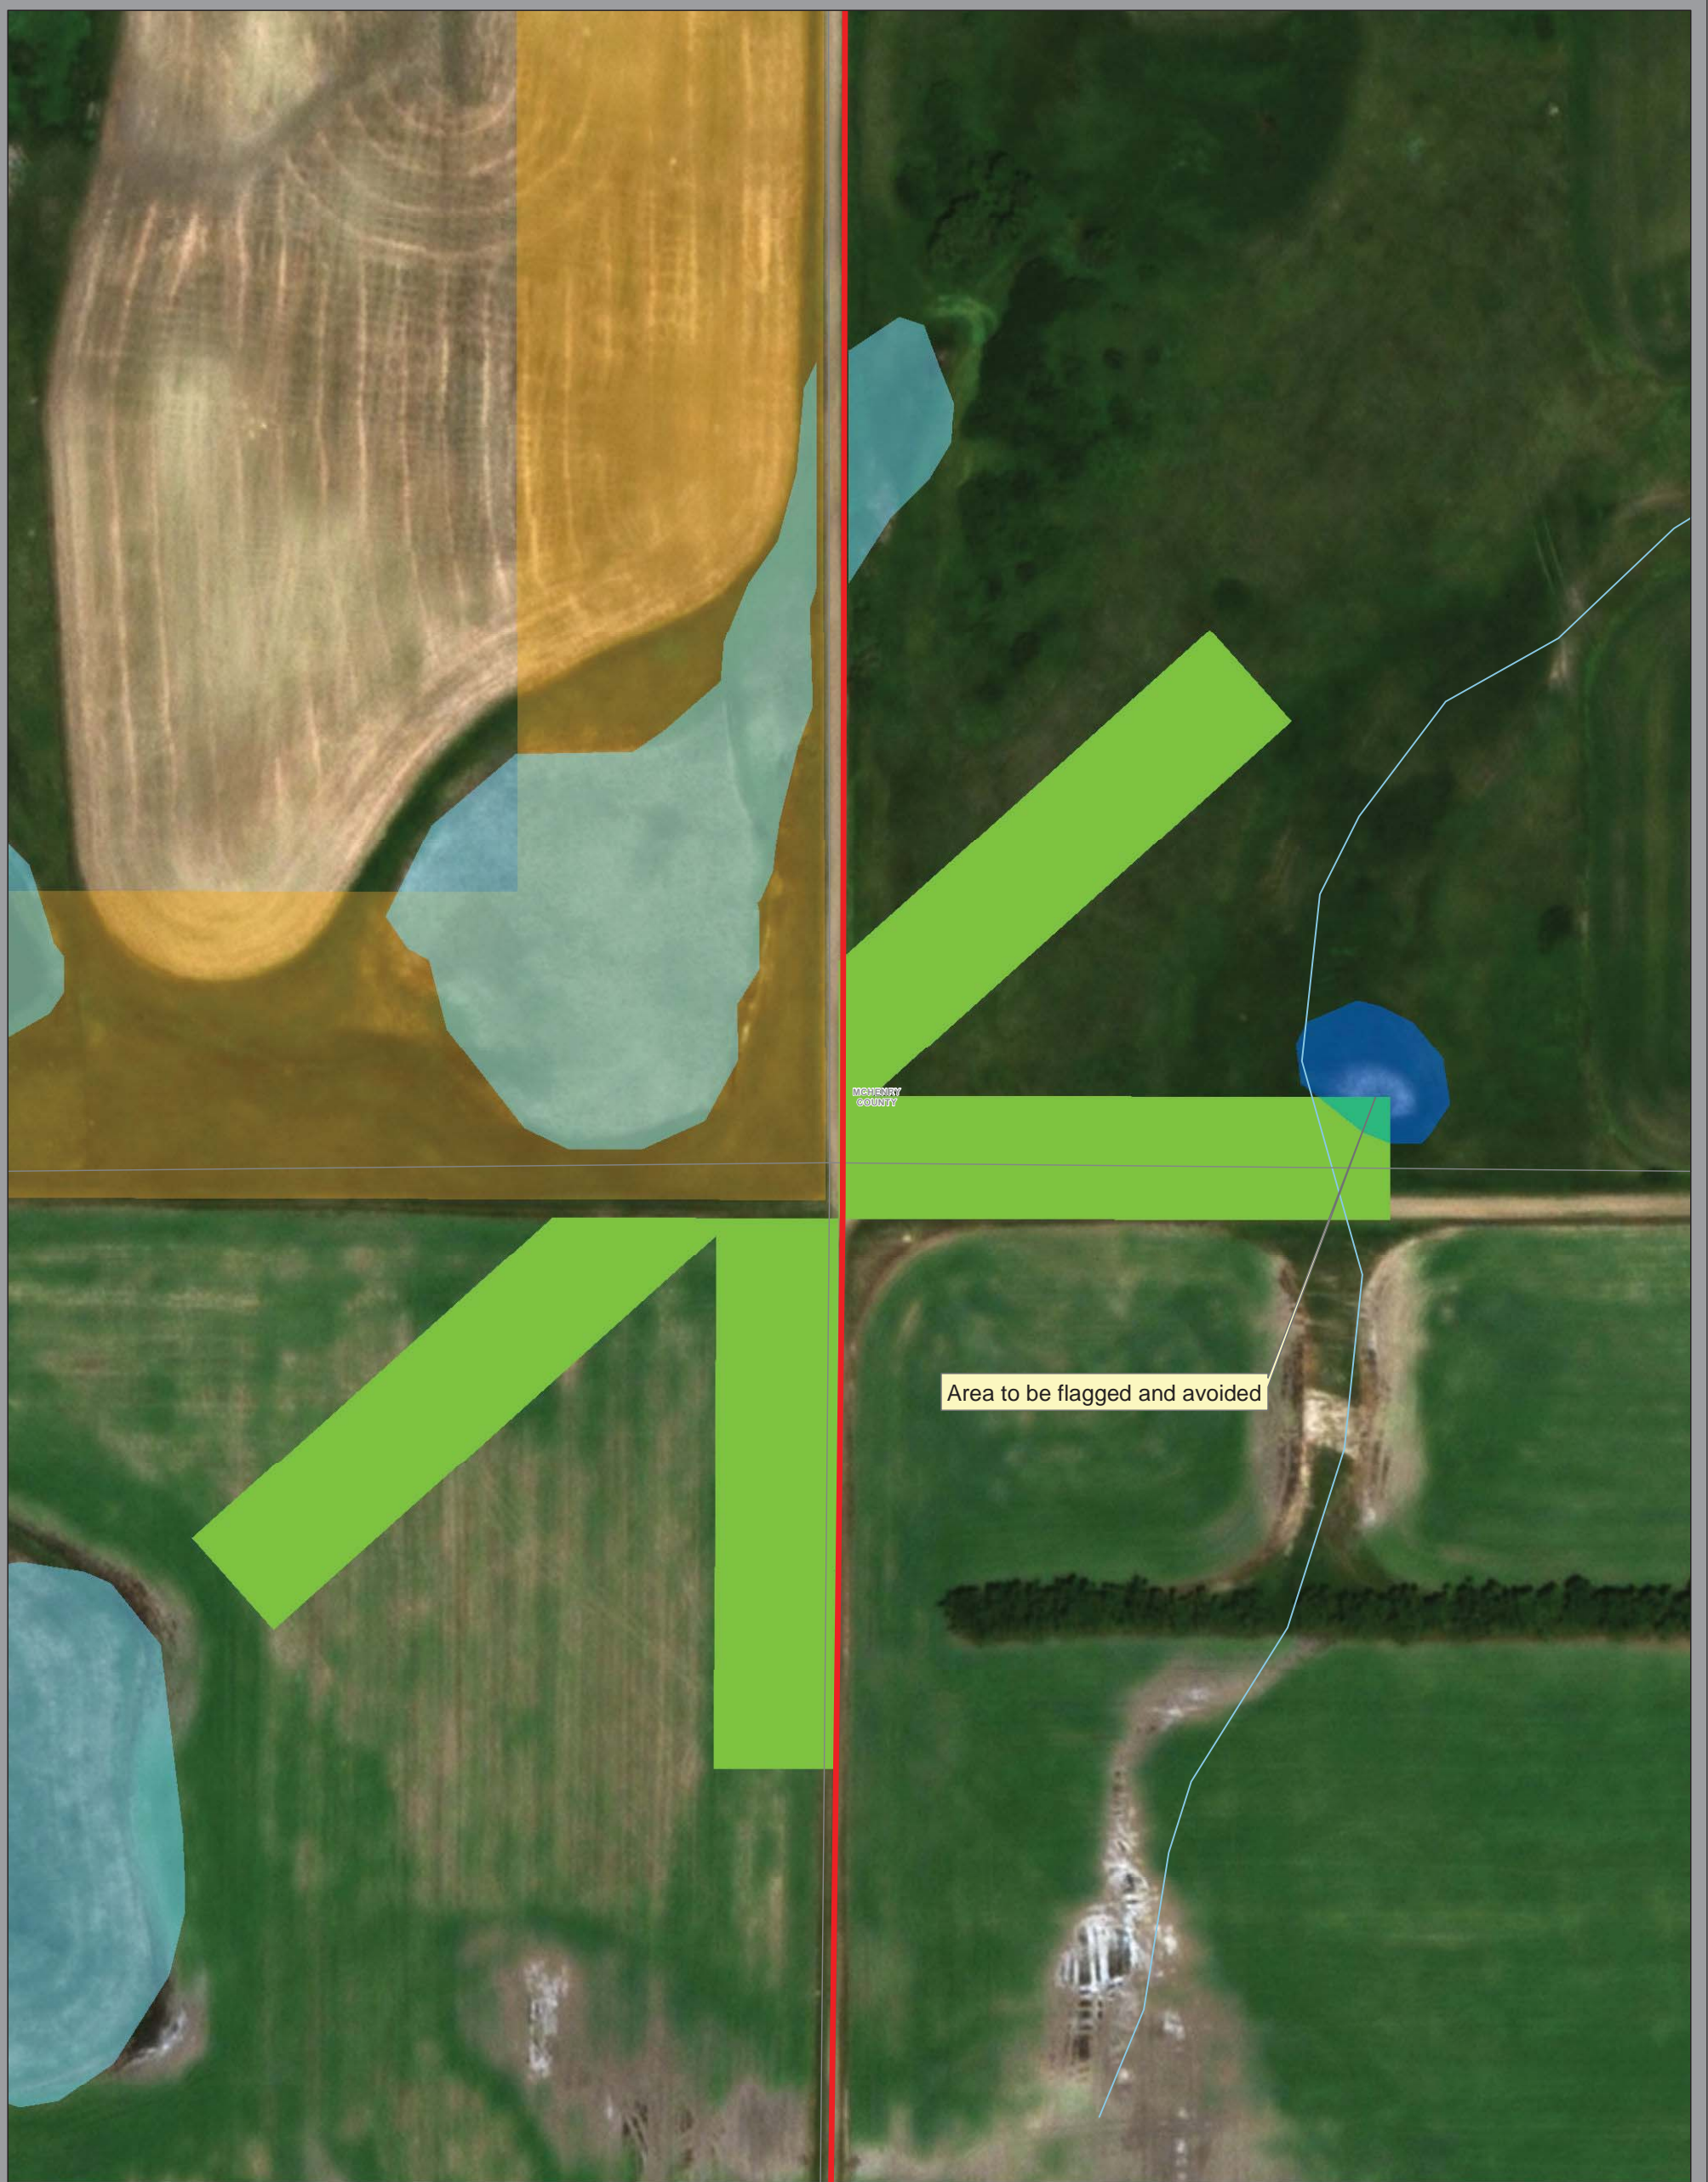
## Observation Point OB-B-58

**Observation Point OB-B-58**— This previously un-surveyed area is near a planned pulling site for the transmission line at latitude 47.86306663, longitude -100.86270185 (Figure Observation Point OB-B-58).

It contains a small portion of a USACE jurisdictional wetland. The wetland boundary will be flagged prior to construction and the planned pulling site along the transmission line will avoid any impact to the jurisdictional wetland feature.

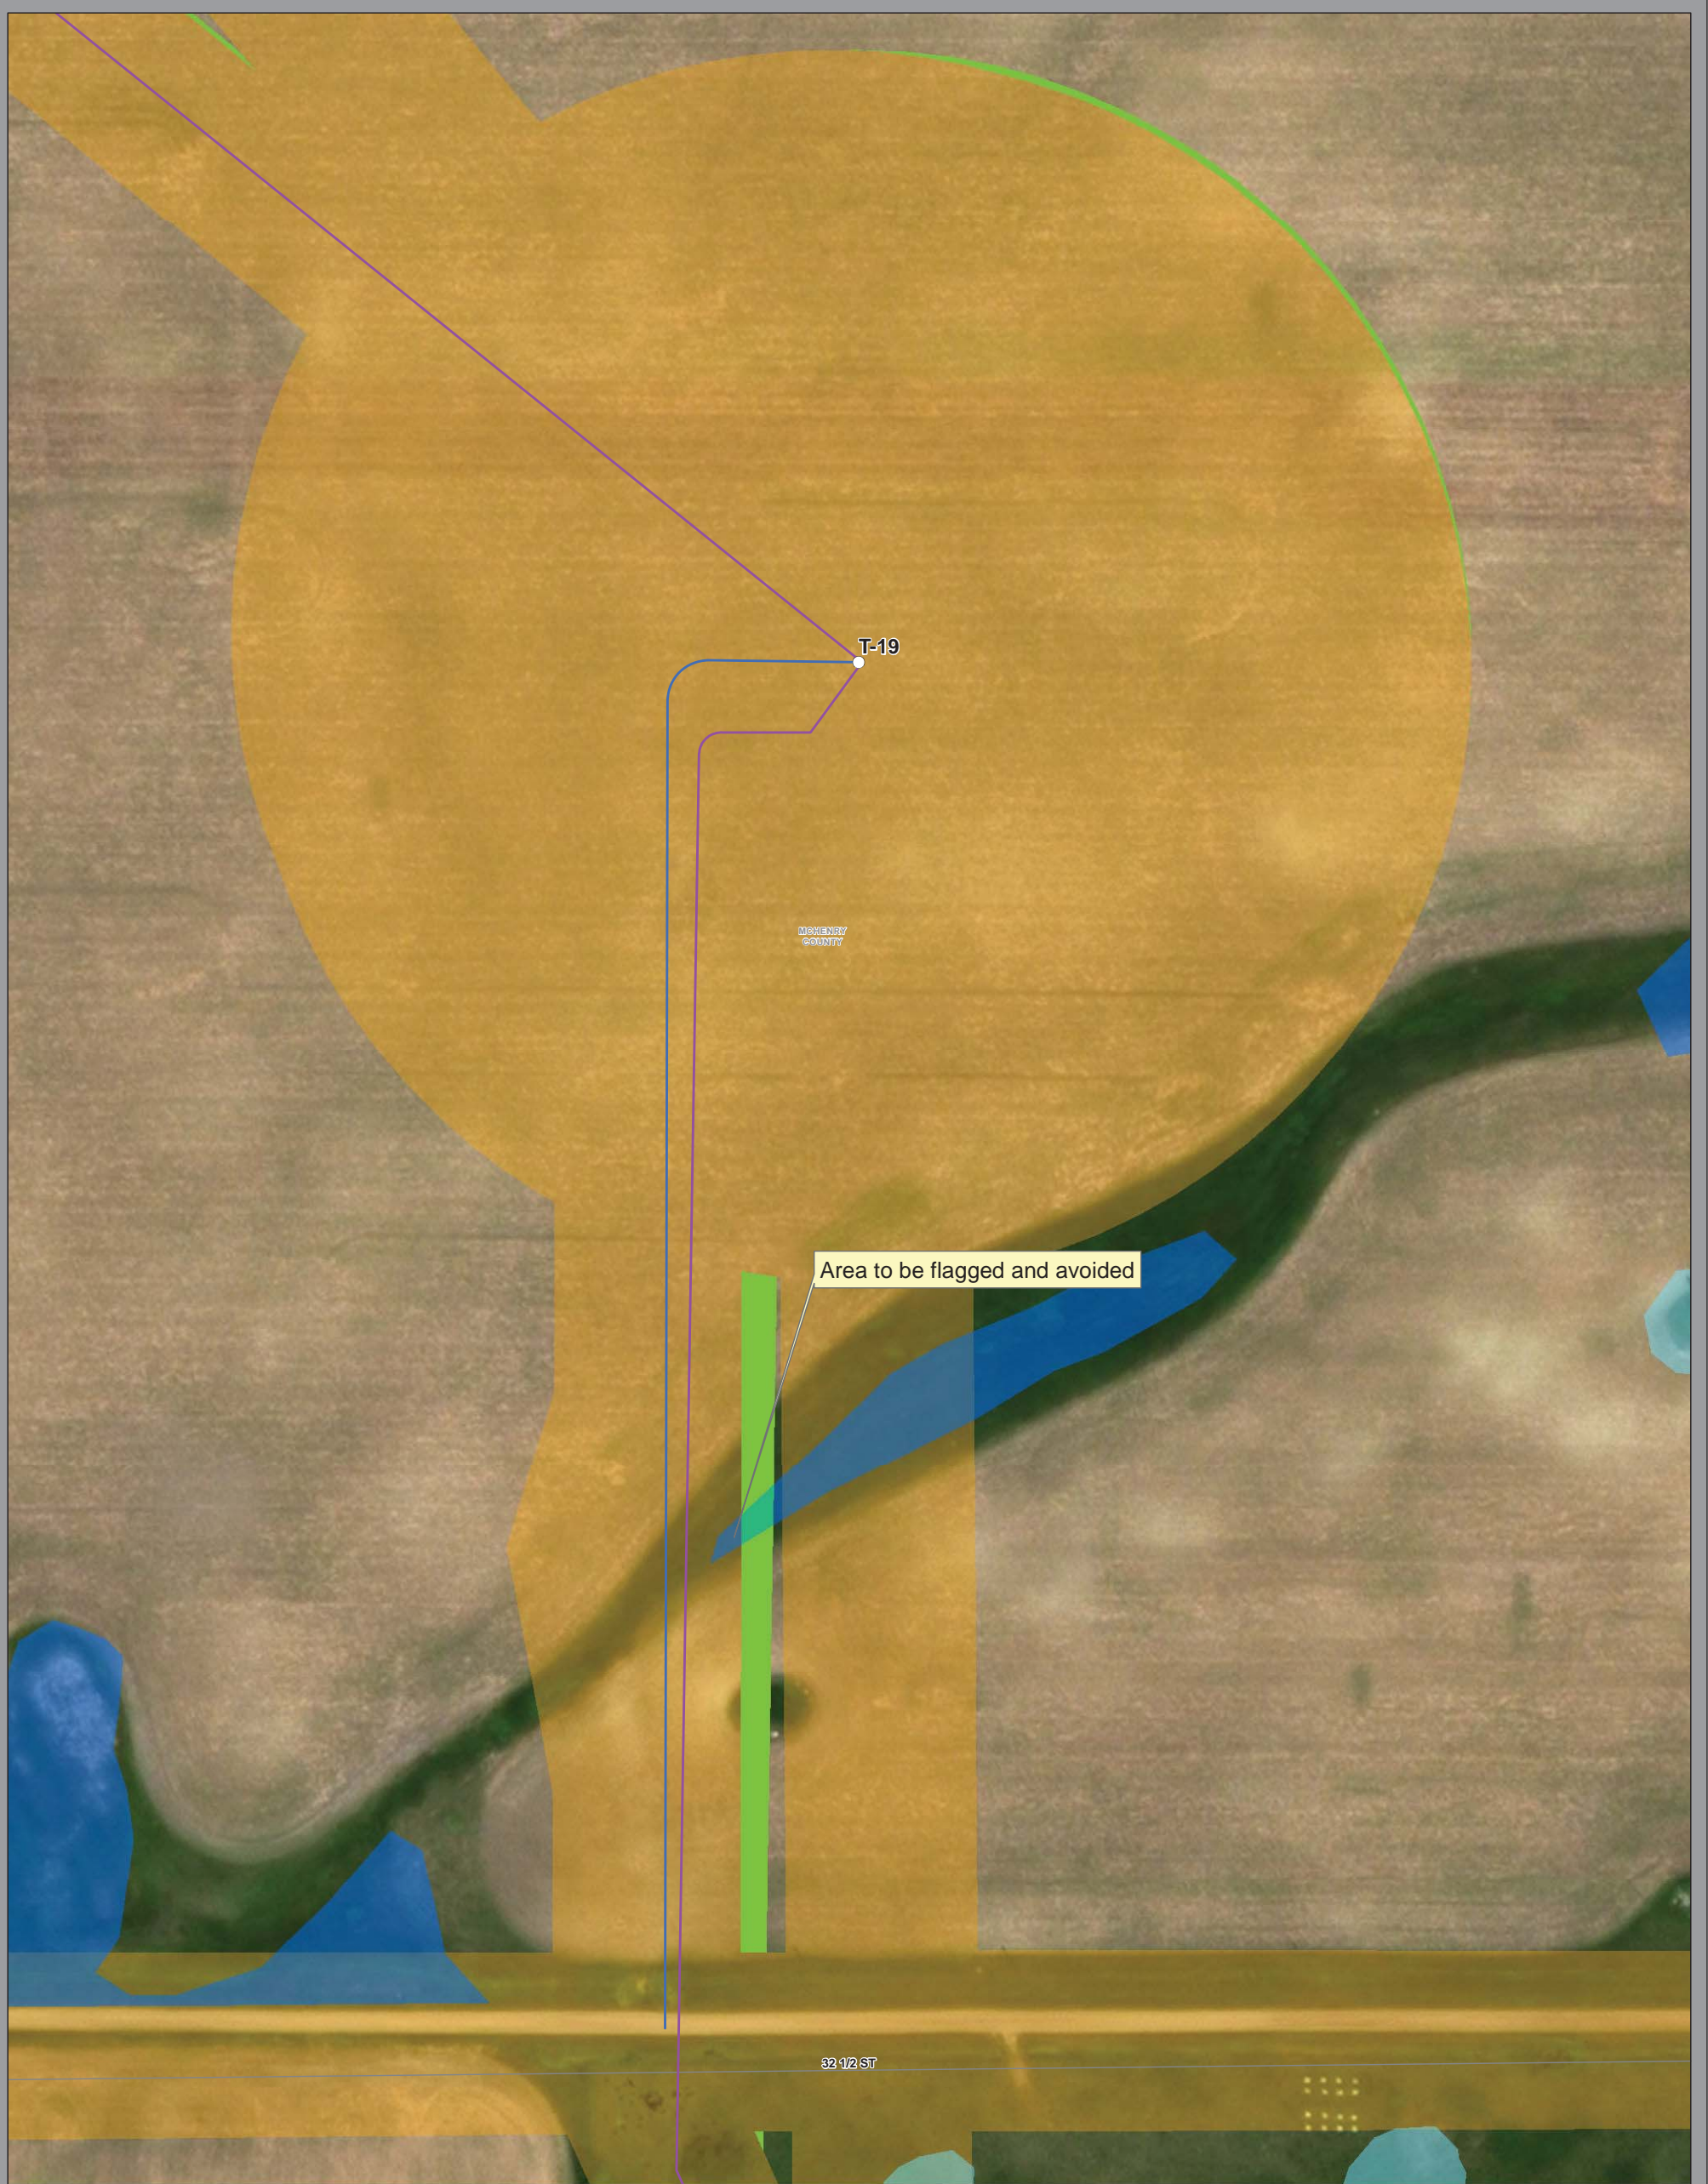
## Observation Point OB-B-64

**Observation Point OB-B-64**— This previously un-surveyed area is near Turbine 19 and contains a USACE jurisdictional wetland at latitude 47.88571268, longitude -100.92449798 (Figure Observation Point OB-B-64). The wetland boundary will be flagged prior to construction and the proposed access road that leads to Turbine 19 will avoid any impacts to the jurisdictional wetland feature.

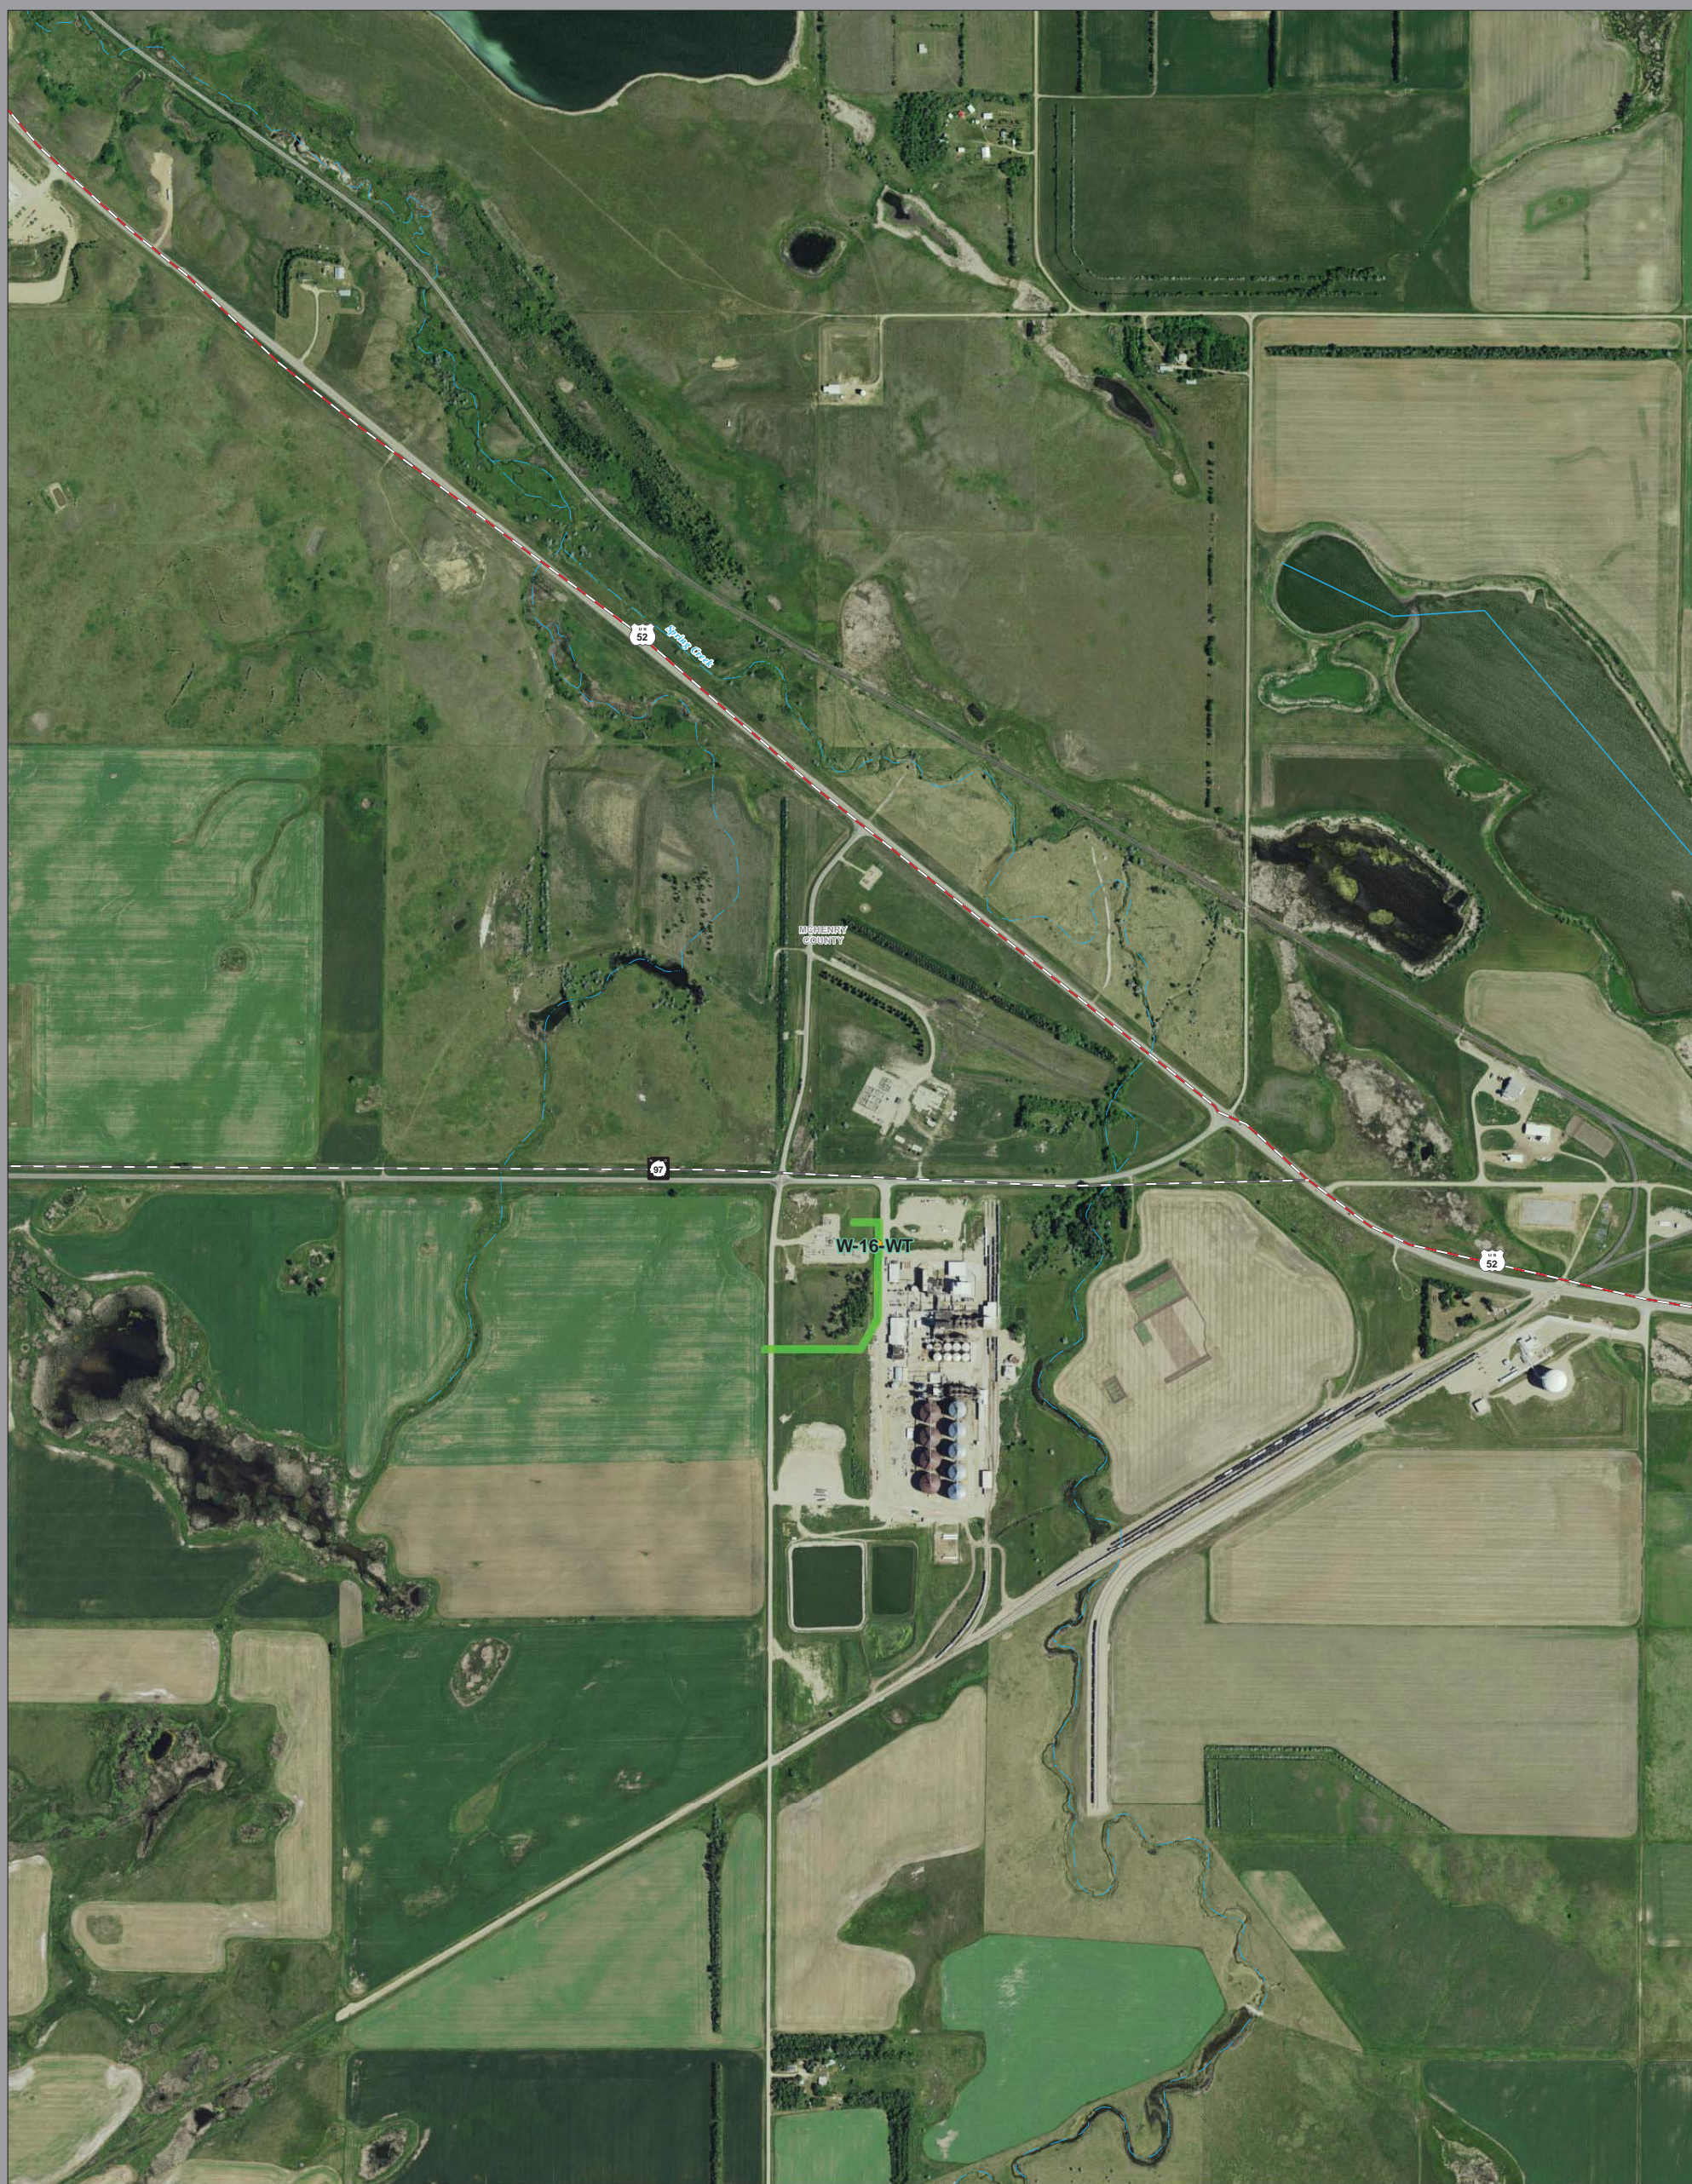
**Figure 2: Project Detail Map Sheet:11**

Wetland A-13 is a linear wetland within a roadside ditch. The feature is located within the transmission line corridor along the east side of McHenry substation south of Highway 97 (Figure 2, Mapsheet 11). This wetland was previously mapped; however, this wetland was re-mapped during the field surveys. Vegetation in the plot was dominated by cattails and white dock (*Rumex trianguivalvis*, FACW), which was still identifiable despite the fact that the area had recently been mowed. Soils were observed to be a silty clay that qualified for the hydric soil indicators Depleted Matrix (F3) and Redox Dark Surface (F6). Hydrology indicators for the wetland included Oxidized Rhizospheres on Living Roots (C3), FAC-Neutral Test (D5) and Geomorphic Position (D2). The feature is connected to a previously mapped non-

jurisdictional wetland with no connection to a WoUS. Therefore, the wetland does not likely meet the definition of a jurisdictional WoUS.
