**CLASS II HISTORICAL ARCHITECTURE  
RECONNAISSANCE SURVEY**

**OLIVER III WIND ENERGY CENTER  
MORTON COUNTY, NORTH DAKOTA**

**January 10, 2012**

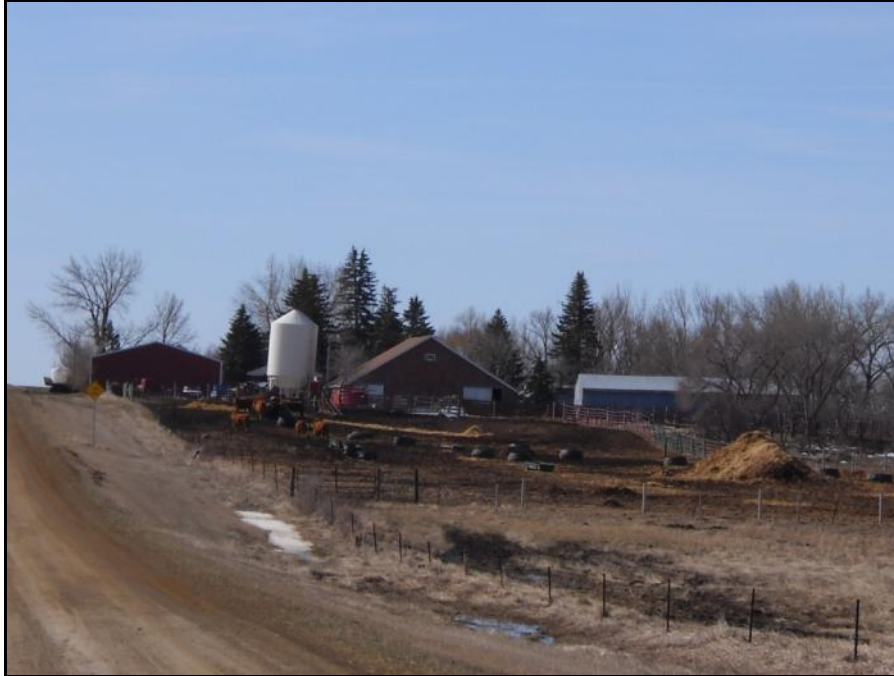
Property 32MOx539 (Farmstead) is an active farmstead located along the west side County Road 83 within the southeast  $\frac{1}{4}$  of Section 9, Township 140 North, Range 83 West (Appendix A, Figure 1; Appendix C, 32MOx539; [Photographs 1, 2, 3, and 4](#)). The farmstead includes one ranch-style house, two metal outbuildings (one painted red, the other galvanized steel), a brick barn, and a cattle lot. The buildings at this farmstead appear to be more recent than those observed at other farmsteads in the area. A review of historic plat maps reveals this farmstead was not present in 1917 ([Geo A. Ogle and Company 1917](#)), but was present by 1962 ([Midwest Atlas Company 1962](#)).

The farmstead appears intact and has integrity of location, design, setting, materials, and feeling. Due to the scope of this assessment, integrity of workmanship or association was not addressed. Tetra Tech's preliminary evaluation of the farmstead indicates it is not known to be associated with any historic events important to local, state or national history (Criterion A), does not have significant or unusual architecture (Criterion C), nor is it thought to have significant potential to yield historical information (Criterion D). Further research may yield information about those who have lived here; at this time no association with a significant historical figure is known (Criterion B). Tetra Tech's preliminary evaluation suggests the farmstead be recommended as not eligible for inclusion to the National Register.

**Photograph 1 (South): An overview of Property 32MOx539 from County Road 83.**

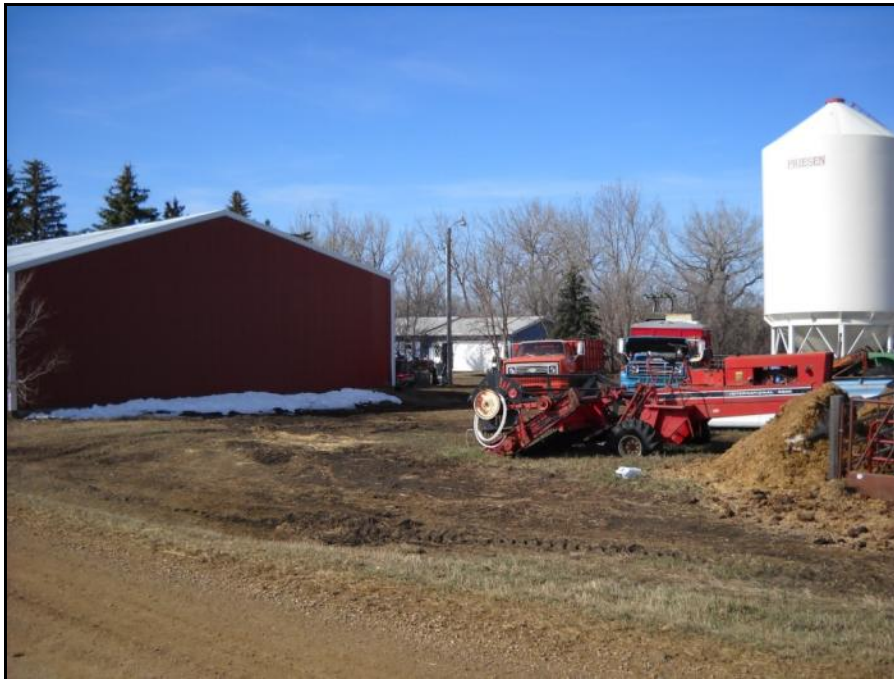
**Photograph 2 (Southwest): A view toward Property 32MOx539 from County Road 83. The painted steel building is in the foreground and the ranch-style house is located in the background.**

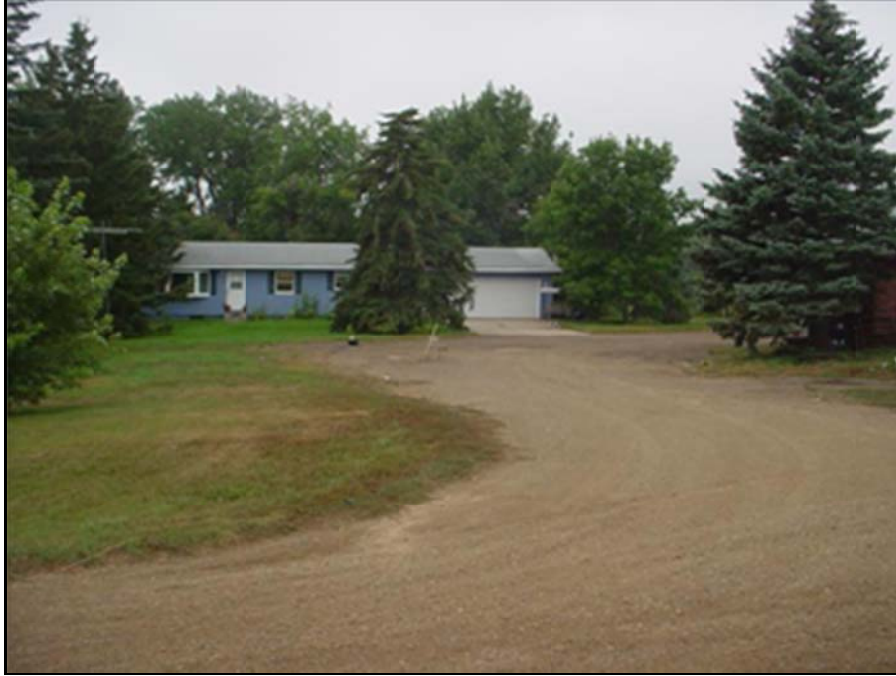
**Photograph 3 (West):** A view toward the house at Property 32MOx539 from County Road 83. This photograph was taken 8/28/2009 by Swenson, Hagen & Company.

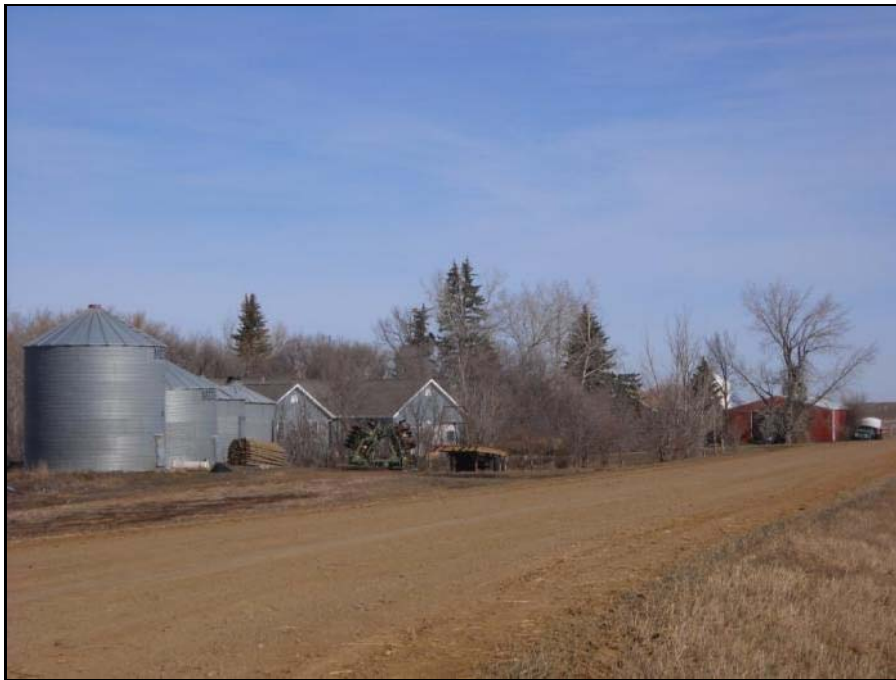
**Photograph 4 (Northwest):** A view towards Property 32MOx539 from County Road 83. Most of the farm is obscured by trees with the exception of the red outbuilding. The grain bins and blue house in the foreground are not part of Property 32MOx539.

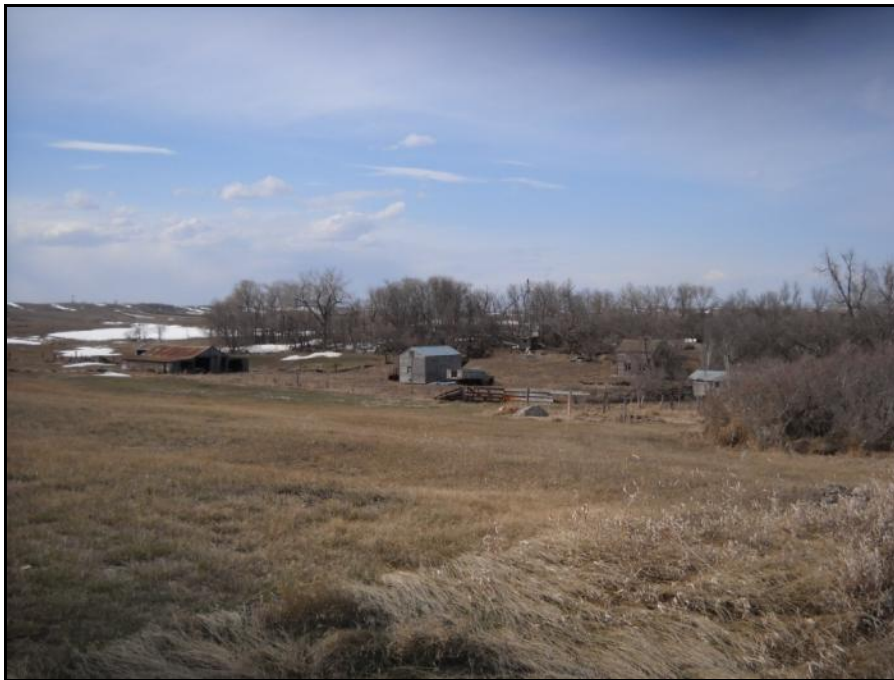
[Photographs 5, 6, and 7](#)). The farmstead does not appear to be occupied; however, several structures in poor condition were observed on the property including a farm house, mobile home, several wood-framed outbuildings, and a latticed-framed windmill. Tetra Tech did not have access to the farmstead so a detailed examination of the structures was not possible. Several vehicles and other farm machinery were also observed in the farmstead. Based on a review of the [Geo A. Ogle and Company \(1917\)](#) plat map and field observations, this farmstead may date to the early 1900s during the period of the initial Euro-American settlement.

The farmstead appears intact and has integrity of location, design, setting, materials, and feeling. Due to the scope of this assessment, integrity of workmanship or association was not addressed. The presence of an abandoned mobile home and several non-functional vehicles within the farmstead appears to reduce the integrity of feeling. Tetra Tech’s preliminary evaluation of the farmstead indicates it is not known to be associated with any historic events important to local, state or national history (Criterion A), does not have significant or unusual architecture (Criterion C), nor is it thought to have significant potential to yield historical information (Criterion D). Further research may yield information about those who have lived here; at this time no association with a significant historical figure is known (Criterion B). Tetra Tech’s preliminary evaluation suggests the farmstead be recommended as not eligible for inclusion to the National Register.

**Photograph 5 (Northwest): An overview of Property 32MOx540 from 31st Avenue, south of the farmstead.**

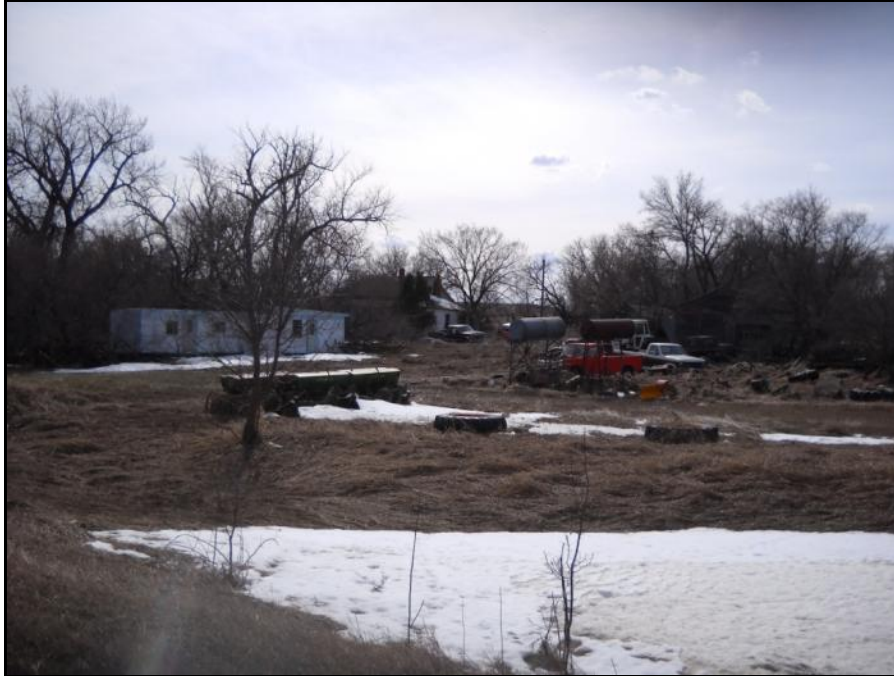
**Photograph 6 (Southwest):** An overview of Property 32MOx540 from 31st Avenue, east of the farmstead. The farmstead was not occupied.

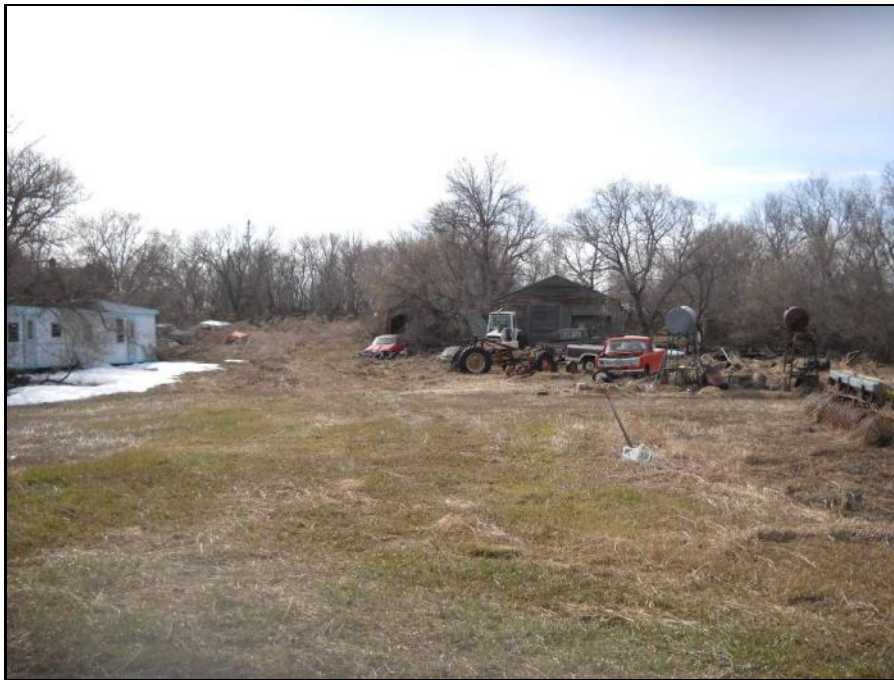
**Photograph 7 (West):** An overview of Property 32MOx540 from 31st Avenue, east of the farmstead.

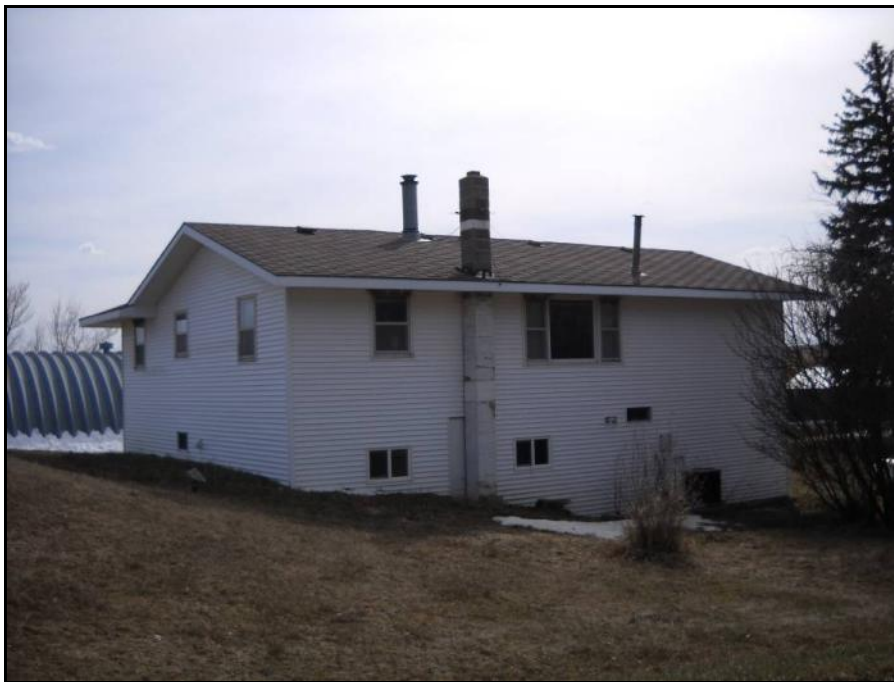
[Geo A. Ogle and Company \(1917\)](#) plat map, includes one modern split level-style house, one metal Quonset hut, and several other outbuildings. Only one wood-framed building (in addition to the house) could be observed within the farmstead (function could not be determined); however, due to dense tree cover in and around the farmstead, a detailed description of this structure and other structures within the farmstead could not be ascertained. The remaining buildings appeared to have steel exteriors. The buildings at this farmstead appeared to have been constructed throughout the existence of the farmstead, and represent different styles or themes of construction.

The farmstead appears intact and has integrity of location, setting, and feeling. Integrity of design and materials may have been compromised when elements of the farmstead were updated such as the farm house and several of the metal outbuildings. These structures do not represent the original materials or design of the farmstead, but rather represent alterations that occurred over time. Due to the scope of this assessment, integrity of workmanship or association was not addressed. Tetra Tech's preliminary evaluation of the farmstead indicates it is not known to be associated with any historic events important to local, state or national history (Criterion A), does not have significant or unusual architecture (Criterion C), nor is it thought to have significant potential to yield historical information (Criterion D). Further research may yield information about those who have lived here; at this time no association with a significant historical figure is known (Criterion B). Tetra Tech's preliminary evaluation suggests the farmstead be recommended as not eligible for inclusion to the National Register.

**Photograph 8 (South): A view the Farmstead 32MOx541 from 35th Street.**

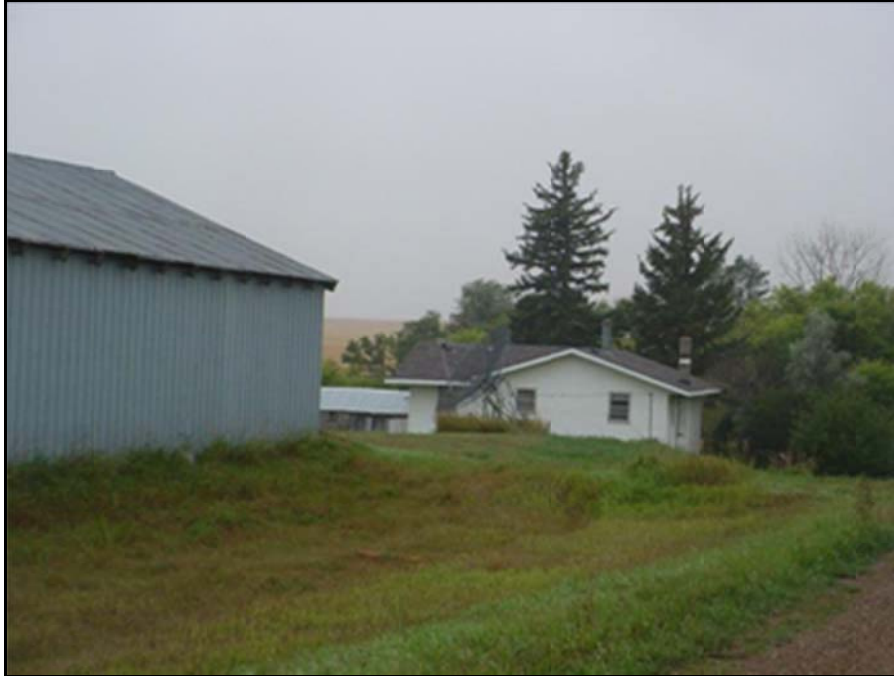
**Photograph 9 (Southwest): A view a metal outbuilding east of the house at 32MOx541 from 35th Street. This photograph was taken 8/28/2009 by Swenson, Hagen & Company.**

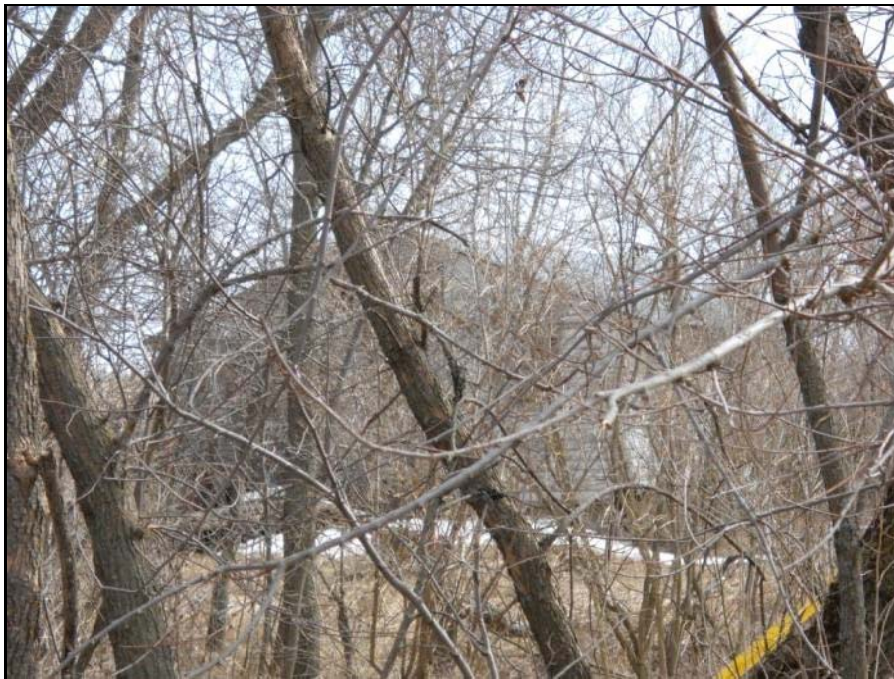
**Photograph 10 (South): A view an outbuilding west of the house at 32MOx541 from 35th Street. Due to tree cover, this building is difficult to view.**

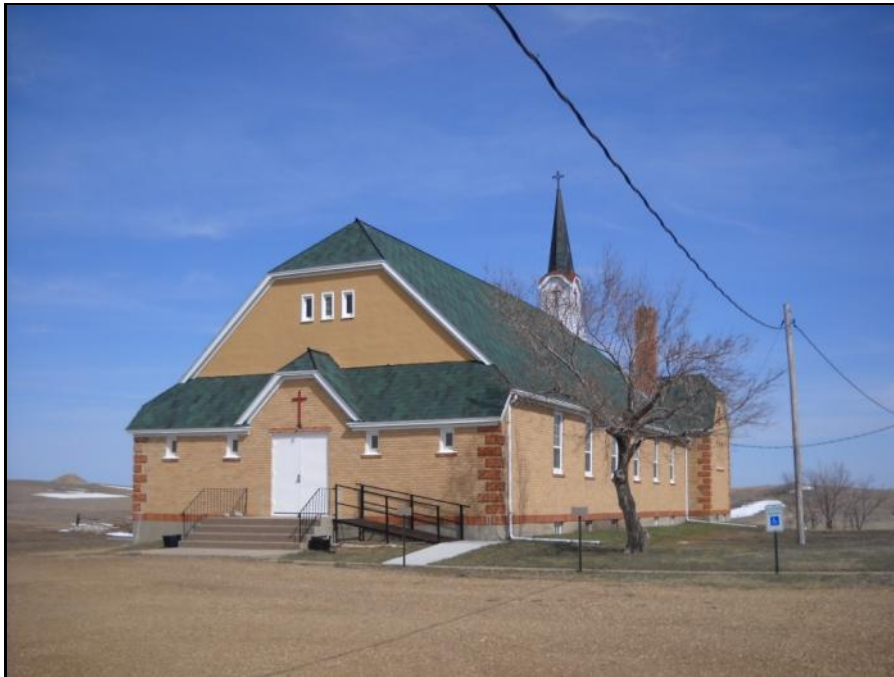
The St. Vincent Catholic Church (32MO1337) is located at 3180 36<sup>th</sup> Street, Mandan, North Dakota (Appendix A, Figures 1 and 2; [Photographs 11](#) and [12](#)). The main entrance of the church is on the west side of the building, with parking areas located to the west of the entrance. Manicured lawns were observed on the south, east, and north sides of the church.

At the time of the survey in April 2010, the church appeared intact and relatively unaltered, and retains integrity of location, design, setting materials, workmanship, and feeling. However, the current church is not directly associated with the community that placed the WICs in the St. Vincent Cemetery (Criterion A). These grave markers were erected between ca. 1900 and ca. 1921 and would have been associated with the sod church (1896-1902), which was replaced by a wood-framed church (1902-1907), and which was subsequently replaced by a larger wood-framed church (1907-1933). The sod church and the first wood-framed church were located adjacent to the cemetery, while the second wood-framed church was located on the same parcel as the current church. By the time the current church was constructed (1934), WICs were no longer be placed in the cemetery. The church does not appear to have significant or unusual architecture (Criterion C), nor is it thought to have significant potential to yield historical information (Criterion D). Further research may yield information about those who have worshiped here; at this time no association with a significant historical figure is known (Criterion B). Tetra Tech's preliminary evaluation suggests the church be recommended as not eligible for inclusion to the National Register.

**Photograph 11 (Northeast): A view of St. Vincent Catholic Church from the church parking lot.**

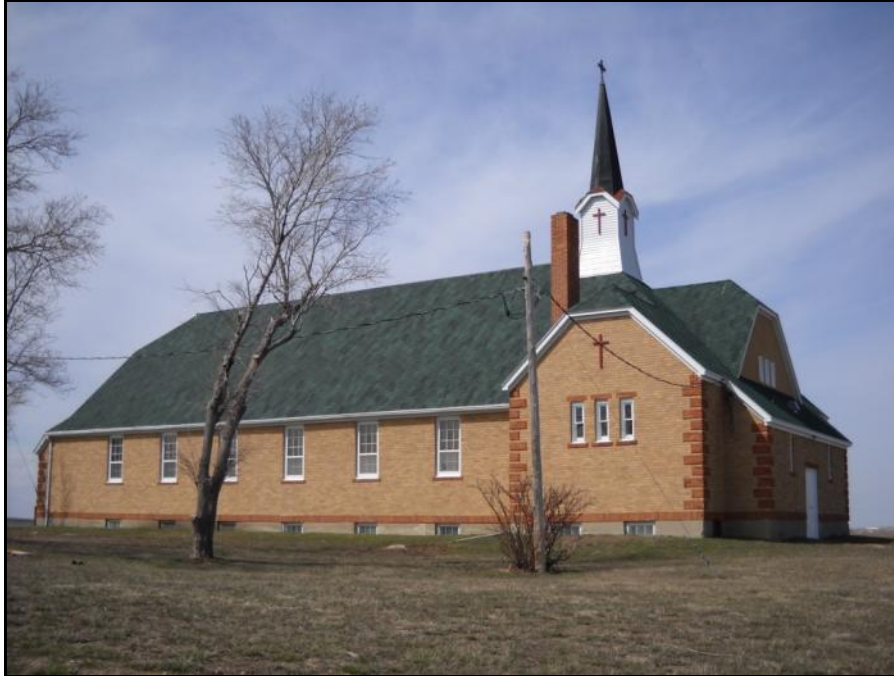
**Photograph 12 (Northwest): A view of St. Vincent Catholic Church from the church lawn southeast of the building.**

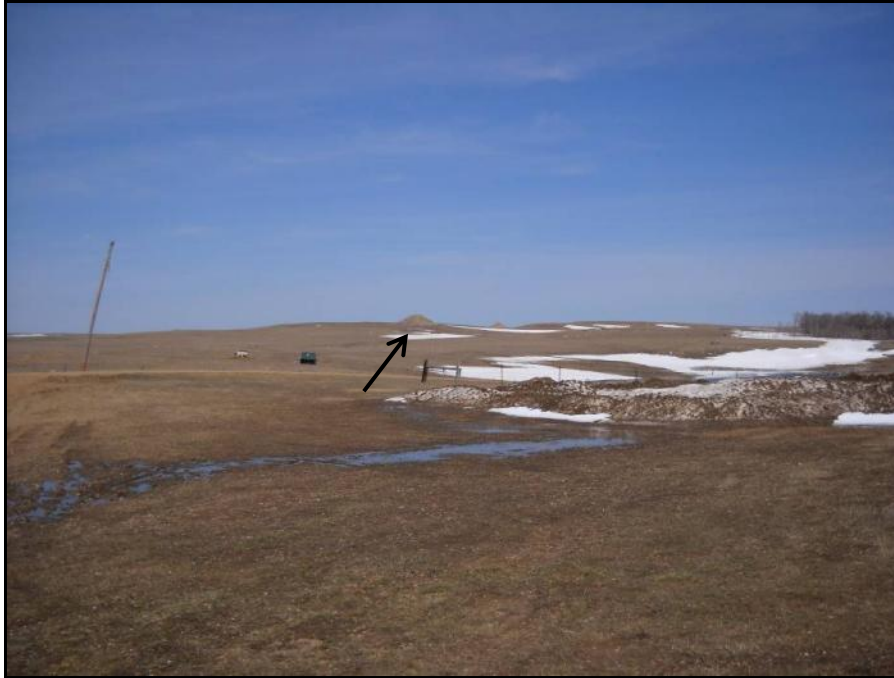
**Photograph 13 (Northeast):** A view toward proposed Turbines 1 through 8 from the church parking lot. The foreground distance zone is visible; the aggregate pile located on the horizon (arrow) is approximately 0.7 mi northeast of the church, with the nearest turbine (Alt 1) located 1.6 mi beyond. Due to the presence of the ridge in the foreground distance zone, the middleground or background distance zones are not visible.

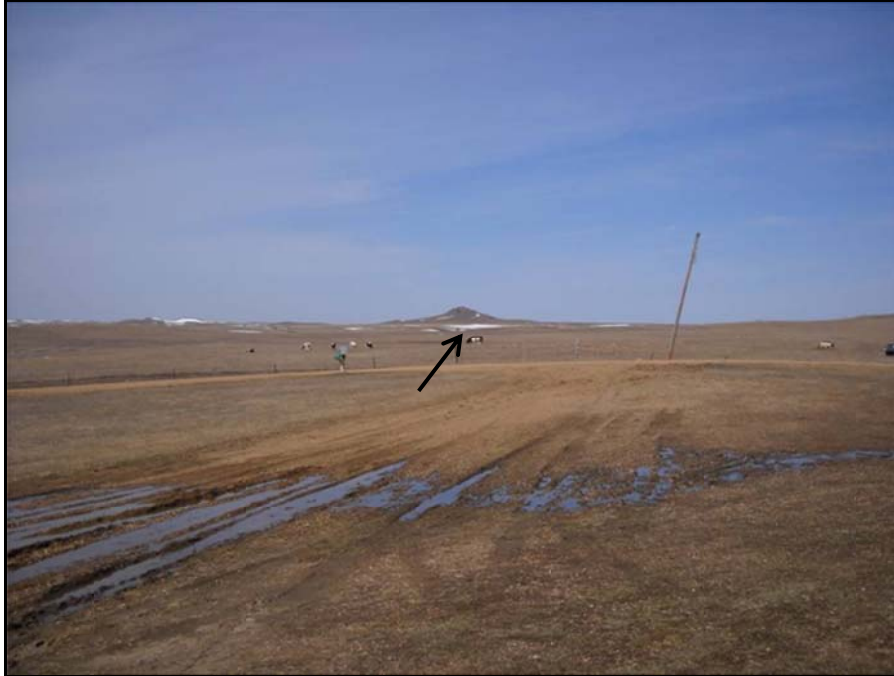
**Photograph 14 (North-Northeast):** A view toward proposed Turbines 9 through 14 from the church parking lot. The foreground distance zone is visible; this butte located on the horizon (arrow) is approximately 1.5 mi north of the church, with the nearest turbines located 0.9 mi beyond. Due to the presence of the butte and ridge in the foreground distance zone, the middleground or background distance zones are difficult to discern on the horizon.

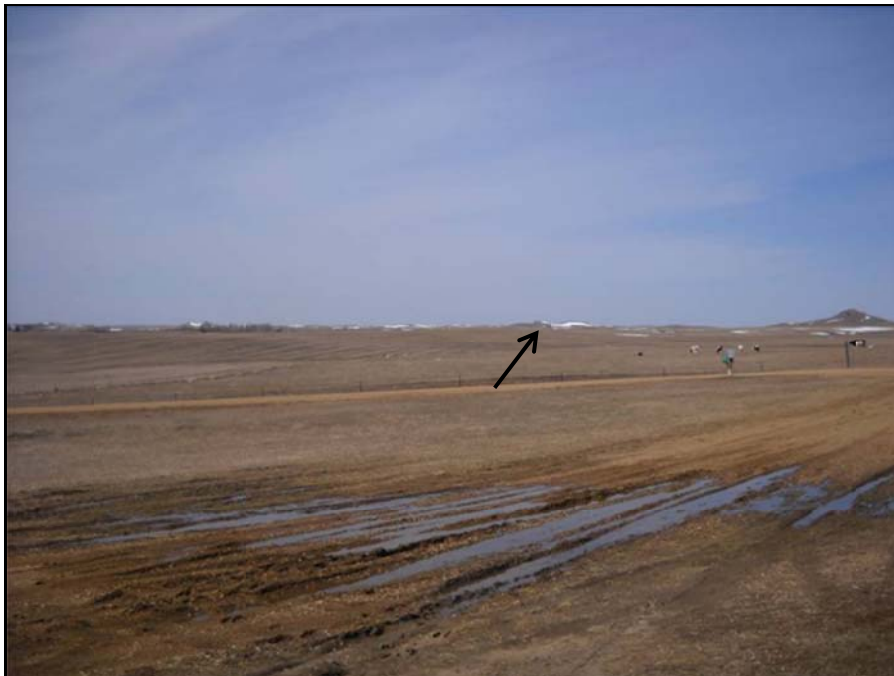
**Photograph 15 (North-Northwest):** A view toward proposed Turbines 15 through 19 from the church parking lot. The foreground distance zone is visible; this hill located on the horizon (arrow) is approximately 2 mi northwest of the church, with the nearest turbines located 1.2 mi beyond. Due to less topography of the west side of the Project area, the middleground distance zone is visible.

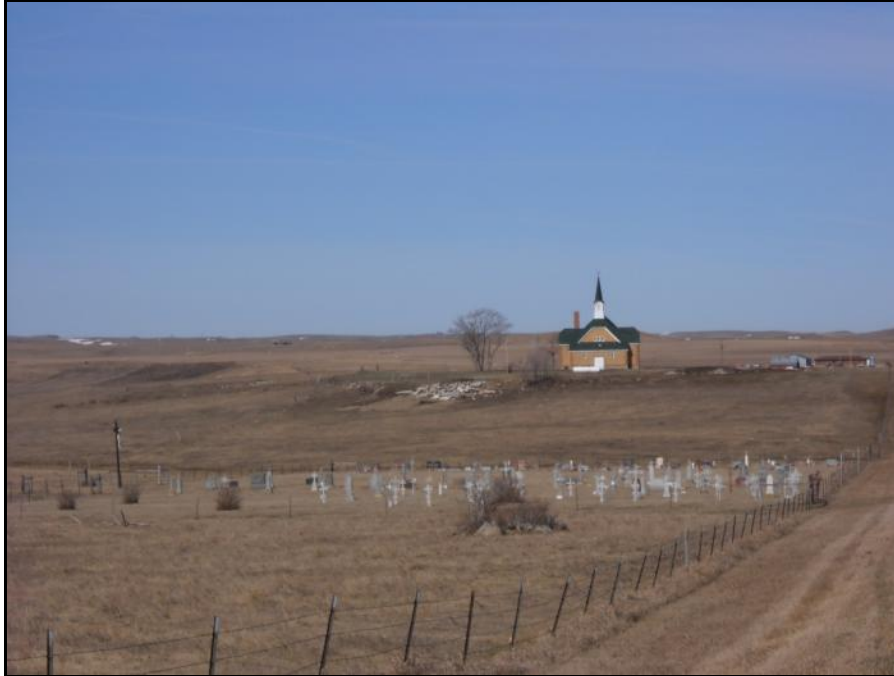
The St. Vincent Cemetery (32MO186) is located 0.25 mi east of the St. Vincent Catholic Church on the side slope of a small draw at an elevation between 2,040 and 2,060 ft above sea level (asl) (Appendix A, Figures 1 and 3; [Photograph 16](#)). This is relatively low compared to the buttes and ridges surrounding the cemetery to the north and east. Agricultural pasture was observed to the east and south; pasture and the St. Vincent Catholic Church were observed to the west; and 36<sup>th</sup> Street and pasture was observed to the north.

**Photograph 16 (West): A view of the St. Vincent Cemetery and the St. Vincent Catholic Church from 36th Street.**

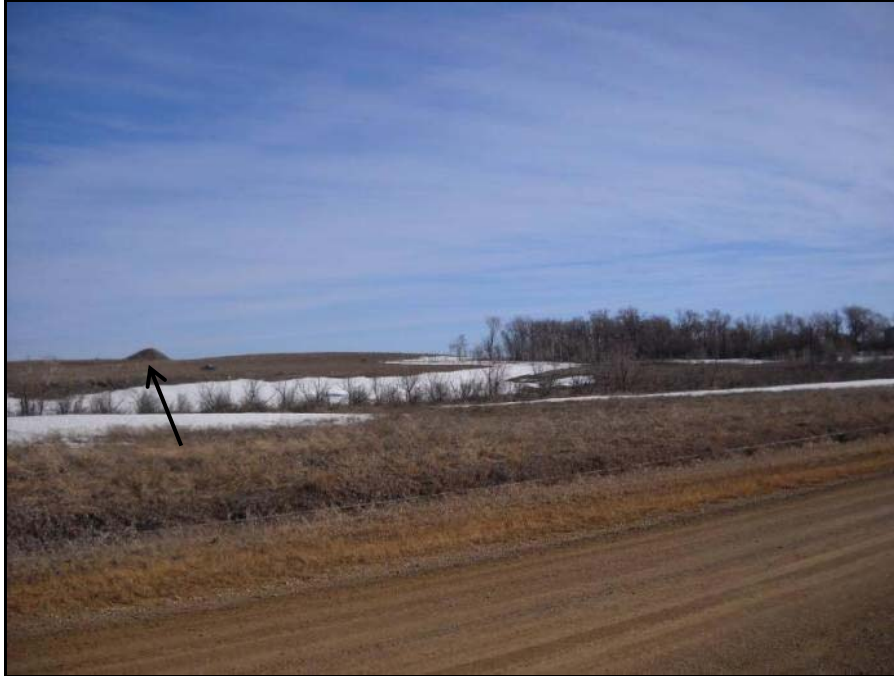
**Photograph 17 (Northeast):** A view toward proposed Turbines 1 through 5 from the public ROW north of the St. Vincent Cemetery. The foreground distance zone is visible; the aggregate pile located on the horizon (arrow) is approximately 0.6 mi northeast of the cemetery, with the nearest turbines located 1.5 mi beyond. Due to the presence of the ridge and the treeline in the foreground distance zone, the middleground or background distance zones are not visible on the horizon.

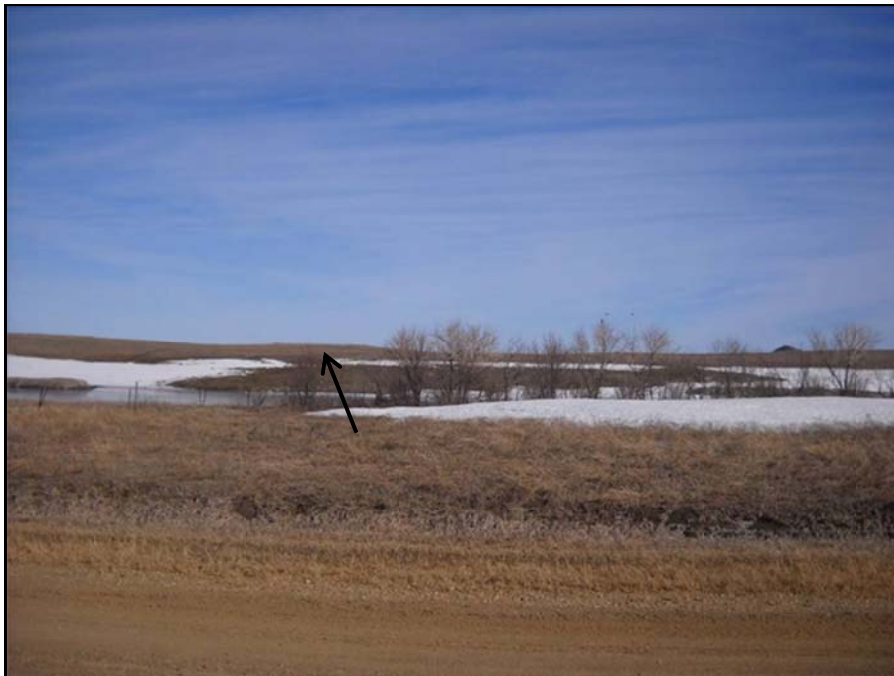
**Photograph 18 (North):** A view toward proposed Turbines 6 through 19 from the public ROW north of the St. Vincent Cemetery. The foreground distance zone is visible; these hills located on the horizon (arrow) are approximately 0.5 mi north of the cemetery, with the nearest turbines located 2 mi beyond. Due to the presence of the ridge in the foreground distance zone, the middleground or background distance zones are not visible on the horizon.

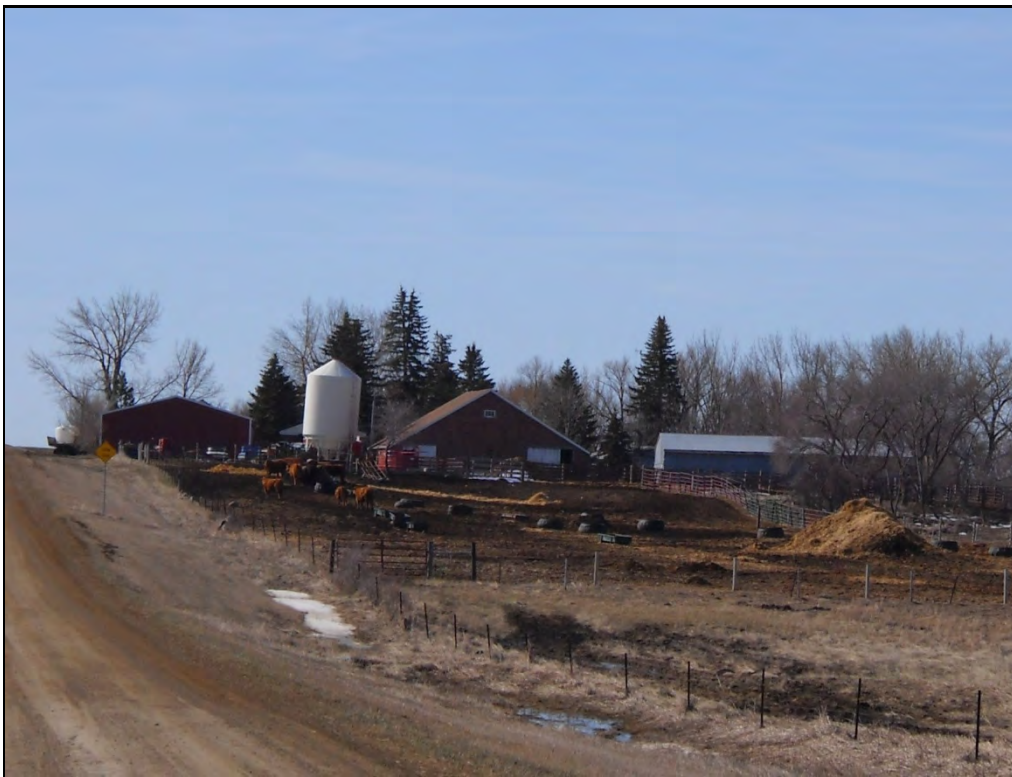
**Photograph 1 (South): An overview of Property 32MOx539 from County Road 83. Photograph taken on 4/8/10.**

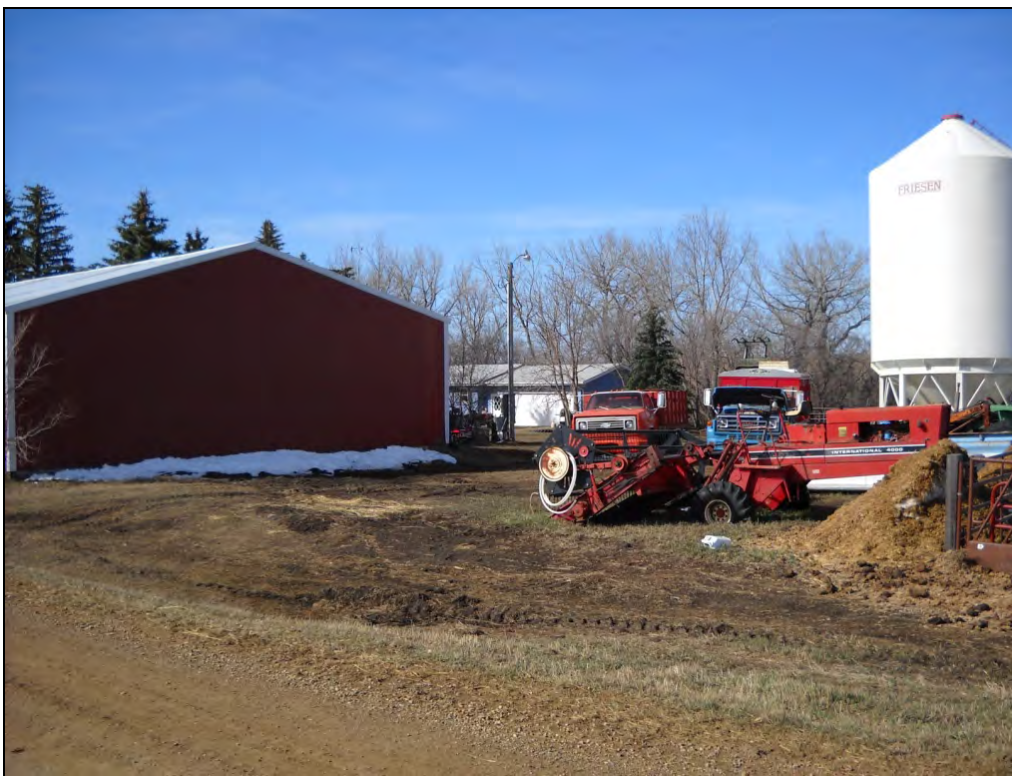
**Photograph 2 (Southwest): A view toward Property 32MOx539 from County Road 83. The painted steel building is in the foreground and the ranch-style house is located in the background. Photograph taken on 4/8/10.**

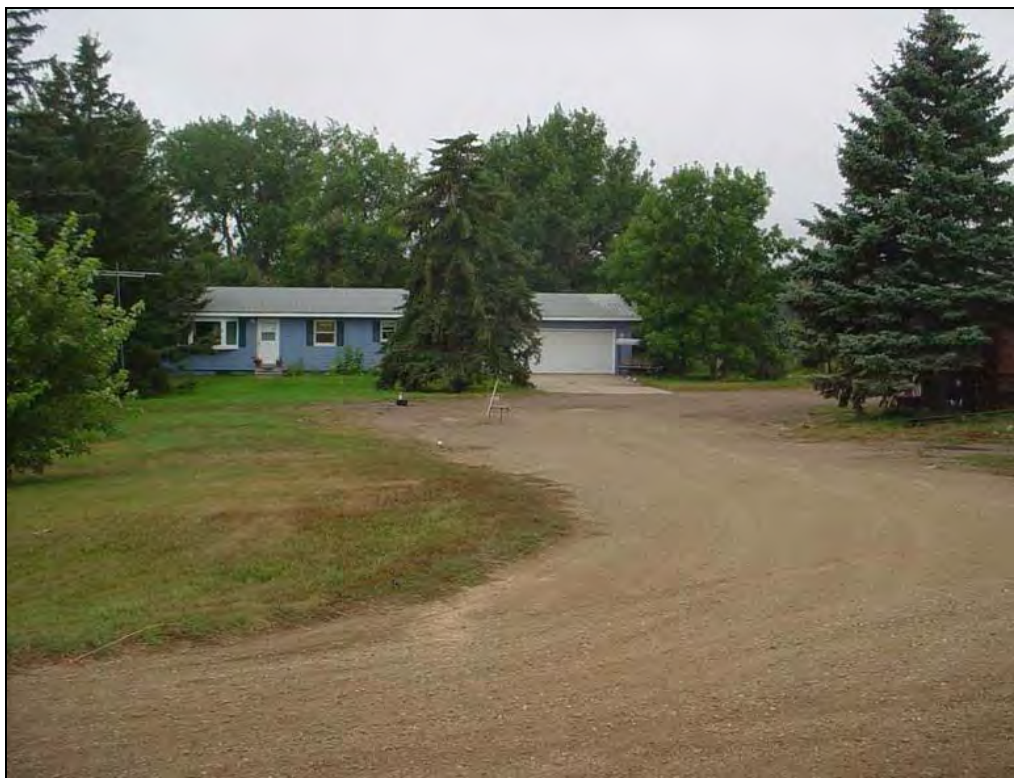
**Photograph 3 (West):** A view toward Property 32MOx539 from County Road 83. The house is in the foreground. Photograph taken on 8/28/09 by Swenson, Hagen and Company.

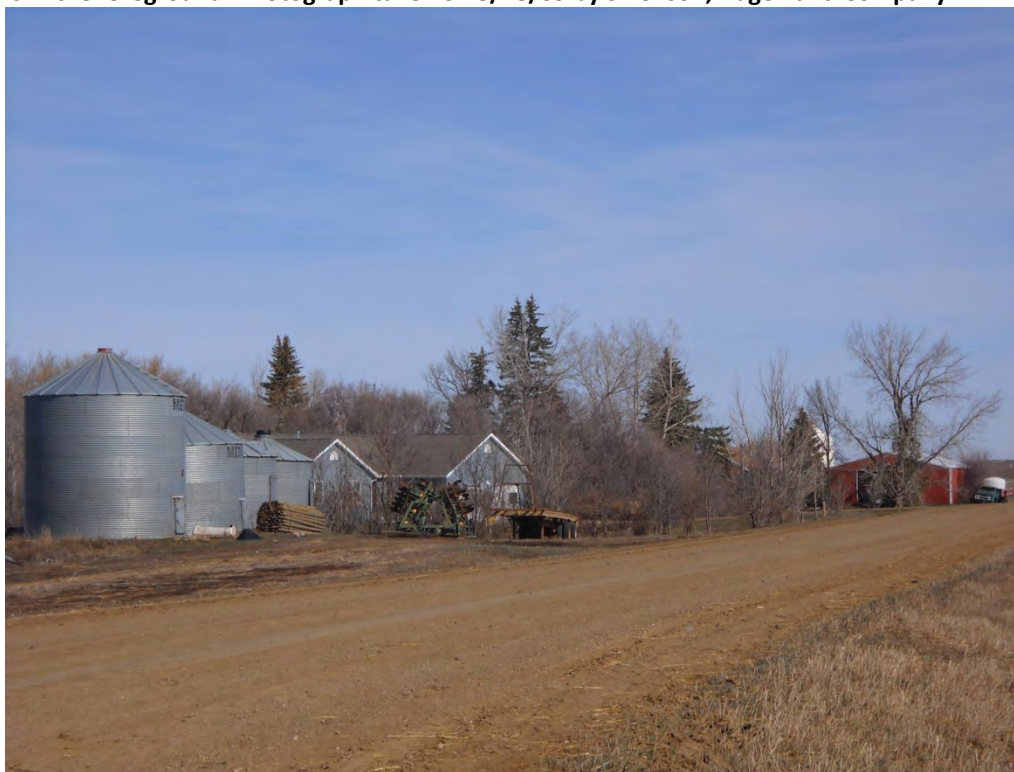
**Photograph 4 (Northwest):** A view towards Property 32MOx539 from County Road 83. Most of the farm is obscured by trees with the exception of the red outbuilding. The grain bins and blue house in the foreground are not part of Property 32MOx539. Photograph taken on 4/8/10.

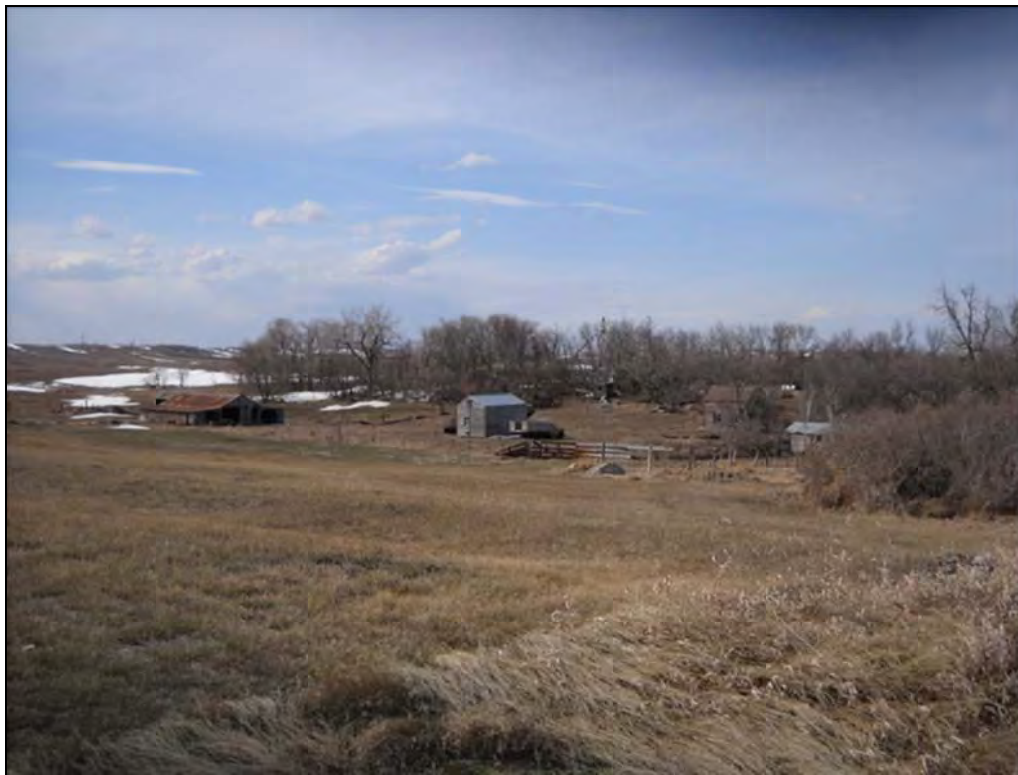
**Photograph 1 (Northwest):** An overview of Property 32MOx540 from 31<sup>ST</sup> Avenue. Photograph taken on 4/7/10.

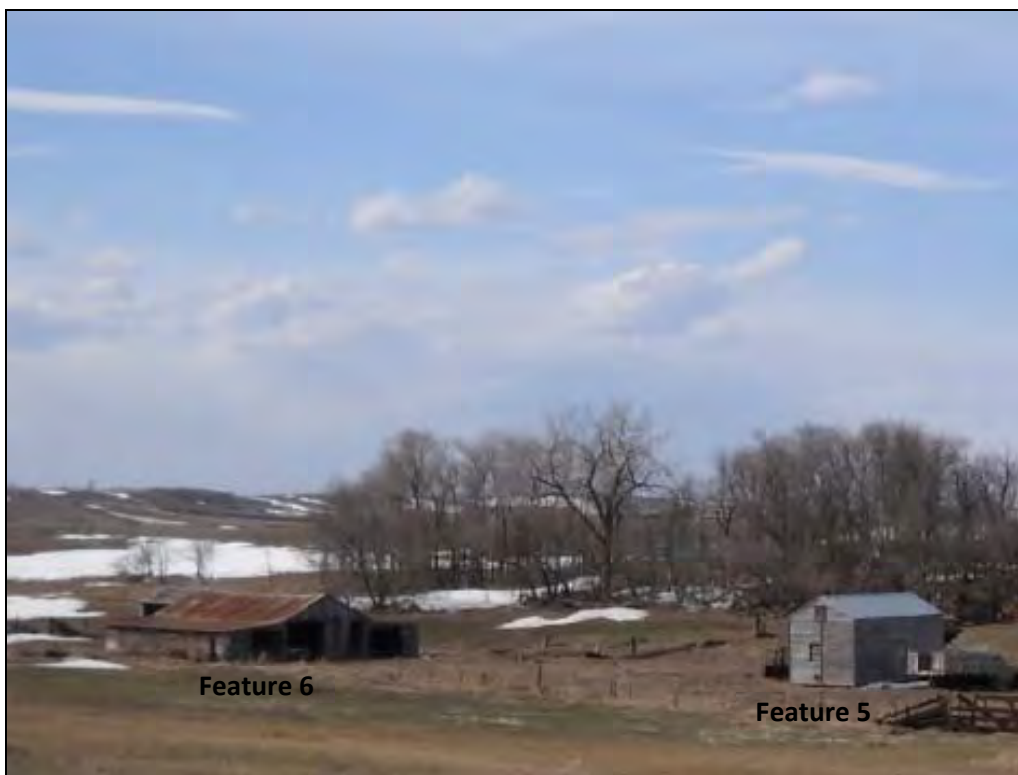
**Photograph 2 (Northwest):** A view toward Feature 5 and Feature 6 from 31<sup>ST</sup> Avenue south of the farmstead. Photograph taken on 4/7/10.

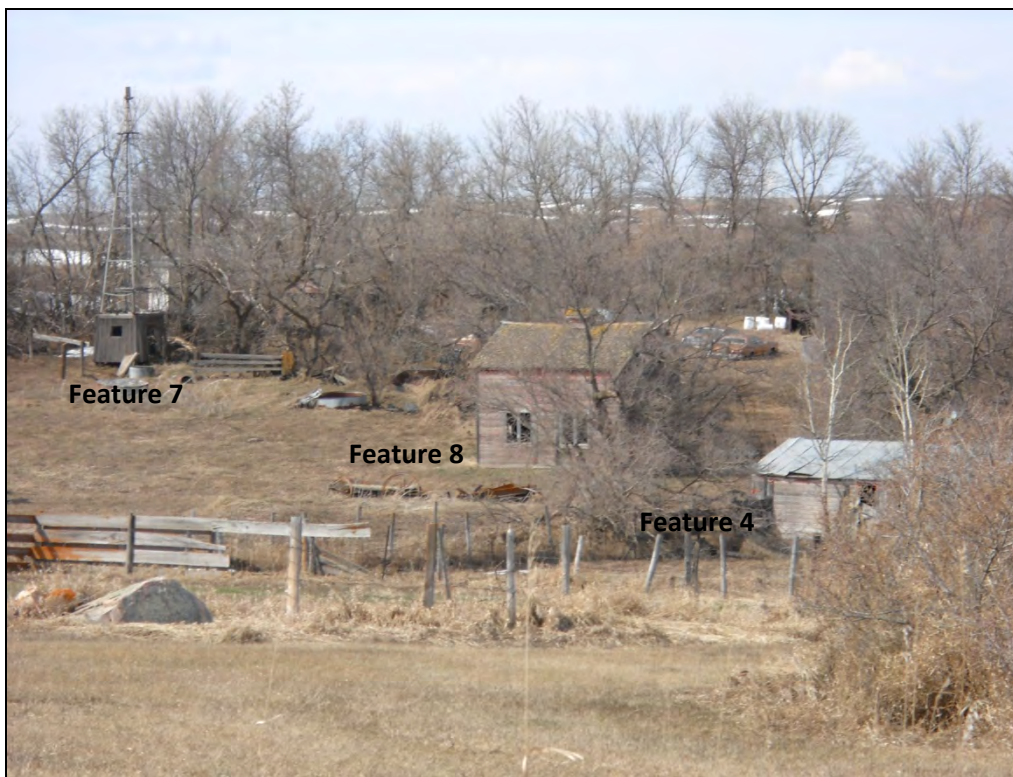
Photograph 3 (Northwest): A view toward Feature 4, Feature 7, and Feature 8 from 31<sup>ST</sup> Avenue south of the farmstead. Photograph taken on 4/7/10.

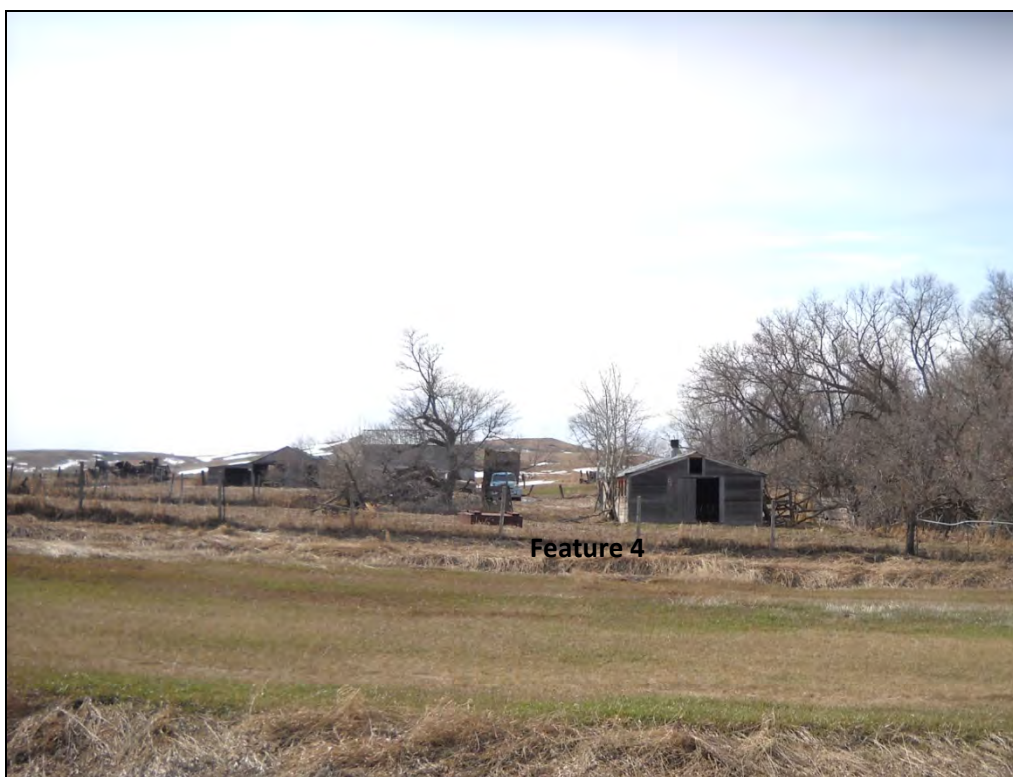
Photograph 4 (West): A view toward Feature 4 from 31<sup>ST</sup> Avenue. Photograph taken on 4/7/10.

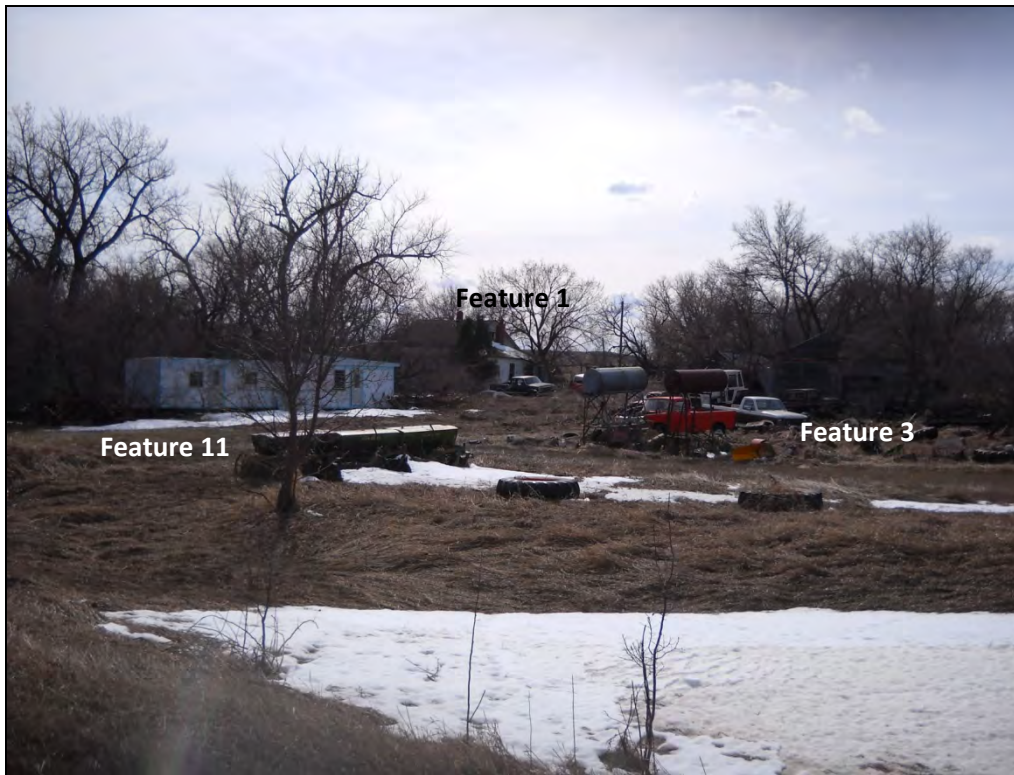
Feature 1 is an abandoned house located in an agricultural area off 31st Avenue. The house is located in the center of the farmstead and is difficult to view from the public road ROW due to trees on the east and south sides. A view of the north side of the house revealed broken windows and missing doors. A review of historic plat maps reveals this farmstead was present in 1917 (Geo A. Ogle and Company 1917); therefore, it is likely the house dates from this time period.

The condition of the house is poor based on observations from the public road ROW, but it has integrity of location, design, setting, materials, and feeling. Due to the scope of this assessment, integrity of workmanship or association was not addressed.

**Photograph 5 (Southwest): A view toward Feature 1, Feature 3, and Feature 11 from 31<sup>ST</sup> Avenue south of the farmstead. Photograph taken on 4/7/10.**

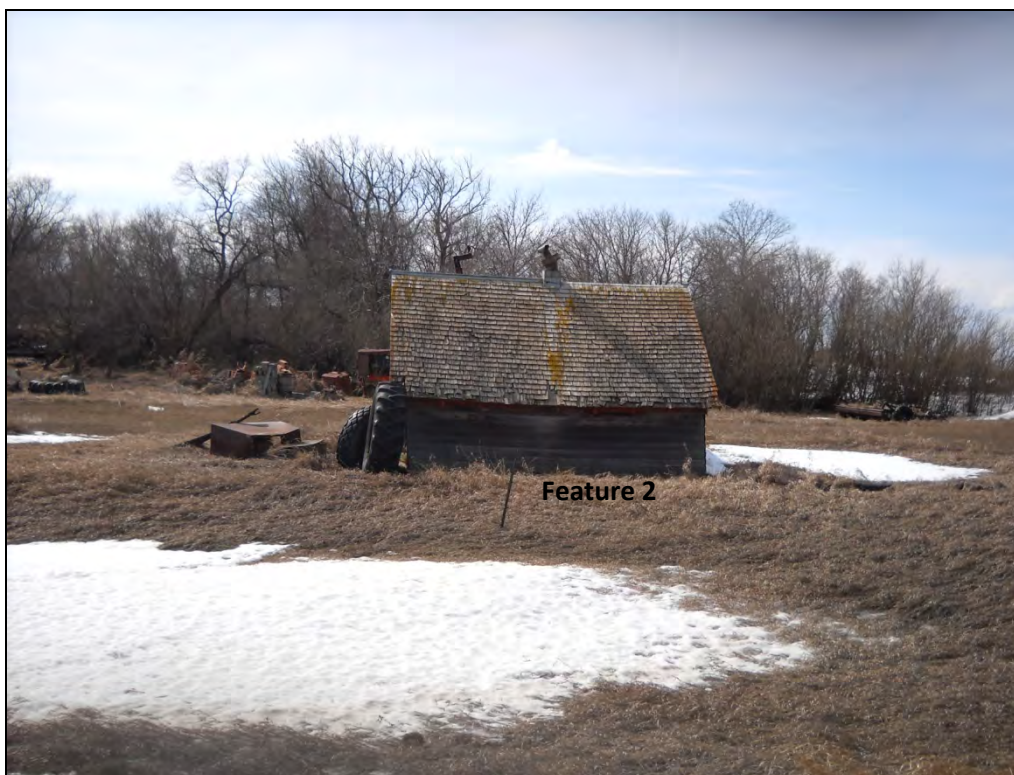
**Photograph 6 (West): A view toward Feature 2 from 31<sup>ST</sup> Avenue. Photograph taken on 4/7/10.**
