**CLASS II HISTORICAL ARCHITECTURE  
RECONNAISSANCE SURVEY**

**OLIVER III WIND ENERGY CENTER  
MORTON COUNTY, NORTH DAKOTA**

**January 10, 2012**

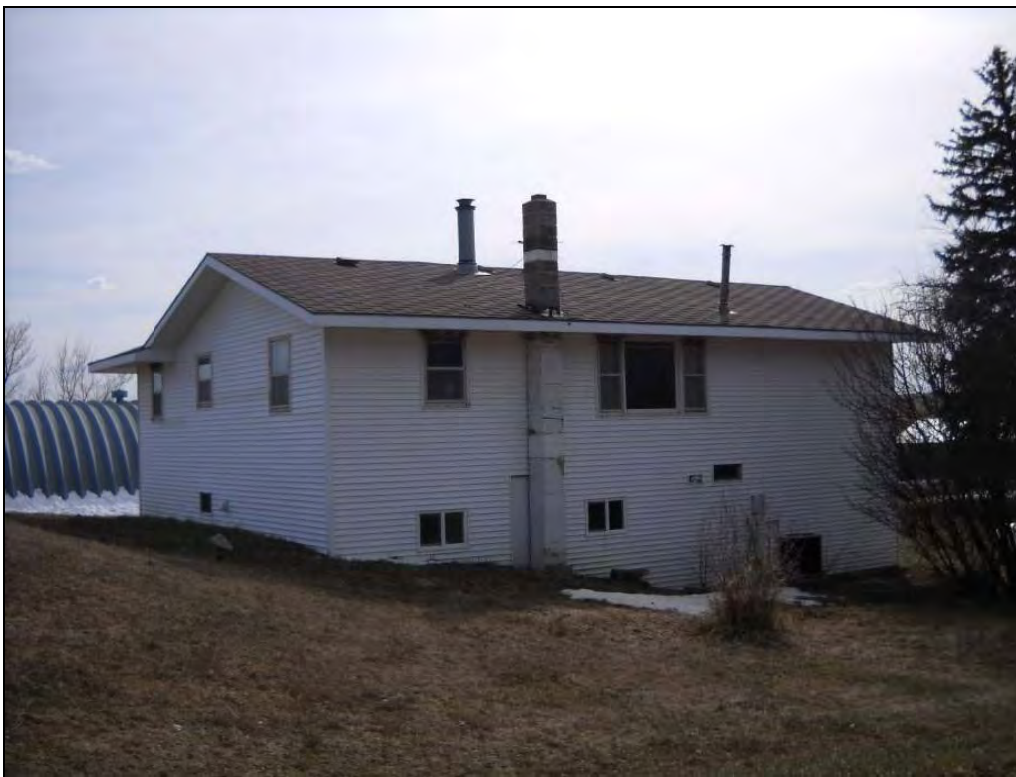
**Photograph 1 (Southwest):** An overview of Farmstead 979.502 from 35<sup>ST</sup> Street. Feature 1, the house, is in the foreground and Feature 2 (quonset hut) is in the background. Photograph taken on 4/7/10.

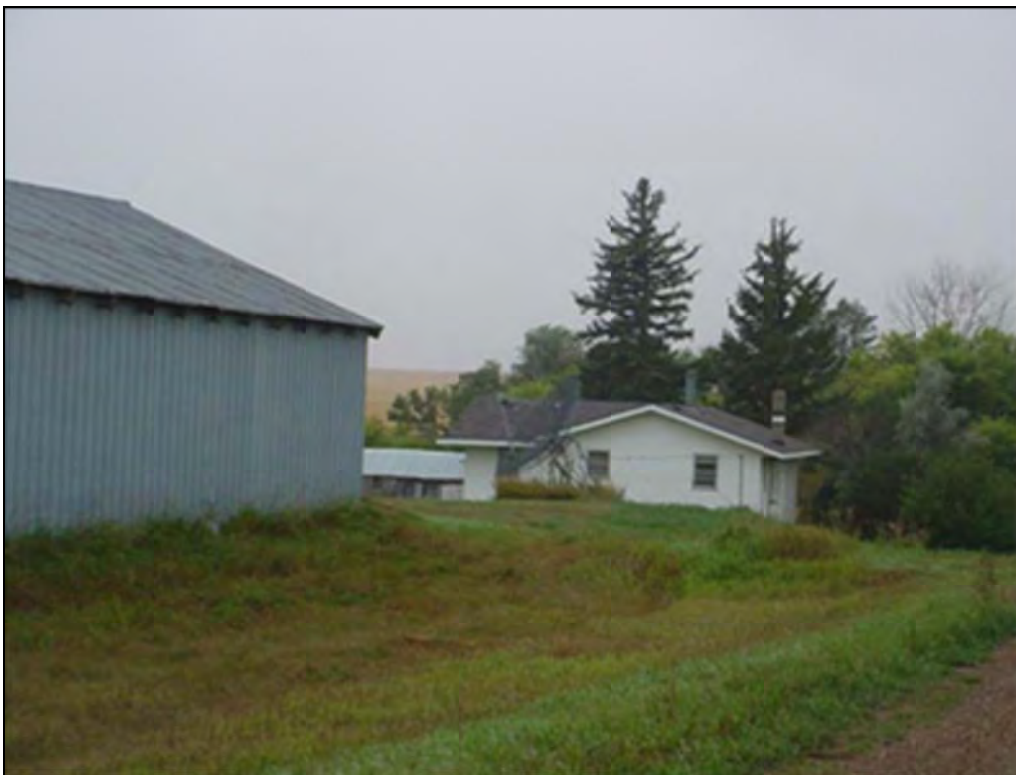
**Photograph 2 (South):** A view a metal outbuilding east of the house at 32MOx541 from 35th Street. This photograph was taken 8/28/2009 by Swenson, Hagen & Company.

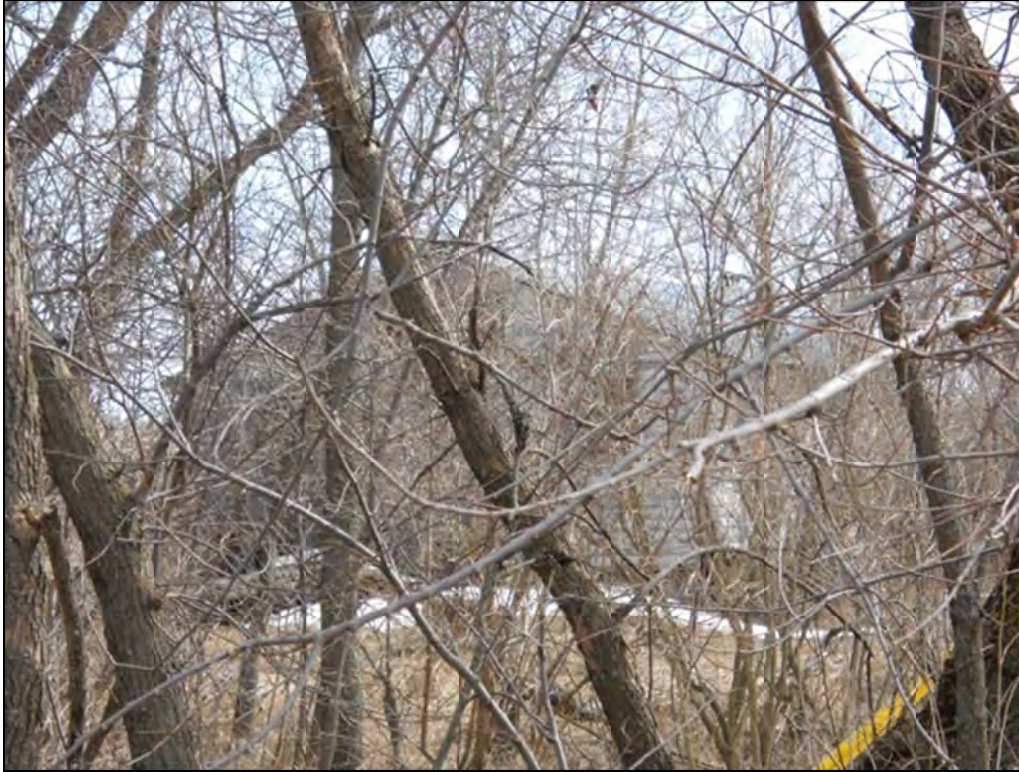
**Photograph 2 (South): A view toward Feature 3 from 35<sup>ST</sup> Street. Photograph taken on 4/7/10.**
