# **Grenora Pump Station Post-Construction Inspection Report PU-11-605**

## **NORTH DAKOTA PUBLIC SERVICE COMMISSION**

## **WENCK ASSOCIATES, INC.**

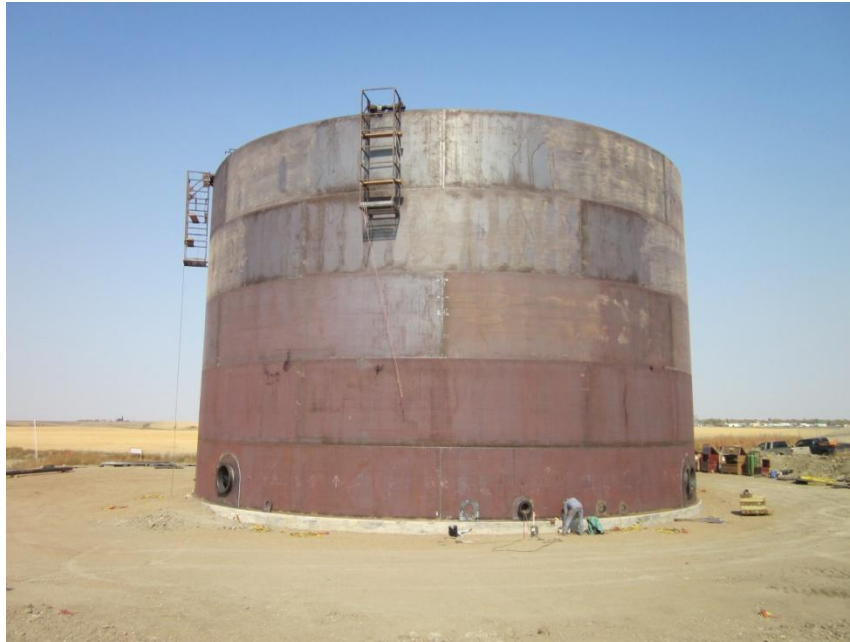
**Photo 1.** Direction: North. 40,000 Barrel Tank under construction during the September 2012 site visit.

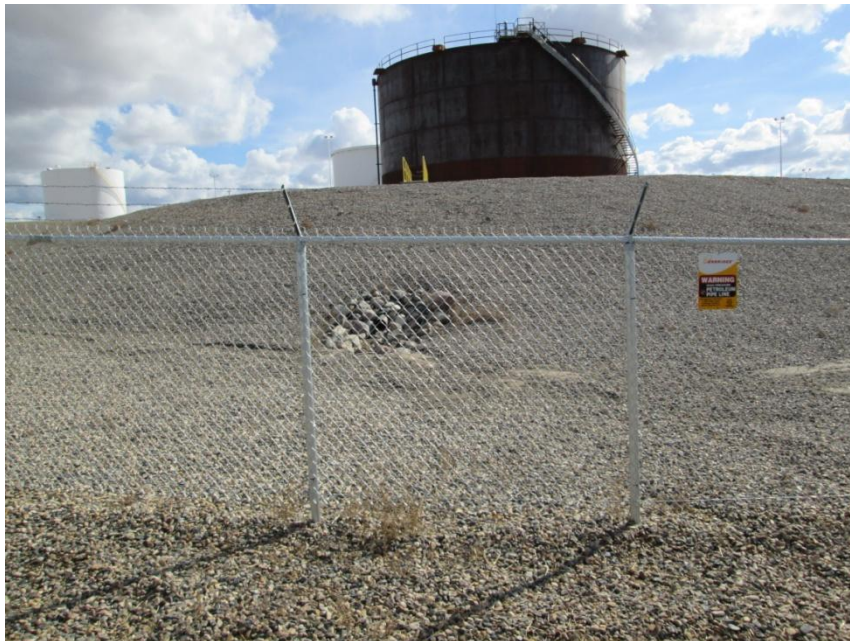
**Photo 2.** Direction: East. New Tank after completion during the October field survey. Note the culvert and rip-rap used for water and erosion control.

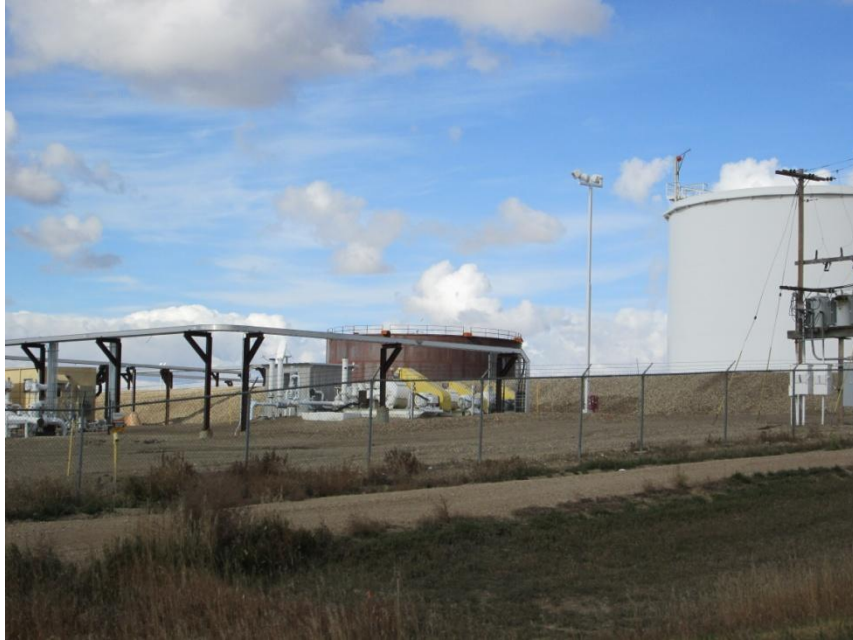
**Photo 3.** Direction: West. Storage tank and the associated structures after completion.

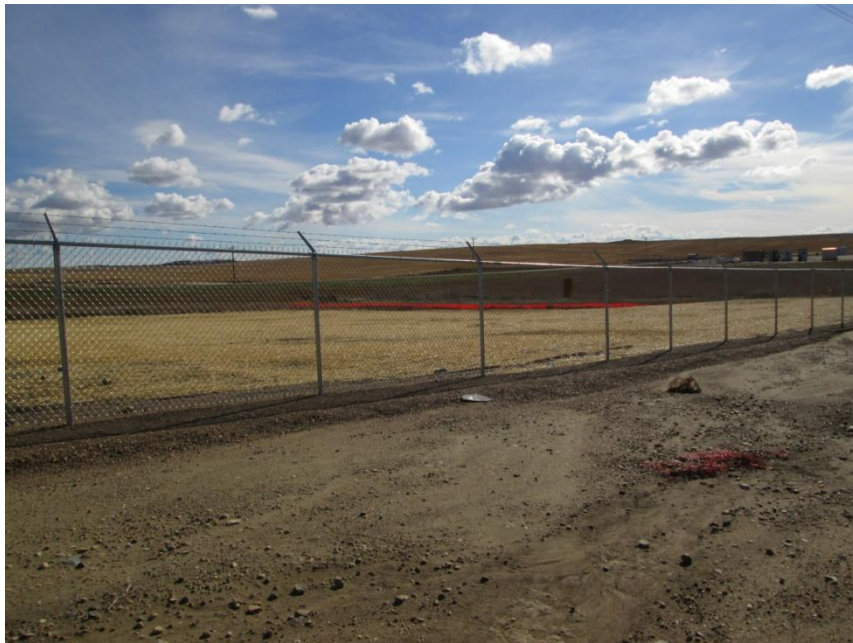
**Photo 4.** Direction: Southeast. Fiber blanket and silt fence in place prevent erosion and sedimentation of waterways.

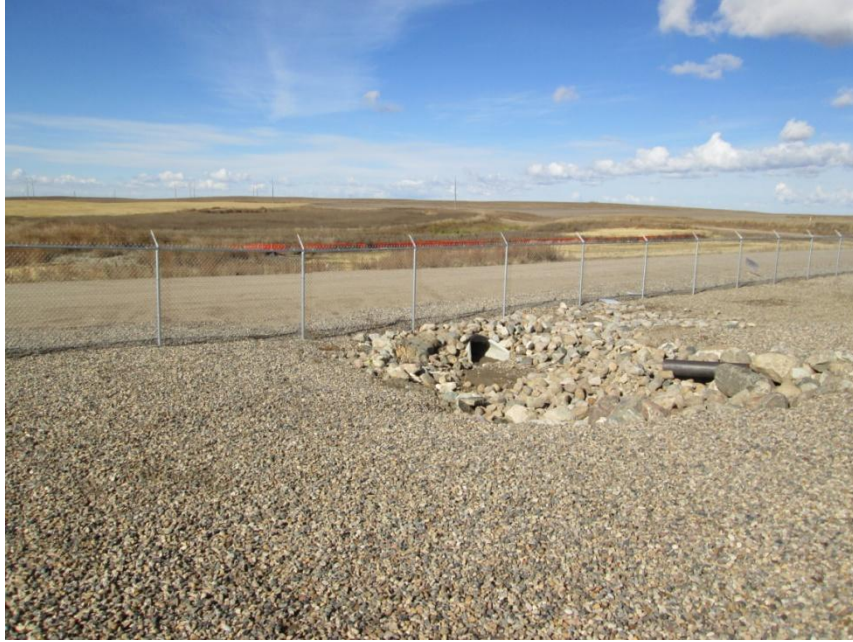
**Photo 5.** Direction: Northwest. Sediment fence placed near a wetland. Note culverts and rip-rap installed to promote natural drainage and prevent erosion.

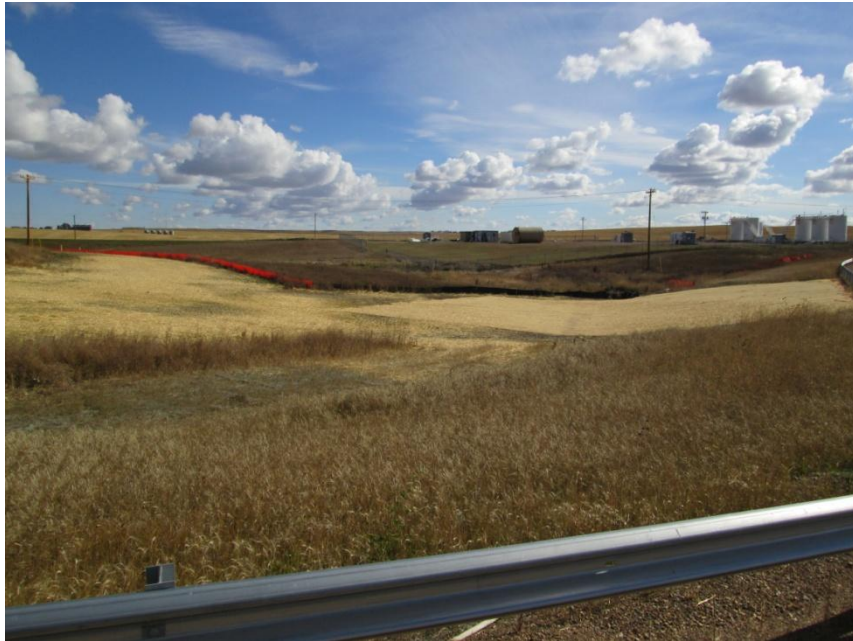
**Photo 6.** Direction: Southwest. Silt fence and fiber blanket were in place to prevent sedimentation into the natural wetland area.

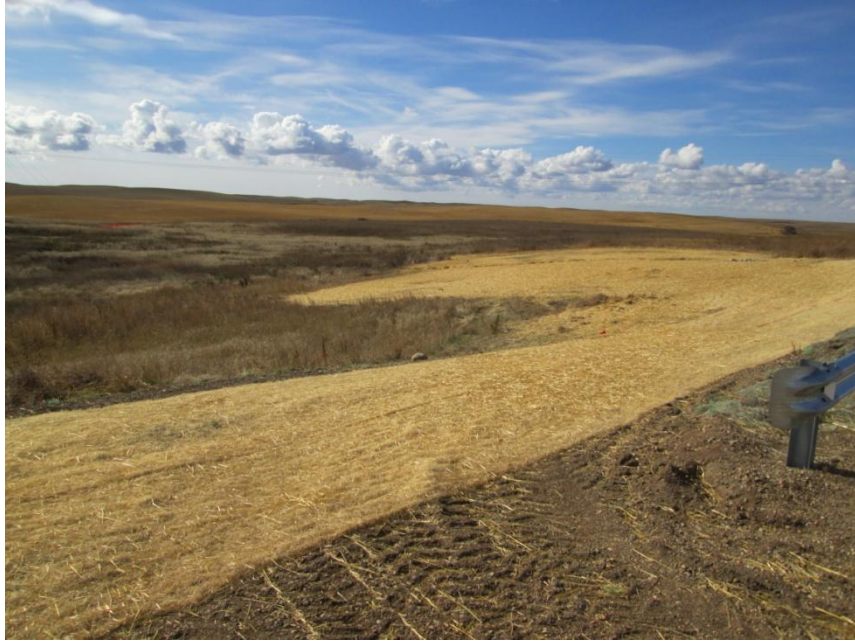
Reclamation was still ongoing at the time of the site inspection, but soils had been recontoured, and reseeded had been completed, with vegetation beginning to establish in some areas (Appendix A, Photo 7). Vegetation was beginning to emerge in most of the reseeded areas, though it was not fully established. The timing of the inspection was too early in the revegetation process to identify the species composition of the emerging vegetation. Wenck recommends the PSC request documentation from Enbridge once vegetation has fully established in the grassland area.

**Photo 7.** Direction: West/Southwest. Fiber blanket in place to prevent sedimentation of the wetland. The area has been reseeded and vegetation was just beginning to emerge from under the fiber blanket.

Establishment of vegetation was ongoing within the disturbed construction footprint along the berm surrounding the new pump station, and in the road ditches near the pump station. Wenck recommends the PSC request monitoring and documentation when reclamation is complete. Soil amendments or re-seeding may be necessary if vegetation does not readily reestablish.

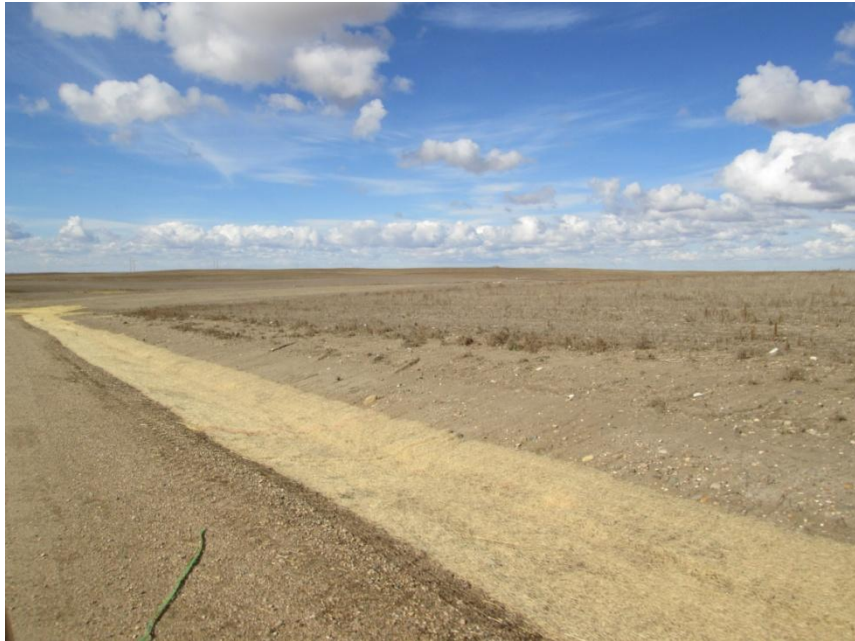
**Photo 8.** Direction: East. Fiber blanket placed in a ditch to control erosion and sediment migration along the northern edge of the project area.

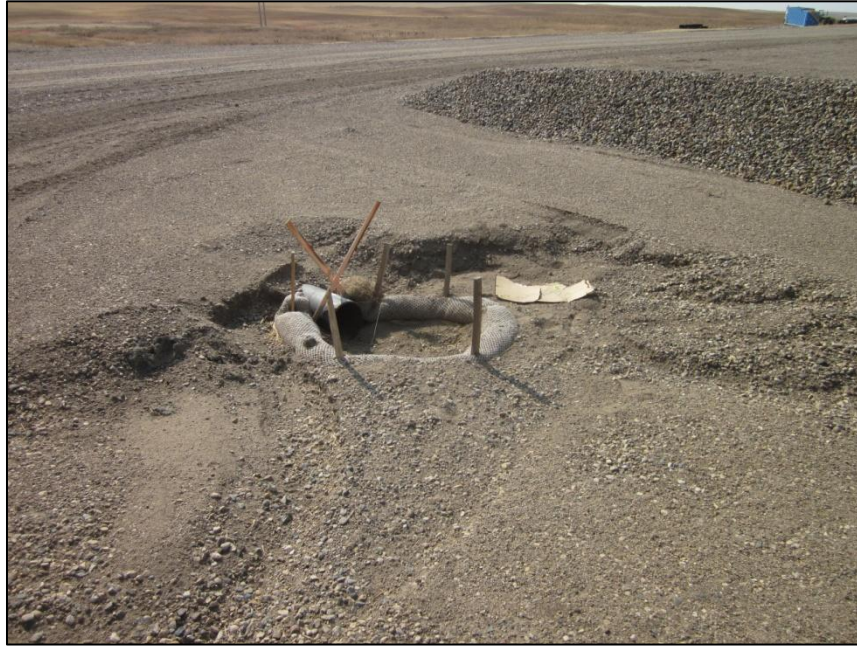
**Photo 9.** Direction: Northeast. Drain line surrounded by straw wattles to prevent sediment from entering the drainage.

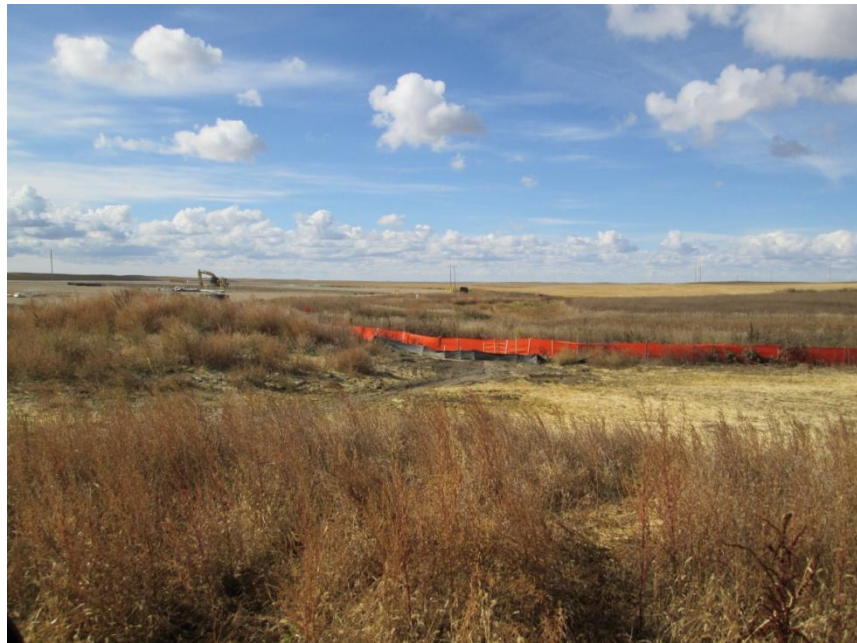
**Photo 10.** Direction: West. Silt fences in place around a wetland installed to prevent sedimentation.

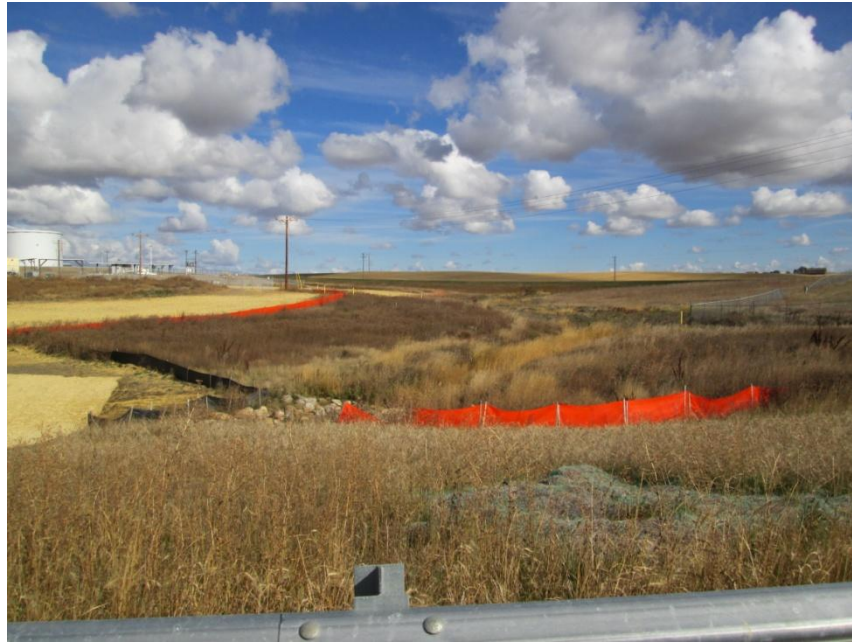
**Photo 11.** Direction: East. Silt fences and rip-rap around a drainage to protect the wetland for sedimentation.

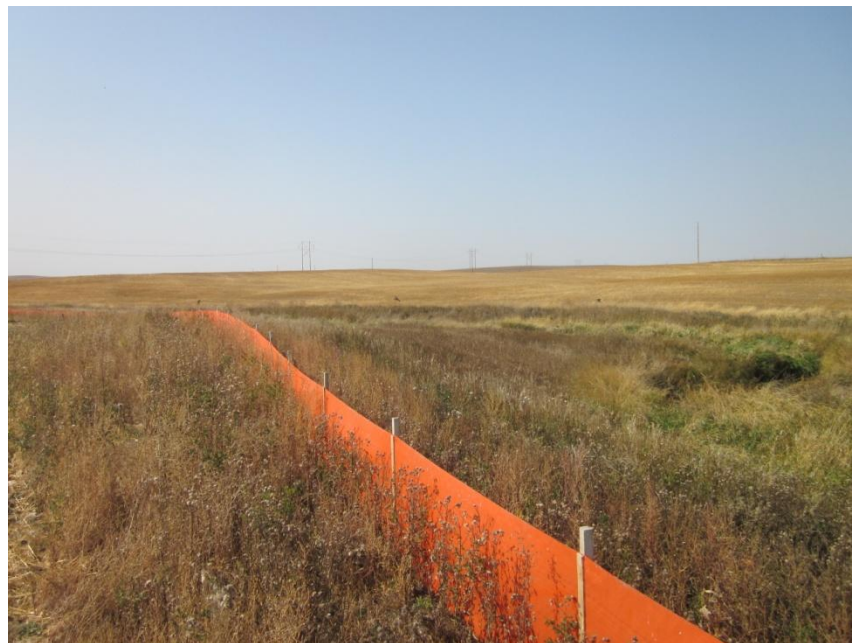
**Photo 12.** Direction: Northwest. Silt fence installed on the north edge of the project area, preventing sediment from entering the drainage located to the north (pictured on the right edge of the photo).

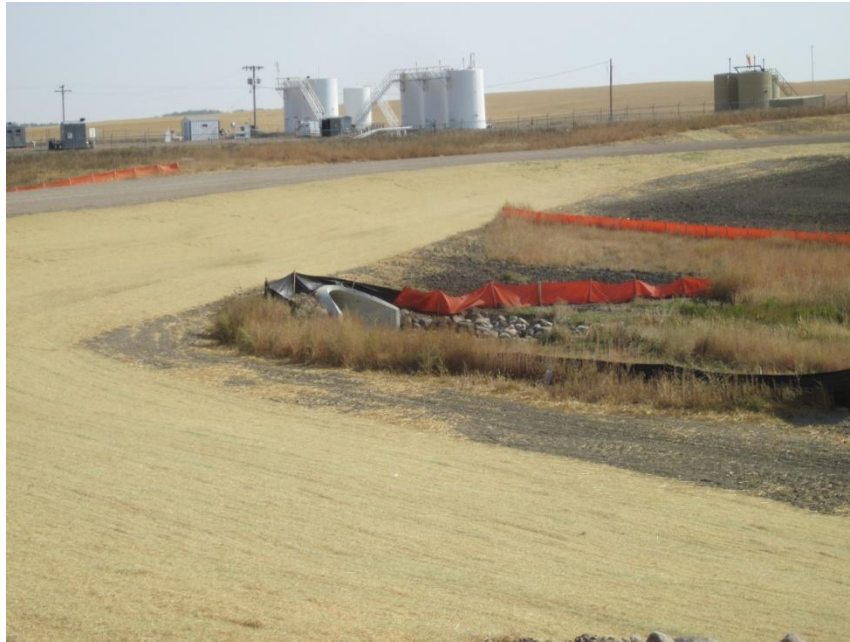
**Photo 13.** Direction: East. Culvert surrounded by rip-rap and silt fences to prevent sedimentation.

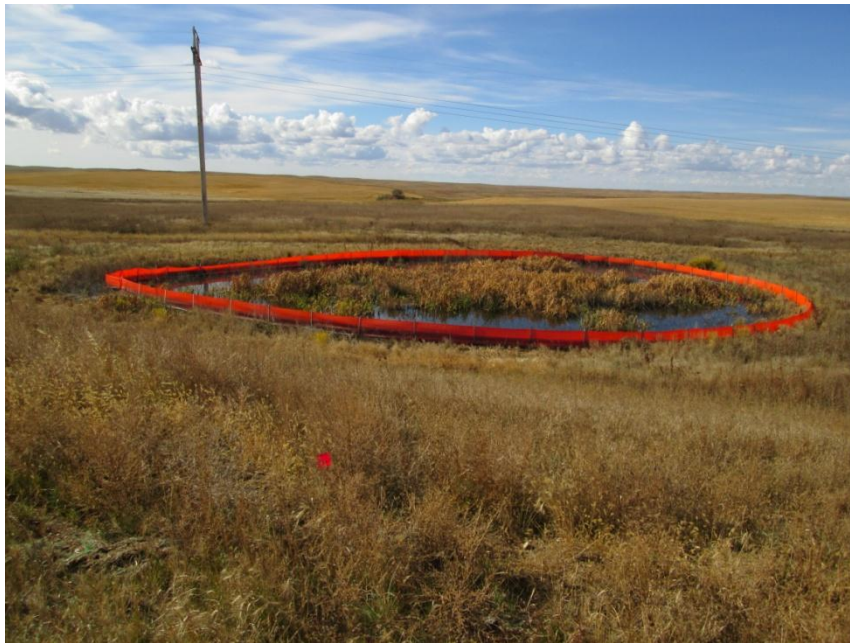
**Photo 14.** Direction: West. Natural wetland basins surrounded by a silt fence to prevent sediment migration.
