**RE: Construction Inspection Report for the Little Muddy Station Connection, Williams County, ND, PU-10147**

# Little Muddy Station Connection Project Post-Construction Inspection Report PU-11-606

## **NORTH DAKOTA PUBLIC SERVICE COMMISSION**

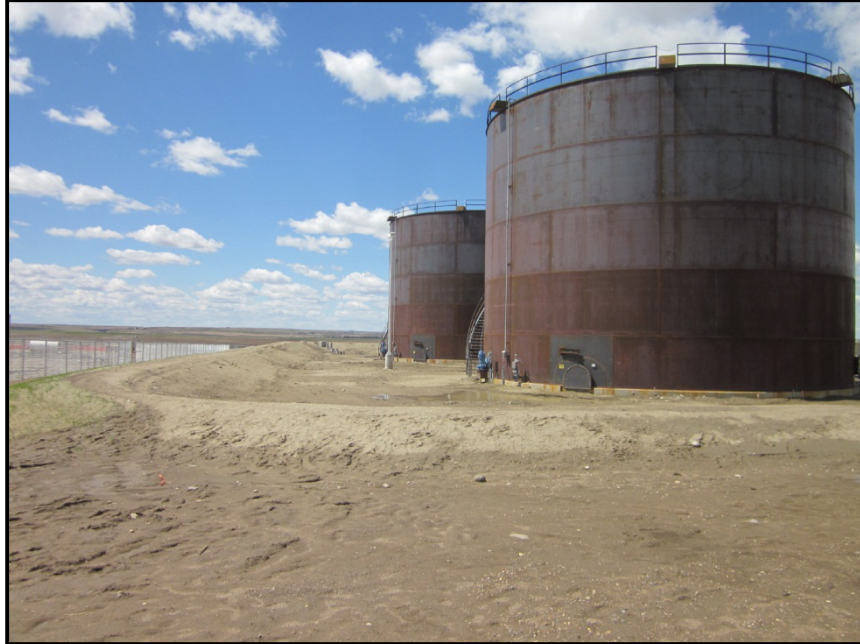
**Photo 1.** Direction: West. South side of tanks at Little Muddy Pump Station showing spill-containment berm still being put in at the time of field visit. Tanks were to be painted summer 2013. Tanks are 30,000 bbl (oil barrel) capacity; only one will be used at first; the other will be reserved for future use.

The Project was built as proposed within the estimated construction ROW, resulting in the conversion of 18 acres of agricultural land to industrial land use. This acreage was for the new Little Muddy Pump Station (Appendix A, Photos 1, 2, 10, 11).

Fences had been repaired where the Project crossed fence lines and a new fence line was installed at the approach to LACT lots and surrounding the new pump station (Appendix A, Photos 1, 9, 24). Enbridge reported there had not been any agricultural fields with drainage tile impacted by construction of the Project. There was no waste or debris observed at the site.

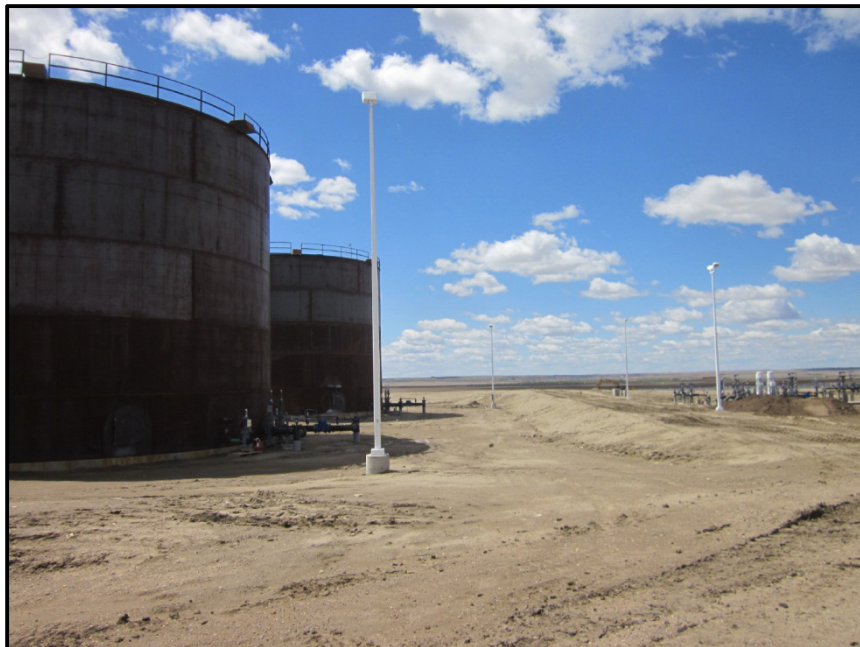
**Photo 2.** Direction: West. North end of tanks showing berm.

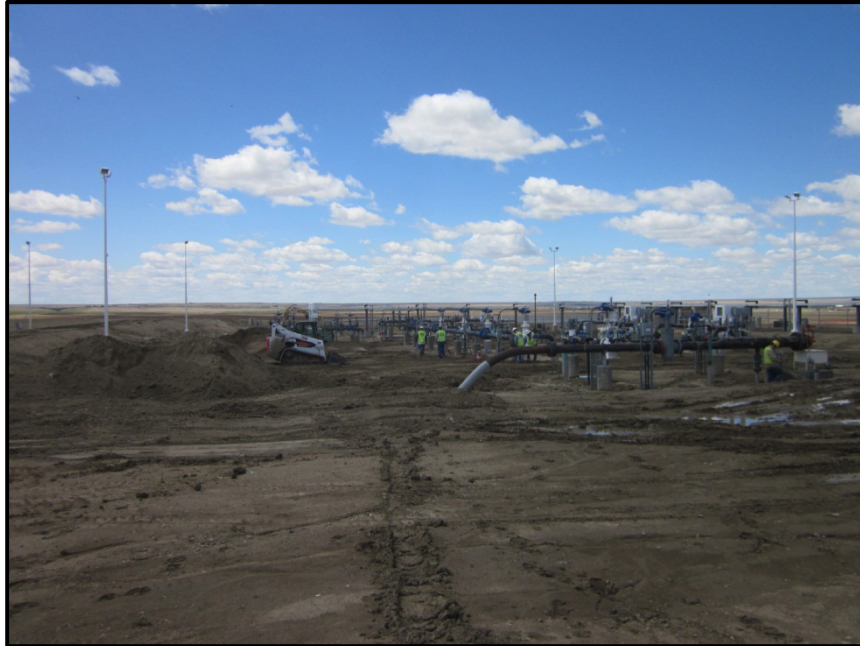
**Photo 3.** Direction: West. Pipeline tie-in area to the north of the two tanks. At time of visit trenches were being backfilled and electricians were finishing up work. After that, they would be putting clay lining in the area and testing for compaction. In foreground is header to East Fork (pipeline associated with the pump station).

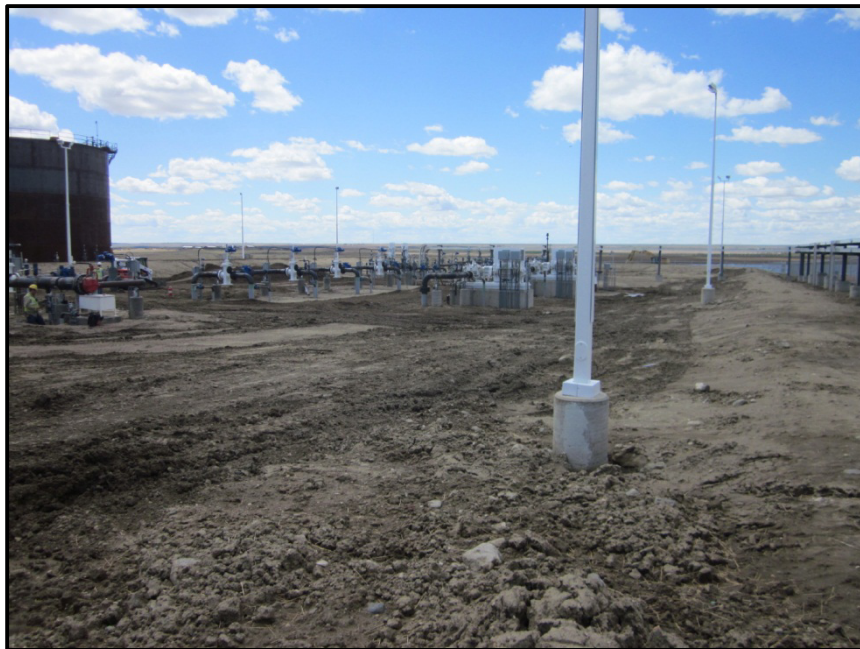
**Photo 4.** Direction: West. Another view of the tie-in area on north side.

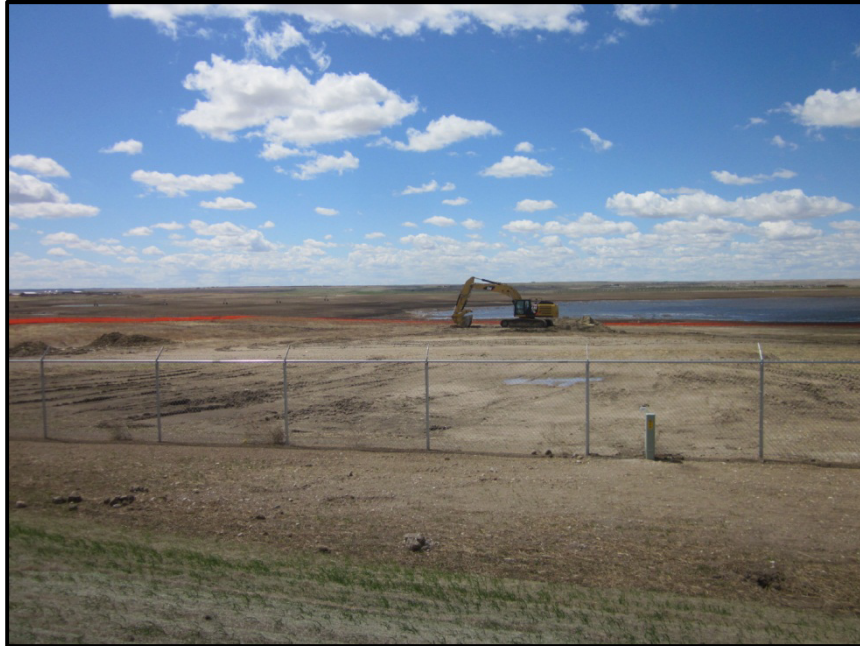
**Photo 5.** Direction: West. Off west side of pumping station where hydrostatic test waters had been released during pipeline testing. There was still some cleaning up to be done. A silt fence was visible in the distance.

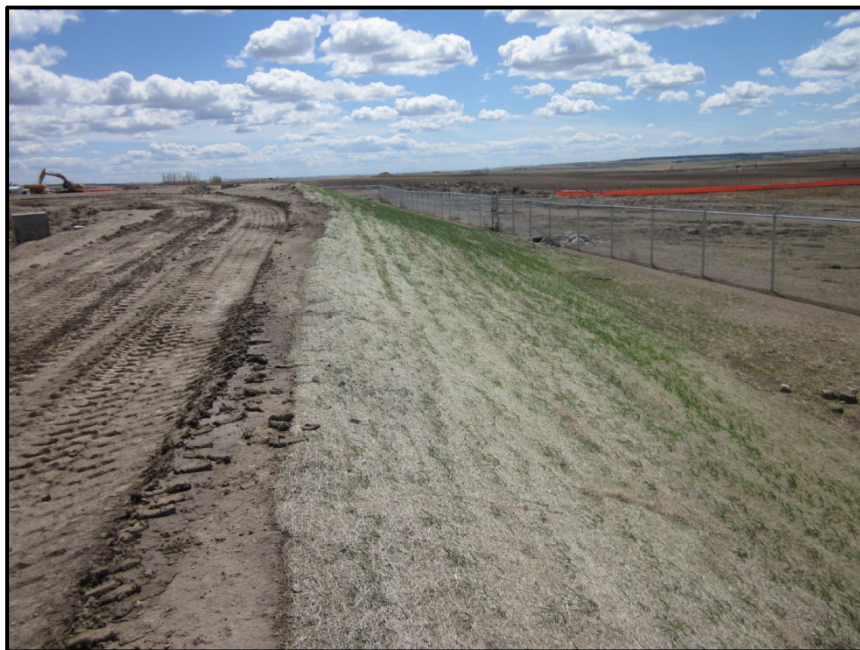
**Photo 6.** Direction: South. West side of berm around tanks. Grasses had been seeded into erosion control blanket and were coming up well.

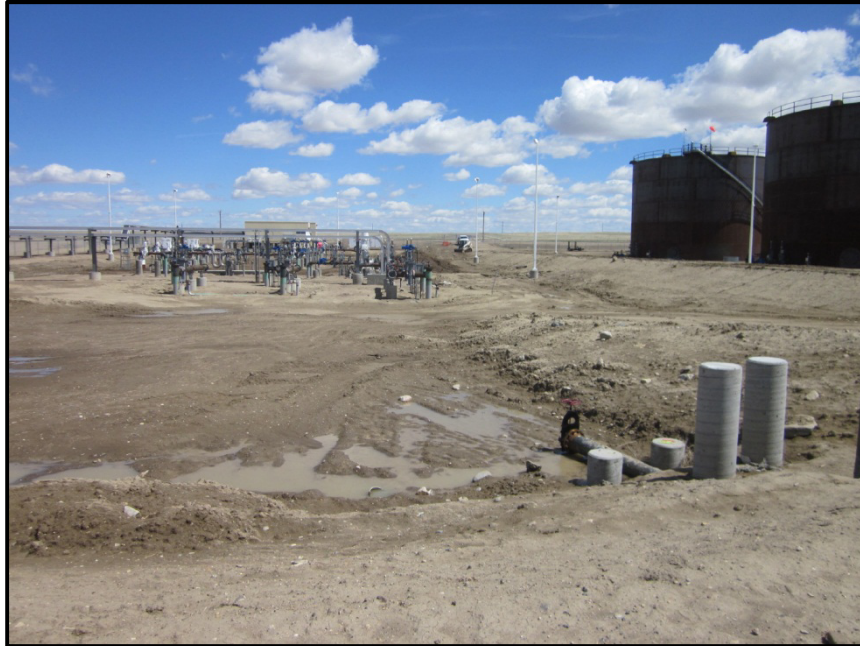
**Photo 7.** Direction: East. View across site from west to east. Drain valves in foreground release rain water collected within containment berm, which are closed except when drainage is needed.

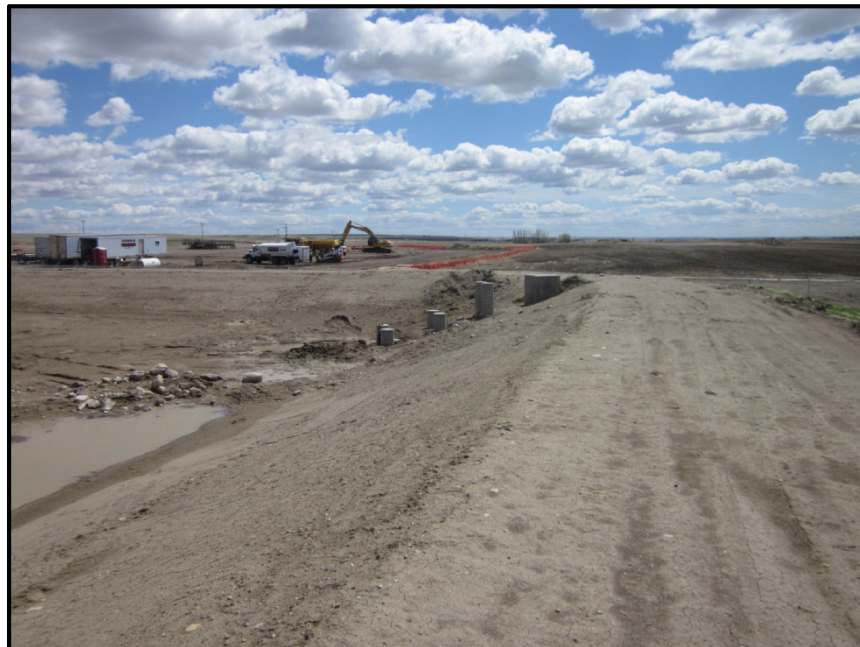
**Photo 8.** Direction: South. Drain valves within tank berm.

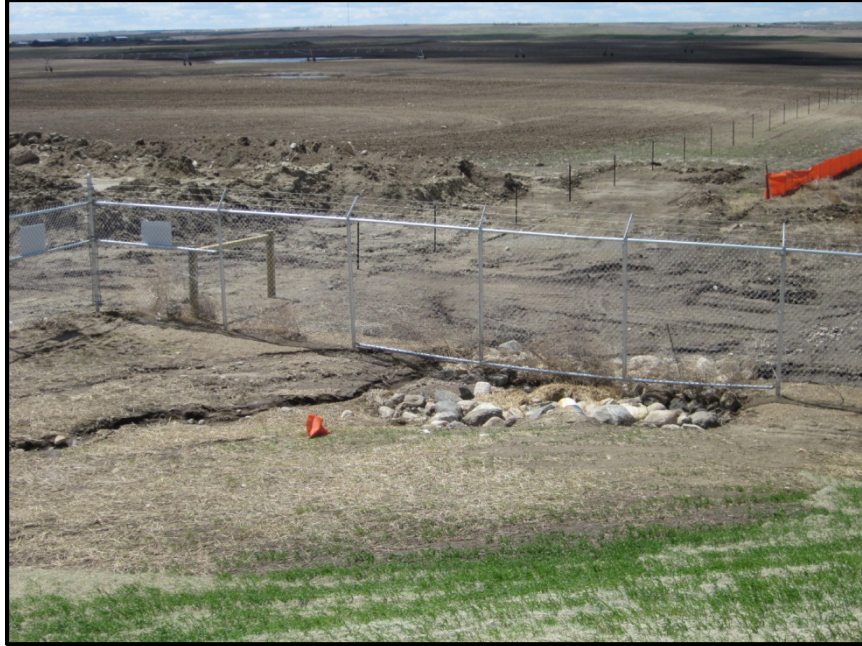
**Photo 9.** Direction: Southwest. Rip-rap on outside of berm showing where water will exit site when the drain valves are used.

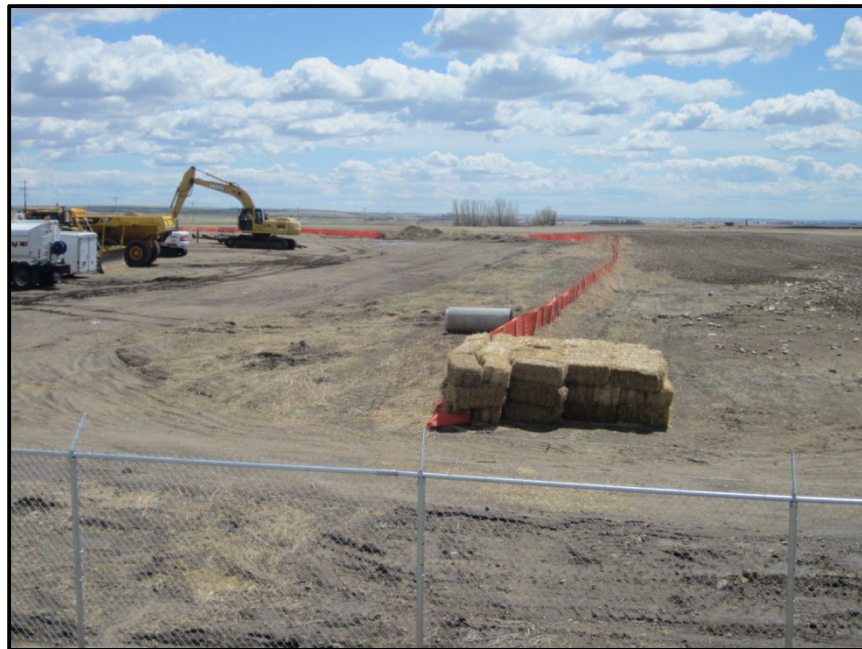
**Photo 10.** Direction: South. Area to south of pumping station used as a staging and lay down. Bales and silt fence used for erosion control and other various equipment are shown.

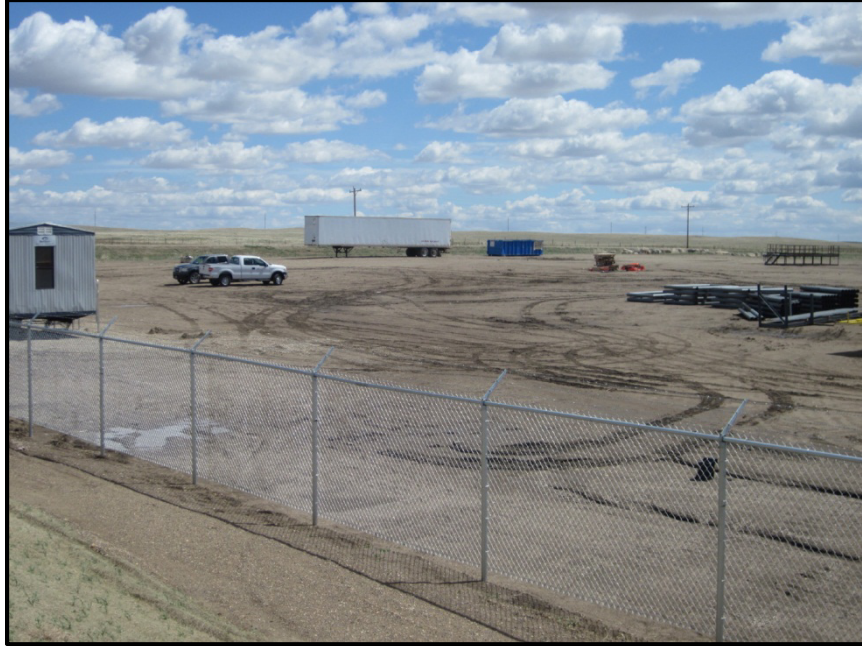
**Photo 11.** Direction: Southeast. Another view of staging area, which may be kept for potential future staging. If it is determined future staging is not needed, it will be reclaimed to cropland.

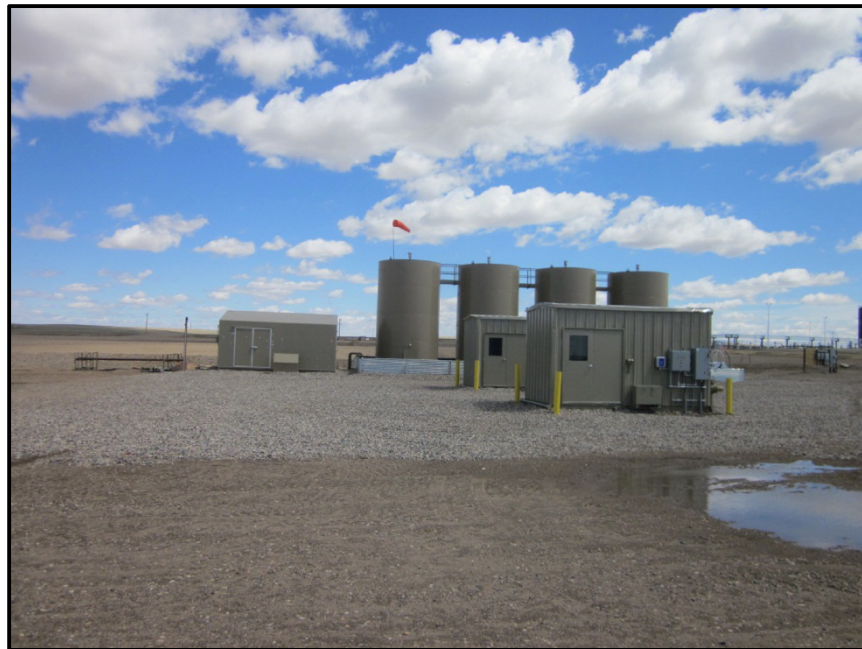
**Photo 12.** Direction: East. Photo shows one of the leased “LACT” lots. Eight of these lots were built north of the pump station for use by companies to lease and move their oil in Enbridge’s pipelines. Each lot has a hook-up with transfer units and meters which measure the oil.

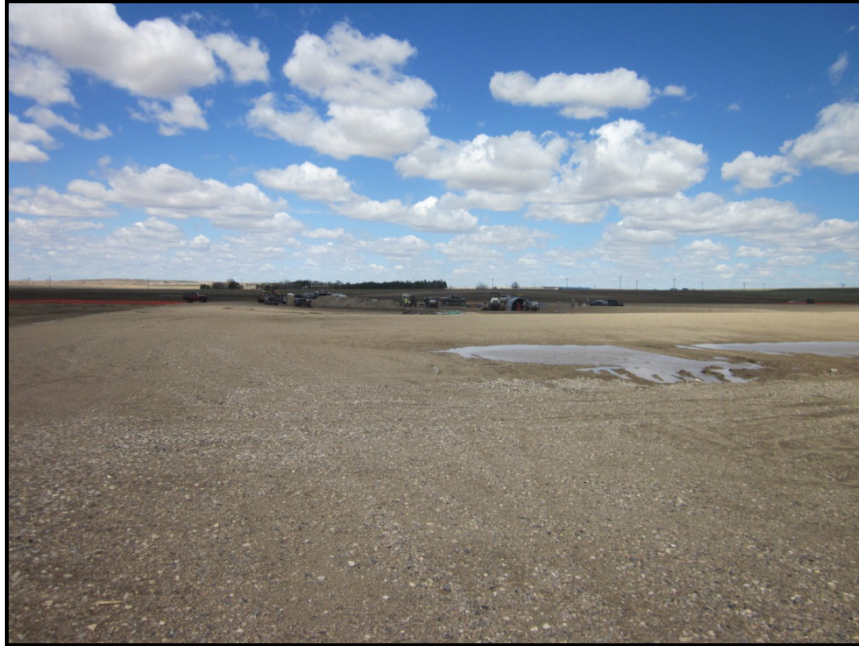
**Photo 13.** Direction: North. Showing other empty lots and one being built. On the lots, companies can set up buildings, tanks, and anything else they need.

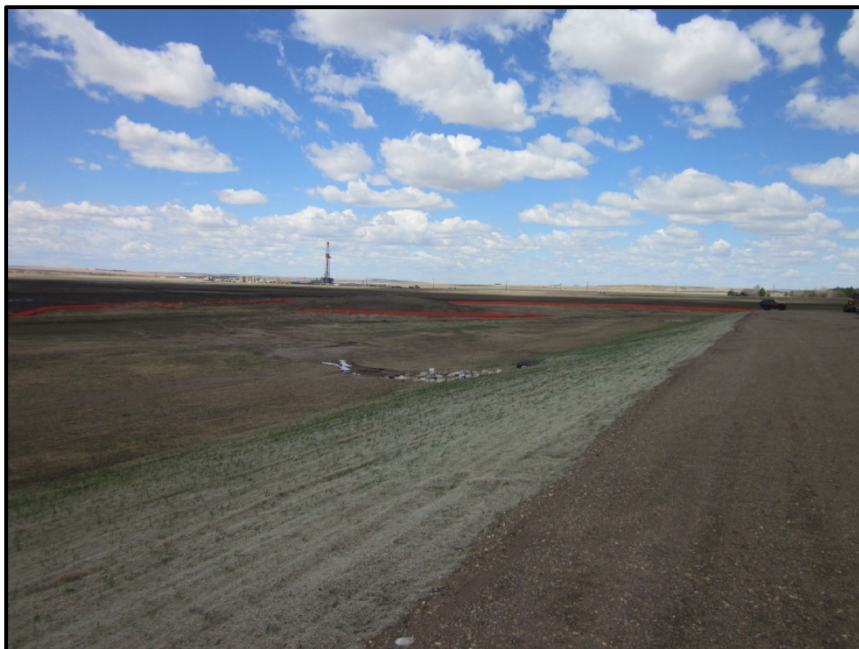
**Photo 14.** Direction: North. East edge of LACT lots showing erosion control measures in place and drainage set up along adjacent roadway.

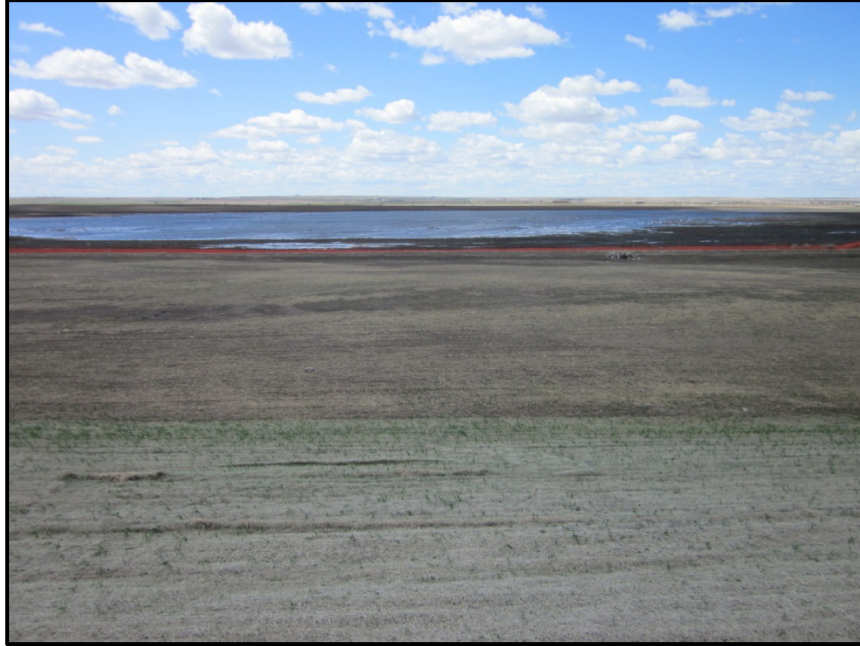
**Photo 15.** Direction: West. Silt fence in distance to west of LACT lots prevent sedimentation to wetland in the distance. Soil was stabilized and reclaimed with no problems apparent.

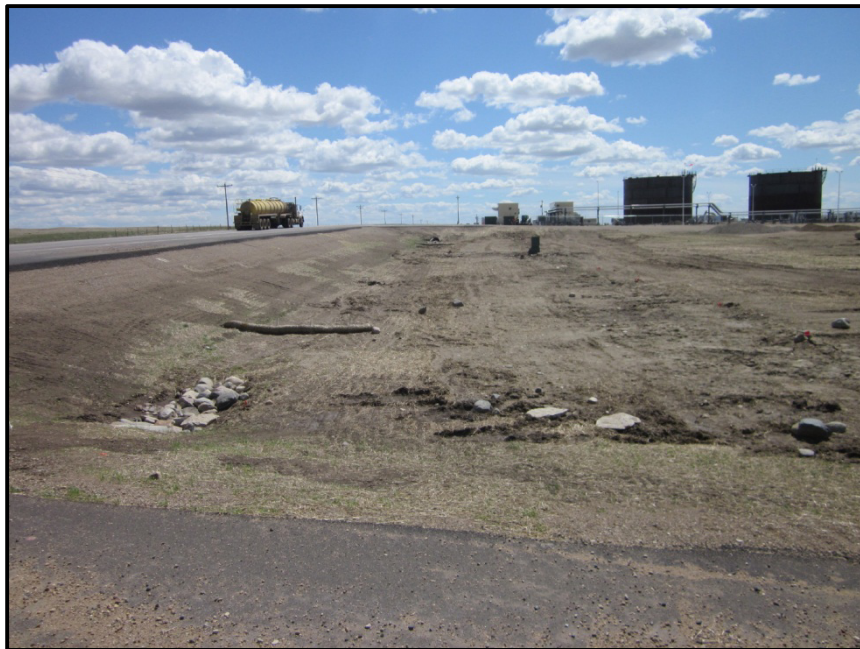
**Photo 16.** Direction: South. As part of the project Enbridge paved the road leading up to the pump station (133<sup>rd</sup> Ave NW). Ditches were reclaimed with erosion control and drainage in place with everything in good condition. A turning lane was added at the approach to the LACT lots to accommodate truck traffic.

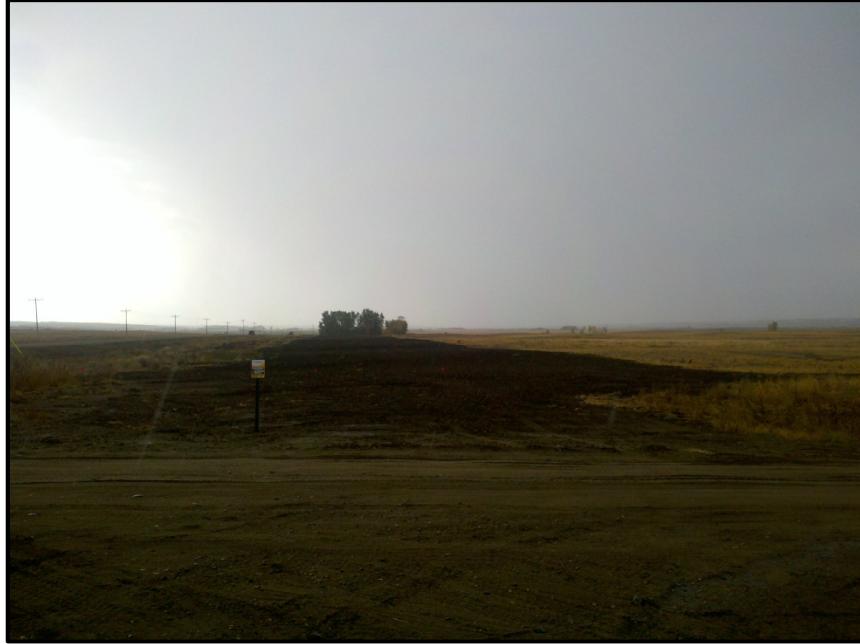
**Photo 17. Direction:** South. ROW obtained by Enbridge at north end of Little Muddy pipeline where it connected to the pump station. Follows 133<sup>rd</sup> Ave NW.

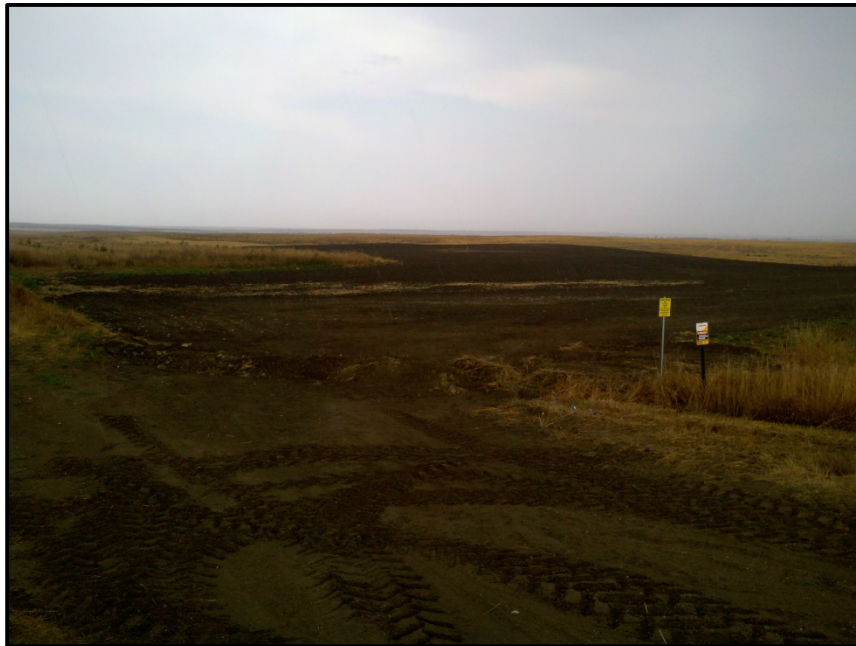
**Photo 18. Direction:** West. As part of the project Enbridge limited the amount of disturbance to wetlands. Enbridge bored underneath this wetland which is parallel to 63<sup>rd</sup> Ave/CR 8B on the south side. The wetland was farmed through.

No concerns were identified during the site review that would indicate that Project operation was out of compliance with the Application or safety regulations. Examples of operational safety measures observed at the site include: use of personal protective equipment, and warning signs surrounding the pump station and marking the pipeline route (Appendix A, Photos 18, 19). No reports of extraordinary events were filed to date with the PSC.

Warning signs marking the location of the pipeline had been installed and were in place at all fence lines and road crossings (Appendix A, Photos 18, 19). Enbridge indicated that resident/landowner concerns and issues are handled promptly and Enbridge makes every reasonable attempt to alleviate problems caused by the Project.

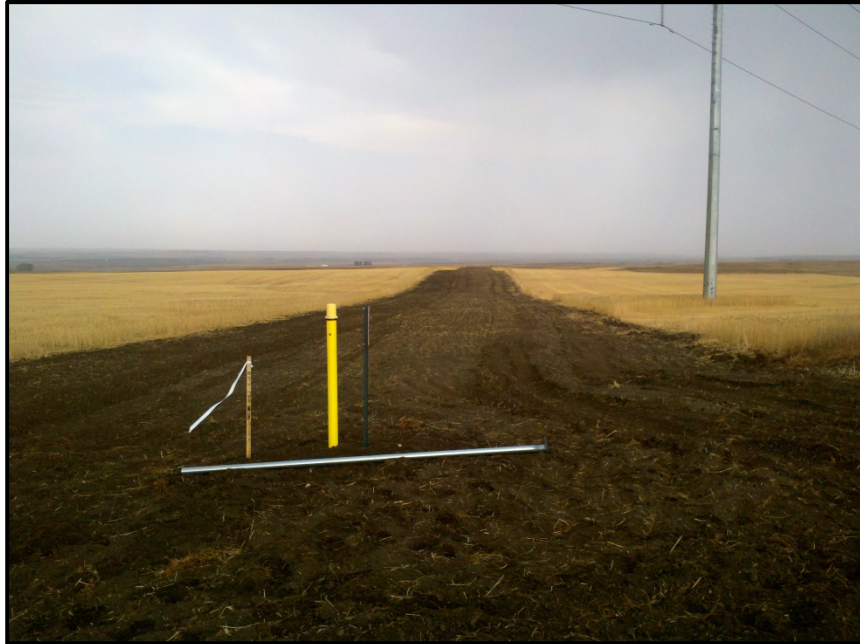
**Photo 19.** Direction: Northwest. Pipeline continued through cropland. Enbridge placed markers to show location of pipeline after backfilling, topsoil restoration, and general clean-up had been completed.

at 75ft in width and 300ft in length. The pipeline appeared to have been constructed according to these maximum widths (Appendix A, Photos 19, 22, 23).

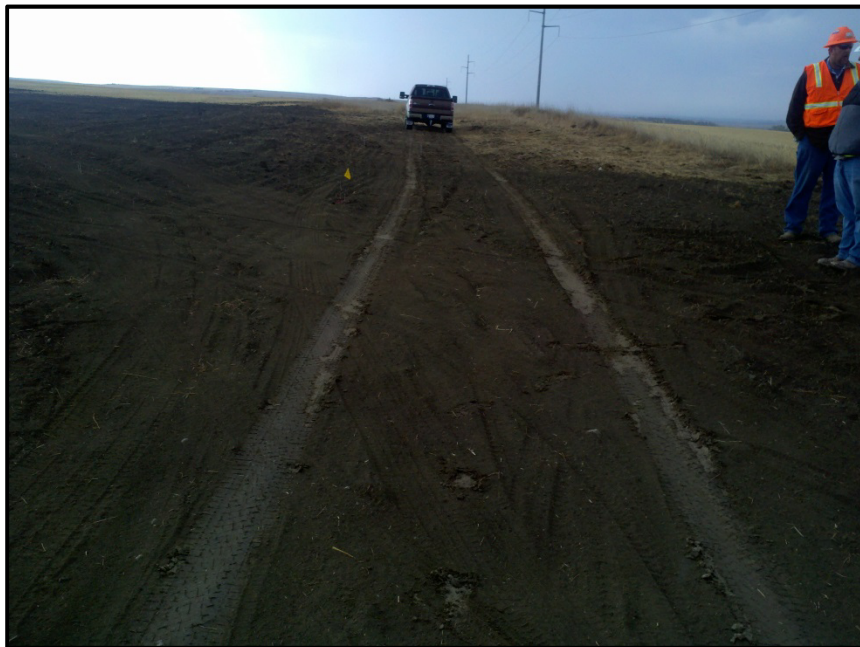
**Photo 20.** Direction: South. Intersection of pipeline with section line road. Road had been open cut. Everything had been repaired and was in good condition.

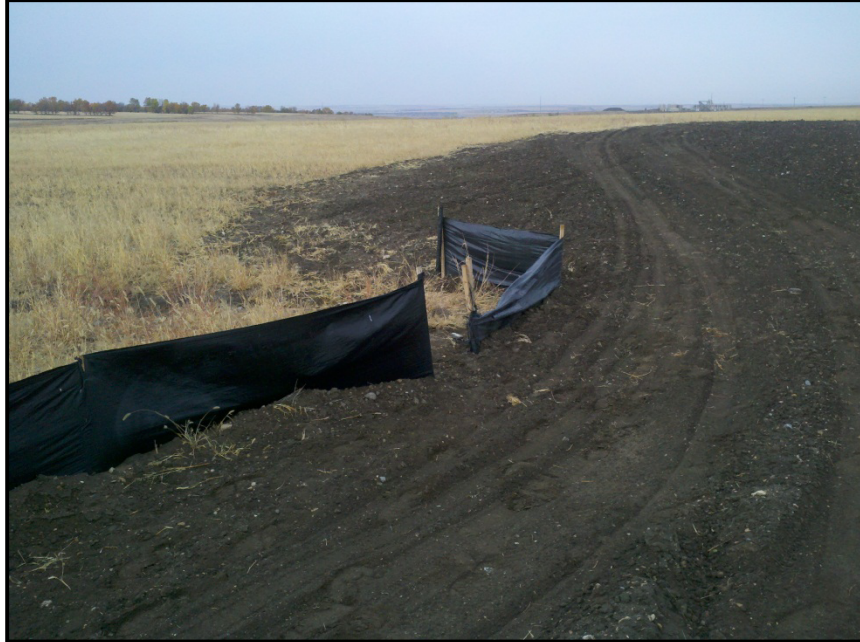
**Photo 21.** Dry upland field drain with erosion control silt fence in place. The fence is in need of minor repair.

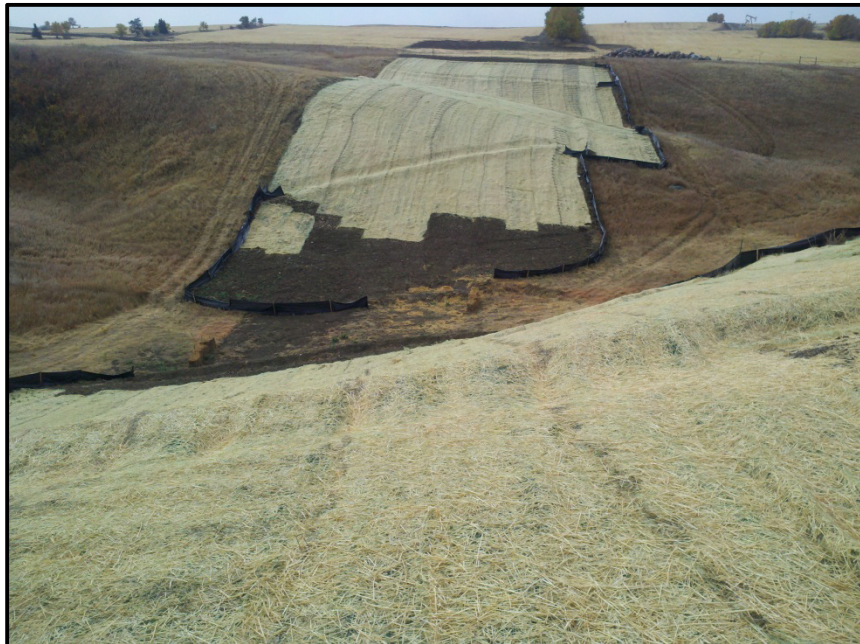
**Photo 22.** Direction: South. Pipeline route crossed several steep hills with dry drainages at base. In these instances, erosion control blankets were used, the hills were double seeded with local native seed using local NRCS guidelines. Extra straw mulch was used as well as a cover crop of winter wheat. On the distant hill the ROW was reduced to miss the row of trees to the south.

It was noted during the inspection that the width of the pipeline disturbance through grassland areas had been minimized, thus maintaining the temporary and permanent ROW requirements, fulfilling the USFWS request (Appendix A, Photo 22).

At the time of the site inspection, the pipeline trench had been backfilled, soils had been recontoured, and reseeded in grassland areas (Appendix A, Photo 22 and 23). Vegetation was beginning to emerge along most of the reseeded portion of the route as well as on the berms of the new pump station (Photo 6), though it was not fully established. The timing of the site inspection was too early to identify the species composition of the emerging vegetation. Wenck recommends the PSC request documentation from Enbridge once vegetation has fully established in the grassland area.

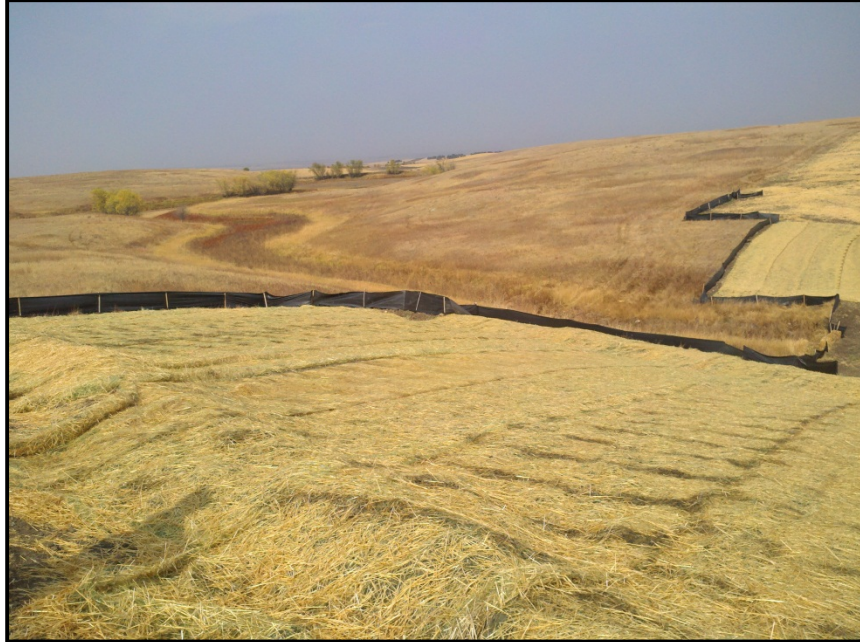
**Photo 23.** Direction: Northwest. Another steep hill crossing, this one with a wetland drainage at its base. The ROW width had been reduced, but open cut through the wetland. Proper erosion and sediment control and seeding had been done and was effective. Note the water bar in the foreground.

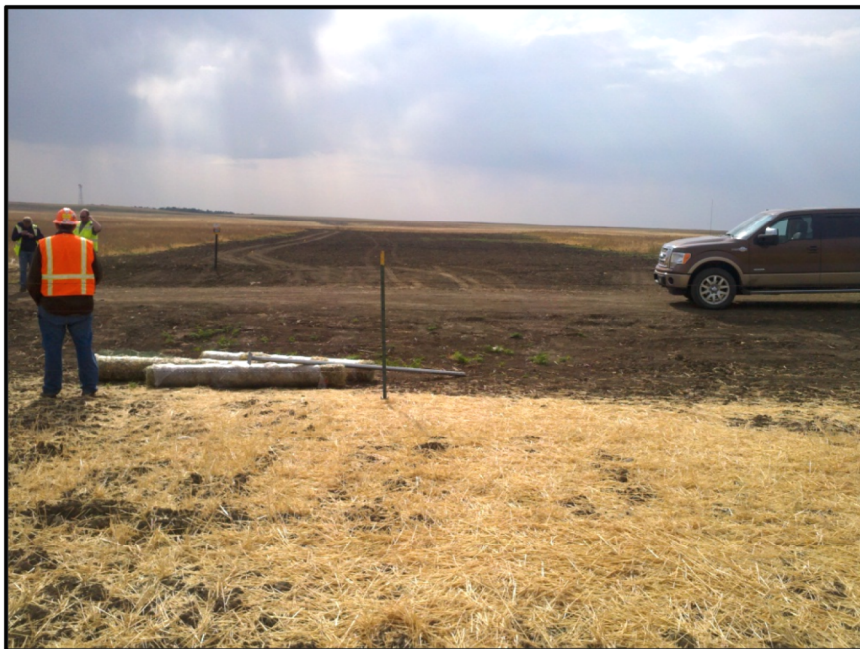
**Photo 24.** Direction: South. An open cut crossing of a section line road. The road, adjacent ditches and fields, and fences had been repaired properly. No problems were noted.

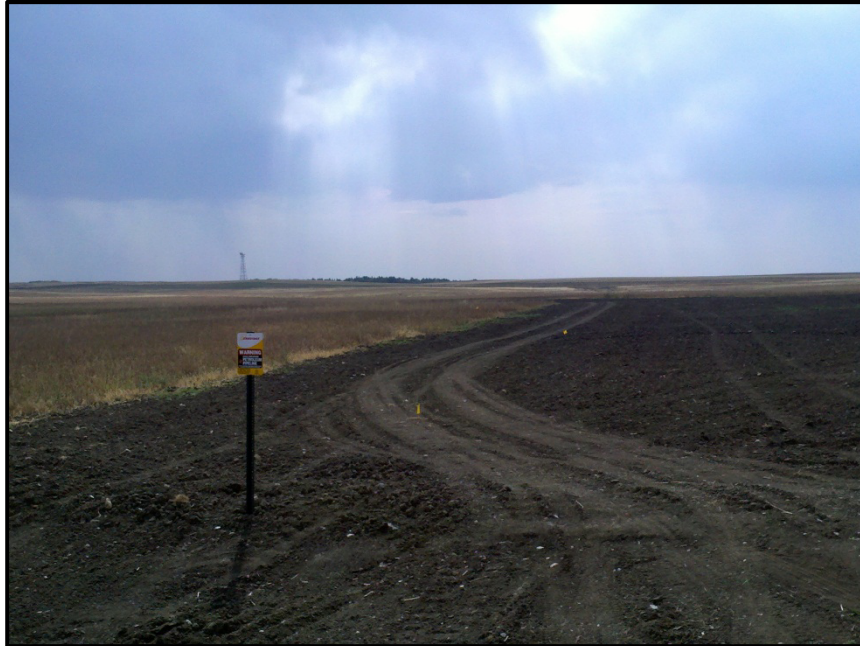
**Photo 25.** Direction: South. Pipeline was installed across fields and topsoil was replaced to necessary standards.

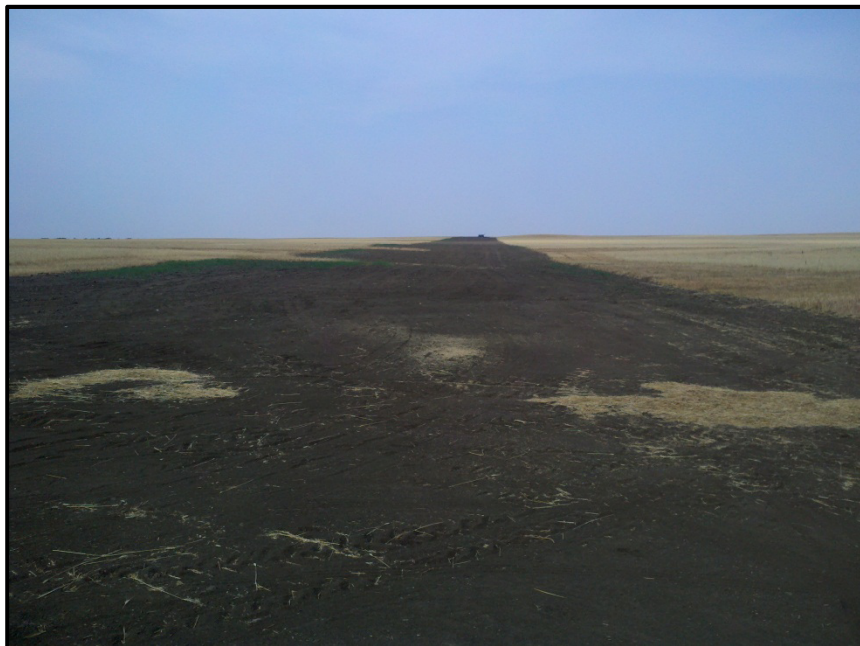
**Photo 26.** Direction: Northwest. Pipeline route northwest of East Fork Station.
