RE: Prairie Substation to Ramsey Substation 230 kV "GD" Transmission Line Clearance Issues

**Great River Energy 230-KV "GD" Line  
Clearance Discrepancy Locations  
Figure 1**

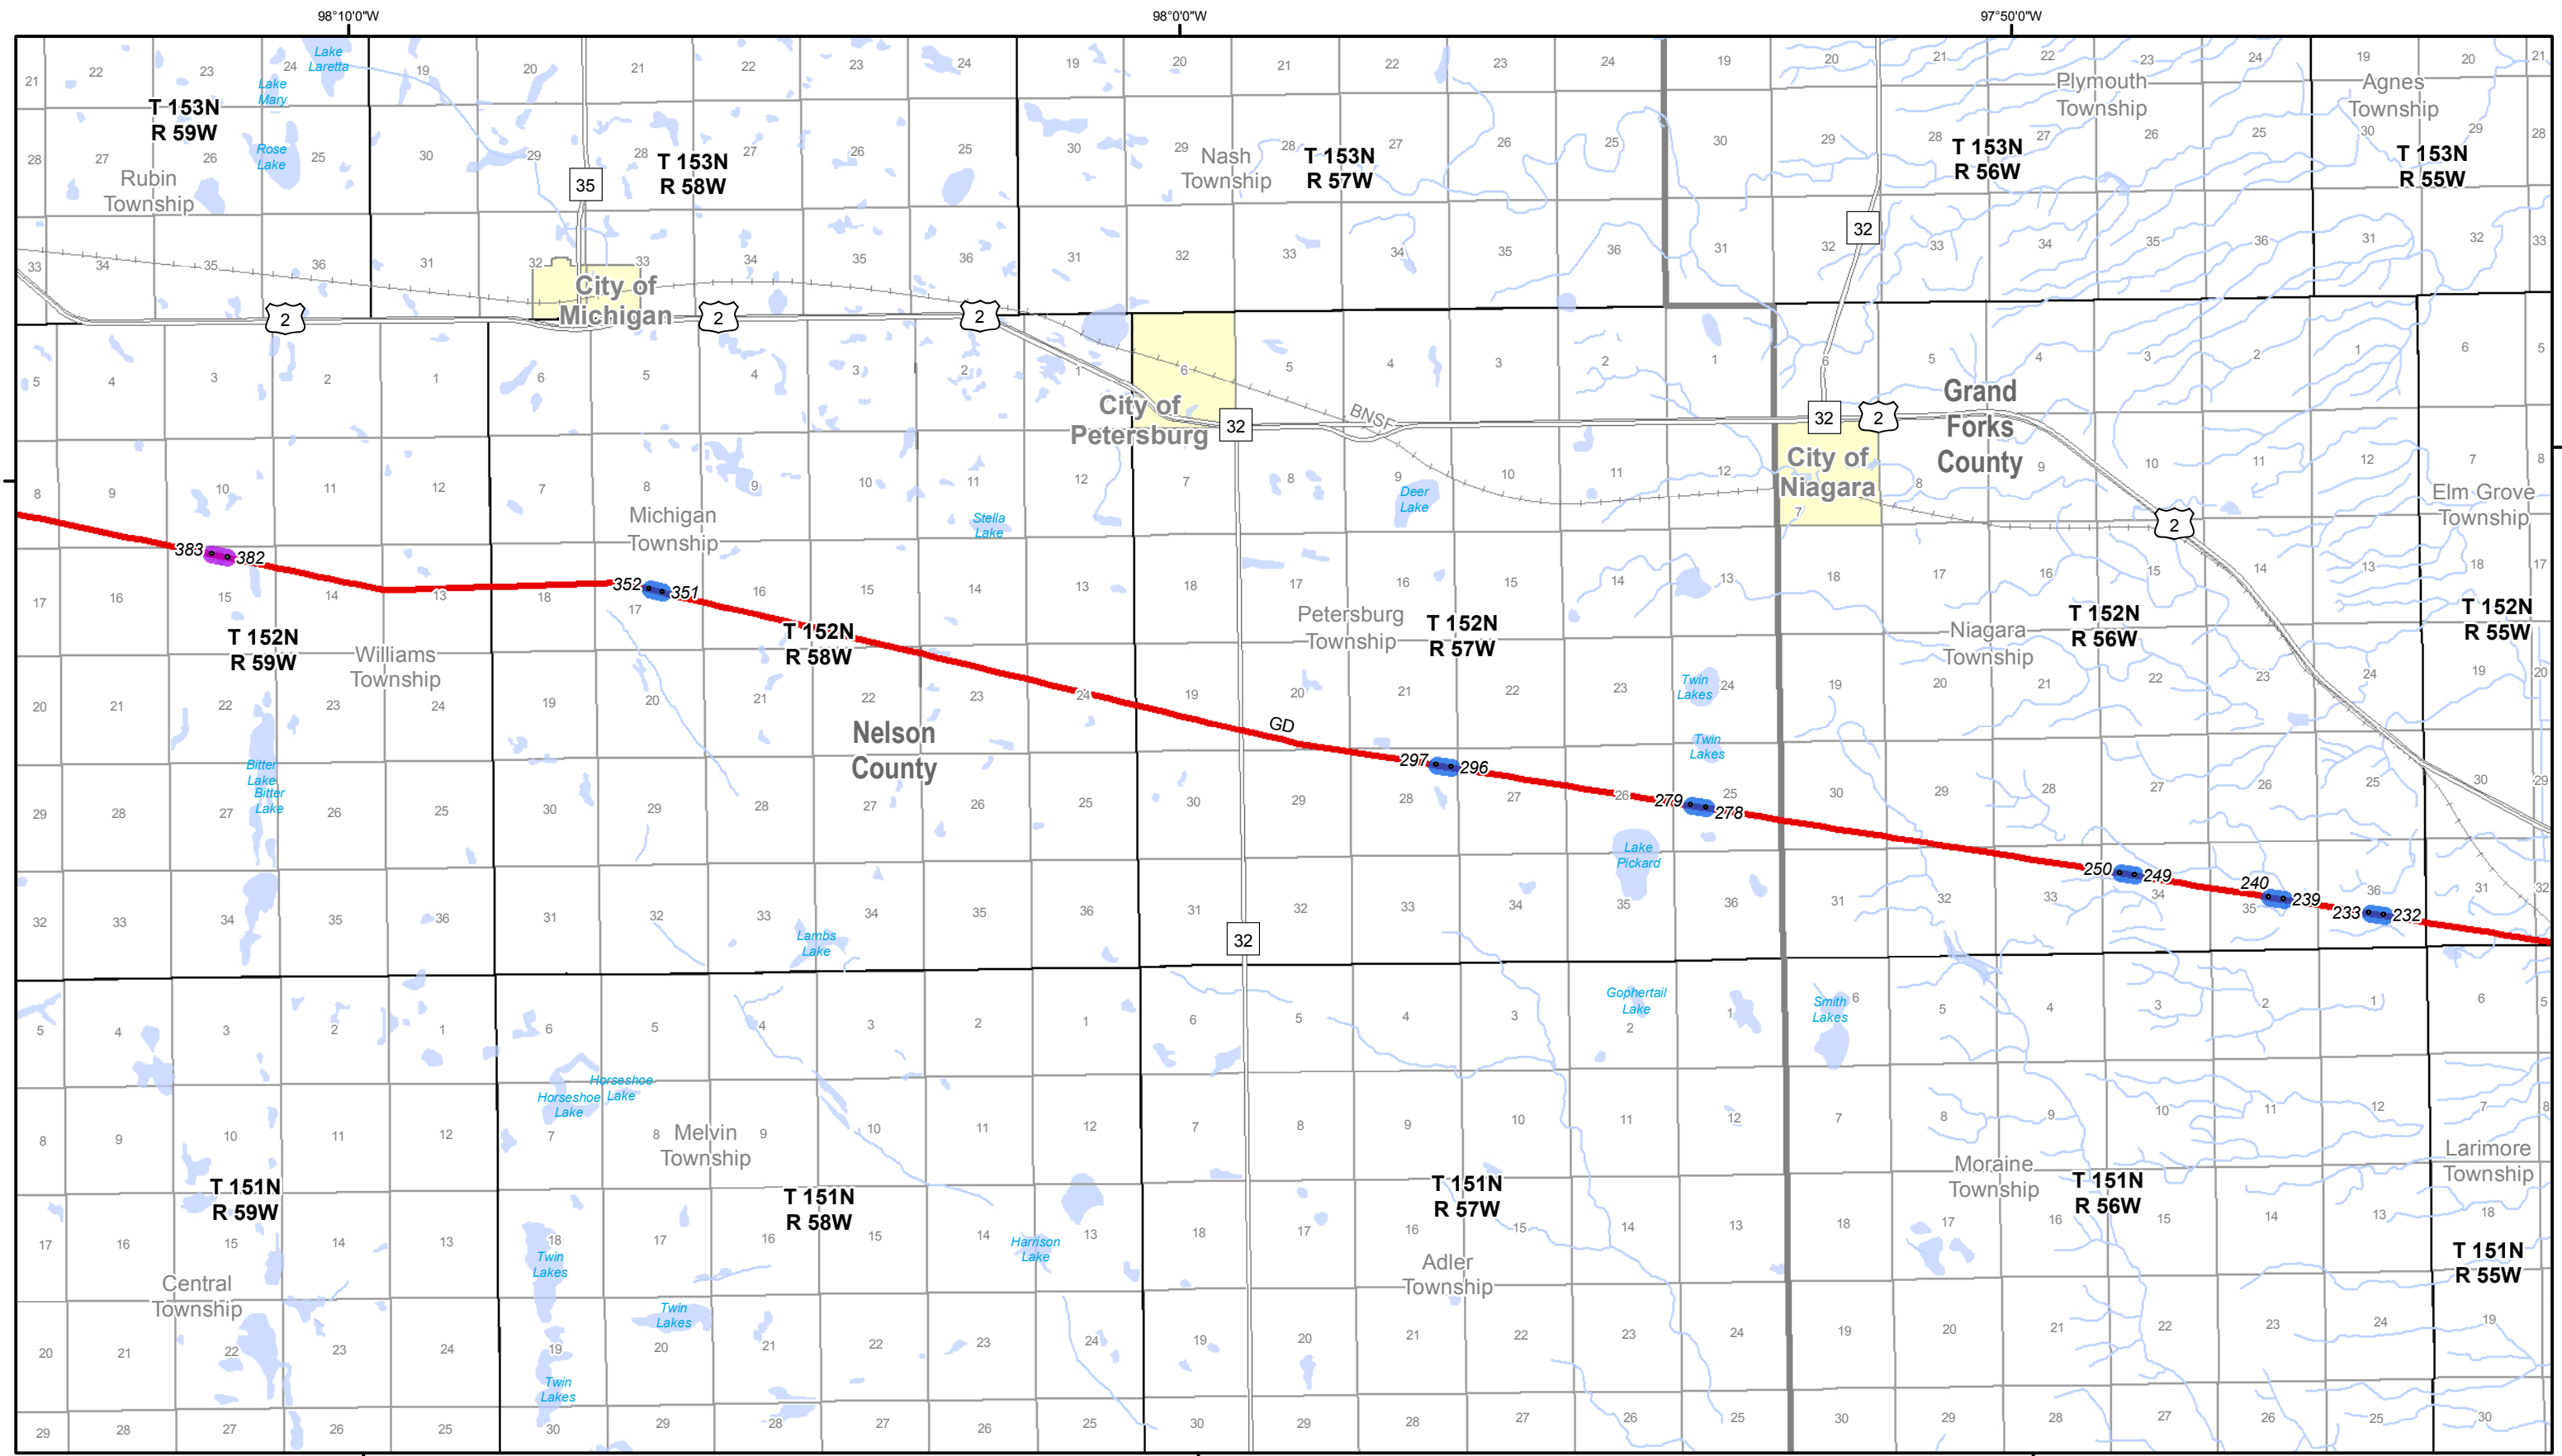
The analysis revealed a number spans located in upland areas (blue areas, Figures 1 and 2 and attached aerials) of the GD Line that do not meet clearance requirements as specified by the 2007 National Electric Safety Code (NESC). The following structures need to be replaced:

Structure Number	NESC Clearance Requirement (ft) (including 1 foot buffer)	Existing Above Ground Clearance (ft) at 168°F	Clearance Discrepancy (ft) at 168 ° F (including 1 foot buffer)	Segment of GD Line
232	23.4	20.99	2.41	4
240	23.4	21.66	1.74	4
250	23.4	20.86	2.54	4
279	23.4	23.26	0.14	4
296	23.4	22.34	1.06	4
352	23.4	23.04	0.36	5
444	23.4	21.64	1.76	6
484	23.4	21.31	2.09	7
540	23.4	23.26	0.14	7
545	23.4	22.19	1.21	8
548	23.4	21.12	2.28	8
550	23.4	18.38	5.02	8

The following spans over wetlands (purple areas, Figures 1 and 2 and attached aerials) were found to have clearance discrepancies:

Structure Numbers	NESC Clearance Requirement (ft) (including 1 foot buffer)	Existing Above Ground Clearance (ft) at 168°F	Clearance Discrepancy (ft) at 168 ° F (including 1 foot buffer)	Segment of GD Line
382-383	21.9	19.7	2.20	6
452-453	21.9	13.78	8.12	7
453-454	21.9	20.82	1.08	7
456-457	21.9	15.35	6.55	7
457-458	21.9	20.33	1.57	7
552-553	21.9	14.28	7.62	8
553-554	21.9	13.97	7.93	8
554-555	21.9	14.30	7.60	8
555-556	21.9	14.54	7.36	8
556-557	21.9	15.58	6.32	8
558-559	21.9	19.36	2.54	8

The GD Line is currently out of service for the rebuild of Segment 3. Although the maintenance required on these structures to address the clearance issues is unrelated to the rebuild of the line, Great River Energy is going to take advantage of the outage window to replace these upland structures with taller structures (within five feet of the existing locations) to achieve the necessary clearance requirements. The work will begin very soon and should be completed by April 9, when the outage ends. It is the intent of Great River Energy that these structure replacements will be permanent, and thus, will not have to be replaced again at a later date when these segments are rebuilt over the next seven years.

To temporarily mitigate the clearance discrepancies in these areas, Great River Energy is proposing to install buoys and/or signage surrounding the identified clearance discrepancies until a more permanent solution can be constructed in winter of 2012/2013. The buoys that Great River Energy would like to install are standard nautical buoys used by both state and federal agencies. The buoys are 61 inches in height, 9 inches in diameter, and have a visibility of 36 inches above water. If necessary, Great River Energy will also string rope between the buoys to create a continuous barrier.
