Stateline NGL Pipeline Post-Construction Inspection Report PU-11-683

Prepared for:

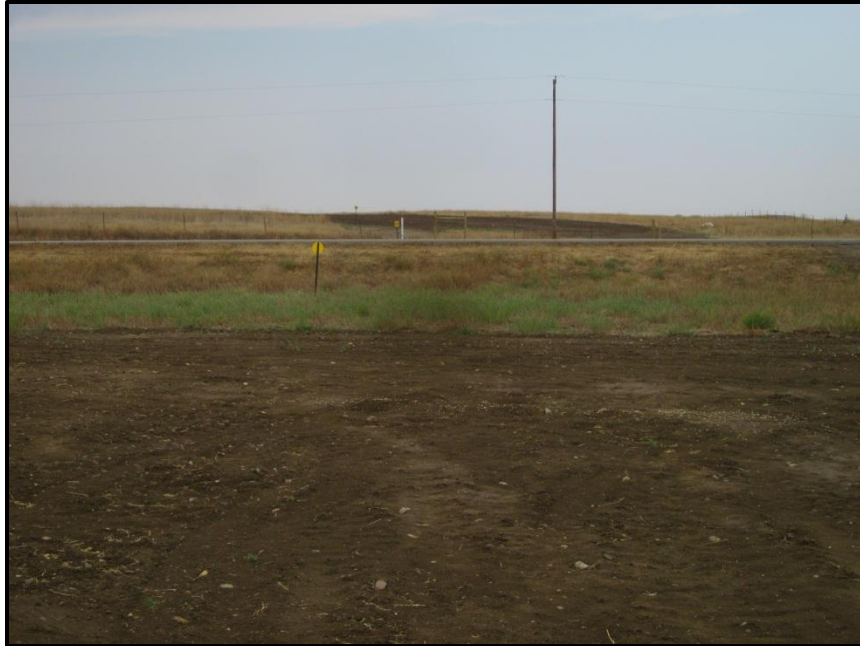
Photo 5. Direction: West. View shows the road bore of County Highway 5 on the east side. No settling to the roadway was noted. Note the three posted signs: on the east and west side of the roadway, and one near the fenceline on the west side.

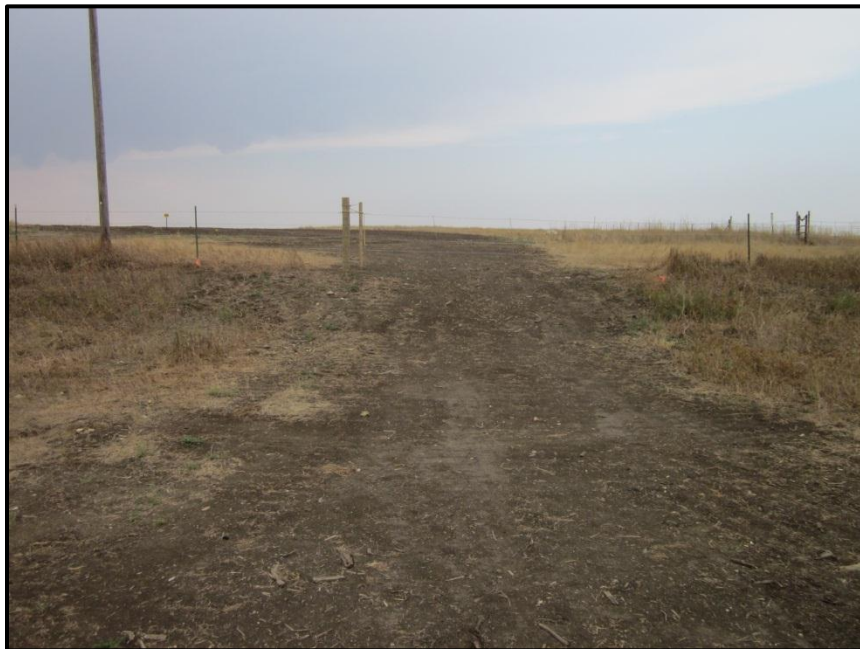
Photo 6. Direction: West. View of the west side of the road bore of County Highway 5, shown by the disturbance area on the west side of the repaired fence. A posted sign is just visible in the distance, to the right of the power pole.

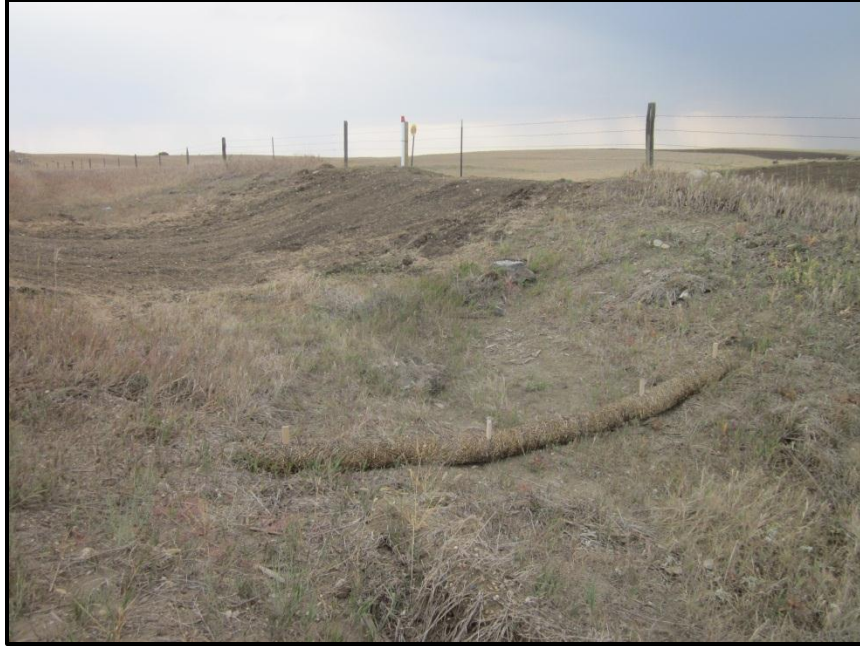
Photo 7. Direction: West/Southwest. The east side of 52nd St NW showing erosion control in the road ditch, repaired fence, posted signage, and the cathodic protection system (indicated by the red topped white tube on the fenceline).

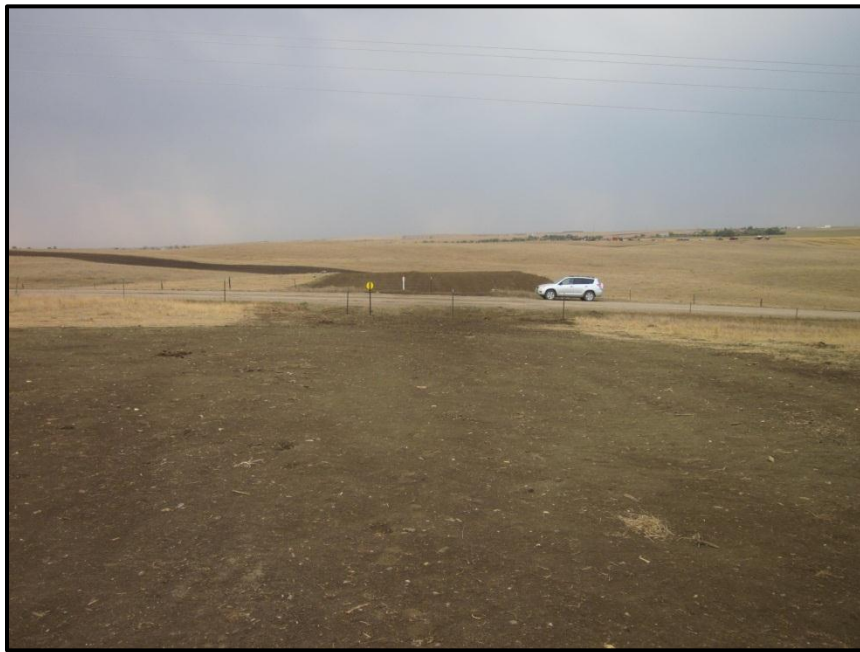
Photo 8. Direction: South. View of the road bore underneath 52nd Ave. Note posted signs and the cathodic protection system (white tube located near the center of the ROW).

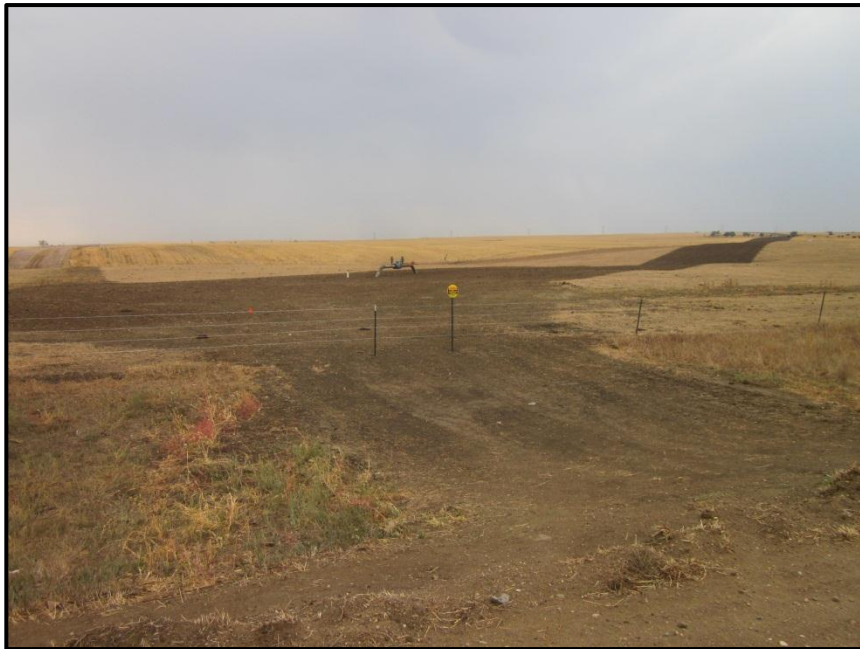
Photo 10. Direction: Southwest. View of 51st St block valve, south of 51st St. Note posted signage and repaired fence. Sandblasting and fence construction around the block valve was completed after the construction inspection.

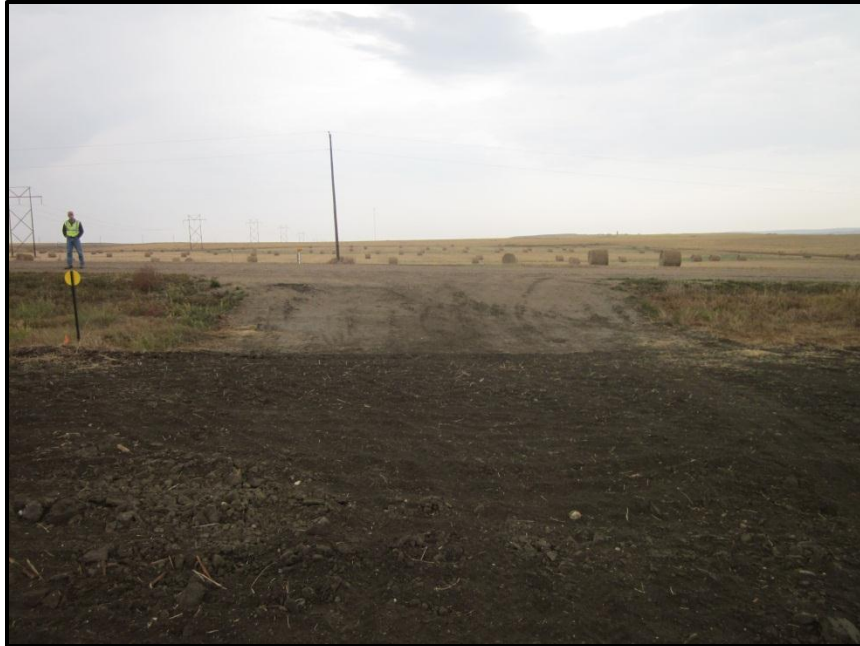
Photo 11. Direction: East. View of the road bore of County Road 5A on the west side. No settling or disturbance was noted to the roadway. Note posted signage indicating the pipeline route. The field access/approach was in place prior to construction, and appeared in good condition.

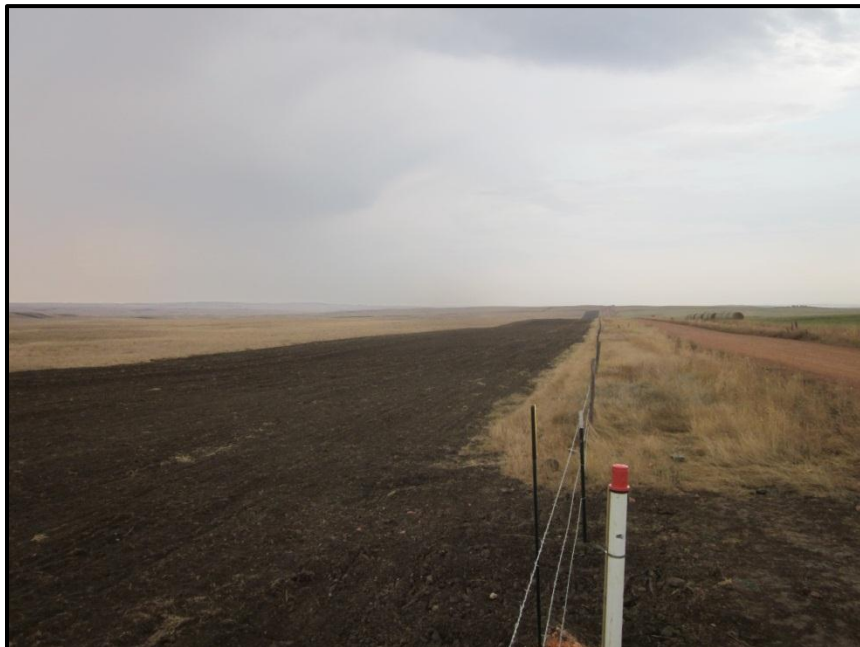
Photo 12. Direction: South. View of the pipeline south of 49th St. An aboveground cathodic protection system marker is shown here (white tube with red cap), next to the repaired fenceline.

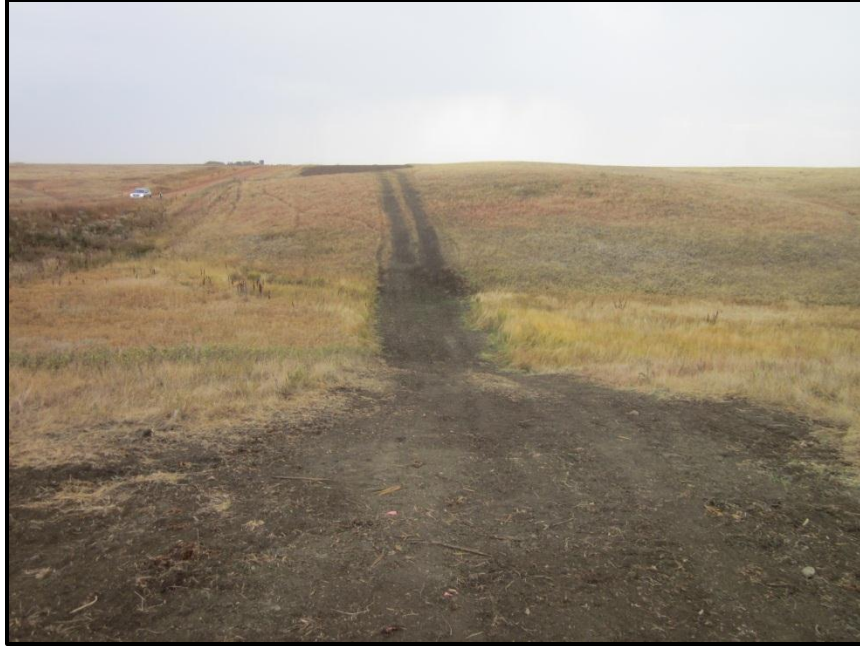
Photo 13. Direction: West. Just south of 49th St., view of the pipeline where it was bored under a wetland. No sedimentation to the wetland was noted, but vegetation had been disturbed by vehicle traffic.

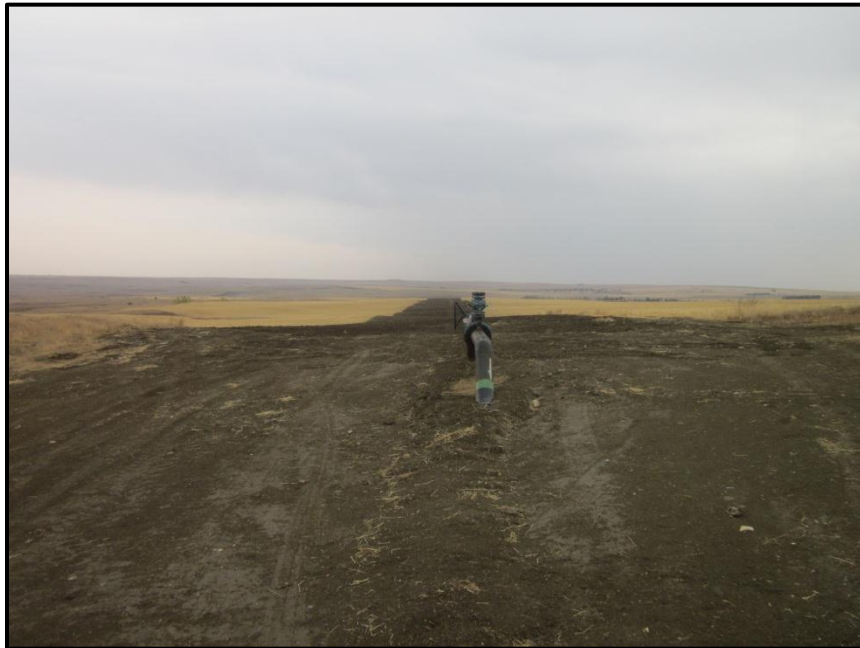
Photo 14. Direction: Northeast. View of the third valve setting along the route in North Dakota. Sandblasting and fence construction around the block valve was completed after the construction inspection.

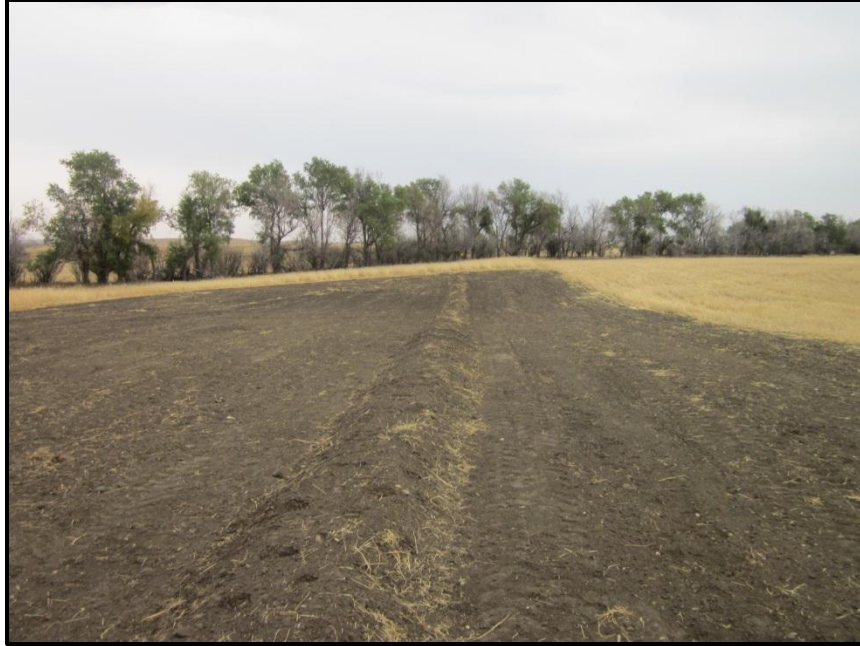
Photo 15. Direction: Northeast. View of the proposed pipeline where it was bored under a shelterbelt. No disturbance to the area or to trees or shrubs was noted.

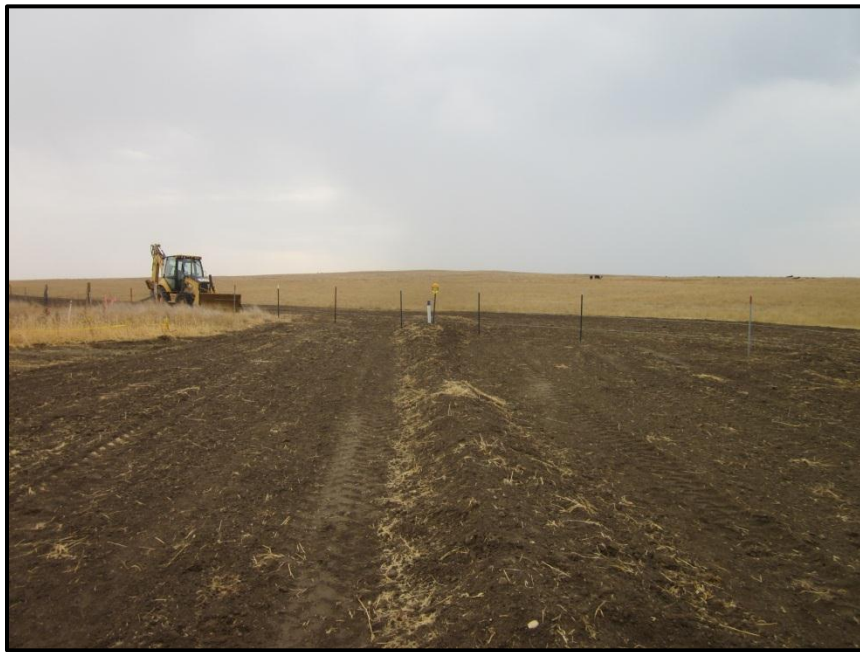
Photo 16. Direction: Southwest. The fenceline is the boundary where the pipeline leaves North Dakota and enters Montana. Note the posted signage and cathodic protection system (black topped white tube). The construction vehicle shown in the upper left had yet to be demobilized from the Site.
