Construction Inspection Summary

Plains Pipeline, L.P. Nelson to Ross Pipeline (NRP) - Mountrail County

PSC Case No. PU-12-40

Construction Inspection Summary
Plains Pipeline, L.P. Nelson to Ross Pipeline (NRP) - Mountrail County
PSC Case No. PU-12-40

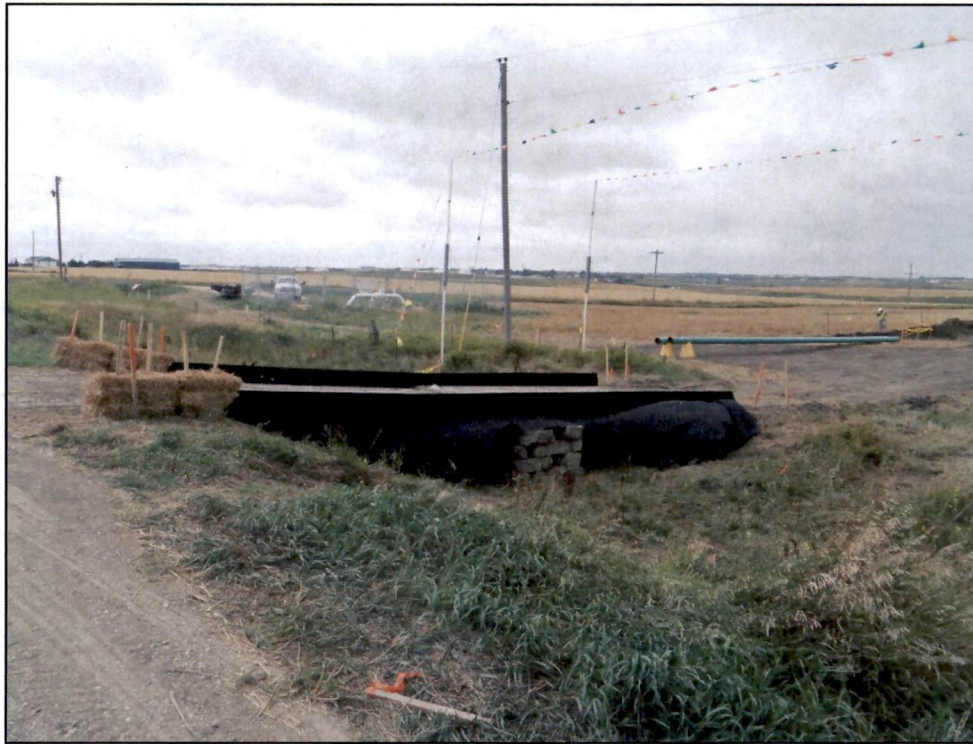
Figure 1. Typical wooden mat bridge at roadway ditch crossing. Additional protection provided by geofabric lining placed under mat and straw bales placed at edges.

- Matting in place over ditch crossing
- Sediment fencing in place - functioning
- Plann Pipeline has gone over & above min req. by geo lining ditch crossings & straw waddle placement to reduce potential erosion into ditch from ROW

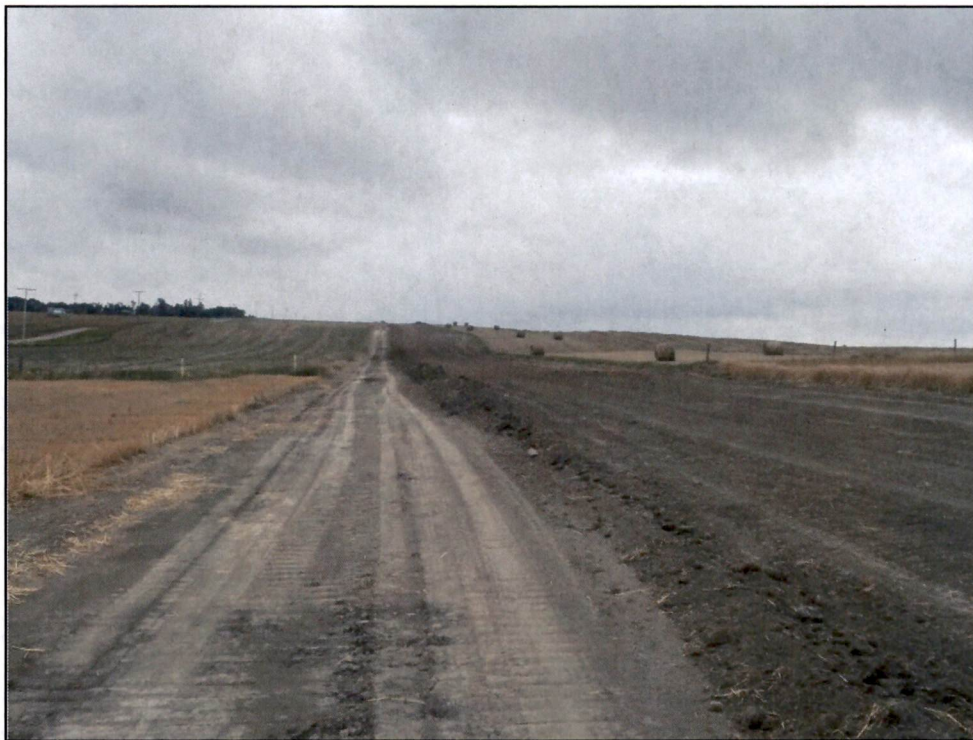
Figure 2. Partially reclaimed ROW. Pipeline installed, trench backfilled and topsoil spread. Topsoil not spread on travel corridor still in use.

- ROW has been stripped, erosion control devices (ECD) placed, trench dug, pre-laid, backfilled & topsoil replaced except on travel corridor
- ECD's are kept in place at appropriate areas as entire ROW has been reclaimed
- ROW very clean looking & no erosion noted

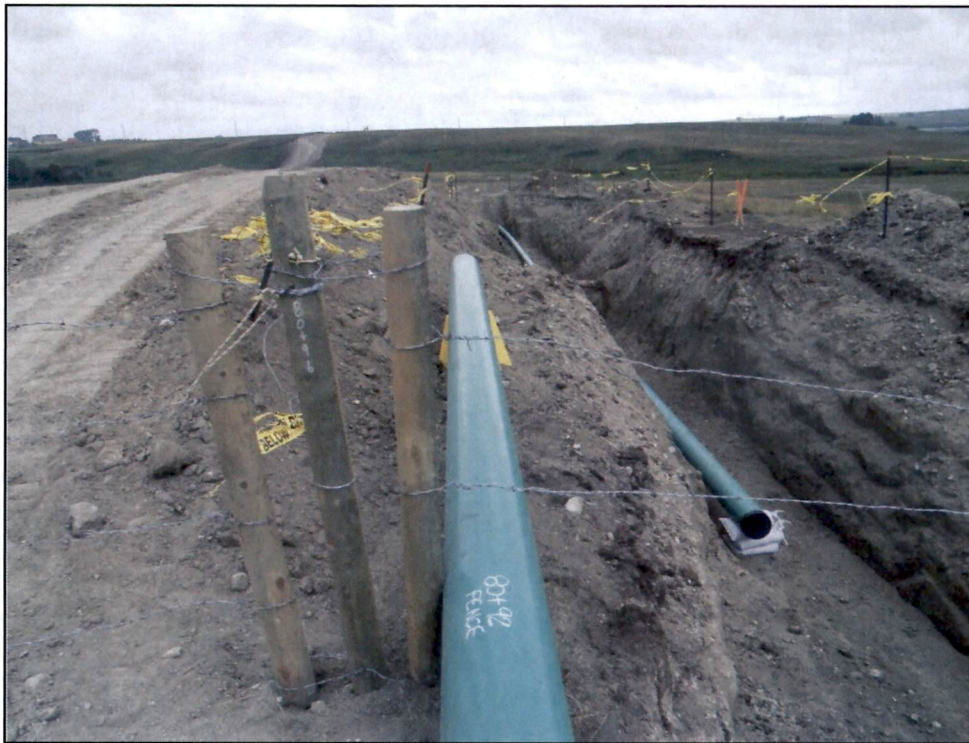
Figure 3. Typical fence line and foreign pipeline crossing.

- Landowners fence being maintained during construction, - Gated

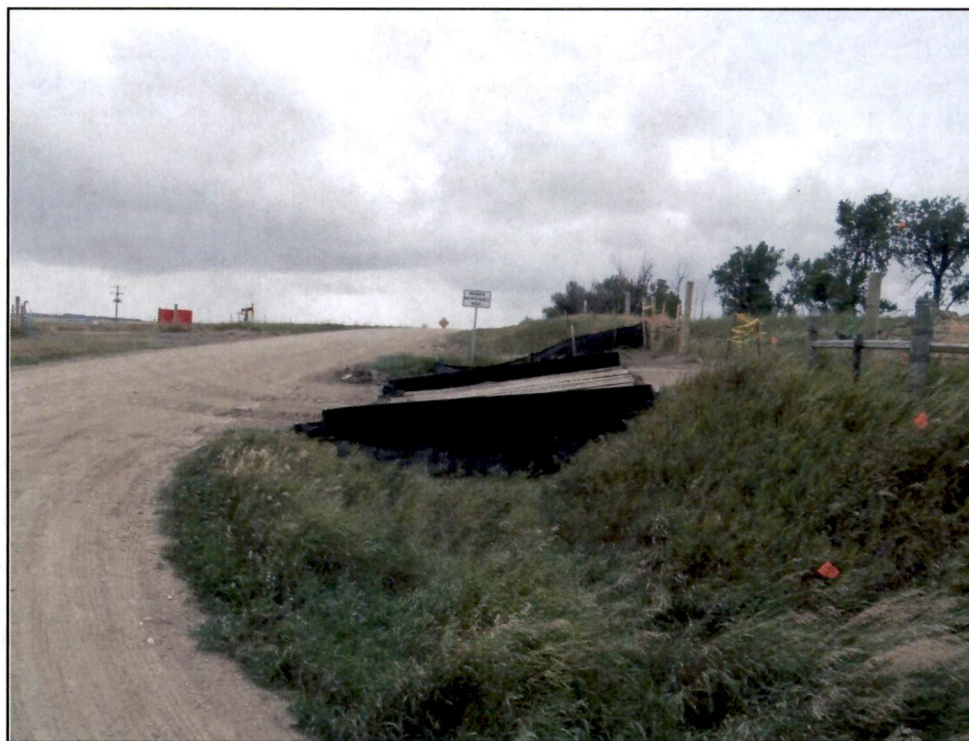
Figure 4. Additional example of road ditch crossing in ROW for vehicles and equipment.

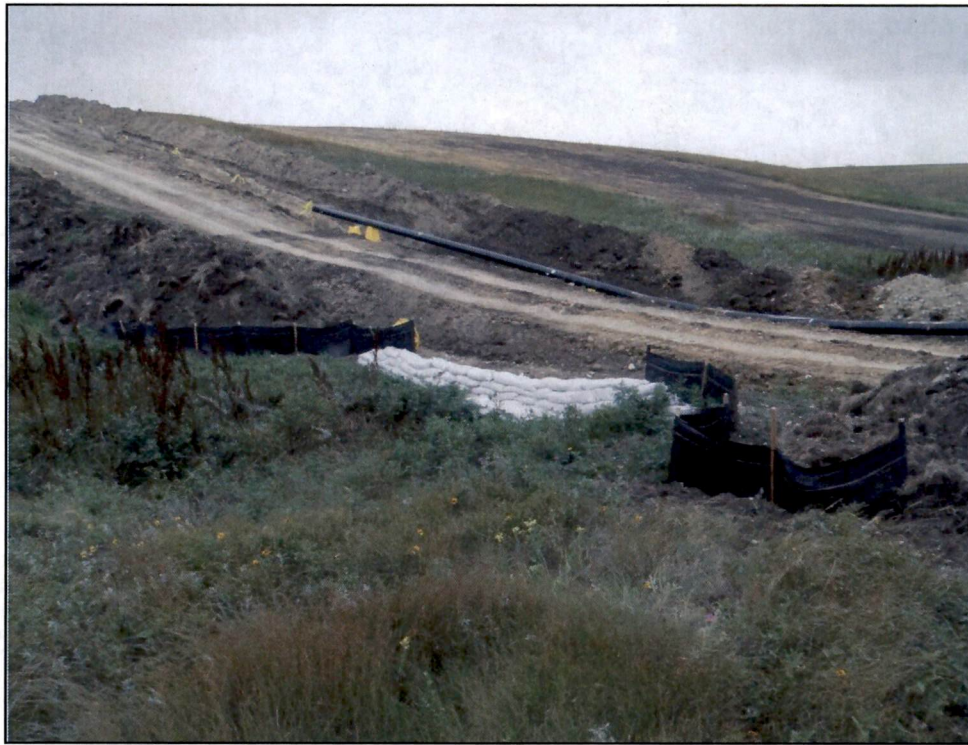
Figure 5. Typical flume pipe crossing of an ephemeral drainage.

- Drainage crossing - Flume pipe under travel corridor
- Sand bags top side of pipe w/ silt fence skirted sides
- Silt Fence & ECD below drainage as well

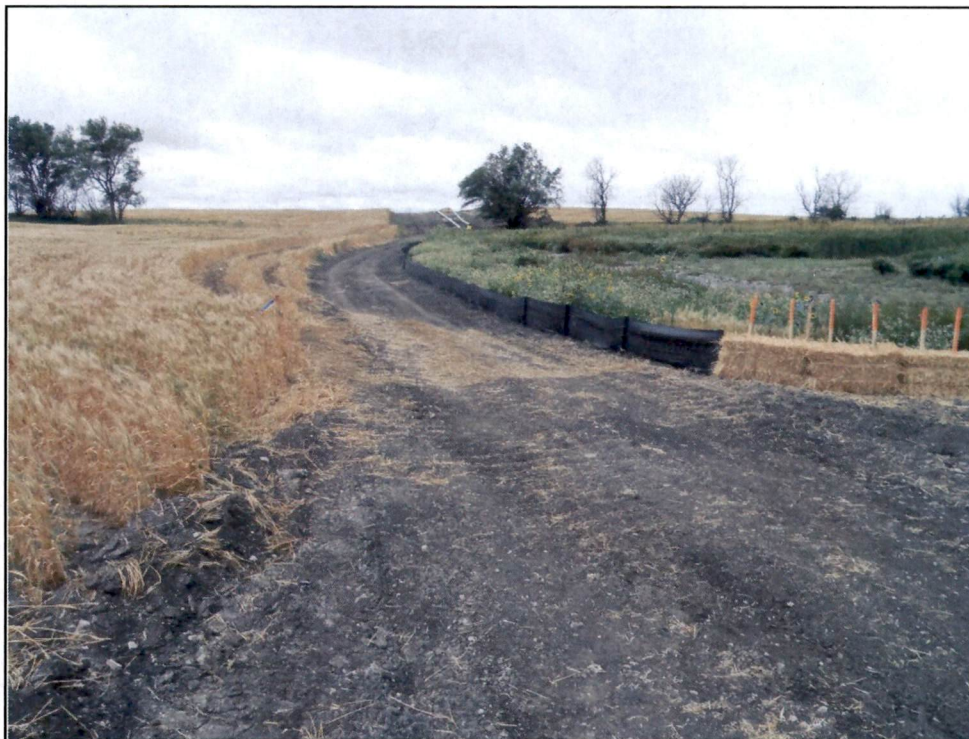
Figure 6. USFWS easement wetland avoided within an agricultural field. The easement wetland will be bored under. A travel corridor is established around wetland and protected by silt fence and straw bales.

- Agricultural field
- Silt fence installed at cultivated field edge, ~ 15 ft from current water edge
- No former vegetative buffer to be maintained at 2050 ft vegetative buffer
- Well maintained fence(s) + Storm bales
- Travel corridor established around wetlands with permission of landowner to access outside of ROW to ensure no impact to easement wetland

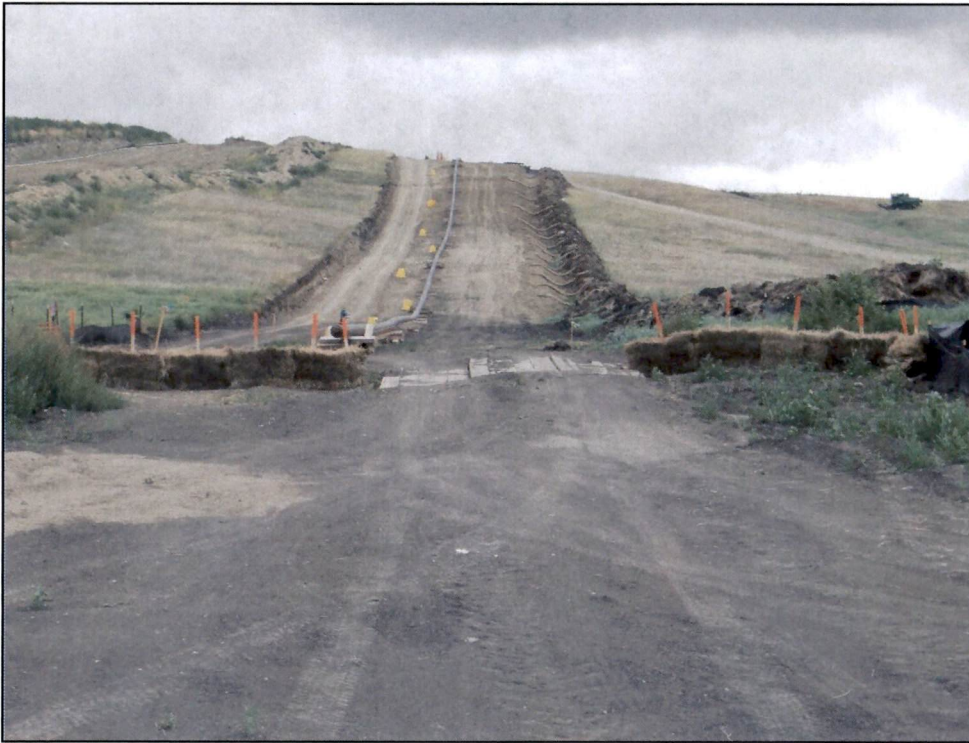
Figure 7. Photo taken facing east along ROW from east side of the Little Knife River. Straw waddles are utilized in slope trenches, slope breakers are placed across ROW where topsoil is removed, straw bales and silt fence are placed across ROW at bottom of slope.

- Straw wattles placed in trenches on hill slopes leading to bore location of Little Knife on East side
- Breaker's cut across stripped ROW \approx 100 ft
- Extra work space silt fenced $>$ 100 ft from wetland edge (setback based on SWPP specs)
- West side of Little Knife
- ★ Planned bore location too close to water edge
- Wetland edge determination suspect
- Recommended to bring out wetland scientists to review with Plains Pipeline
- Potentially move bore location back out of flat lands to higher elevation (\approx 200 ft)

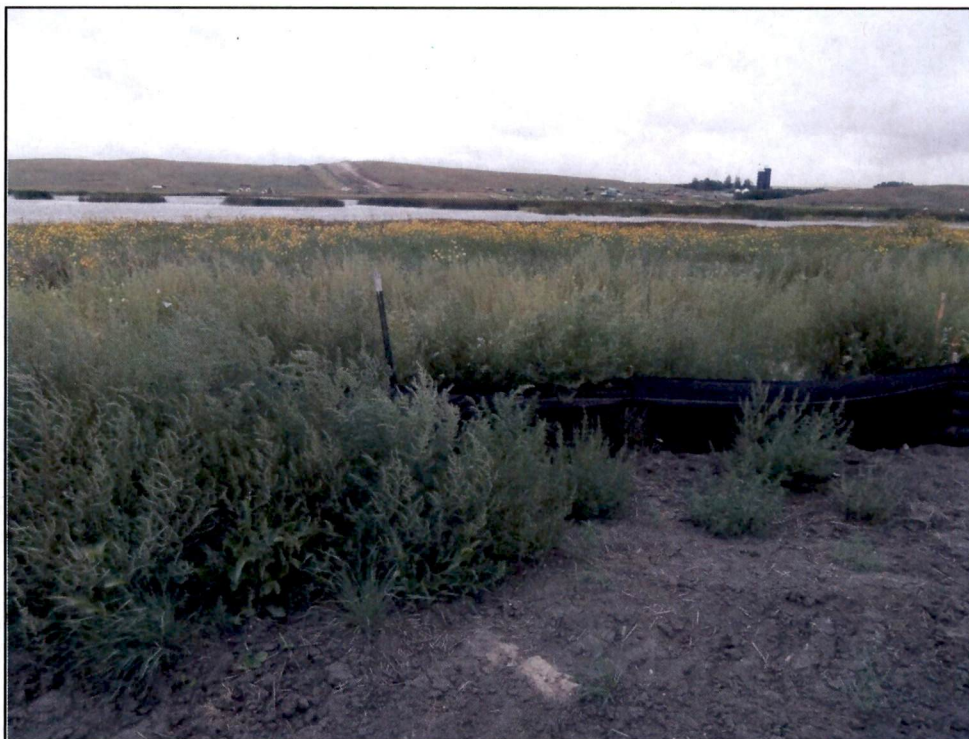
Figure 8. Photo taken looking west along ROW from west side of the Little Knife River. Silt fence borders the location of the bore pit work area appropriately set back from wetland.

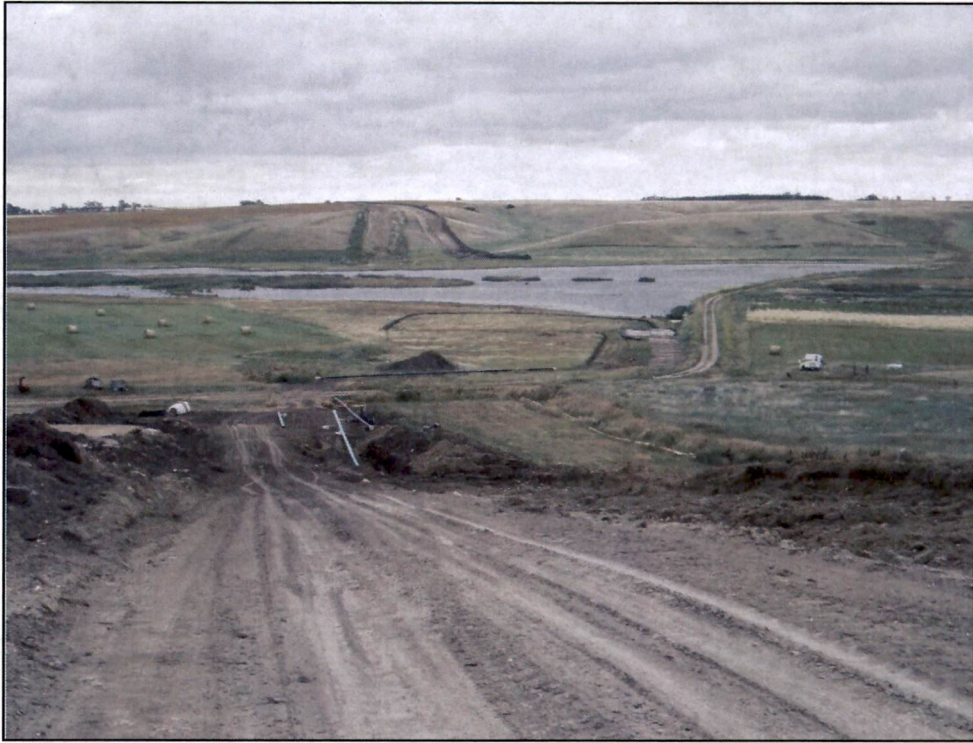
Figure 9. East facing overview photo of Little Knife River planned west side of bore pit work area.

- 1) Further review of the planned bore pit location on the west side of the Little Knife River. The delineated wetland edge was staked near the edge of the existing surface-water level. Hydric vegetation was observed beyond the staked wetland edge, within the proposed construction ROW.
- 2) Review submitted typical detail of wetland crossing to ensure crossing construction procedures will be in compliance.

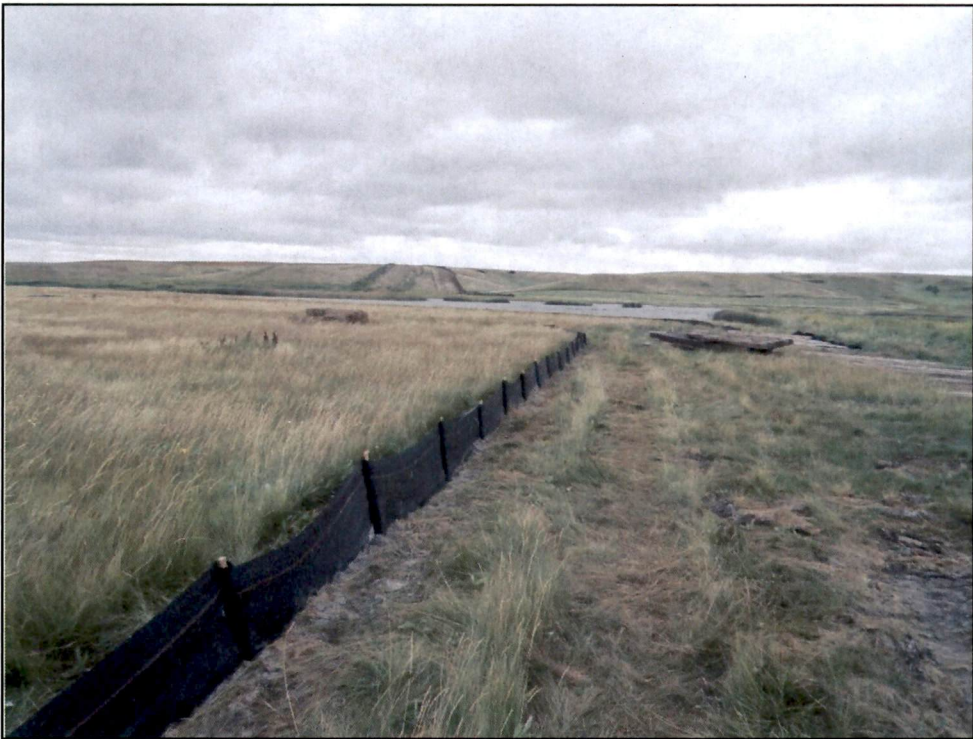
Figure 10. Bore pit work area in flat above water edge with silt fence installed. Wooden mats were in place to allow soil sample truck to drill at planned bore pit location (right).

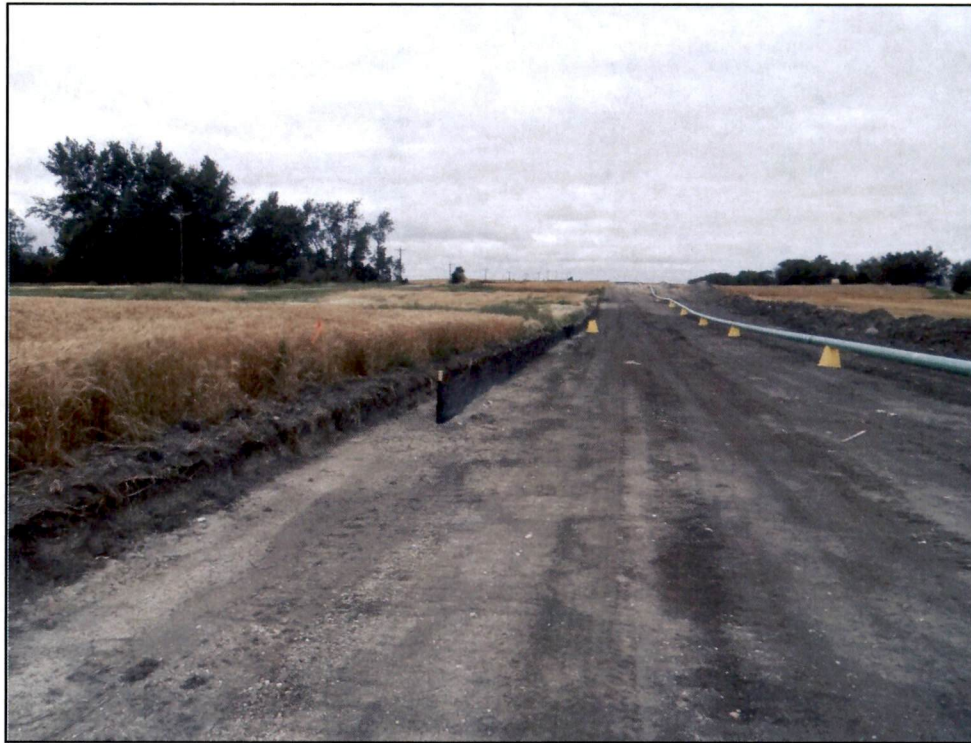
Figure 11. Photo of silt fence placed at edge of the ROW in an area of potential surface water intrusion onto the ROW.

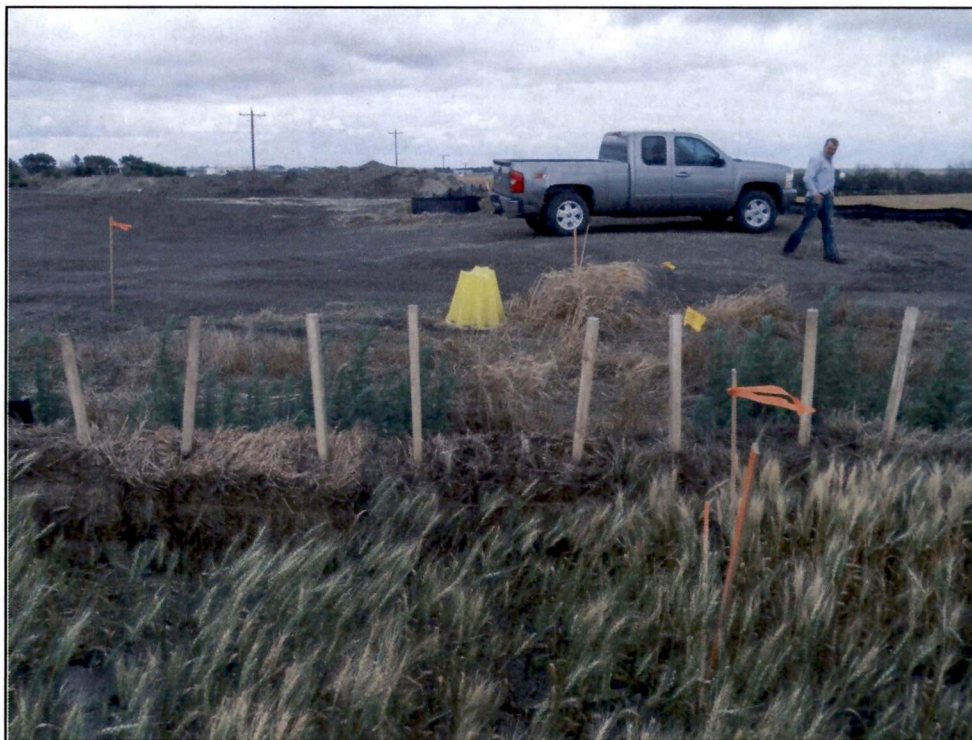
Figure 12. Foreign pipeline marking at ROW crossing. Additional soil placed on top of pipeline crossing per request of pipeline owner.

- ROW Work Area + Spoil Piles bordered by silt fence + straw bales -
- Slope breakers in place
- No erosion concerns or notations
- Foreign pipeline crossing built up per owner requests (photo of pickup on top)
