**Great River Energy 230 kV
Transmission Line Reroute
Post-Construction Inspection Report
PU-12-398**

Prepared for:
**North Dakota Public Service
Commission**

1.0 Executive Summary

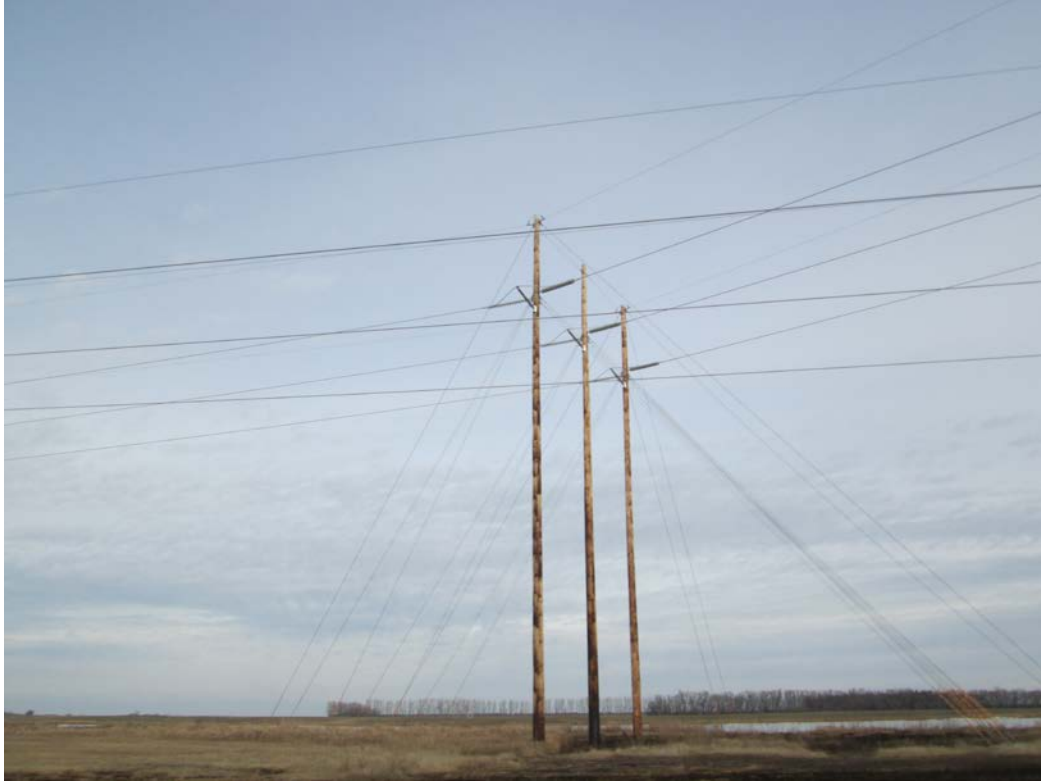
Above: Photo 1 (Structure 459) – Reroute connection to existing transmission line structure at west end of Segment 7 reroute of the Project in Nelson County. Part of the field below had been burned. Looking northwest.

New wooden structures were observed along the new transmission line route; the structures were either double pole with H-frame structures or triple pole structures with guywires (see Appendix A, Photos 1, 4, 10, 11, 13, and 14). Structures were backfilled with rocks and/or soil (see Appendix A, Photos 2, 3, and 8). Span lengths and structure heights appeared to match those specified in the Application.

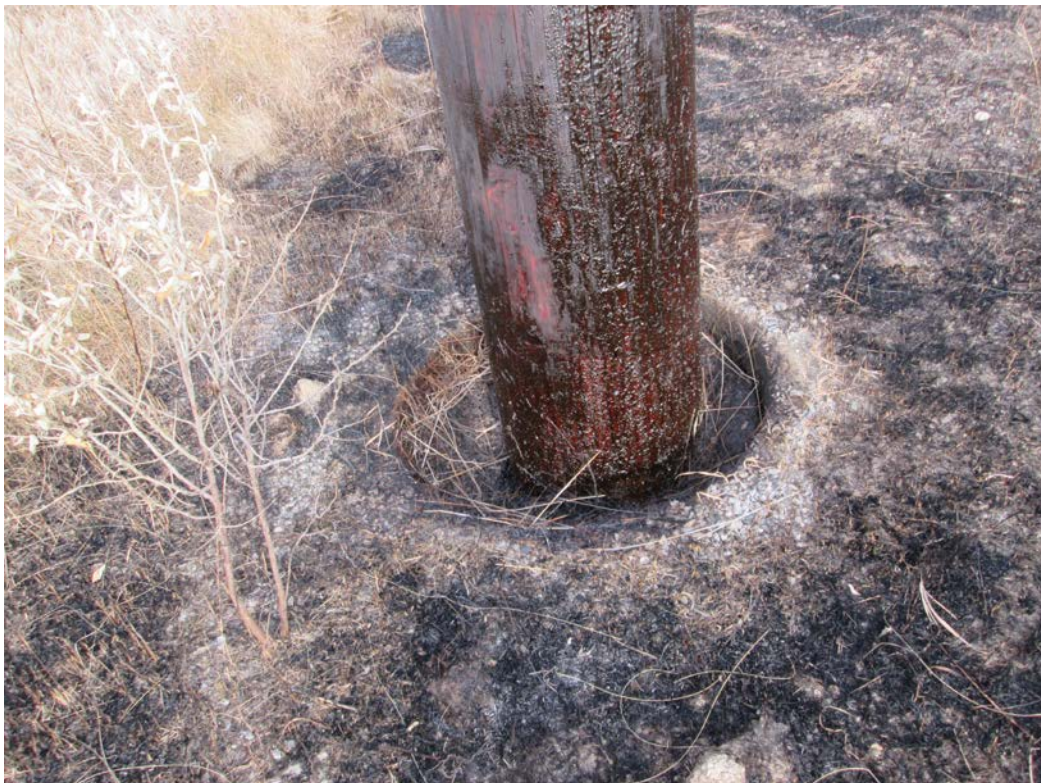
Below: Photo 2 (Structure 459) – Structure's base is below ground level, shows possible settling.

Areas disturbed during construction appear to have been mostly restored to their previous condition. Around most of the new structures there is an area approximately 5 to 10 feet in diameter where tall grass and weeds are present, a few of the areas were likely sprayed with pesticides, but otherwise crop growth around the structures appears to be good (see Appendix A, Photos 8, 10, 14, 15 and 16). Wenck also observed possible settling of one structure, holes near the guywire anchors and dark stained soil around many of the poles (see Appendix A, Photos 2, 3, 8 and 9).

Wenck observed few small areas of weeds near the structures, possible settling of one structure and holes near the guywire anchors, as noted in Section 3.6.2 (see Appendix A, Photos 2, 3, 8 and 9).

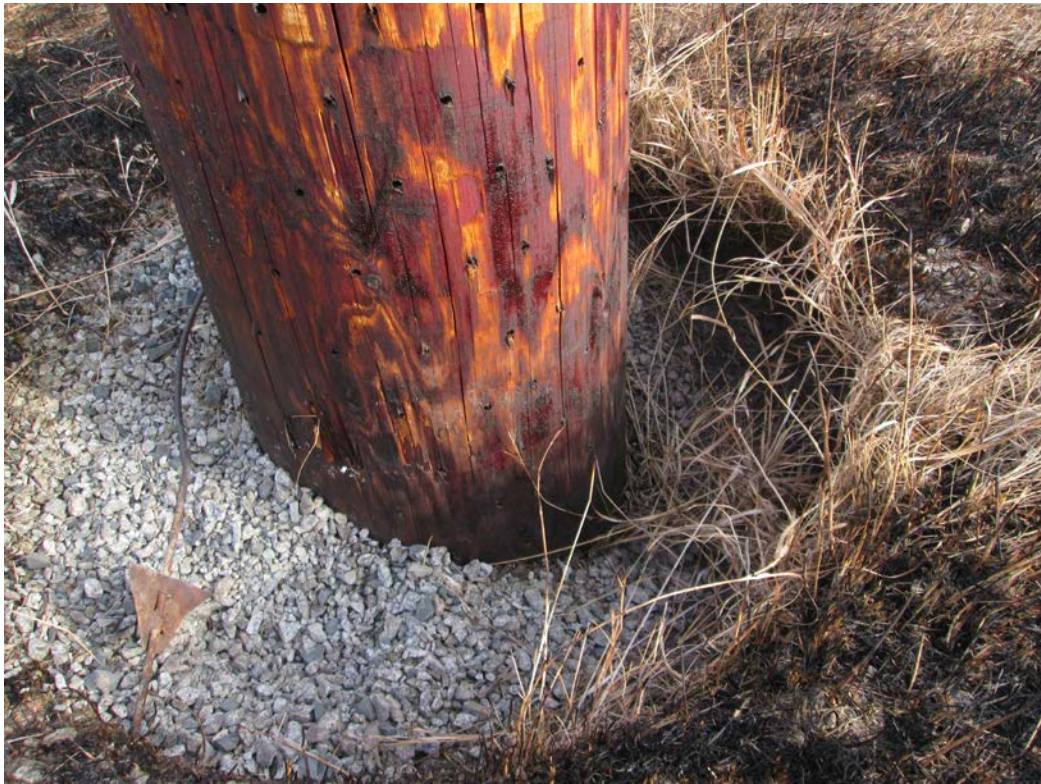
Above: Photo 3 (Structure 459) – Structure's base shows possible settling, as rocks are below ground level, shown on the right side.

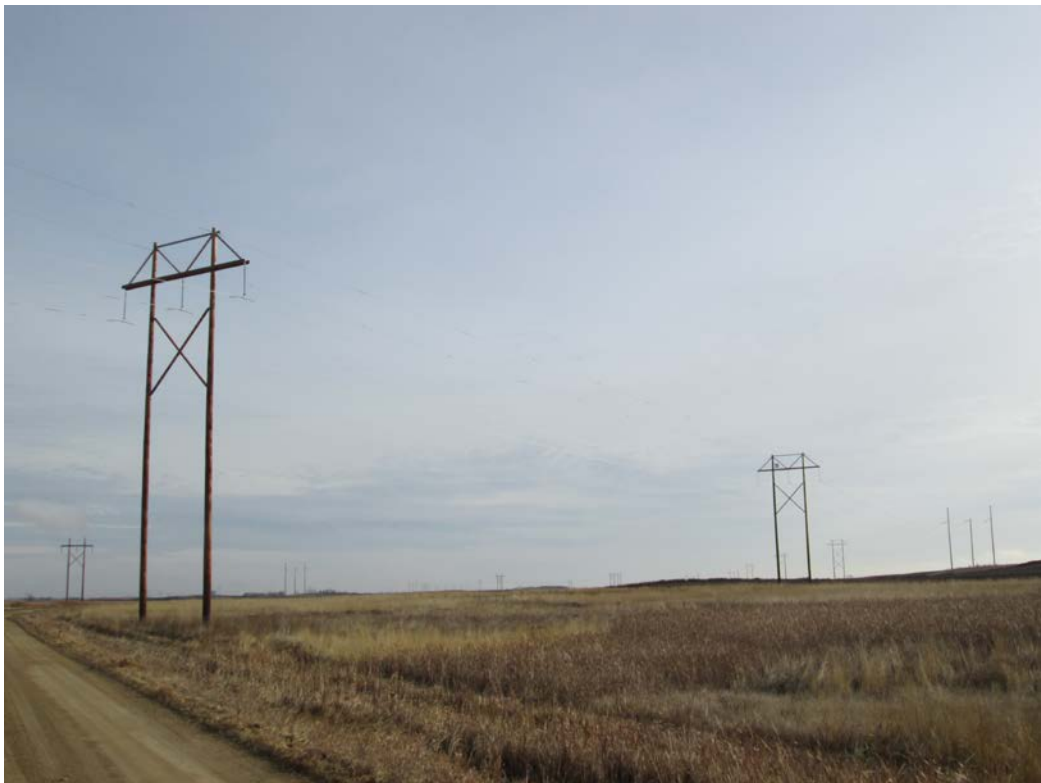
Below: Photo 4 (Structure 458) – Typical double pole structures with H-frame cross arms and braces. Looking east.

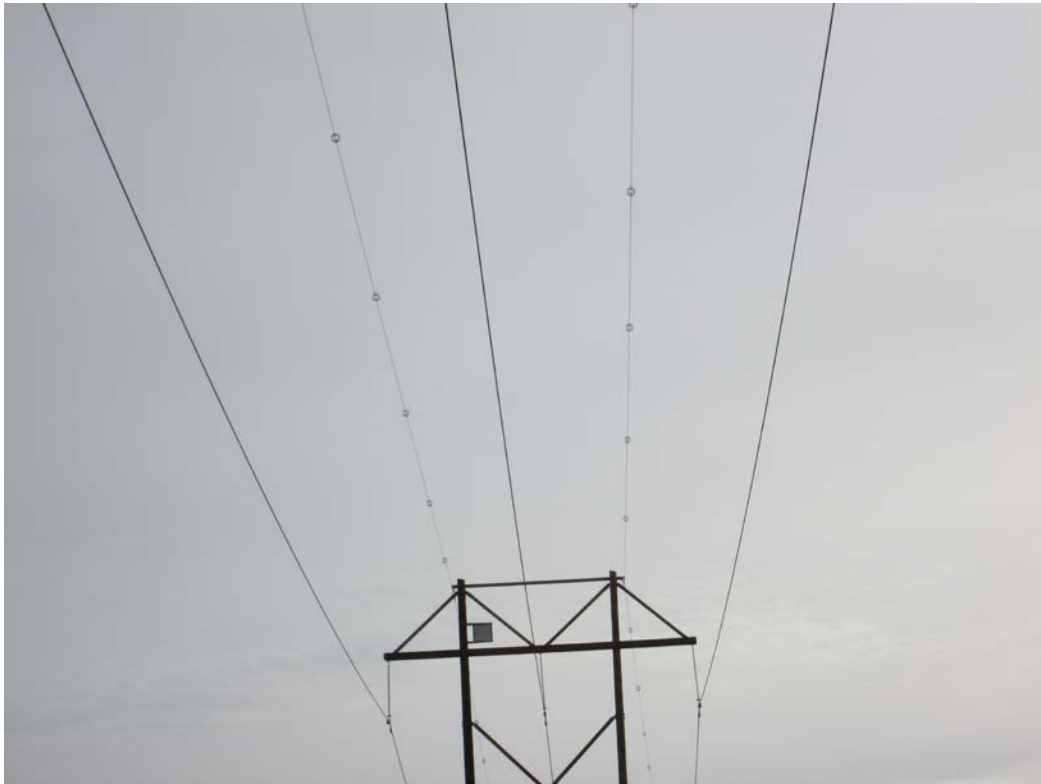
Above: Photo 5 (Structure 457) – Typical double pole structure showing bird diverters along line. Looking southeast.

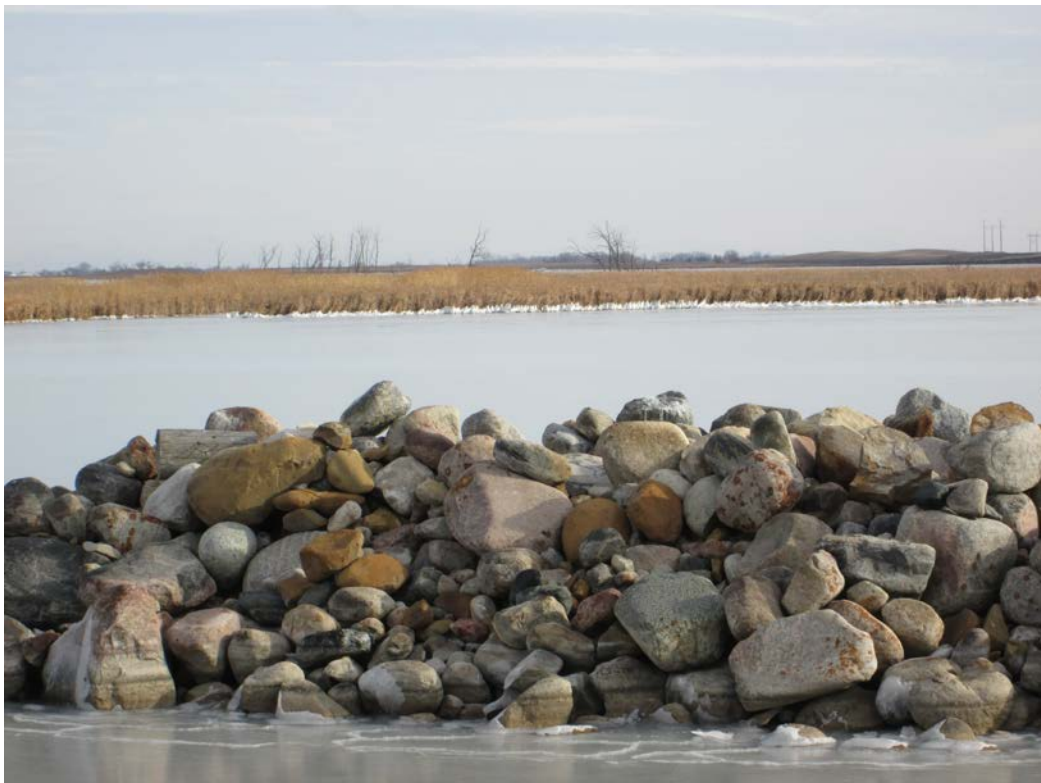
Below: Photo 6 (Observation Point rock piles 1) – Rock pile in wetland where old structure was, can see cut wooden pole.

Wenck confirmed that existing structures along the original alignment have been removed. The rock remains and the top of a cut structure near rock level were observed in the wetland of section 7 of the transmission line (see Appendix A, Photo 6). This area was raised about 1-2 feet above the water surface, but it was difficult to see this in detail due to limited access through the wetland areas. No other evidence of structures along the original alignment was observed, though with limited access to the wetland areas it is possible that other structures were not entirely removed.

Due to limited access around the wetland areas, it was unclear if all the structures were fully removed, or if it was just cut off and abandoned with the foundation remaining. Wenck recommends that the PSC request documentation from GRE showing that all old structures along the original alignment were fully removed.

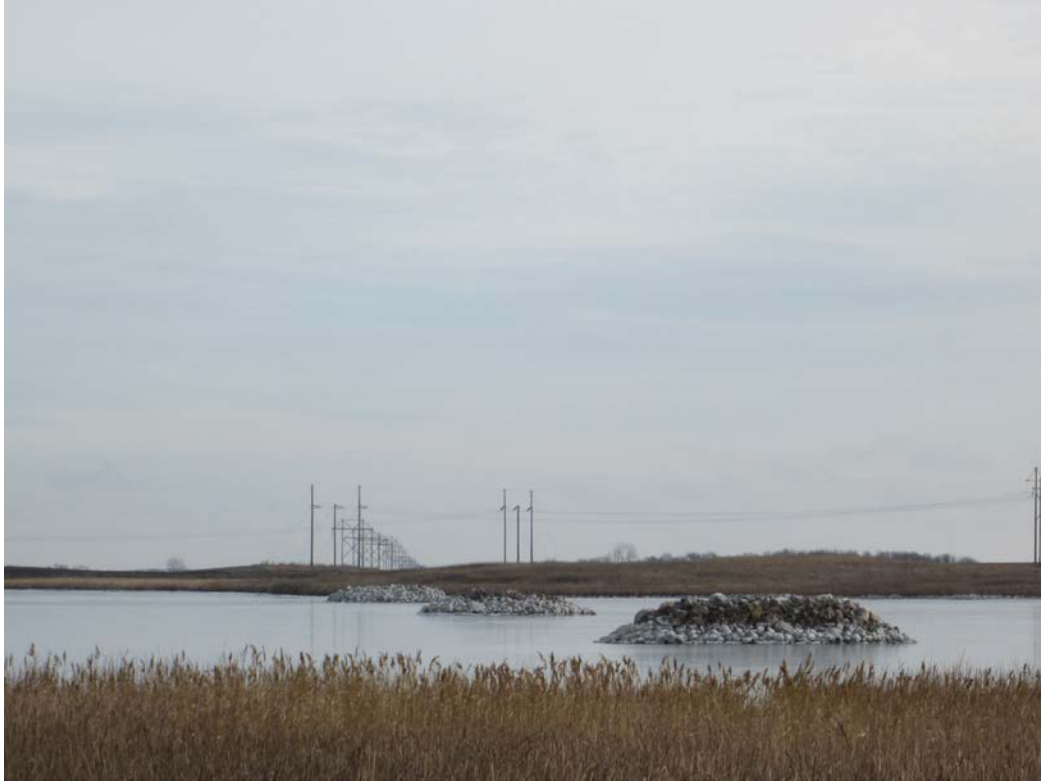
Above: Photo 7 (Observation Point rock piles 2) – Rock piles in wetland where old structures were located. Looking east.

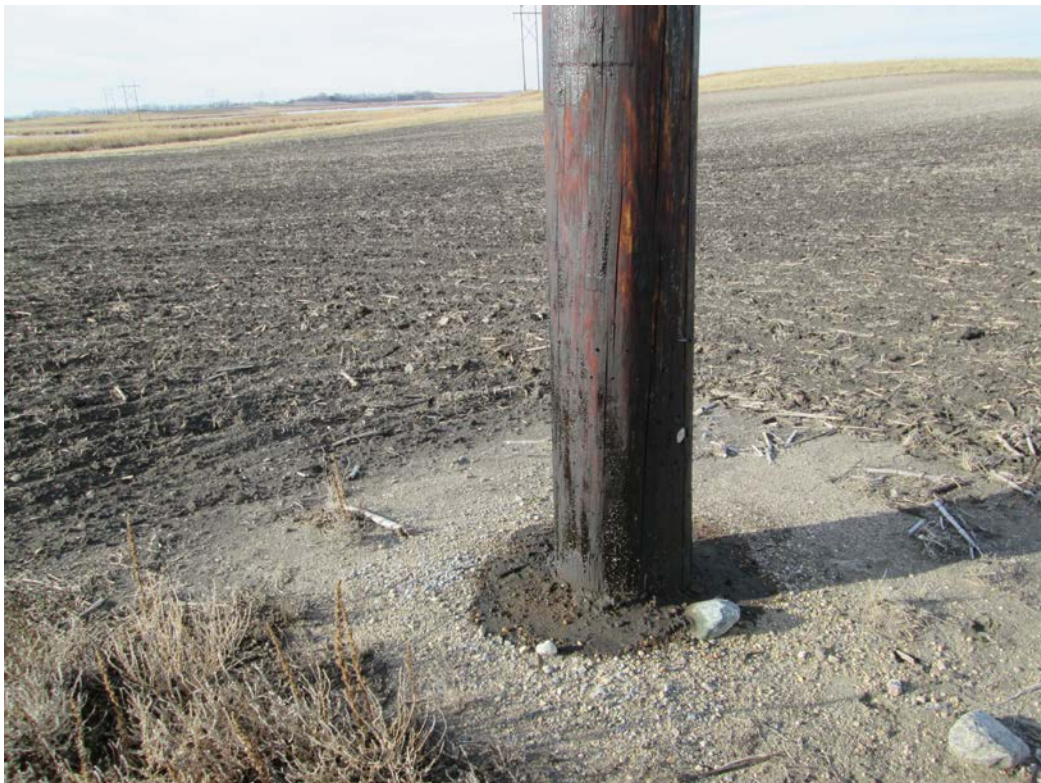
Below: Photo 8 (Structure 450) – Dark stained soil/rocks around the structure. Weeds were observed between the 2 poles of the transmission line structure (only one pole shown).

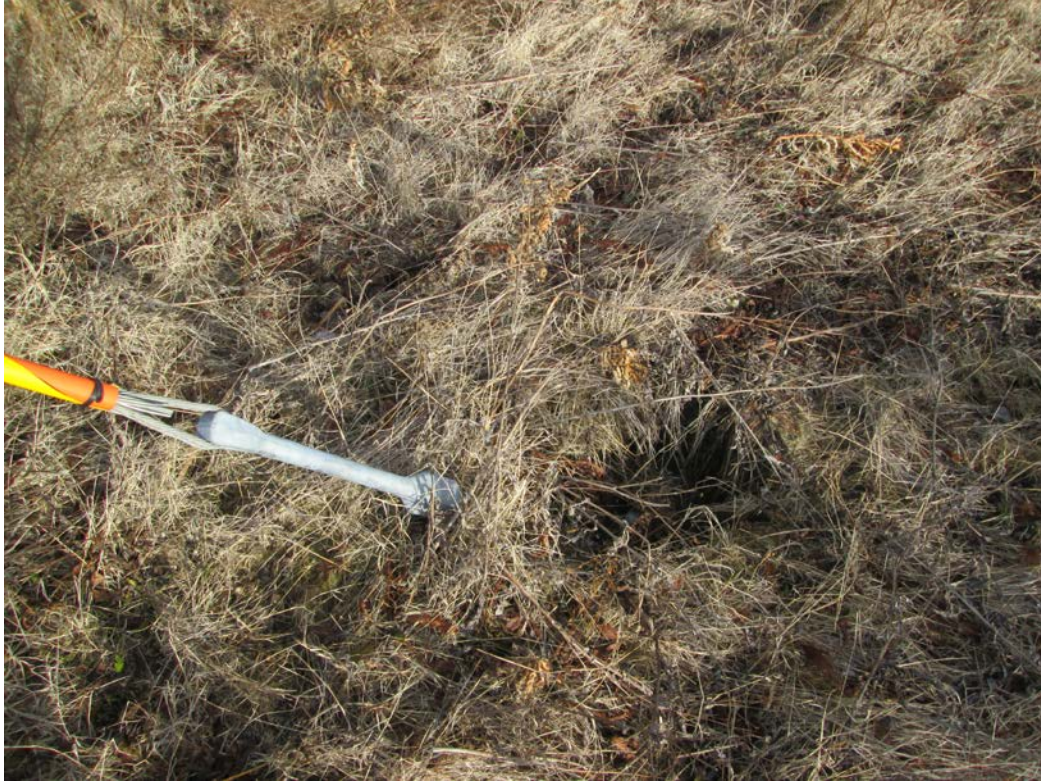
Above: Photo 9 (Structure 452) – Small hole approximately 6 inches deep where guywire anchors from 3-pole structure connect to the ground.

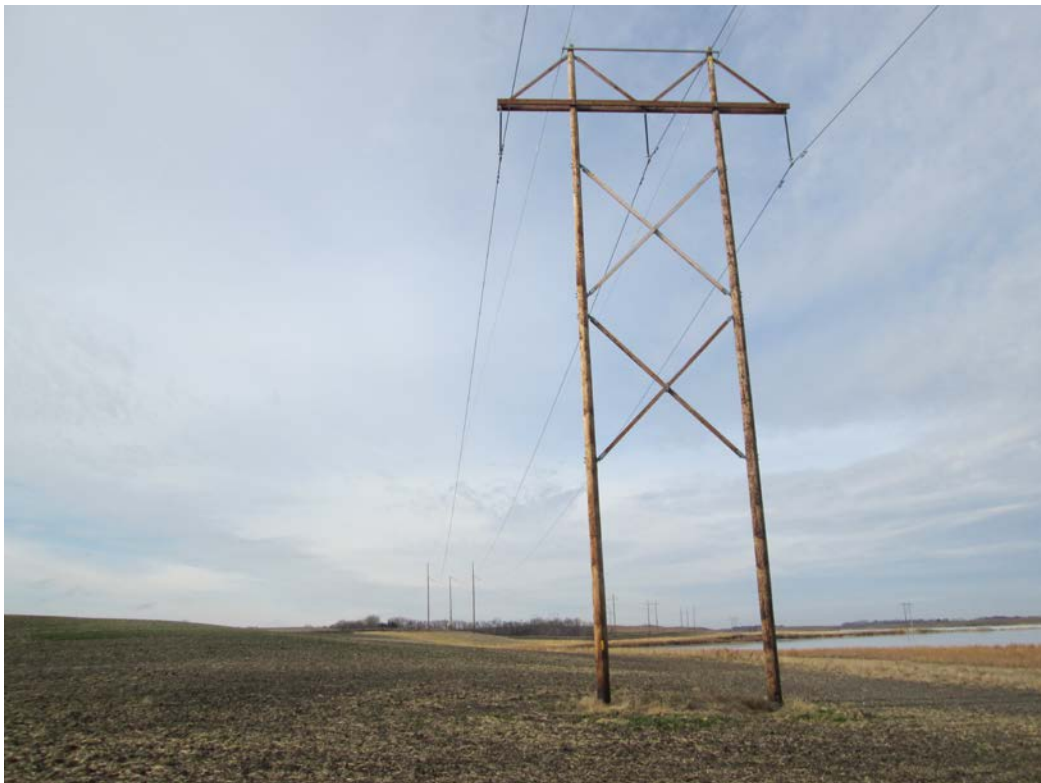
Below: Photo 10 (Structure 455) – Structures going through agriculture field. Weeds and grasses between poles of structure.

Installation of the new transmission line structures has resulted in approximately 1.23 acres for the Segment 7 reroute and 1.37 acres for the Segment 8 reroute of active farmland being converted to use as a transmission facility (Docket #28, Exhibit 3, Amendment to Application). Wenck confirmed during the site inspection that the area surrounding the new structures has resumed its previous agricultural production use (see Appendix A, Photos 8, 10, 11, 14 and 15).

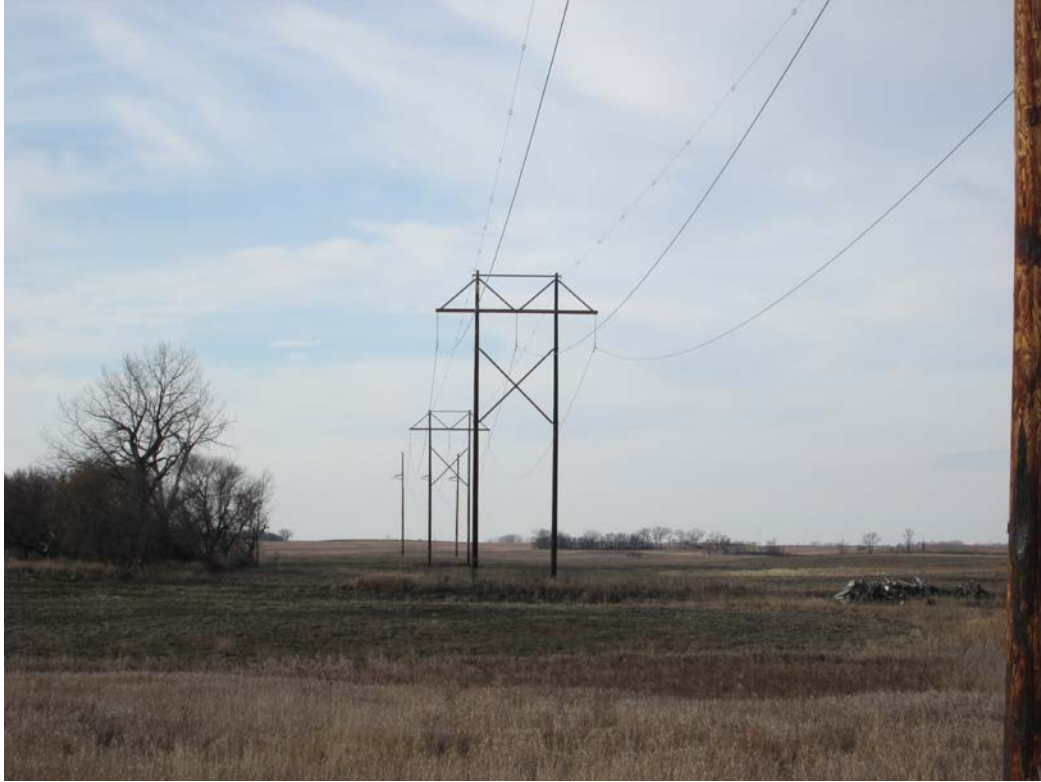
Above: Photo 11 (Structure 554 (far right), and 555) – Structures crossing grassy area and agriculture field. Looking northwest.

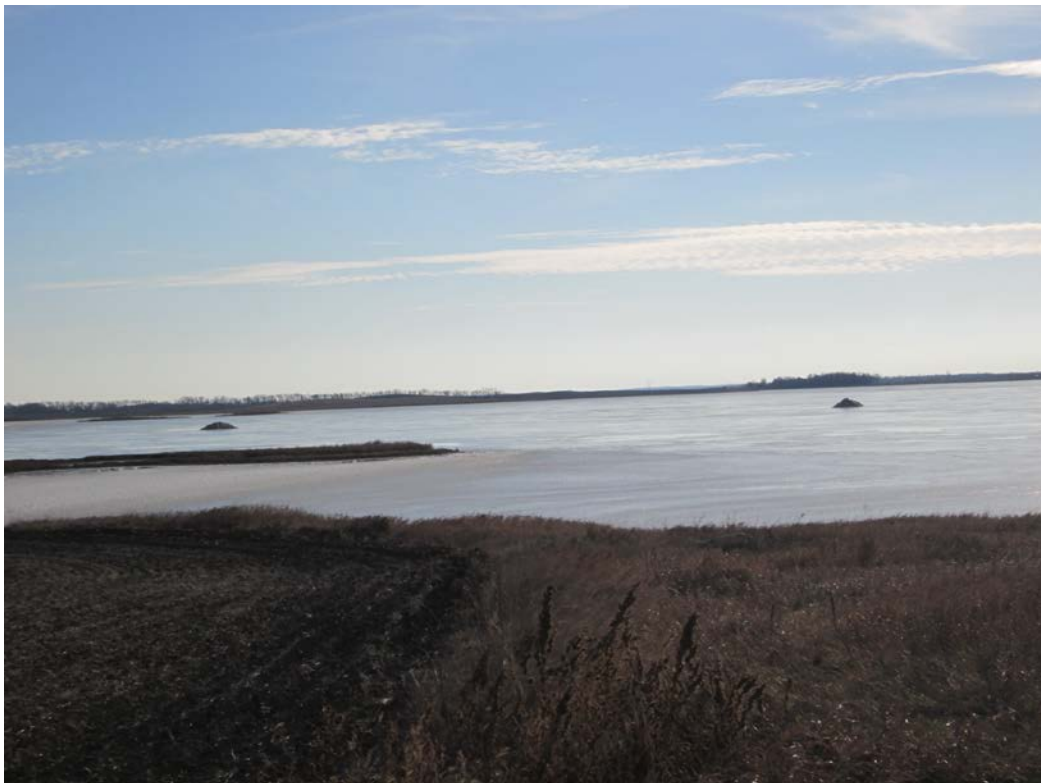
Below: Photo 12 (near structure 554) – Abandoned Rocks piles from old structures in section 8 (Crary). Looking south.

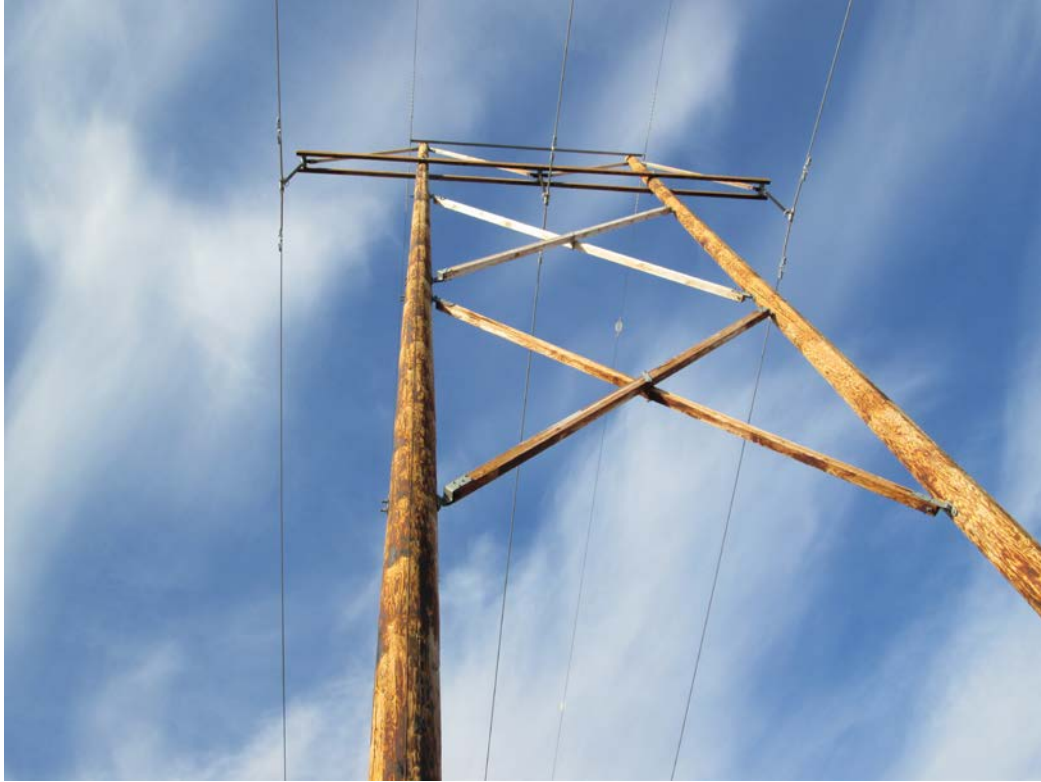
Above: Photo 13 (Structure 553) – Typical double pole structure. Bird diverters along line.

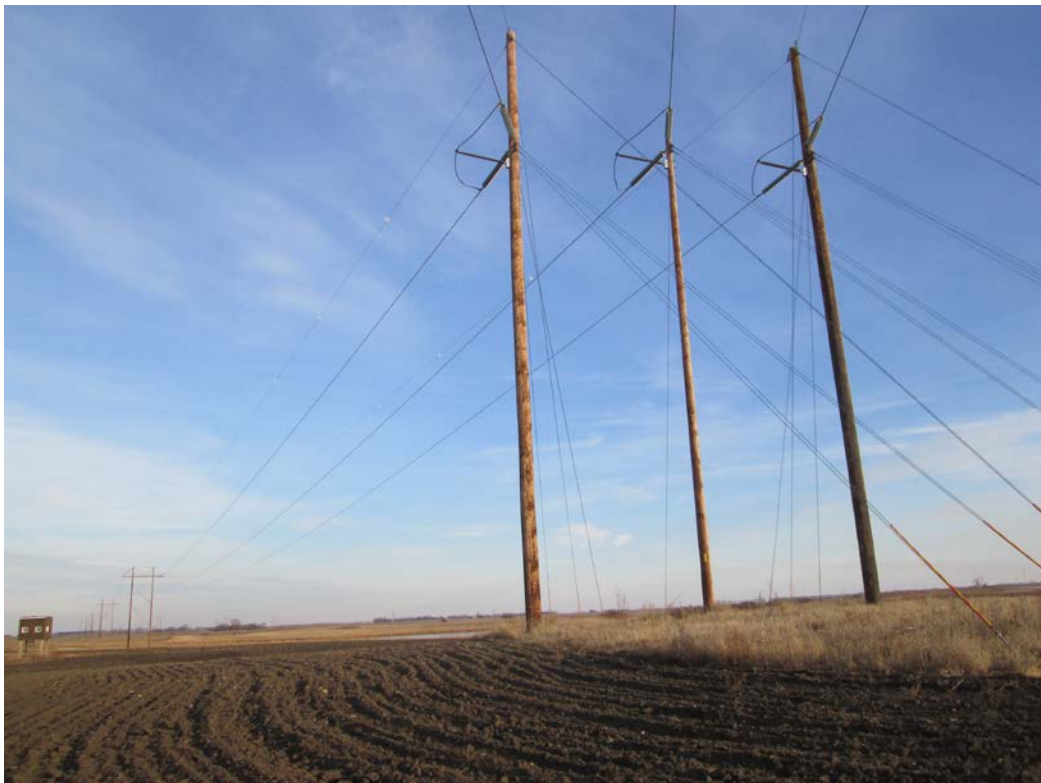
Below: Photo 14 (Structure 562) – Triple pole structure with guy wires. Structure between agriculture field and wetland. Looking northeast.

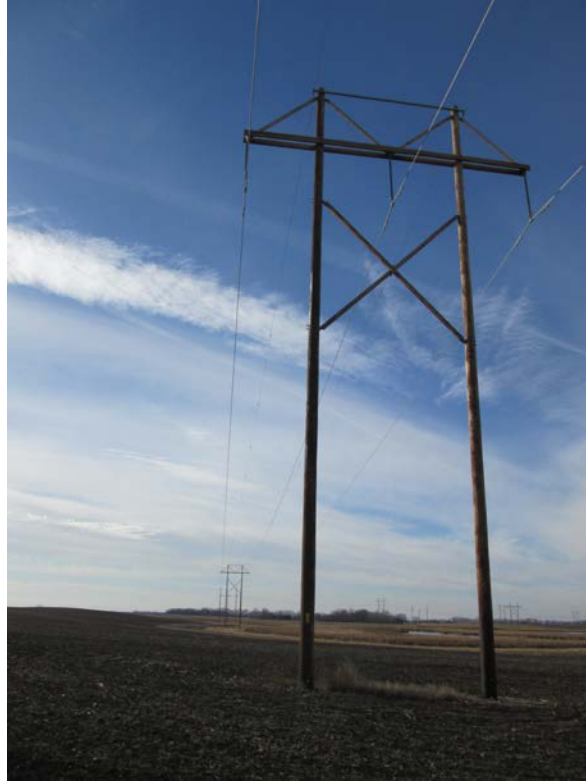
Above: Photo 15 (Structure 450) – Double pole structure along agriculture field and near wetland. Looking southwest.

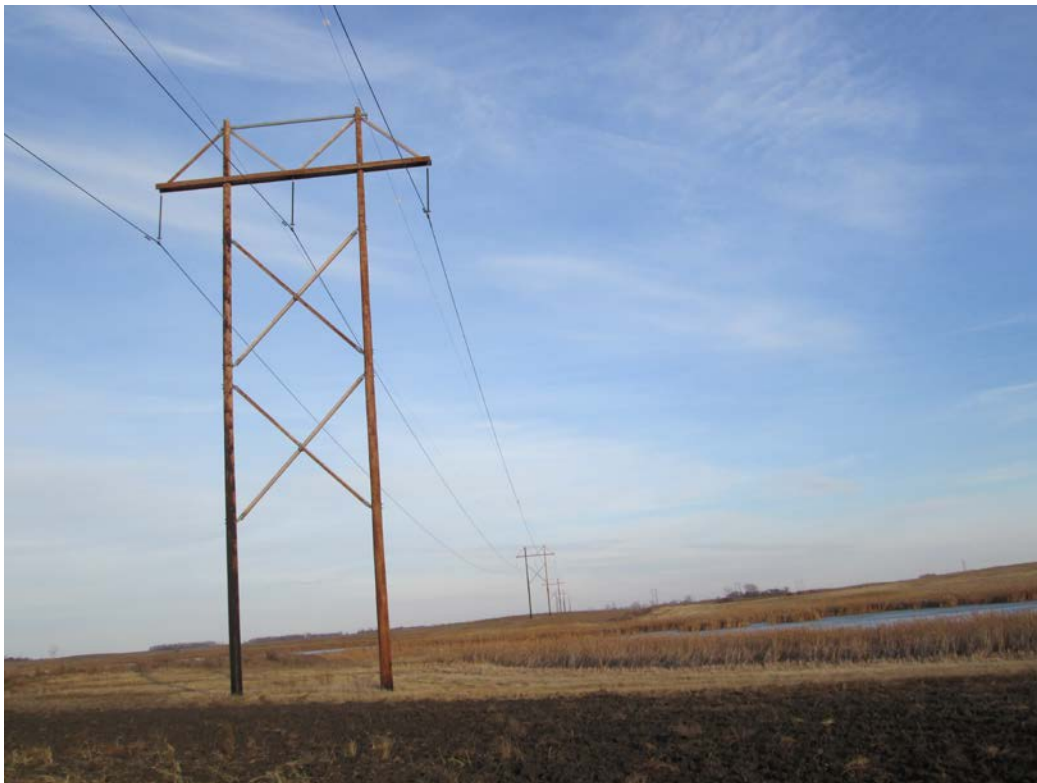
Below: Photo 16 (Structure 561) – Double pole structure next to agriculture field crossing over wetland. Bird diverters along line. Looking northeast.
