Salutation: Construction Inspection Report for Hess Ramberg Truck Facility Connect to Crude Oil Pipeline Project

50 **PU-12-683** Filed: 7/2/2015 Pages: 34
Final construction inspection report

**Hess Ramberg Truck Facility Connect
to Crude Oil Pipeline Project
Post-Construction Inspection Report
PU-12-683**

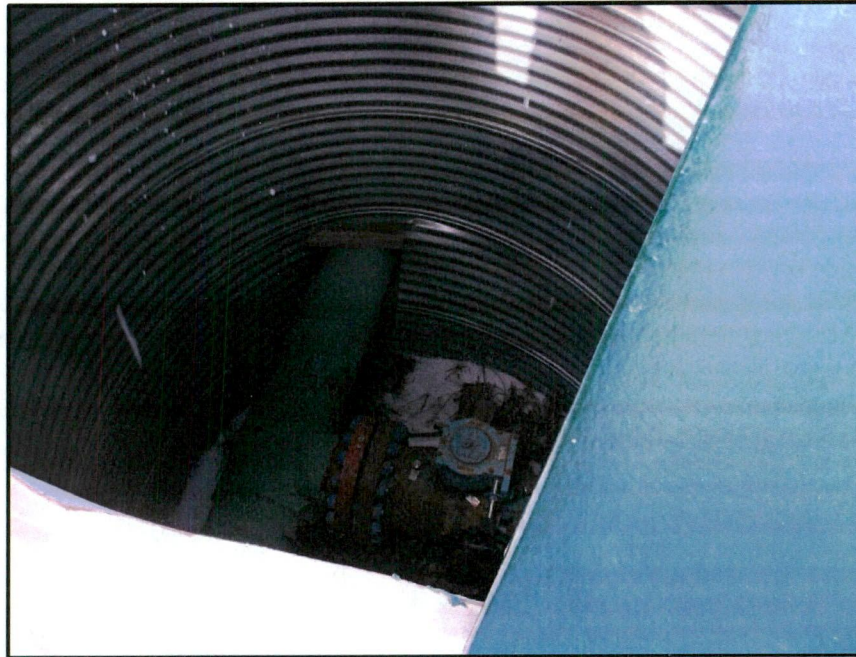
Photo 1. Direction: North. Inside protective container around transition between existing and new pipeline, located directly south of Tioga Rail Terminal.

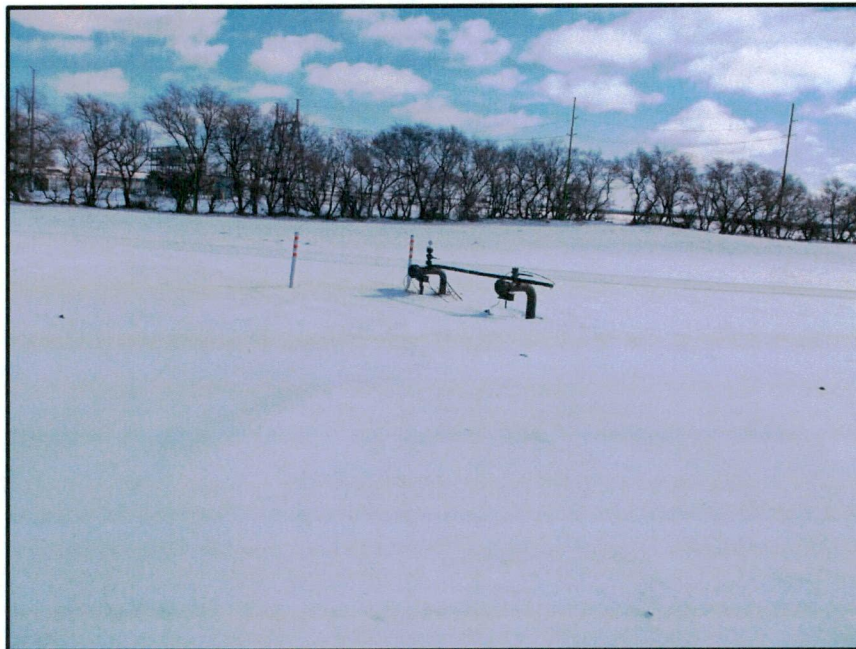
The Project was authorized as the conversion of 10.2 miles of existing 14in diameter underground pipeline from gathering lines to crude oil transmission pipelines, as described in the Application and at the hearing. The site inspection observations coincide with these parameters. Aboveground markers were in place along the route and the pipeline tied into the Tioga Rail Terminal at its north end and the Ramberg Truck Facility on its south end (**Appendix A, Maps; Appendix B, Photos 2, 5, 6, 10**).

The Order for the Project authorized construction within the designated route and corridor. The pipeline appeared to have been constructed within the proposed route and corridor. (**Appendix B, Photos 2-6, 10**).

Fence lines were not crossed during construction of the Project. Hess reported there had not been any agricultural fields with drainage tile impacted by construction of the Project. There was no waste or debris observed at the site (**Appendix B, Photos 2-6, 10**).

Photo 2. Direction: East. One of the pipeline markers that outlines transition point from existing to new pipeline running north to south, leading to Tioga Rail Terminal. East to west existing pipeline connecting to Ramberg Truck Facility.

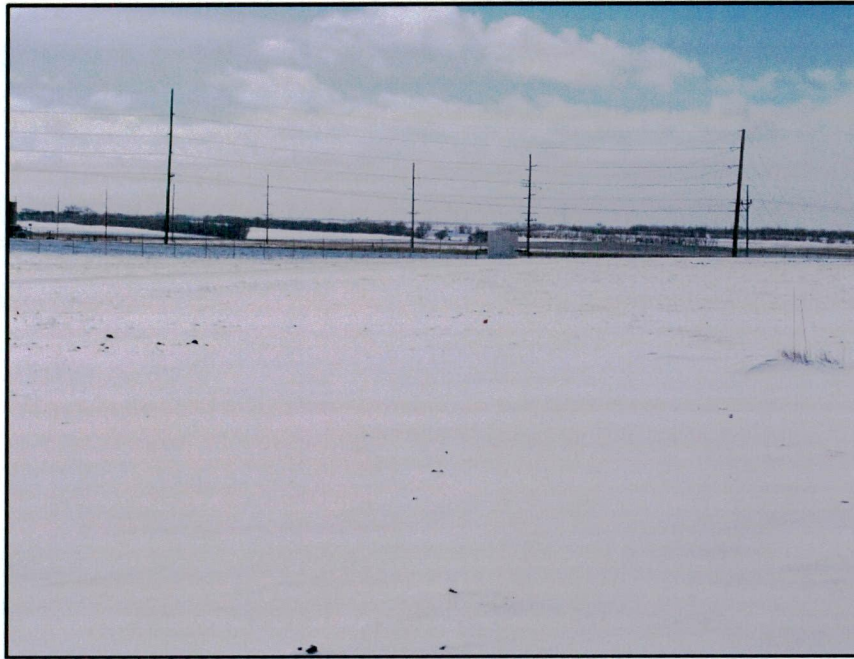
The Project was completed as proposed within the estimated construction ROW in the Route Application. As planned, there was no impact to agricultural lands since the Project was primarily a conversion of pipeline use and did not require moving or constructing pipeline. The minor area of ground disturbance required for the tie-in pumps and valves were on previously disturbed, industrial properties. Topsoil restoration, grading, and compaction within the ROW in these areas were not complete at the time of the field visit and will need to be completed once the ground thaws. Hess is aware of the needed repairs and stated that they would be completed in spring of 2015. (**Appendix B, Photos 3, 10**).

At the time of the site inspection, the pipeline trench had been backfilled, soils still needed to be recontoured, and reseeded and compaction has been scheduled to be completed in spring of 2015 once the ground thaws.

It appeared from the site visit that soil disturbance was minor and limited to Hess property at the ends of the pipeline route (**Appendix B, Photos 3, 10**).

Photo 3. Direction: South. Area where existing pipeline ties into the Tioga Rail Terminal on the north end of the Project. The area still needs to be graded, compacted, and reseeded.

There were a couple outstanding issues at the Project site related to reclamation. Hess stated during the inspection that grading, compaction, and seeding will be completed over the pipeline and ROW in the spring 2015 once the ground thaws. Wenck recommends the PSC request monitoring and documentation of these issues.

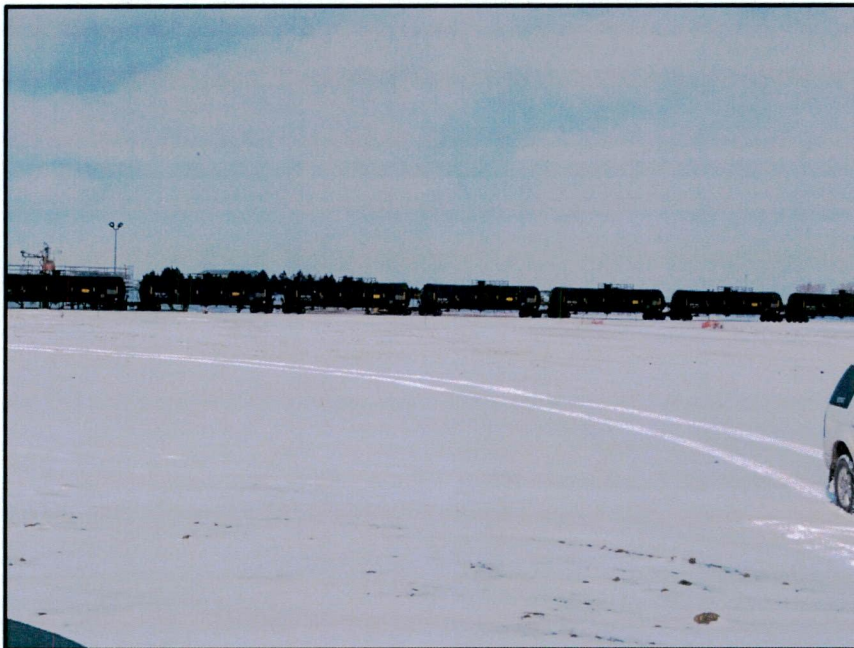
Photo 4. Direction: North. Pipeline running toward Tioga Rail Terminal on the north end of the Project. Additional view of area that still needs to be reclaimed.

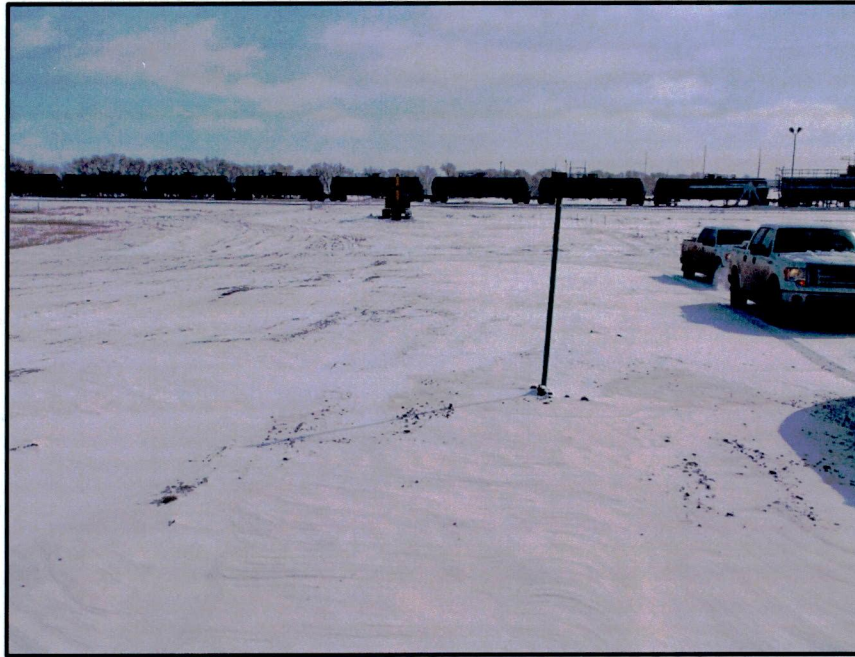
Photo 5. Direction: North. Pipeline ROW north toward rail terminal pig launcher on north end of Project. One pipeline ventilation marker is visible in foreground.

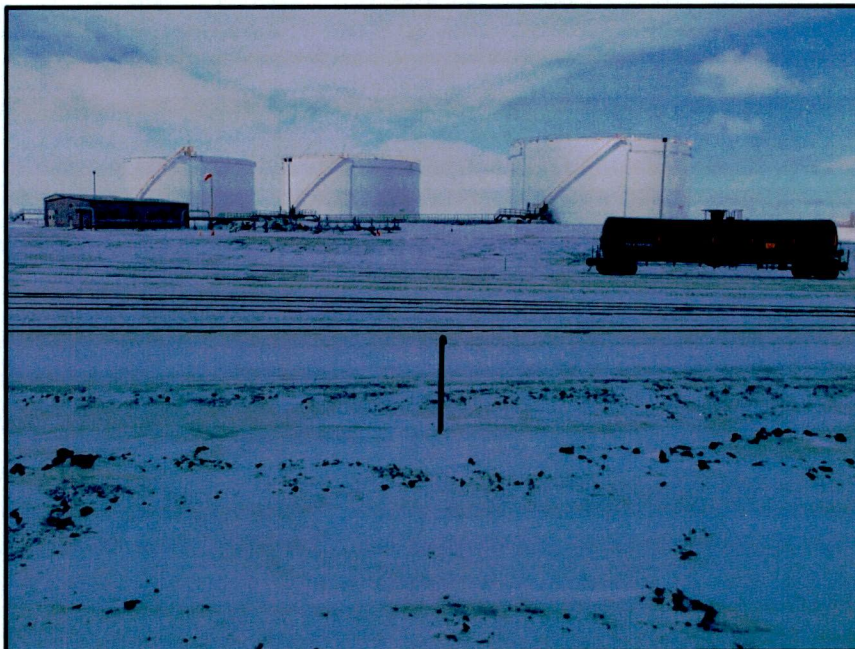
Photo 6. Direction: North. Another view of pipeline ROW toward rail terminal pig launcher on north end of Project. An additional pipeline ventilation marker is visible in foreground.

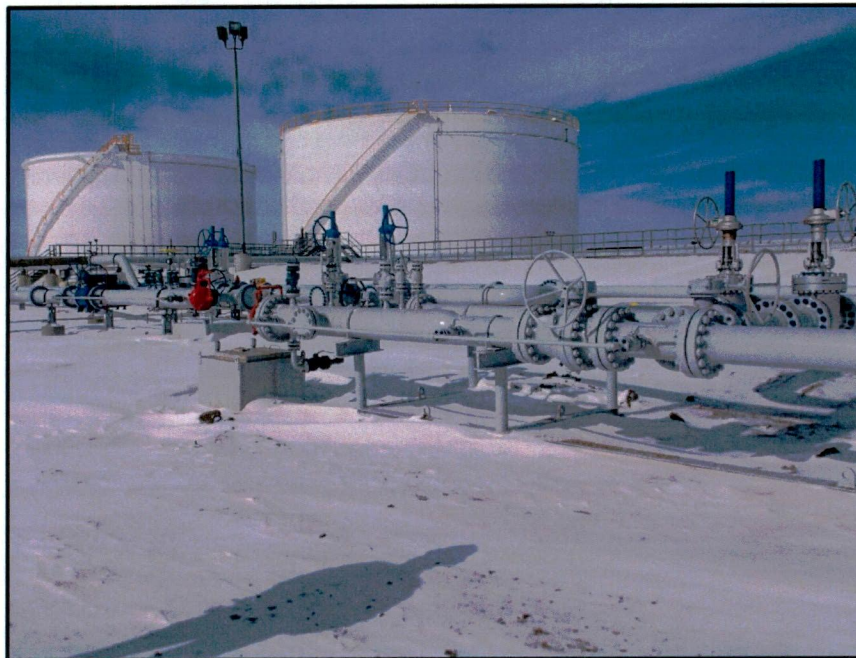
Photo 7. Direction: Northwest. Rail terminal transition area with between TRT and RFT, located on the north end of the project at Tioga Rail Terminal.

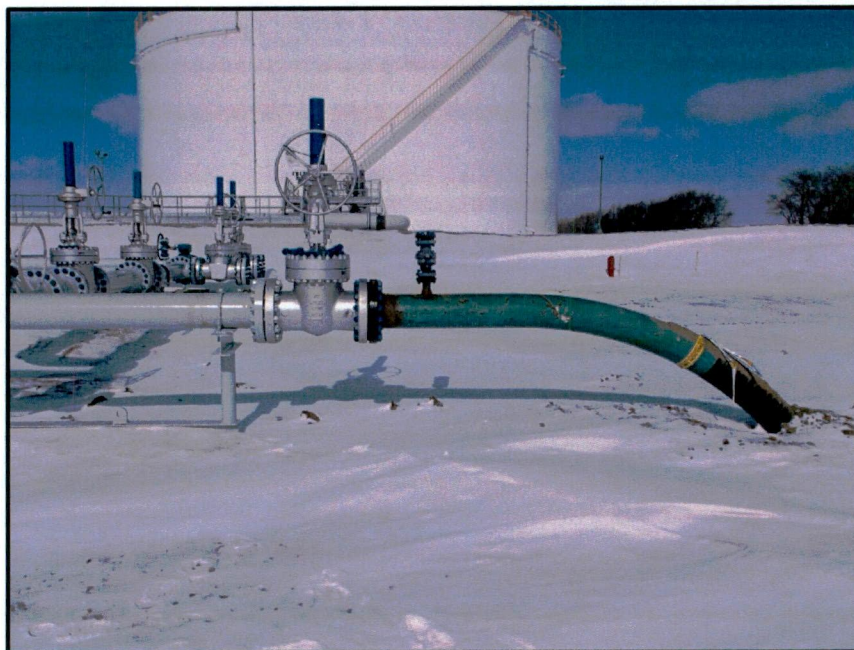
Photo 8. Direction: North. Tioga Rail Terminal pig launcher leading into transition area between RFT and TRT.

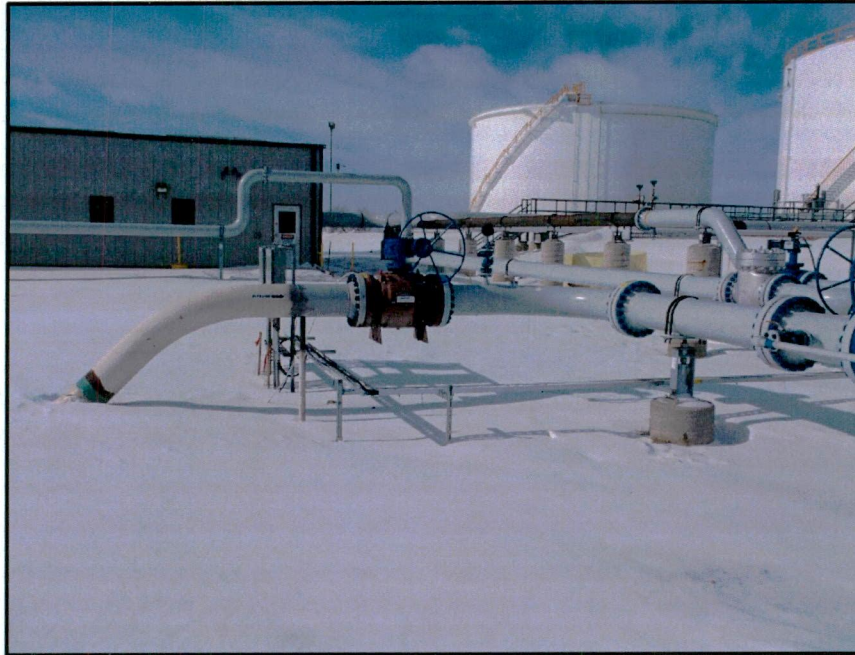
Photo 9. Direction: West. Ramberg Truck Facility pig launcher leading into transition area between RFT and TRT.

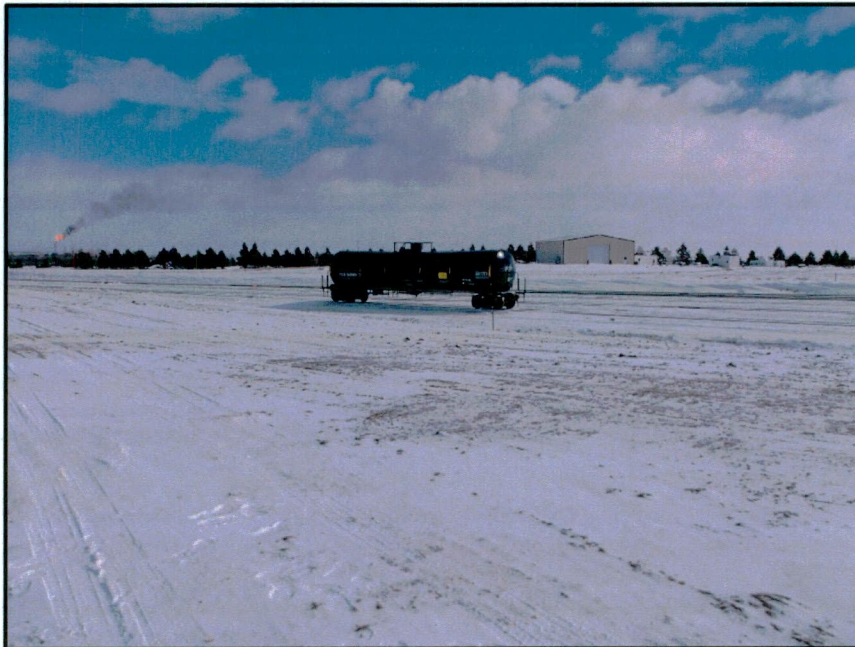
Photo 10. Direction: Southwest. Existing pipeline ROW area running north and south that connects tie in point shown in photo 1 and Tioga Rail Terminal, that still needs grading, compaction, and seeding.
