# **APPLICATION**

## **Waiver of Procedures and Timelines Consolidated Certificate of Corridor Compatibility and Route Permit**

### **LIGNITE PIPELINE**

**Basin Transload**  
3529 Gabel Road  
Billings, MT 59102

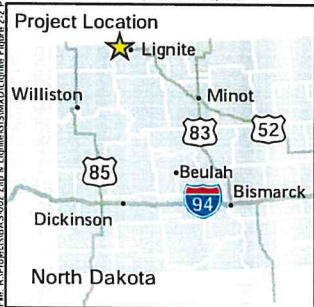
- 1-Mile Wide Project Study Corridor
- Existing Facility
- Proposed Facility
- Proposed 10" Pipeline Route (with mile posts)
- Roads
- Railway (\*\* indicates underlying rights owned by Canadian Pacific)
- Streams
- Farmland of statewide importance
- Prime farmland if drained

Figure 2-2 shows the Prime Farmland soil distribution along the Route and Table 2-3 reflects the acres of Prime Farmland within the Corridor.

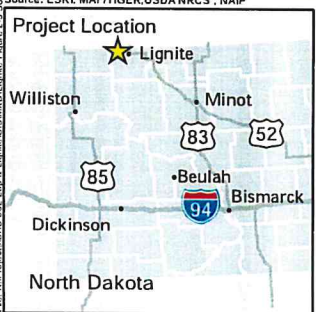
Figure 2-3  
**THPP Lignite Lateral Pipeline Soils**

1-Mile Wide Project Study Corridor	Hamerly-Tonka complex	Southam silt loam
Existing Facility	Harriet, Regan, and Stirum soils	Tonka silt loam
Proposed Facility	Heil silt loam	Vallers loam, saline
Proposed 10" Pipeline Route (with mile posts)	Miranda-Noonan loams	Williams-Niobell loams
Roads	Niobell-Noonan-Tonka complex	Williams-Zahl complex
Railway (** indicates underlying rights owned by Canadian Pacific)	Noonan-Niobell loams	Williams-Zahl loams
Streams	Portal-Lihen fine sandy loams

Information from three U.S. Department of Agriculture NRCS sources was used to identify the general soil map units present in the Corridor and Route. These resources include the Soil Survey for Burke County, the State Soil Geographic Database (ND-STATSCO), and the Soil Survey Geographic Database (SSURGO). See Figure 2-3 for a map of the soils along the project and Table 2-4 for a summary of acres based on soil type.

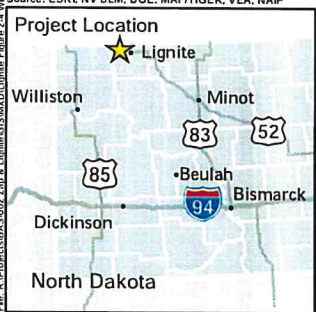
Figure 2-4  
**THPP Lignite Lateral Pipeline Wetlands**

| 1-Mile Wide Project Study Corridor | Streams |

The U.S. Fish and Wildlife Service (USFWS) also holds three wetland easements within the Project Corridor. These easements are located in the NW1/4 of Section 1-T162N-NR93W; the NE1/4 of Section 4-T162N-R92W; and the NE1/4 of Section 3-T162N-R92W. A wetland easement is a legal agreement signed with the United States of America, through the USFWS, that pays landowners to permanently protect wetlands. Wetlands covered by an easement cannot be drained, filled, leveled, or burned. The USFWS maintains a map of all wetland easements and copies of the easement and maps are sent to the landowner. When these wetlands dry up naturally, they can be farmed, grazed, or hayed. Wetlands covered by an easement are paid for in a single lump sum for the appraised value. No signs are placed on the property and the easement will not affect hunting or mineral rights. See Figure 2-4.

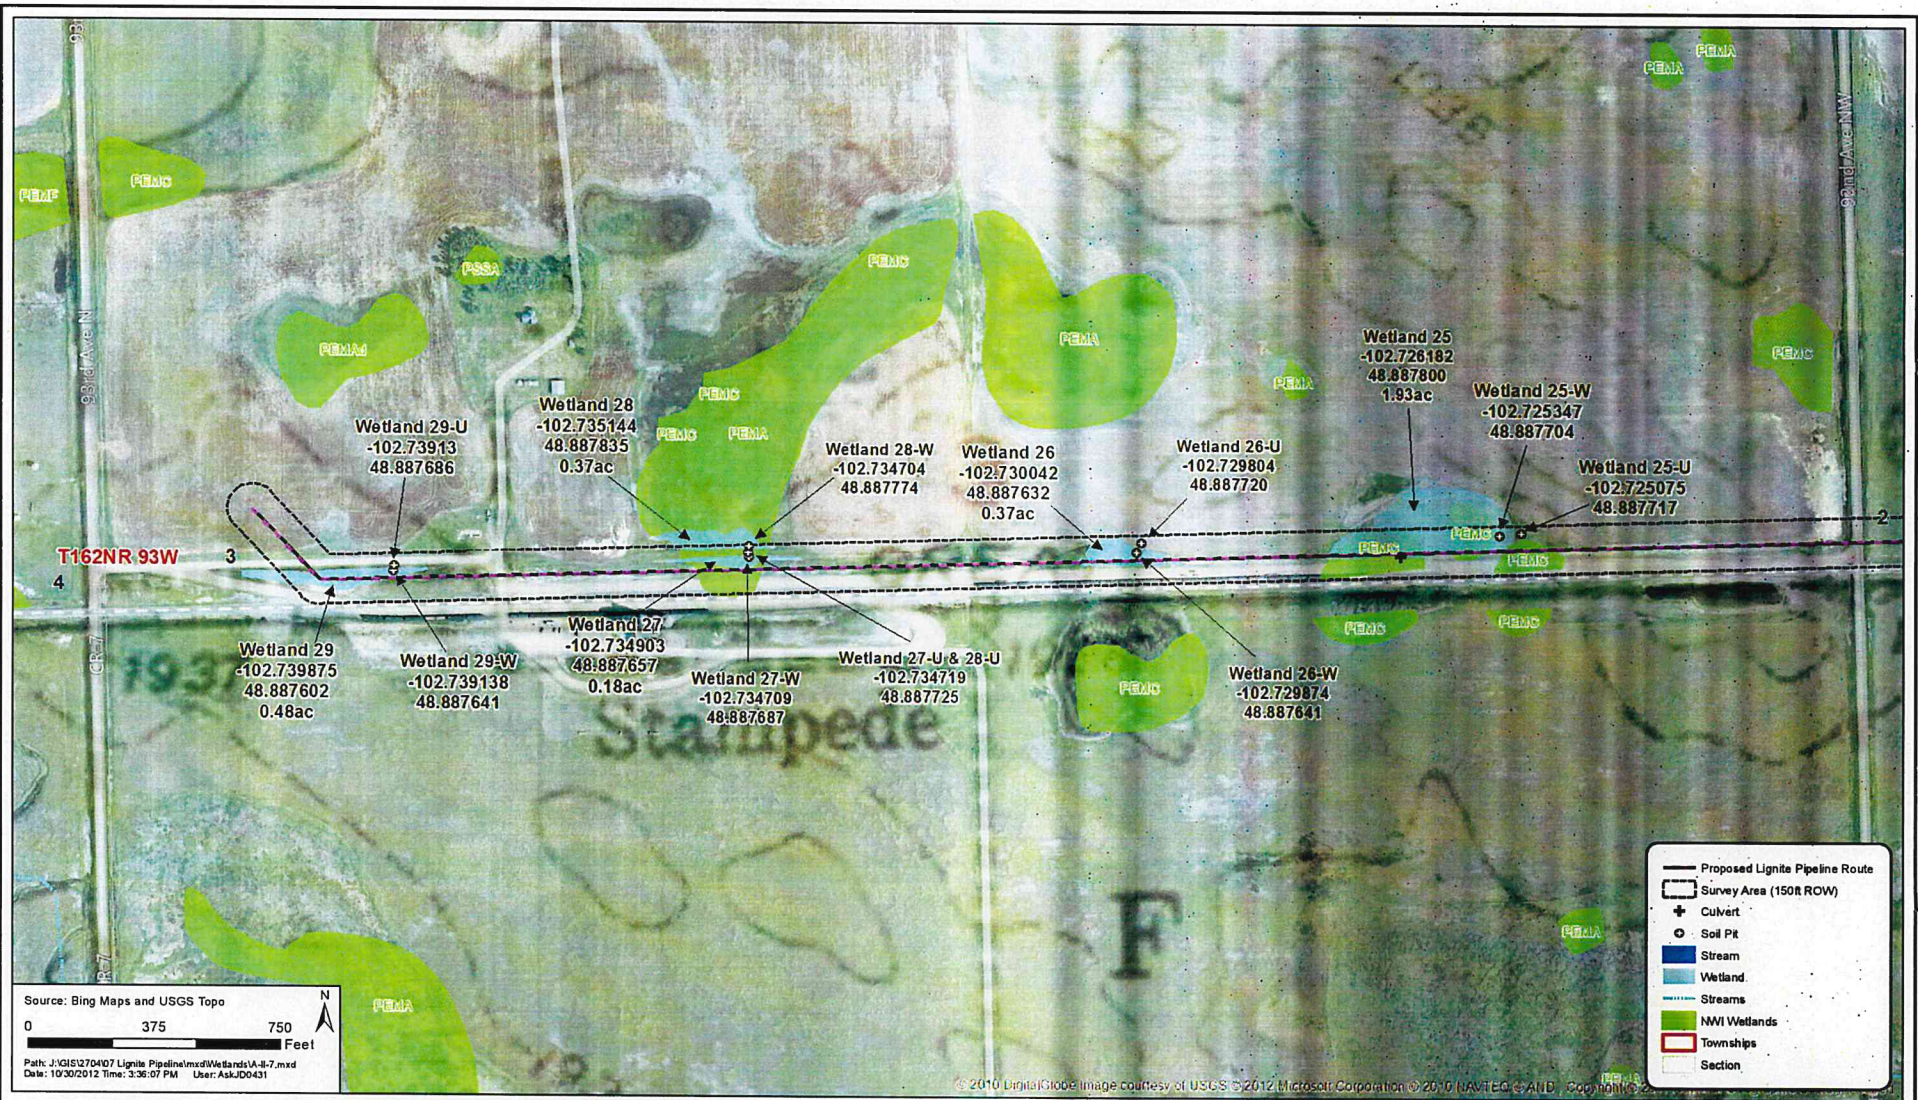
APPENDIX A-II-6

Lignite Pipeline-Wetlands 25, 26, 27, 28 and 29  
Section 3, T162N, R93W Burke County, ND

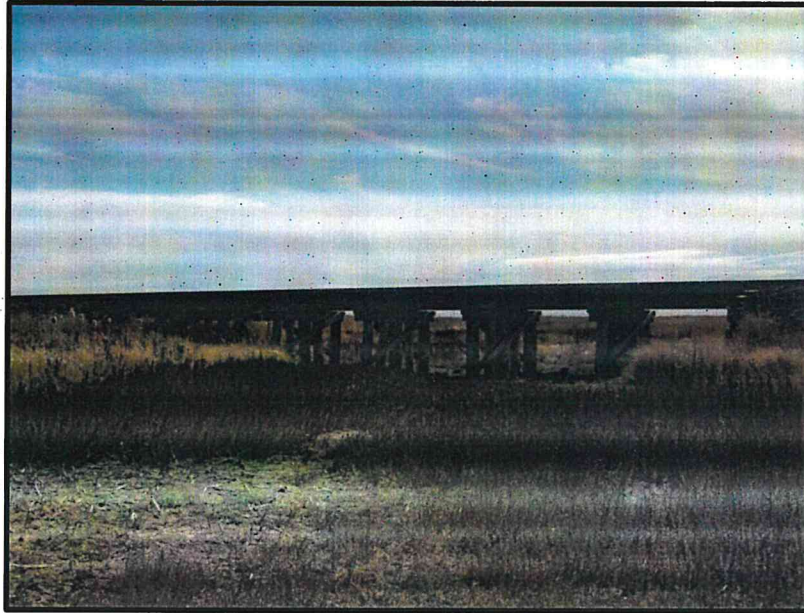
**Photo 17.** Direction: Southeast. Stream 19. Note the bridge allowing water movement.

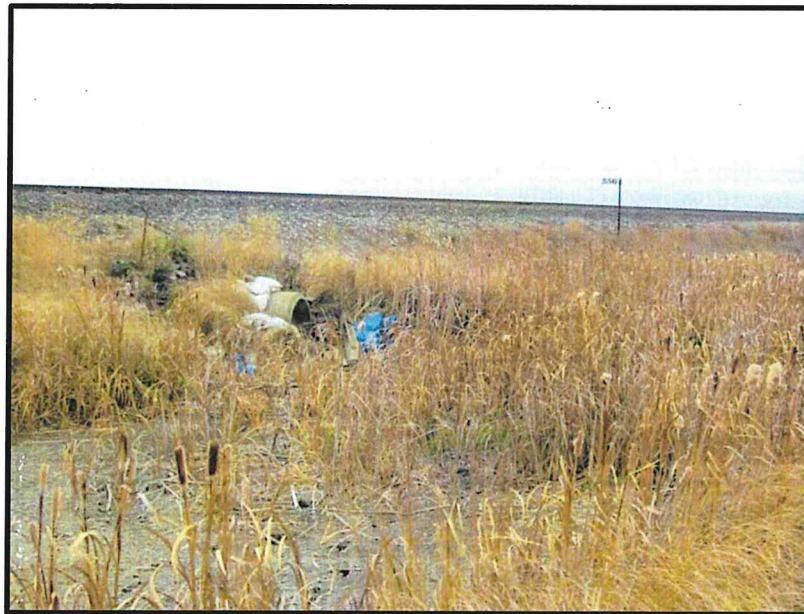
**Photo 22.** Direction: Southwest. Stream 24. Note the culvert allowing water movement under the railroad tracks.

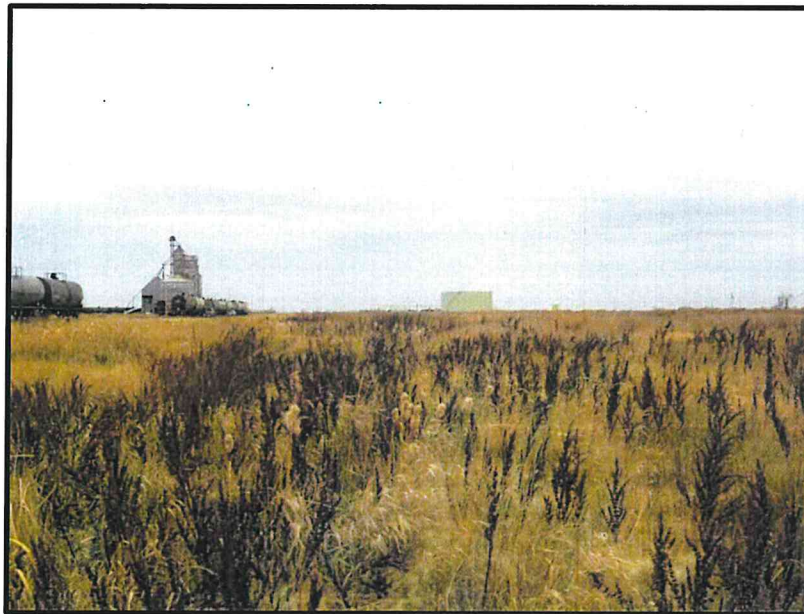
**Photo 24.** Direction: West. Wetland 26. Note the storage tank on the horizon.

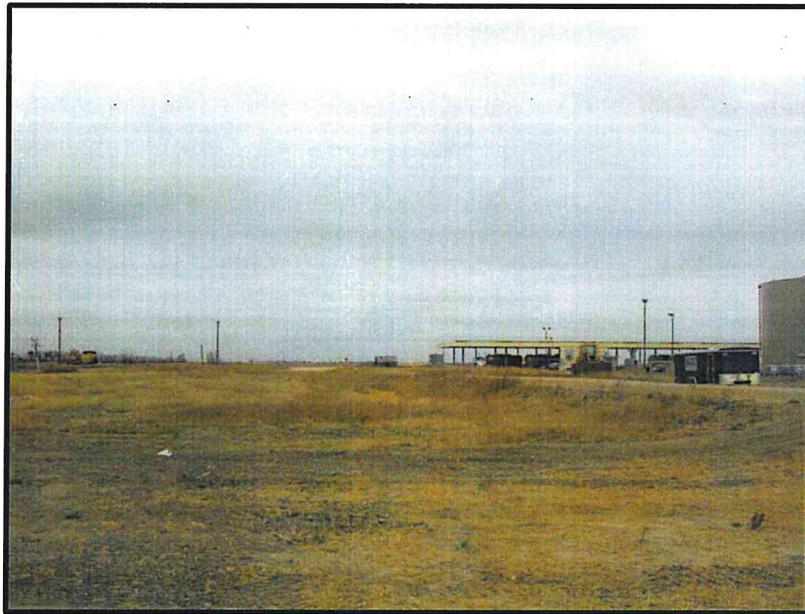
**Photo 26.** Direction: Northwest. Wetland 29 in the middle of the image. The facility on the right side of the image is the pipeline endpoint.

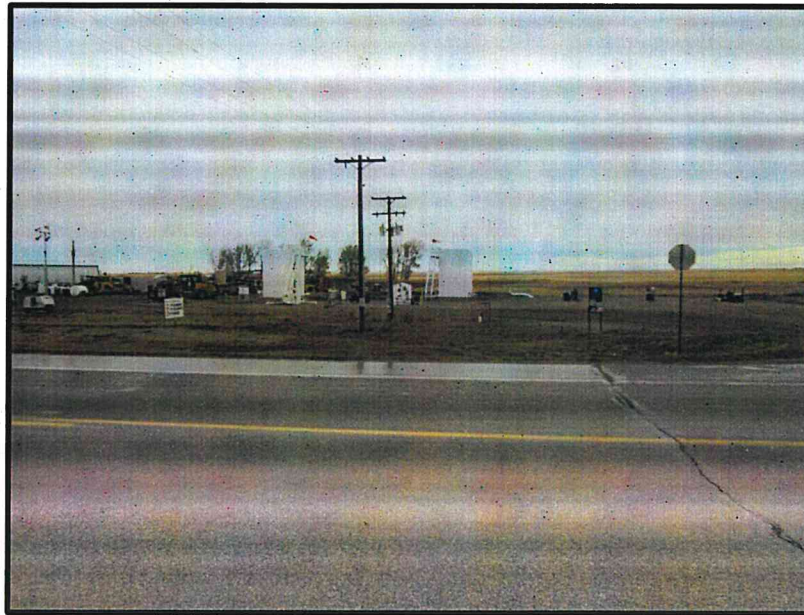
**Photo 1.** Direction: North. Start of the proposed pipeline in the SE¼ of Section 34, T163N R92W. This tank site is on the northeast end of the proposed pipeline.

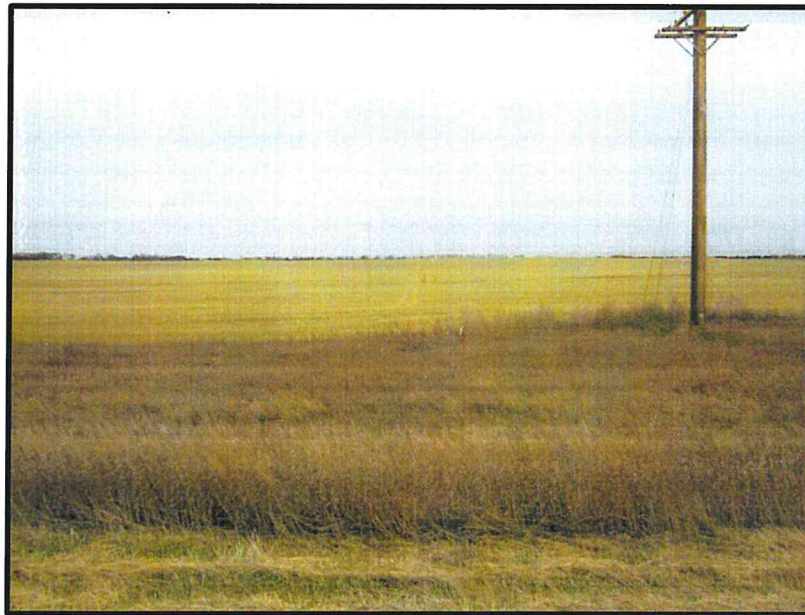
**Photo 2.** Direction: South. Proposed pipeline route directly south of the tank site after it crossed ND Highway 5.

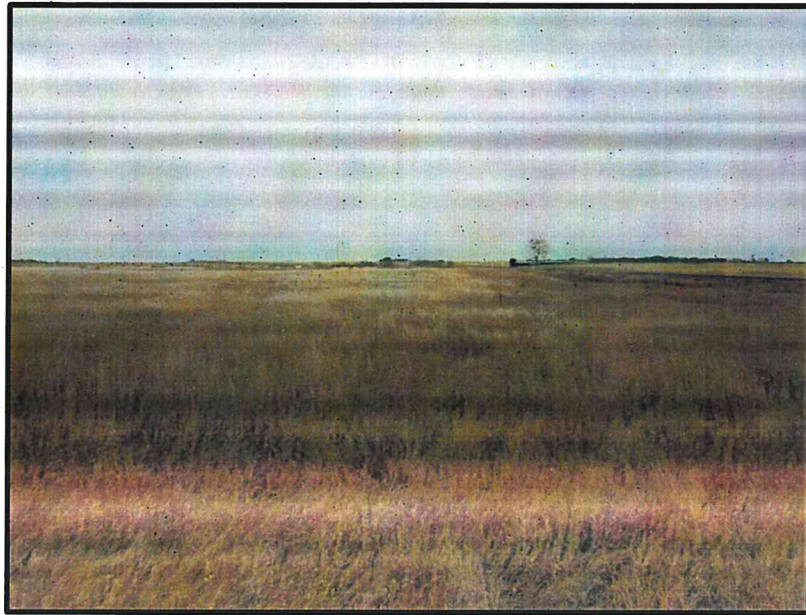
**Photo 3.** Direction: East. Proposed pipeline route as it crossed the section line between Sections 3 and 4, T162N R92W, looking back into the west half of Section 3. The proposed pipeline route paralleled the north side of the existing railroad tracks visible in the photo.

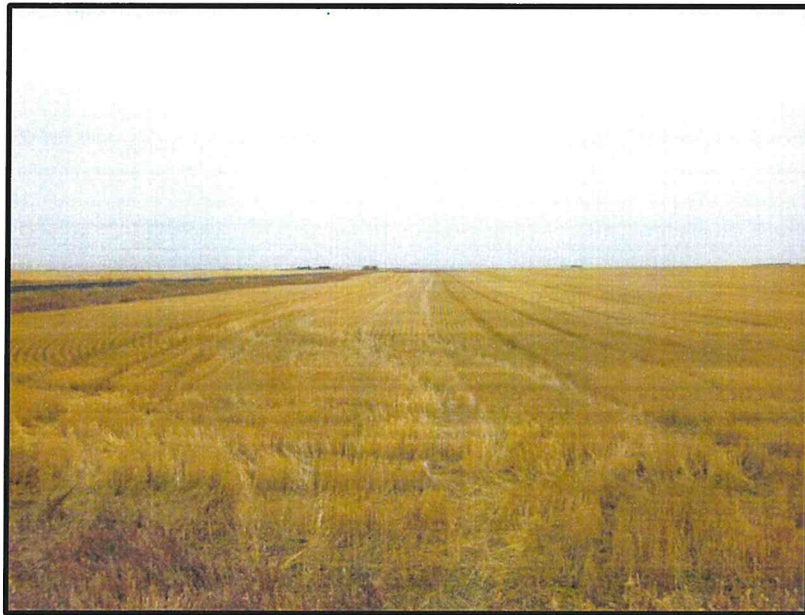
**Photo 4.** Direction: West. The route as it crossed the section line between Sections 3 and 4, T162N R92W, toward the east half of Section 4. The proposed route paralleled the north side of the existing railroad tracks visible in the photo.

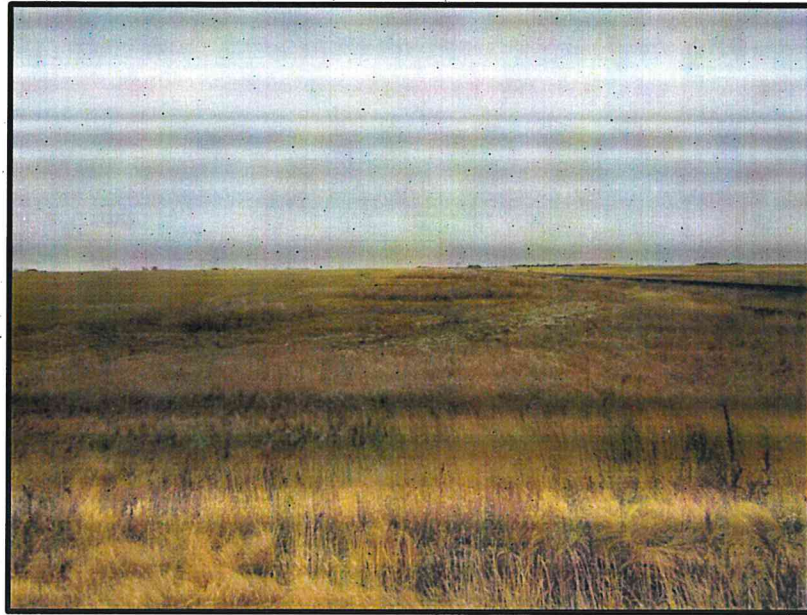
**Photo 5.** Direction: East. Pipeline route as it crossed the section line between Sections 4 and 5, T162N R92W, looking east into the west half of Section 4. The proposed route paralleled the north side of the existing railroad tracks visible in the photo.

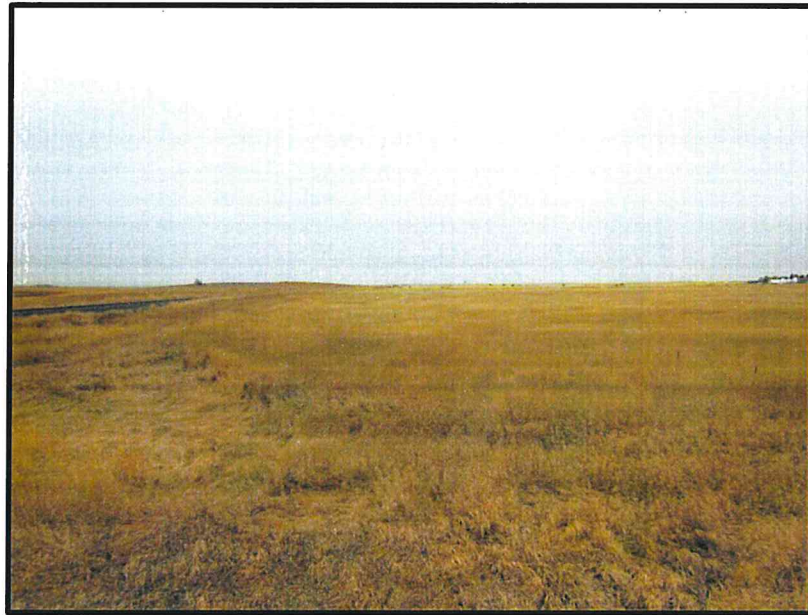
**Photo 6.** Direction: West. The proposed pipeline route as it crossed the section line between Sections 4 and 5, T162N R92W, looking into the east half of Section 5. The proposed route paralleled the north side of the existing railroad tracks visible in the photo.

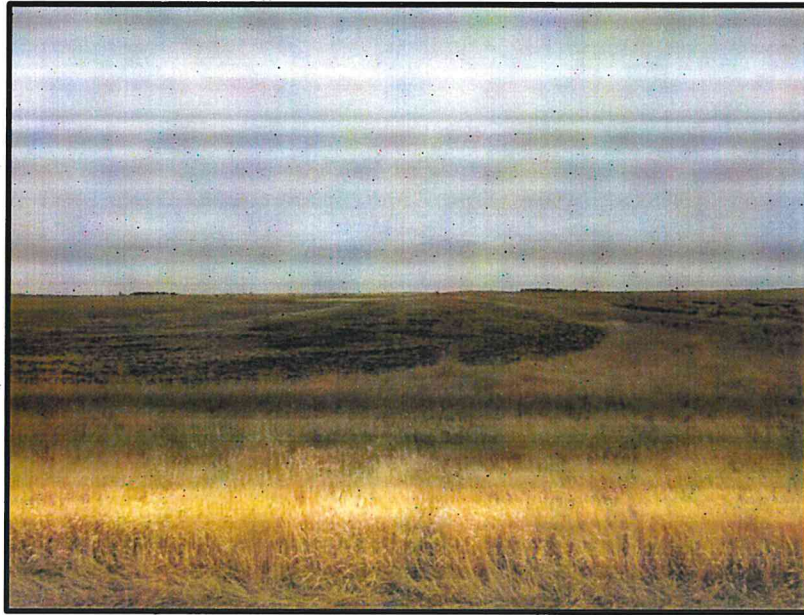
**Photo 7.** Direction: East. Pipeline route as it crossed the section line between Sections 5 and 6, T162N R92W, looking back into the west half of Section 5. The proposed route paralleled the north side of the existing railroad tracks visible in the photo.

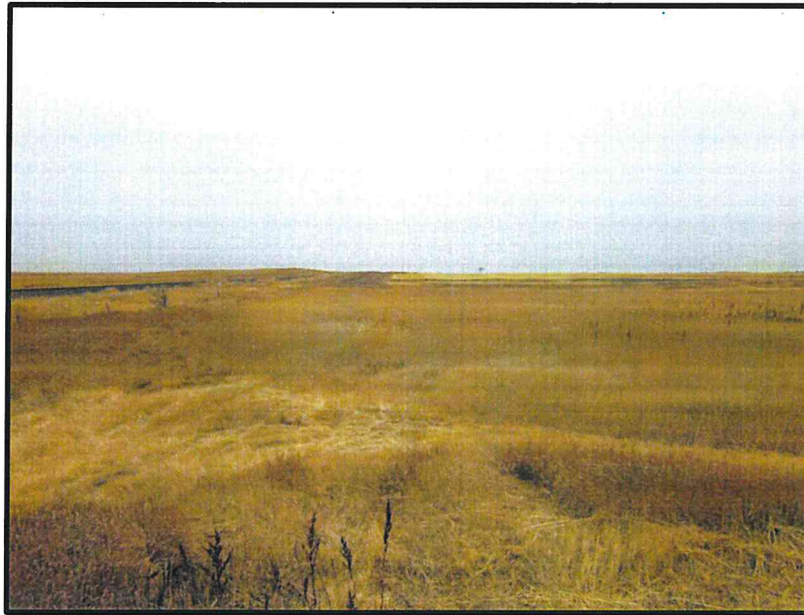
**Photo 8.** Direction: West. Proposed pipeline route as it crossed the section line between Sections 5 and 6, T162N R92W, toward the east half of Section 6. The proposed route paralleled the north side of the existing railroad tracks visible in the photo.

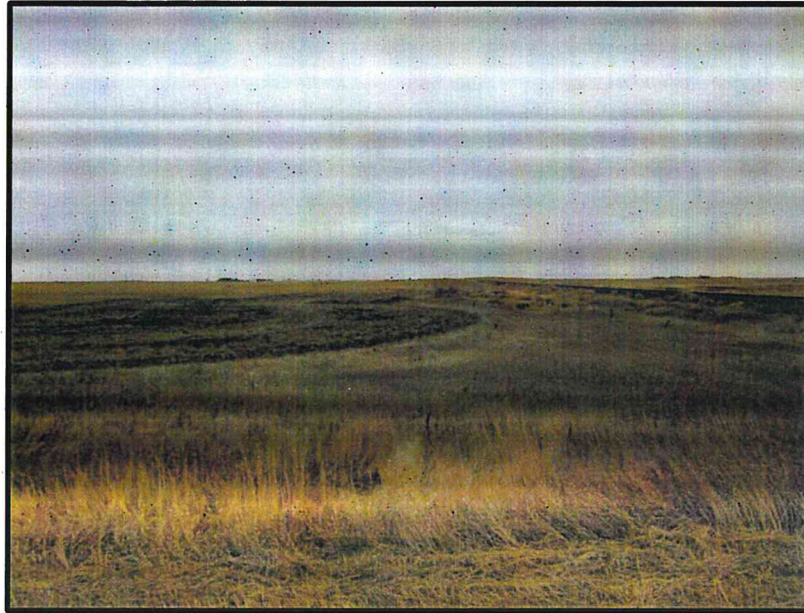
**Photo 9.** Direction: East. The route as it crossed the section line between Section 6, T162N R92W and Section 1, T162N R93W, toward the west half of Section 6. The proposed route paralleled the north side of the existing railroad tracks visible in the photo.

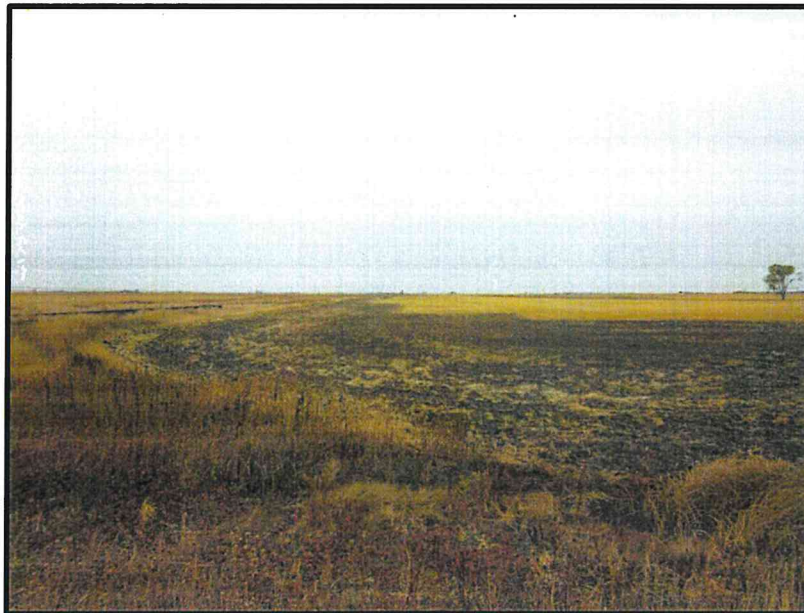
**Photo 10.** Direction: West. Pipeline route as it crossed the section line between Section 1, T162N R93W and Section 6, T162N R92W, toward the east half of Section 1. The proposed route paralleled the north side of the existing railroad tracks visible in the photo.

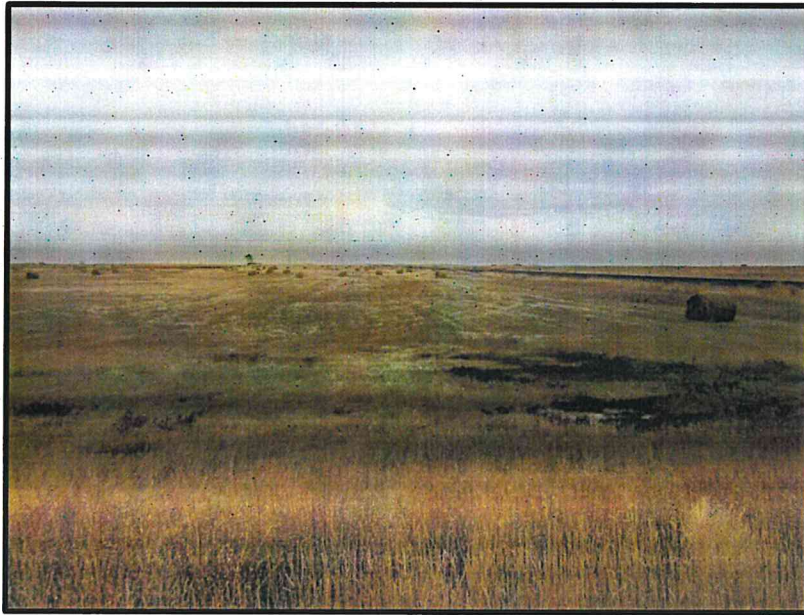
**Photo 11.** Direction: East. Pipeline route as it crossed the section line between Sections 1 and 2, T162N R93W, toward the west half of Section 1. The proposed route paralleled the north side of the existing railroad tracks visible in the photo.

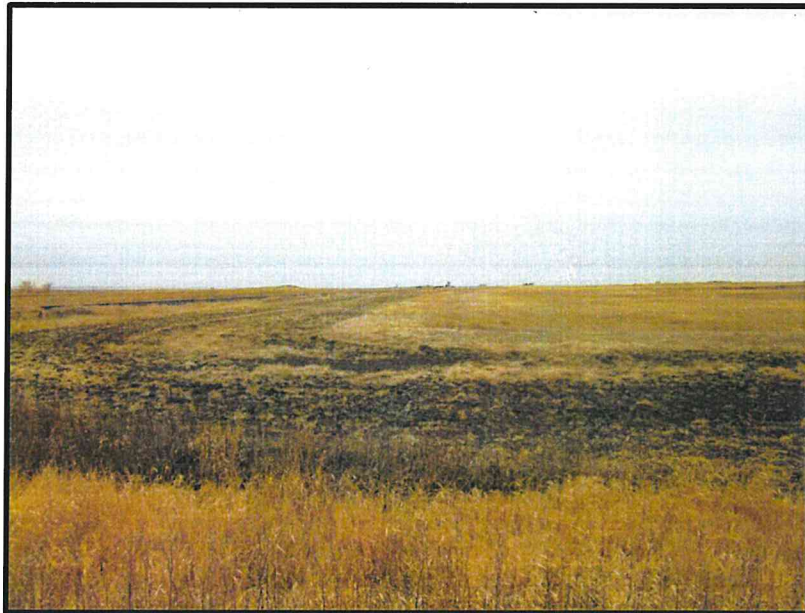
**Photo 12.** Direction: West. Pipeline route as it crossed the section line between Sections 1 and 2, T162N R93W, looking into the east half of Section 2. The proposed route paralleled the north side of the existing railroad tracks visible in the photo.

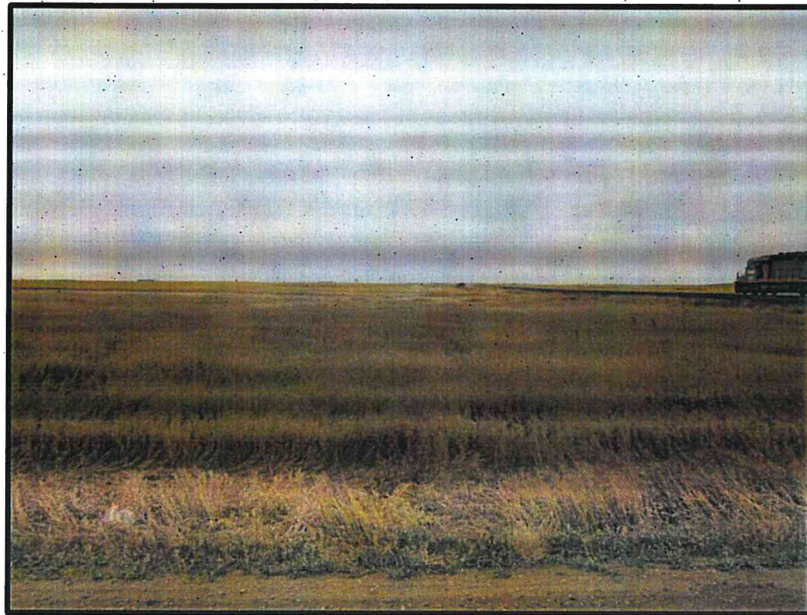
**Photo 13.** Direction: East. Pipeline route as it crossed the section line between Sections 2 and 3, T162N R93W, toward the west half of Section 2. The proposed route paralleled the north side of the existing railroad tracks visible in the photo.

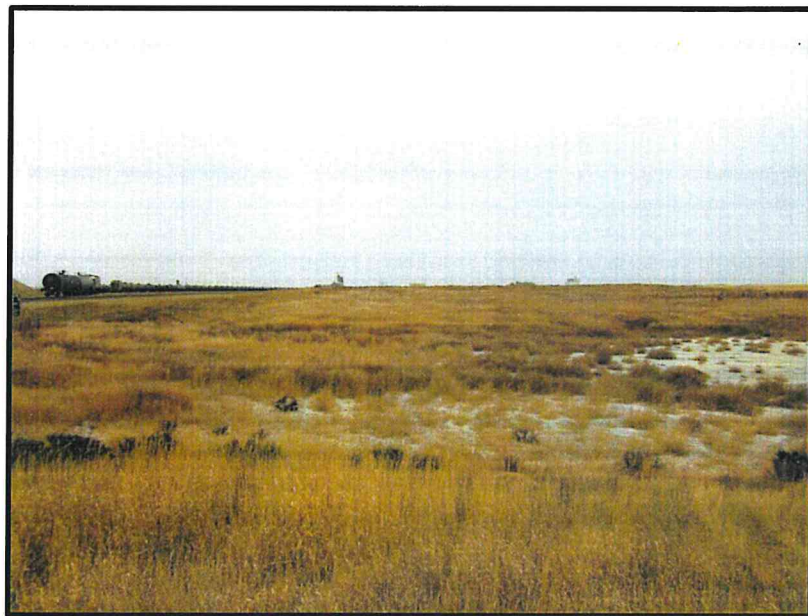
**Photo 14.** Direction: West. Pipeline route as it crossed the section line between Sections 2 and 3, T162N R93W, toward the east half of Section 3. The proposed route paralleled the north side of the existing railroad tracks visible in the photo.

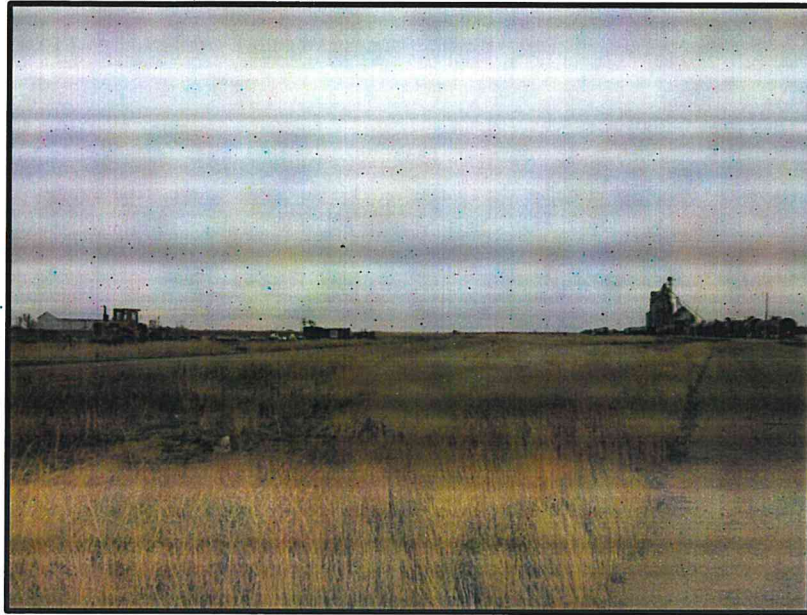
**Photo 15.** Direction: East. The western end of the proposed pipeline route as it connected with existing tanks located to the left just outside the view of the photo, in the west half of Section 3, T162N R93W.
