# Antelope Valley Station Natural Gas Pipeline Project Post-Construction Inspection Report PU-13-022

*Prepared for:*  
**North Dakota Public Service  
Commission**

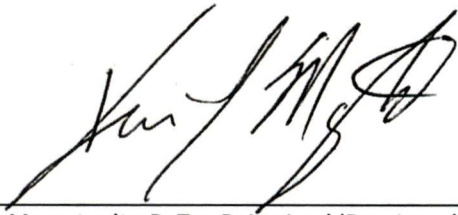
Kevin Magstadt, P.E., Principal/Regional Manager

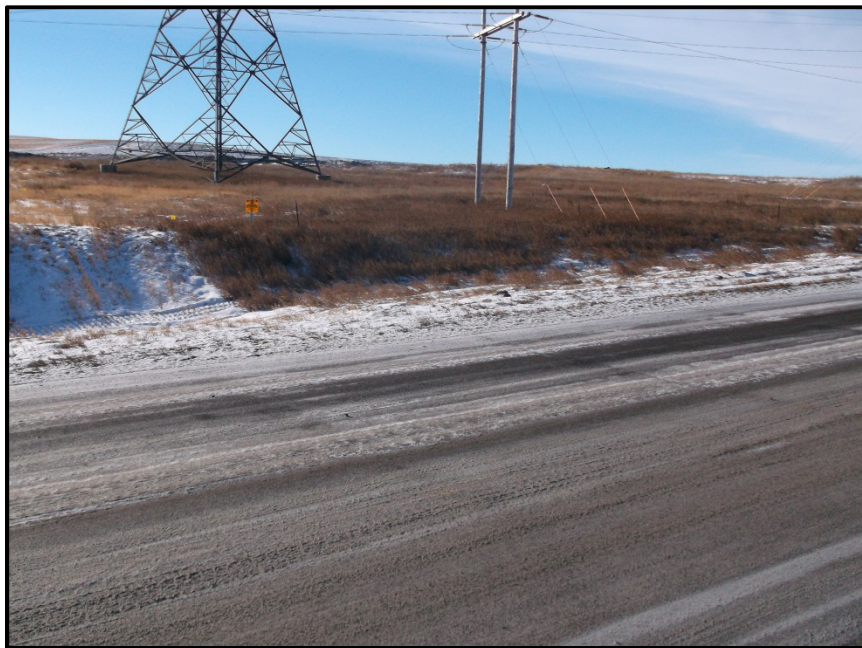
**Photo 6.** Direction: South. 4<sup>th</sup> St SW (County Road 26) bore. Yellow marker indicates location of the start of the bore. No impacts to the road were observed during the inspection.

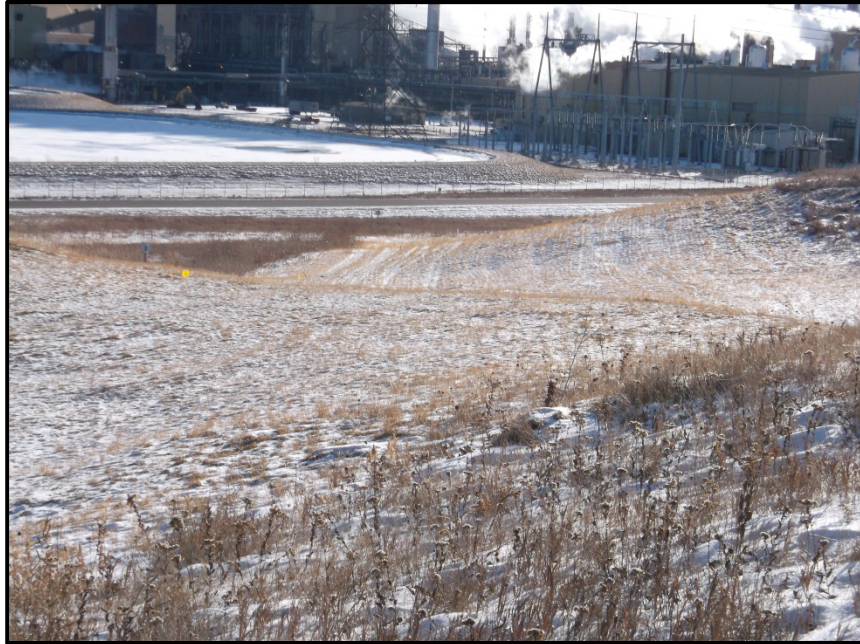
**Photo 7.** Direction: East. Pictured above is the pipeline corridor running north and south, parallel to and west of County Road 15. Vegetation is fully established and above ground yellow pipeline markers can be seen.

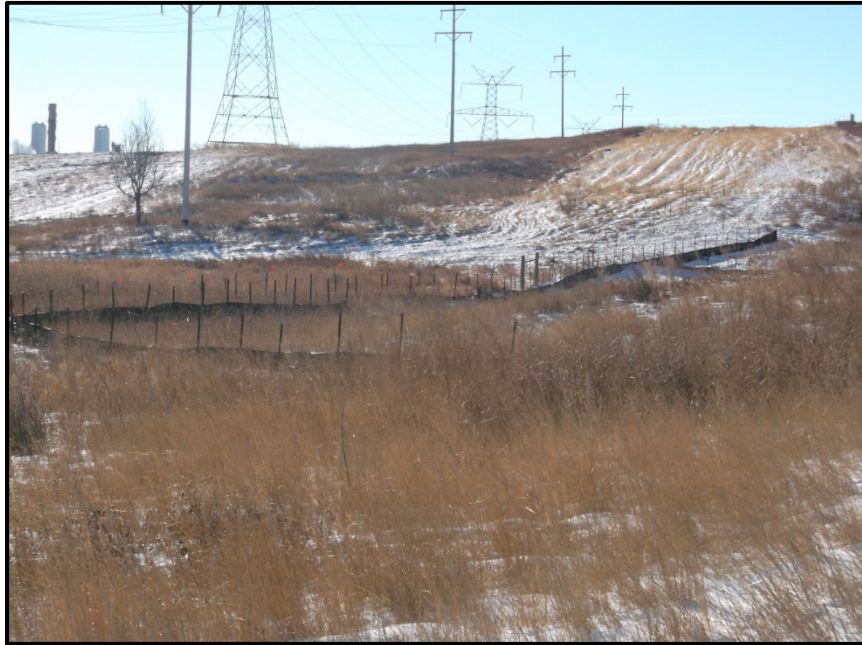
**Photo 11.** Direction: South. Silt fence encompassing one of the wetlands along the pipeline corridor. The silt fence has remained installed to continue to protect the wetland. During the inspection no impacts to the wetland were observed.

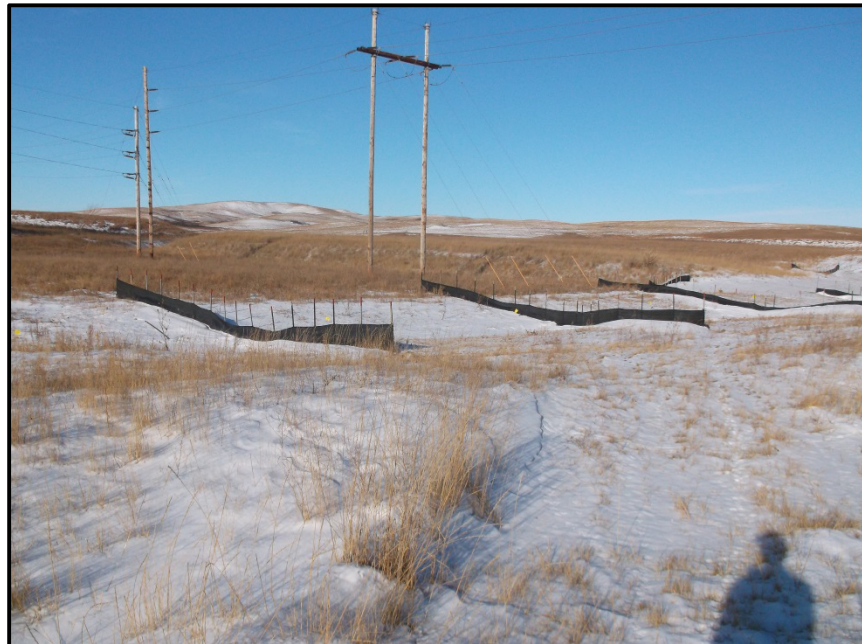
**Photo 12.** Direction: Northwest. BMP's are still in place along pipeline corridor to prevent against erosion during this downhill portion of the corridor, where a channel has been created.

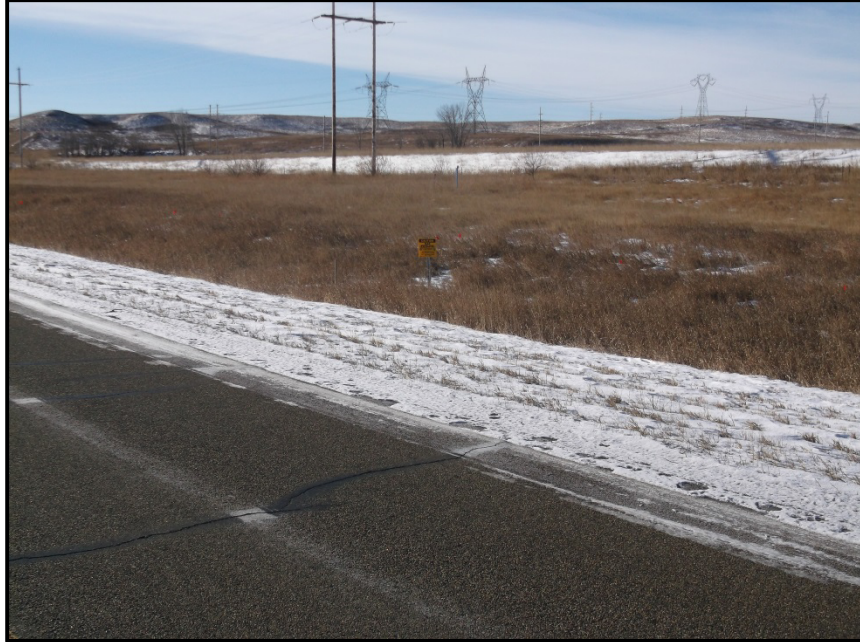
**Photo 15.** Direction: Northeast. This is the entry point for the third bore of the project underneath County Road 15. An above ground pipeline yellow marker shows the entrance point of the bore. During the inspection no impacts to the road were observed.

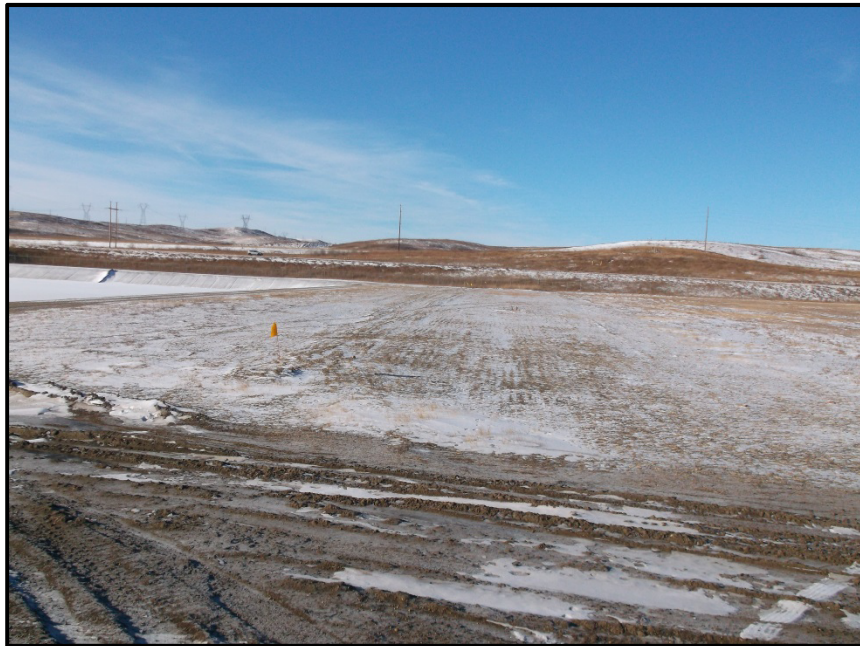
**Photo 16.** Direction: West. Pictured above is the pipeline running west and east towards the end of the project on the north side of the Dakota Gasification Plant. There is no vegetation in this section because it is location on the Dakota Gasification Company's property. The pipeline also bends south towards the pig receiver.
