**Minnesota Power 250 kV DC  
Transmission Line Reroute  
Post-Construction Inspection Report  
PU-13-103**

*Prepared for:*  
**North Dakota Public Service  
Commission**

**WENCK Associates, Inc.**  
301 1<sup>st</sup> Street NE, Suite 202  
Mandan, ND 58554  
Phone: 701-751-3370  
Fax: 763-479-4242

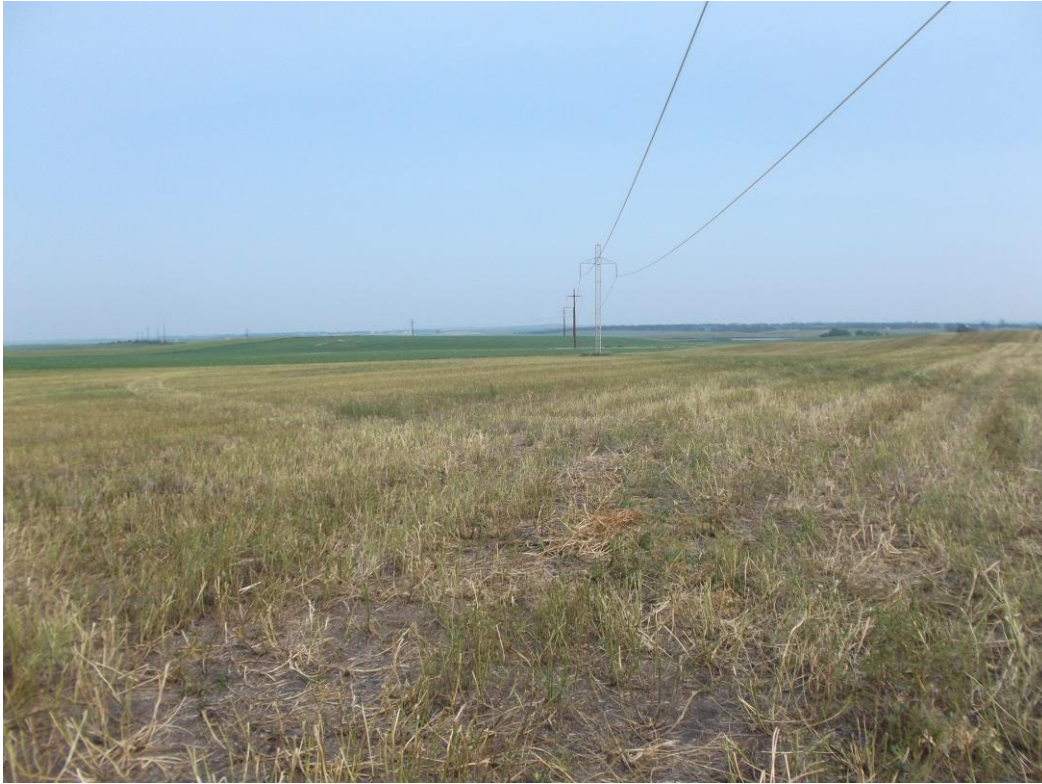
**Above: Photo 1 (Observation Point 1) - Connection to existing transmission line structure at south end of Project. Looking northwest.**

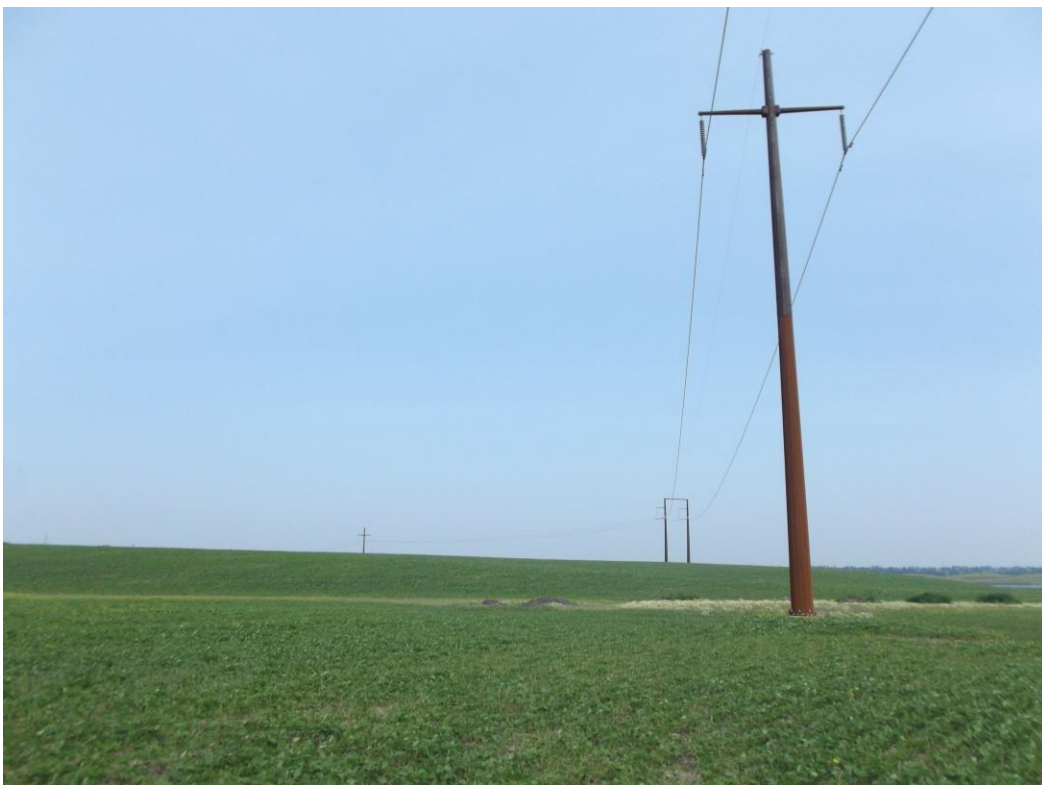
Seven new steel structures were observed along the new transmission line route; four structures were single-pole and three were double-pole (see Appendix A, Photos 2, 6, 13, and 17). The structures are supported by a circular concrete base which is embedded into the ground. Span lengths and structure heights appeared to match those specified in the Application.

**Below: Photo 2 (Observation Point 3) – First new structure at south end of project. Typical single pole structure. Looking northwest.**

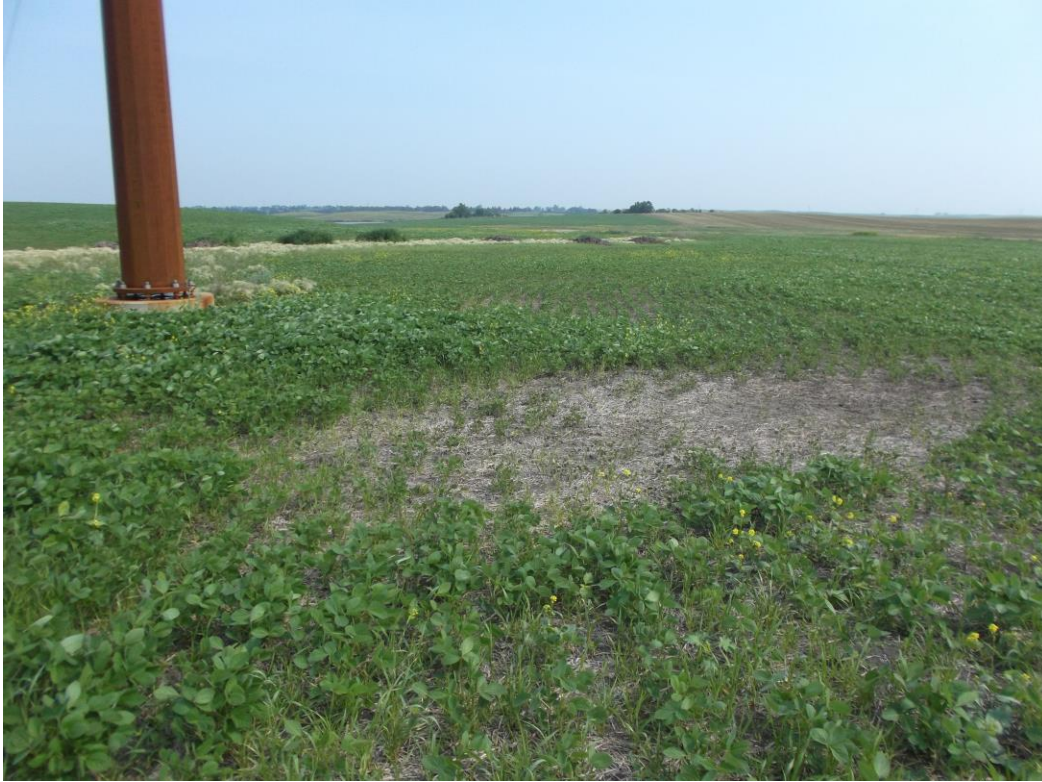
**Above: Photo 3 (Observation Point 4) – Small barren area near new structure at south end of project. Looking northeast.**

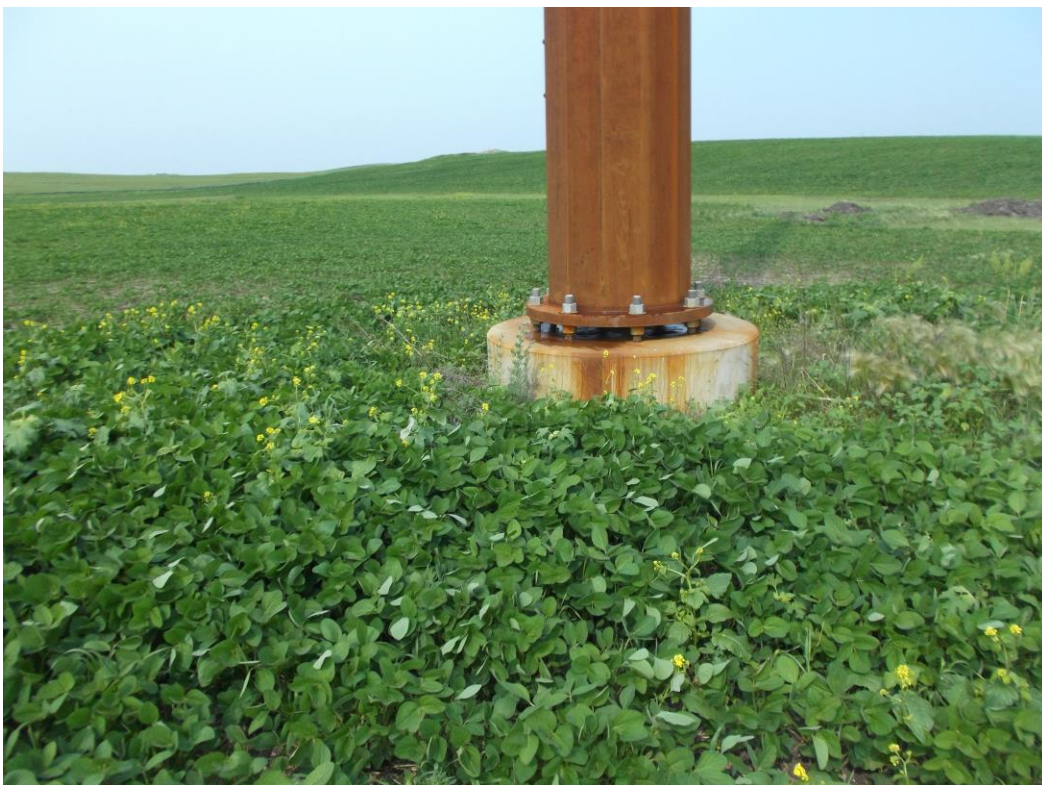
Installation of seven new transmission line structures has resulted in approximately 0.01 acres of active farmland being converted to use as a transmission facility. The Natural Resources Conservation Service (NRCS) stated that farming in the project area will not be significantly impacted due to minimal acreage, and that the Farmland Protection Policy Act (FPPA) does not apply in this situation (letter dated 4-22-2013). Wenck confirmed during the site inspection that the area surrounding the new structures has resumed its previous agricultural production use (see Appendix A, Photo 4).

**Below: Photo 4 (Observation Point 4) – Good vegetation near base of new structure. Looking west.**

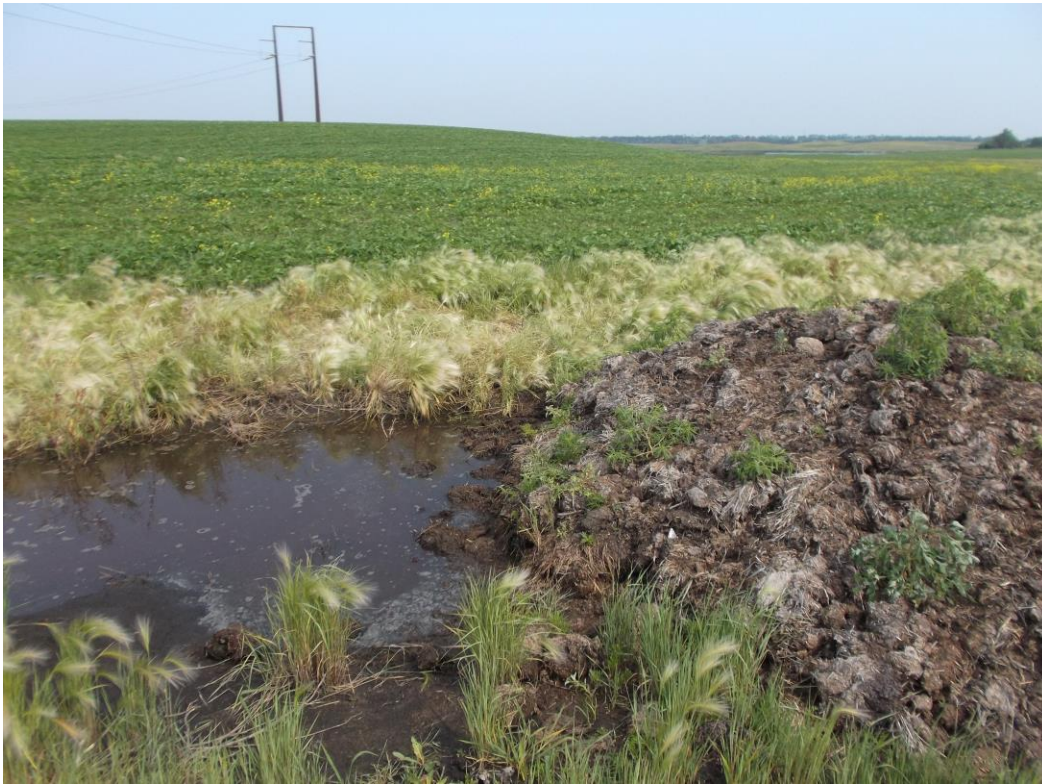
One area of interest is located in the SE corner of the Project, between two new structures. In this area there are several small piles of soil in a drainage way, which cause pools of water to form (see Appendix A, Photo 5). It is unclear if this was caused by construction of the transmission line.

**Above: Photo 5 (Observation Point 6) – Pile of soil with pool of water near south end of project. Looking northwest.**

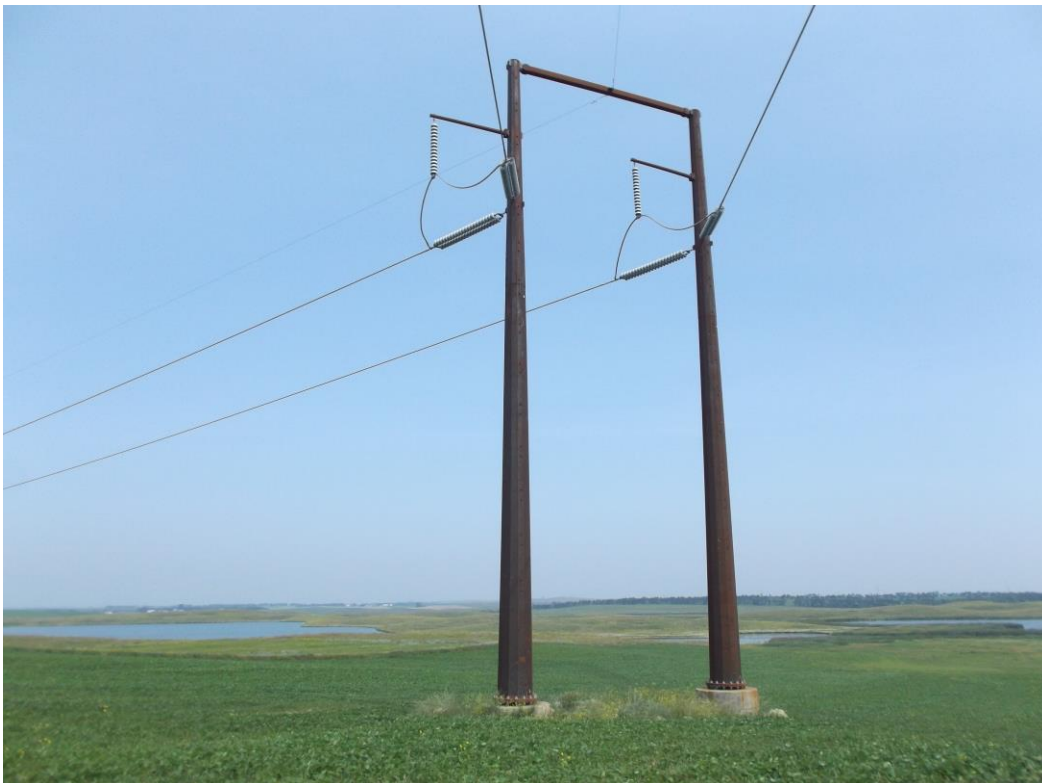
**Below: Photo 6 (Observation Point 7) – Typical double pole structure at bend, where new alignment bends to avoid wetlands. Looking northwest.**

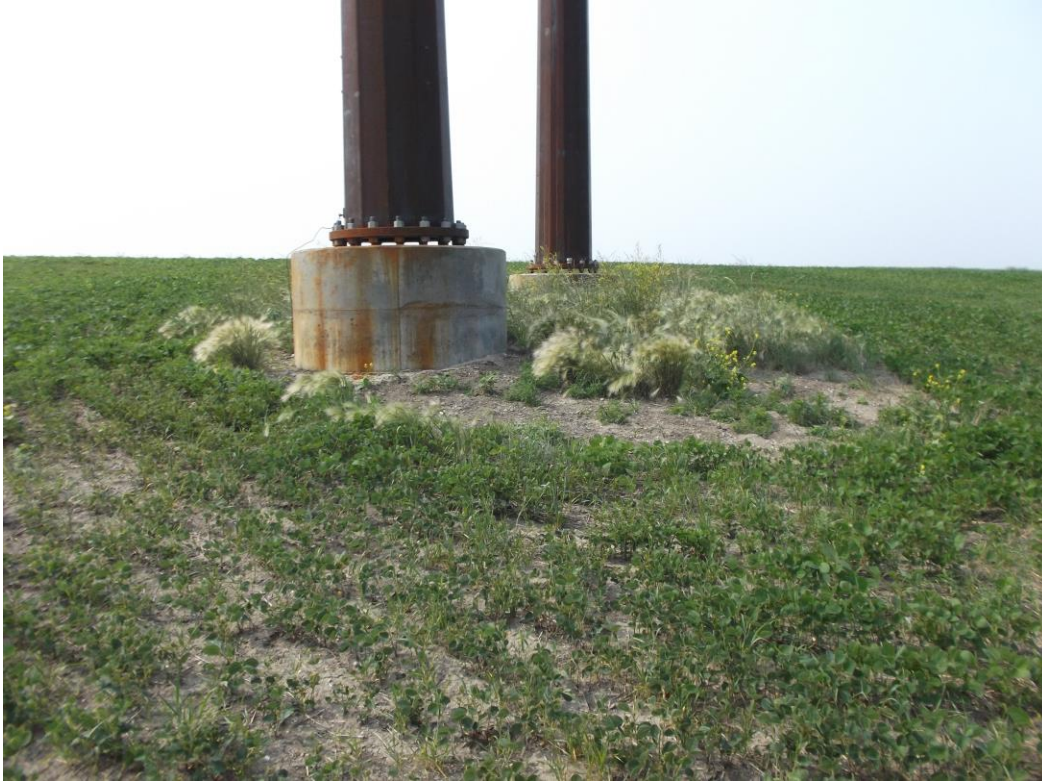
**Above: Photo 7 – Typical vegetation around structure. Grass and weeds within 5 to 10 feet of base, but crop growing in surrounding area. Looking south.**

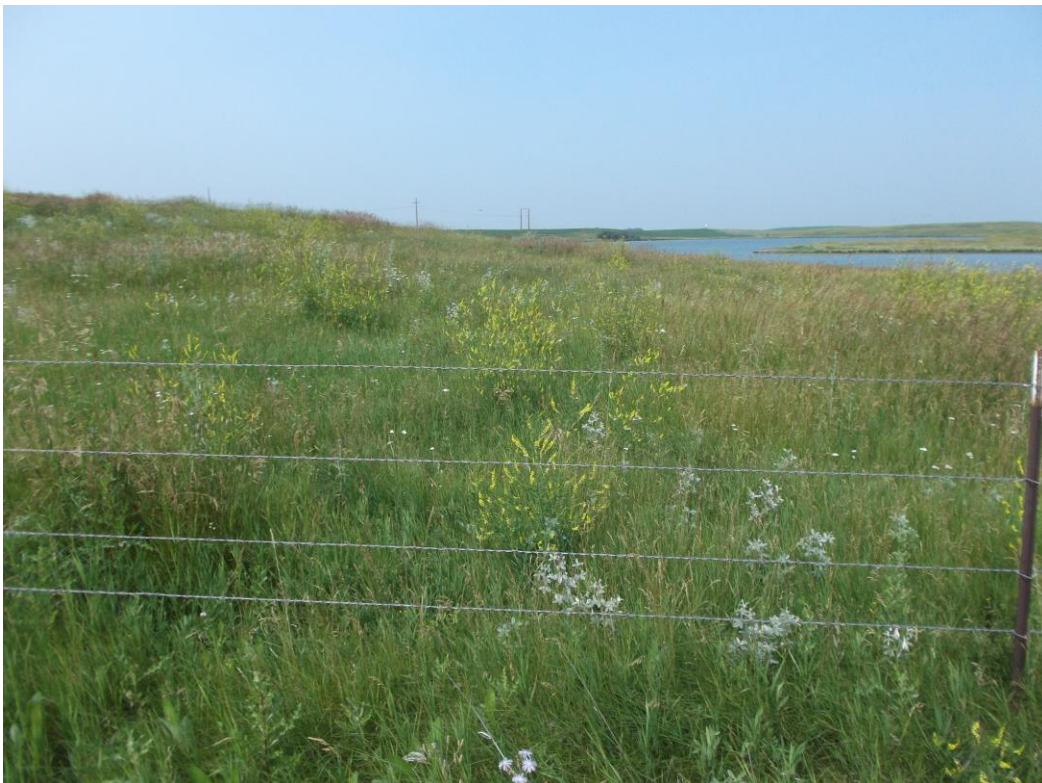
No damages to property were observed during the site inspection. It is likely that fence around the wetland area in the middle of the project was removed and/or relocated to facilitate construction in and out of the wetland. The fence appeared to be functional and it looked like portions of the fence were relatively new (see Appendix A, Photo 8).

**Below: Photo 8 (Observation Point 10) – Apparently new barbed wire fence near wetland. This photo was taken near apparent bend of the old alignment. Looking west.**

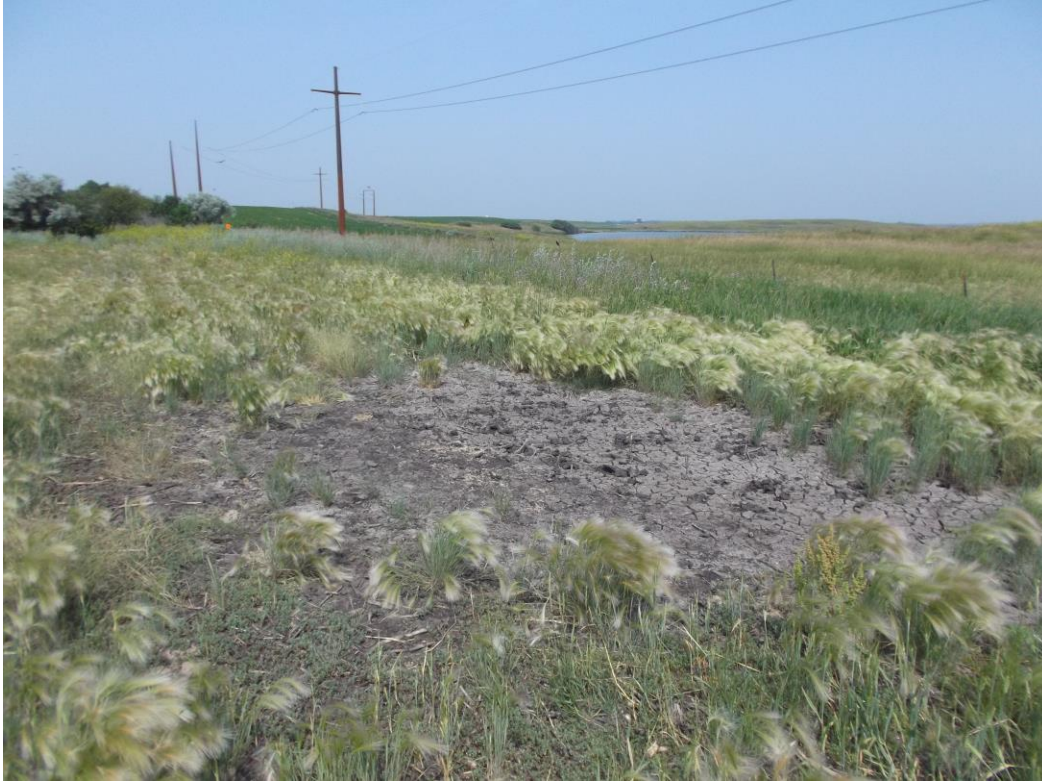
**Above: Photo 9 (Observation Point 11) – Small barren area on south side of transmission line. Looking northwest.**

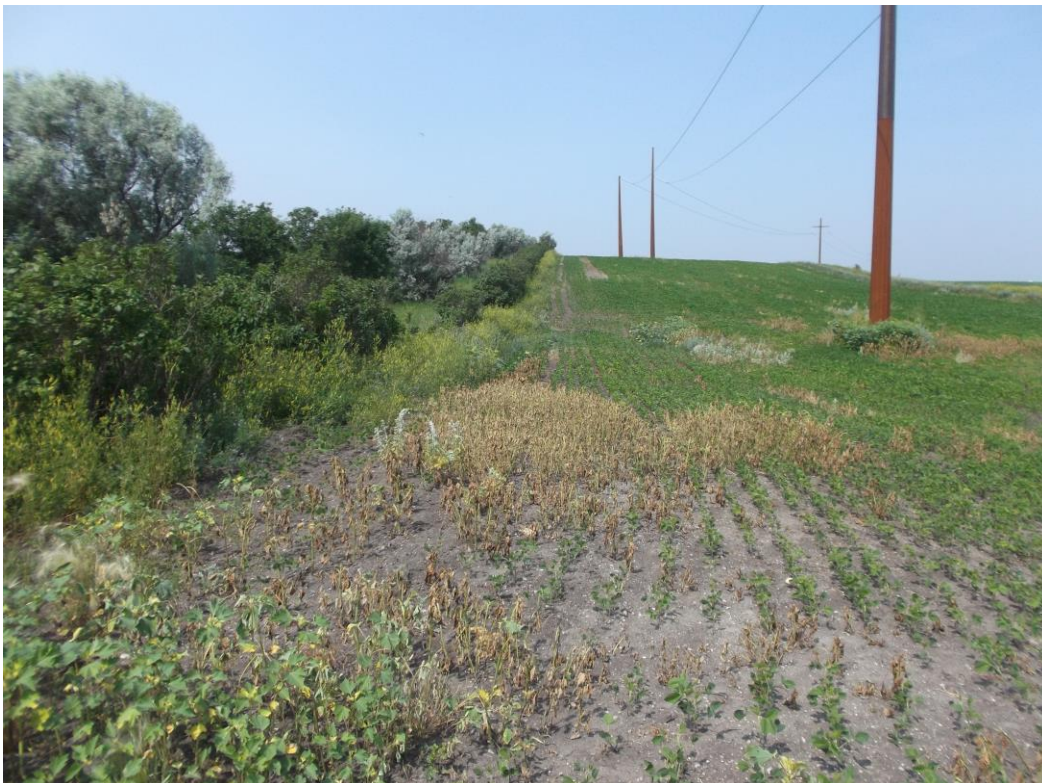
**Below: Photo 10 (Observation Point 13) – Line of trees and shrubs on south side of transmission line. Disturbed areas, possibly used for staging or construction traffic. Looking west.**

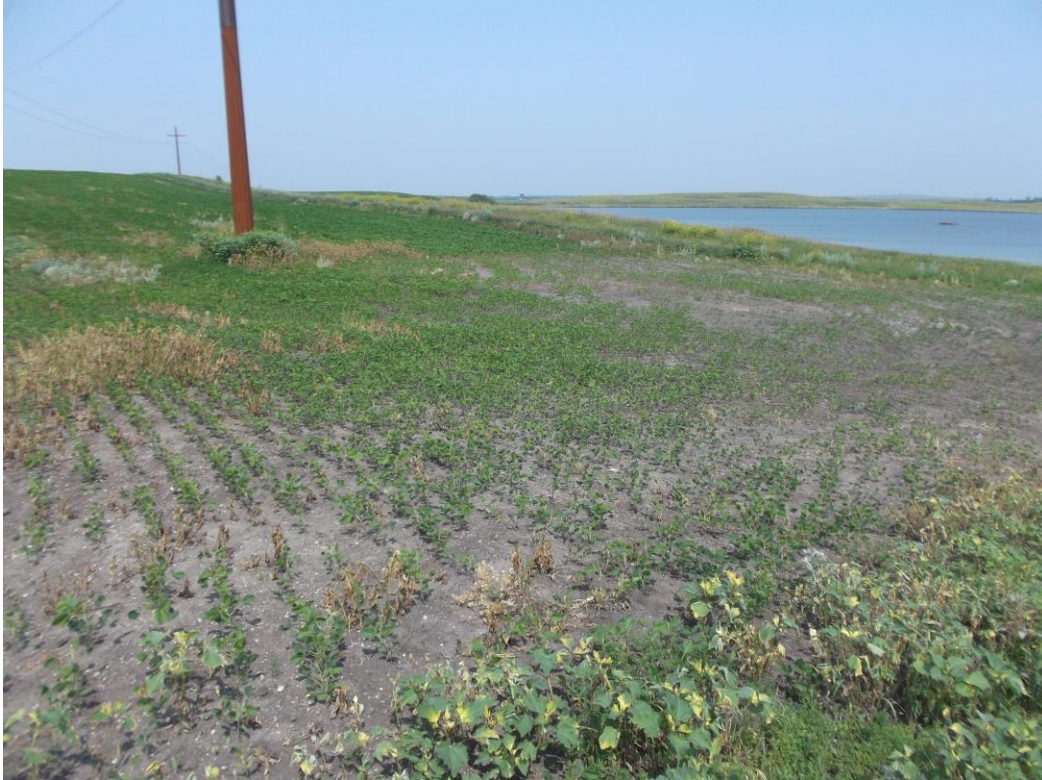
**Above: Photo 11 (Observation Point 13) – Limited crop growth in low area near structure. Looking northwest.**

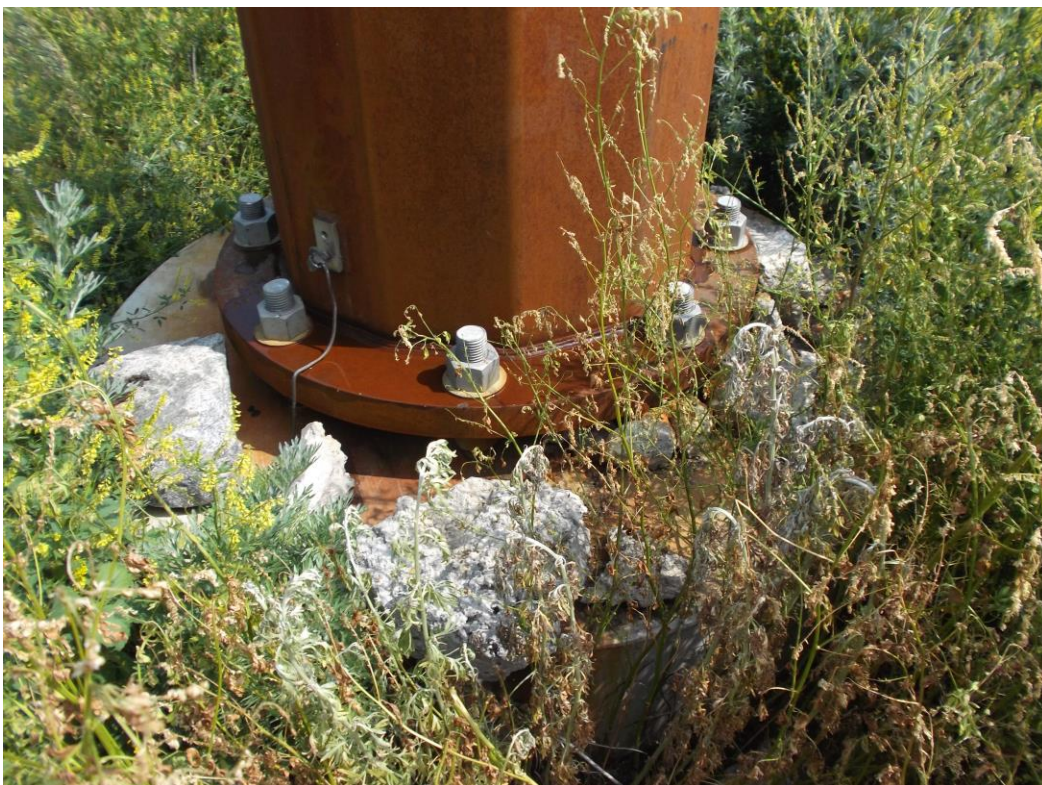
Small chunks of concrete waste were observed around several of the new transmission line structures (see Appendix A, Photo 12 and 14). The rest of the Project area was free of debris and equipment.

**Below: Photo 12 (Structure 0685C) – Rocks and concrete waste set on structure base.**

At the time of the site inspection, several small chunks of concrete waste were observed around the new transmission line structures. Wenck recommends that the PSC request documentation from Minnesota Power when this waste has been removed.

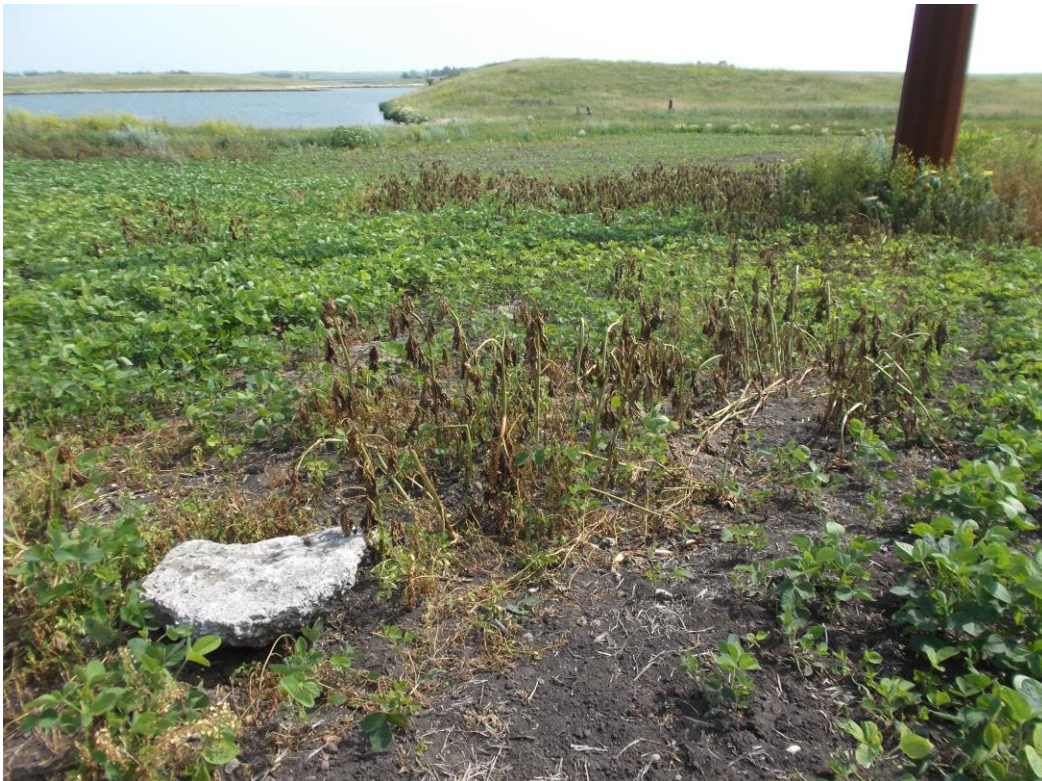
**Below: Photo 14 (Structure 0685C) – Concrete waste near new structure. Looking northeast.**

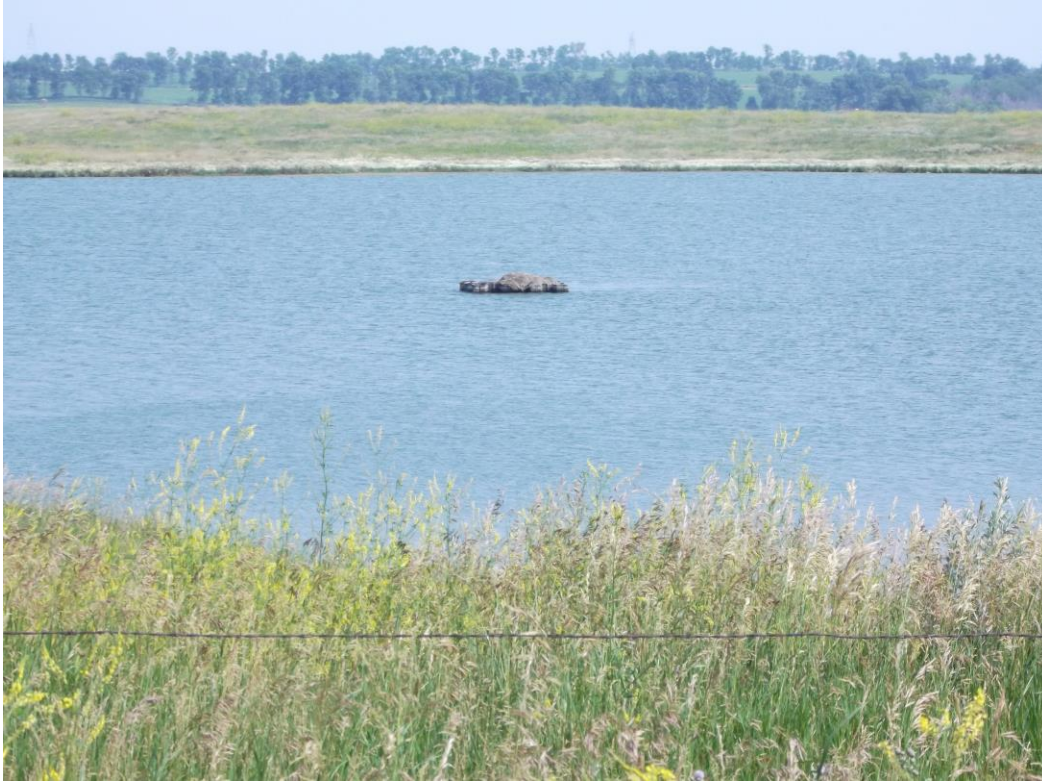
The Project application calls for replacing eight existing structures. Wenck confirmed that the existing structures along the original alignment have been removed. The apparent remains of a structure were observed in the wetland north of the transmission line (see Appendix A, Photo 15). This area was raised about 1-2 feet above the water surface, but it was difficult to see this in detail due to limited access through this wetland area. It's unclear if the structure had been entirely removed, or perhaps it was cut and capped, with the base still present. It is recommended that the PSC verifies that this structure was removed completely. No other evidence of structures along the original alignment was observed,

though with limited access to the wetland area it is possible that other structures were not entirely removed.

Wenck verified during the site inspection that there were no bodies of water located within the new transmission line route. However, surface water was observed in the immediate vicinity of the transmission line (see Appendix A, Photo 15). In addition, surface water was present beneath the transmission line west of the point where the rerouted transmission line joined the original alignment (see Appendix A, Photo 20). The structures in this area appeared to be located in upland areas and were not inundated.

**Above: Photo 15 (Observation Point 14) – Apparent abandoned/removed structure in wetland. Looking north.**

Wenck observed one location where an old structure along the original alignment was abandoned or removed. Due to limited access around the wetland area, it was unclear if this structure was fully removed, or if it was just cut off and abandoned with the foundation remaining. Wenck recommends that the PSC request documentation from Minnesota Power showing that this and any other old structure along the original alignment was fully removed.

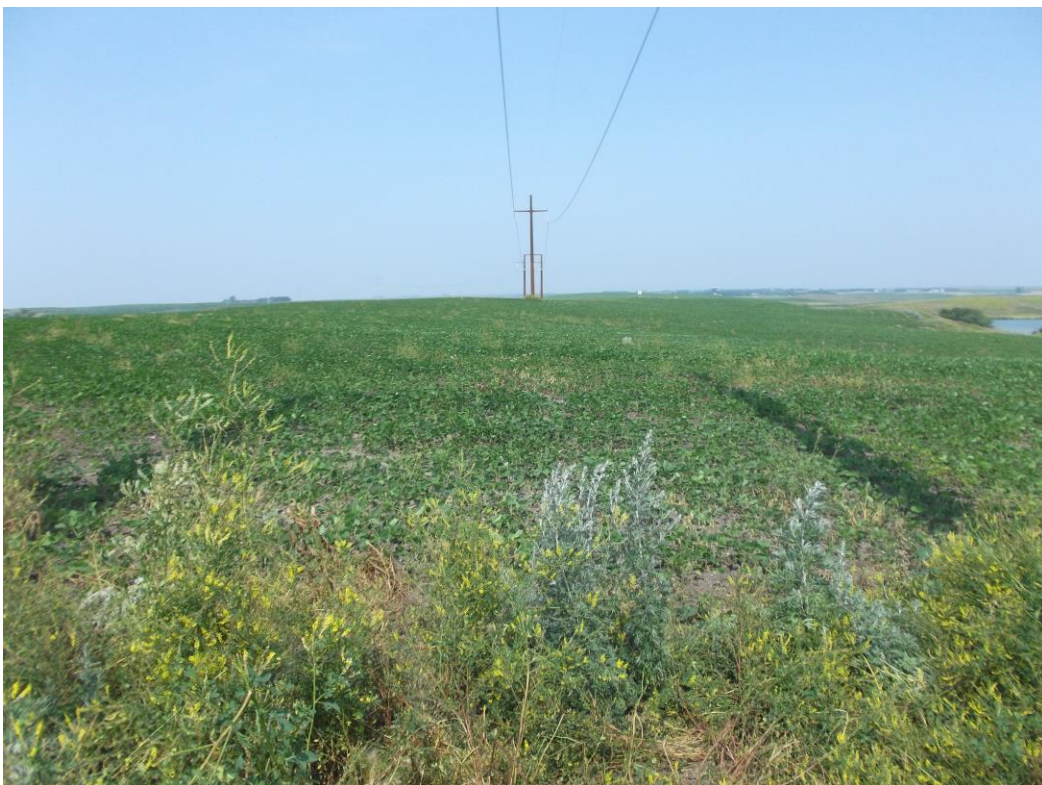
**Below: Photo 16 (Structure 0685B) – Typical vegetation between new structures. Looking northwest.**

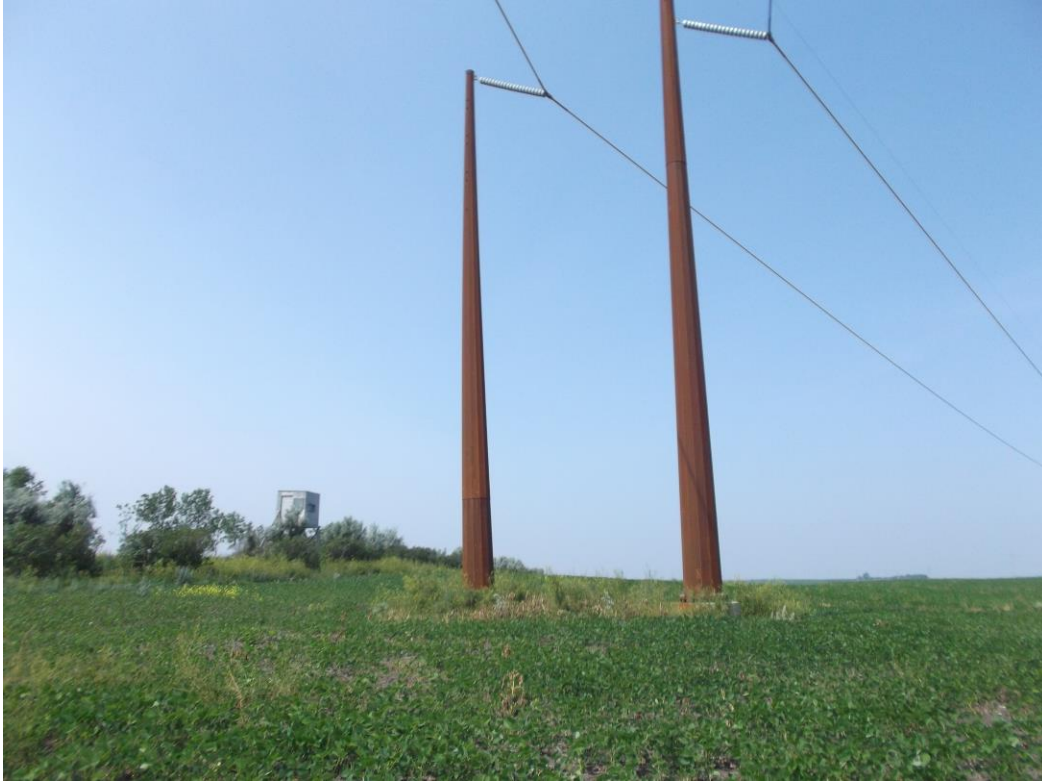
**Above: Photo 17 (Observation Point 15) – Alternate double pole structure at bend. Looking west.**

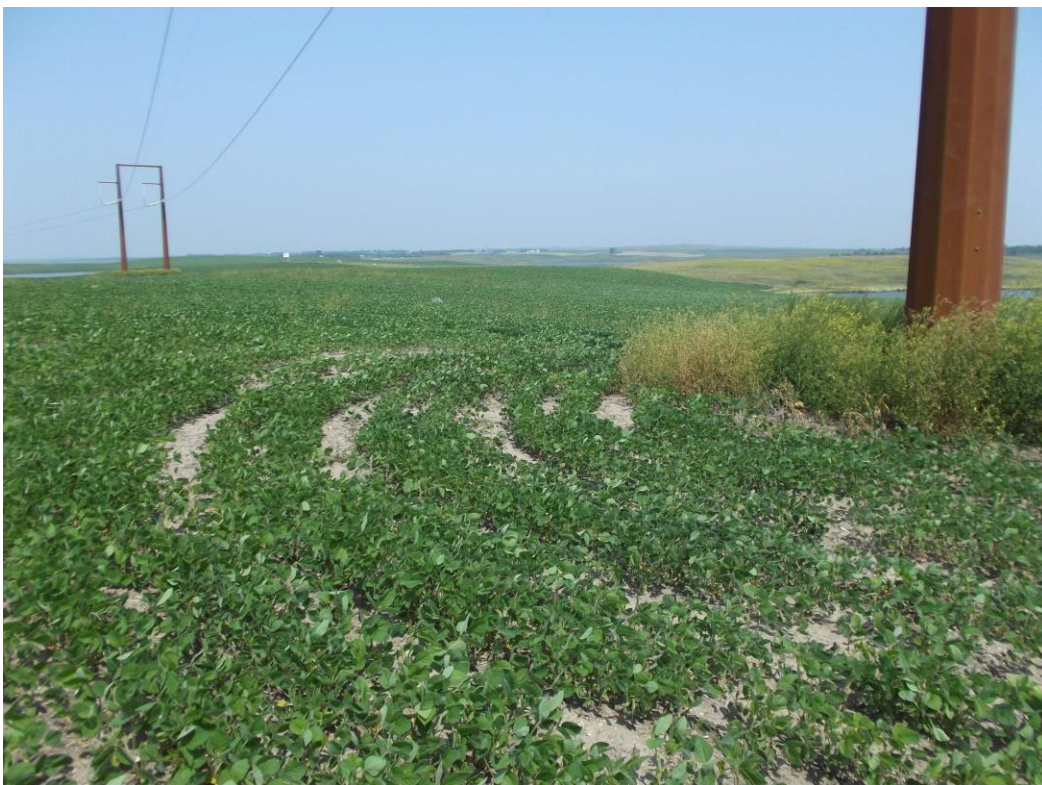
**Below: Photo 18 (Structure 0685A) – Typical vegetation near base of new structure. Looking northwest.**

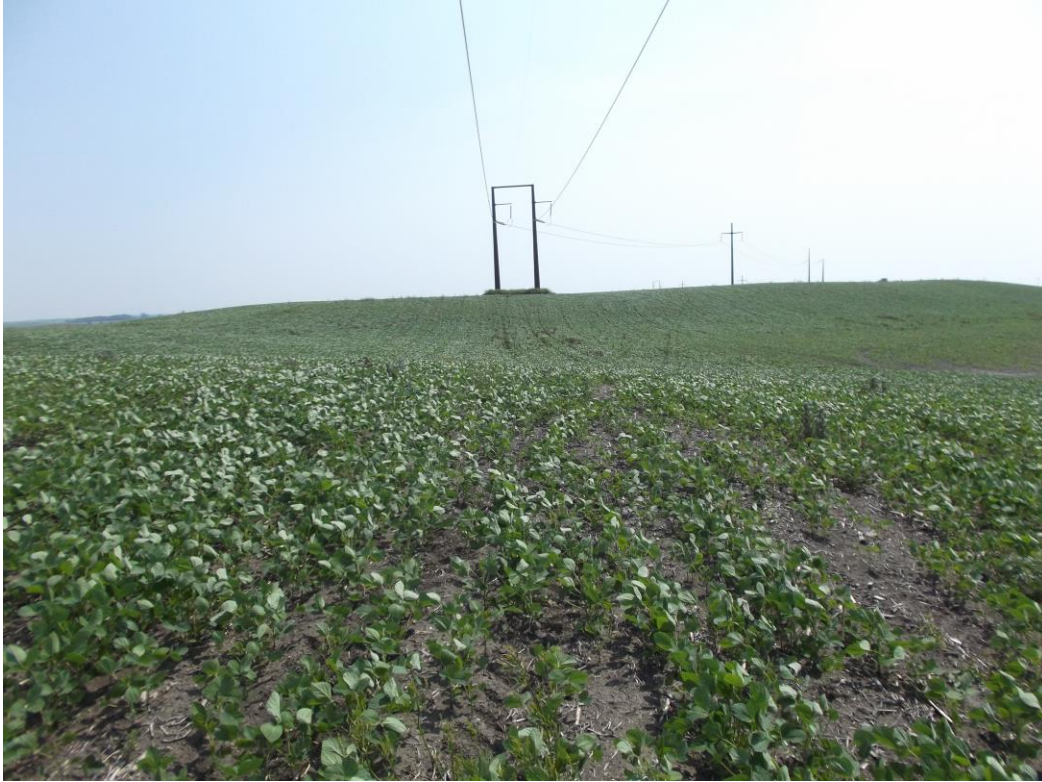
**Above: Photo 19 (Observation Point 18) – Near connection to existing structure at northwest corner of project. Looking east.**

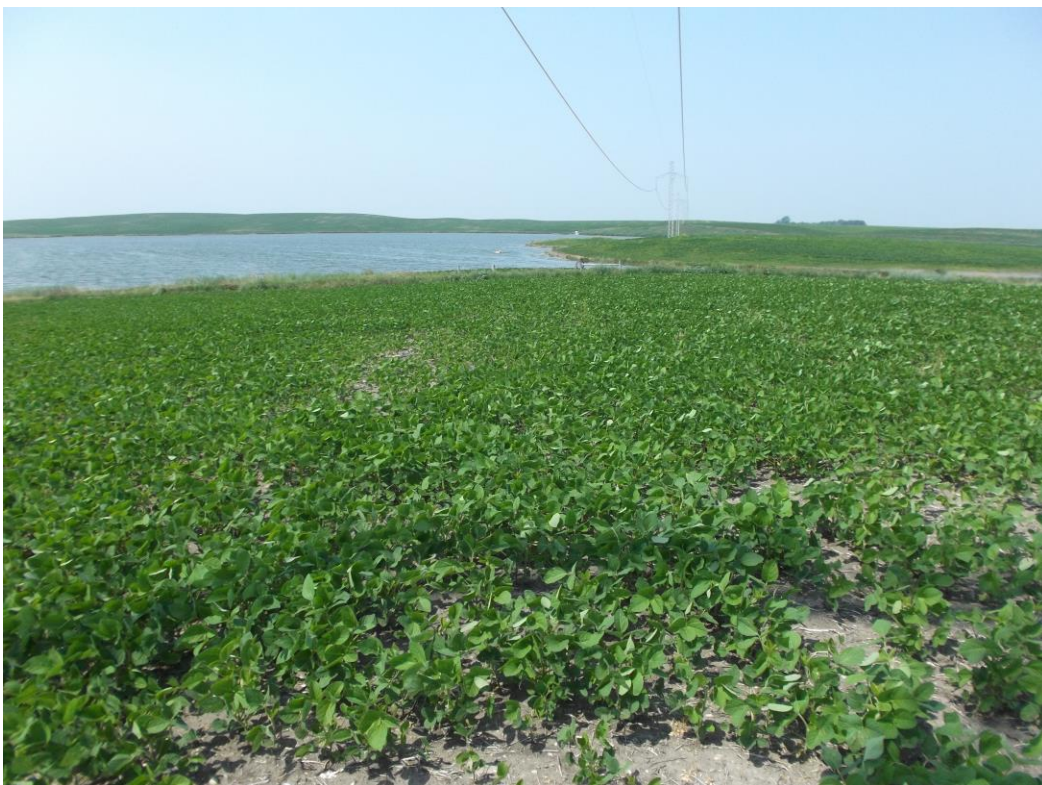
**Below: Photo 20 – Existing transmission line at northwest corner of project. Looking west.**
