Hiland Crude Oil Pipeline Project Post-Construction Inspection Report PU-13-136

Prepared for:
**North Dakota Public Service
Commission**

WENCK Associates, Inc.
301 1st Street NE, Suite 202
Mandan, ND 58554
Phone: 701-751-3370
Fax: 763-479-4242

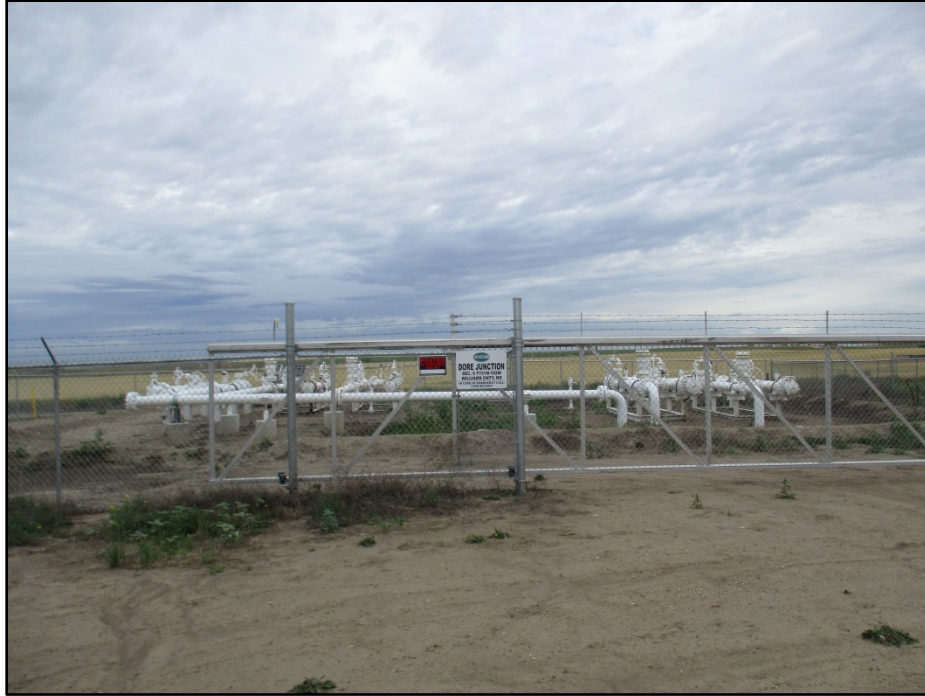
Photo 1. (GPS Point #10) – Dore Junction. Area has signs and is fenced in.

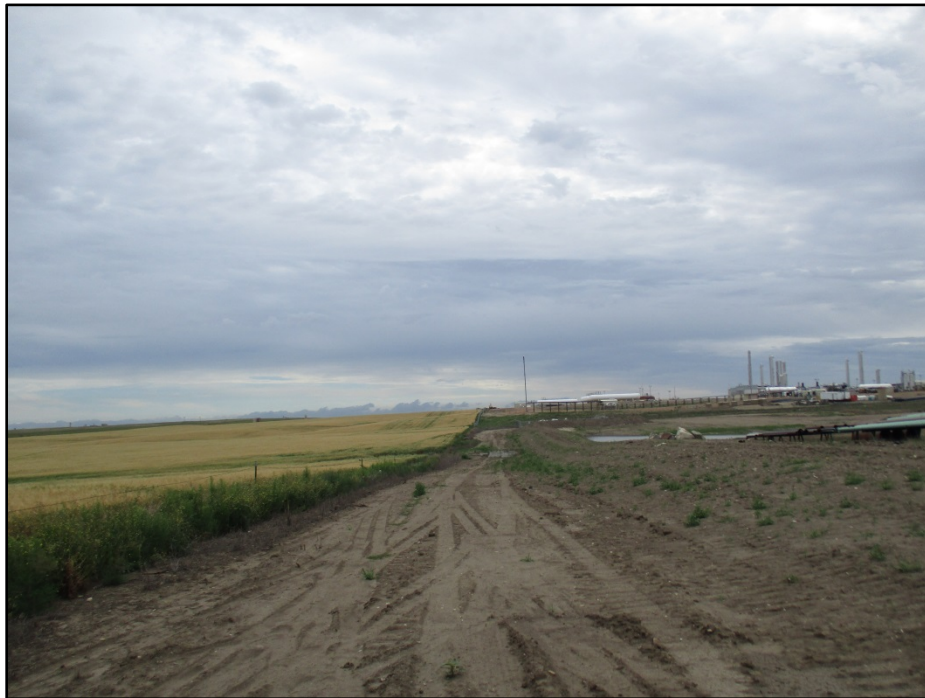
Photo 2. (GPS Point #10) – Dore Junction area. Berm (to the right of photo) was put up to stop stormwater runoff to the adjacent farmer's field.

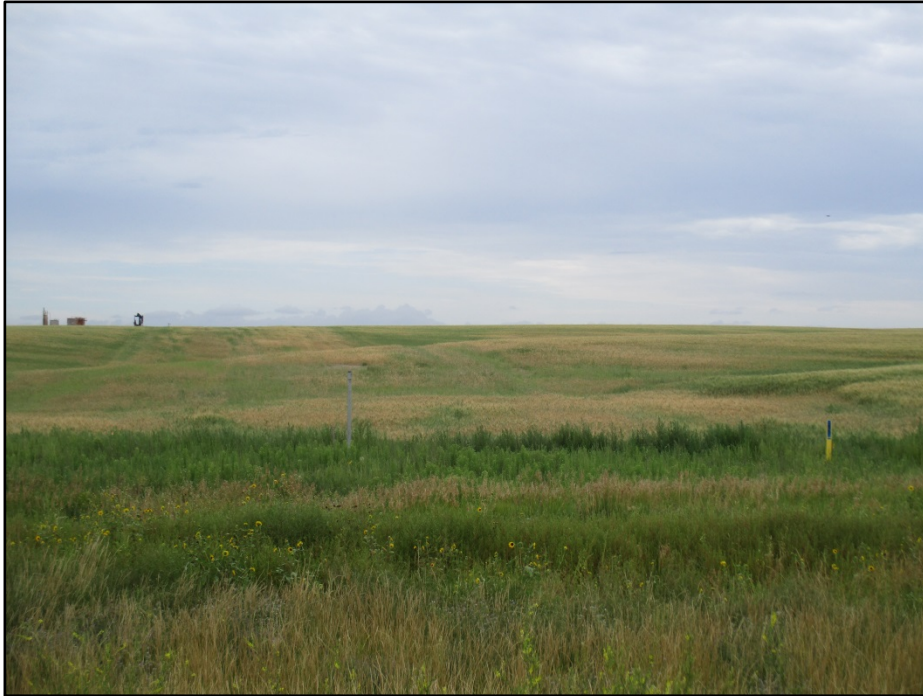
Photo 3. (GPS Point #13) Pipeline ROW through field. Pipeline marker/sign is missing the placard, with only the metal pole standing (in center of photo). Yellow and blue pipeline marker to the right of photo. Good vegetative growth in crop field comparable to adjacent part of field. Direction: East.

Warning signs marking the location of the pipeline had been installed and were in place at fence lines and road crossings (**Appendix A**, Photos 19, 21, 27, 29, 31). There were a few locations that had broken signs. Kinder Morgan indicated that resident/landowner concerns and issues are handled promptly and makes every reasonable attempt to alleviate problems caused by the Project. Ryan Dahl (Kinder Morgan- Senior ROW Agent) is the company representative responsible to receive and resolve any landowner issues (Docket #91, Preconstruction meeting minutes). Hiland Crude, LLC's emergency response plan was filed in this docket on 15 July 2014 (Docket #30. Late-filed exhibit 4).

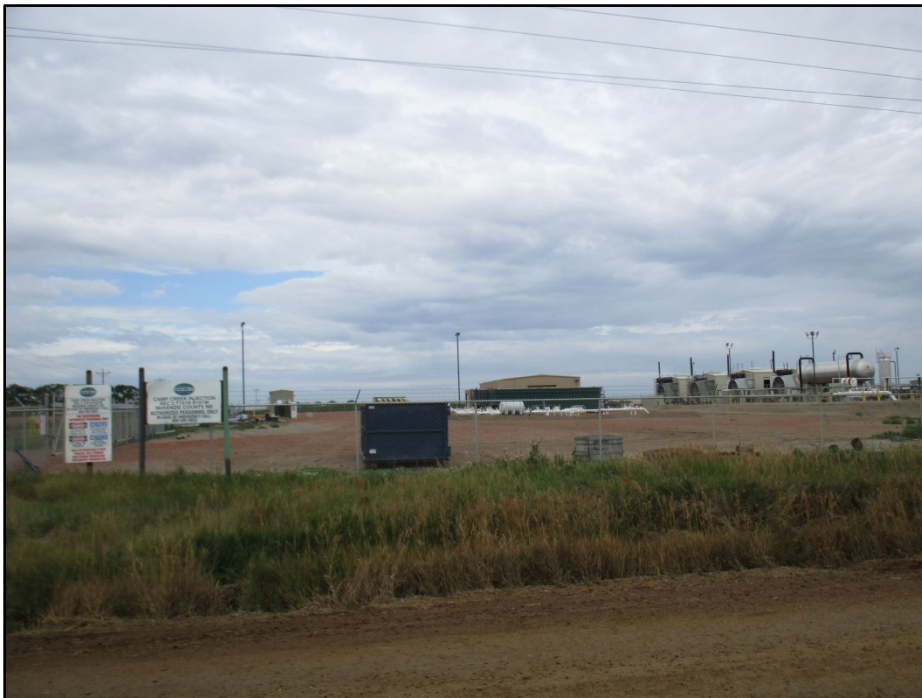
Photo 4. (GPS Point #14) – West Camp Creek Injection Station. Area is fenced and has signs. Direction: West.

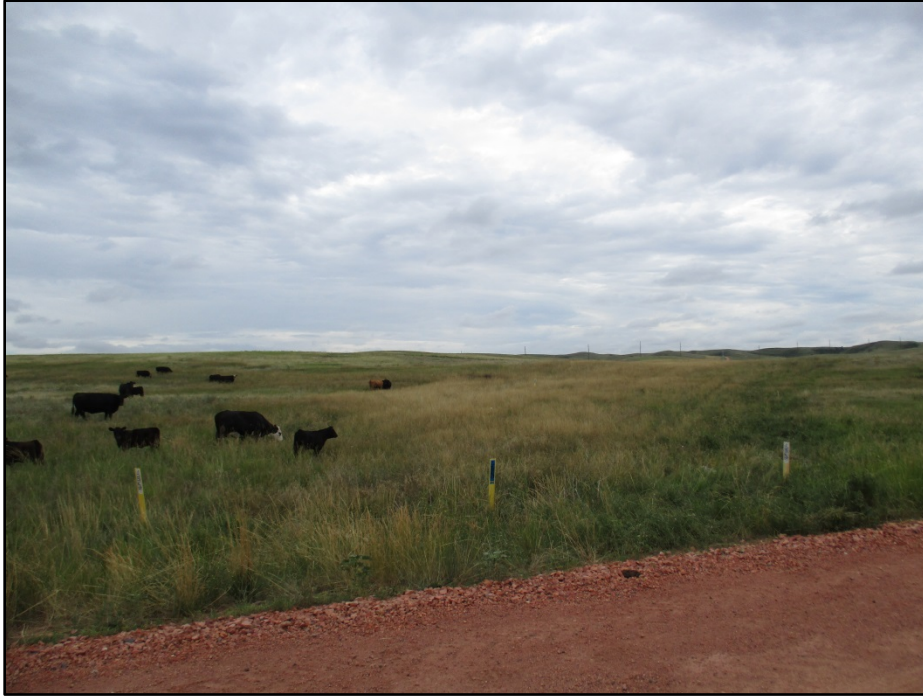
Photo 5. (GPS Point #16) – Cattle grazing in pasture. Pipeline ROW goes through pasture. Area has markers. Direction: Southeast.

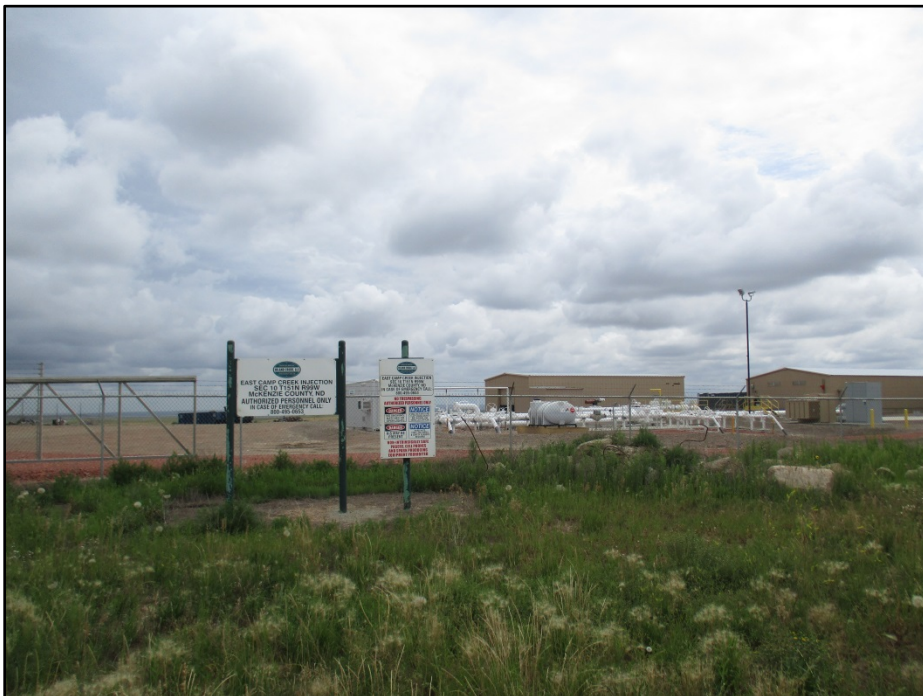
Photo 6. (GPS Point #17) – East Camp Creek Injection Station. Area is fenced and has signs. Direction: East.

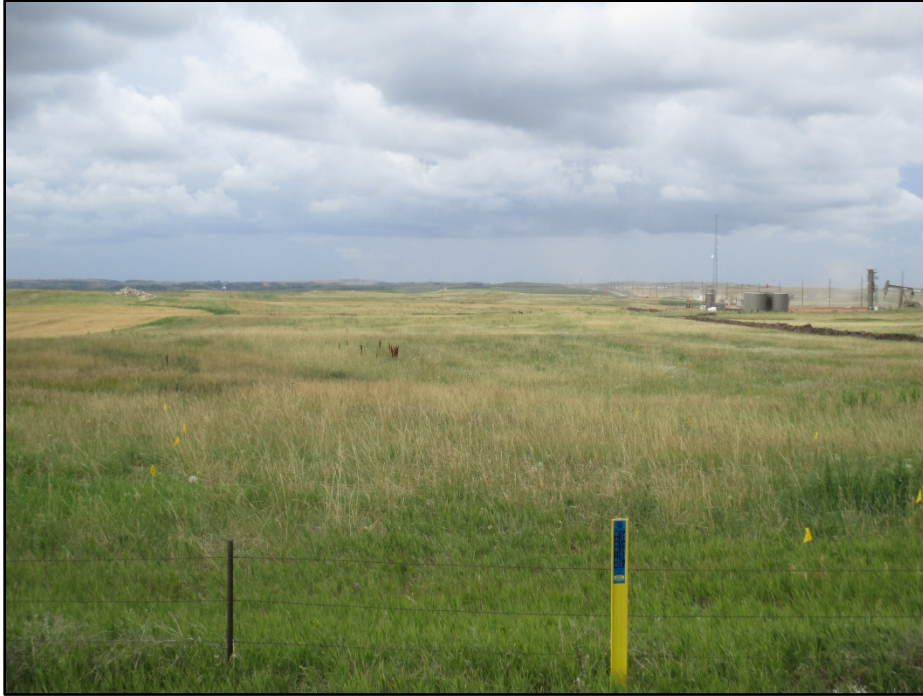
Photo 7. (GPS Point #17) – Area across from East Camp Creek Injection Station. Pipeline markers and flags in the ROW, flags due to nearby construction (seen to the right of photo). Direction: West.

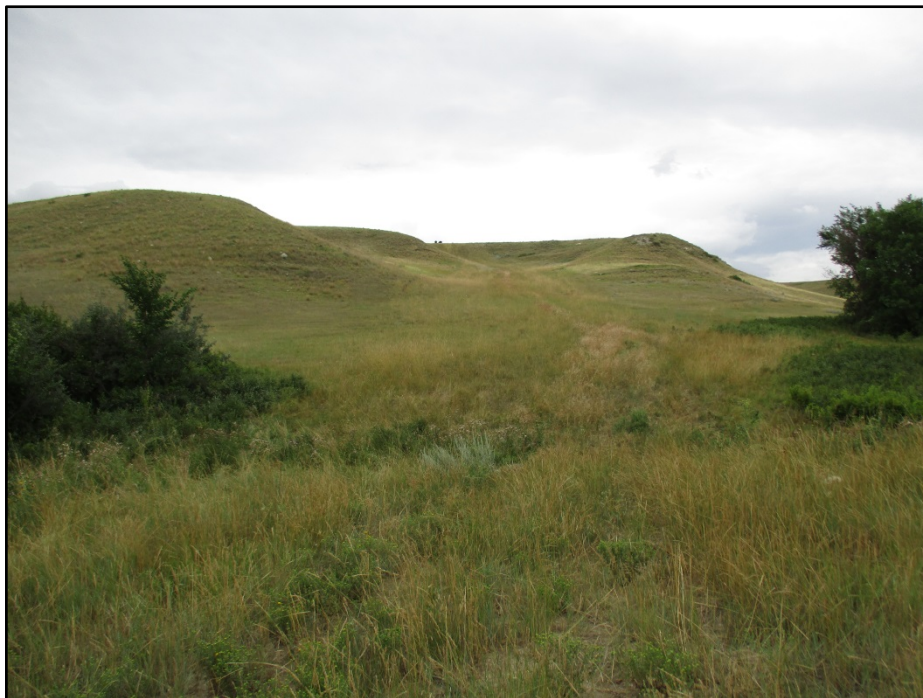
Photo 8. (GPS Point #21) – ROW through pasture that is being grazed. Cows on hill top. Hillslope area was reclaimed. Topsoil was brought in to the area (hillslope) in 2014 and re-seeding in spring of 2015. Contouring appears to match slopes well. Direction: North.

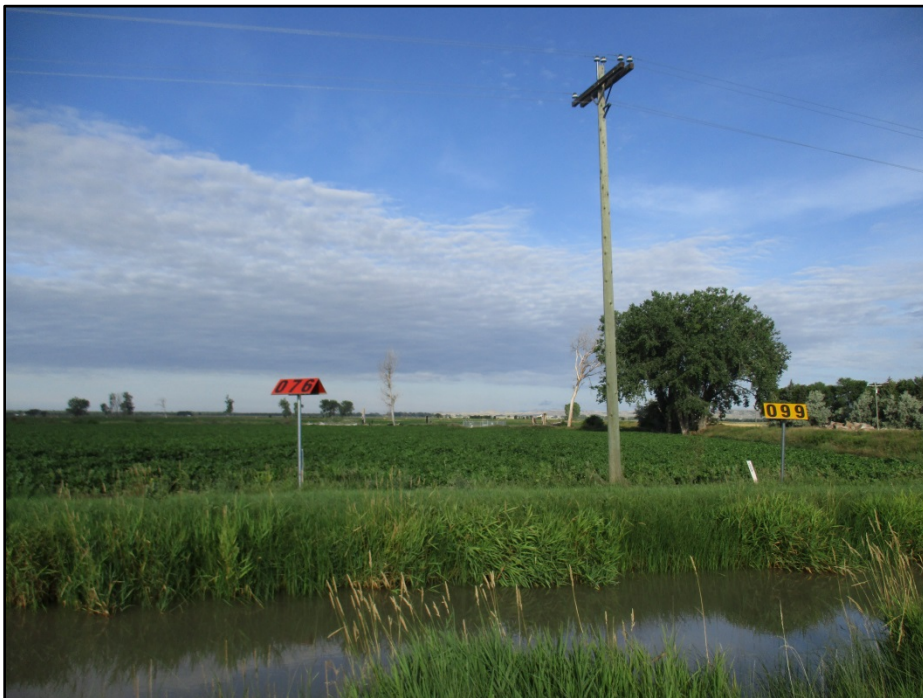
Photo 10. (GPS Point #23) – ROW bored under canal. Area is just west of river crossing. Valve station is fenced in the background. Direction: West.

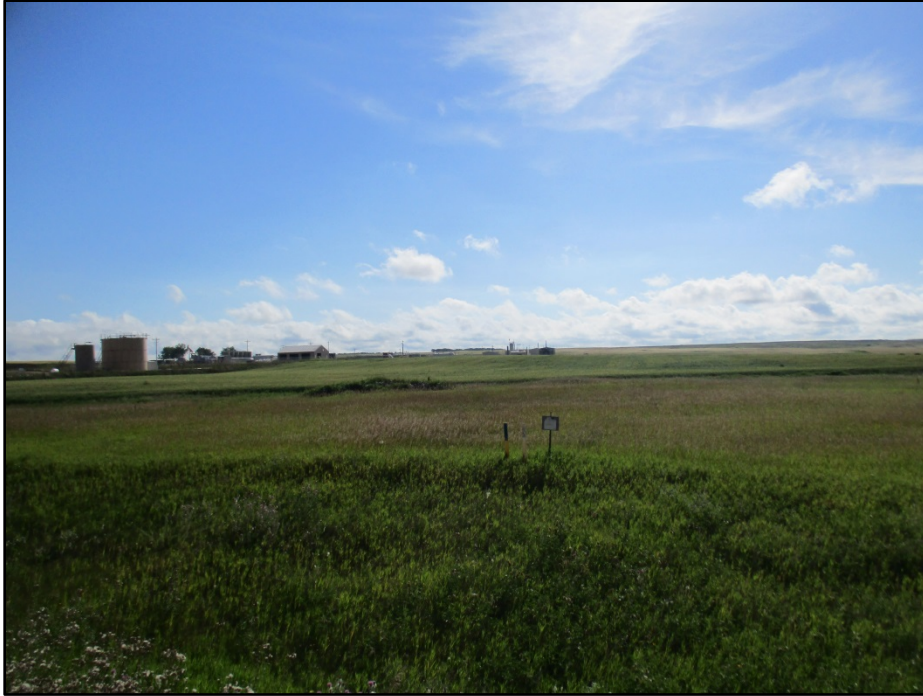
Photo 11. (GPS Point #27) – Pipeline marker off of road. ROW going through agricultural field. Direction: East.

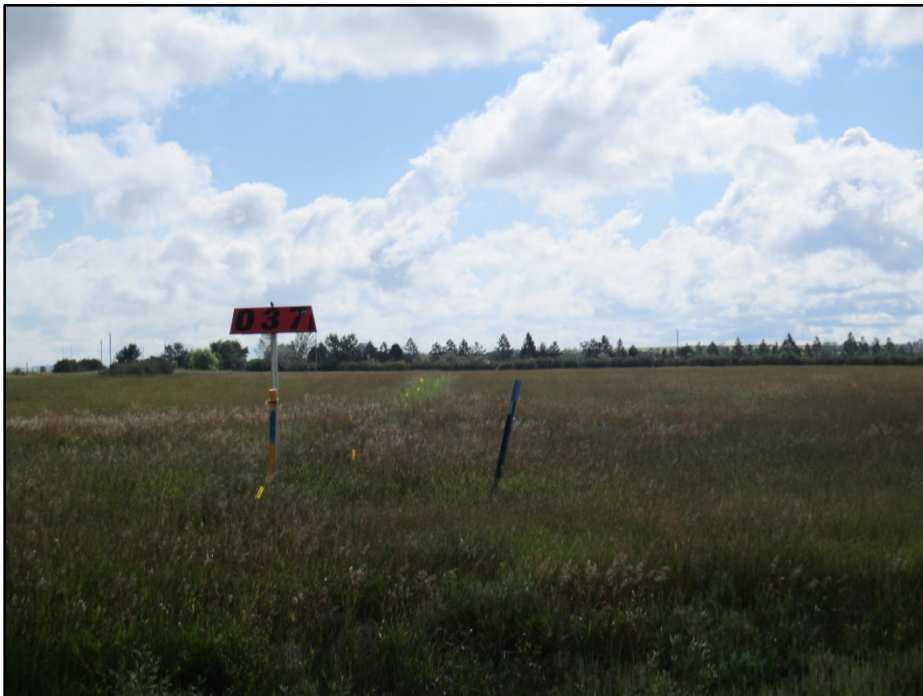
Photo 12. (GPS Point #28) – Pipeline ROW is flagged through field; there are also signs just off the road. Notice the color change in vegetation at the pipeline centerline. Direction: East.

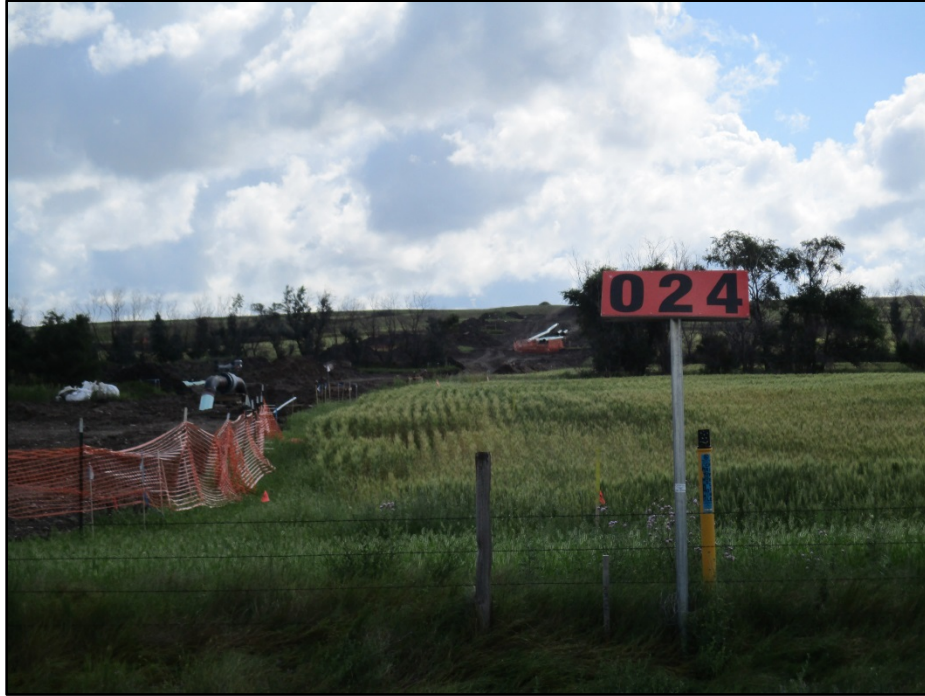
Photo 13. (GPS Point #30) – Pipeline ROW in crop land. Construction of a different pipeline is to the left of photo, paralleling part of Hiland’s Market Center pipeline. Direction: East.

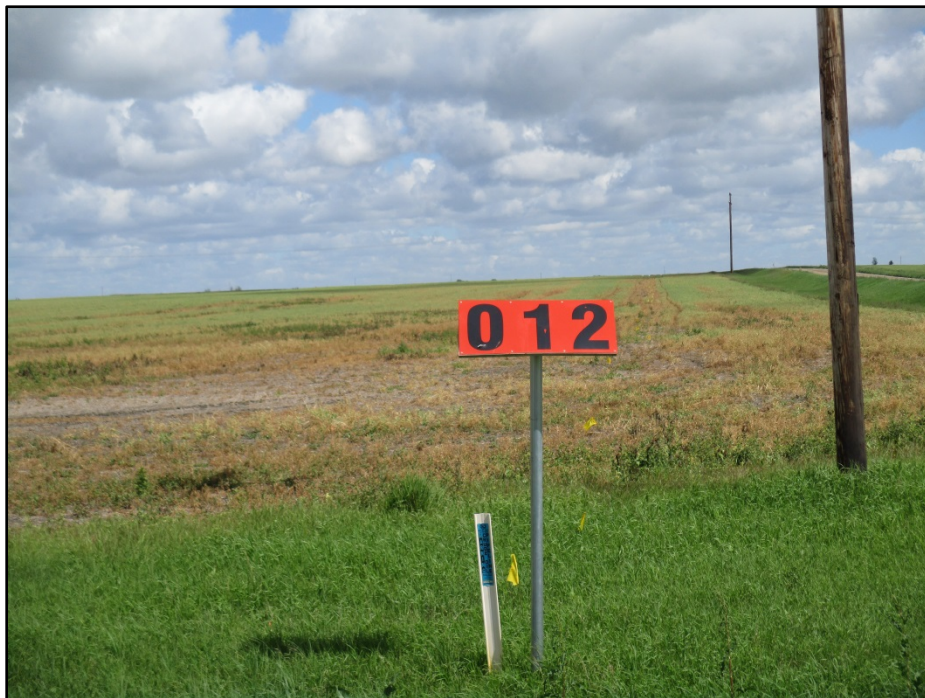
Photo 14. (GPS Point #33) – Pipeline ROW in Crop land. Pin flags and signs are marking the line. Direction: North.

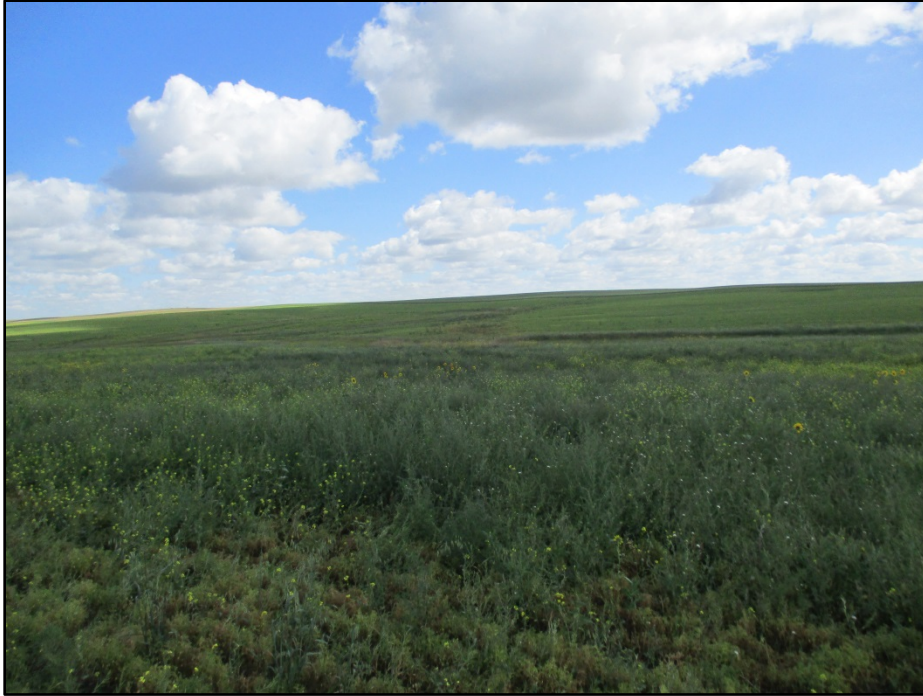
Photo 15. (GPS Point #34) – Pipeline ROW goes through crop field (center of photo, then turns left), can still see pipeline scar in background. Some annual weeds throughout ROW. This area was a re-route. Direction: Northwest.

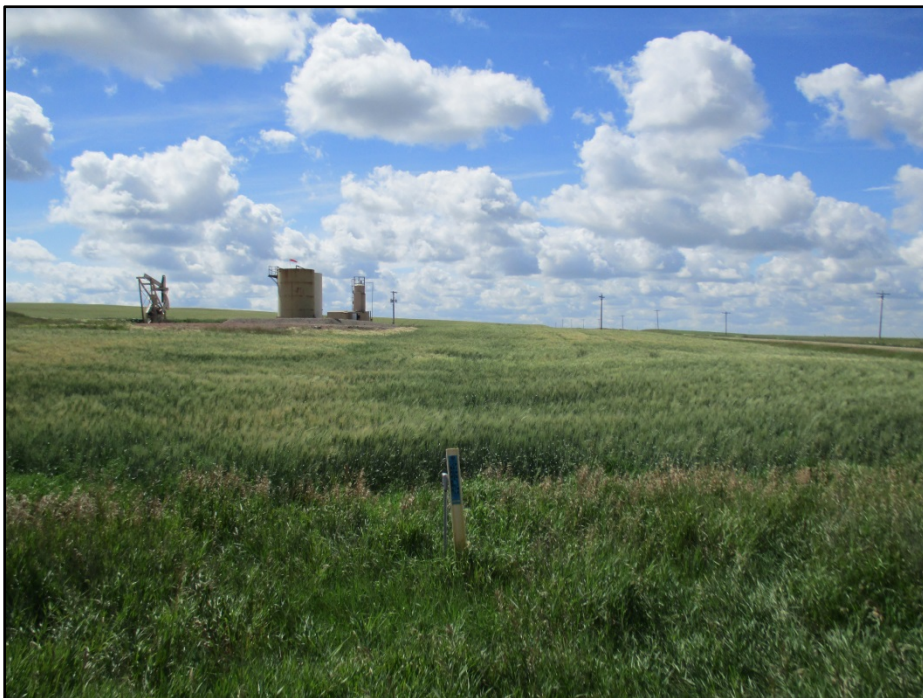
Photo 16. (GPS Point #36) – Pipeline ROW, goes through a crop field. Direction: South.

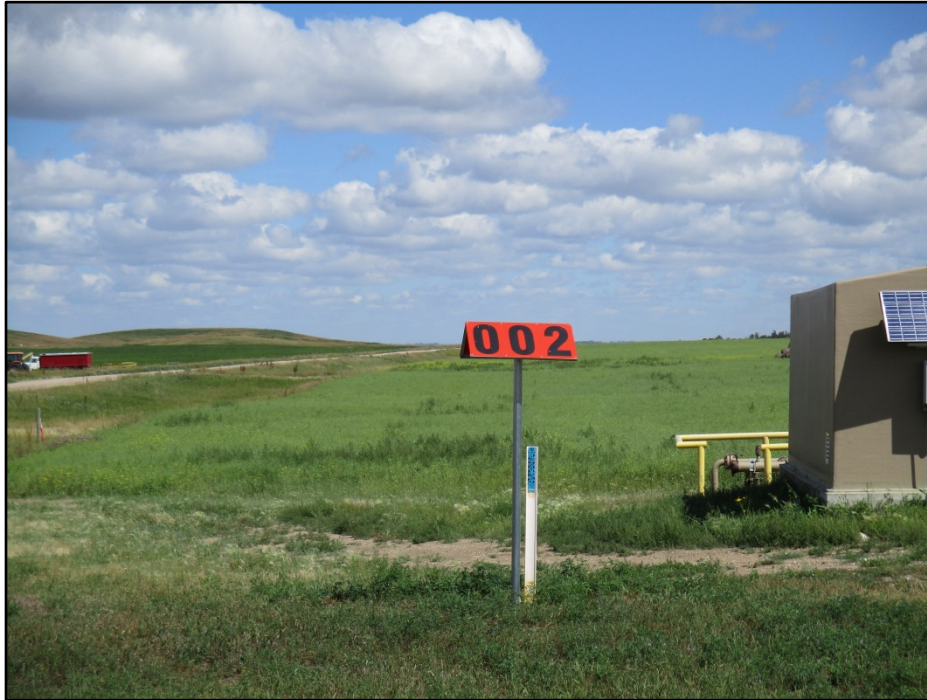
Photo 17. (GPS Point #36) – Pipeline ROW going though field. Direction: North.

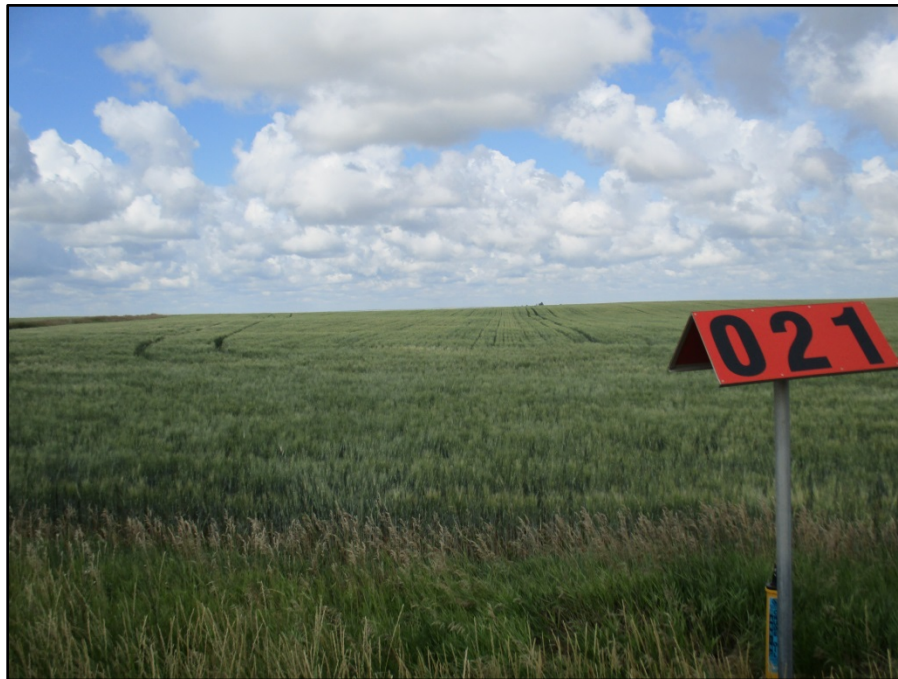
Photo 18. (GPS Point #31) – Pipeline ROW going through crop field. Area looks good.

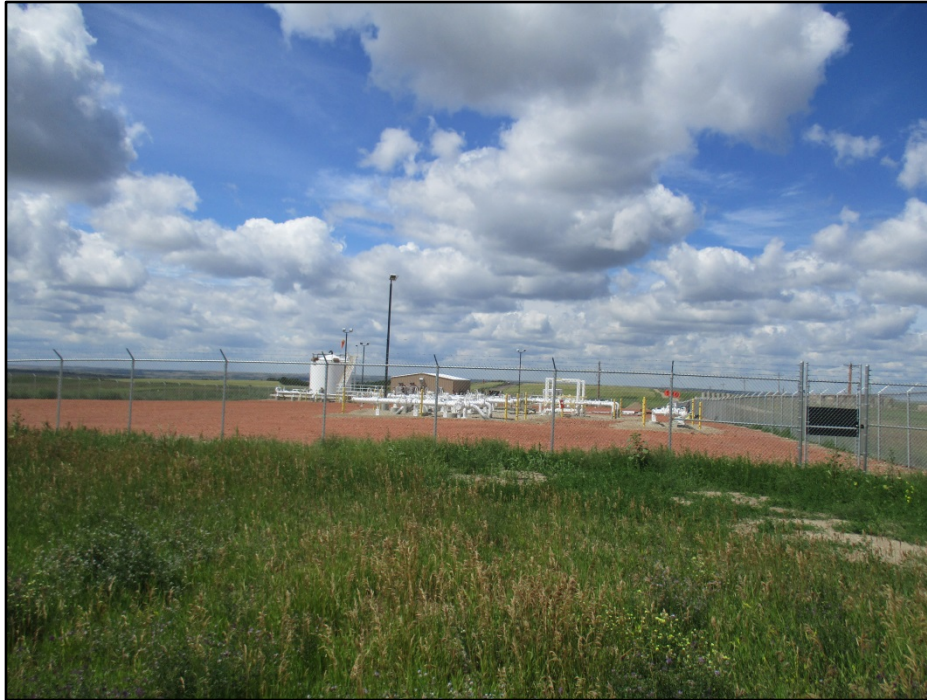
Photo 19. (GPS Point #37) – White Earth Booster Station. Direction: West.

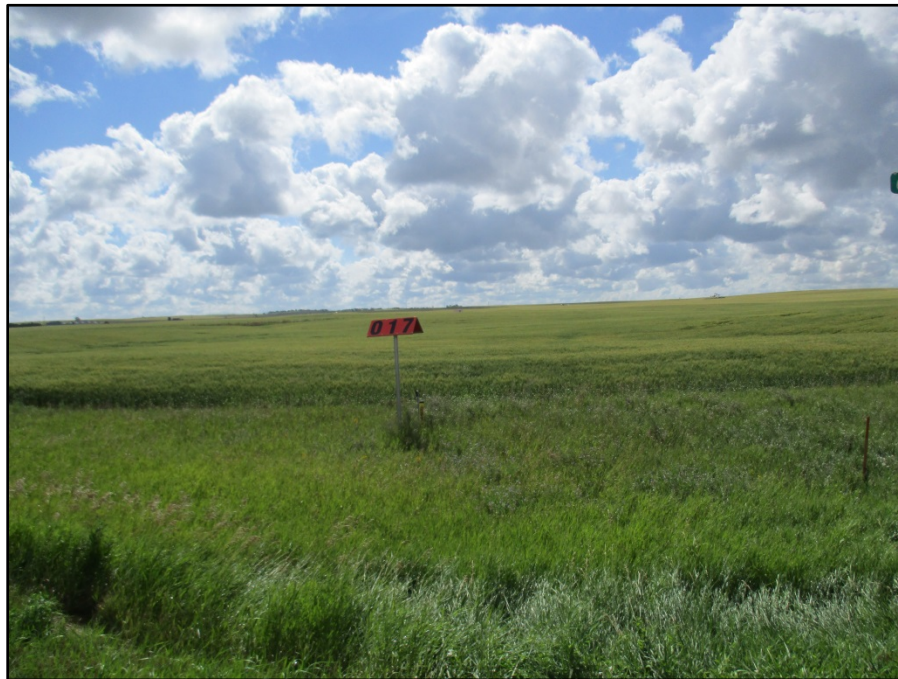
Photo 20. (GPS Point #32) – Pipeline ROW through a crop field. Crop field vegetation looks good. Some thistle was observed in the road ditch and up to the field edge.

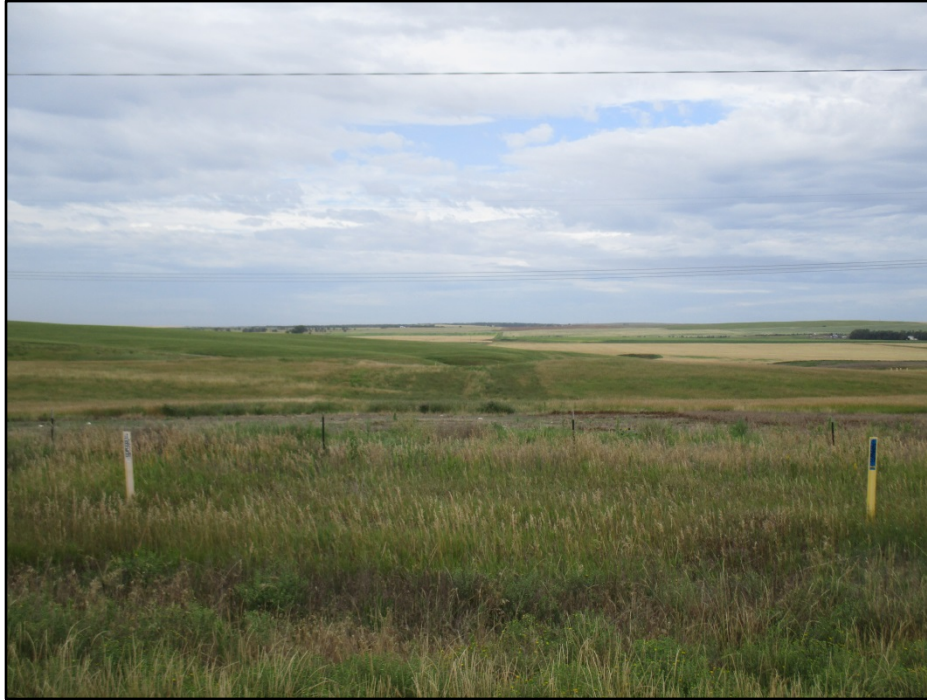
Photo 21. (GPS Point #13) – ROW through grassland. Can still see scar (vertical). Unsure what horizontal bare spot near barbed wire fence is from, possibly from other pipeline or water line. Direction: East.

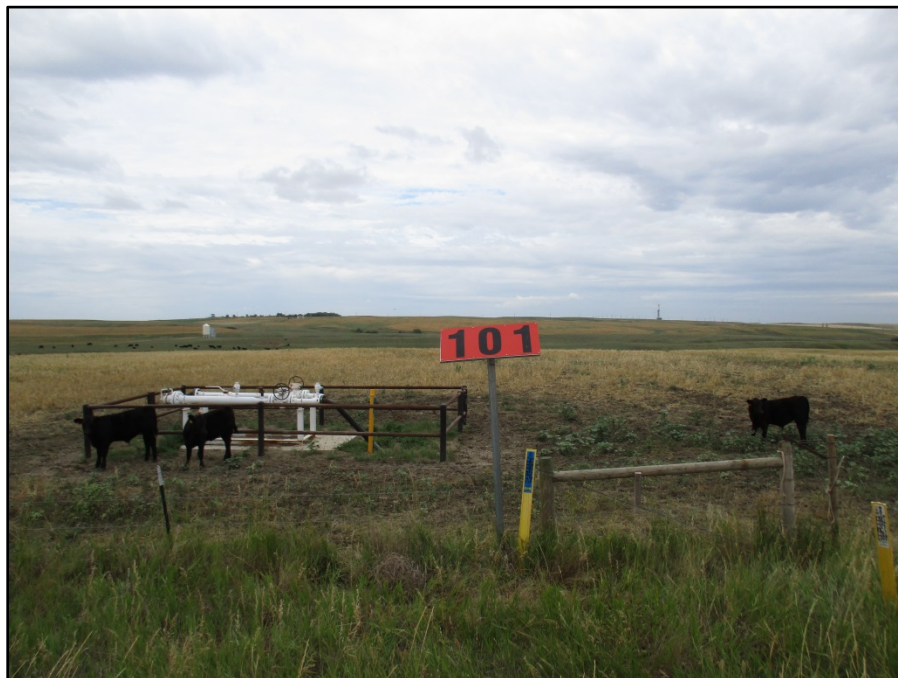
Photo 22. (GPS Point #16) – Pipeline ROW through pasture land. Cattle near block valve. Direction: West

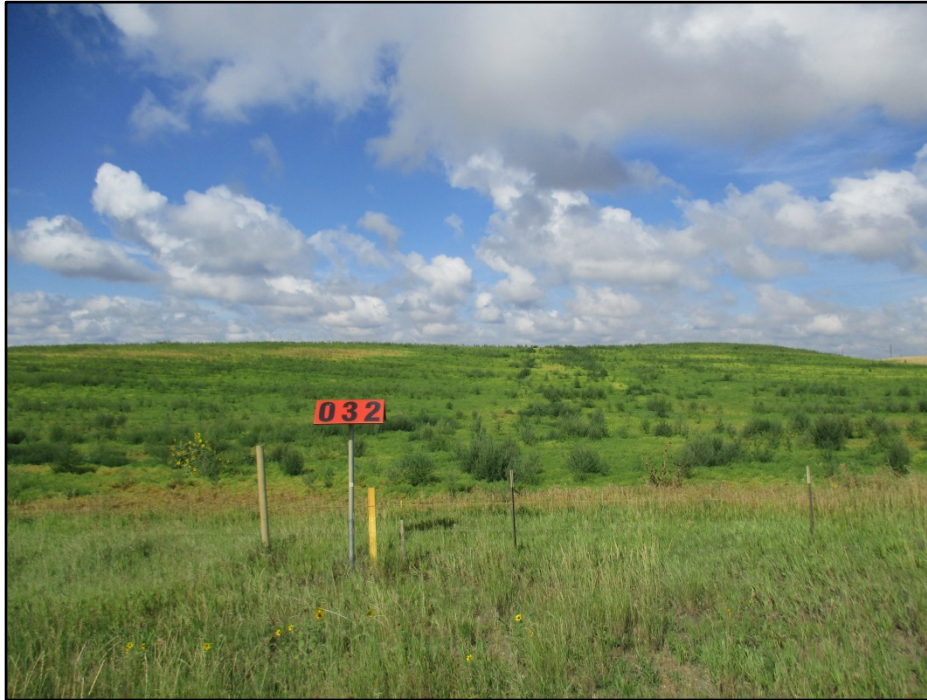
Photo 23. (GPS Point #29) – ROW through field. Some weeds observed throughout the field. Direction: West.

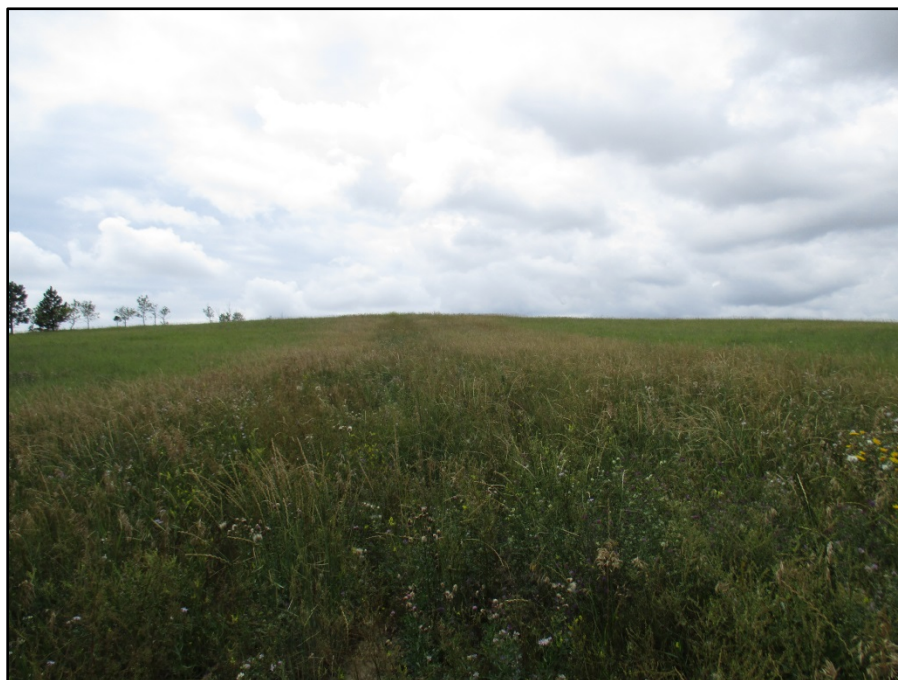
Photo 24. (GPS Point #20) – Pipeline ROW through grassland, can still see scar. Some weeds throughout ROW. Direction: West
