# Dakota Prairie Refinery Post-Construction Inspection Report PU-13-799

*Prepared for:*  
**North Dakota Public Service  
Commission**

**WENCK Associates, Inc.**  
301 1<sup>st</sup> Street NE, Suite 202  
Mandan, ND 58554  
Phone: 701-751-3370  
Fax: 701-751-3372

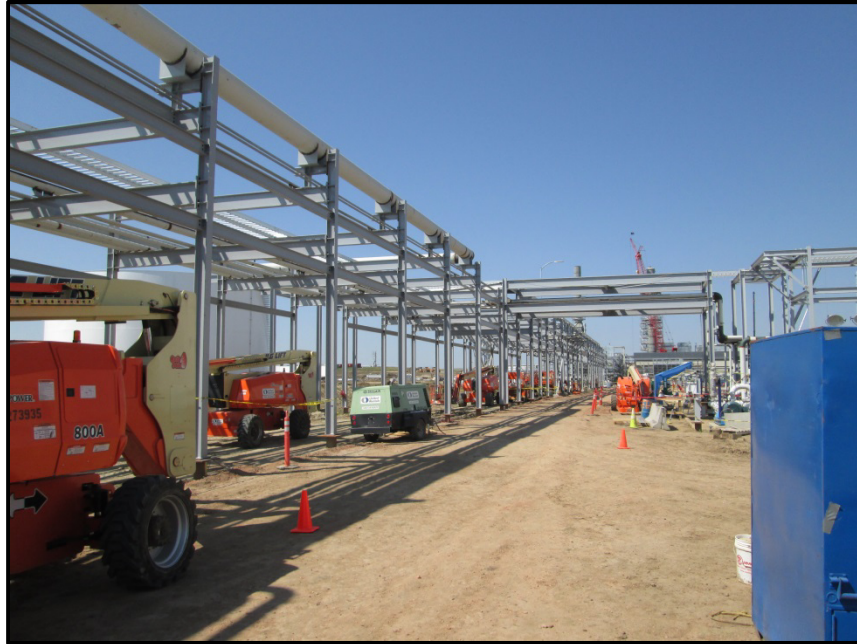
**Photo 1.** Direction: Northwest. Pipeline leaving the Dakota Prairie Refinery and under construction in the photo.

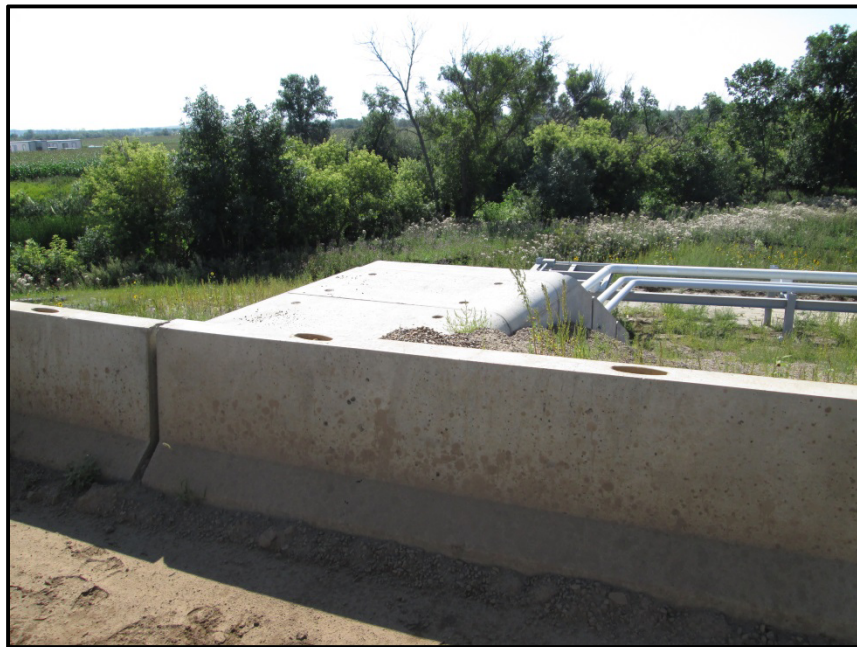
**Photo 2.** Direction: Southeast. Pipeline entering underground box culvert beneath the facility access road and running parallel to the Heart River.

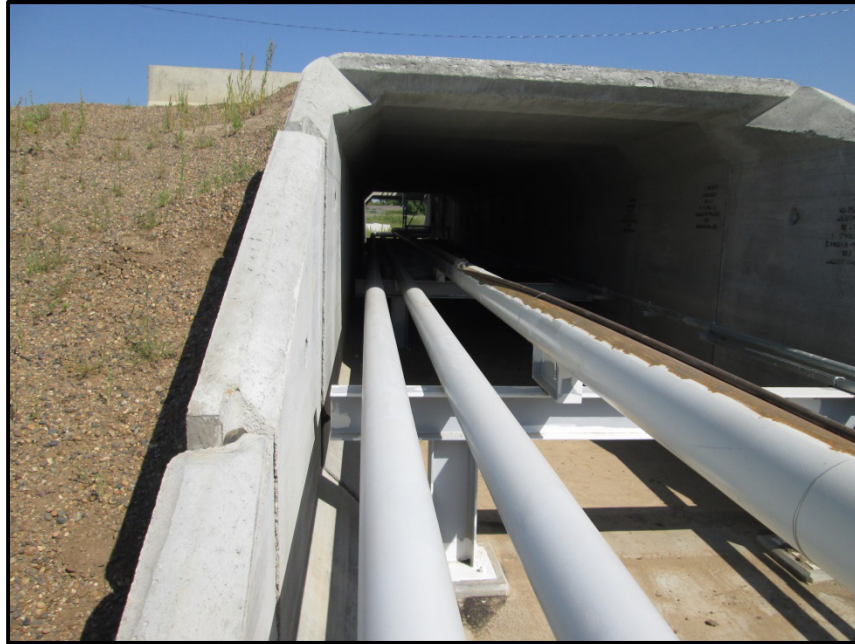
**Photo 3.** Direction: North. View of the pipeline section that runs through the box culvert underneath the facility access road. Preventative spill/leak containment measures taken are depicted in the photo above as well.

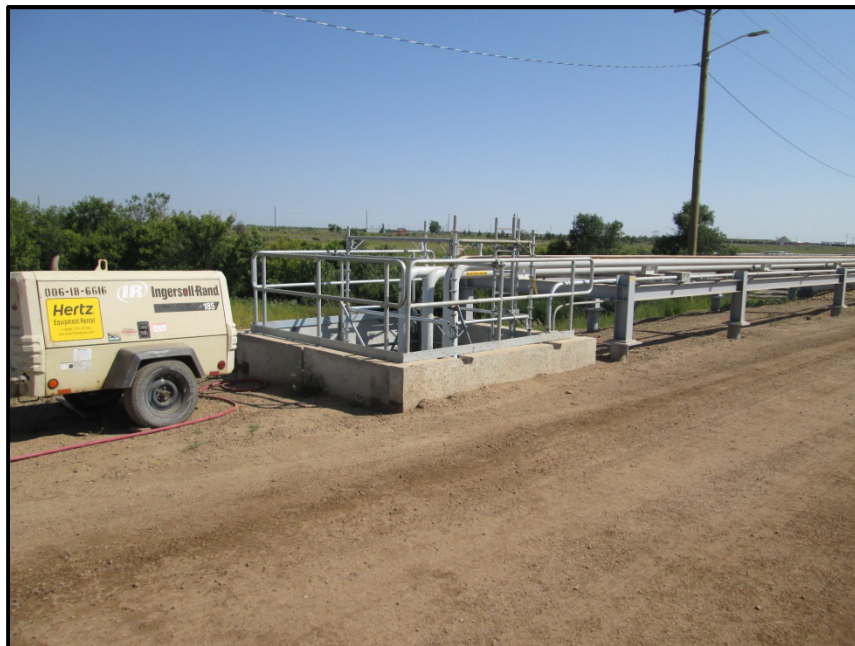
**Photo 4.** Direction: Northeast. Vertical entrance point of pipeline where it bends south, parallel to the Heart River and underneath the facility access road.

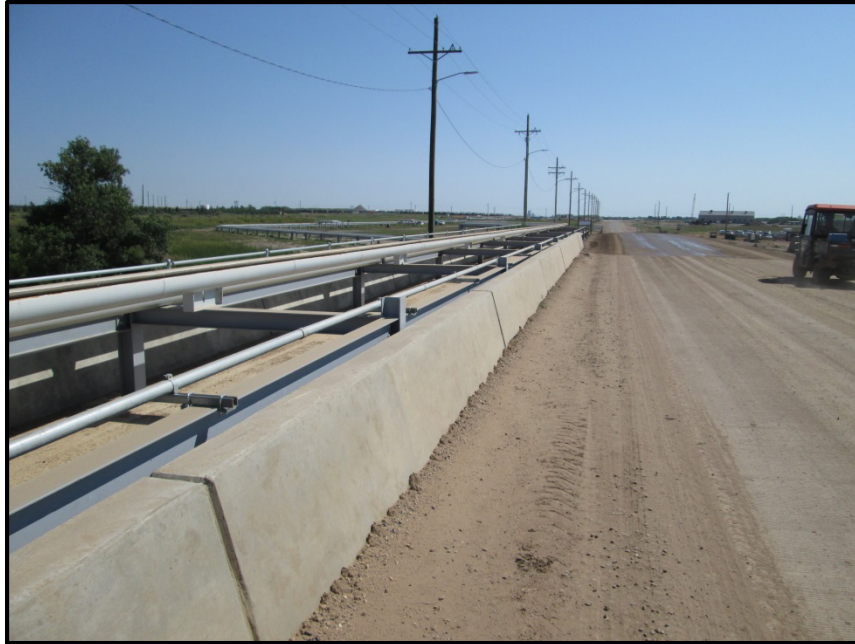
or cutting into an existing roadway. Roads accessing the site appeared to be in a condition typical for the area, and do not appear to have been negatively impacted by construction traffic (Appendix A, Photos 5, 11). Evidence of new roads or temporary roads was not observed during the site inspection.

**Photo 5.** Direction: East. Pipeline running east and west, crossing the Heart River along a bridge. While installing the pipeline damage was done to the bridge or roadway as depicted above.

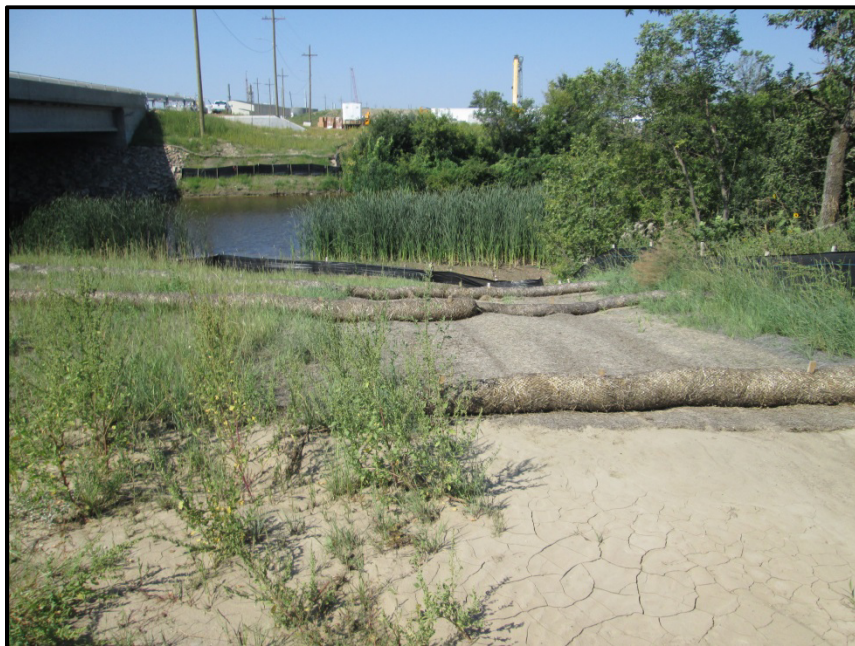
The Project Application states that BMPs would be utilized during construction to minimize the potential for sedimentation and erosion control. No erosion or sedimentation issues were observed during the site inspection (Appendix A, Photo 6).

**Photo 6.** Direction: East. Erosion control measures and BMP's (Best Management Practices) in place along bridge and pipeline crossing the Heart River.

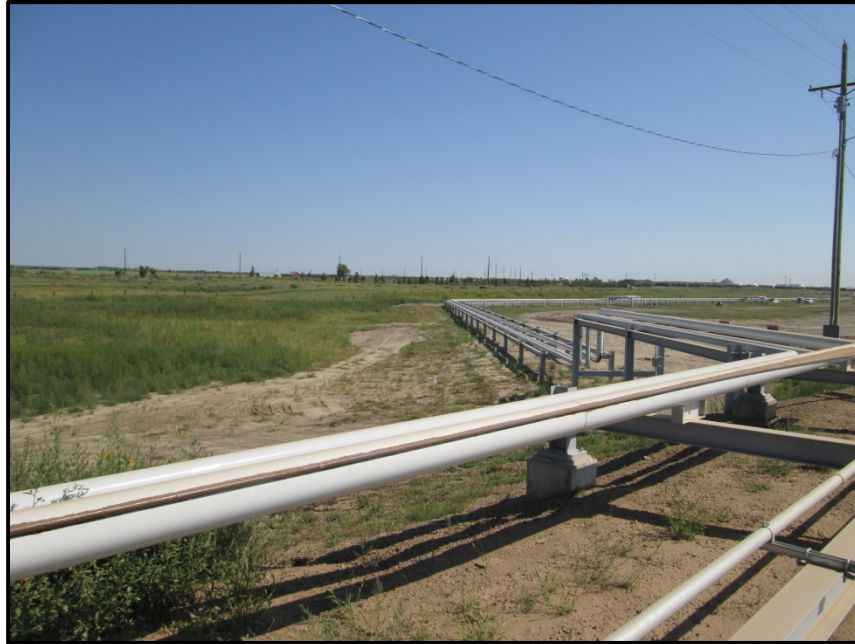
**Photo 7.** Direction: Northeast. Pictured above is the pipeline bending to the northeast, where it will continue to run north of the facility access road. Also pictured is the corridor where no permanent impacts to the ROW can be seen.

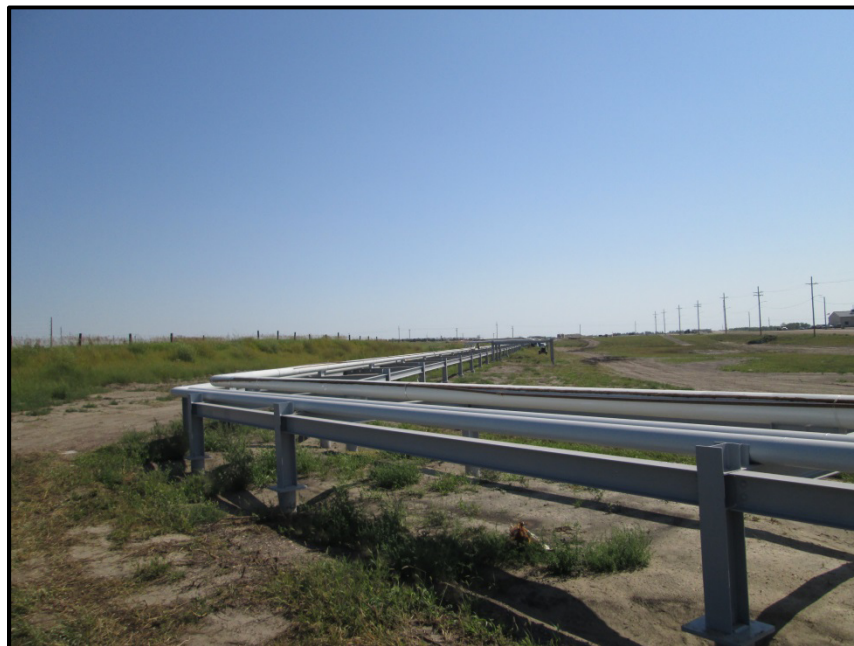
**Photo 8.** Direction: East. Pictured above is the pipeline bending back to the east to run parallel to the rail road tracks and facility access road and approaching 116<sup>th</sup> Ave SW from the west. Pictured also is no permanent impacts to the ROW.

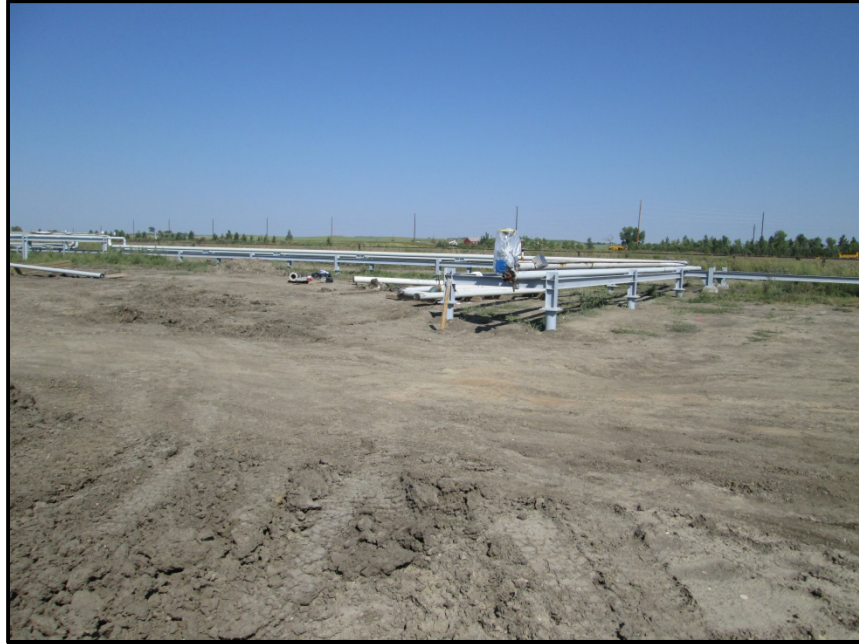
**Photo 9.** Direction: Northwest. Termination of the Pipeline prior to boring under 116<sup>th</sup> Ave SW.

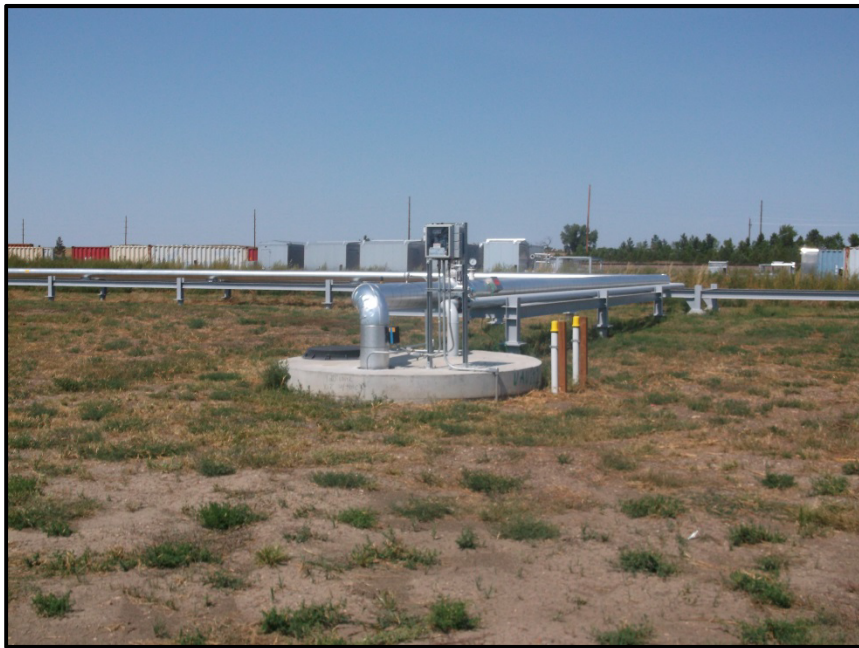
**Photo 10.** Direction: Northwest. Pictured above is the pipeline bending to the south prior to boring under 116<sup>th</sup> Ave SW and entering underground structure. (This photo is from the second and final inspection of the pipeline).

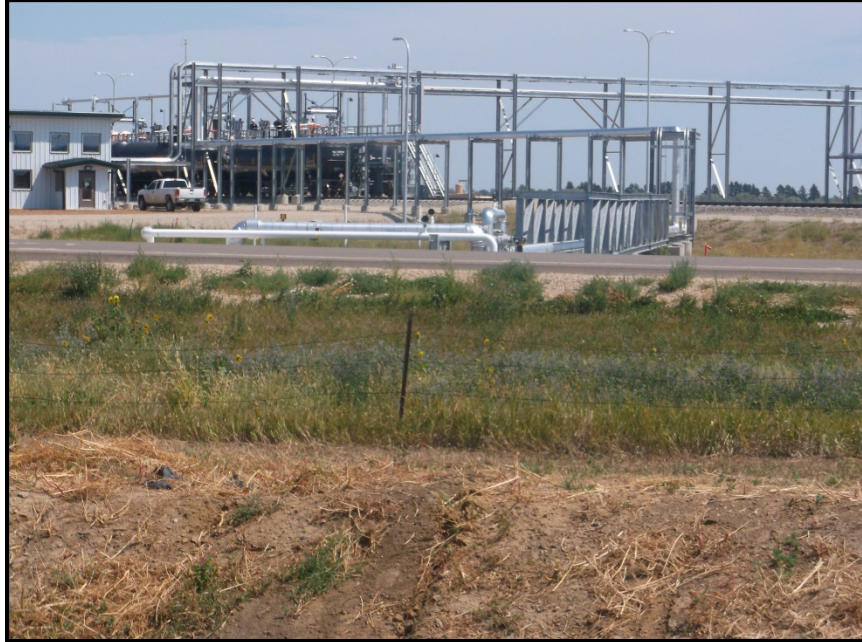
**Photo 11.** Direction: East. View of the location of the boring that went underneath 116<sup>th</sup> Ave SW before entering and terminating at the rail yard. (This photo is from the second and final inspection of the pipeline).

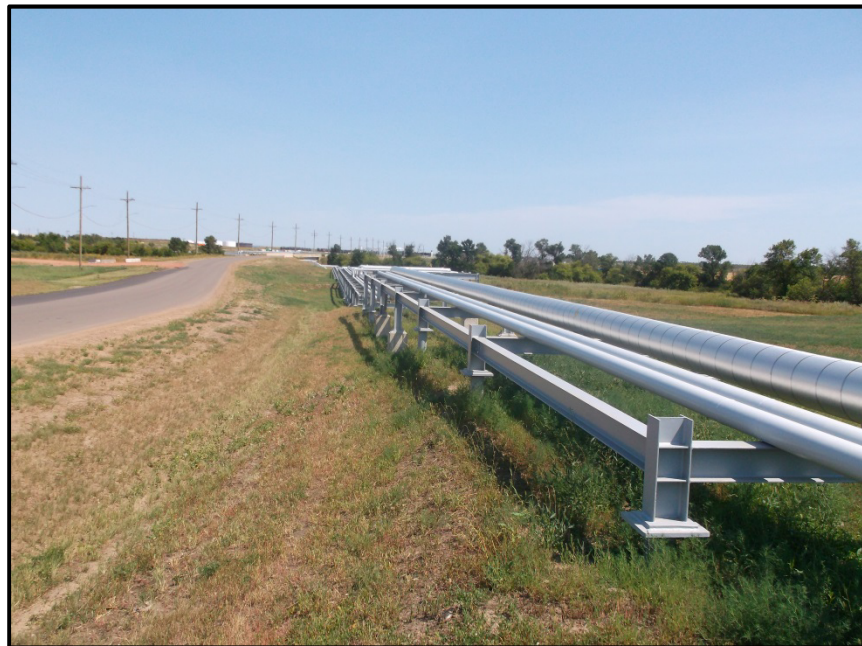
Areas disturbed by construction appear to be successfully restored to previous conditions (Appendix A, Photos 12, 14, 17, and 18).

**Photo 12.** Direction: West. Completed pipeline with 8" line insulated and heat traced, ROW returned to pre-construction conditions. (This photo is from the second and final inspection of the pipeline).

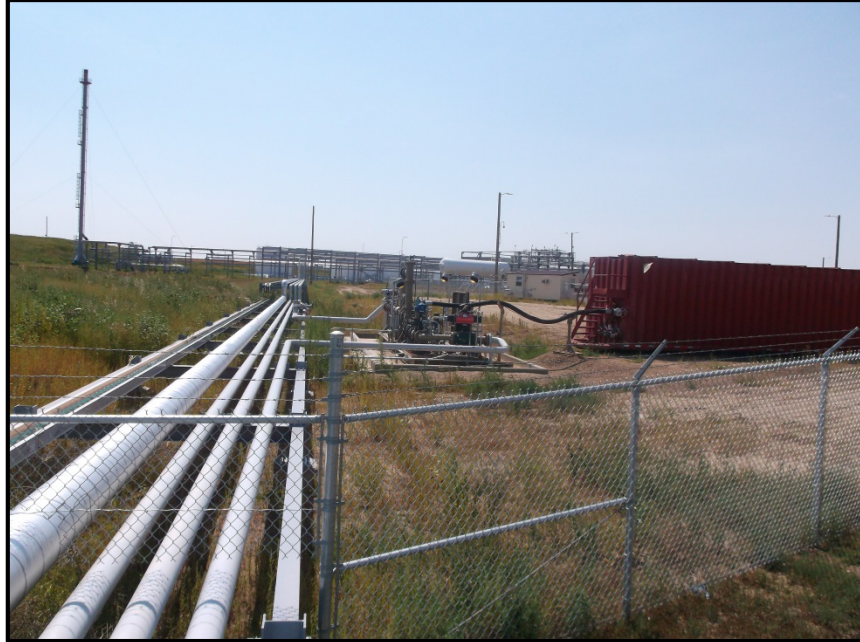
**Photo 13.** Direction: Southwest. The picture above depicts where the pipeline enters the Dakota Prairie Refinery, the security measures in place are also depicted. (This photo is from the second and final inspection of the pipeline).

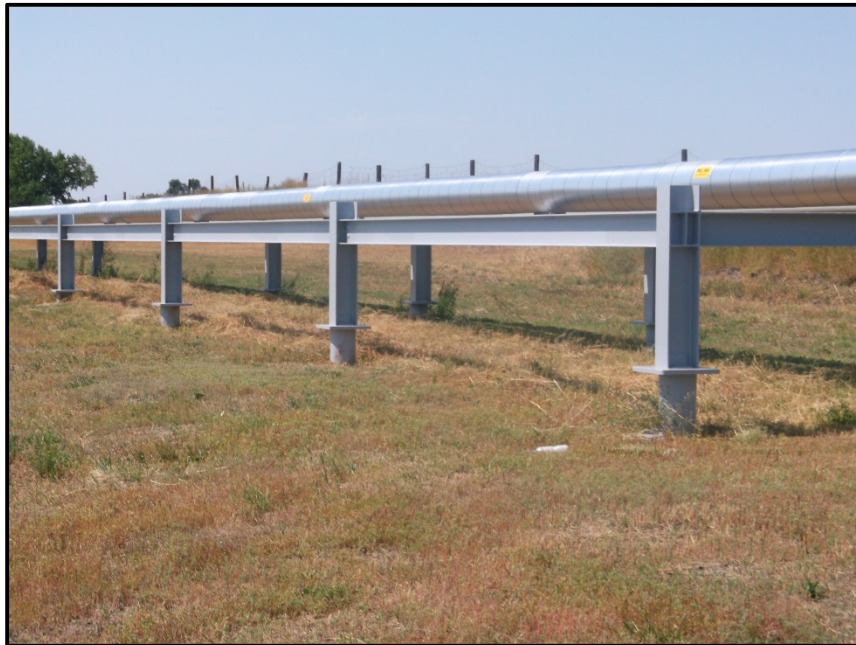
**Photo 14.** Direction: Northwest. Depicted above is an example of the recovery of the ROW to preconstruction conditions. (This photo is from the second and final inspection of the pipeline).

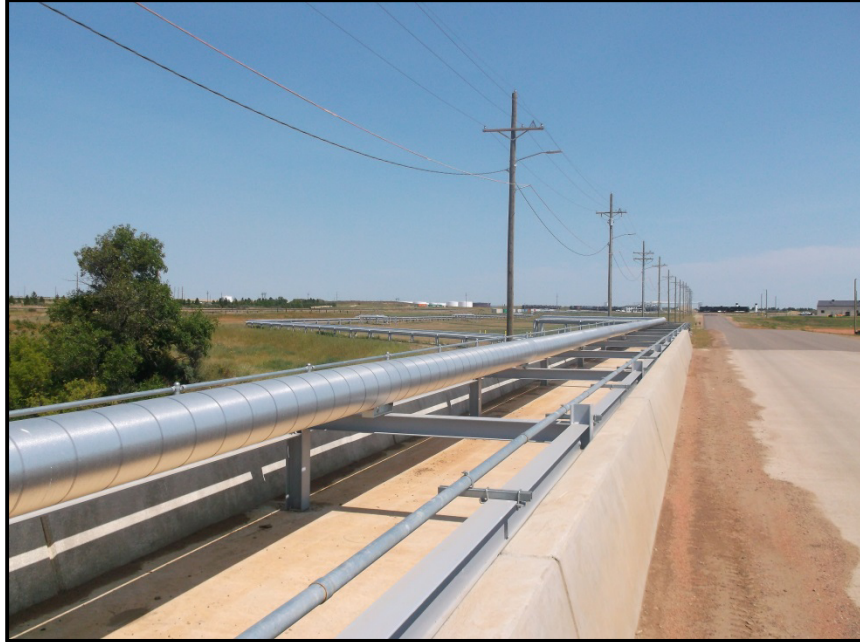
**Photo 15.** Direction: East. Pipeline running east and west, crossing the Heart River along a bridge. While installing the pipeline damage was done to the bridge or roadway as depicted above. (This photo is from the second and final inspection of the pipeline).

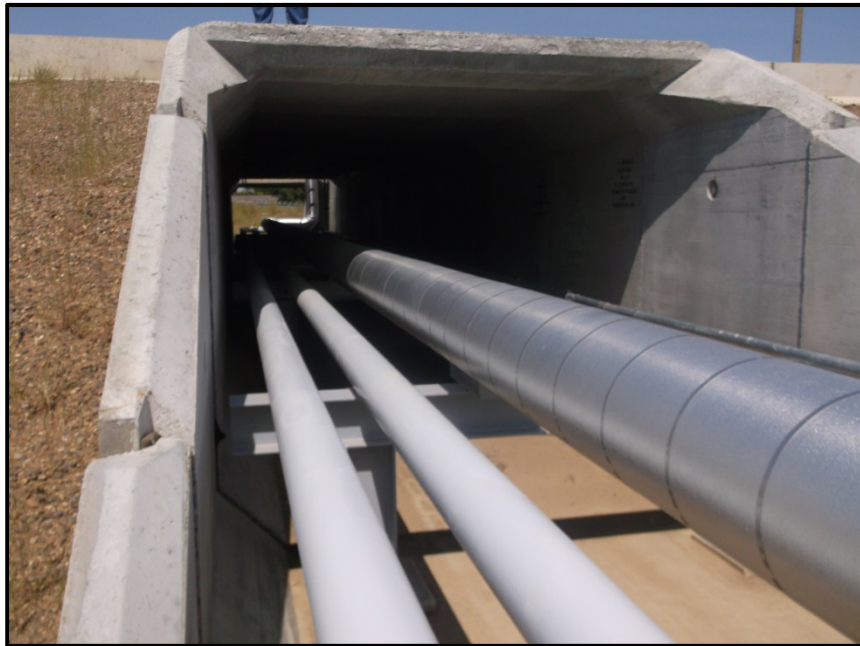
**Photo 16.** Direction: North. View of the insulated pipeline section that runs through the box culvert underneath the facility access road. Preventative spill/leak containment measures taken are depicted in the photo above as well. (This photo is from the second and final inspection of the pipeline).

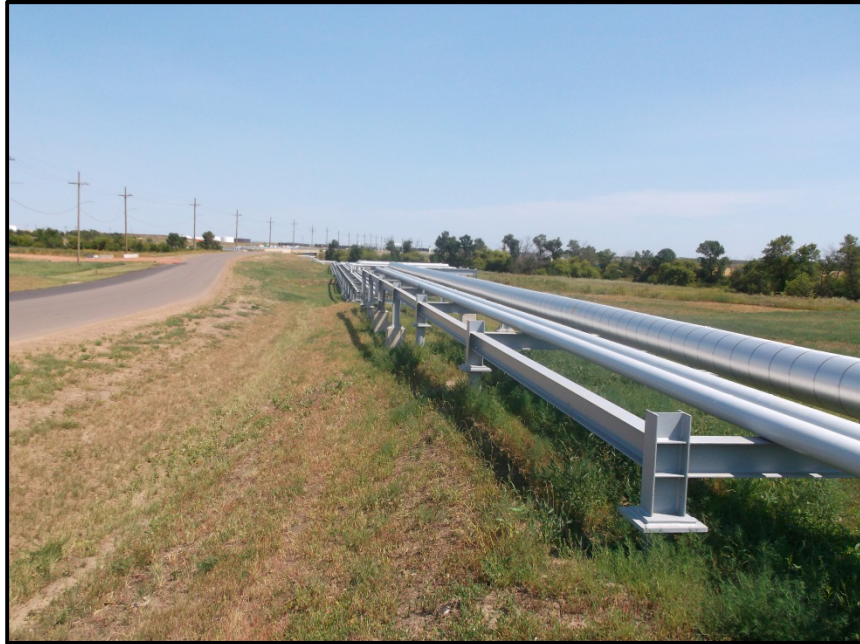
**Photo 17.** Direction: East. Depicted above is an example of the recovery of the ROW to preconstruction conditions. This section of the pipeline is south of the facility access road running east to west. (This photo is from the second and final inspection of the pipeline).

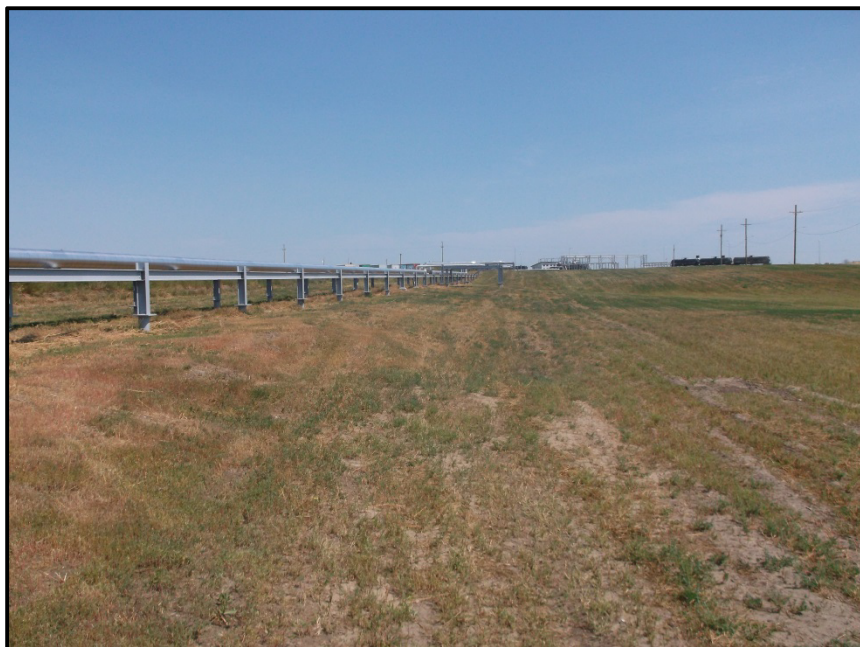
**Photo 18.** Direction: East. Depicted above is an example of the recovery of the ROW to preconstruction conditions. This section of pipe is north of the facility access road, runs east to west until it reaches the bore location at 116<sup>th</sup> Ave SW. (This photo is from the second and final inspection of the pipeline).
