**PUBLIC SERVICE COMMISSION**

**Memorandum**

**SUBJECT:** Coyote Creek Mine Alluvial Valley Floor field investigation

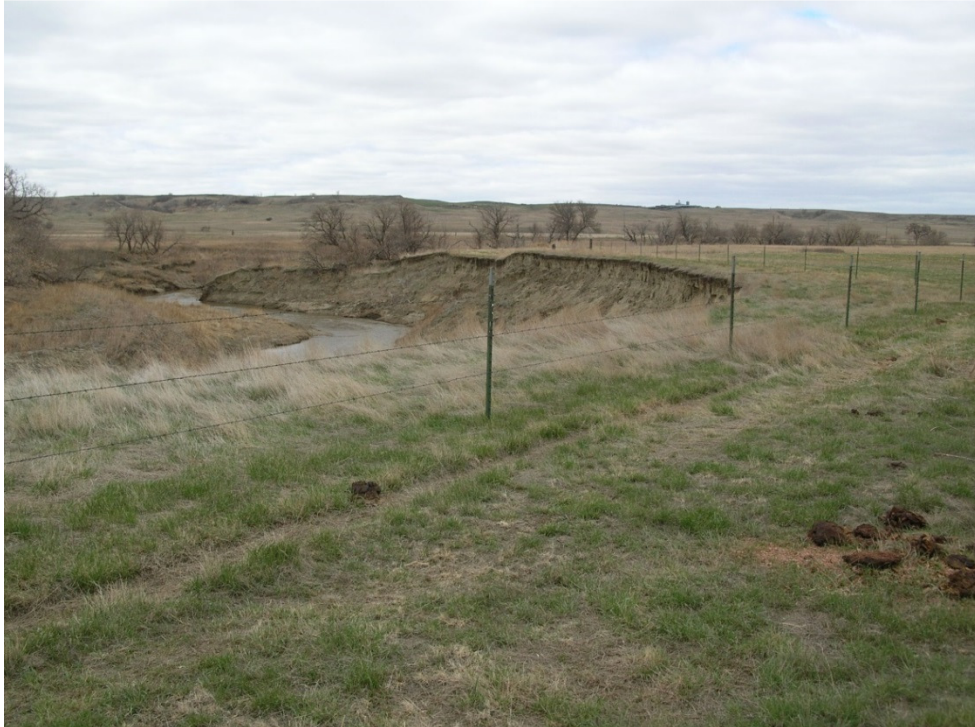
Site 1 is generally located at the northeastern corner of the study area and represents a 160-acre tract of cropland at the west end of the tract and hayland at the east end of the tract adjacent to, and on the south side of the Knife River where the Knife River leaves the AVF study area. This particular site is located within the S1/2 of Section 3, T143N, R88W approximately 1 mile down-gradient of the confluence of Brush Creek and Knife River.

**View of Knife River looking northwest from Site 1**

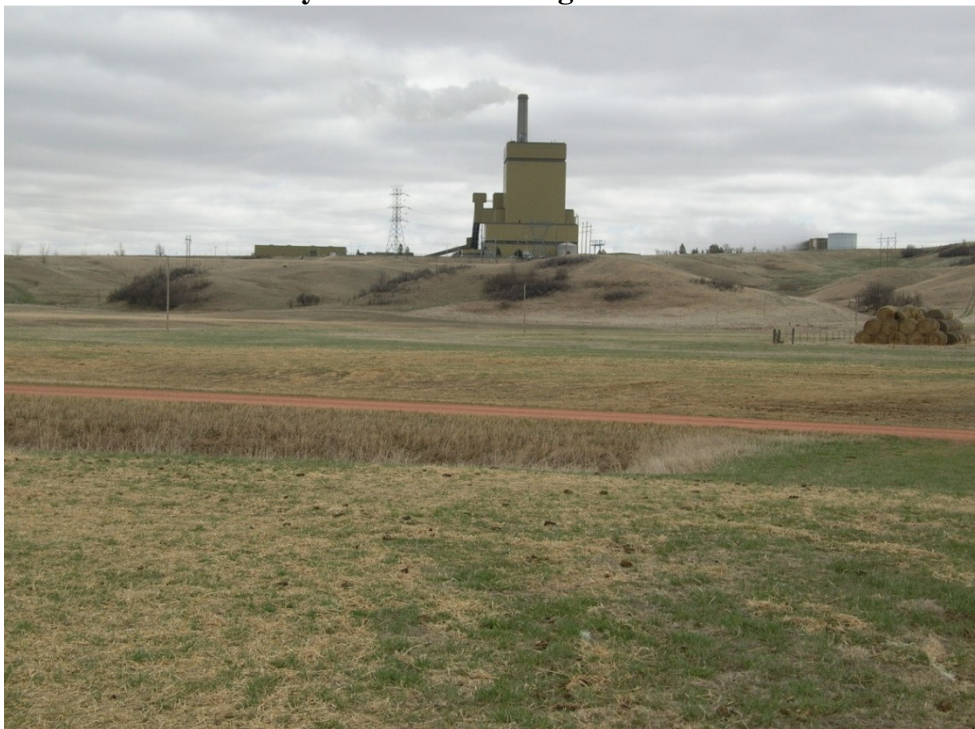
**View of Coyote Station looking south across Site 1**

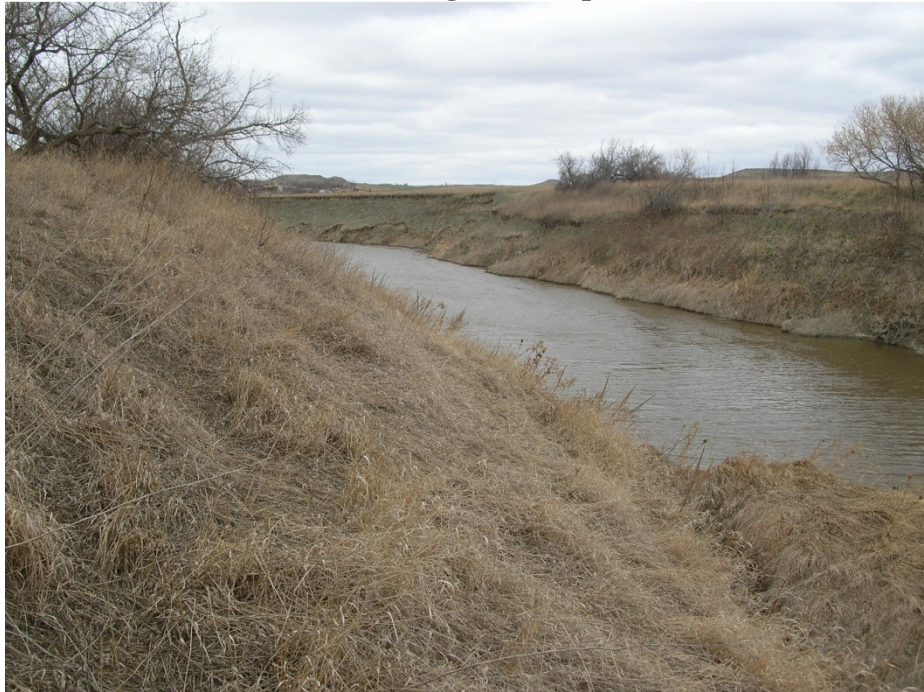
Site 2 represents two cropland tracts that are irrigated with separate center pivot sprinkler irrigation systems, each tract encompassing approximately 80-90 acres. The southern-most irrigated field is located wholly within the NW1/4 of Section 18, T143N, R88W and the northern-most irrigated field is located within the SW1/4 of Section 7 and NW1/4 of Section 18, T143N, R88W, and within the SE1/4 of Section 12 and NE1/4 of Section 13, T143N, R89W. Both irrigation systems are supplied by alluvial ground water from the Knife River Aquifer and the well is located north of the tracts about 250 feet from the Knife River in the SW1/4 of Section 7, T143N, R88W.

**View of Knife River looking north (upstream) near Site 2**

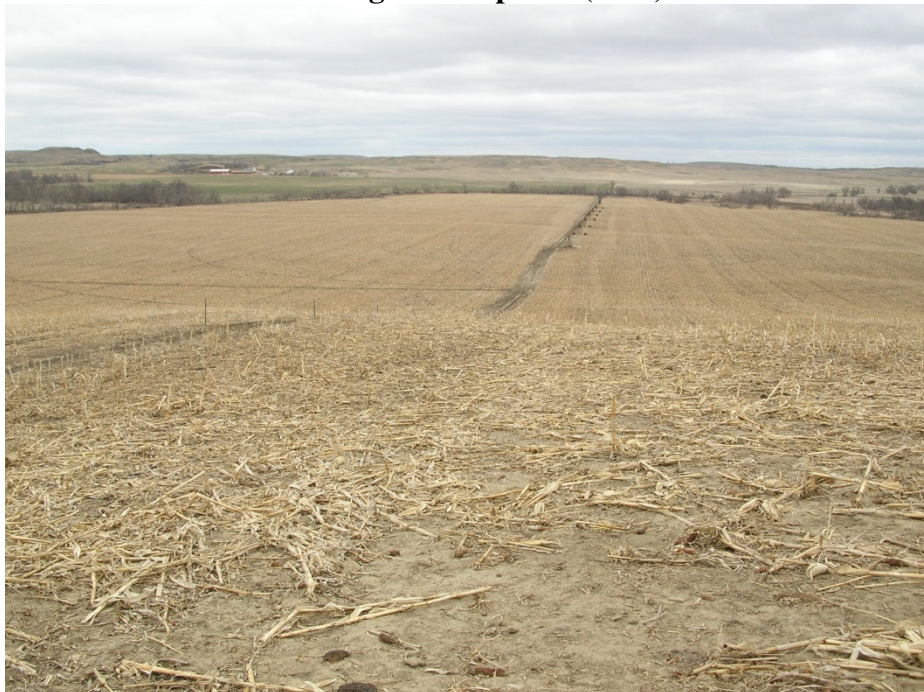
**View to north of irrigated cropland (corn) within Site 2**

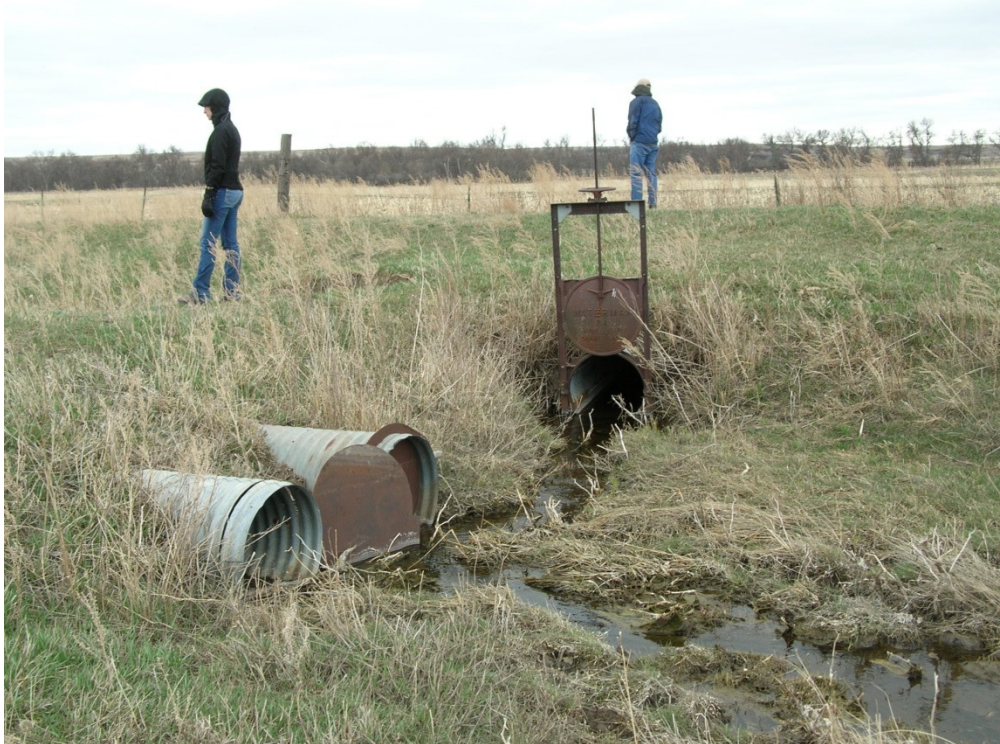
Site 3 depicts a an approximate 40-acre cropland tract that has been developed into a spreader dike system and is situated between two unnamed tributaries to the Knife River in the NW1/4 of Section 14, T143N, R89W. Within the 40-acre tract there appeared to be approximately a half-dozen spreader dikes constructed within the tract to divert surface water runoff from the two unnamed tributaries for artificial flood irrigation. The cropland tract appeared to be located on a floodplain within an abandoned oxbow/meander loop of the Knife River.

**Culvert gate valves and stops within stream channel of north tributary at Site 3**

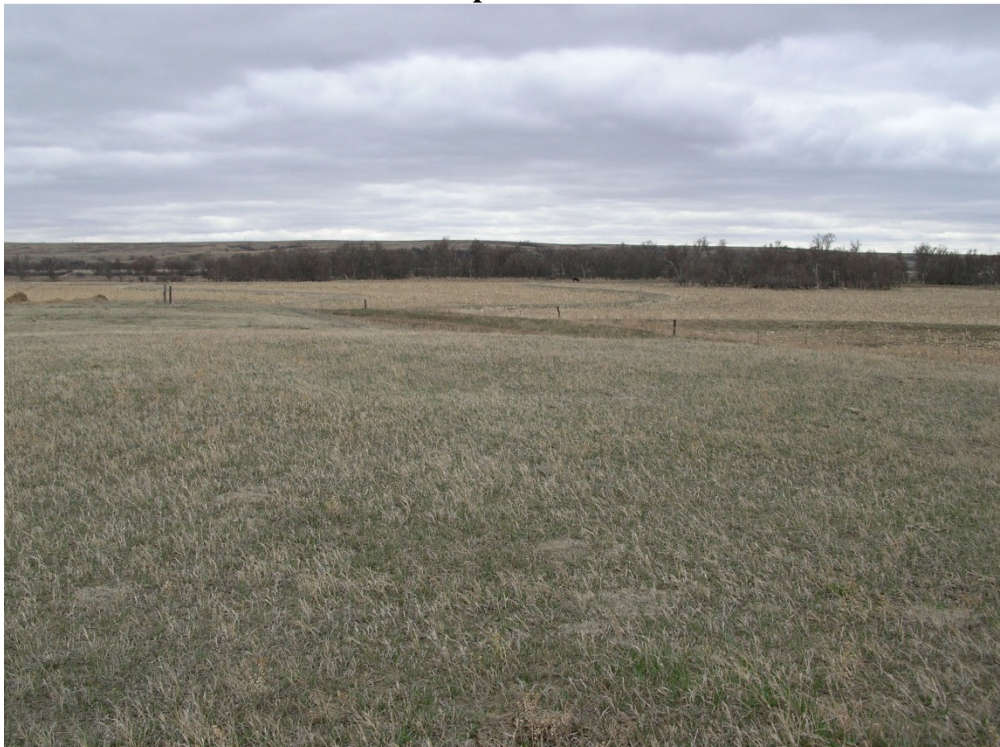
As noted below, Site 3 depicts a cropland tract in which spreader dikes have been constructed to divert surface water flow from two unnamed (assumed ephemeral) tributaries to the Knife River. This site represents two stream channels that do not appear to be unconsolidated stream laid deposits holding a stream. The streams however, do appear to border alluvial deposits of the Knife River and that area of floodplain/terrace has been developed for artificial flood irrigation by construction of a spreader dike system. The unnamed ephemeral streams providing the surface water for the spreader dike system cannot by definition be classified as AVF. At the conclusion of the field review, it was the general consensus of the PSC inspectors that the stream valleys at Sites 1 through 6 located within the AVF Evaluation Report study area do not meet the criteria of an AVF for flood irrigation and subirrigation defined by NDAC 69-05.2-08-13-2(b). The two small tracts of possible subirrigation depicted in the report and the 43-acre spreader dike flood operation described would not represent “productive lands that form the backbone of the agricultural and cattle ranching economy of the area” (OSM Study Guidelines, page II-7).

**View to south of spreader dikes at Site 3**

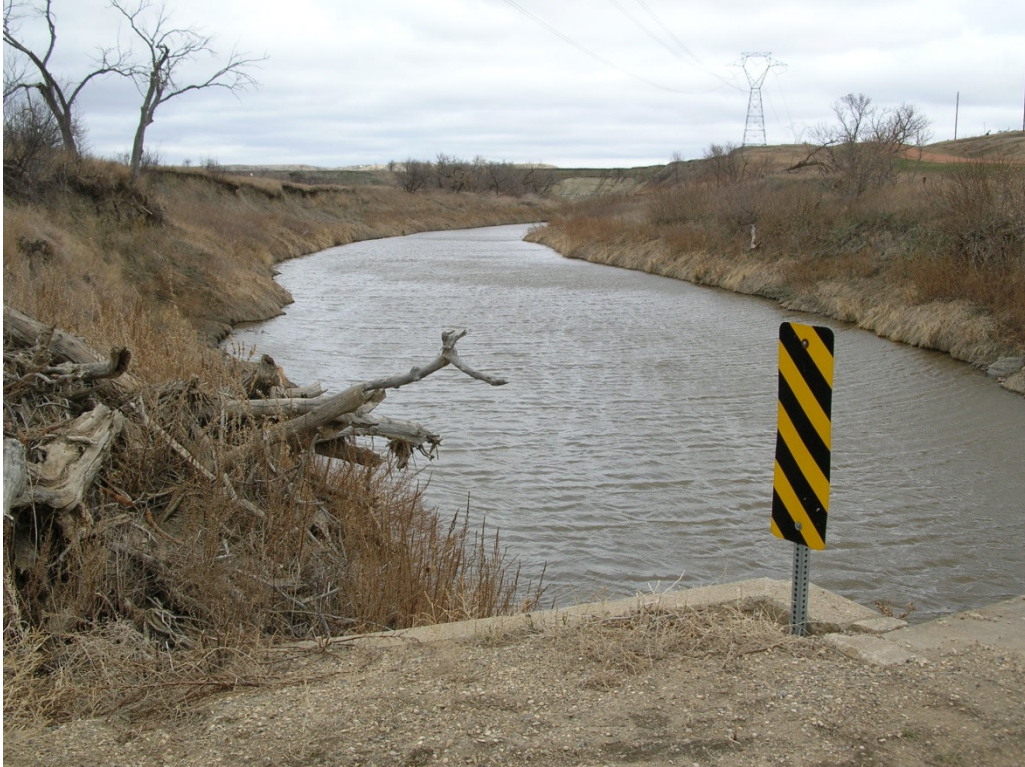
Site 4 is a series of cropland tracts located along the west side of a bridge crossing of the Knife River along 69<sup>th</sup> Ave. SW within the W1/2 of Section 15, T143N, R89W. Approximately 1400 acres of cropland tracts are located adjacent to, and to the north and west of Site 4.

**View of Knife River from bridge crossing looking upstream to northwest of Site 4**

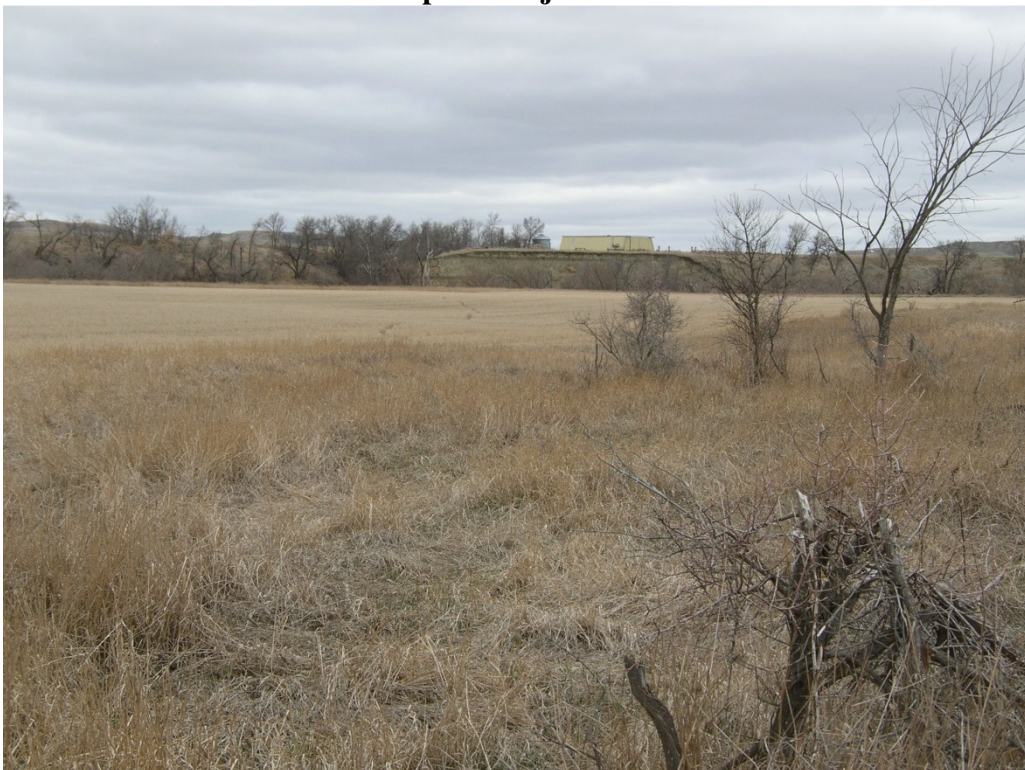
**View to northwest of cropland adjacent to Knife River at Site 4**

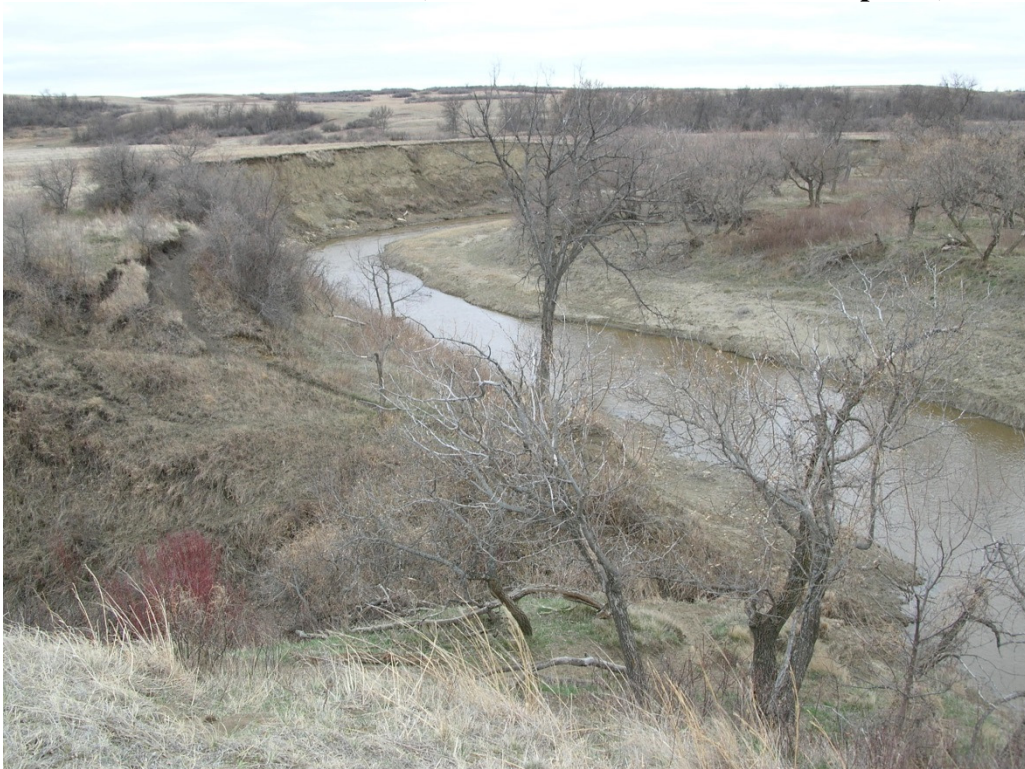
Site 5 depicts cropland tracts north and west of the confluence of Mud Creek and the Knife River within the NW1/4 of Section 29, T143N, R89W.

**Confluence of Mud Creek and Knife River at Site 5  
View is toward the west (Mud Creek at bottom center of photo)**

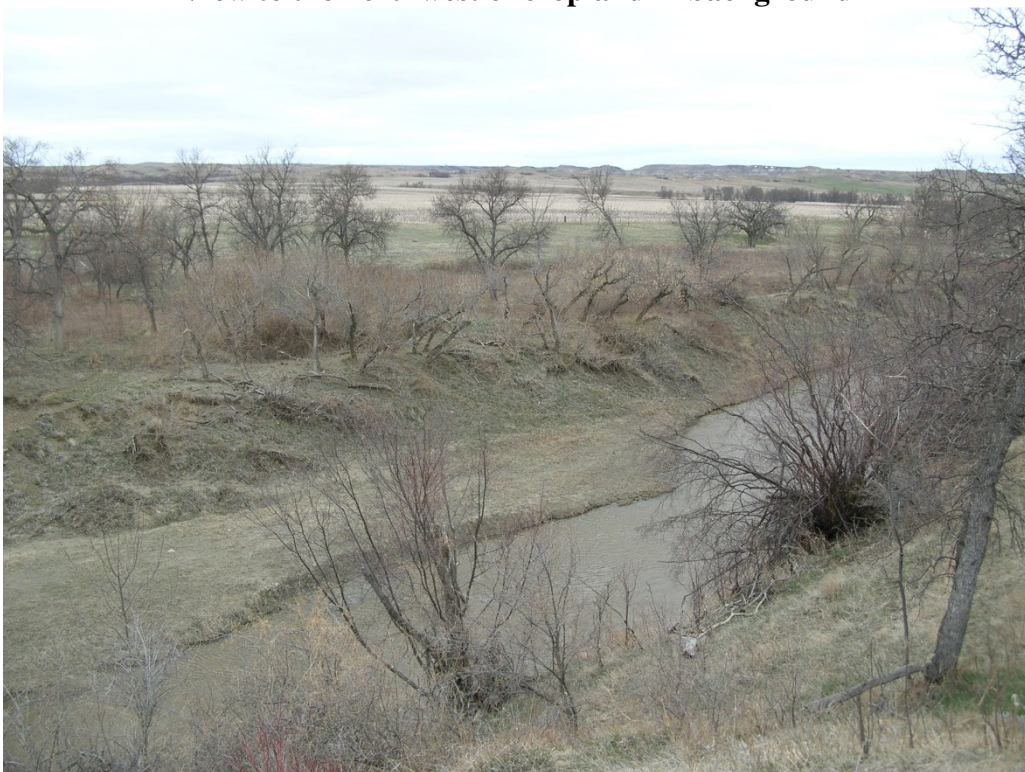
**View to the northwest of cropland in background**

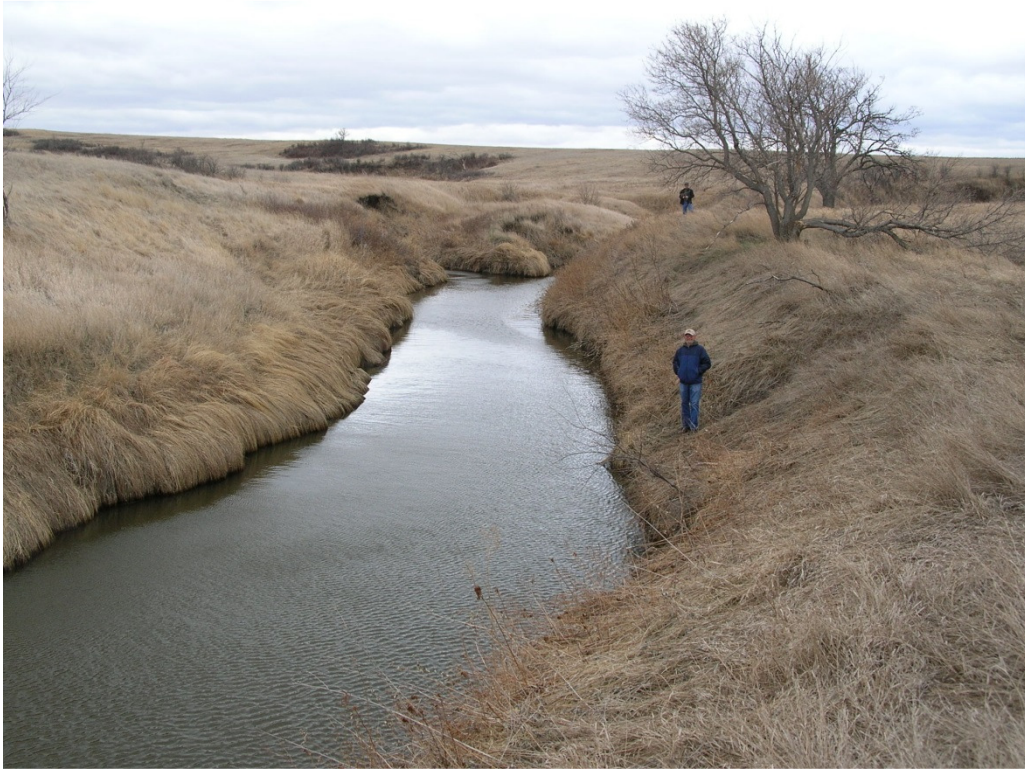
Site 6 depicts cropland at the confluence of Beaver Creek and Coyote Creek at the furthest southeastern portion of the AVF study area in the E1/2 and portions of the W1/2 of Section 17, T142N, R88W.

**Confluence of Beaver Creek and Coyote Creek at Site 6  
View is toward the southwest (upstream of Coyote Creek)**

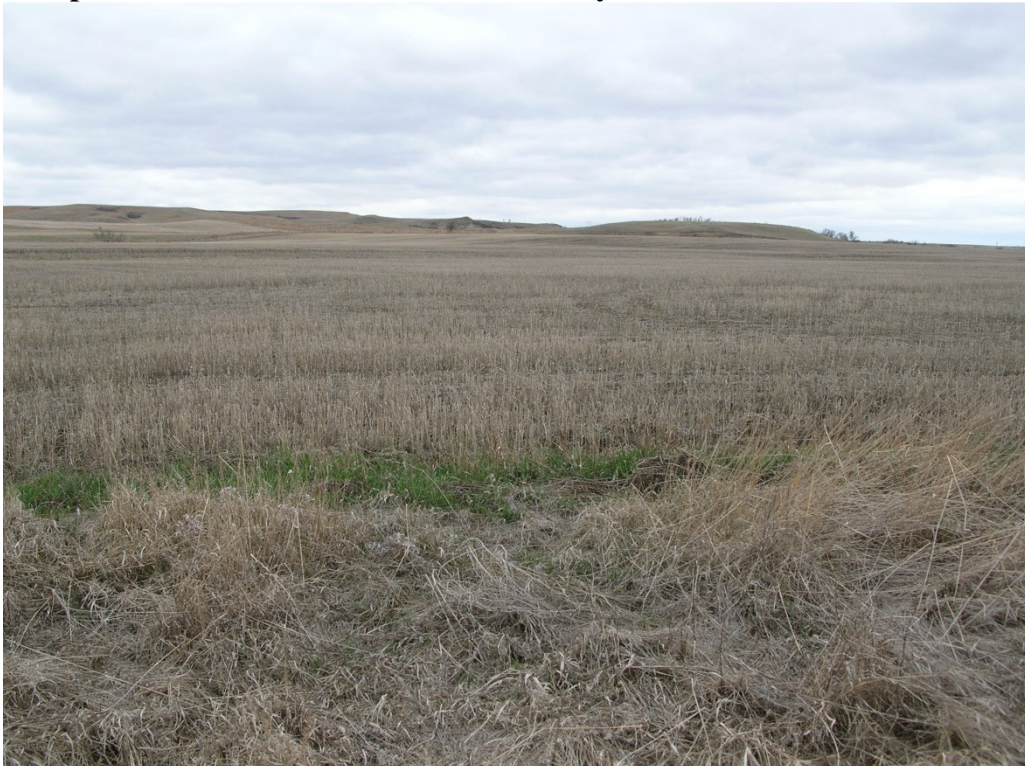
**Cropland to the north of Beaver Creek/Coyote Creek confluence at Site 6**
