Memorandum

SUBJECT: Coyote Creek AVF field investigation

On June 11, 2009 the PSC personnel listed above met with representatives of Dakota Westmoreland Corporation to conduct a field review of potential alluvial valley floor (AVF) areas that lie within the terraces and floodplains delineated in the 2009 Coyote Creek Alluvial Valley Floor Study area. In particular, observations were recorded for areas along Coyote Creek in Sections 19 and 30, T143N, R88W in Mercer County. Areas proposed for mining operations by Dakota Westmoreland Corporation with Revision 22 to Permit KRSB-8603 are located within ¼ mile of the Coyote Creek drainage. Dakota Westmoreland Corporation representatives on site for the field investigation were Greg Smestad and Jeff Frohlich. The field review was conducted between 10:45 a.m. and 1:00 p.m. on June 11, 2009. The skies were clear and the temperature was near 60°F. Access to the study area was good.

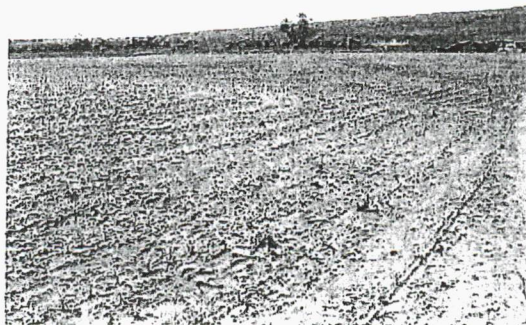
As mentioned earlier the focus study area is cropland and was seeded to corn approximately 3 weeks previous to the field investigation. The corn is generally at the 3-5 leaf stage and averages about 6 inches in height. Historically, this area has been cropland for as long as landowner Casey Voigt can recall. Evidence of the late March and early April, 2009 spring snow melt flooding event was apparent. Mr. Voigt apparently expended a great deal of time and effort in collecting and disposing of drift wood and other water-borne debris carried by the floodwaters and deposited on the flood plain/valley floor.

**Corn crop that was planted approximately 3 weeks prior to field review
Photograph location is the NE1/4 of the SW1/4 of Section 19**

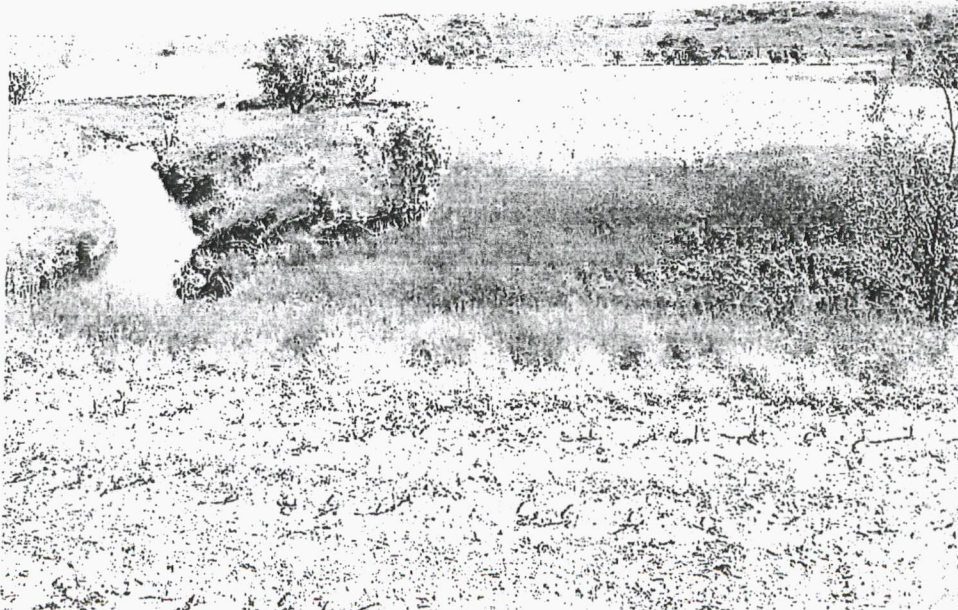
Within the study area Coyote Creek is substantially incised and occupies an under-fit drainage system. Coyote Creek is a meandering low-gradient drainage that has formed many oxbows along its course. Remnant or abandoned oxbows have provided utility as cropland on the north side of the creek. The average water depth of Coyote Creek within the study area appeared to be 3-4 feet and the stream was actively flowing. Elevation of the flood plain varied with geographic position compared with the position to Coyote Creek. The flood plain/terrace elevation averaged about 5-8 feet above the surface of the water for areas north of Coyote Creek and the flood plain/terrace elevation averaged about 12-15 feet above the surface of the water for those areas south of Coyote Creek. In the field, the elevation difference between terrace levels south of Coyote Creek and terrace levels north of Coyote Creek is readily visible and marked.

**View looking north across Coyote Creek to corn field in the SE1/4 of Section 19
Terrace elevation on north of Coyote Creek averages about 7 feet lower than south side**

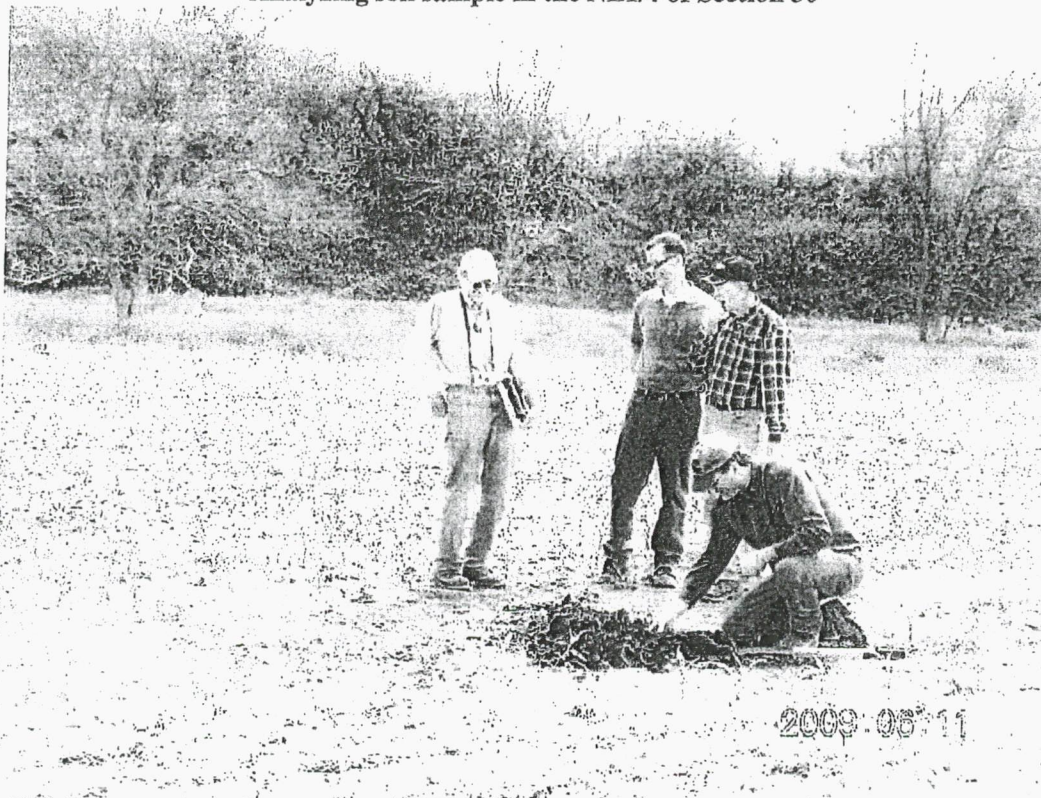
Soil samples to a depth of approximately 18 inches were excavated by shovel and analyzed at several representative locations throughout the flood plain/cropland portion of the study area. Generally, soils associated with cropped areas were of the Straw loam series that is typical of flood plains, and also the Shambo loam series that is typical of terrace soils. Soils were also analyzed for indications of redox, or reducing/oxidizing conditions associated with subirrigation. No indications of redox or soil mottling were observed in the 6 or so soil samples that were analyzed. Soil stratification indicated evidence of historic flooding events on the flood plain/terrace and indications of recent flooding events were noted for areas immediately adjacent to Coyote Creek with sand and coarser materials dominating the upper soil horizon.

Analyzing soil sample in the NE1/4 of Section 30

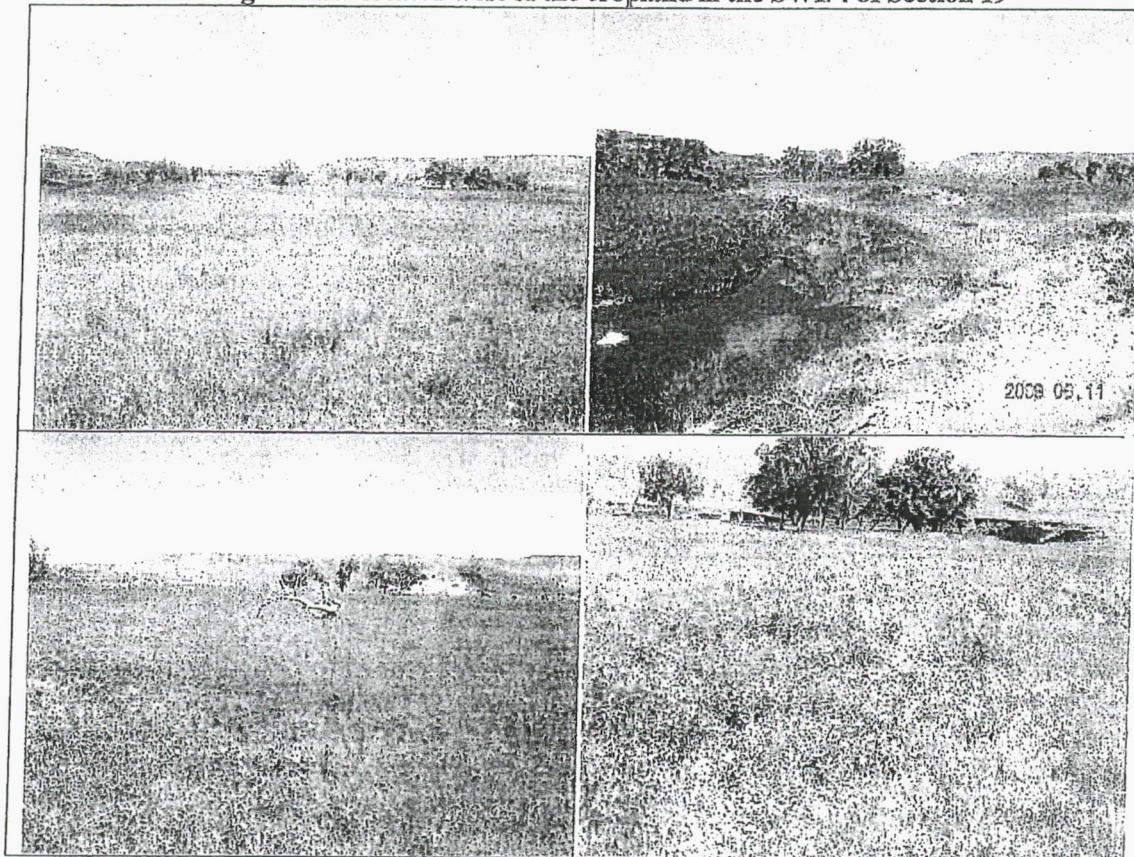
The native grassland floodplain terraces adjacent Coyote Creek located west of the cropland fields in the SW1/4 of Section 19 are zeric sites. The upper terraces are dominated with western wheatgrass, blue grama, Prairie junegrass, needle and threadgrass, needleleaf sedge and crested wheatgrass. Forb species present include green sage, dandelions, wild onions, Indian wheat, bastard toadflax, fringed sagewort and penstemon and oxytropis species. The lower terrace or those closest to the creek are dominated with smooth brome grass, Kentucky bluegrass, western wheatgrass and buckbrush. Cudweed sagewort, common dandelion and scarlet globemallow were some of the forbs present on this site. This terrace is 5-10 feet above the bottom of the channel of Coyote creek and there was evidence that the lower terrace had flooded with snow melt runoff this past spring. Floodwaters deposited soil and an accumulation of smaller rocks or cobbles in places on the floodplain and there was head cutting and scour erosion along the banks of the channel of Coyote Creek.

Native grassland located west of the cropland in the SW1/4 of Section 19
