**Lonesome Creek Gas Plant – ONEOK Rockies Midstream, LLC (PSC Case No. PU-14-218)**

Permit Compliance / Construction Inspection Review  
NDPSC Contract No.: PU-701-14-EE

Reporting Period: July 17, 2014 – April 7, 2015

Prepared By: Houston Engineering, Inc. / Josh Kadrmas, Environmental Engineer and Bart Schultz,  
Project Manager

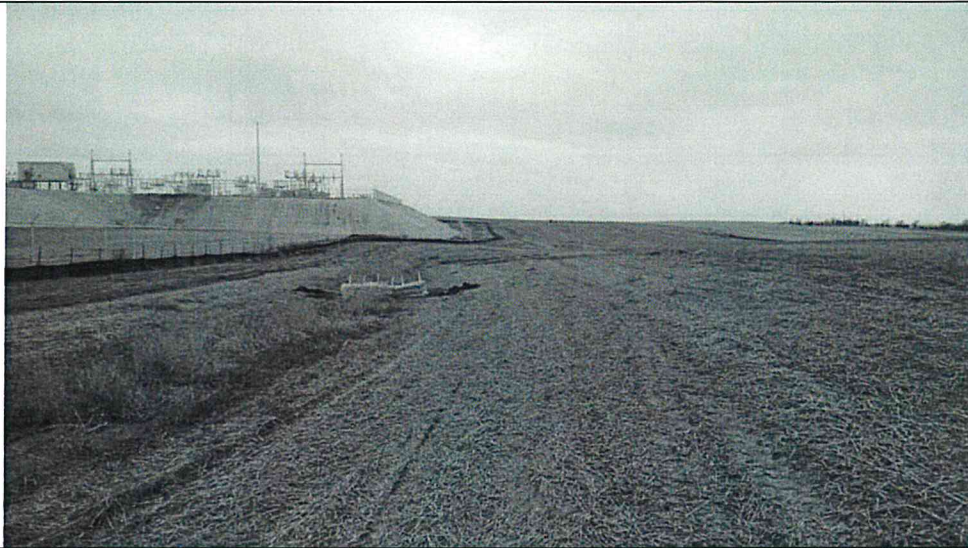
Silt fence was in place along the downstream extent of the project as perimeter control. Straw bales and rock checks were spaced within the drainage ditches to slow the flow of water and prevent scour. Steep slopes were temporarily stabilized with an erosion control blanket.

**Photo 1:**  
Downstream  
extent of project,  
showing erosion  
control  
measures.

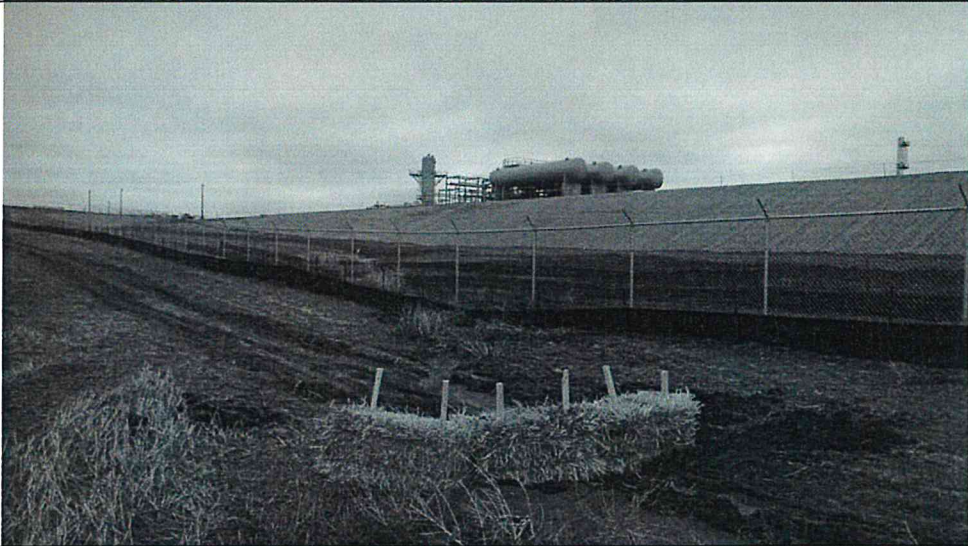
**Photo 2:**  
Looking  
upstream at silt  
fence and straw  
bales across the  
primary drainage  
from the onsite  
activities.

1400 Arrive @ Lonesome Creek Site
1430 Completed safety training w/ Bruce Parnell, H&S manager for The Linde Group. SWPPP is in good order. Last inspection was 3-30-15
1440 Begin site tour.
1530 Finished tour of down gradient perimeter control (silt fence + straw bales); interior drainage to pond, " containment for fuels/oils; and up stream diversion ditch. Made recommendation for additional bales or bio roll in diversion ditch. Final grading is expected to be done

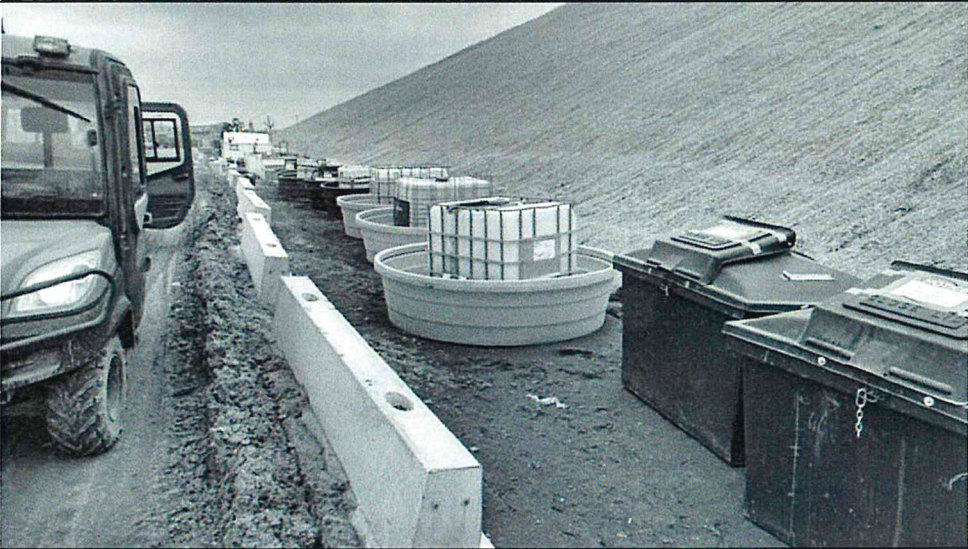
Hazardous chemicals and petroleum products used onsite for construction or equipment maintenance were stored in plastic or metal secondary containment systems. Spill kits were positioned at strategic locations around the site.

**Photo 3:**  
Barriers and  
secondary  
containment  
systems in place  
to prevent spills.

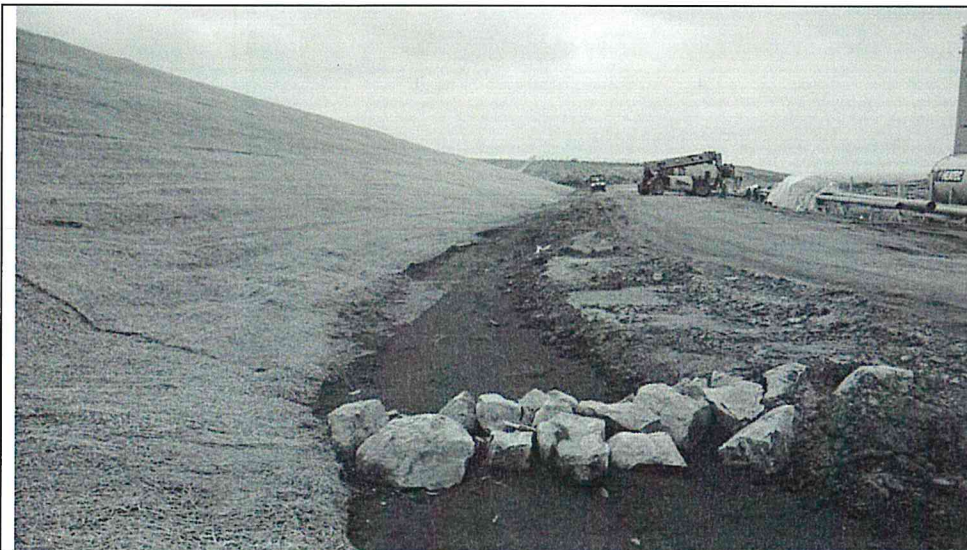
**Photo 4:** Rock checks in interior drainage ditch.

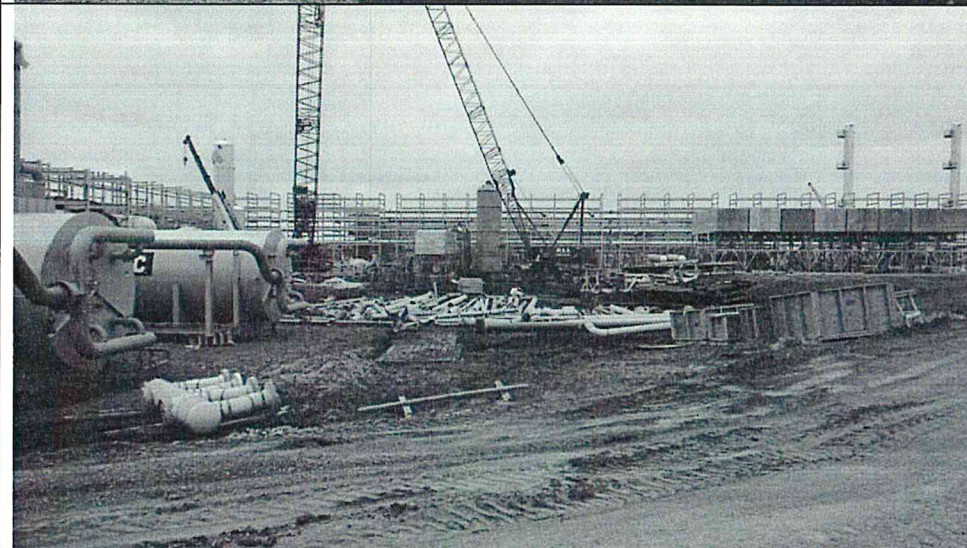
**Photo 5:** Interior construction area.

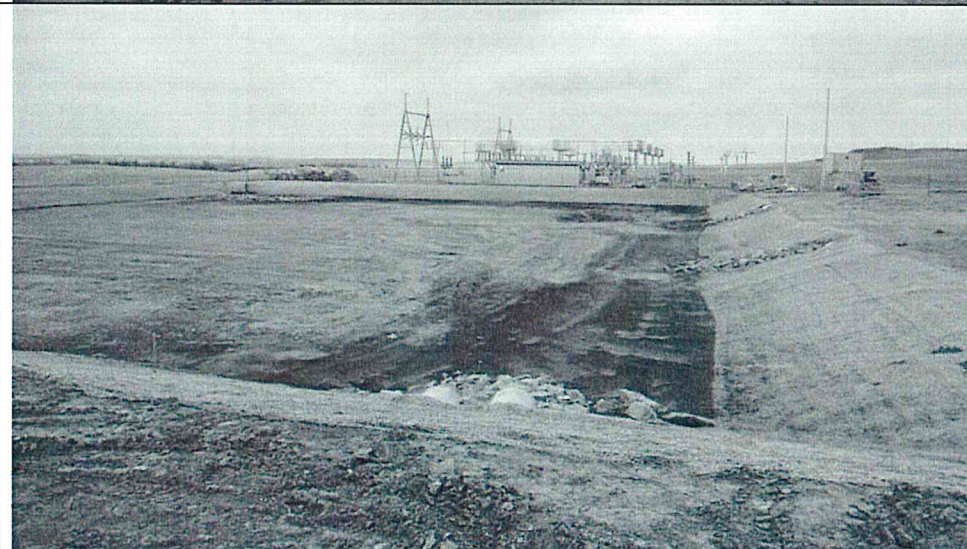
**Photo 6:** Stormwater pond, which will receive interior drainage, and provide spill containment onsite during operation.
