# ONEOK Bakken Pipeline, L.L.C. Targa Lateral Pipeline Project Post-Construction Inspection Report PU-14-254

Prepared for:  
**North Dakota Public Service  
Commission**

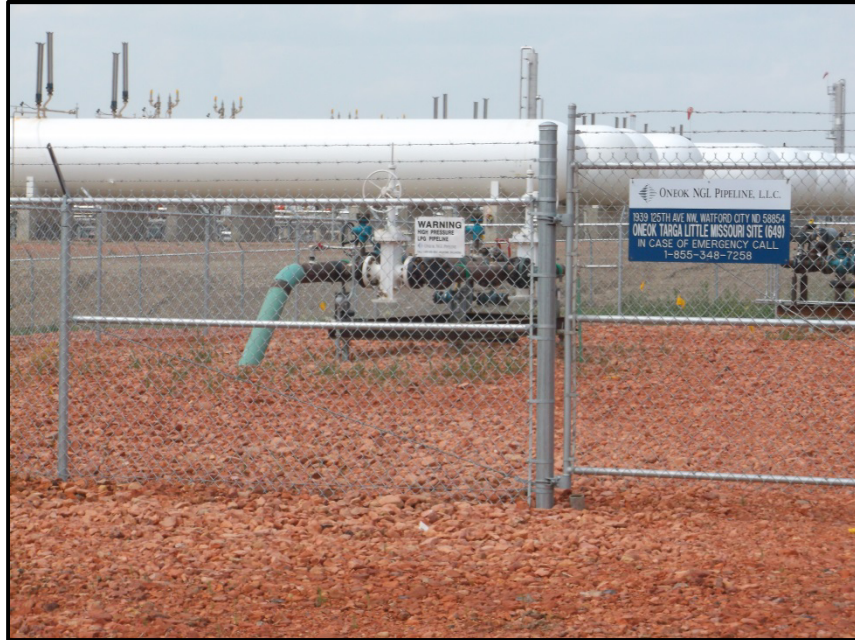
**Photo 1.** Direction: Northwest. Pipeline with pig launcher, leaving the ONEOK Targa Little Missouri Site.

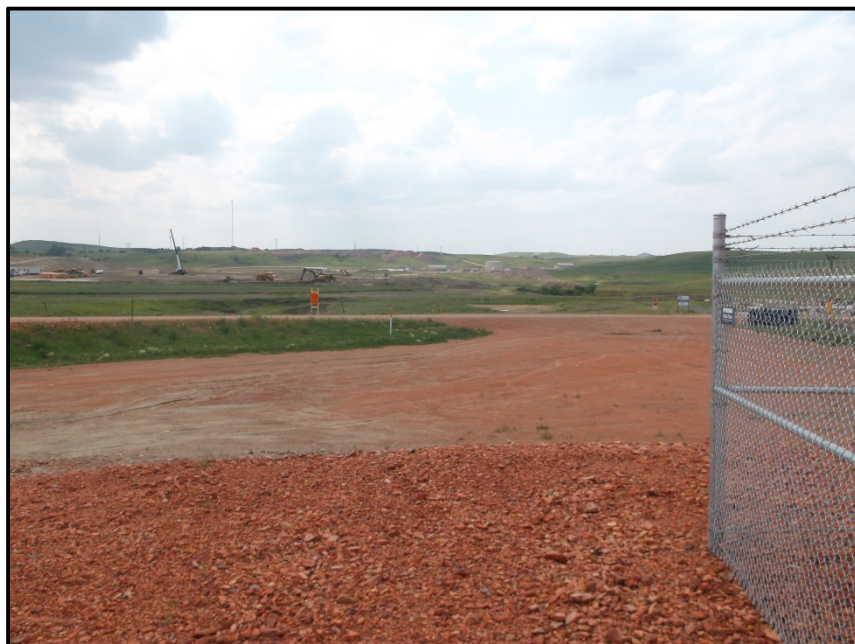
**Photo 2.** Direction: West. Row and pipeline corridor running east to west approaching the first crossing of an access road.

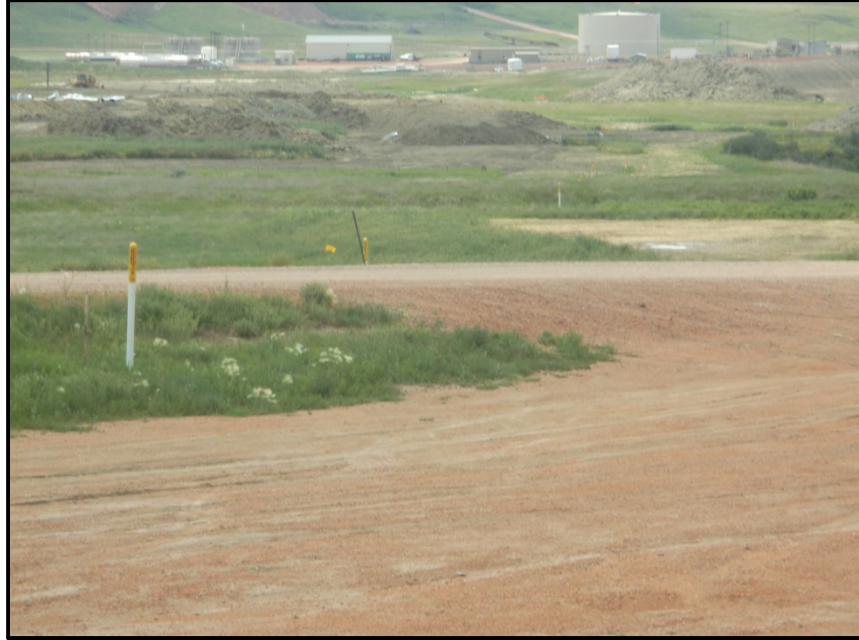
**Photo 3.** Direction: West. Row and pipeline corridor running east to west approaching the first crossing of an access road, four pipeline markers can be seen along the corridor.

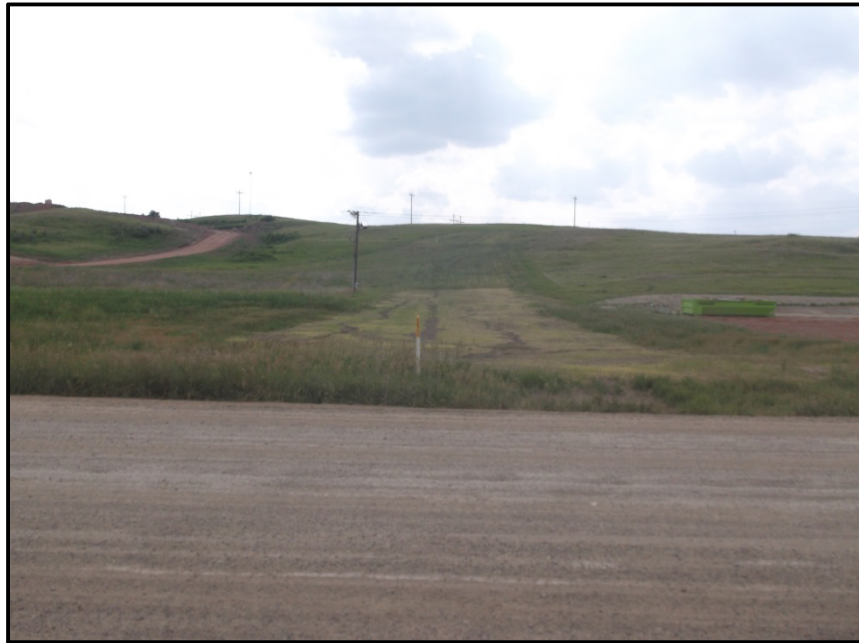
**Photo 4.** Direction: West. Row and pipeline corridor running east to west approaching the second crossing of an access road, a pipeline marker can be seen along the corridor. The remediated corridor is also depicted.

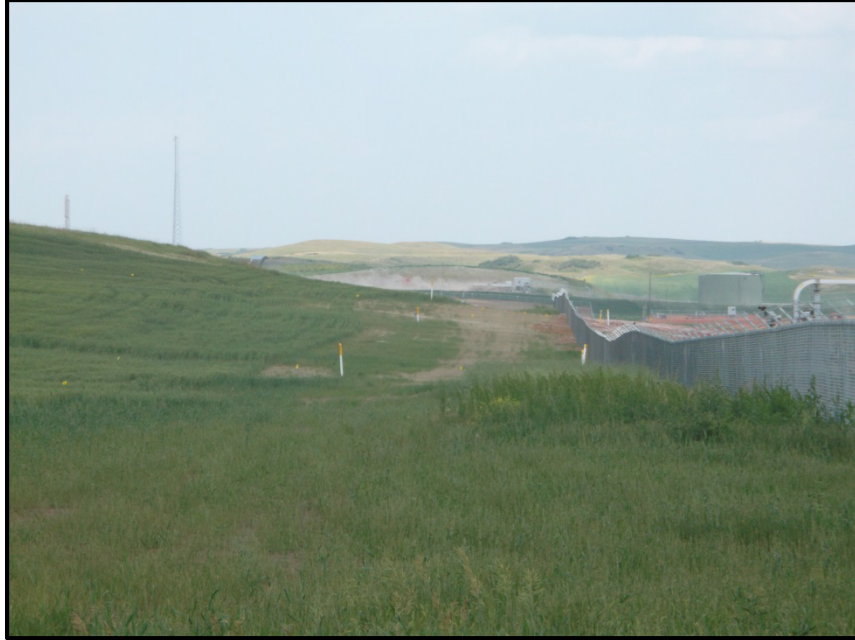
**Photo 5.** Direction: West. Row and pipeline corridor running east to west, three pipelines marker can be seen along the corridor.

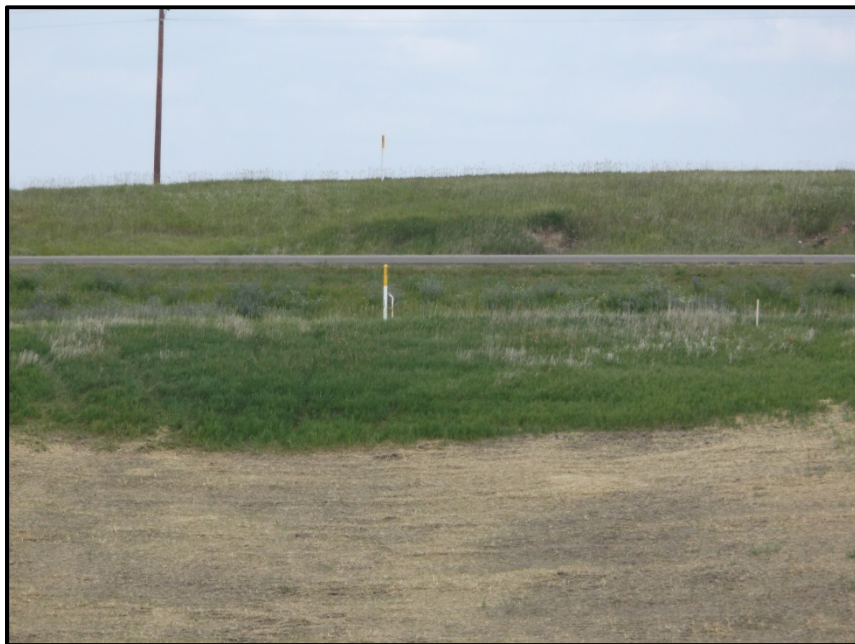
**Photo 6.** Direction: West. Row and pipeline corridor running east to west approaching the crossing of Highway 85, two pipeline markers can be seen along the corridor. Areas of the corridor that need to be seeded are shown as well.

There was an outstanding issue at the Project site related to reclamation. There is one area on the east end of the Project near Highway 85 where vegetation has not been fully established. Wenck recommends the PSC request monitoring and documentation of this issue to ensure the vegetation is established throughout the project.

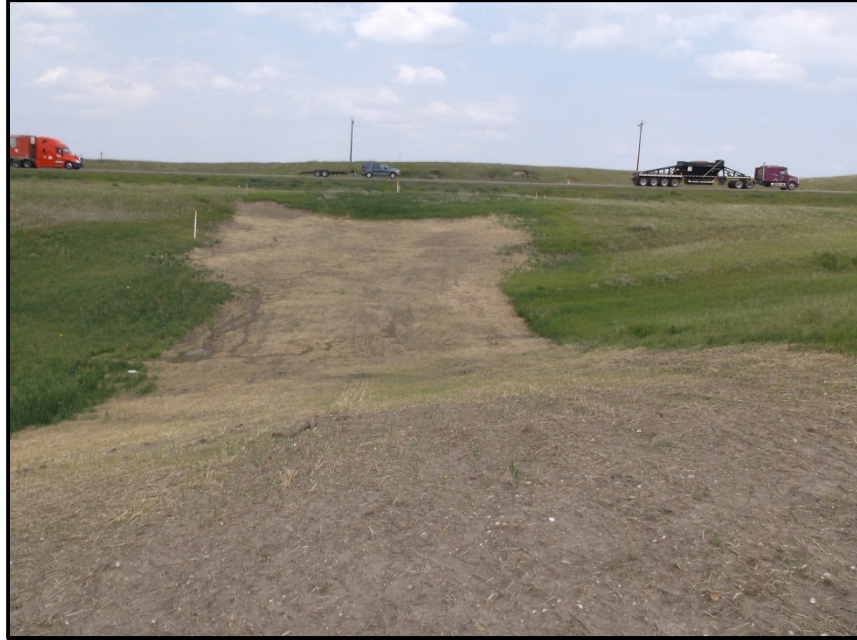
**Photo 7.** Direction: East. Pictured above is the pipeline corridor running East to West that still needs to be seeded and monitored to verify reclamation.

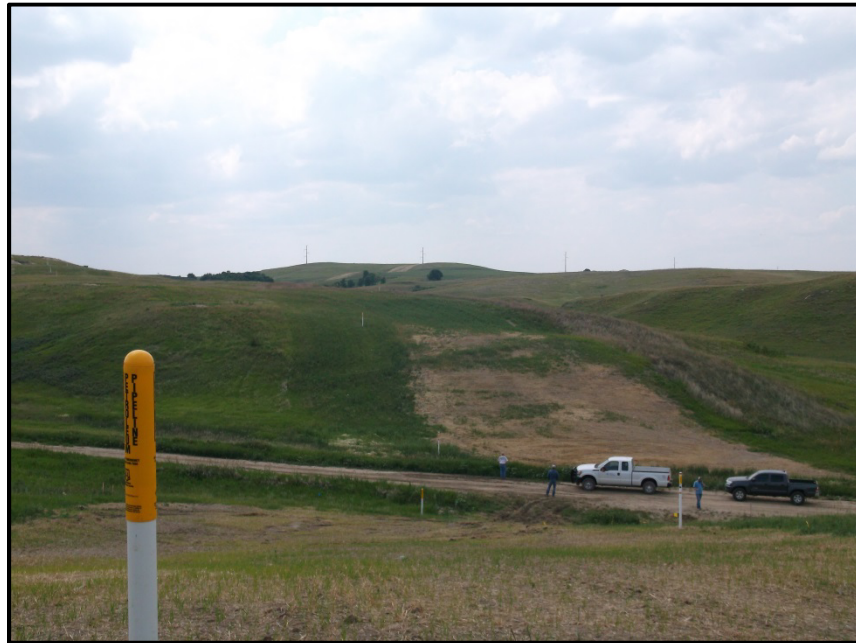
**Photo 8.** Direction: West. Pictured above is the pipeline corridor running East to West that still needs to be seeded and monitored to verify reclamation. Several pipeline markers can be seen along the corridor. An access road that was bored under is also depicted.

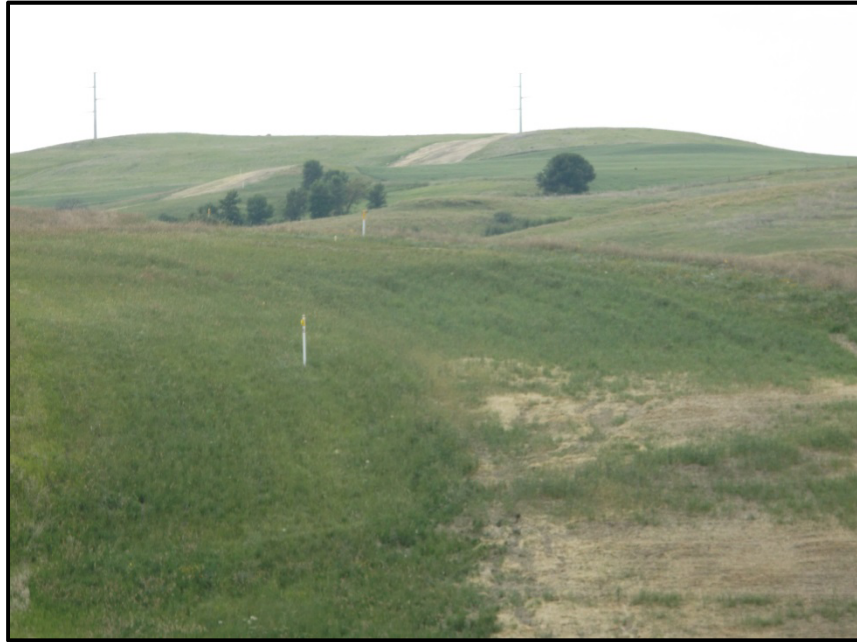
**Photo 9.** Direction: West. Pictured above is the pipeline corridor running East to West that still needs to be seeded and monitored to verify reclamation. Several pipeline markers can be seen along the corridor.

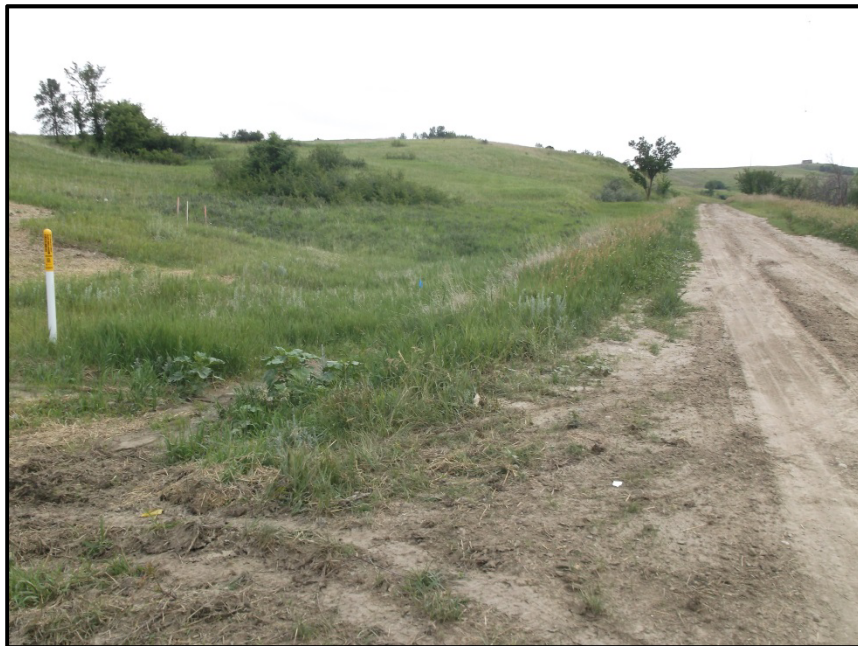
**Photo 10.** Direction: South. Pictured above is the pipeline corridor running East to West that still needs to be seeded and monitored to verify reclamation. A pipeline marker can be seen along the corridor. An access road that was bored under is also depicted.

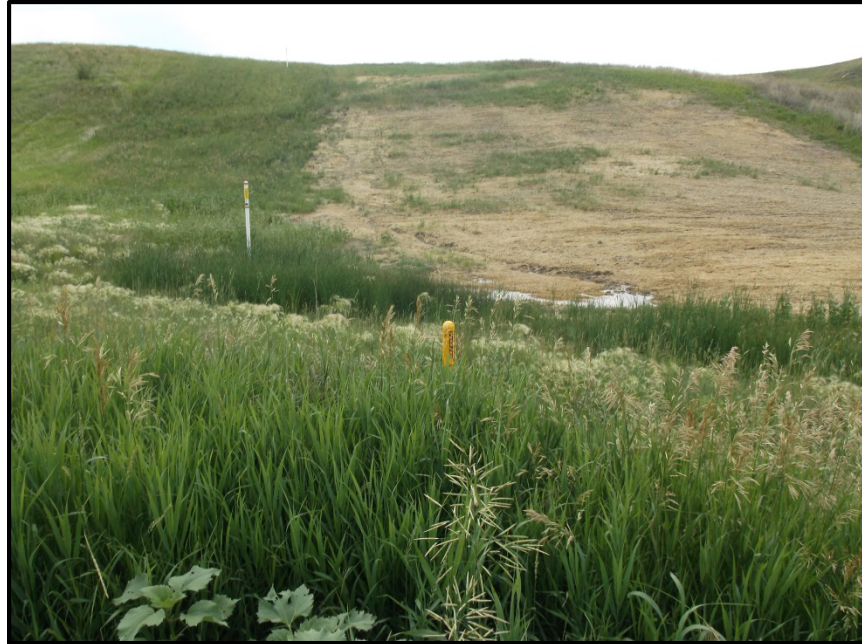
**Photo 11.** Direction: West. One of several wetlands that were delineated is shown above. No permanent impacts were observed during the inspection.

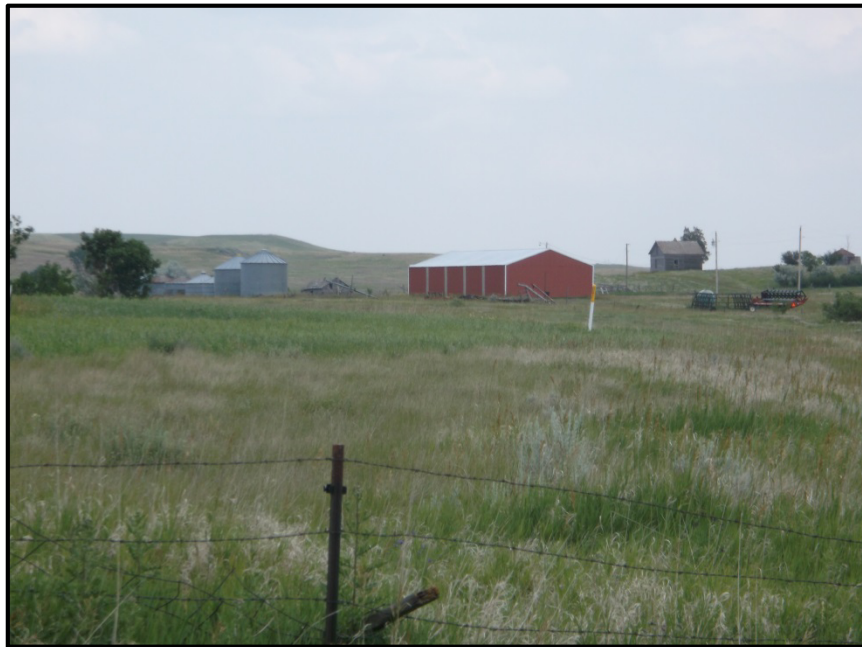
**Photo 12.** Direction: Northeast. Area of corridor near a rural property, a pipeline marker can be seen that will alert property owners. No impacts to the property were observed during the construction inspection.

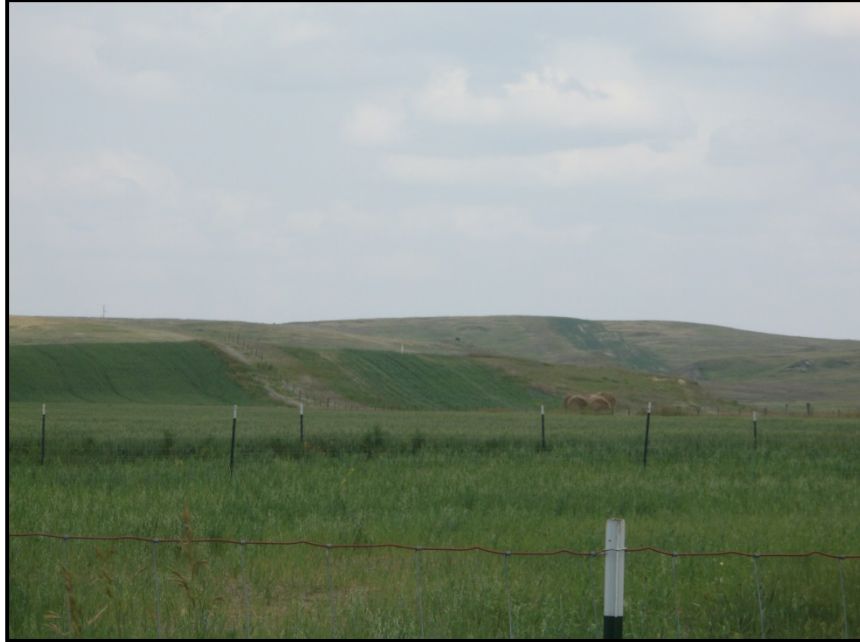
**Photo 13.** Direction: West. Additional areas of agricultural property that the pipeline passes through, again no permanent impacts to farmland. Crops were mitigated appropriately.

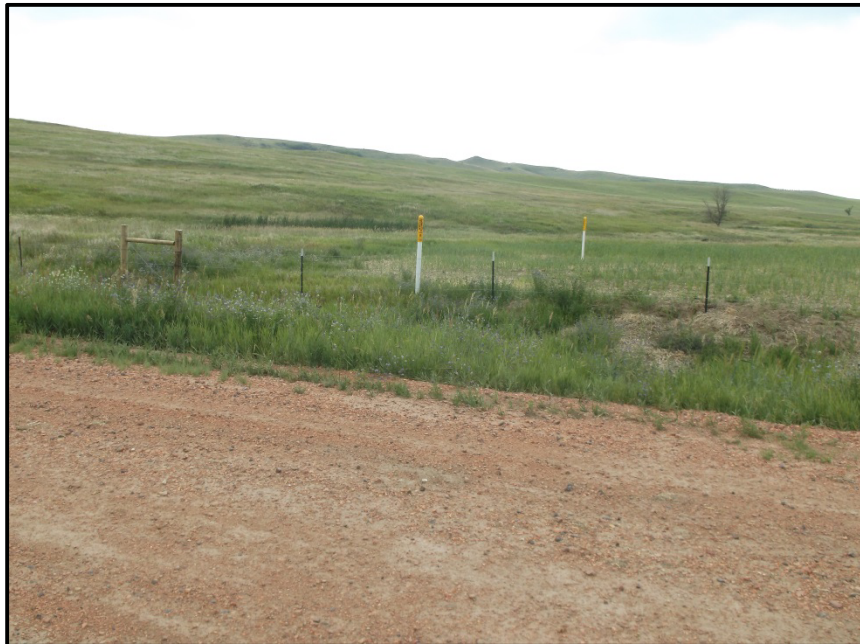
**Photo 14.** Direction: Northeast. Pictured above is the pipeline corridor running East to West that still needs to be seeded and monitored to verify reclamation. A pipeline marker can be seen along the corridor. An access road that was bored under is also depicted. Another delineated wetland is pictured that was not impacted.

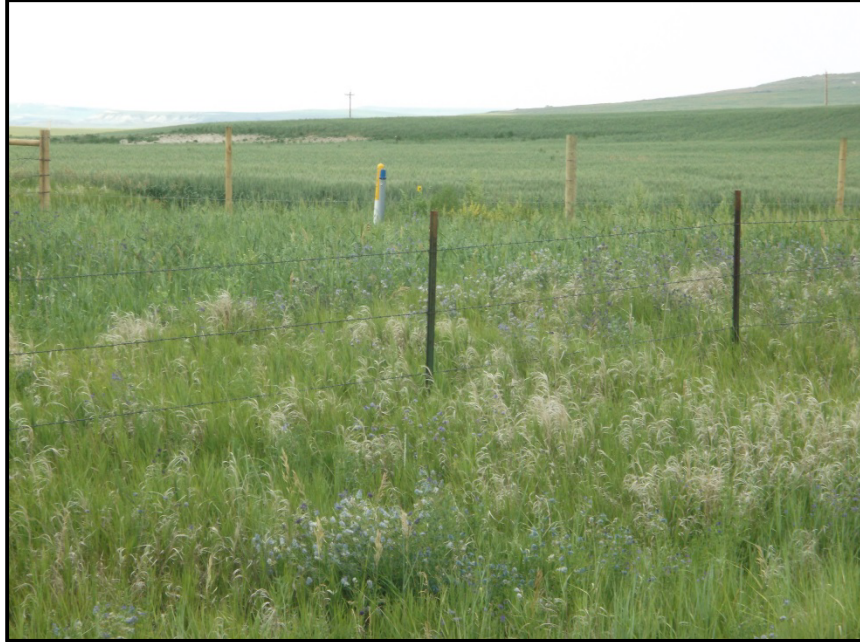
**Photo 15.** Direction: Northwest. Additional areas of agricultural property that the pipeline passes through, again no permanent impacts to farmland. Crops were mitigated appropriately. Property fences shown were repaired as necessary and were not left damaged.

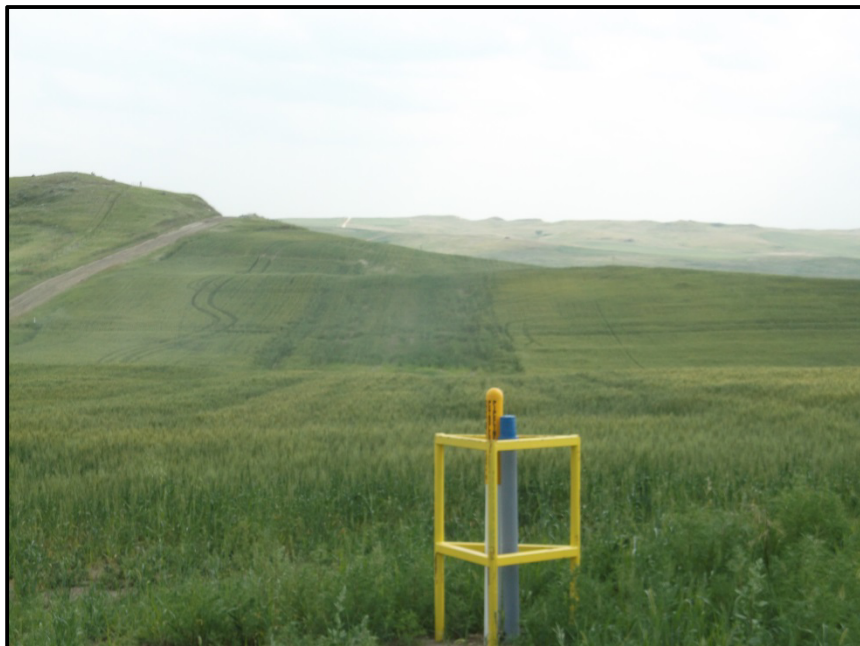
**Photo 16.** Direction: West. Additional areas of agricultural property that the pipeline passes through, again no permanent impacts to farmland. Crops were mitigated appropriately. This area of the corridor is an example of an area that has been completely reclaimed.

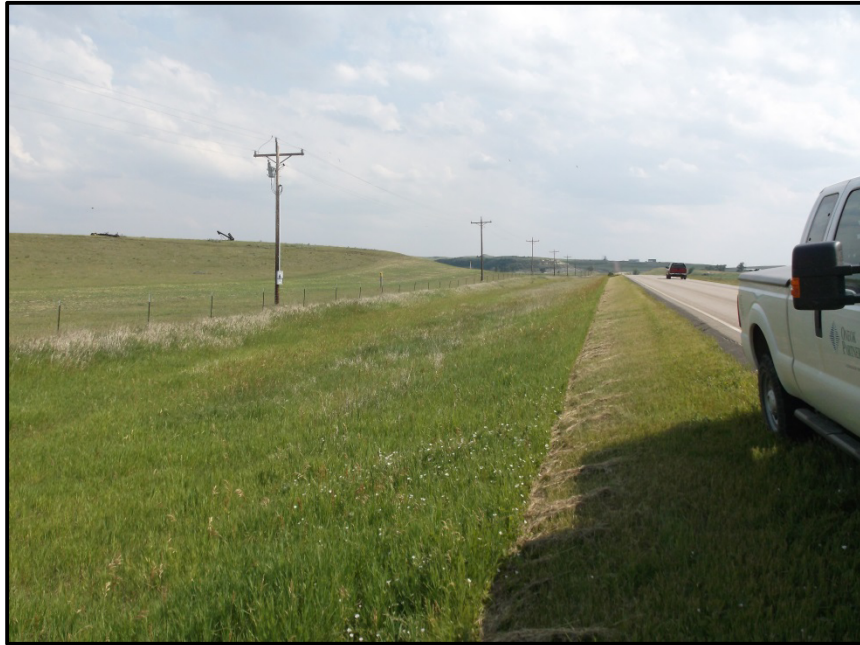
**Photo 17.** Direction: South. The pipeline runs parallel to 130 ½ Ave in the ROW which has been fully reclaimed.

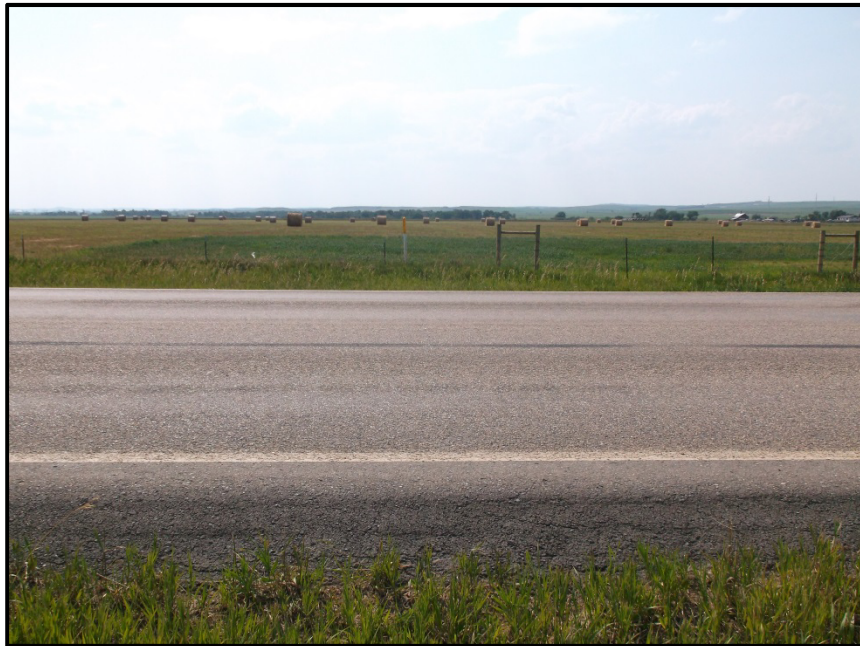
**Photo 18.** Direction: East. The pipeline then bends west and crosses 130 ½ Ave (the road was bored under) before it bends to the north and continues to run parallel to the road.

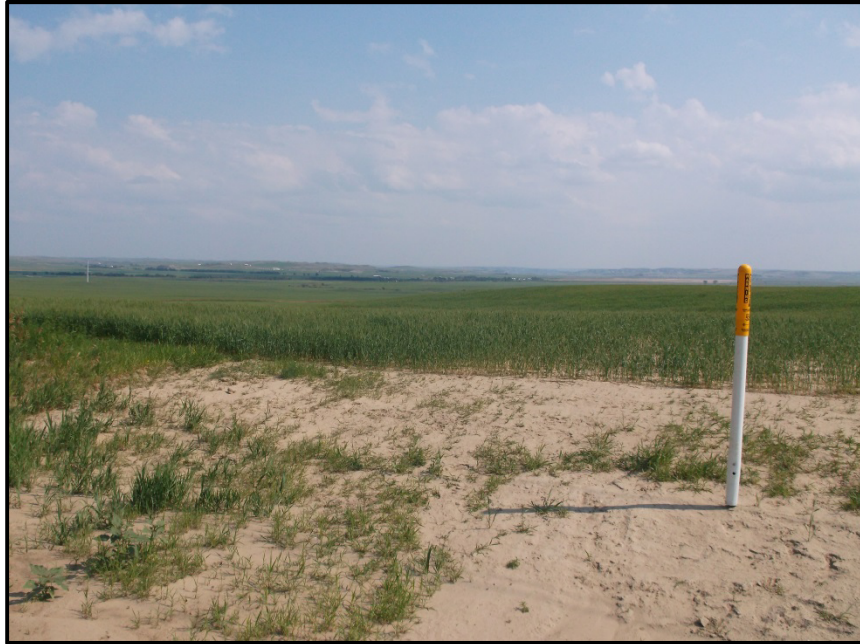
**Photo 19.** Direction: East. This marker signifies a bend to the west where the pipeline will run parallel to 20<sup>th</sup> St. This area of rural land has been restored to preconstruction conditions.

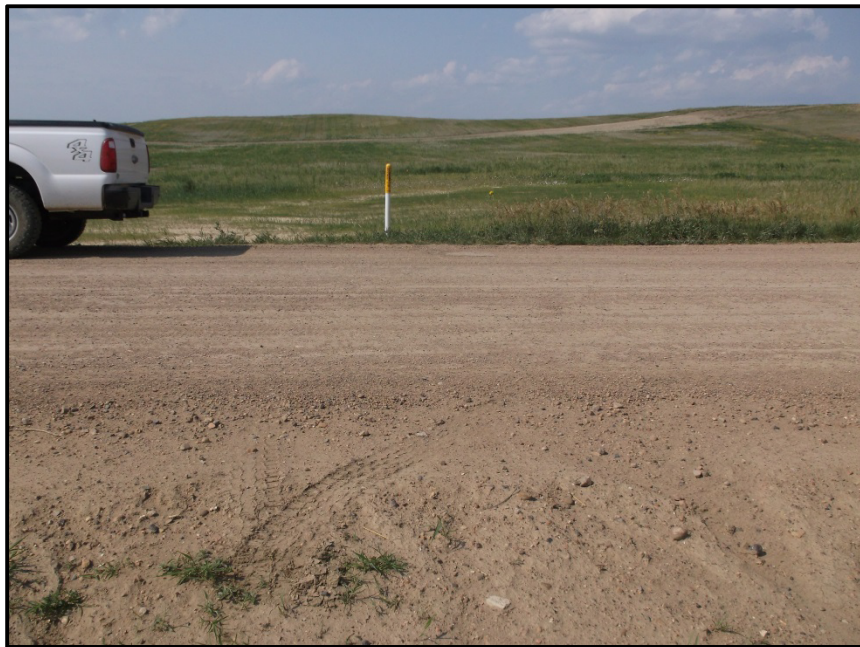
**Photo 20.** Direction: North. Depicted here is a pipeline marker along 20<sup>th</sup> St.

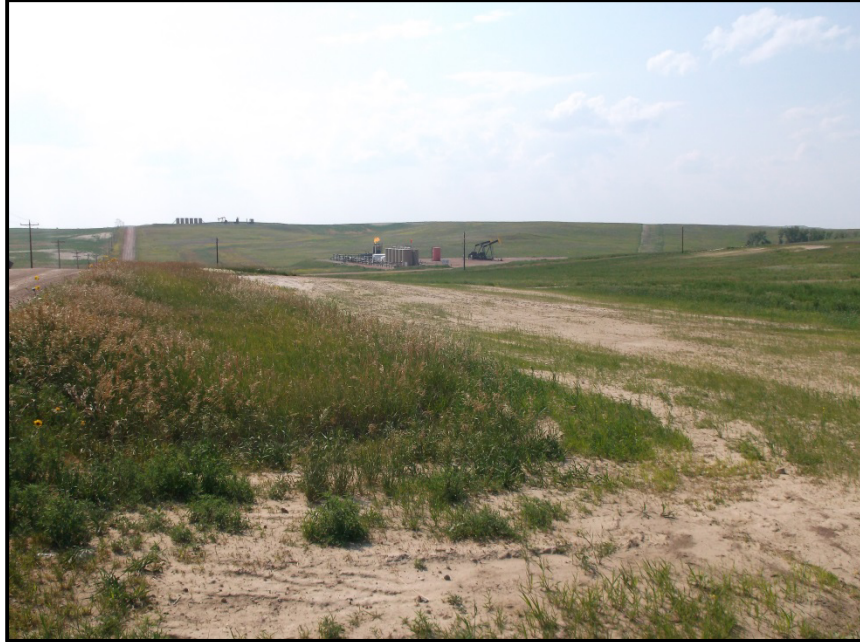
**Photo 21.** Direction: Northwest. Pipeline corridor as it bends away from parallel route along 20<sup>th</sup> St and starts running through agricultural land to the northwest. This particular area needs to be continued to be monitored until seeding takes.

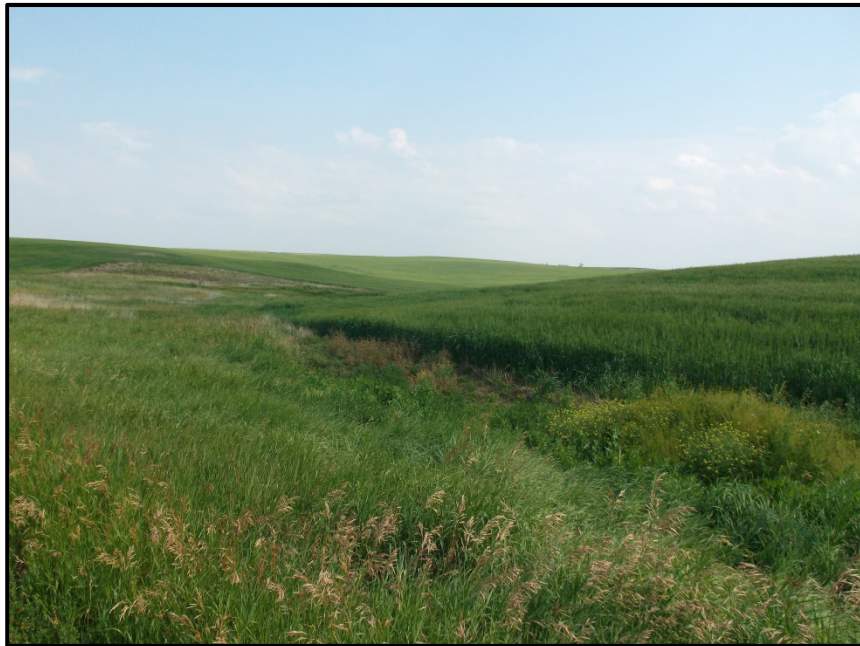
**Photo 22.** Direction: Southeast. Additional areas of agricultural property that the pipeline passes through, again no permanent impacts to farmland. Crops were mitigated appropriately. This area of the corridor is an example of an area that has been completely reclaimed. Also shown is a delineated wetland that was not impacted during construction.

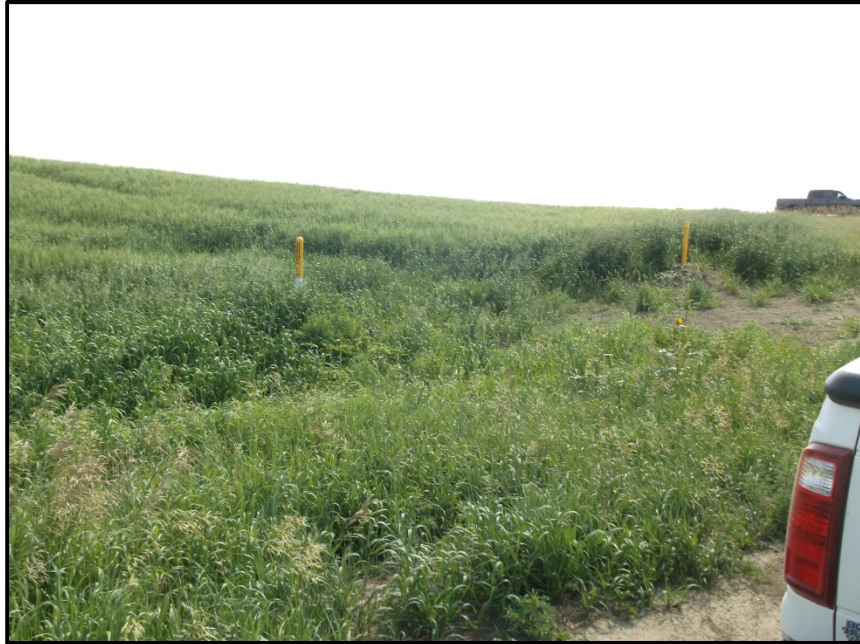
**Photo 23.** Direction: Southwest. Two pipeline markers show another part of the corridor that has been fully reclaimed as the pipeline bends back to west before bending again to the north.

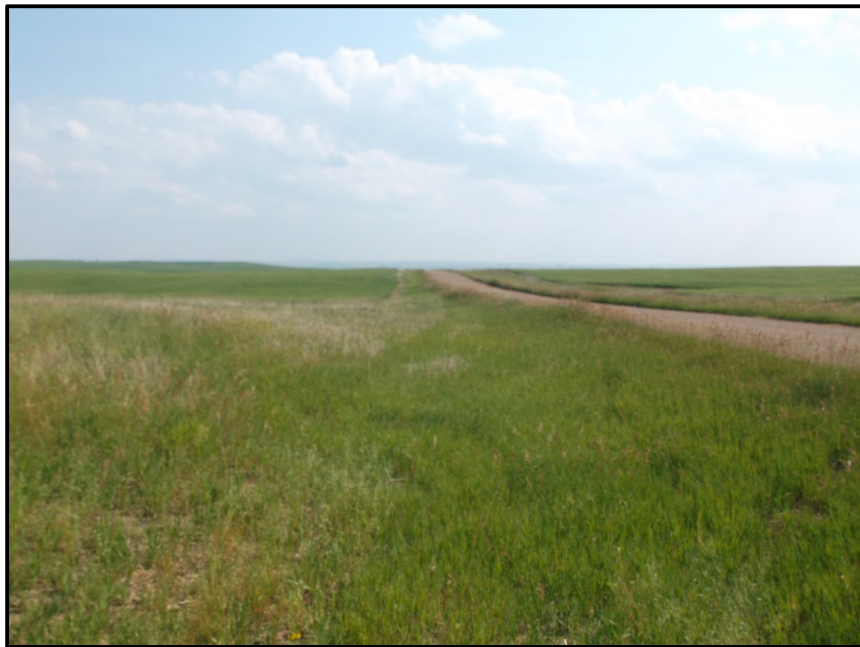
**Photo 24.** Direction: South. This is the section of the pipeline corridor that runs north and south, parallel to 133<sup>rd</sup> Ave. The ROW along the road has been completely reclaimed.

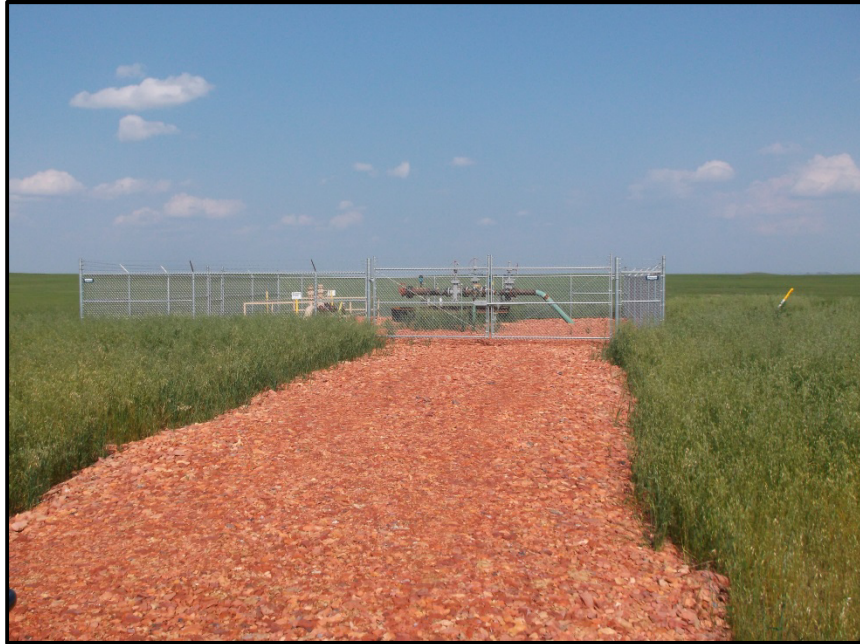
**Photo 25.** Direction: East. Pictured above is the pig receiver and the end of the Targa Lateral Pipeline Project.
