LIUNA North Dakota Investigation of Loenbro Pipeline Construction – 3/31/15

LIUNA's independent investigation of recent work by contractor Loenbro, Inc. uncovered multiple instances of poor-quality work including failure to properly implement several basic environmental, safety, and pipeline integrity measures. Our staff has documented such apparent problems as failure to install or maintain proper erosion controls; maintenance of unsafe bore pits; collapsed skids; and pipe left lying on the ground. We are concerned that these practices may not only increase the risk of spill and injury, but also damage the reputation of pipeline owners and our industry among local residents and regulators.

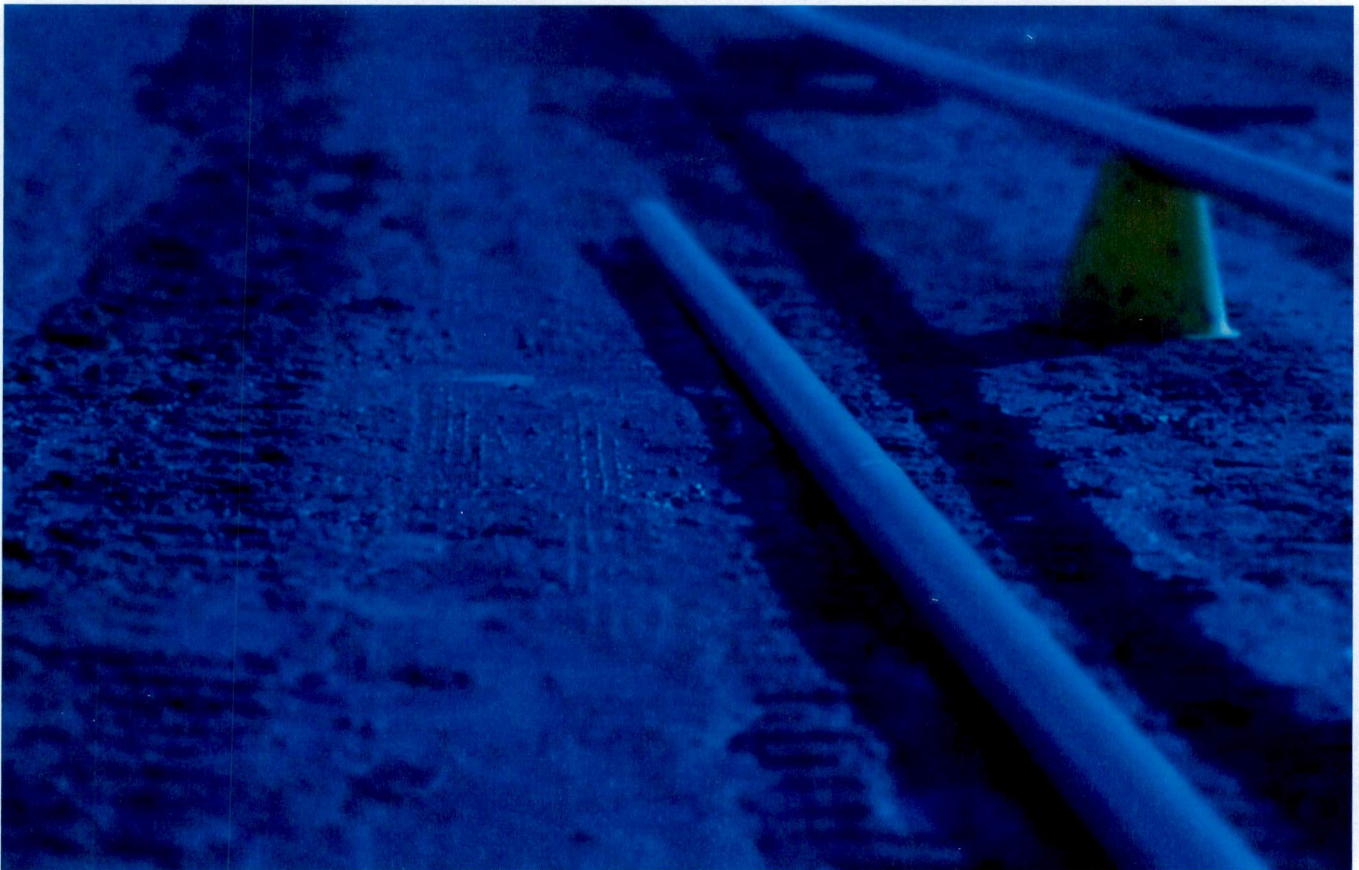
Improper handling of pipe can threaten pipeline integrity

Pipe should never be placed on the ground where rocks and dirt can scratch the factory coating, potentially causing corrosion and integrity problems down the line.

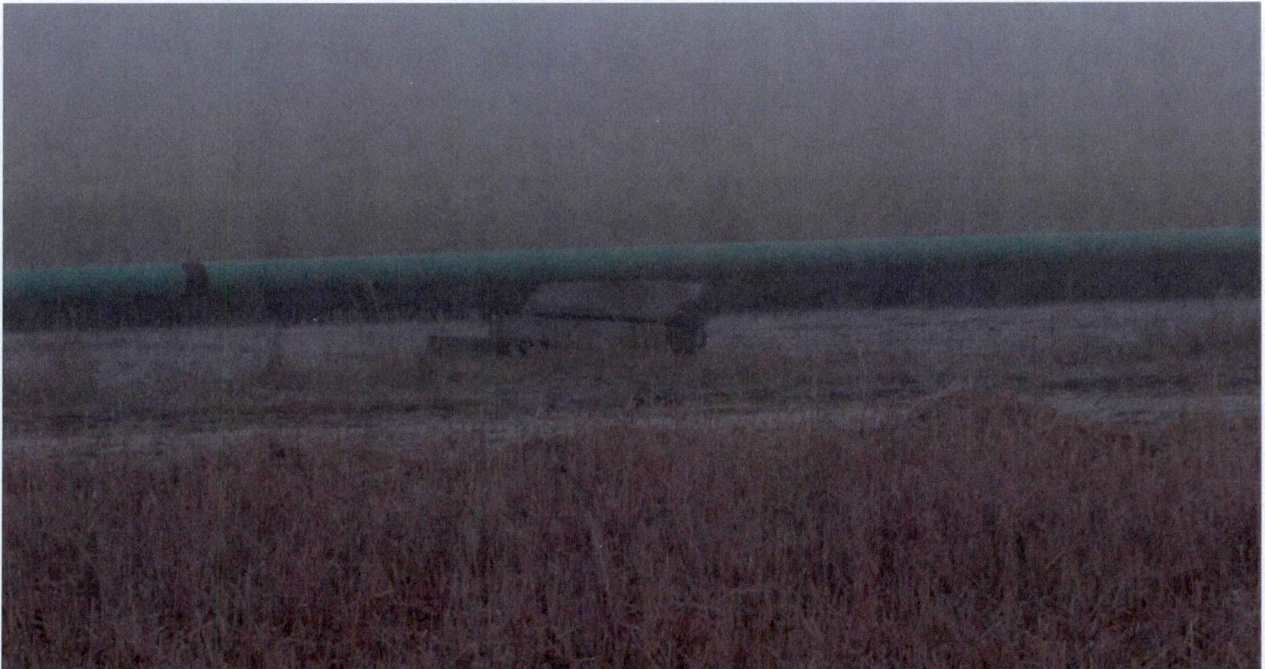
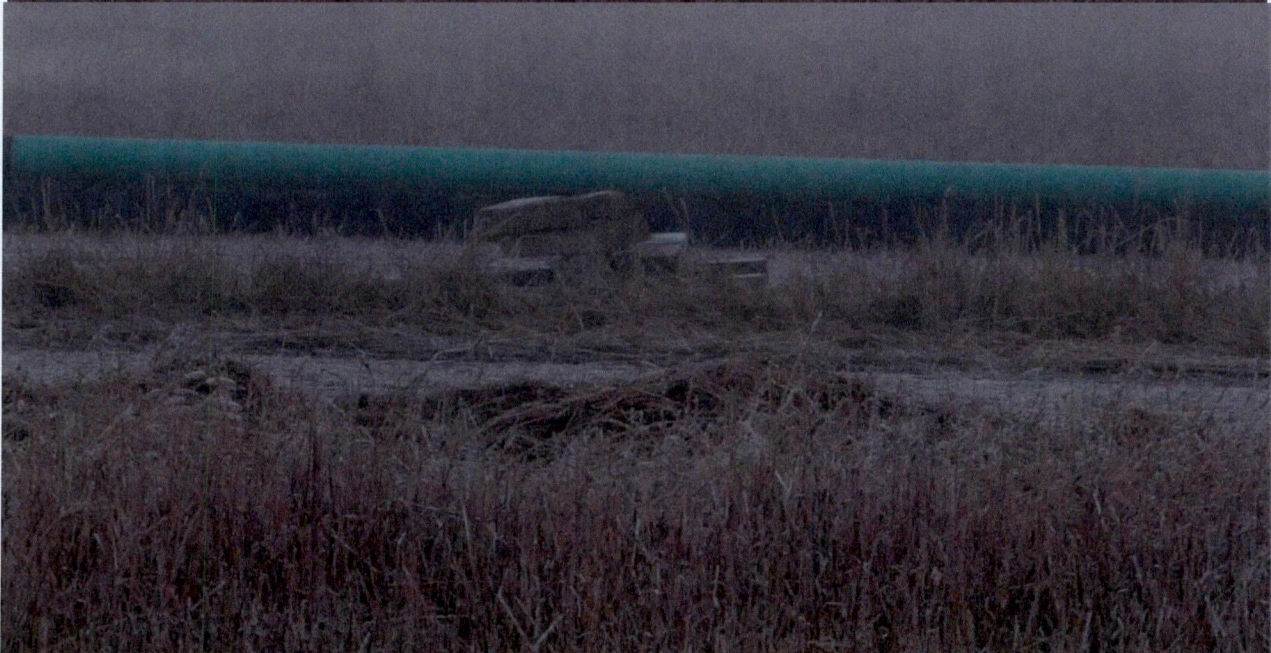
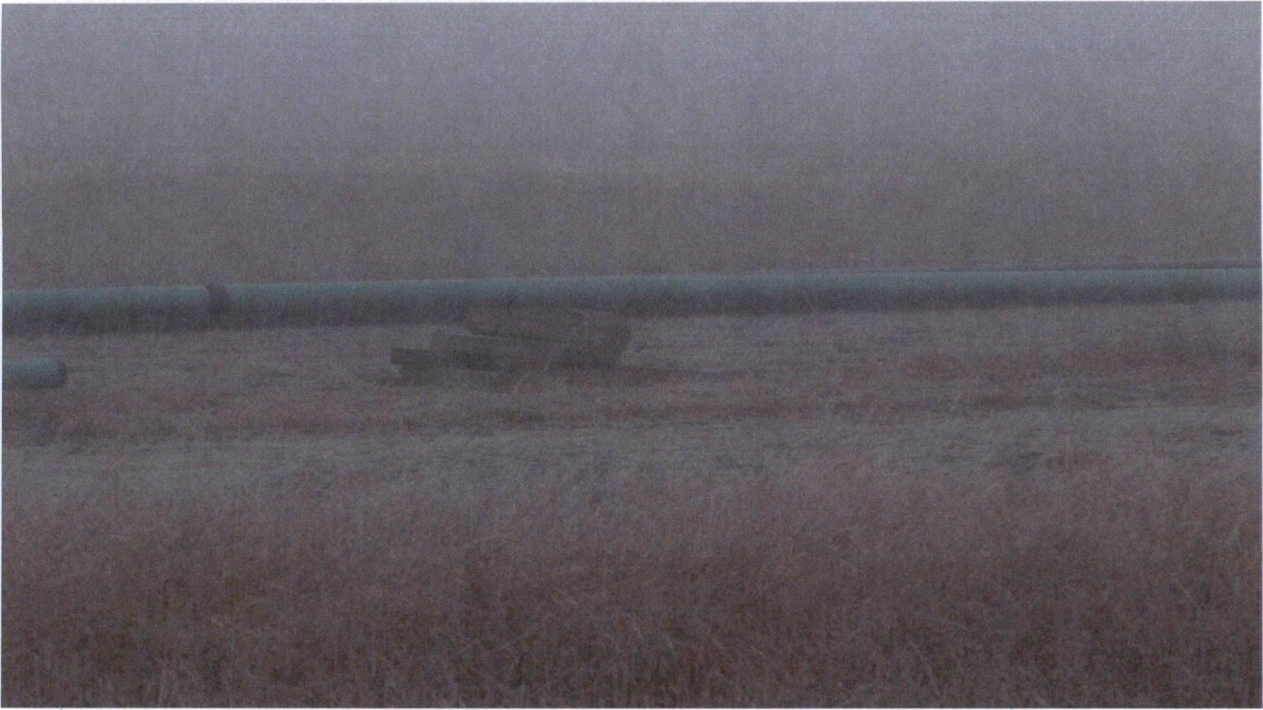
Collapsed skids are a hazard to workers, pipe integrity

Staff witnessed many collapsed skids on the project. Poorly-built and maintained skids can be dangerous to the ground crews handling even working around the pipe. Daily and weather-related temperature changes cause the pipe to expand and contract, which in turn causes the pipe to shift on the skids. A coating crew will soon be working on this pipe, and if the pipe falls during the process the results could be fatal. A fall off collapsed skids can also damage the factory coating, potentially causing corrosion and integrity problems.

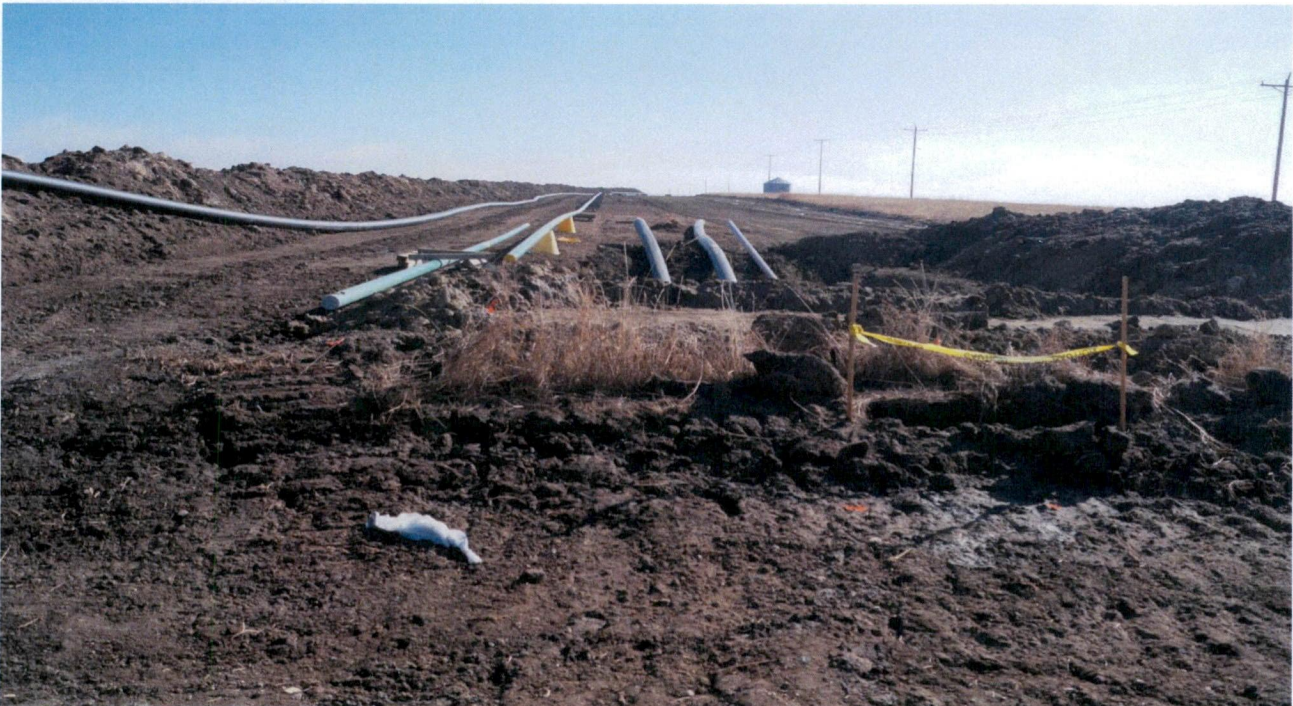
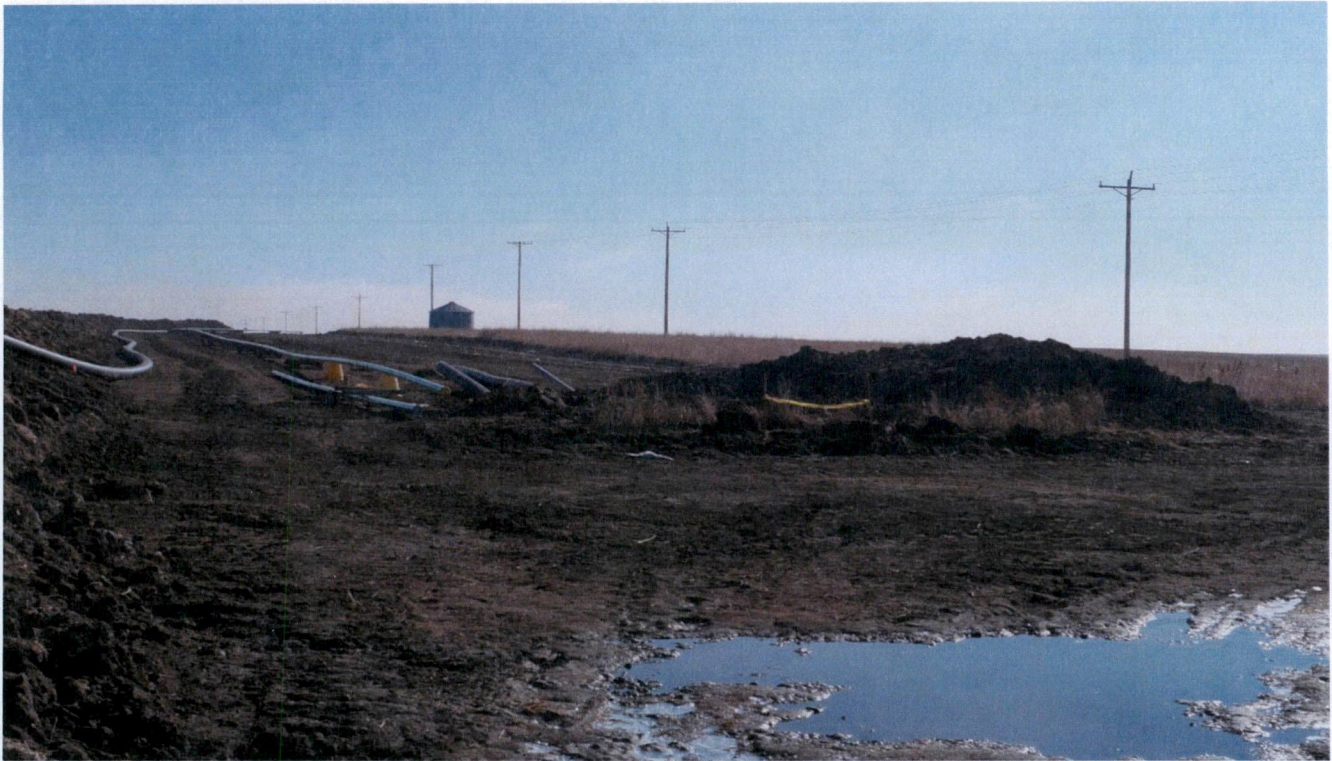
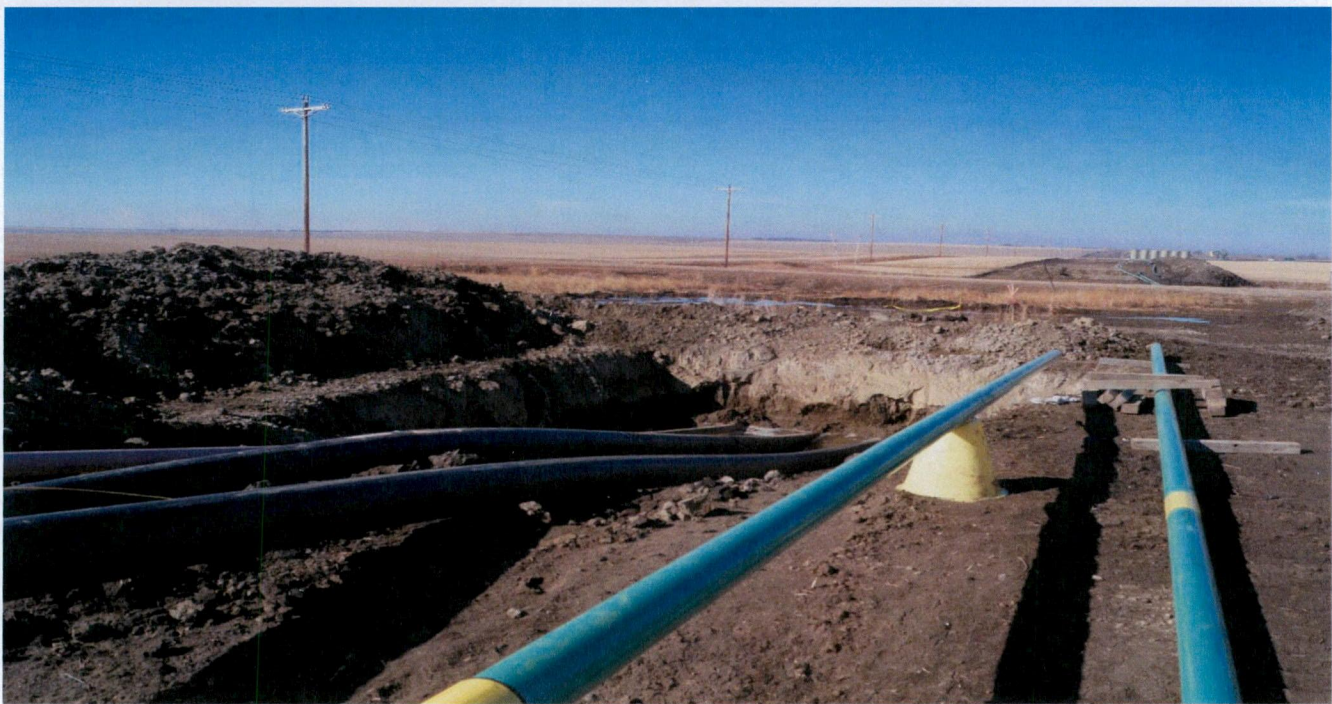
Unsafe bore pit

The following three photos depict is a bore pit from a road bore on an apparent Loenbro project. There is no safety fence around the open excavation, and the fact that it's next to the road is a danger to the public. The walls of the excavation are not sloped properly, which could result in a fatal accident for any worker enters the excavation.

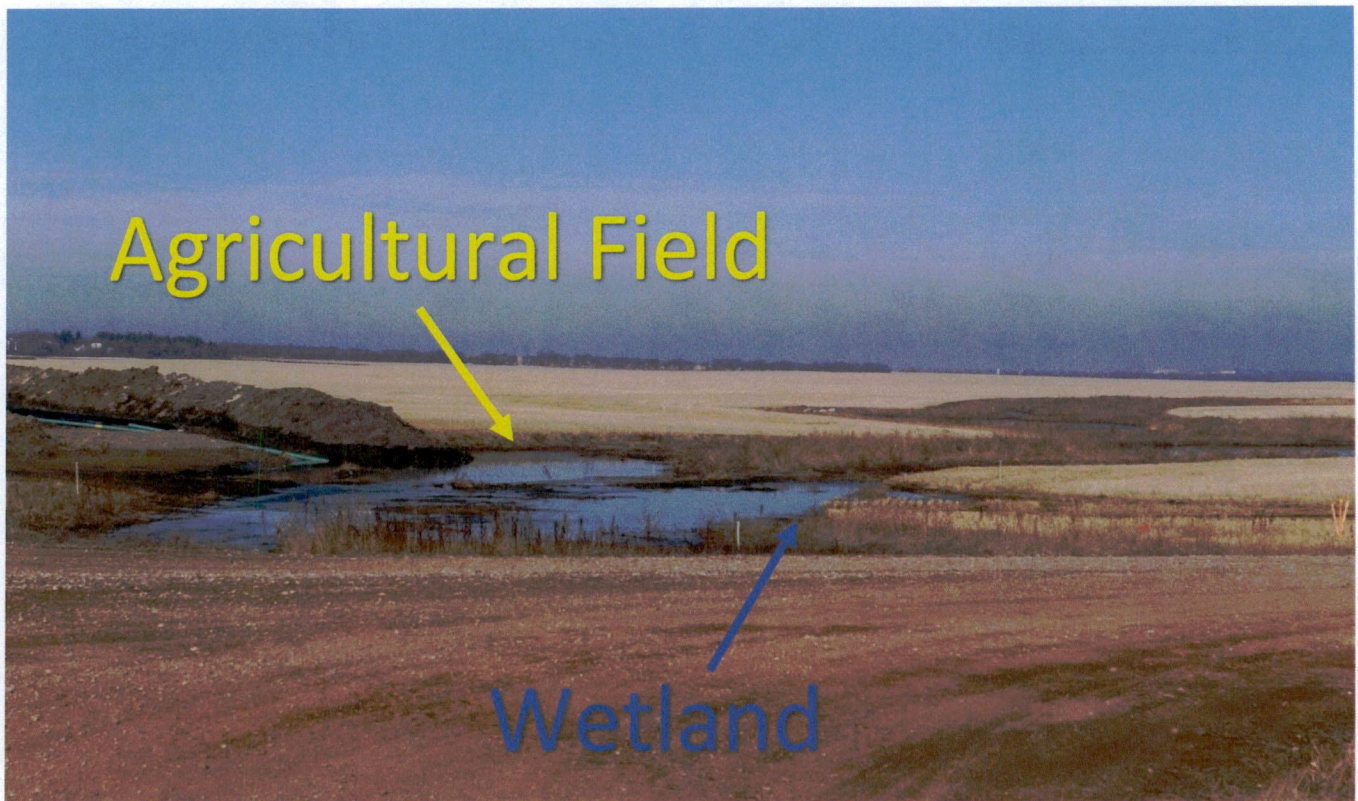
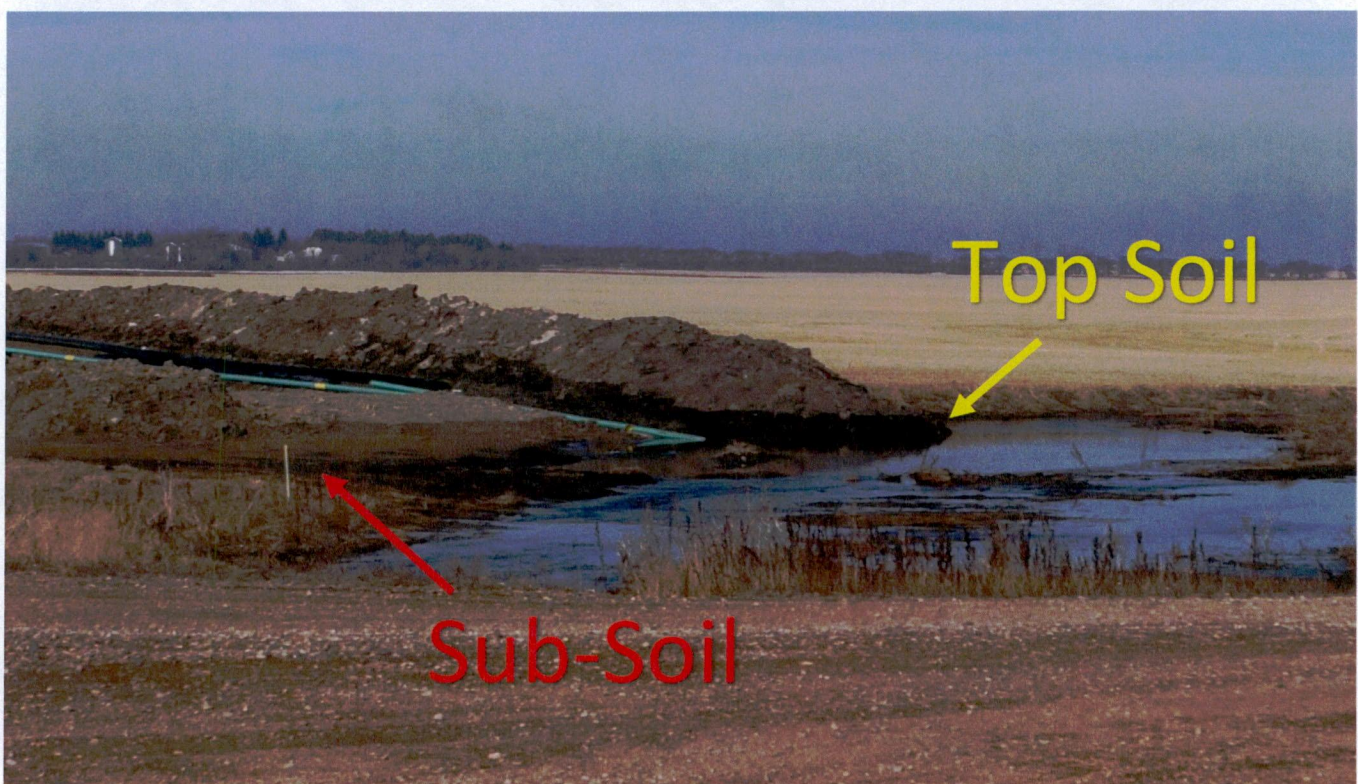
Lack of environmental controls threatens wetland, agricultural productivity

In the following photos, both top soil and sub soil are washing out into a wetland that drains into a farm field. The soil that washes through the wetland can kill wetland vegetation, while the soil washing through to the farmer's field can cause problems with crop growth and weed control. Environmental controls should have been installed to prevent soil erosion and uncontrolled runoff.
