# Bridger Crude Oil Pipeline Project As-Built Construction Inspection Report PU-15-097

*Prepared for:*  
**North Dakota Public Service  
Commission**

**WENCK Associates, Inc.**  
301 1<sup>st</sup> Street NE, Suite 202  
Mandan, ND 58554  
Phone: 701-751-3370  
Fax: 763-479-4242

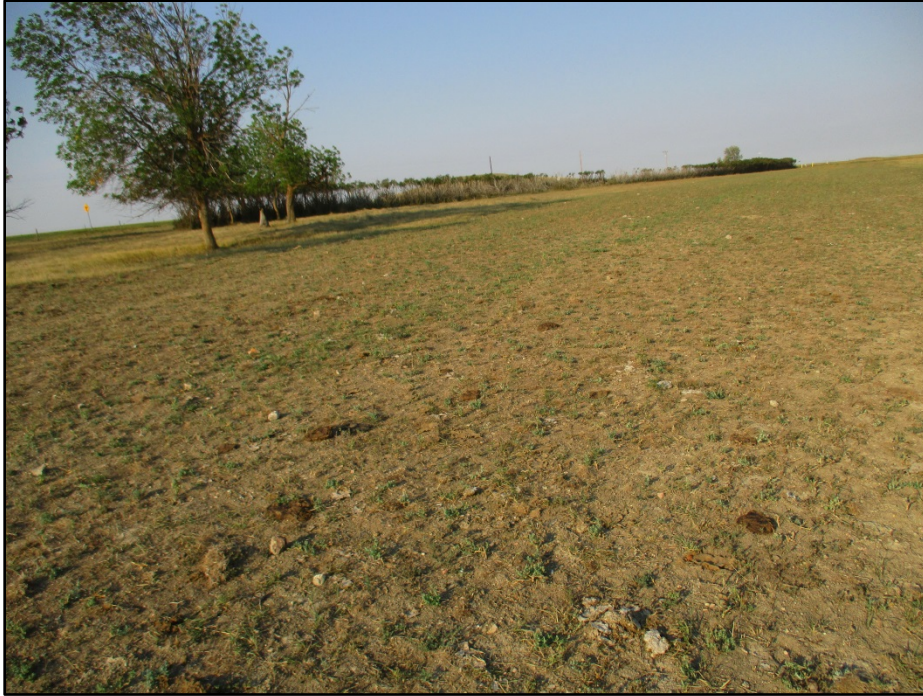
**Photo 1.** (GPS Point #460) – ROW near tree row, trees were not removed at this location; some grasses starting to grow with a few rocks throughout in an area of rangeland. Area has been grazed. Direction: West.

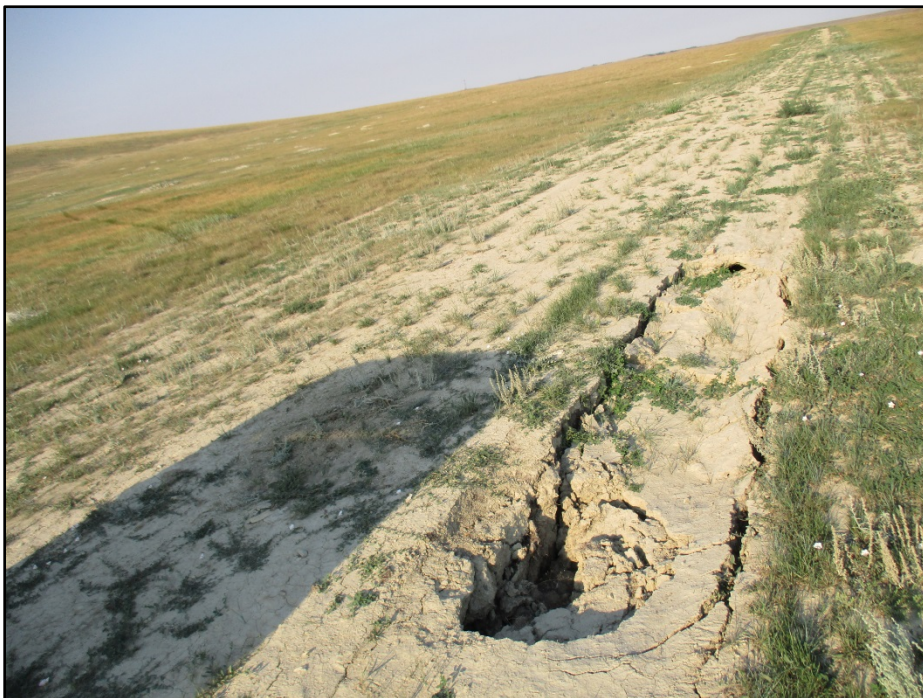
**Photo 2.** (GPS Point #461) – Soil subsidence in grassland on USFS lands. This area will need to be restored. Bridger is aware of this and will address the settling issue soon. Notice the narrow ROW, this area was double ditched as requested by the U.S. Forest Service. Direction: West.

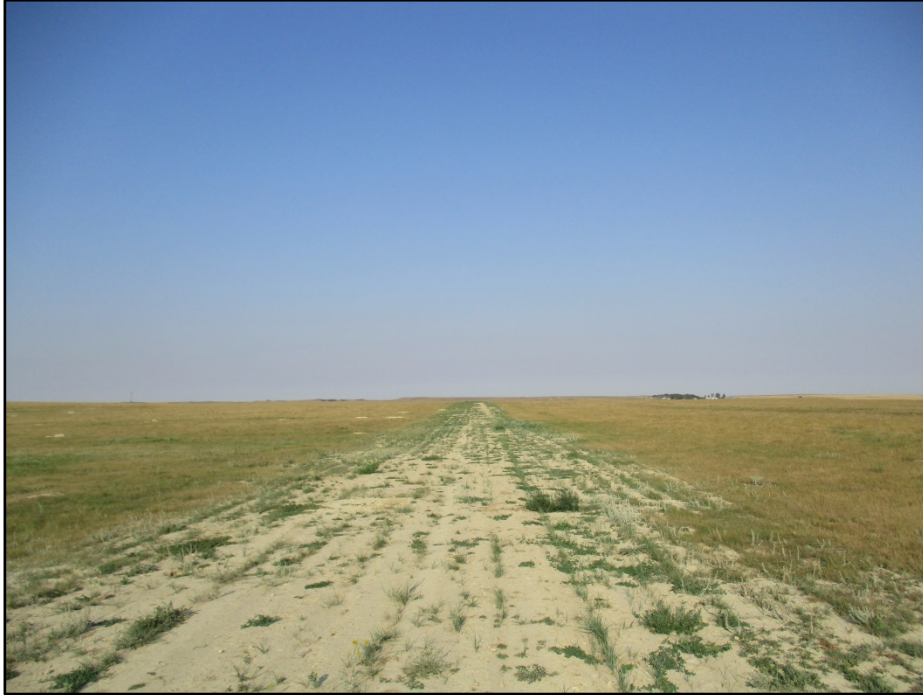
**Photo 3.** (GPS Point #461) – Notice the very narrow ROW, far less than the typical 100 or 75ft ROW. This area was double ditched, not top-soiled, as requested by the U.S. Forest Service. There are a few prairie dog holes along this area. Direction: West.

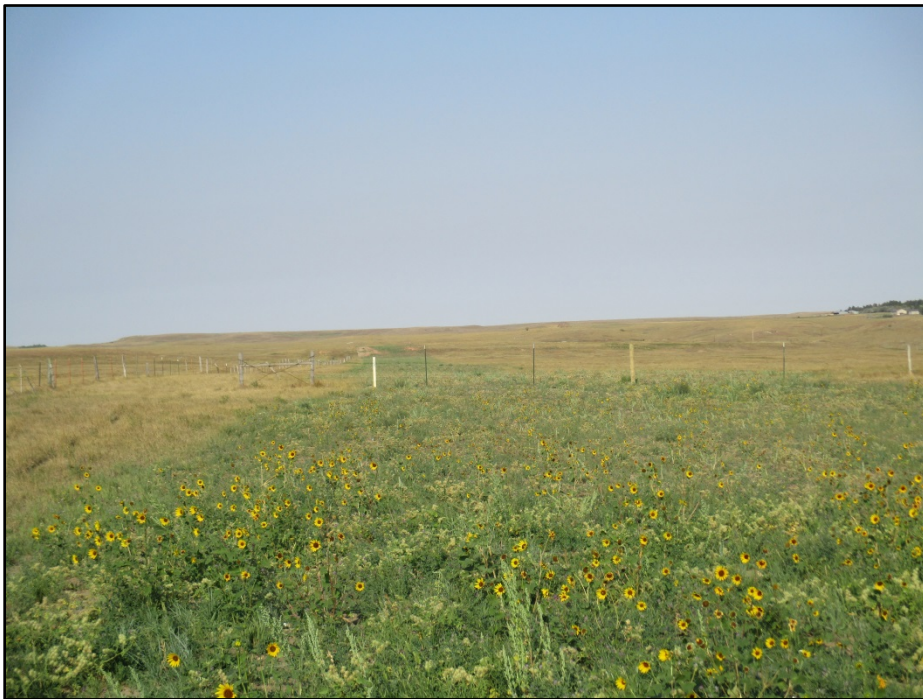
**Photo 4.** (GPS Point #462) – ROW in pasture land with grasses and many wild sunflowers growing. Wild sunflowers are common in disturbed areas; they will likely be abundant in year 1 and 2 along the ROW in this area. Fence was replaced/fixed in the background. Direction: West.

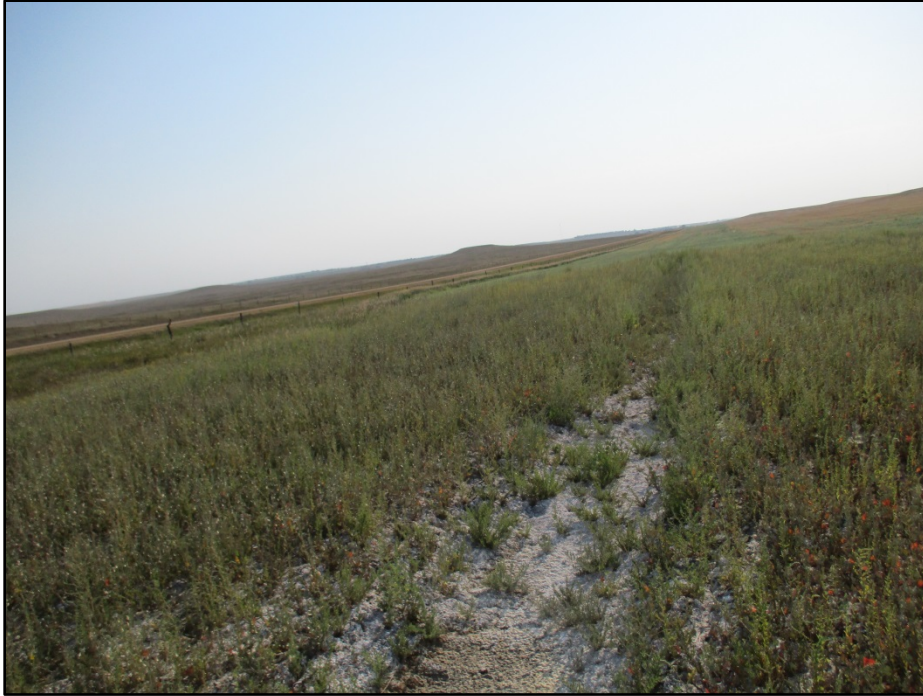
**Photo 5.** (GPS Point #464) – White alkaline area. Inspector stated this area was often soggy and difficult to deal with; also it was likely broadcast seeded (not drilled). Native vegetation appears to be coming in well in most areas, with the exception of an area with white crusts near pipeline centerline. Small amount of soil subsidence was observed.

Direction: East.

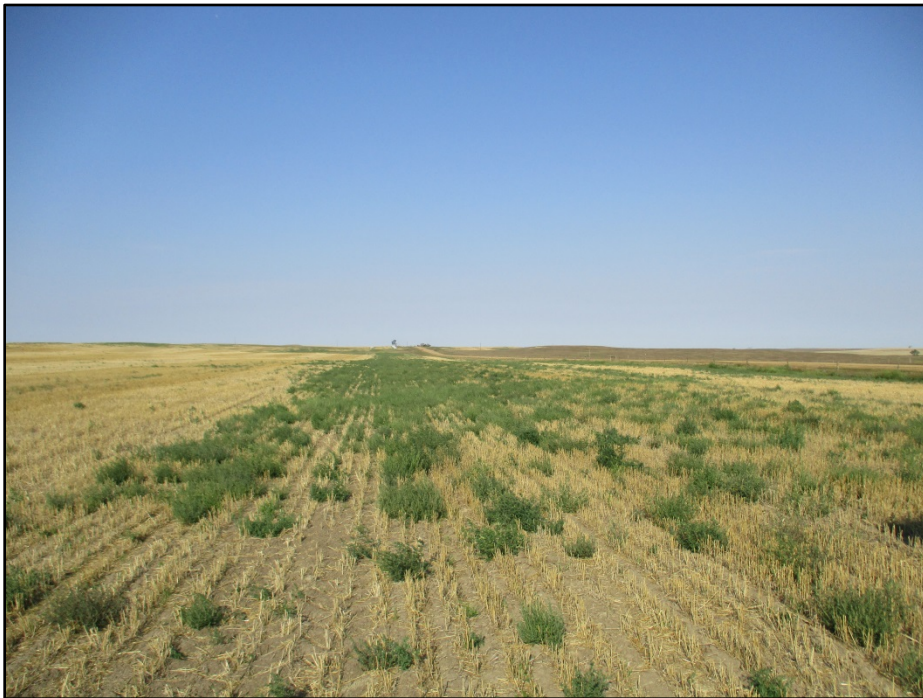
**Photo 6.** (GPS Point #465) – Pipeline ROW goes through a wheat field. Weeds observed as more abundant in ROW compared to outside of the ROW. Direction: West.

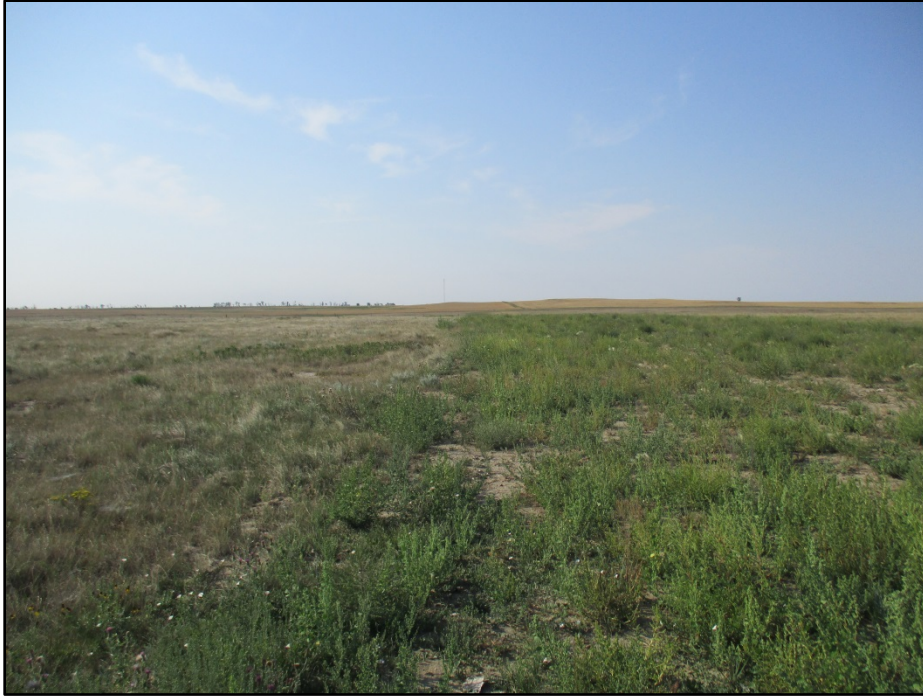
**Photo 7.** (GPS Point #466) – Pipeline ROW to the right of photo in pasture/rangeland, with an abundance of weeds, some foxtail barley and grasses. Direction: South.

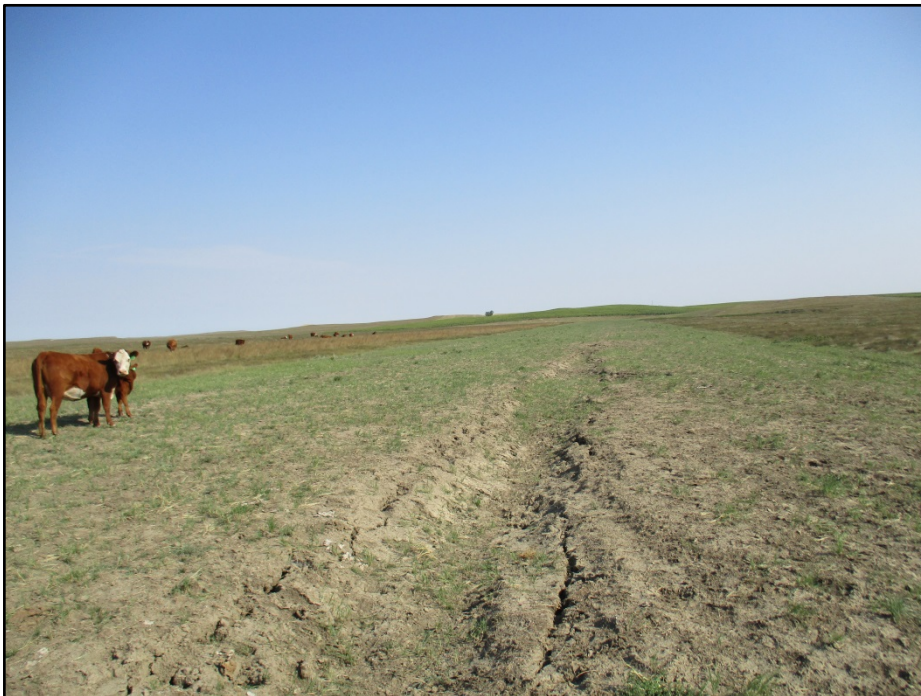
**Photo 8.** (GPS Point #467) – ROW through pasture that was being grazed. Soil subsidence observed. Some grasses growing. Bridger is aware of soil subsidence areas and is waiting till crops have been harvested from the project area before they go in to fix these areas. Direction: North.

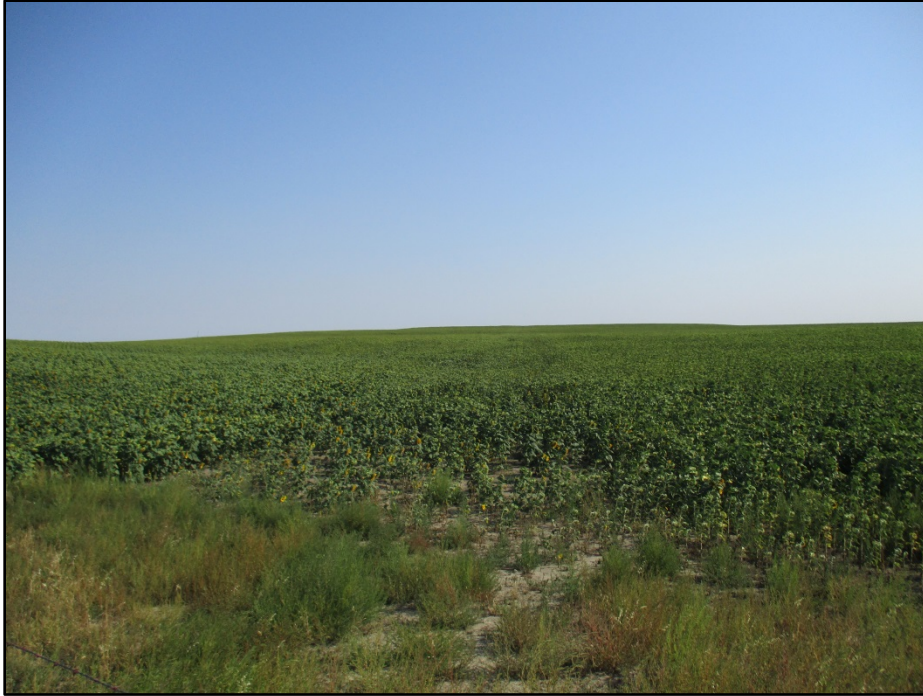
**Photo 9.** (GPS Point #468) – ROW going through a sunflower field. Plants look slightly shorter and less dense within the ROW compared to the adjacent portions of the field.  
Direction: Northeast.

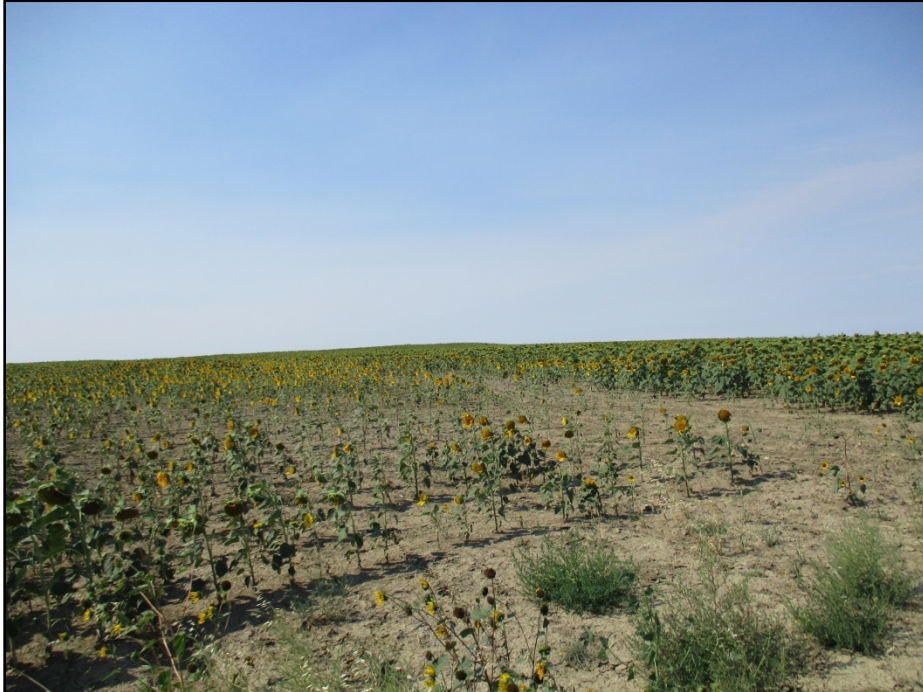
**Photo 10.** (GPS Point #471) – Other side of the sunflower field. The inspector stated that Bridger was doing restoration work on this area in the spring because a gully had started to form along this area (not in the trench line) due to rain. The farmer was able to plant but was unable to fertilize the area. Direction: Southwest.

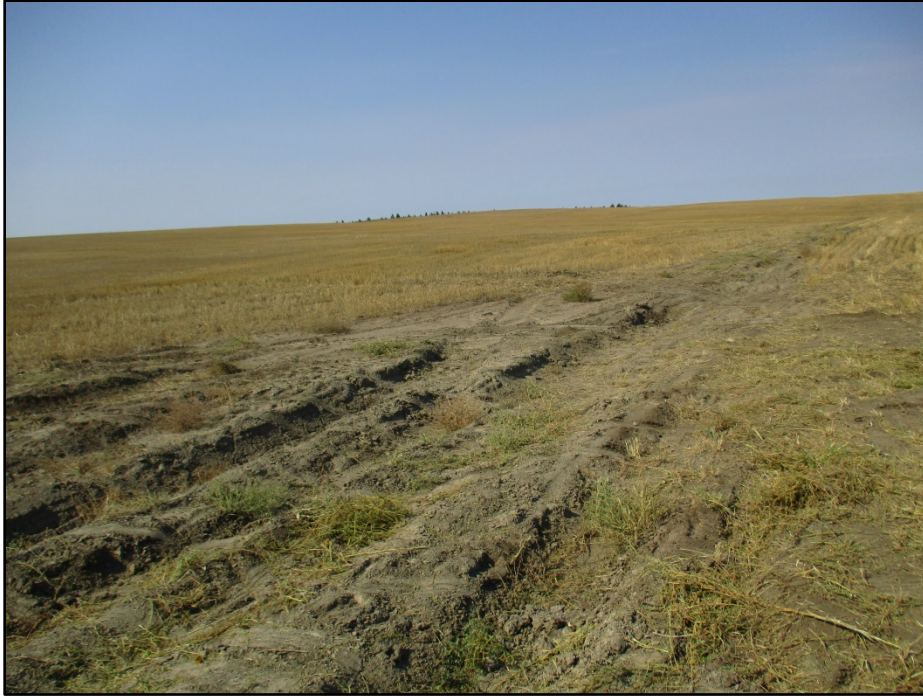
**Photo 11.** (GPS Point #469) – Wheat field with soil subsidence and ruts. This area along the edge of the wheat field was unable to be planted. The company is aware of this area and will be addressing it soon. Direction: West.

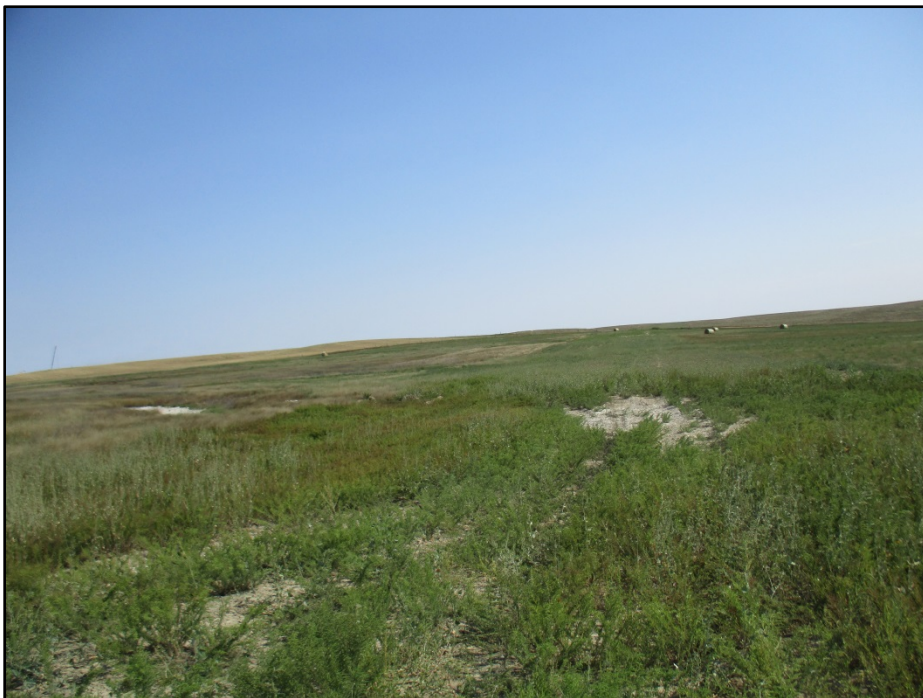
**Photo 12.** (GPS Point #470) – Pipeline ROW is paralleling another pipeline (to the left). This area had white alkaline crusts on surface; note white spots in right center of photo and in the left center of photo within parallel pipeline's ROW. Direction: Northeast.

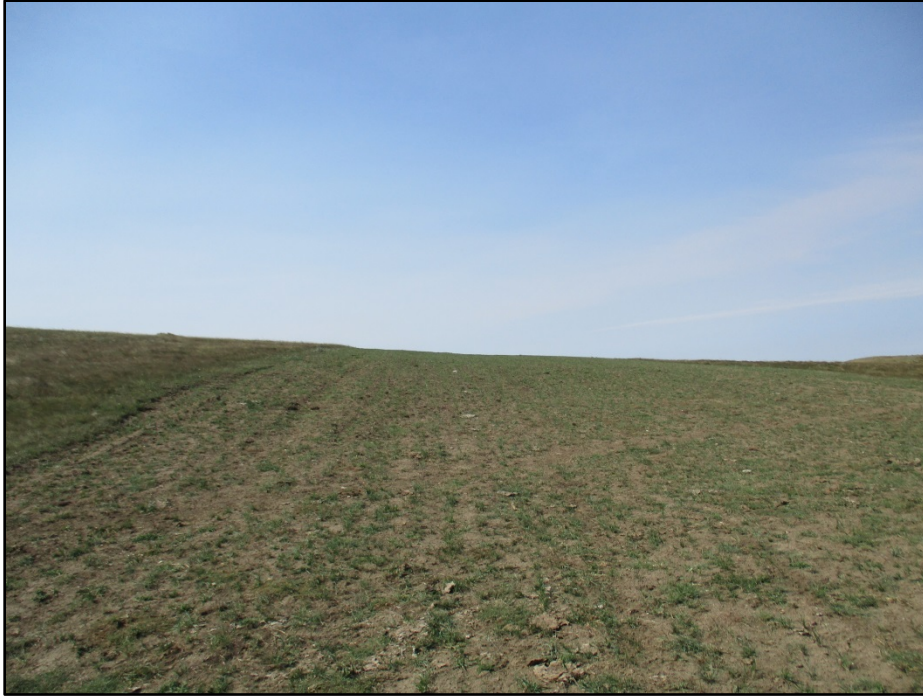
**Photo 13.** (GPS Point #472) – Pipeline ROW in pasture/rangeland; this area has been grazed. Some grasses were growing. Contours appeared to match up well on sloping hills.  
Direction: Northeast.

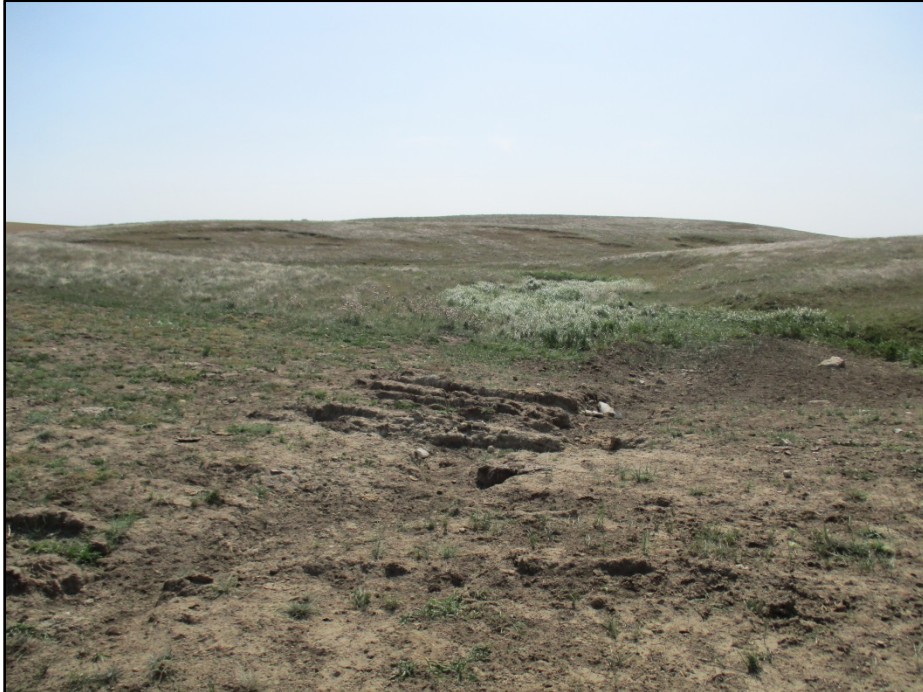
**Photo 14.** (GPS Point #473) – Upland drainage area, which has started to erode. Area will need to be fixed and erosion control devices should be added. Bridger is aware of this location and will be addressing and should provide documentation to PSC.

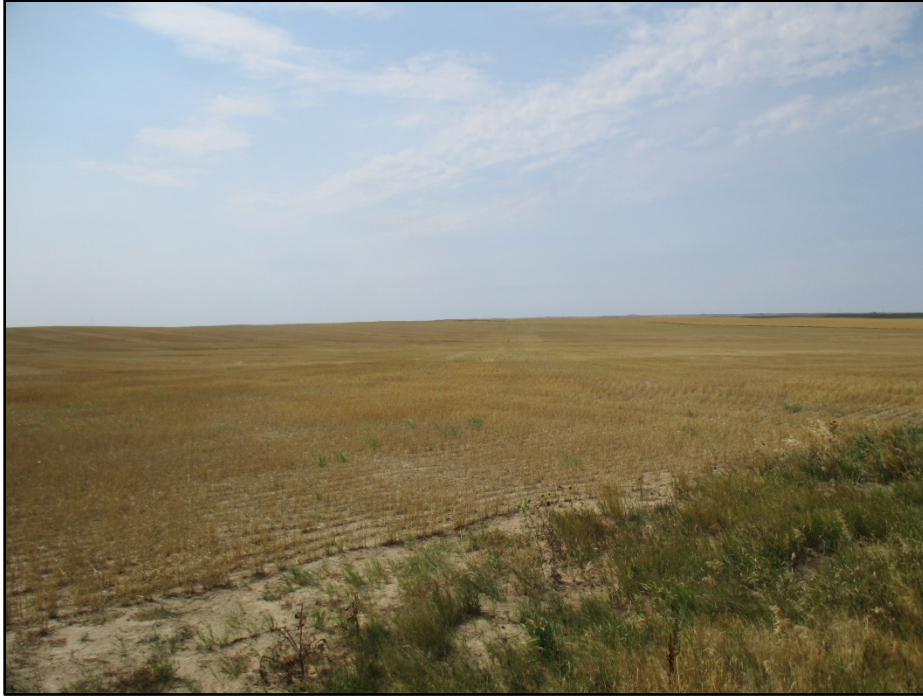
**Photo 15.** (GPS Point #475) – Pipeline ROW goes through wheat field (center of photo). Area looks good. Direction: South.

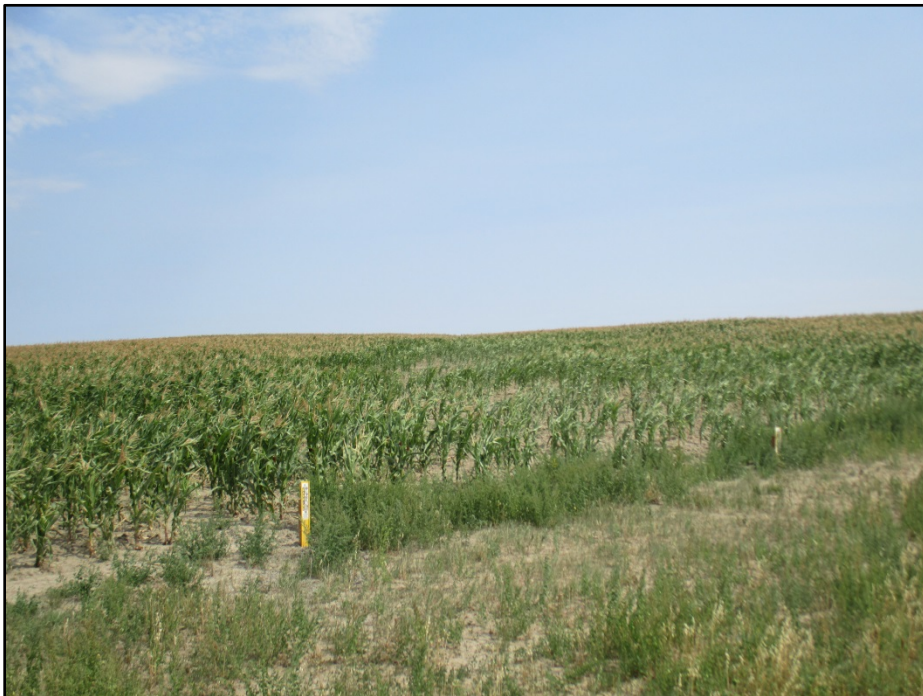
**Photo 16.** (GPS Point #475) – Pipeline ROW, goes through a corn field. The stand of corn plants appeared thinner and were stunted in growth (shorter) compared to adjacent part of the field. Direction: North.

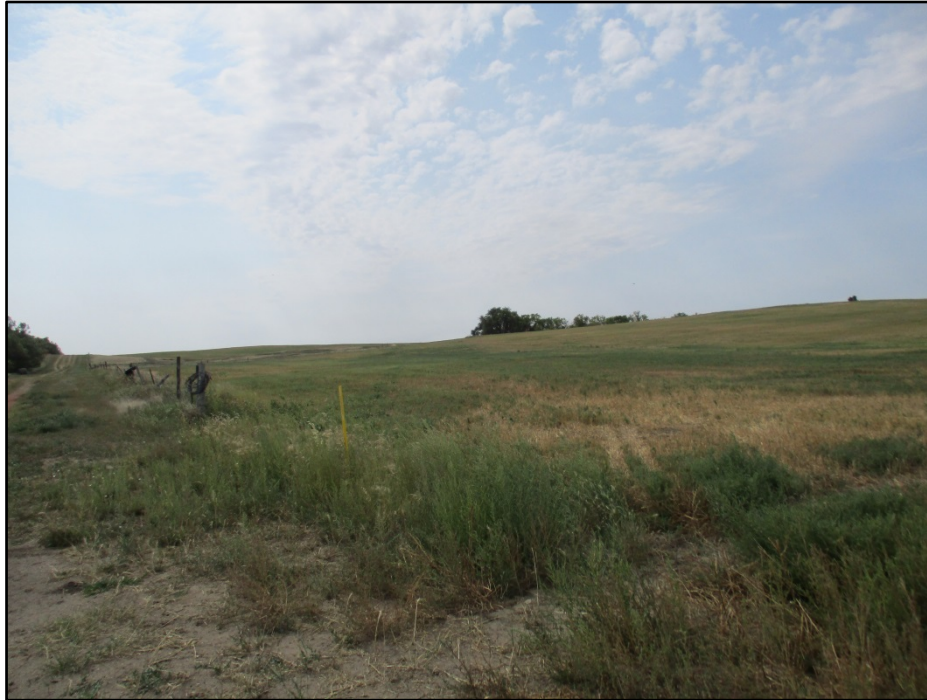
**Photo 17.** (GPS Point #476) – Pipeline ROW going through field. Direction: South.

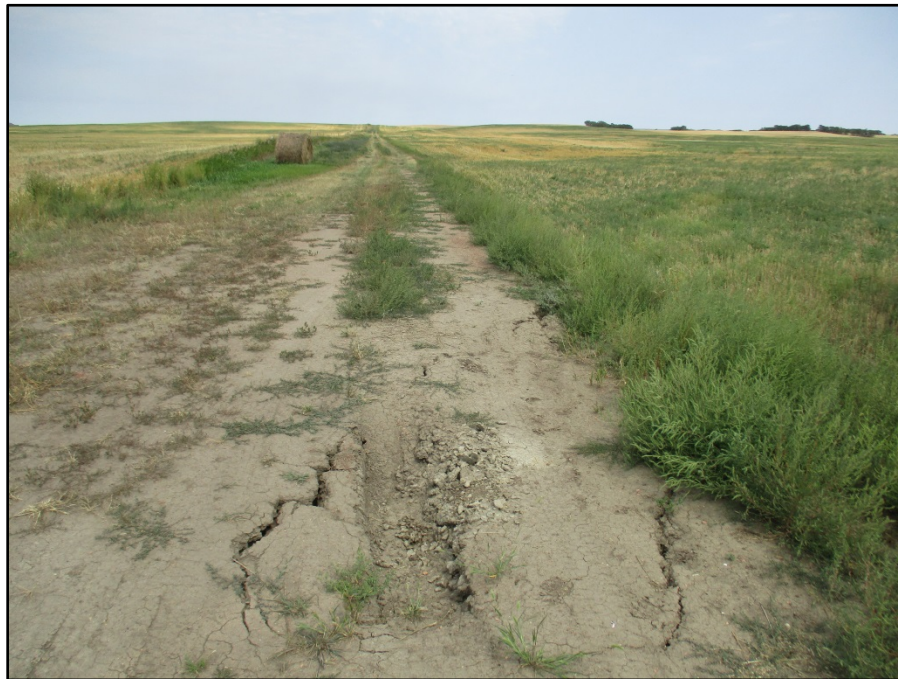
Monthly construction reports indicated that cleanup and reclamation had occurred concurrently with construction activities (Docket #44, 45, 47, 49, Monthly Construction Reports). At the time of the inspection, the pipeline trench had been backfilled, soils had been recontoured, and reseeding had been completed in May 2016. Roads within the Project area that were bored under appeared to be in good condition and properly maintained. There was one "two-track" road that had some soil subsidence that needed to be fixed; the company was aware of it and has plans to fix it in the near future (**Appendix A**, Photo 18). The company should document their compliance and provide to the PSC.

**Photo 18.** (GPS Point #476) – Pipeline ROW veering off to the right of photo. The two-track road is an unimproved section line. The company used bore pipe here and went down deeper than the typical ROW (as needed for an unimproved section line). There is soil subsidence in road area. The company is aware of this soil subsidence and will be addressing it soon. Direction: North.

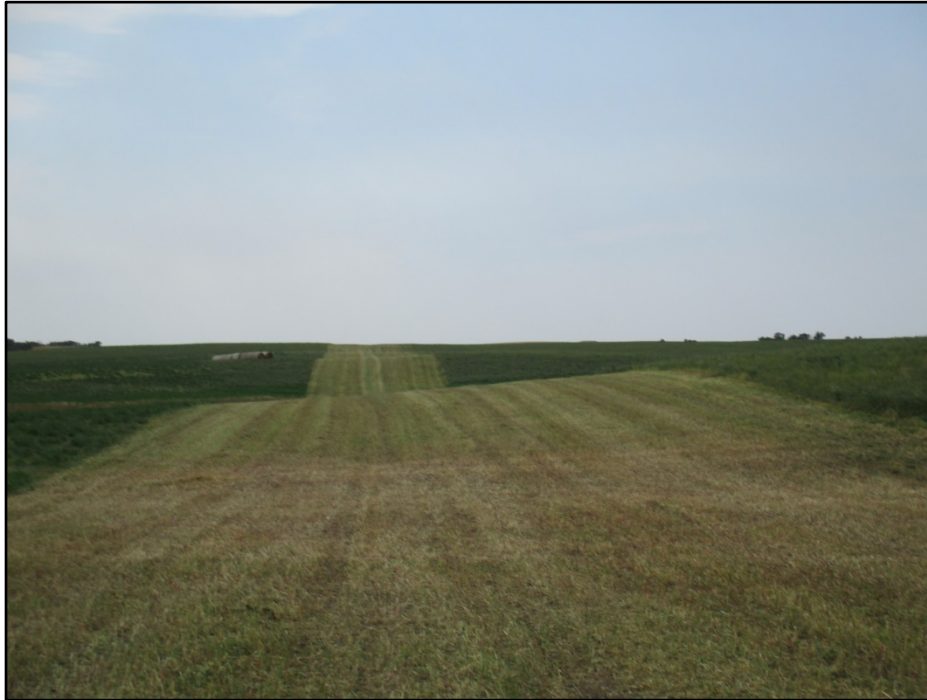
**Photo 19.** (GPS Point #477) – Pipeline ROW in hay field that has been recently mowed (part of easement, used to help control weeds). Direction: Southwest.

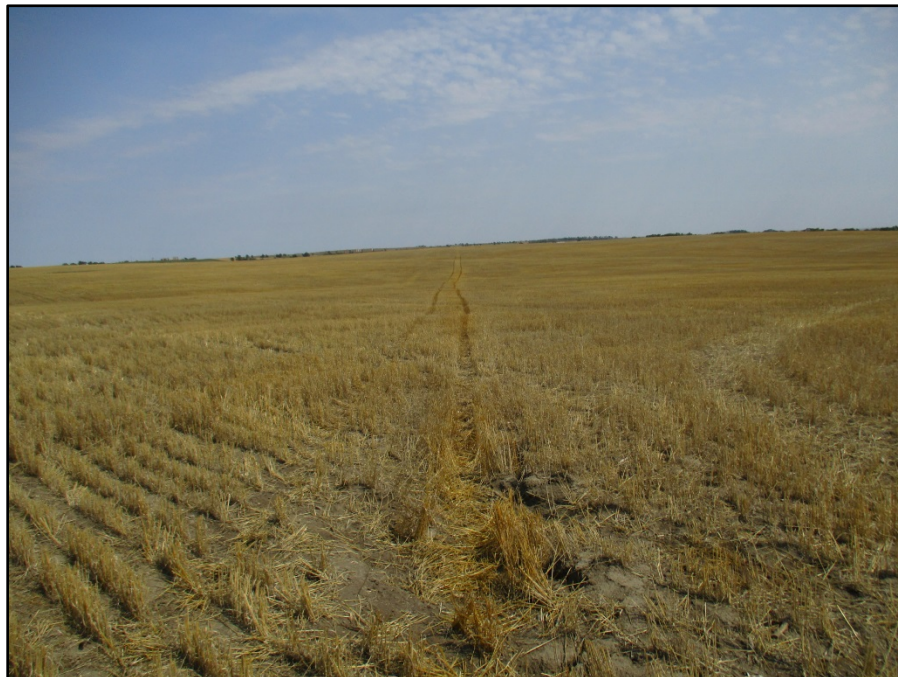
**Photo 20.** (GPS Point #478) – Pipeline ROW through a wheat field that had some soil subsidence. Inspector stated this will be fixed when all crops have been harvested from project area. Direction: Northeast.

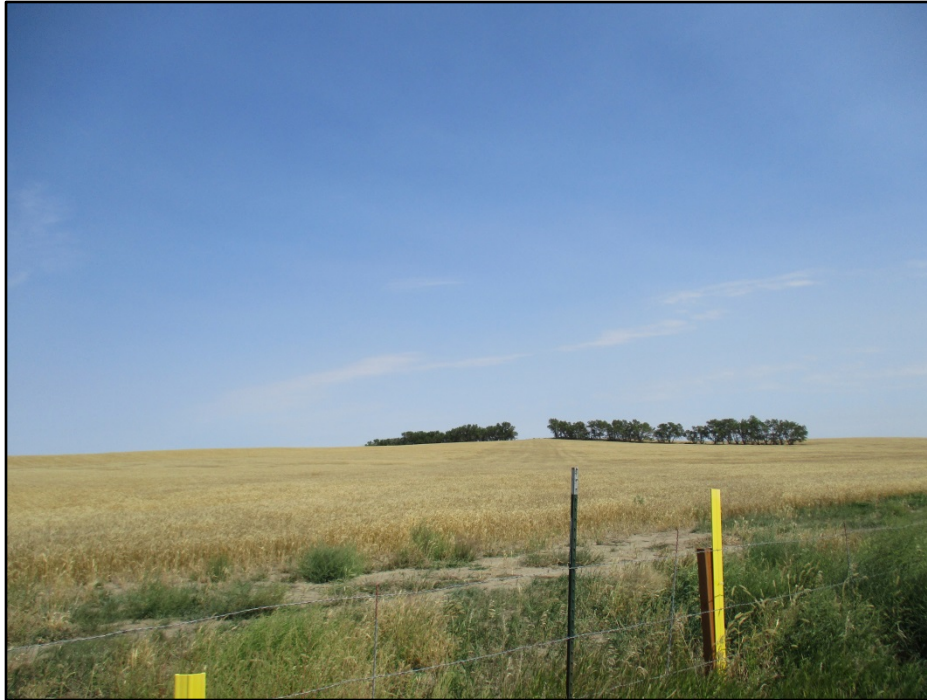
**Photo 21.** (GPS Point #479) – Pipeline ROW through wheat field. The crop within the ROW appeared to be growing similarly in size and density to the adjacent part of the field, indicating proper soil replacement and restored function. Direction: Northeast.

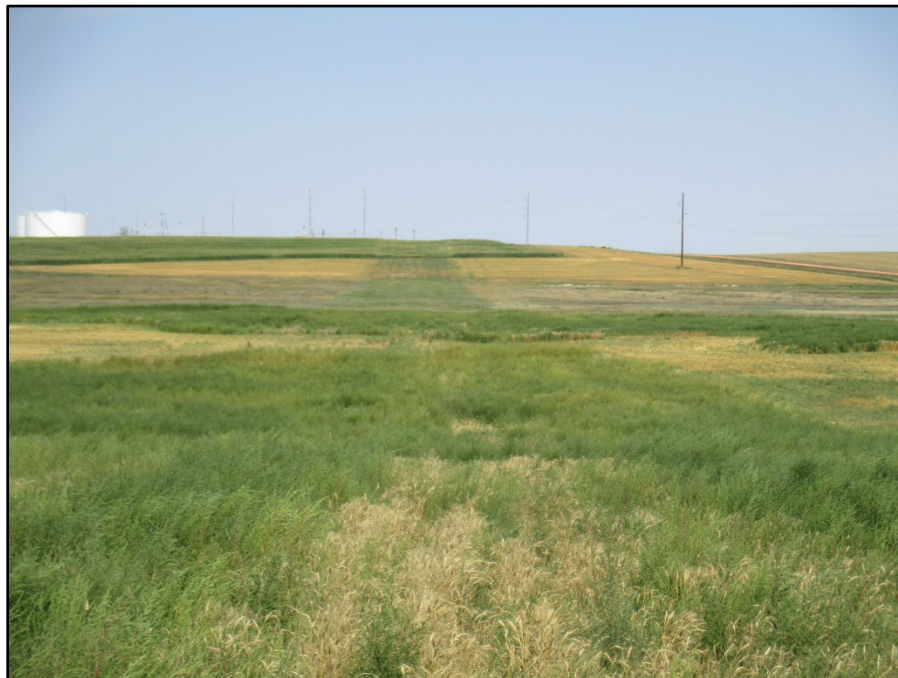
**Photo 22.** (GPS Point #480) – Pipeline ROW connecting to Skunk Hill Station (to the left of photo). Note higher density of annual weeds and visible difference in vegetation through cropland within this portion of the ROW. Direction: North.
