# LONESOME CREEK NGL PIPELINE PROJECT (PU-15-137) Permit Compliance Final Inspection Report

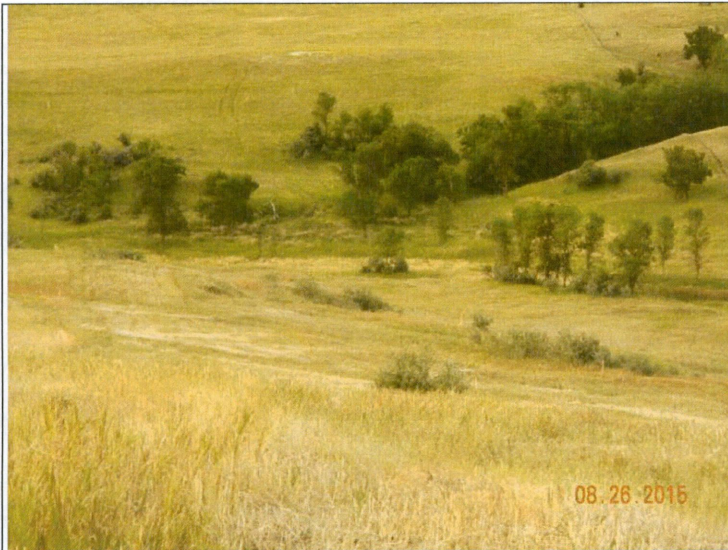
**Photograph 1:** Viewing southward from Sta. 108+00 (MP 2.0) at approach to Wetlands 1 and 2 prior to "right-of-way" activities.

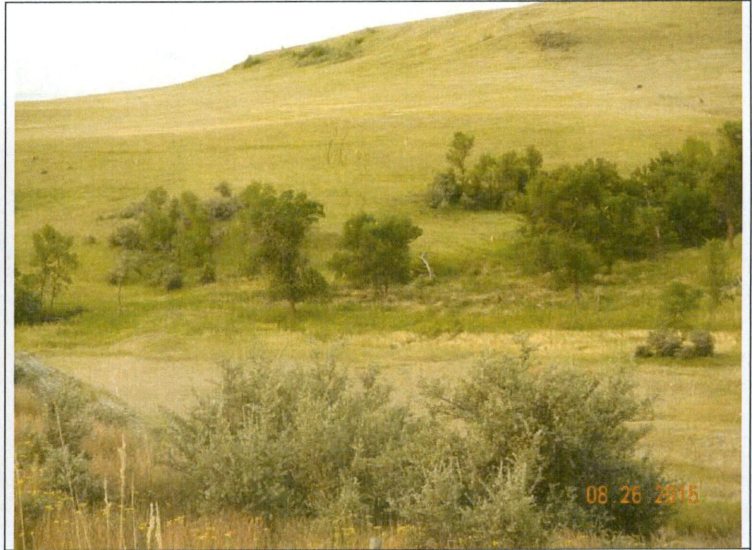
**Photograph 2:** (Close up view of Photograph 1) Viewing southward from Sta. 108+00 at approach to Wetlands 1 and 2 prior to "right-of-way" activities. The 12 clumps (bushes) of Russian Olive will be removed. However, the travel lane will avoid impacts to the trees in the background.

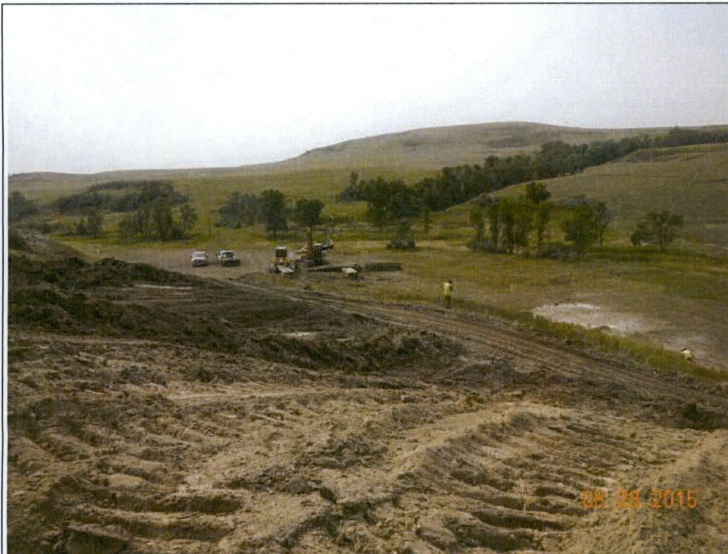
**Photograph 3:** Viewing southward from near Sta. 110+00 (MP 2.1) across Wetlands 1 and 2 at ongoing work to begin installation of travel lane through Wetland 2.

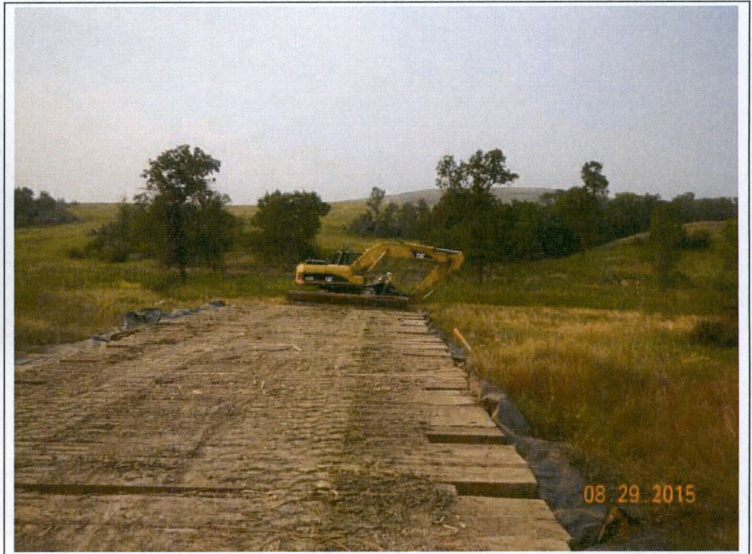
**Photograph 4:** Viewing southward from Sta. ~118+00 (MP 2.2) at the installation of a travel lane through Wetland 2.

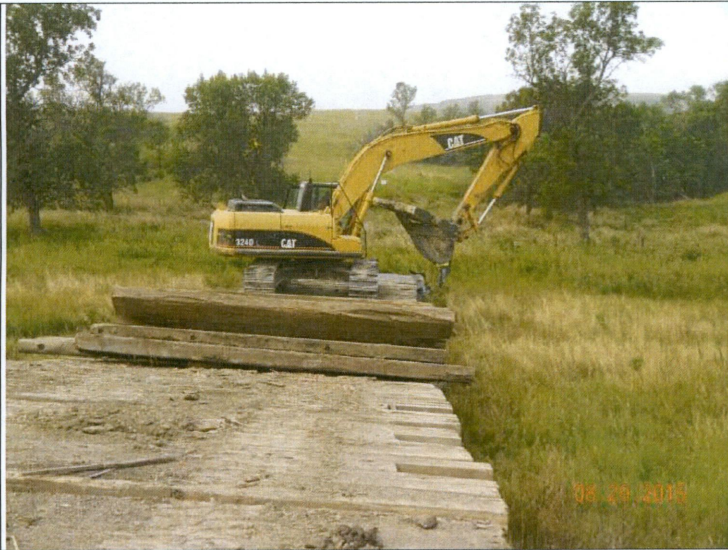
**Photograph 5:** (Close up view of Photograph 5) Viewing southward from Sta. ~118+00 (MP 2.2) at the installation of a travel lane through Wetland 2

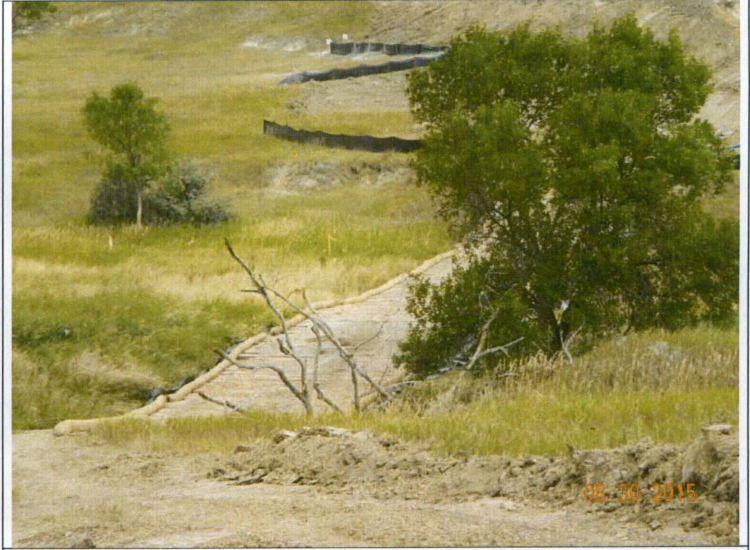
**Photograph 6:** Viewing southward from Sta. 121+50, (MP 2.3) viewing the completed travel lane between the trees with no impacts to woody vegetation. Wetlands 2 and 1 are in the background.

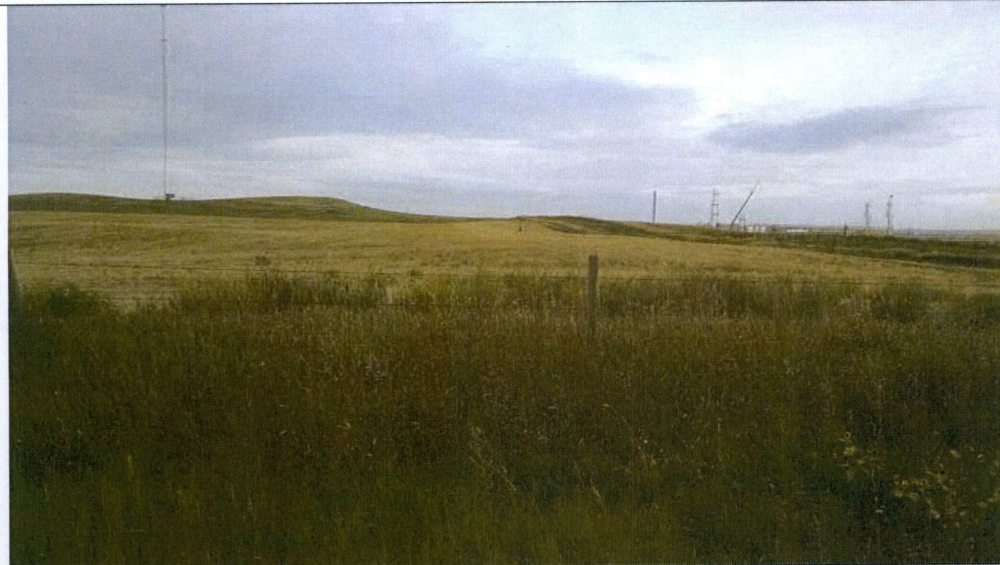
**Photo 7:**  
Looking west at  
pipe line ROW  
in Section 36,  
south of the  
plant.

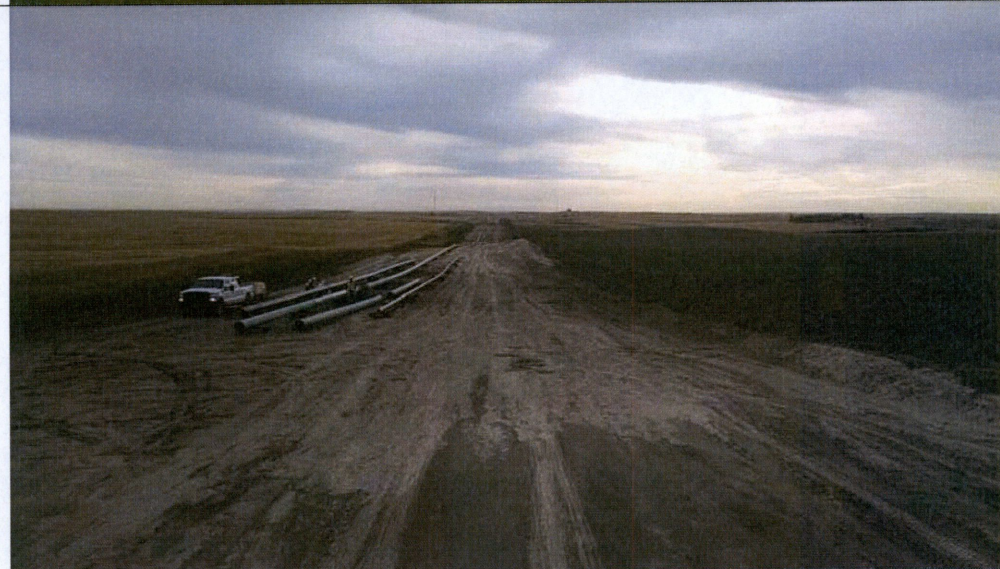
**Photo 8:**  
Looking east at  
east-west portion  
of pipe line  
ROW in Section  
31. 18-inch  
Cherry Creek  
Line (green) is  
assembled.  
Portions of  
Cherry Creek  
and NGL to be  
bored under  
138<sup>th</sup> Ave NW  
are also shown.

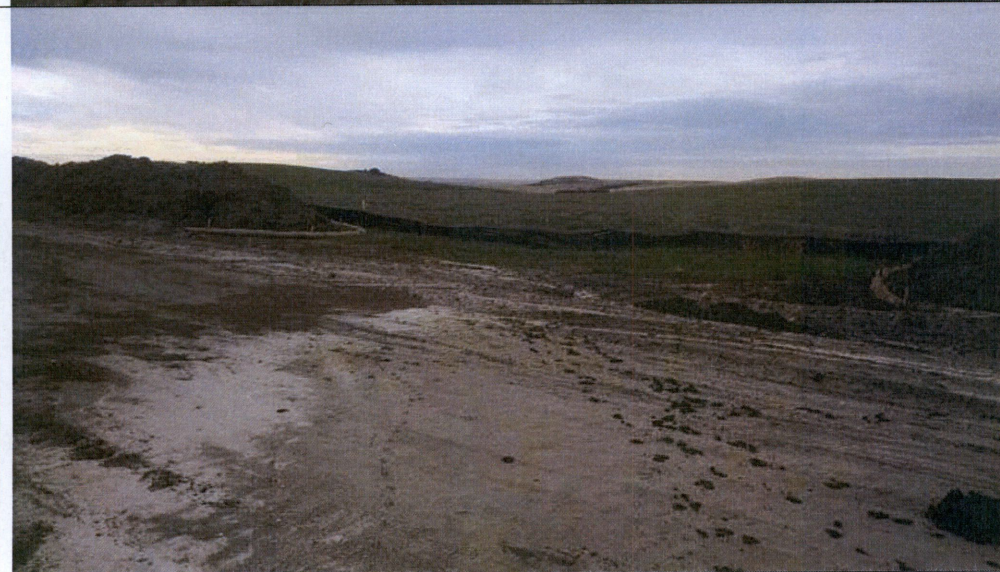
**Photo 9:**  
Looking south in  
Section 31 at  
erosion control  
at a drainage  
swale along the  
ROW.

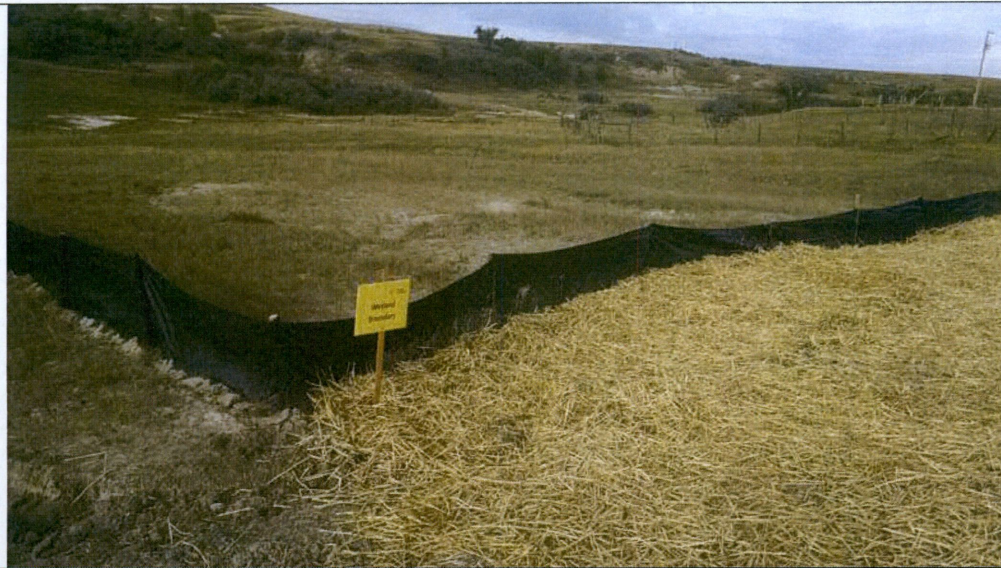
**Photo 10:**  
Looking southwest at silt fence and mulch upstream of Wetland 01 in Section 6.

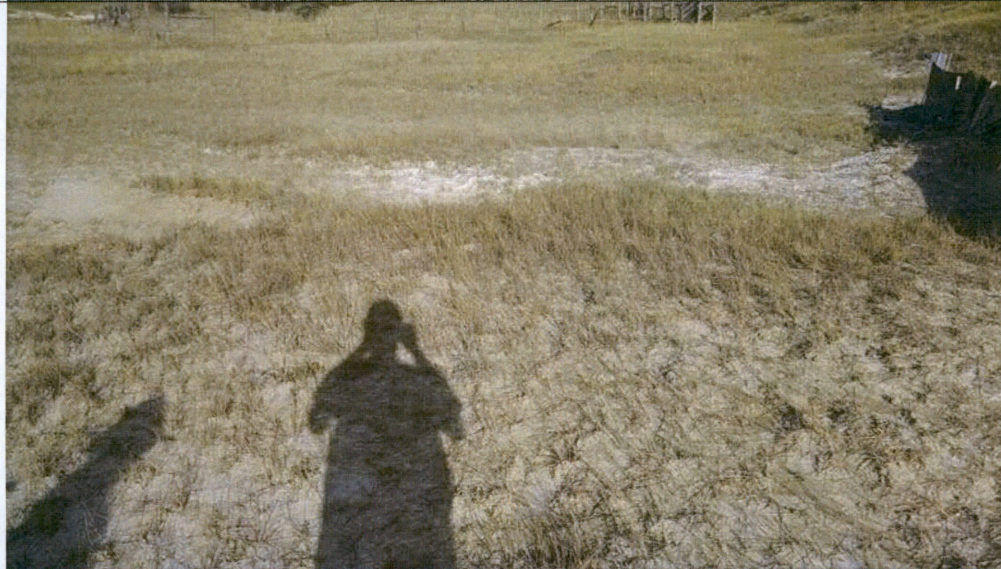
**Photo 11:**  
Vegetation in Wetland 01, looking west.

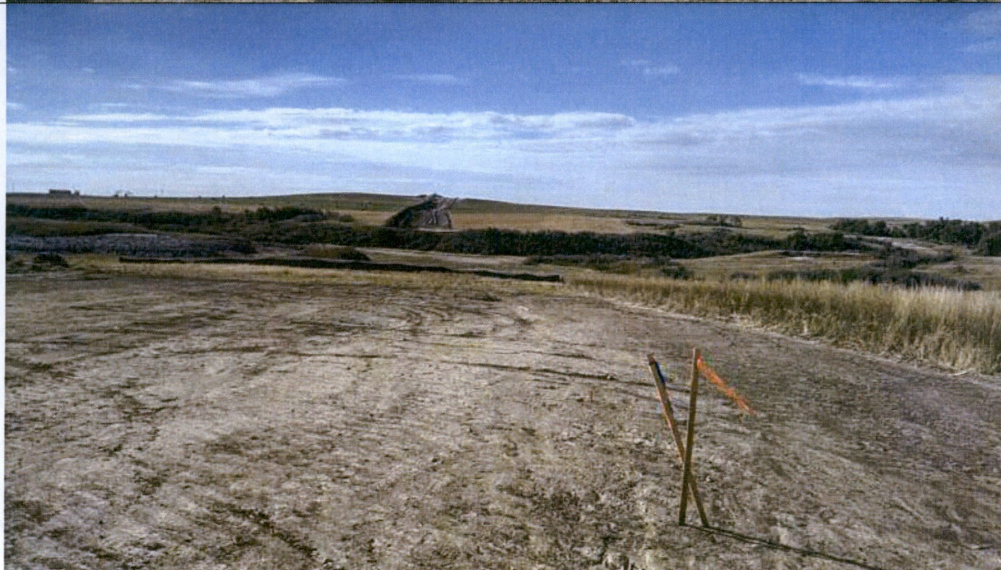
**Photo 12:**  
Looking south from the northern end of directional bore, proposed under Wetland 04.

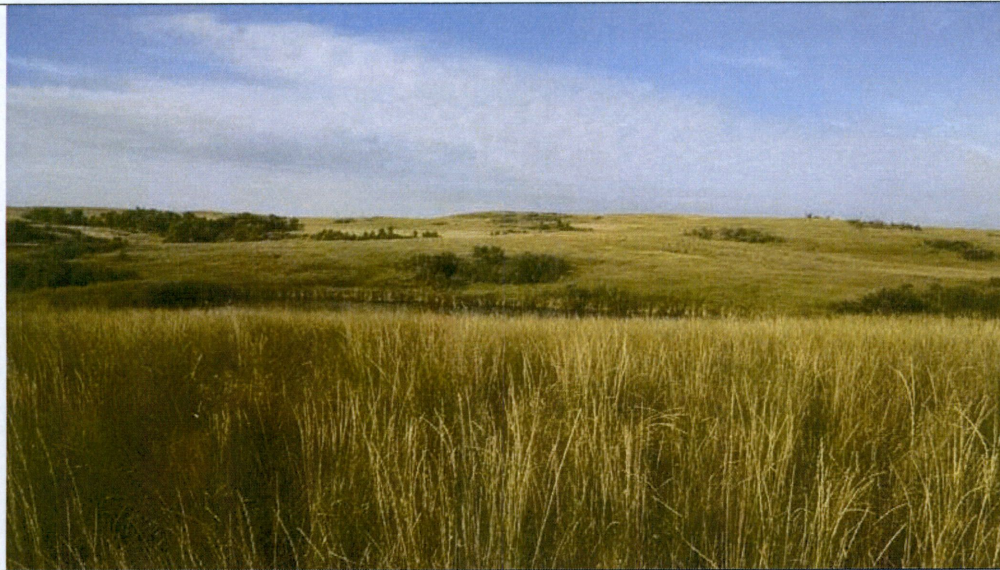
**Photo 13:**  
Looking west at agricultural dam to the west of the ROW alignment and north of Wetland 03.

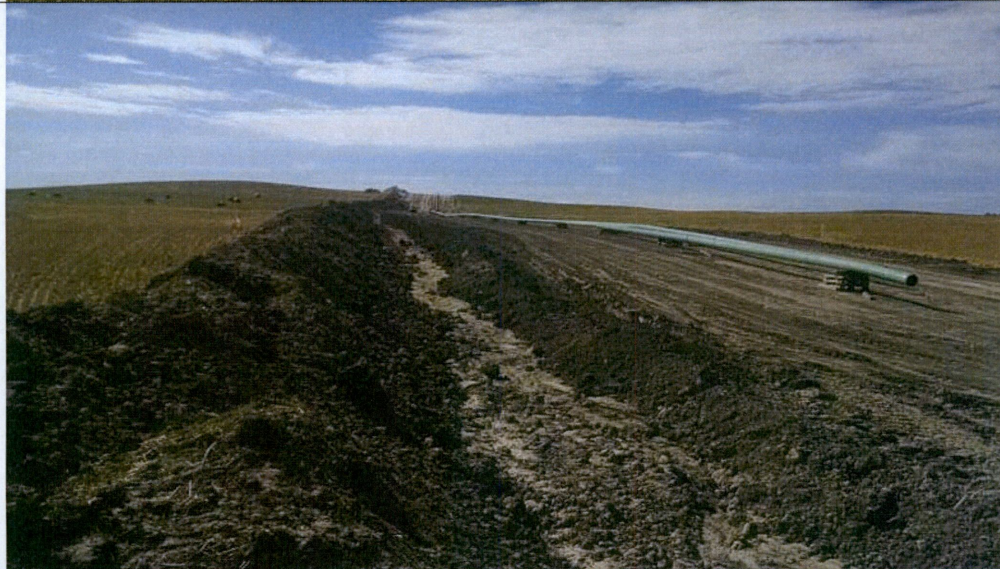
**Photo 14:**  
Looking south at Cherry Creek pipe line in Section 8. Topsoil and subsoil windrows are being used to provide a gutter for stormwater control.

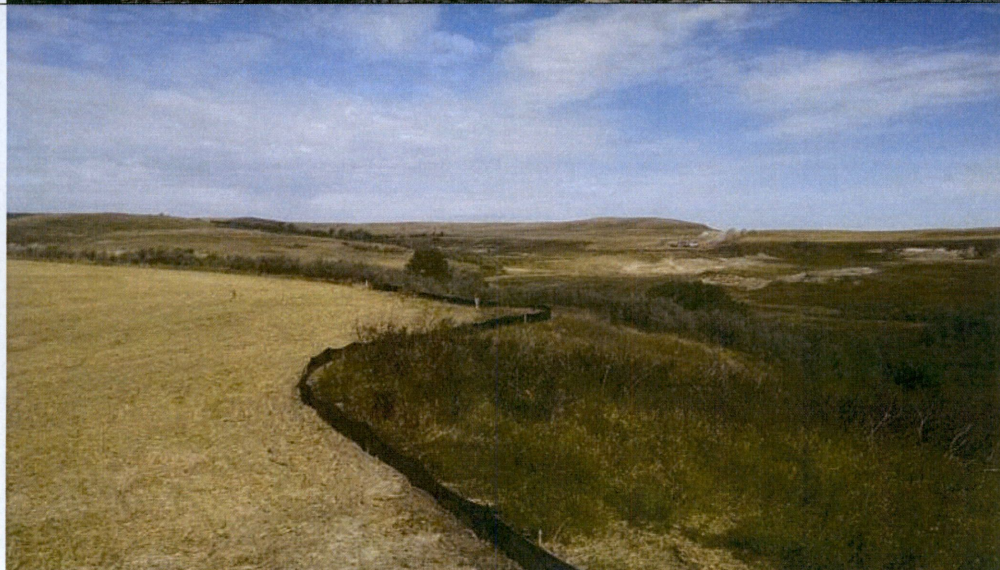
**Photo 15:**  
Looking northwest at south end of proposed directional bore, under Wetland 04.

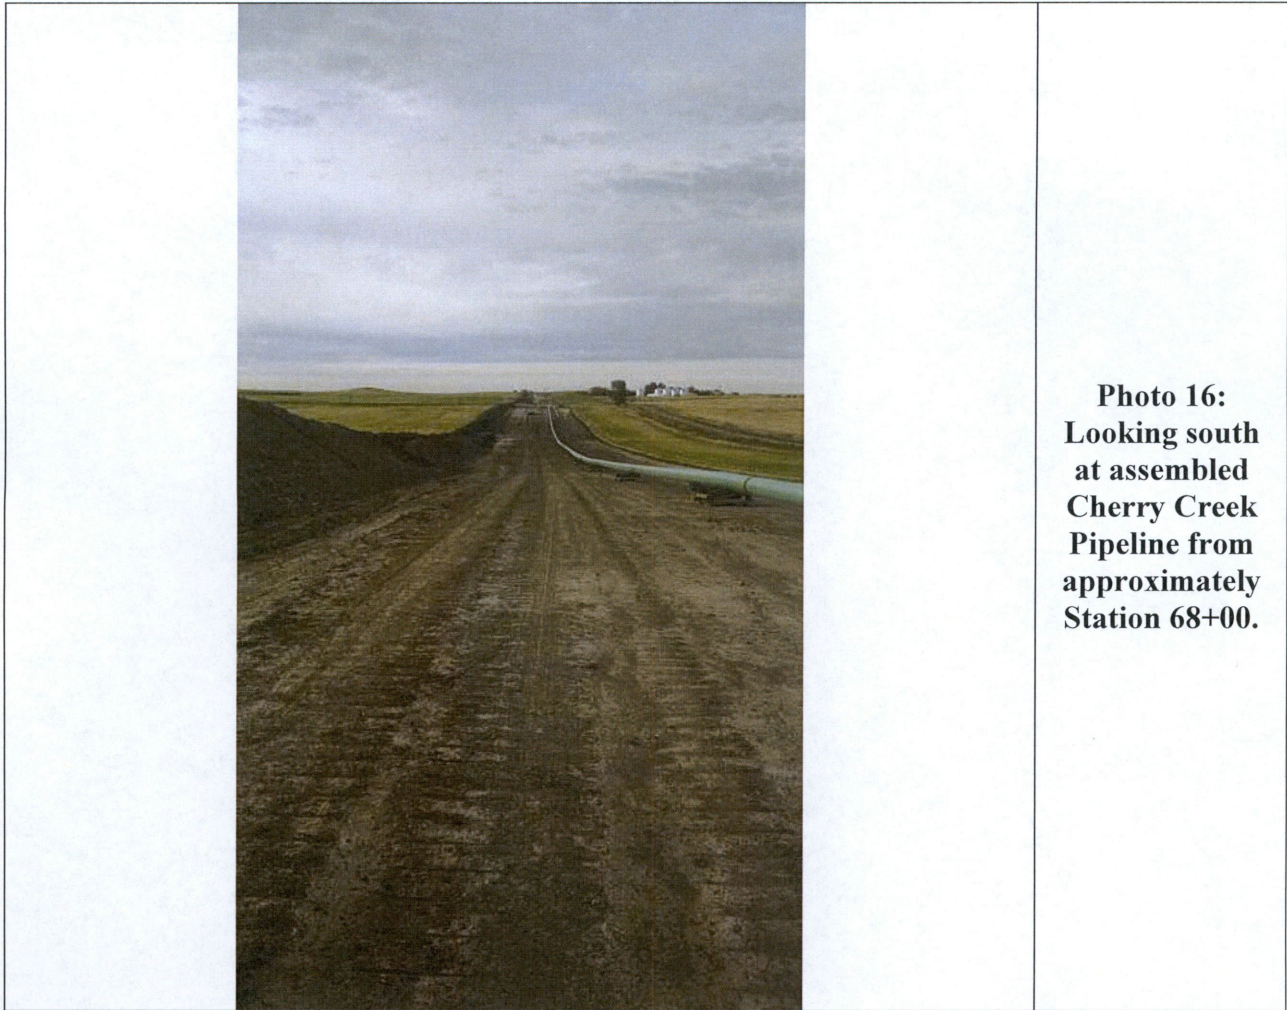
**Photo 16:  
Looking south  
at assembled  
Cherry Creek  
Pipeline from  
approximately  
Station 68+00.**

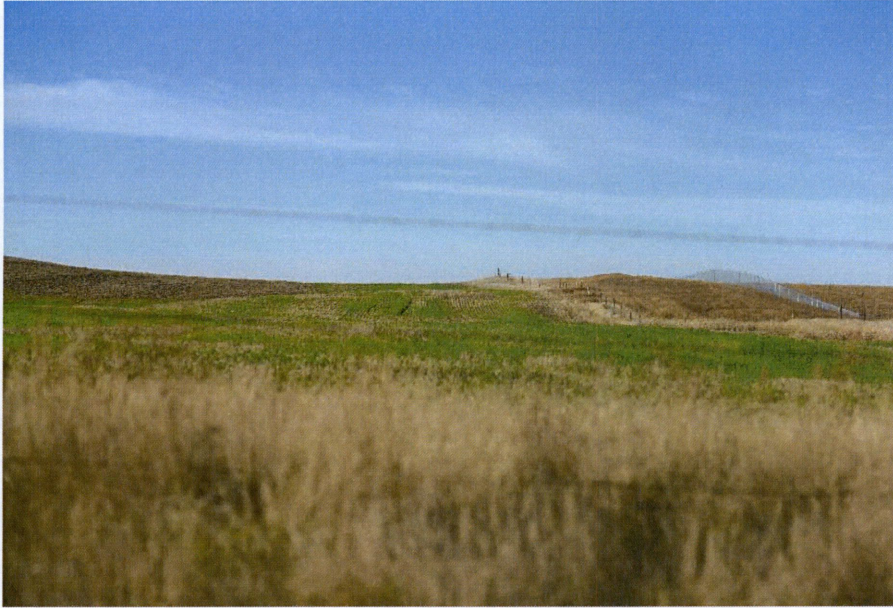
**Photograph 1** was taken at the start of the pipeline alignment near the ONEOK gas plant and shows reclamation in the field near the beginning of the pipeline. Reclamation observed in this area is primarily crop land that was planted this year. Upon visual inspection, the completed grading appears to be level and even with no sinking areas over the pipeline. Crops appear to be uniform across the excavated areas which indicates no issues with topsoil.

**Photo 1:** Beginning of pipeline (facing west).

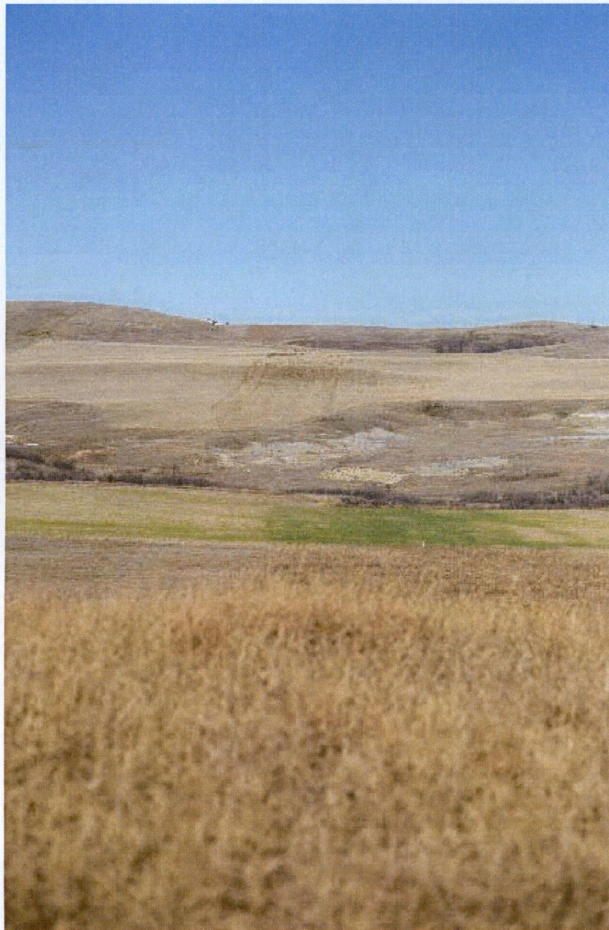
**Photograph 2** was taken at the southern, end-point of the new pipeline. In this area, the seeding had taken well and the vegetation was thick and difficult to walk through. While walking the site, a considerable number of pheasants were present and flew out of the reclaimed area (**Photograph 3**).

**Photo 2:** End of pipeline; wetland bore; reclamation seeding (facing north).

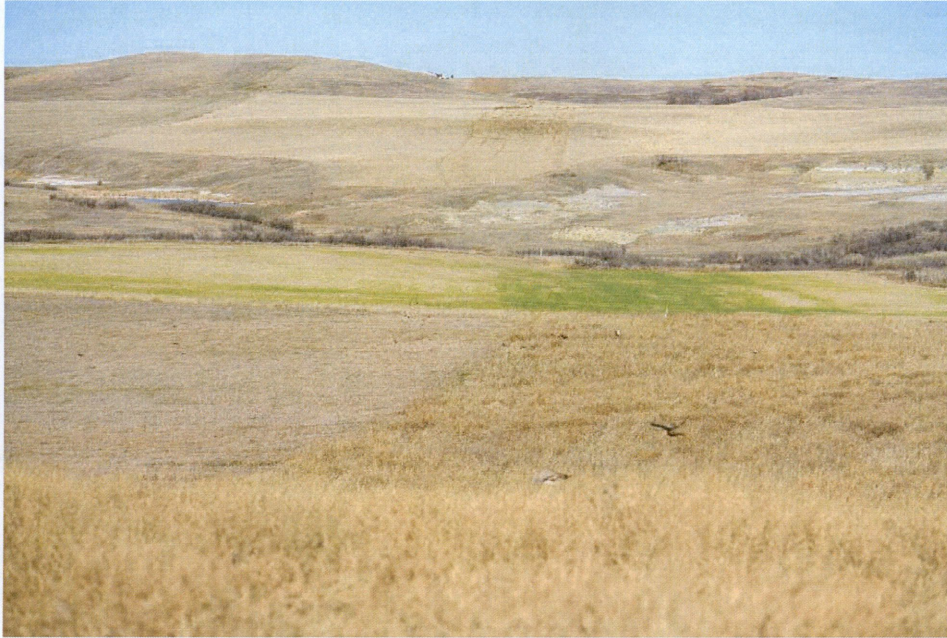
**Photo 3:**  
Established wildlife  
(facing north).

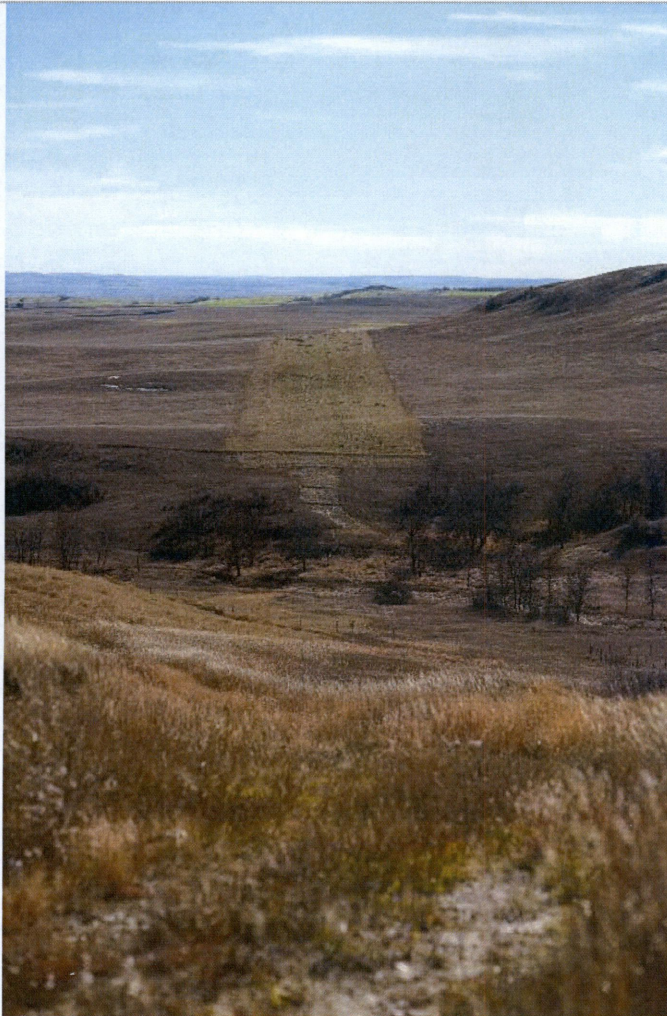
**Photograph 4** shows the pipeline between the end and where the pipeline turns to head west. In both photographs 3 and 4 it is visible where the pipeline switches from open cut to boring for the wetlands. Installation of the pipeline through the wetlands was conducted via HDD boring and minimal disruption occurred in those areas. North of photograph 4, the pipeline ran along a farmhouse road and there was minimal visual evidence of the construction activities.

**Photo 4:** Wetland  
bore; reclamation;  
seeding (facing  
south).
