# Courtenay Wind Farm Project Post-Construction Inspection Report PU-15-174/PU-13-064

North Dakota Public Service  
Commission

**WENCK Associates, Inc.**  
301 1<sup>st</sup> Street NE, Suite 202  
Mandan, ND 58554  
Phone: 701-751-3370  
Fax: 763-479-4242

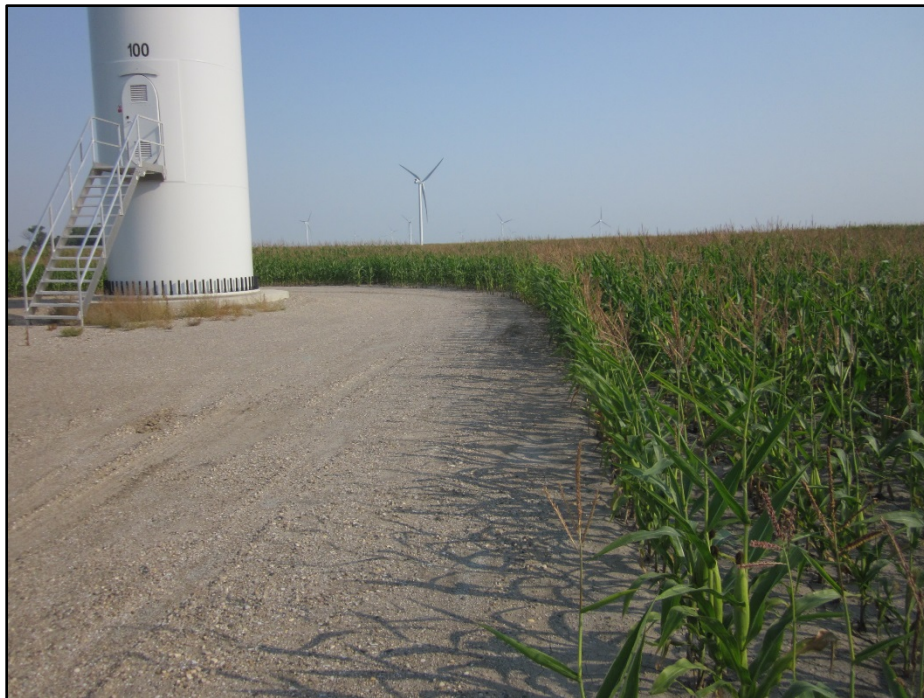
**Photo 1.** (GPS Point #548) – View of base of Turbine 100. Gravel pad/access road surrounds turbine, there is a 16-ft radius around the turbine for the road/gravel pad. Weeds (brown in color) next to the turbine base by stairs have been sprayed, they will be sprayed in the spring and fall for this project. The corn next to the access road, where it has been reclaimed, is somewhat stunted. Direction: North.

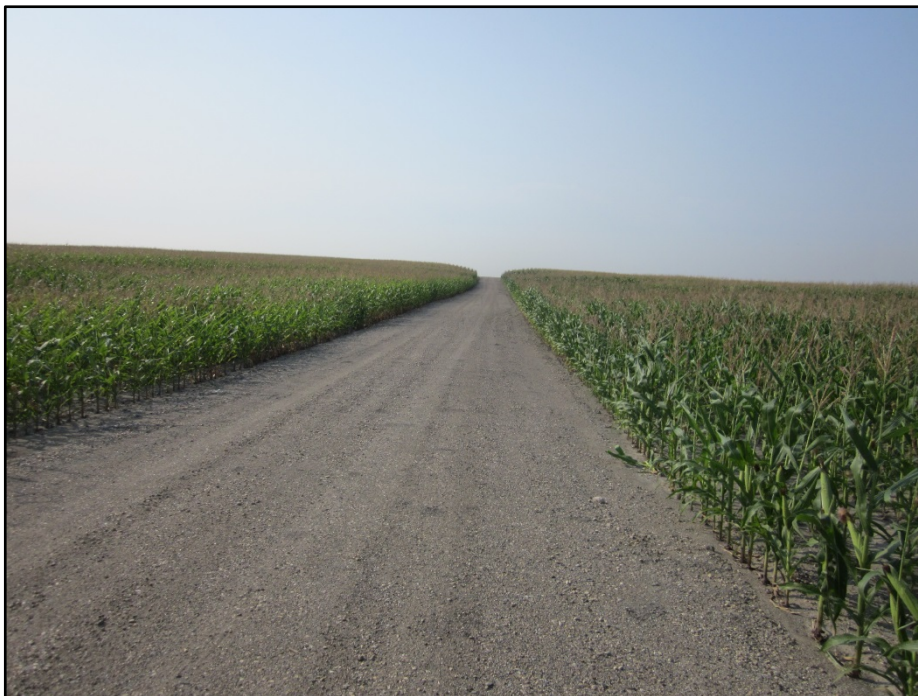
**Photo 2.** (GPS Point #548) – Access road near Turbine 100. The access road is within a cropped corn field. Direction: South.

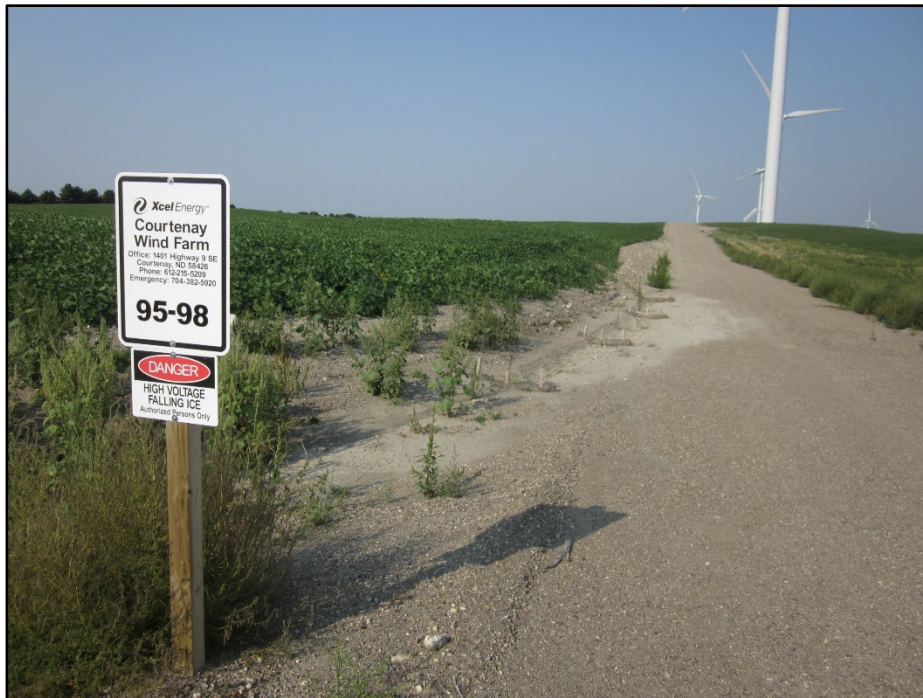
**Photo 3.** (GPS Point #549) – Access road to Turbines 95-98. Warning sign shown. Straw wattles shown to the left of the access road. This access road was cut into the side of the hill. Direction: West.

The Project Application states BMPs would be used during and after construction to minimize soil erosion and protect topsoil and surface water (Docket #5, Application). At the time of inspection straw wattles were observed at an access road along a hillside and between a road and wetland (**Appendix A**, Photos 3, 4, 20). Culverts and drainage structures were installed where necessary to allow for the natural flow of water (**Appendix A**, Photo 9). In general, erosion problems were minor and infrastructure of the Project Area was well maintained.

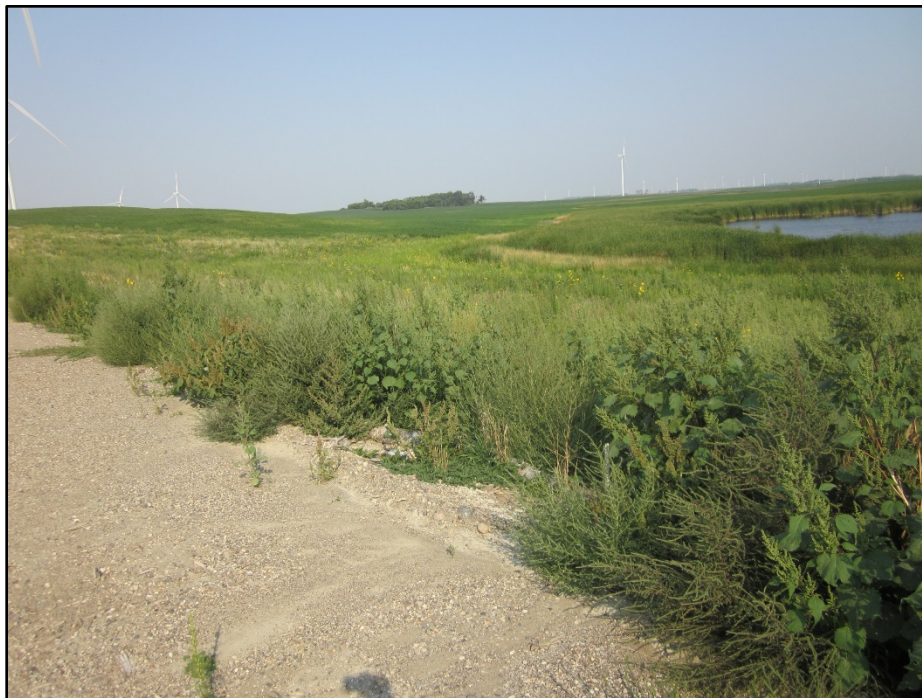
**Photo 4.** (GPS Point #549) – Access road to Turbines 95-98 (same area as photo above). The access road was cut into side of the hill and this area was reclaimed, it has annual weeds growing which is typical for the 1<sup>st</sup> growing season after re-seeding. Note straw wattle by edge of road (weed growth is covering most of the wattle), wetland to the right of photo. Canada thistle (not shown) was observed near the reclaimed area in the county road ditch. Direction: West-northwest.

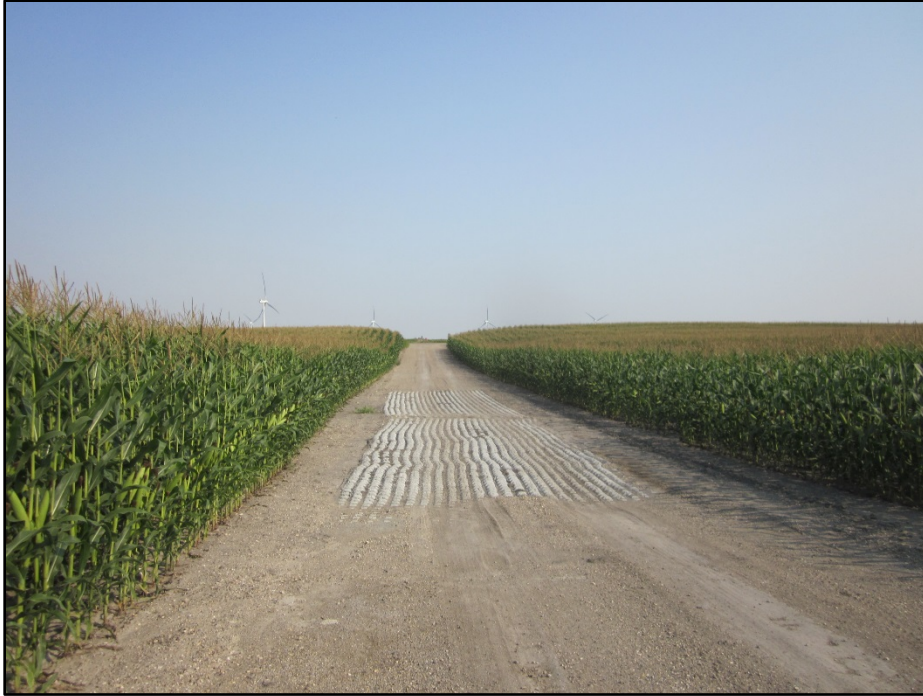
**Photo 5.** (GPS Point #550) – View of low water crossing that was installed on an access road. The concrete is approximately 6-inch depth to help stabilize the road. Direction: North.

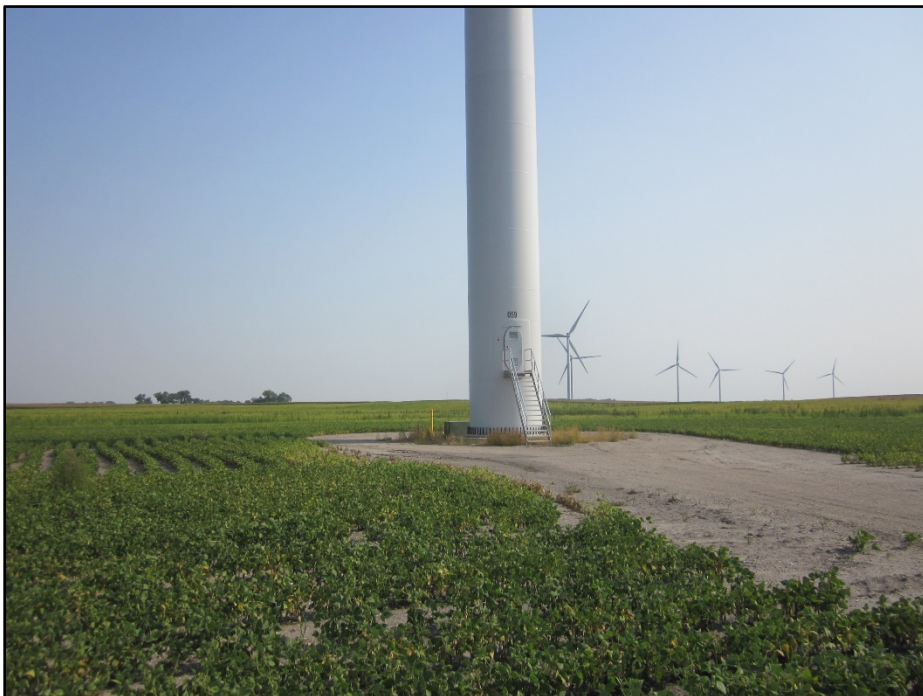
**Photo 6.** (GPS Point #551) – View of Turbine 59, in soybean field. Crops were coming along well but still somewhat thinner in reclaimed areas. Direction: North.

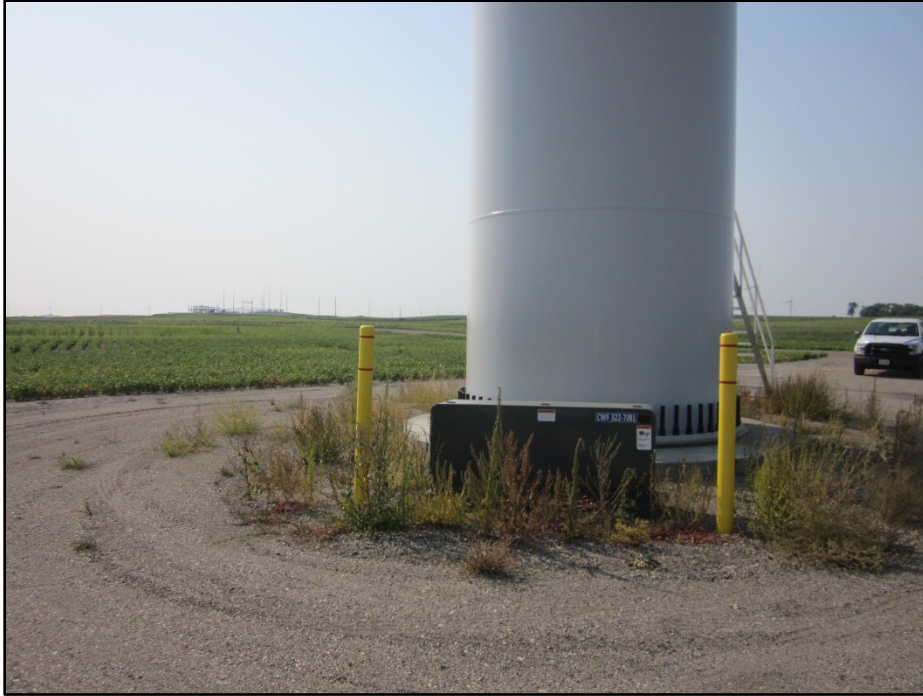
**Photo 7.** (GPS Point #551) – View of base of Turbine 59. Safety warning signs were in place. Box has two cement bollards and gravel around it. Weeds have been recently sprayed. Direction: Southeast.

No concerns were identified during the site review that would indicate that Project operation was out of compliance with the Application or safety regulations. Examples of operational safety measures observed at the site include: use of personal protective equipment, warning signs, and vehicle safety measures (**Appendix A**, Photos 3, 7, 8). No reports of extraordinary events were filed to date with the PSC.

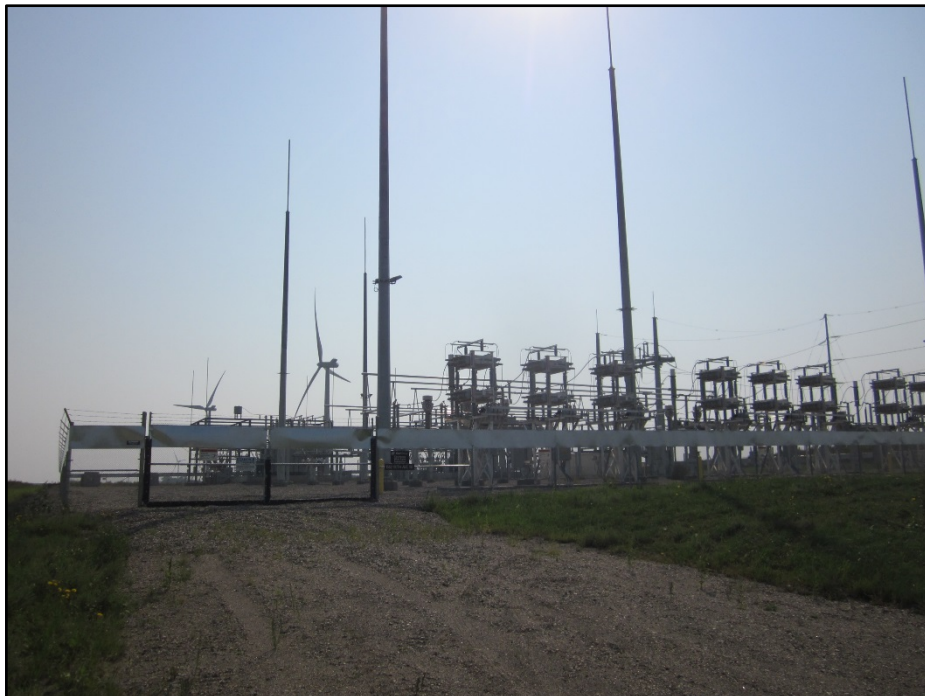
**Photo 8.** (GPS Point #552) – View of substation for Courtenay Wind Farm. The area is fenced. Direction: East.

The Project substation was fenced off and there were warning signs. Several points along the collection line system were observed and it appeared to be constructed where proposed. Points where the collection line was bored under major roads were observed and no concerns were noted. Markers were in place.

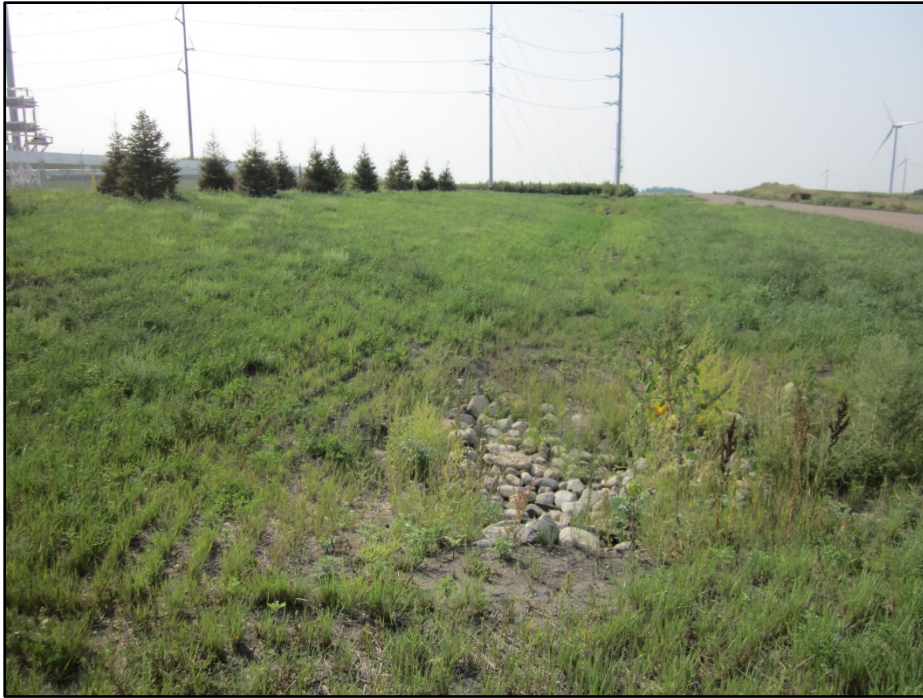
**Photo 9.** (GPS Point #552) – Courtenay Wind Farm Substation to the left of photo. Culvert with rocks were installed, no sedimentation or erosion were observed. This area had previously been washed out but has been reclaimed. Direction: Southeast.

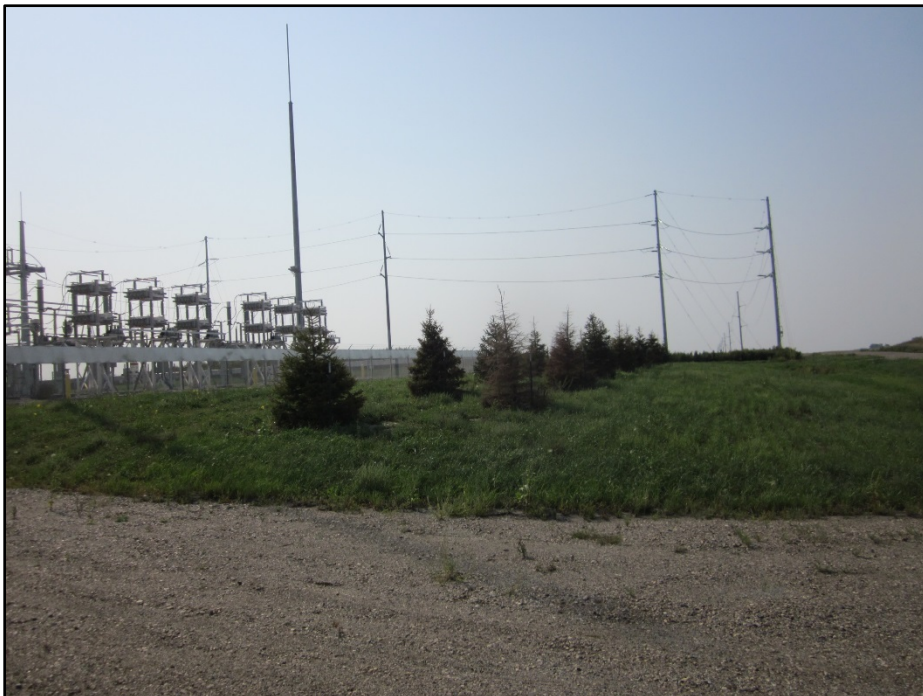
**Photo 10.** (GPS Point #552) – Courtenay Wind Farm Substation to the left of photo. Trees were planted near fenced area. Trees were to be planted in front of the substation to help screen the view of the substation as per an agreement with a landowner. A few of the trees appear to be dying. Direction: Southeast.

It appeared that in general, major woody areas were avoided through Project siting. The Xcel representative thought that no trees were removed from the Project site. However, other than documentation of the tree removed in Section 24, there were no post-construction Tree and Shrub replacement plans or mitigation/survival monitoring reports found in the documentation that would indicate the inventoried trees and shrubs to be removed were replaced as required by the PSC's Tree and Shrub Mitigation Specifications. Wenck recommends the PSC request the required documentation.

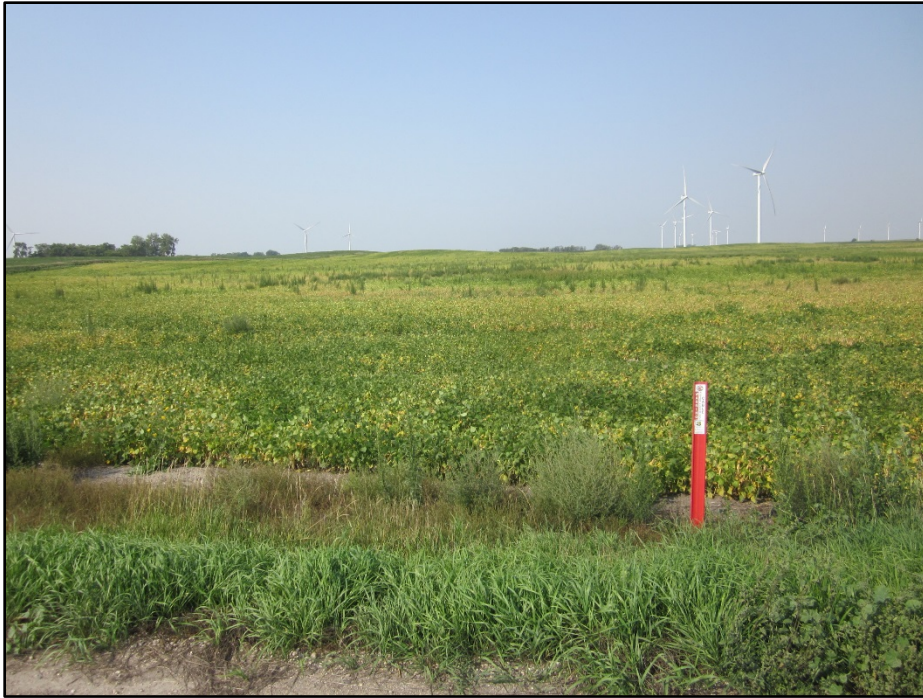
**Photo 11.** (GPS Point #553) – Underground line marker by road. Direction: West.

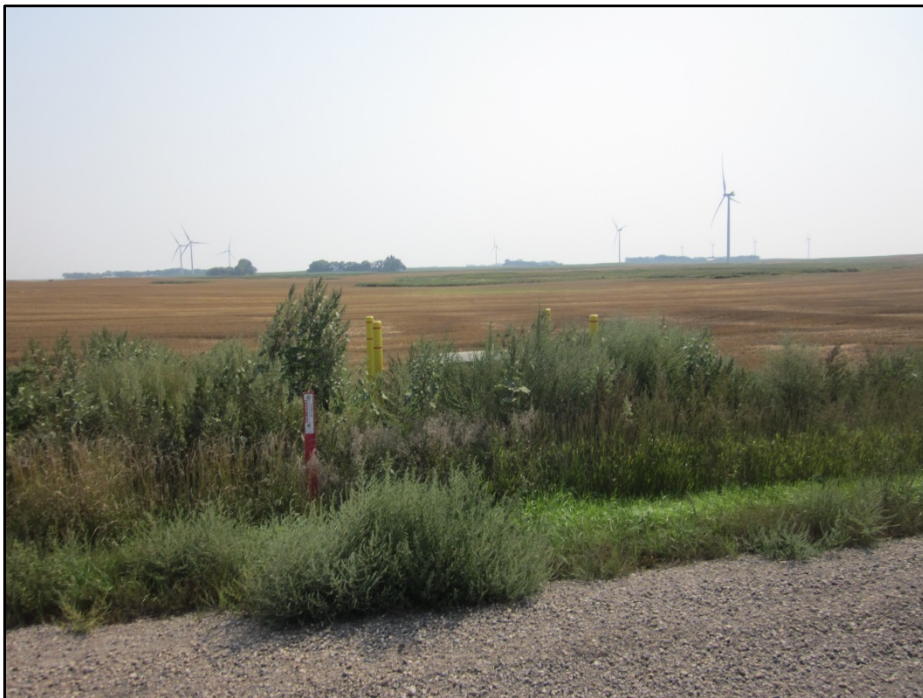
**Photo 12.** (GPS Point #553) – Underground line marker by road. Lines connect to substation. Junction box has cement bollards surrounding it. Annual weeds should be sprayed or mowed to keep junction box clearly visible. Direction: East.

It was stated in the Application that noxious weeds would be controlled in the immediate vicinity of the turbines, access roads, and associated facilities, immediately after construction and periodically for the life of the Project. The Application also stated that CWF would develop a management plan to prevent the spread of noxious weeds throughout the Project Area during construction and ongoing operations in accordance with state and county regulations (Docket #5, Application PU-13-064). The case file did not have any noxious weed management plans on record. Annual weeds were observed near the turbine pads and access roads, which is typical in the first year after reclamation and planting. Canada thistle, a noxious weed, was found in road ditches near a reclaimed area along the Project. At the time of the site visit weeds had recently been sprayed around the pads. Annual weeds should be sprayed or mowed to keep junction box clearly visible (**Appendix**

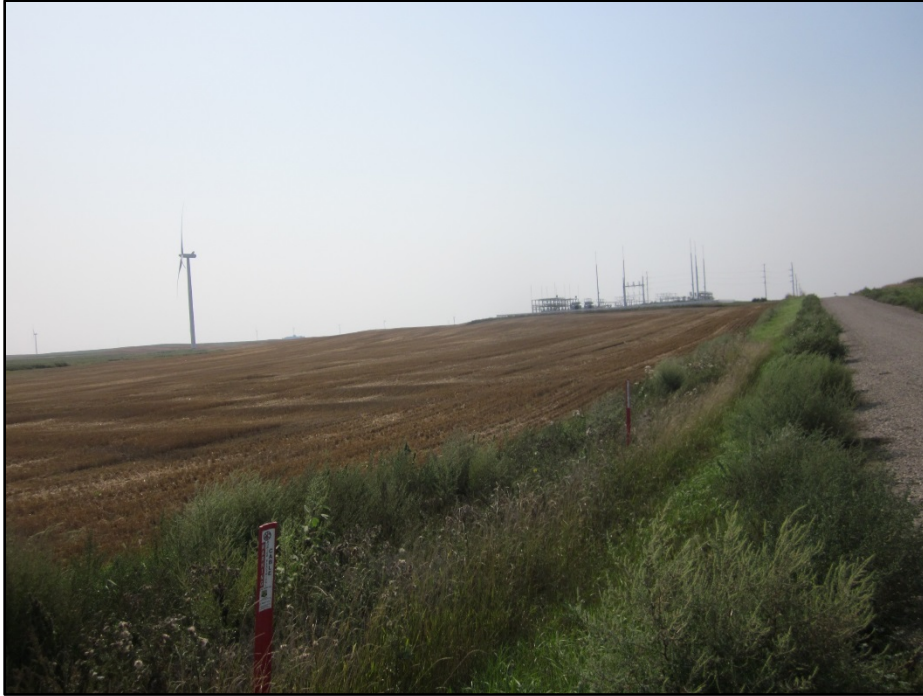
**Photo 13.** (near GPS Point #553) – View of line markers. Underground line connects to substation. There looks to be a slight unevenness in field, unsure if it is from underground lines, natural topography, or something else. Direction: South.

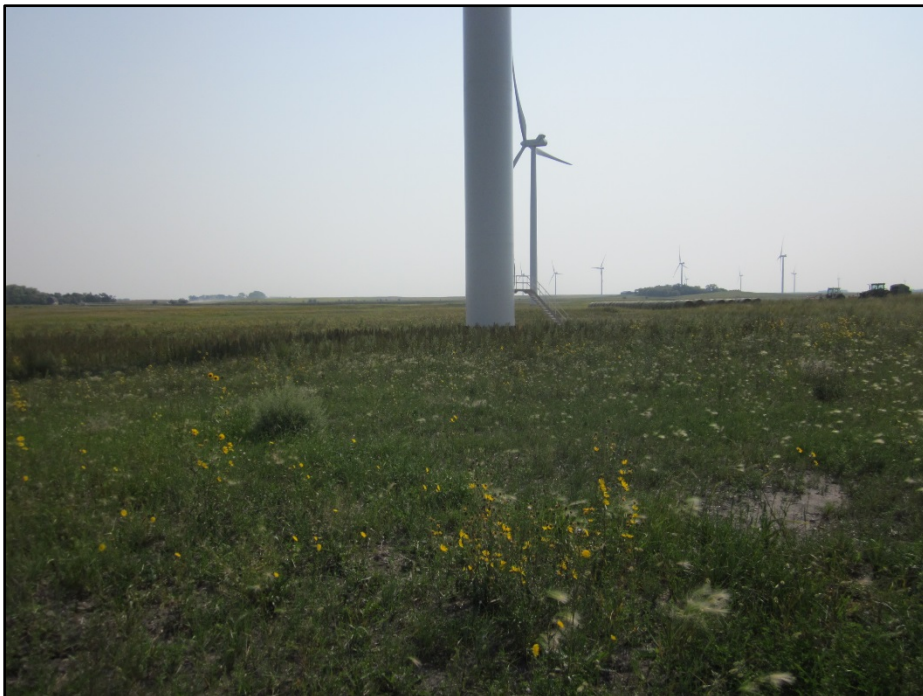
**Photo 14.** (near GPS Point #554) – Area has been reseeded with recommended NRCS seed mix. Some non-planted native species are coming in such as wild sunflowers and foxtail barley. Area has some annual weeds which is typical in first year after re-seeding. Direction: East.

At the time of the site inspection reseeded areas had been completed in non-cropland areas. Reclaimed areas in croplands had been planted with the crops in spring 2017. Reseeding non-cropland areas had started in fall 2016 and finished in May 2017. Cropland areas were on the right trajectory but still somewhat stunted or thinner in the reclaimed area (**Appendix A**, Photos 1, 6, 16). Through communication with the Xcel representative, he stated the seed list was recommended by NRCS and landowners. The typical seed mix included western wheatgrass, green needlegrass, slender wheatgrass, Canada wildrye, and Dacotah switchgrass as cover crops. Seeded grasses were growing in most areas along with annual weeds and some native plants (**Appendix A**, Photos 4, 9, 14, 15, 18, 19, 20). Annual weeds are typical the first year after re-seeding. Native grassland areas had annual weeds though out, Wenck recommends the PSC request photo documentation from Xcel grasses have fully established in all grassland re-seeded areas of the project.

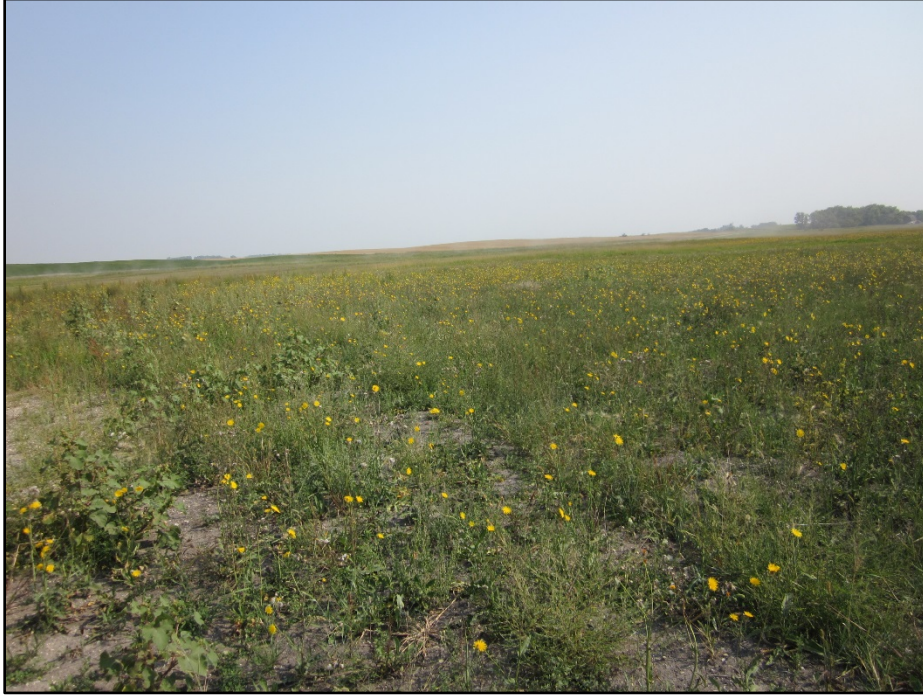
**Photo 15.** (GPS Point #554) – Area has been reseeded with recommended NRCS seed mix. Most of the yellow flower heads here are sow thistle (a weed), not wild sunflowers.  
Direction: East.

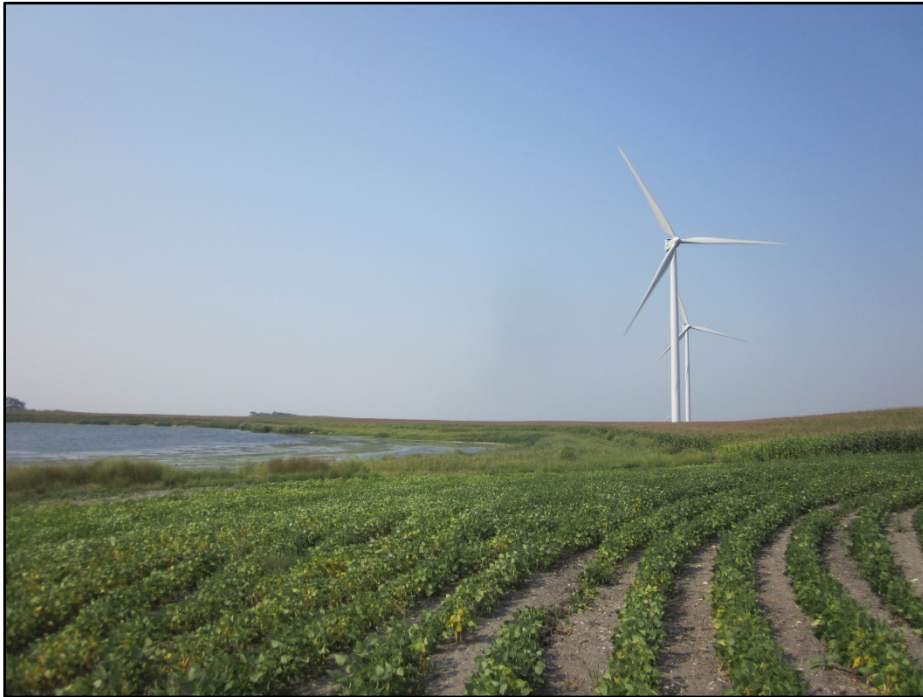
**Photo 16.** (GPS Point #555) – Near Turbine 49. This area has been reclaimed back to cropland (soybeans). Crops were somewhat thinner or stunted in the reclaimed area. There was previously a silt fence near the wetland. Direction: West.

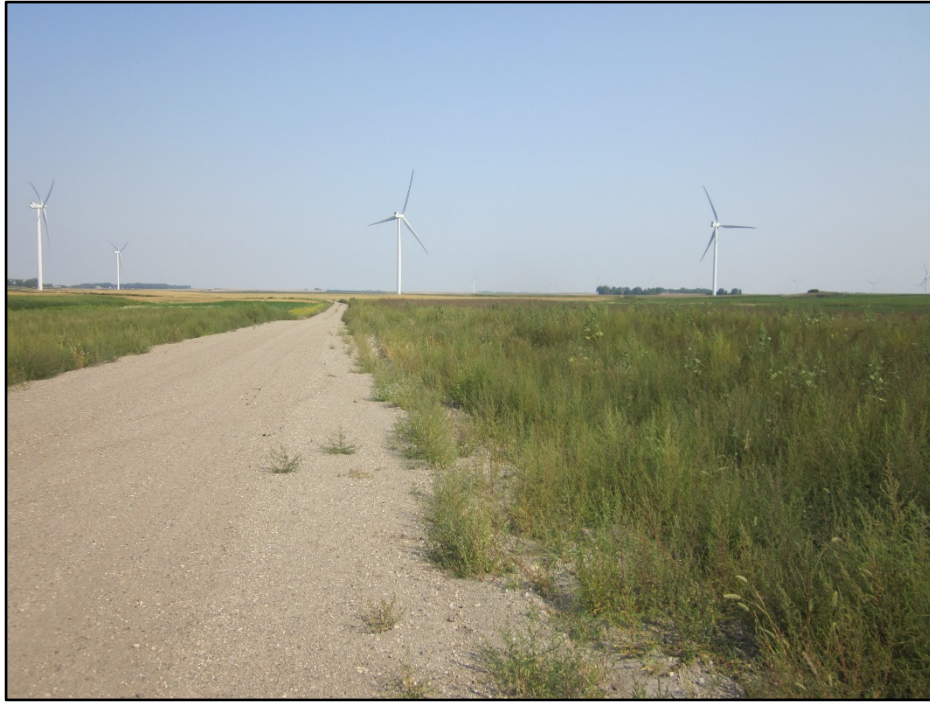
**Photo 17.** (GPS Point #556) – Access road Near Turbine 31 in CRP land. Direction: South.

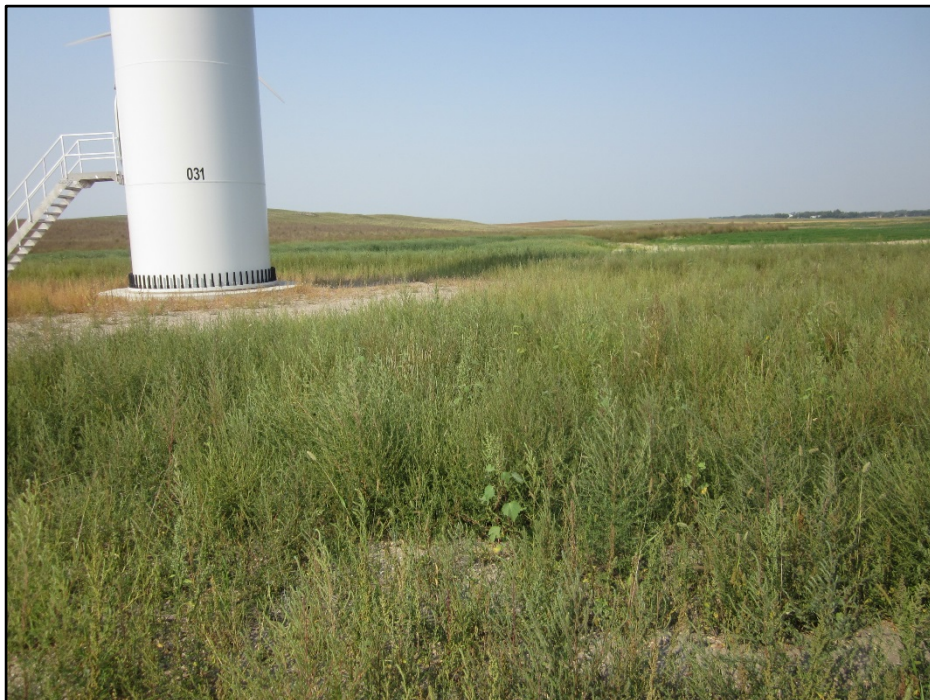
**Photo 18.** (GPS Point #556) – Access road and pad by Turbine 31 in CRP land, that has annual weeds growing throughout, primarily kochia. Direction: Northwest.

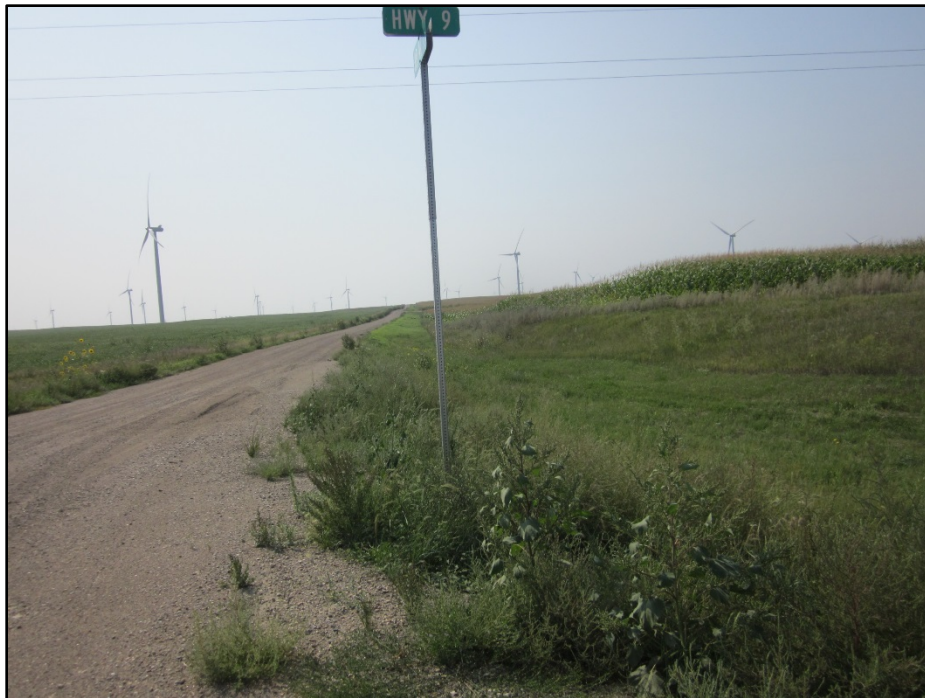
**Photo 19.** (GPS Point #557) – The road (Hwy 9 and 89<sup>th</sup> Ave) had been widened so equipment and vehicles could make the turn during construction. Area has been restored. Direction: South.

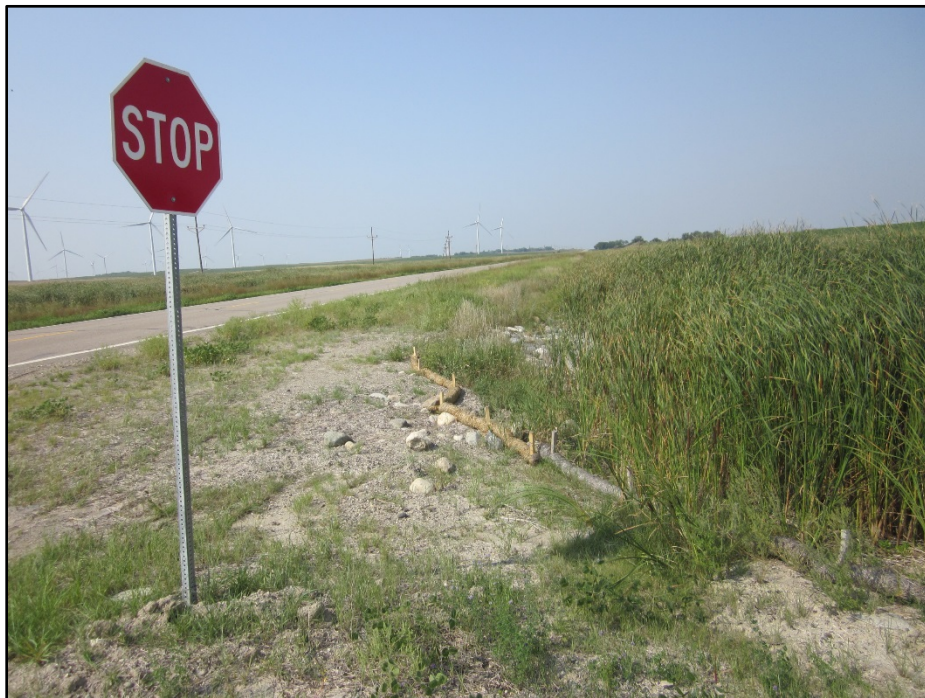
**Photo 20.** (GPS Point #558) – The road (Hwy 9 and 90<sup>th</sup> Ave) had been widened so equipment and vehicles could make the turn during construction. Area is being restored; some vegetation is starting to grow, but bare soils are present. There are straw wattles in place near the wetland to prevent sedimentation. The Xcel representative stated they are monitoring this area. Direction: West.

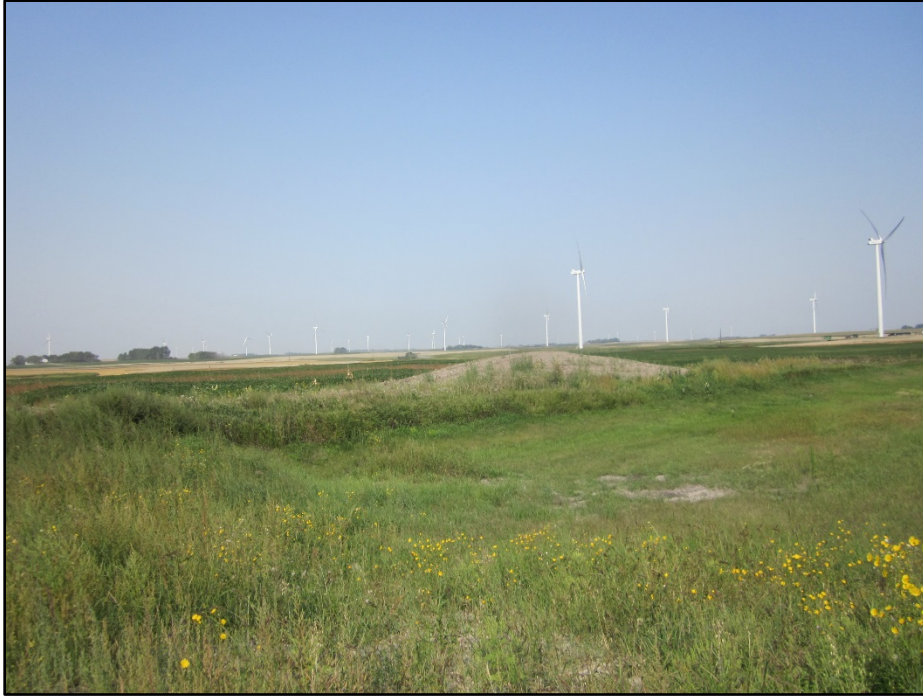
**Photo 21.** (GPS Point #559) – This area was previously part of the laydown yard. Most of the area has been reseeded and reclaimed, except for the dirt and gravel piles, which the landowner asked to be left there. Direction: West-northwest.

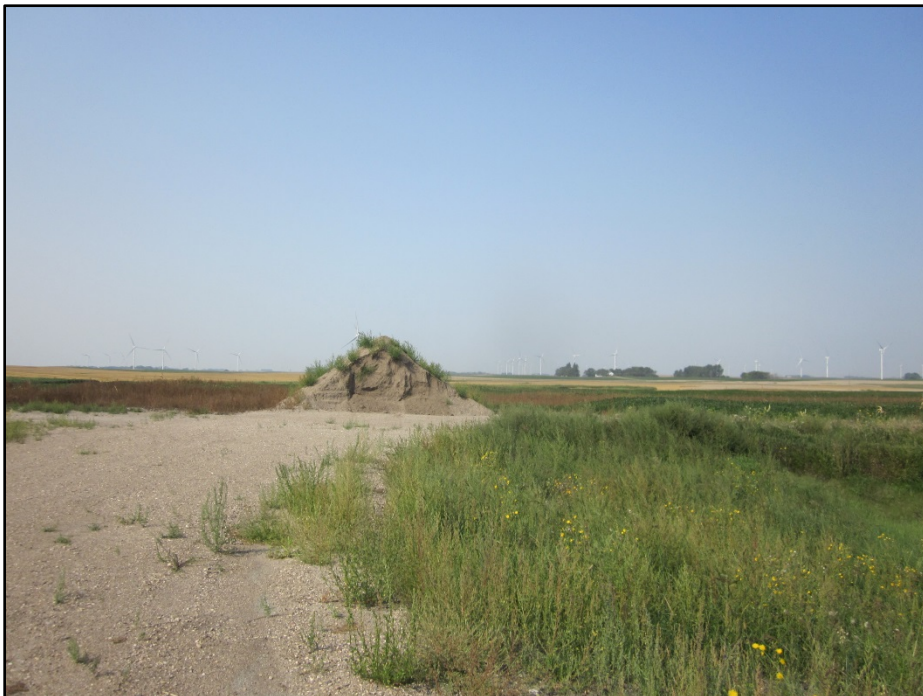
**Photo 22.** (GPS Point #559) – This area was previously part of the laydown yard. Most of the area has been reseeded and reclaimed. The landowner asked for the dirt/gravel piles to be left. Direction: West-southwest.
