Alexander Tank Farm Crude Oil Pipeline

McKenzie County, North Dakota (ND)
Owner: Hiland Crude Oil, Inc.

North Dakota Public Service Commission PU-15-486

Ulteig Engineers, Inc.
1412 Basin Avenue
Bismarck, North Dakota 58501
701-355-2343

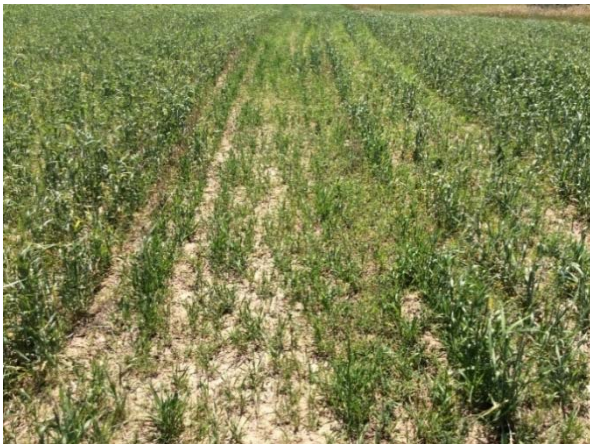
Station 31+82

- 2) Reduced quality and quantity of crop growth between PI#10 and PI#14 station 31+82 thru 51+98 is an indication that top soil was not properly managed during construction. The addition of fertilizer and organics may provide the necessary improvements to the soil to improve crop conditions.

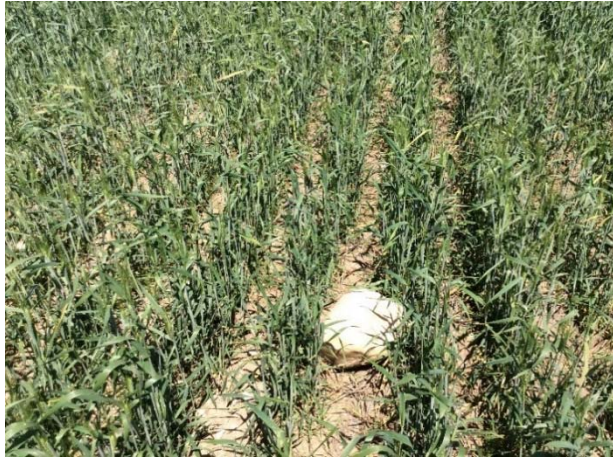
Station 57+71

- 3) Several Rock of this size and smaller were observed from PI#15 to PI#17 (station 57+78 thru station 75+90) in the easement. The rocks need to be removed. There are also indications of reduced crop growth in sporadic locations within this area. The addition of fertilizer and organics may provide the necessary improvements to the soil to improve crop conditions.

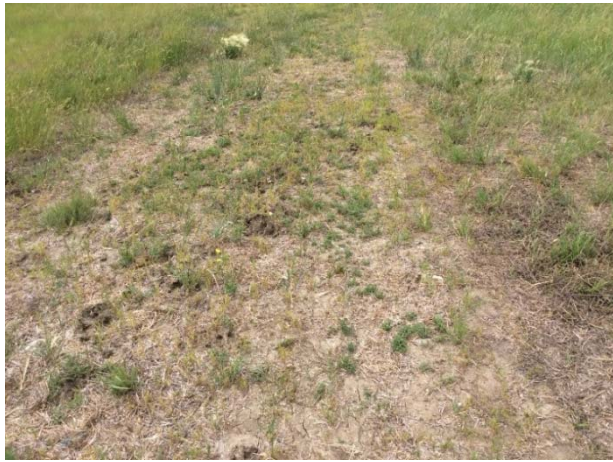
- 7) Station 187+91 thru 204+38: conditions show recent excavation of the subject oil pipeline. It appears that a repair or connection was made to the pipeline at this location. Rehabilitation will need to follow.
