Still frame of the June 25, 2015 Public Service Commission flyover inspection video of the Shop Access Road in Coyote Creek Mine Permit NACG-1302 in relation to Coyote Creek culvert crossings.

ND Public Service Commission August 27, 2015

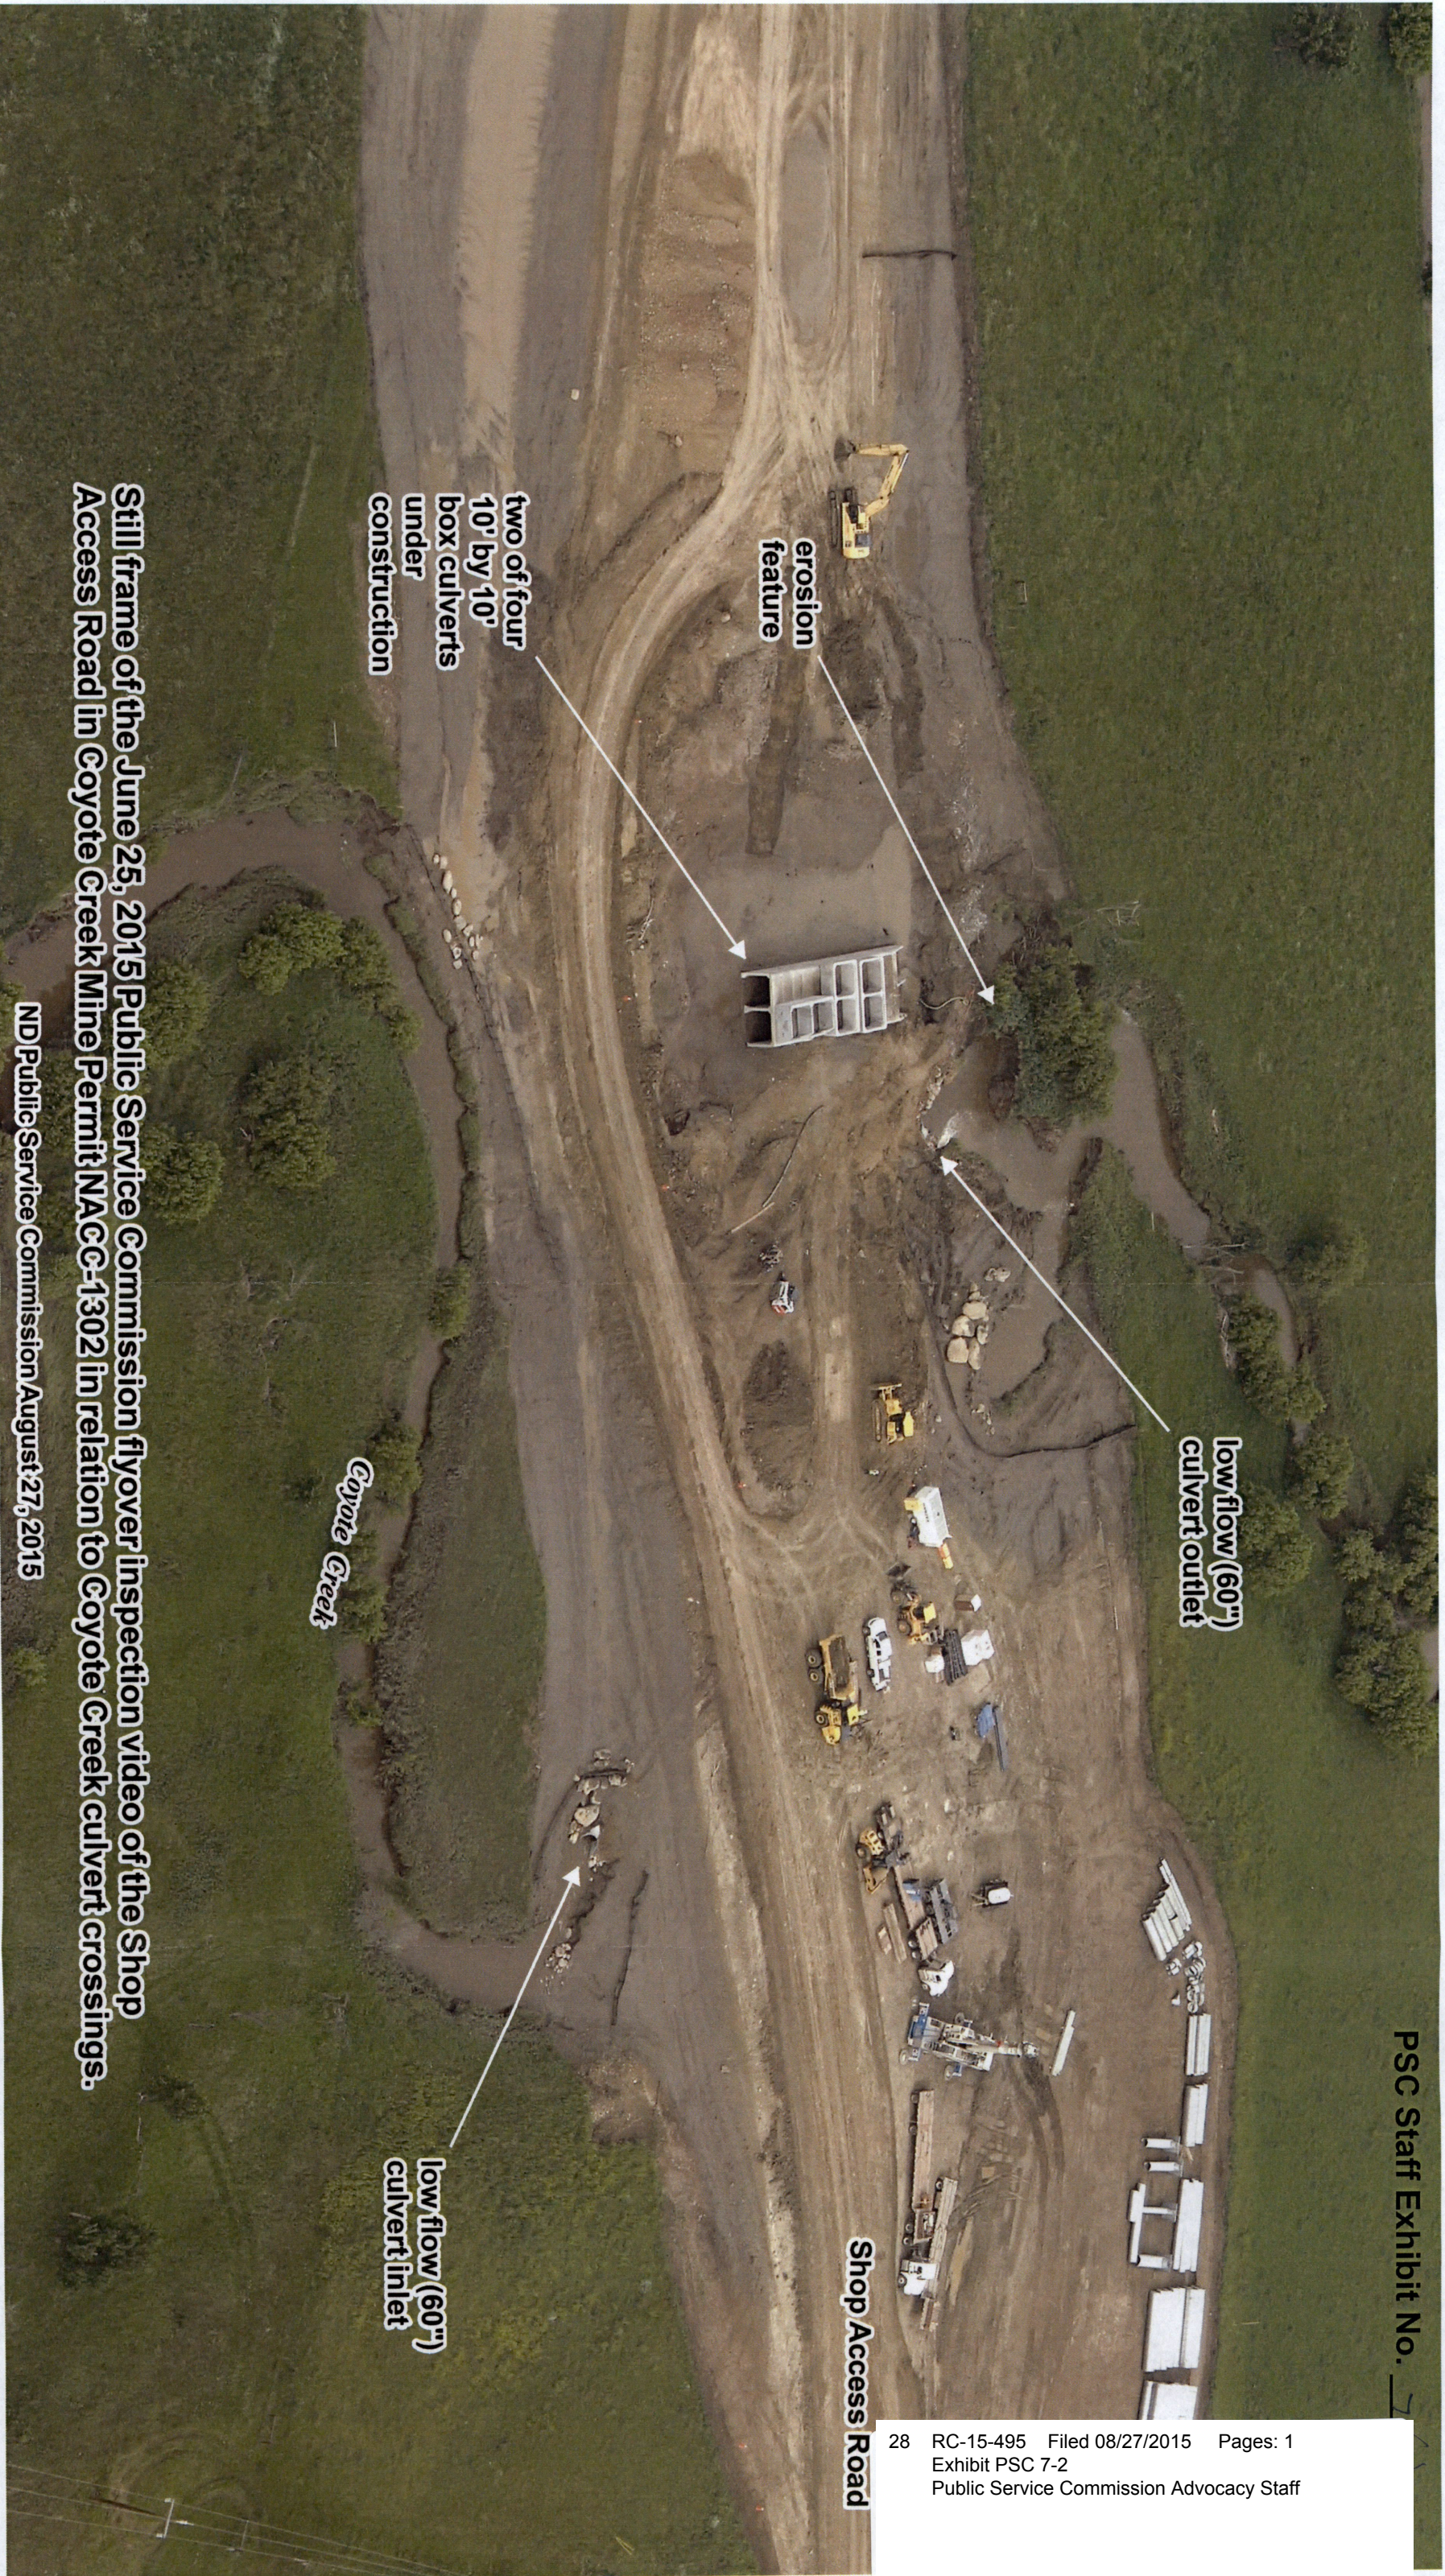
two of four
10' by 10'
box culverts
under
construction

erosion
feature

low flow (60")
culvert outlet

Shop Access Road

low flow (60")
culvert inlet

Coyote Creek
